2007 Annual Inspection of the Monticello Mill Tailings (USDOE) and Monticello Radioactively Contaminated Properties Sites

December 2007

Office of Legacy Management

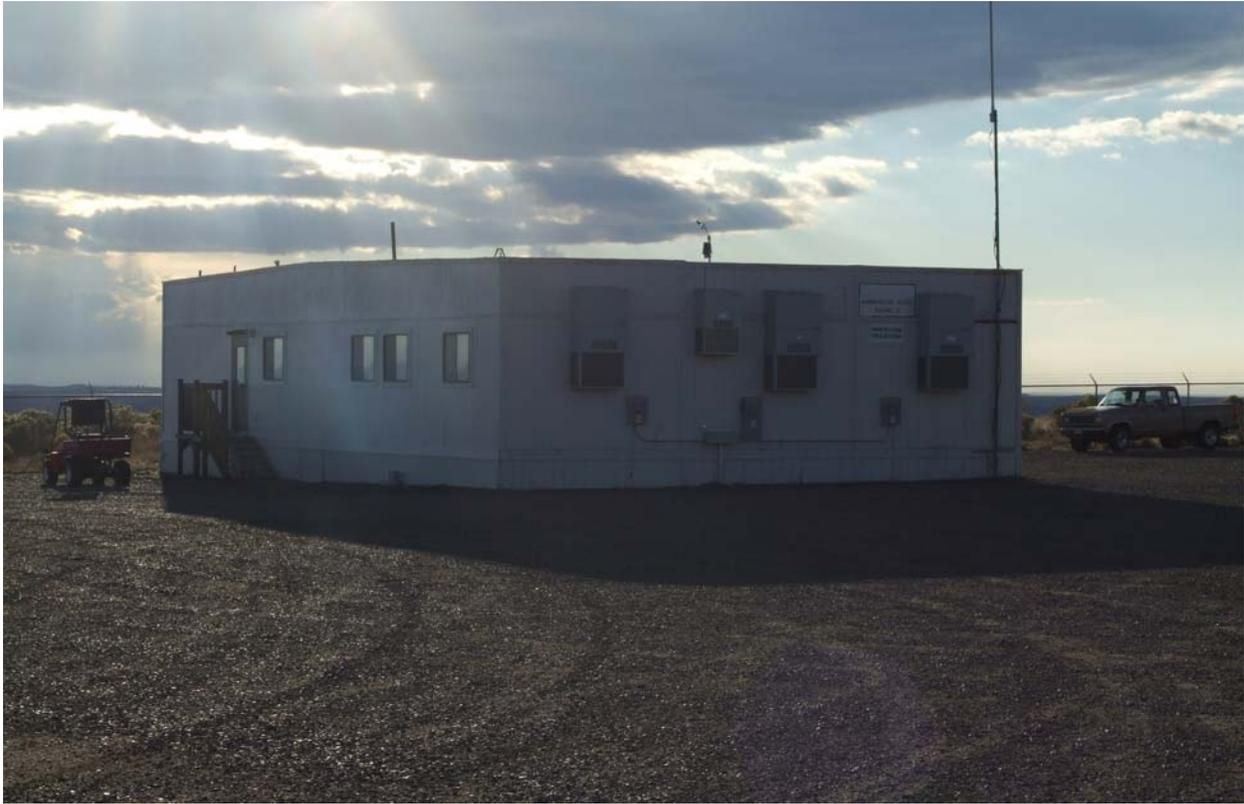
1. DOE-LM Monticello field office.

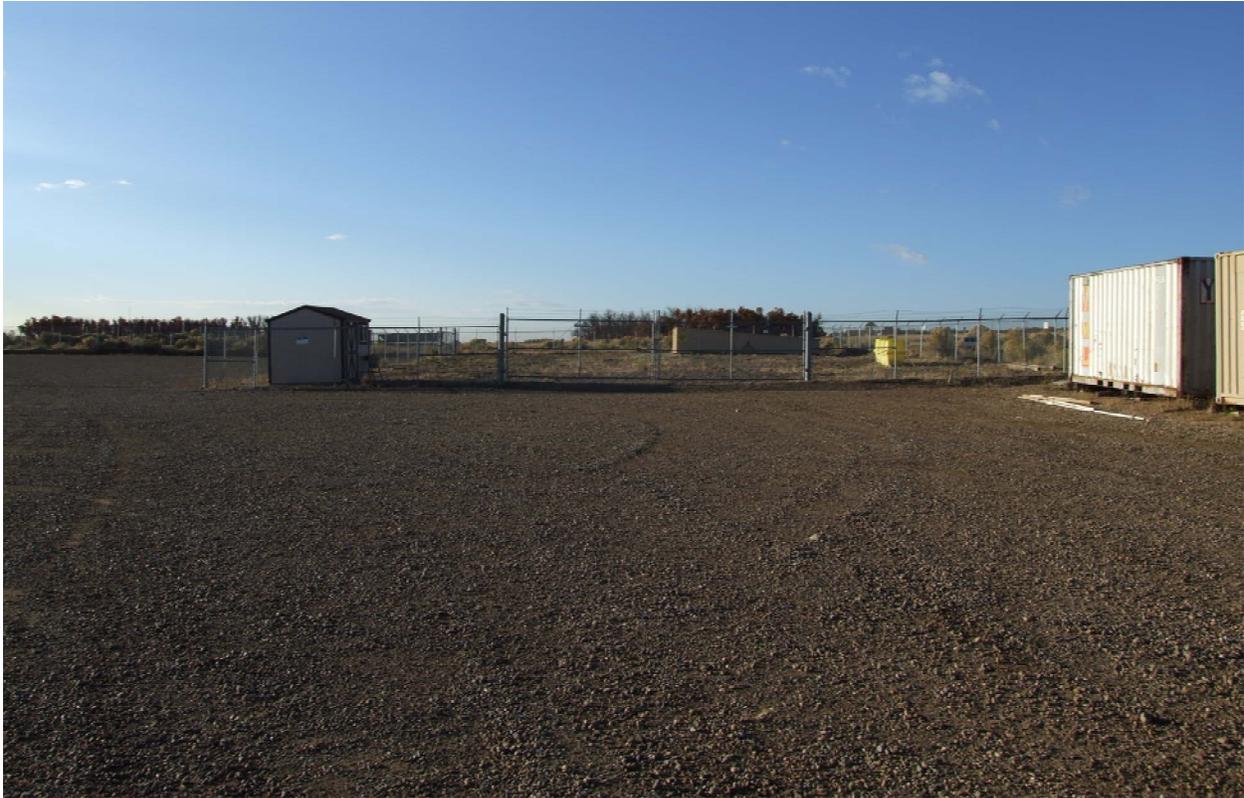
Other contents of the TSF are empty storage drums and secondary containment vessels for temporary storage of mixed or suspected mixed waste, and a small shed containing tarps and miscellaneous tools required for work in the TSF. Steel drums have been discarded and are being replaced with polyethylene drums.

2. On-site TSF (behind fence). Covered bin toward back of photo.

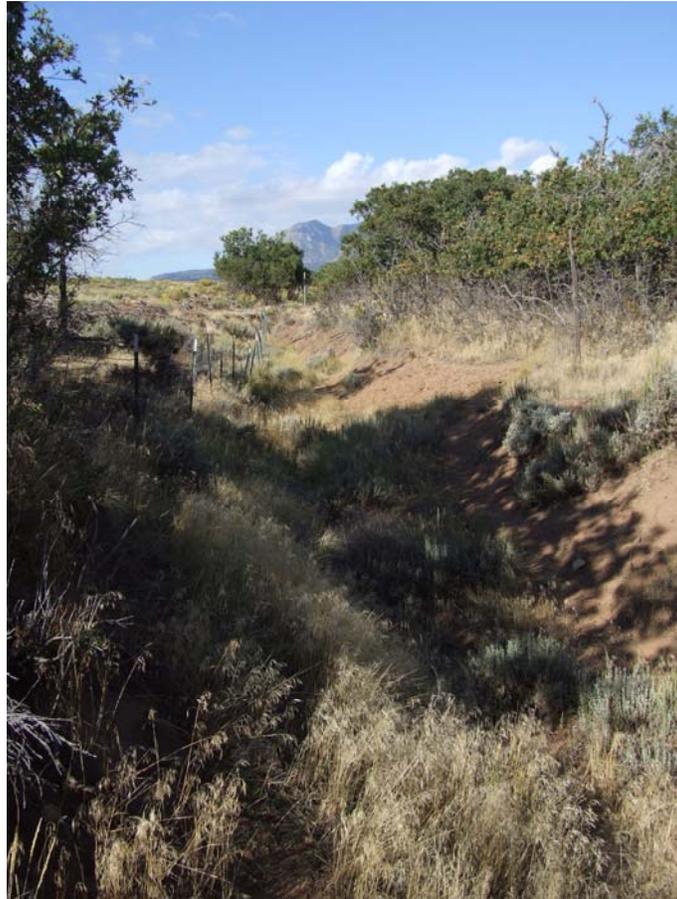
3. Perimeter fence crossing ravine along south boundary of repository site.

Action Item: On-site staff will monitor the fence sections at the noted gully and ravine during routine inspection and will repair collapsing sections of fence as needed.

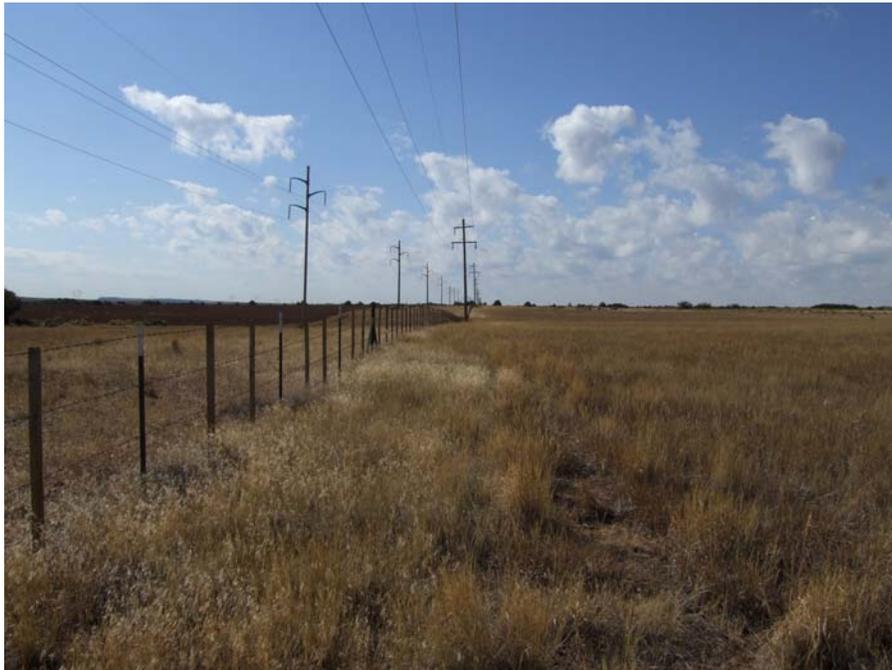
No section of the fence or gate requires repair.

4. Perimeter fence along east boundary of repository site.

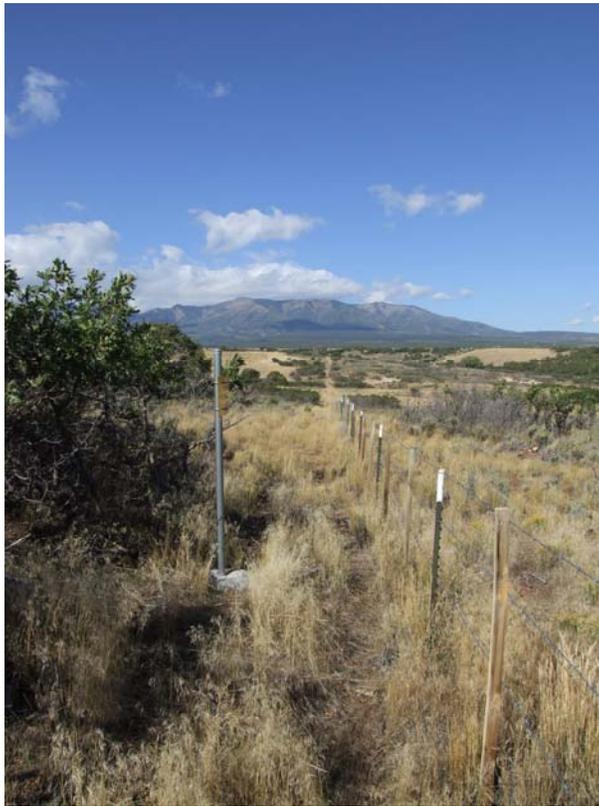
5. Perimeter fence along north boundary of repository site.

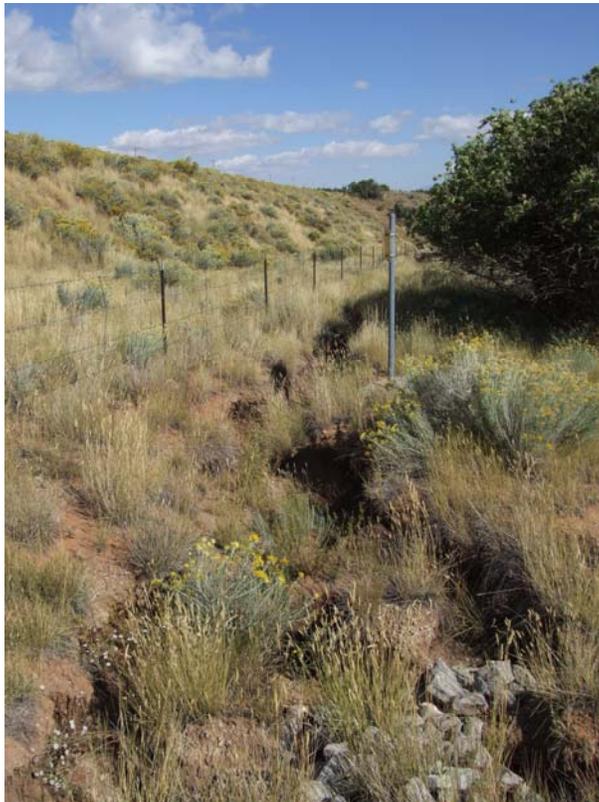
6. Erosion channel along west section of repository perimeter fence.

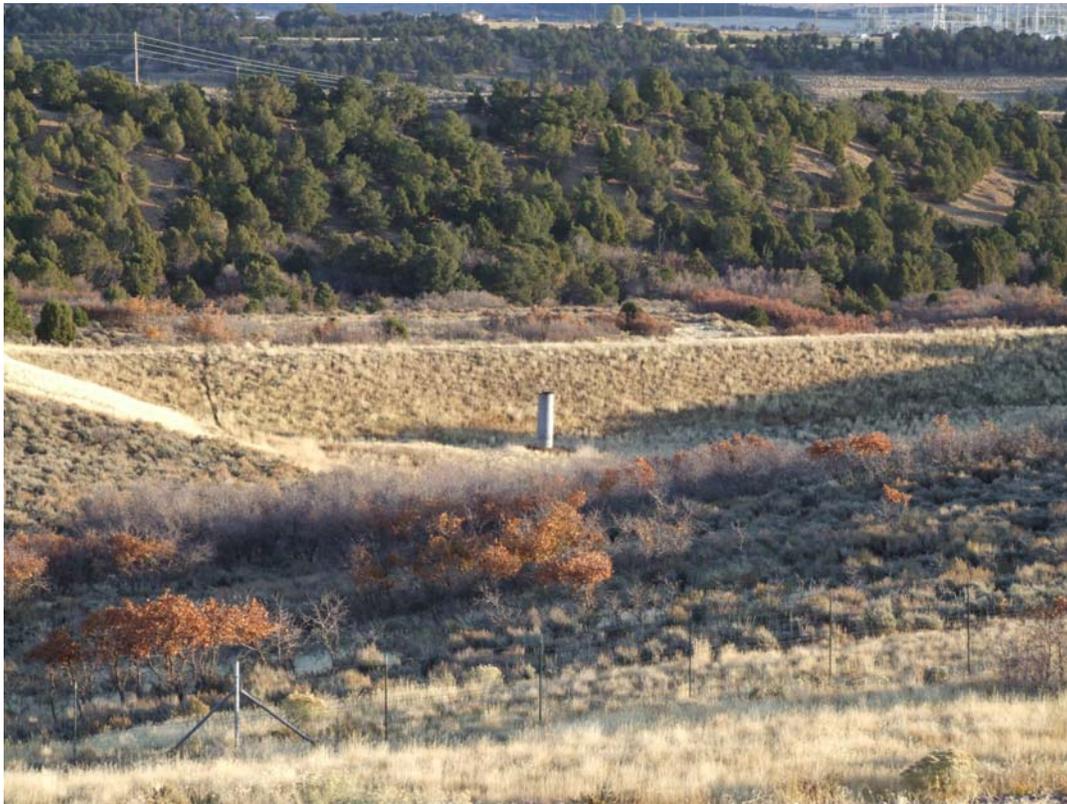
No water was observed in Sediment Pond A, B, or C. There was no evidence of water reaching the spillways, and each spillway was intact. Trash lids capping the standpipes were intact, and the standpipes remain in a vertical position. Sediment accumulation is minor. Pond interiors are absent of debris and noxious weeds.

7. Sediment Pond A.

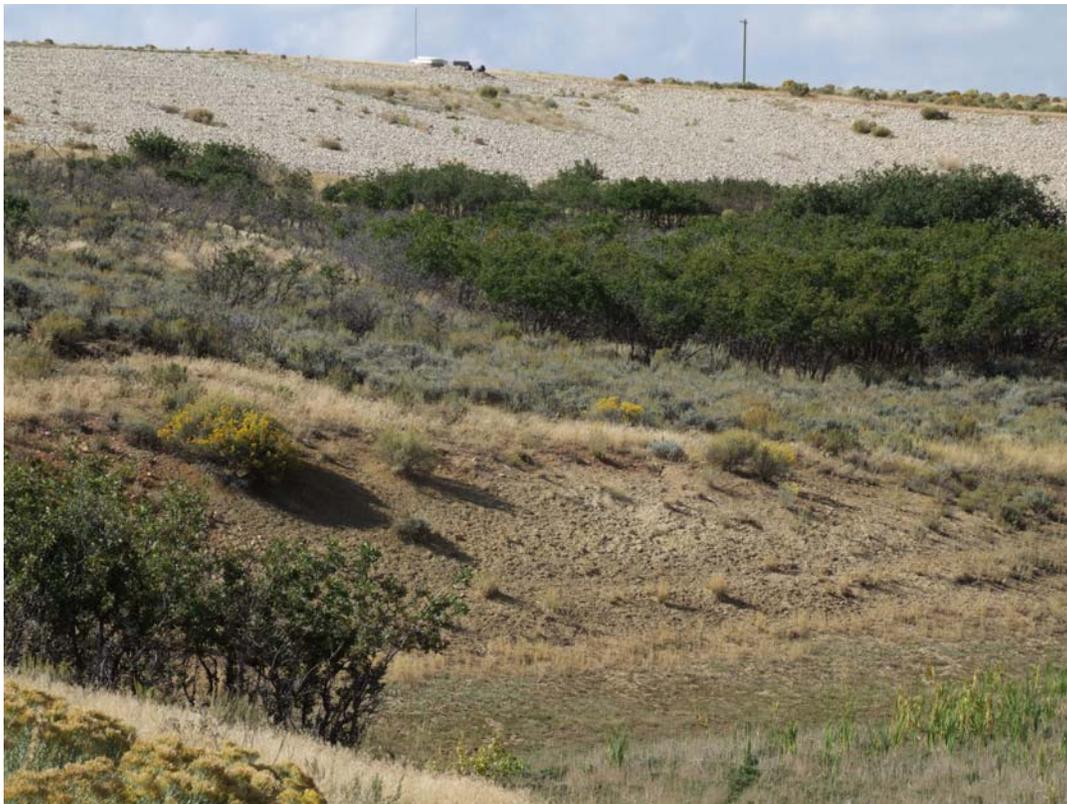
Previously noted minor gully erosion on the inside of the south berm of Sediment Pond A remains stable. Previously noted minor gully erosion on the inside of the south berm of Sediment Pond B remains stable. Berm repair is not needed at this time.

8. Sediment Pond A, south berm.

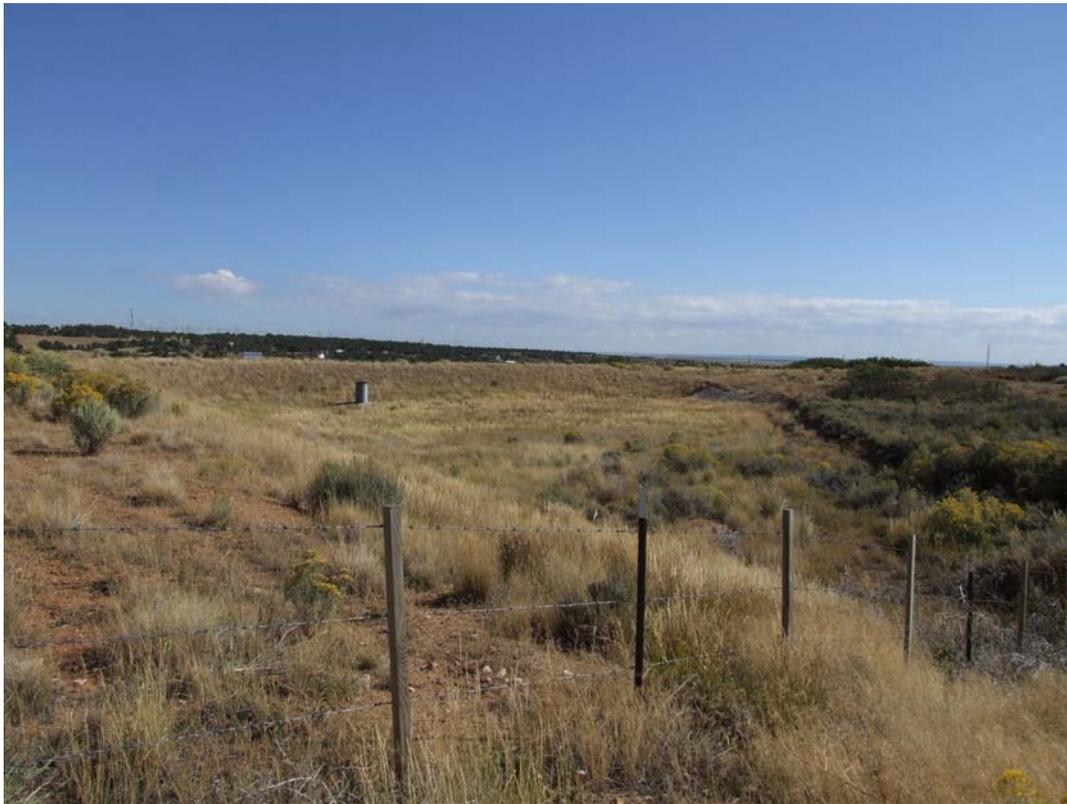
Sediment Pond B is located outside of the repository perimeter fence. The fence around Sediment Pond B does not require repair.

9. Sediment Pond B.

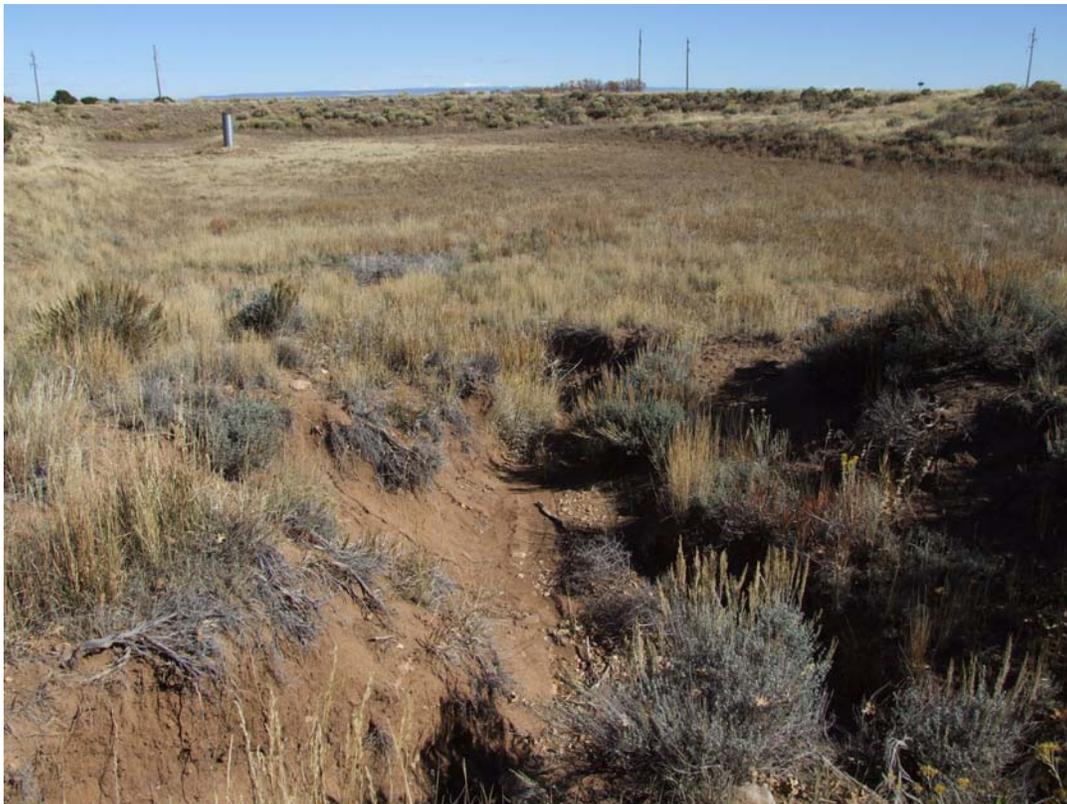
The 2004 inspection noted that the drain at the inlet to Sediment Pond C was not effective in directing runoff to Sediment Pond C. DOE reconstructed the portion of this drain between the inner fence and Sediment Pond C in September 2005. The drainage is now effective in directing flow to Sediment Pond C.

10. Sediment Pond C.

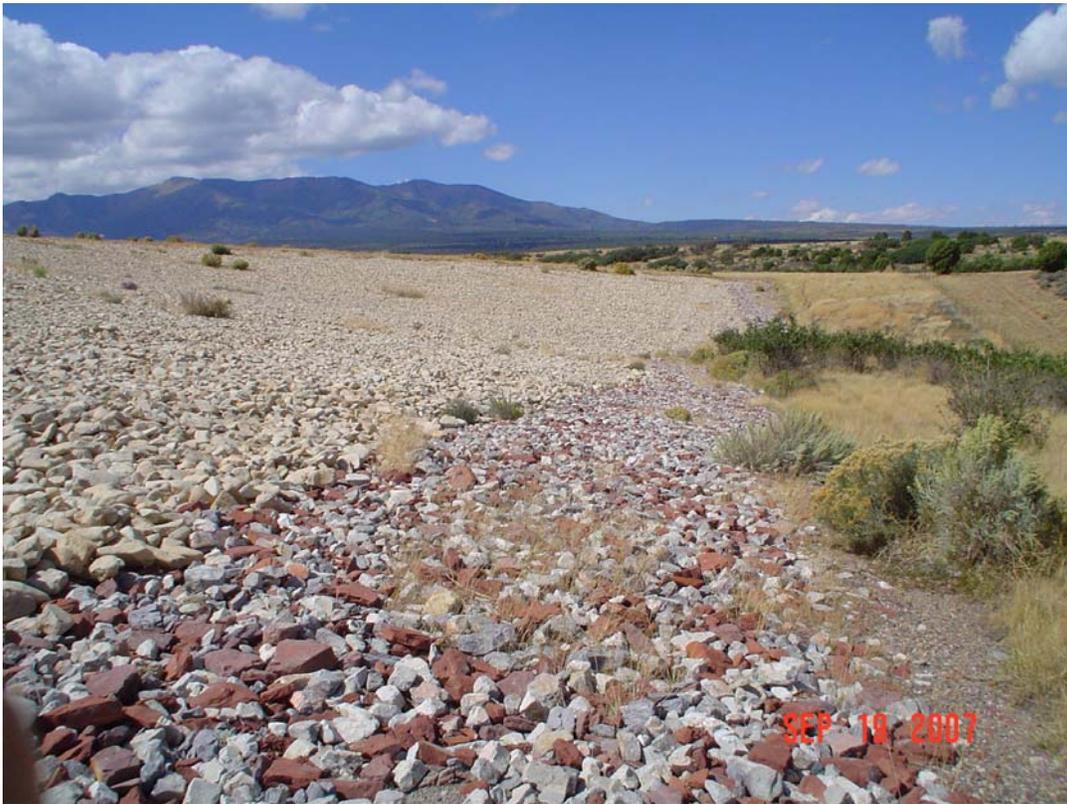
These features are rock-filled trenches that were constructed to capture runoff and subsequently direct water away from the cover in the subsurface. Rock at the surface of both toe trenches is degrading, windblown sediment is accumulating at the surface, and vegetation is becoming established. Erosion or bypass of these trenches is not evident. High-durability rock is stockpiled at the site to overlay the trenches should erosion or bypass occur. The toe trenches are not presently in need of repair.

11. North Toe Trench (rock-filled trench at base of rock slope).

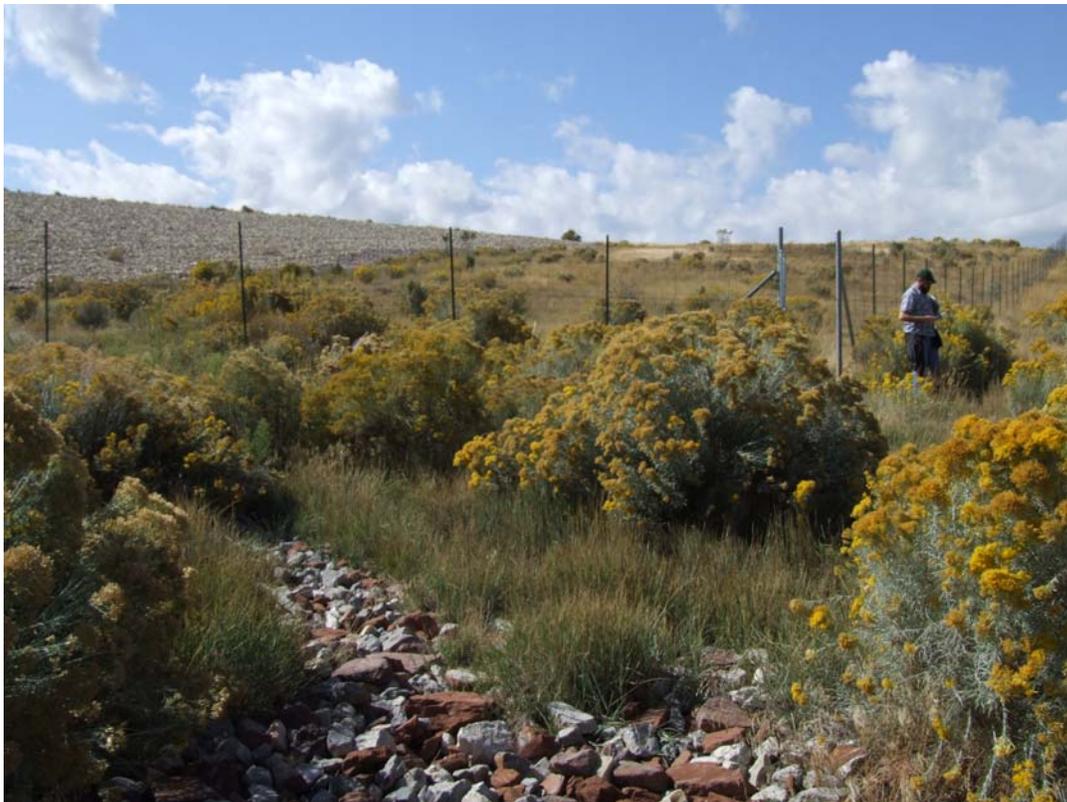
All sections of the inner fence and gates are in working condition. There is no evidence of vandalism or damage. The wildlife gates were open to provide access to wildlife.

12. Near western terminus of North Toe Trench. Inner fence with open wildlife gate in foreground.

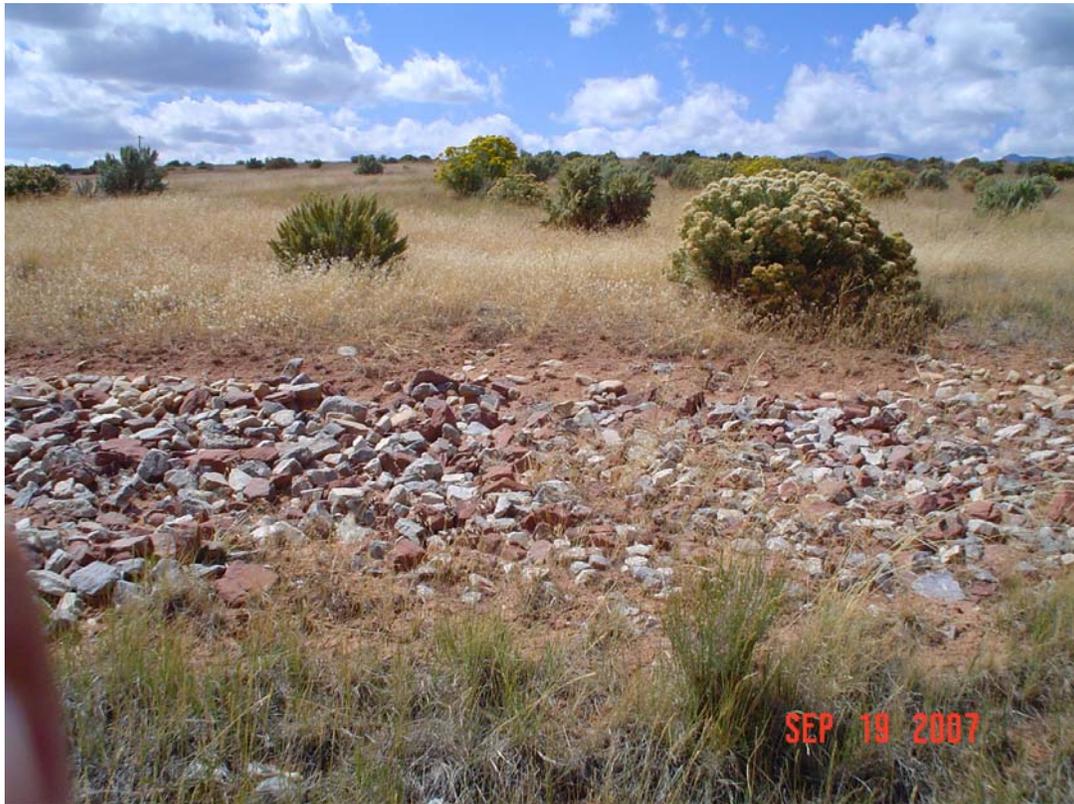
13. East Toe Trench.

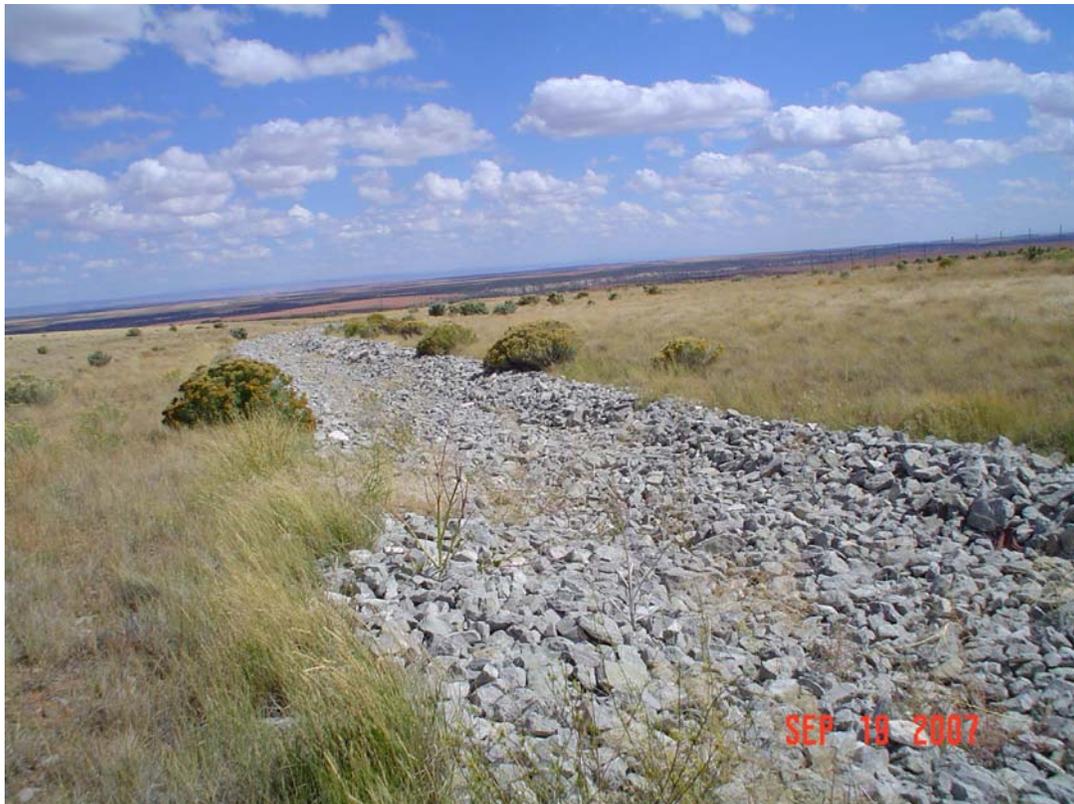
14. South Drain Ditch.

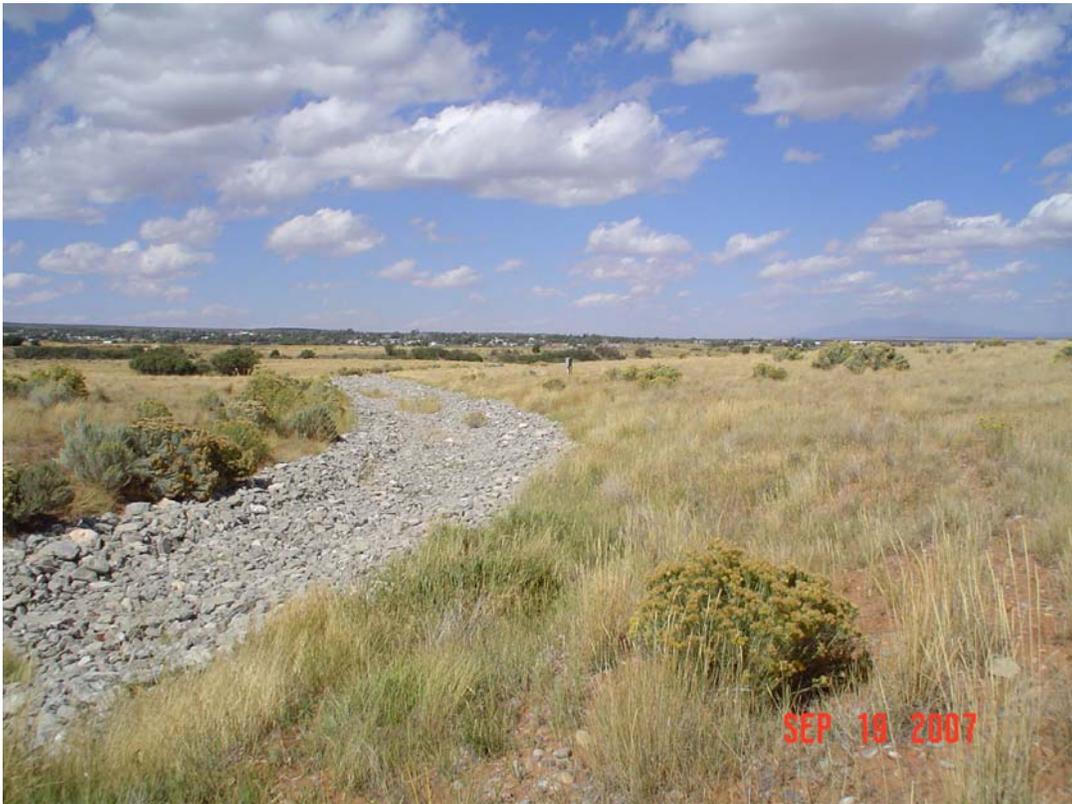
The West Drain Ditch was lined with high-durability rock in July 2002 after deterioration of the original rock was noted in the 2001 inspection. That inspection also noted significant erosion in the steep part of the drain immediately north of the inner fence. The erosion was repaired and rock lining of the channel was extended to North Draw in September 2002. The West Drain Ditch is not in need of repair at present.

15. West Drain Ditch.

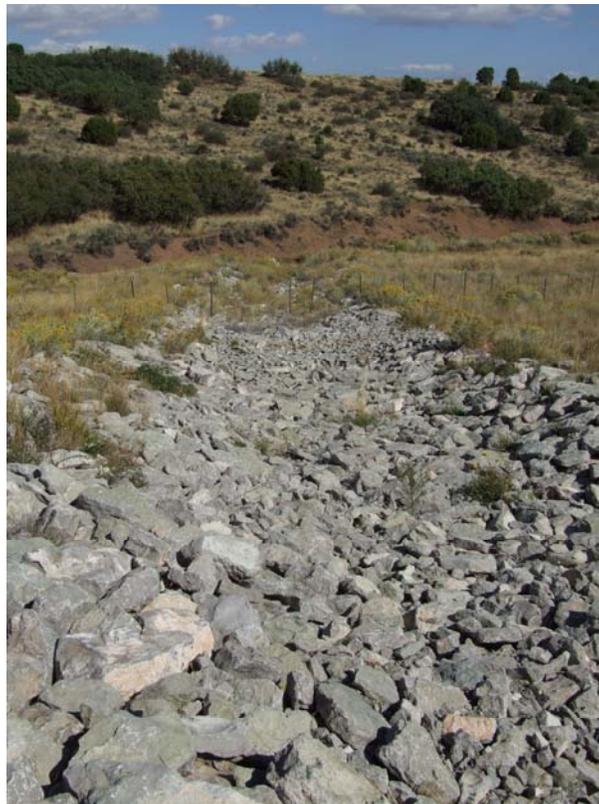
16. View of West Drain Ditch terminus at North Draw.

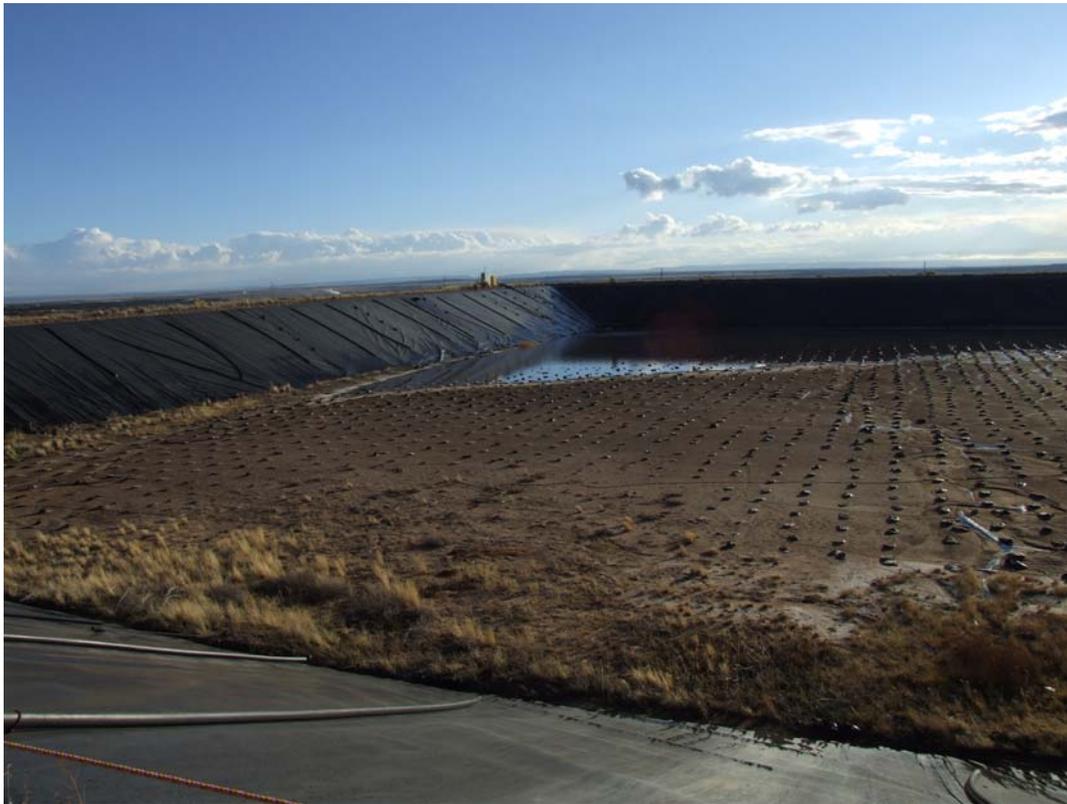
No holes or evidence of holes in the pond liner were observed. The original sandbag anchor system constructed to prevent billowing has since deteriorated. Installation of a replacement system using sand-filled, 3-inch-diameter polyethylene pipe was completed in 2007.

The northeast corner of the pond contains several inches of water. Several inches of windblown silt and sand covers much of the pond floor. Tamarisk plants in these deposits were last eradicated in 2005. No tamarisk was observed in Pond 4 during the 2007 inspection.

17. Pond 4.

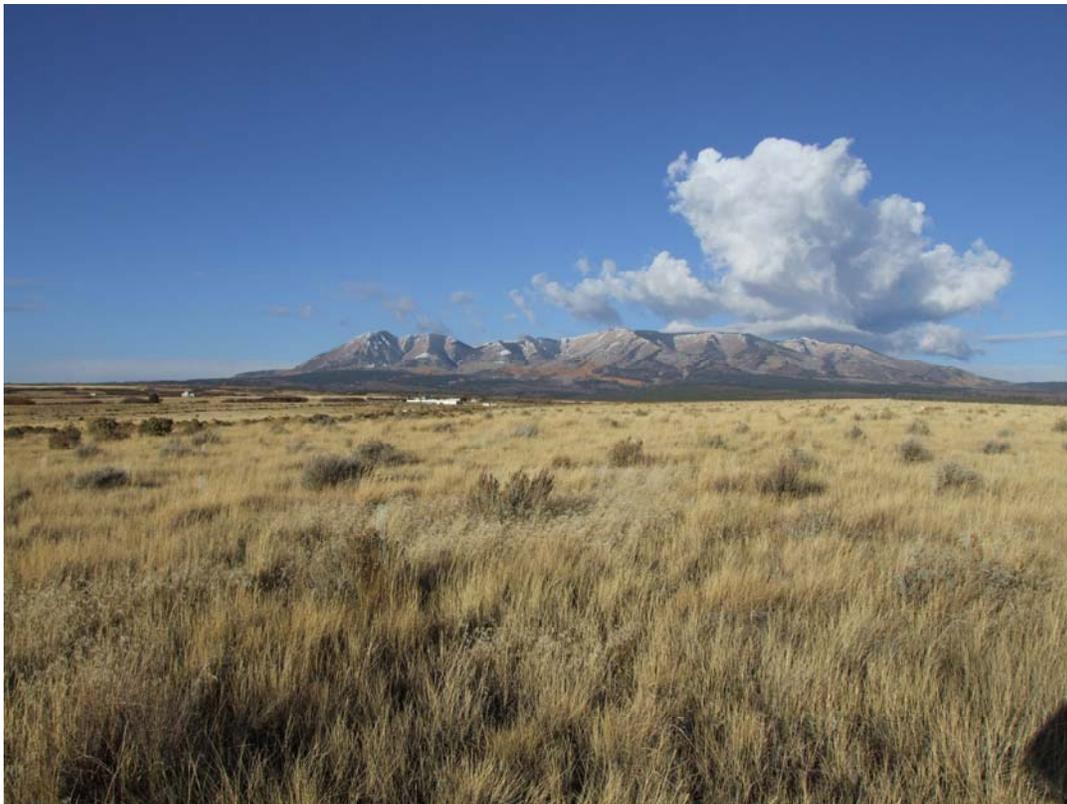
No area of the cover indicated settling, slumping, fracturing, seepage, or significant erosion.

18. Disposal cell cover. Field office in background.

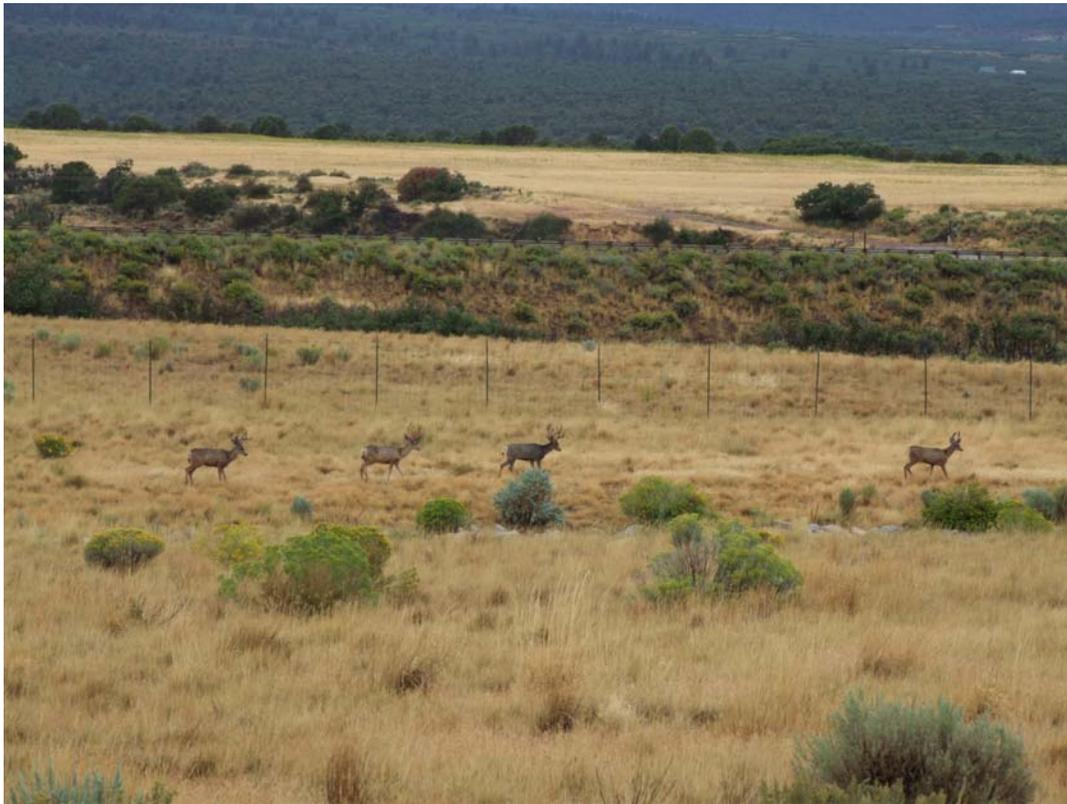
19. Mule deer on disposal cell cover.

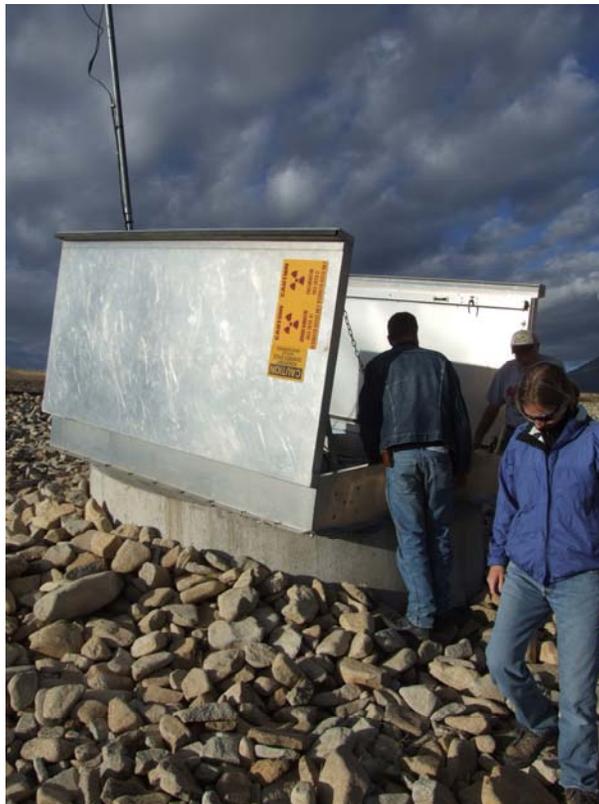
On-site staff demonstrated that Manholes 1 and 3 surface components are in working condition. Manhole interiors are not entered during the annual inspection. The interior of Manhole 3, observed from above ground, was in good condition and free of unnecessary tools, equipment, or obstacles.

20. Disposal cell Manhole 3.

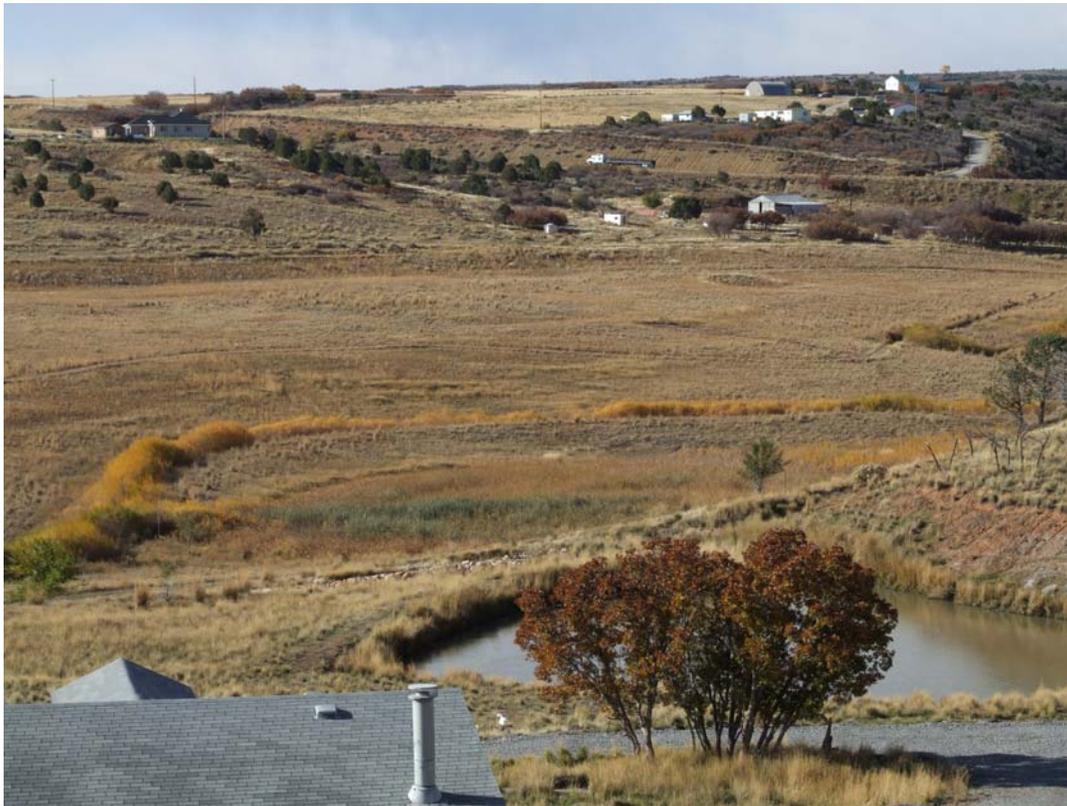
During the 2007 inspection, the creek channel and wetlands showed no evidence of damage by human activity or excessive alteration by natural cause. The wetlands and riparian zone are ecologically healthy. Willow growth is dense along the banks of Montezuma Creek, and cattails, rushes, and sedges are dominant plant species in the wetlands although some tamarisk (or salt cedar, a Utah and San Juan County-listed noxious weed) is present. Wildlife use of the wetlands and riparian zone is very common.

21. Overlooking restored millsite. Wetland 2 and willows along Montezuma Creek are visible below Steele's Pond in foreground.

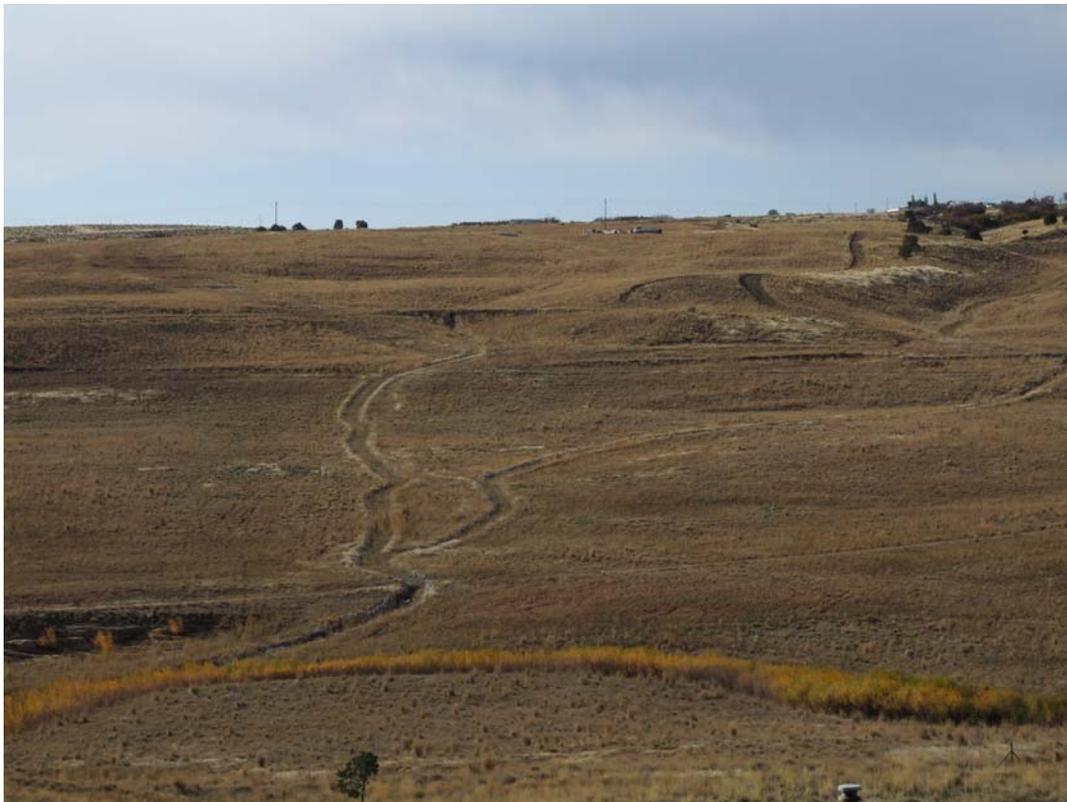
22. Drainage control on south side of former millsite.

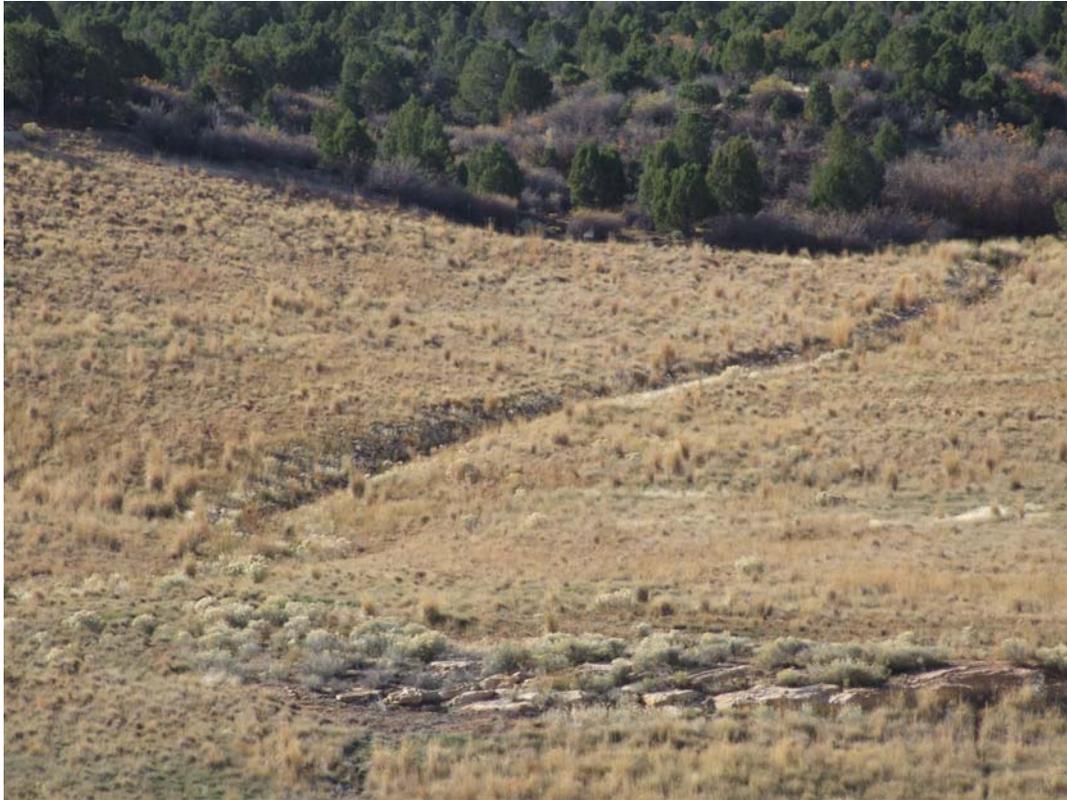
Undercutting of several fence posts by runoff was observed near the mouth of Deer Draw. All remaining fencing that encloses the supplemental standards areas of these properties was intact during the 2007 inspection.

23. Drainage control at terminus of Deer Draw.

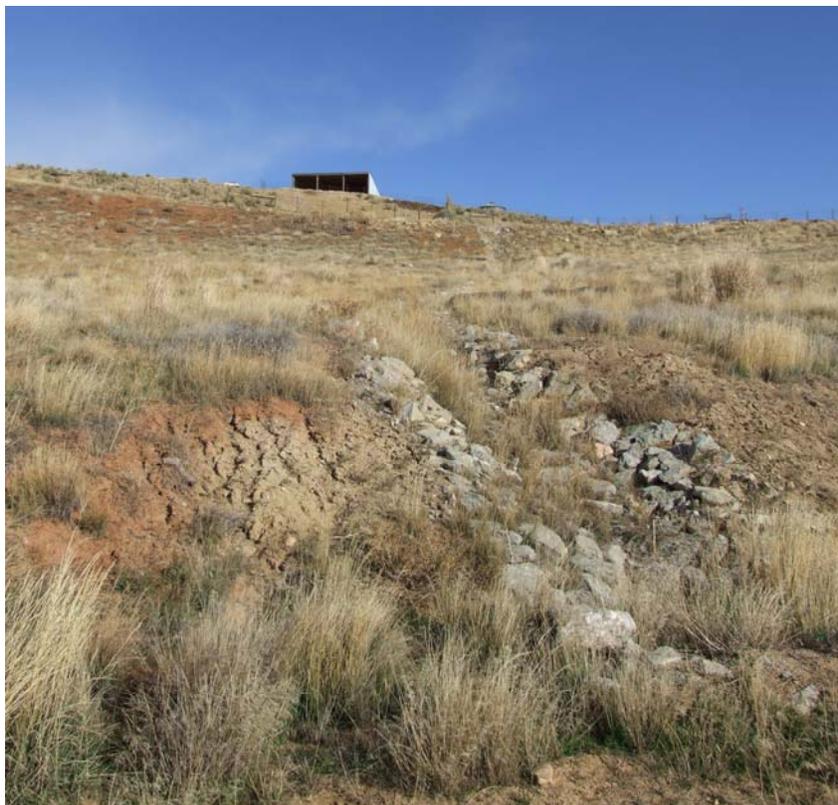
24. Drainage control on north side of former millsite (below stockyard).

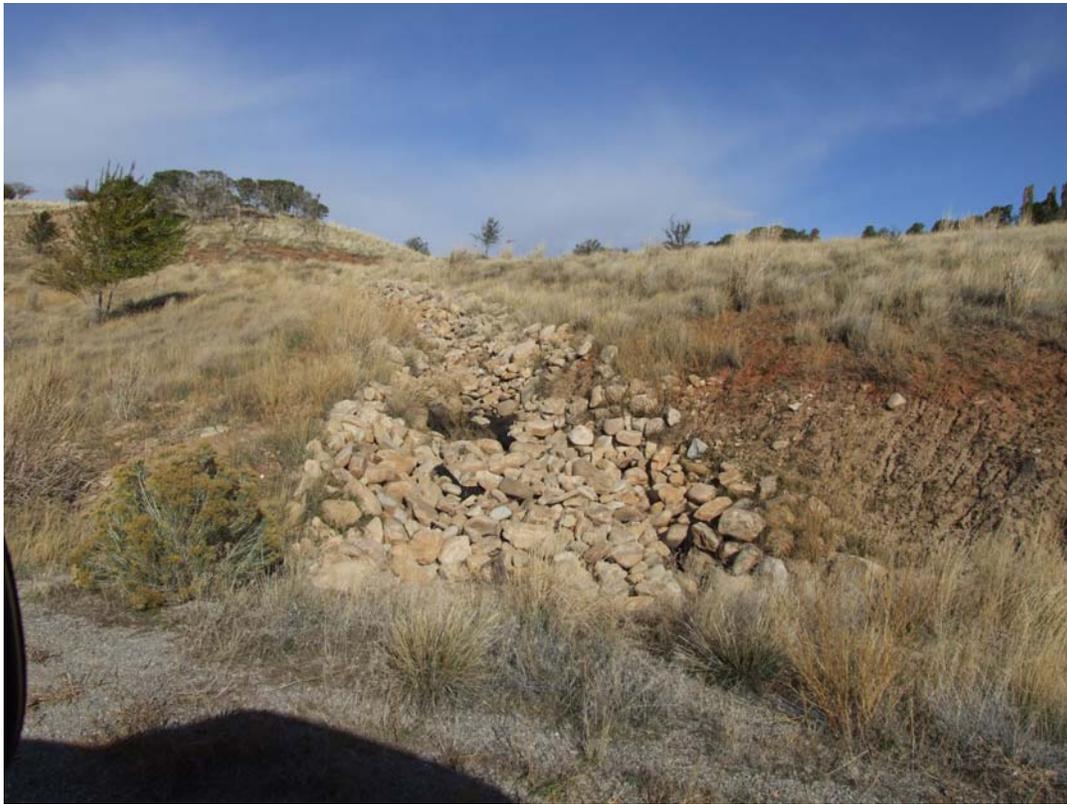
25. Drainage control from Steele's Pond. Washout exposes geotextile beneath riprap.

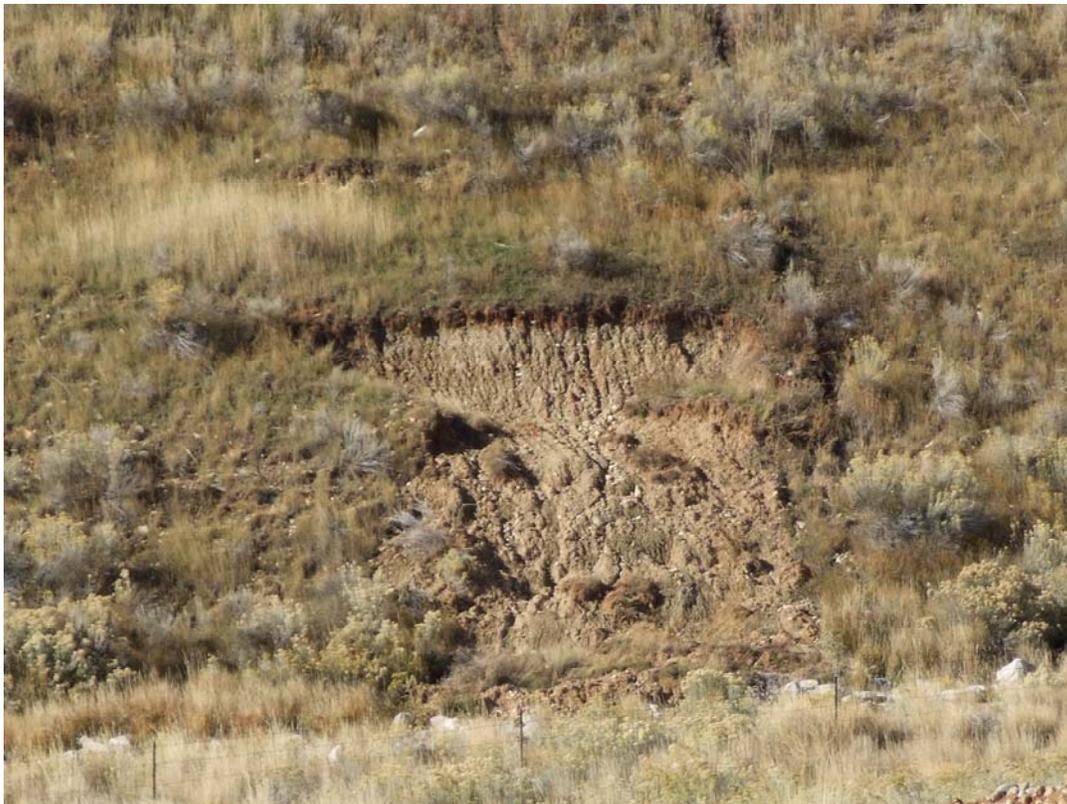
26. Slump on highway embankment on property MP-01081.

- On-site staff will secure the video ports with locks.
- On-site staff will conduct radiological scanning of eroded soil on property MP-00181-OT near the embankment of Highway 191.
- On-site staff will conduct radiological scanning on the bike path from the top of the hill on property MP-01077-VL Phase II to the old haul road on property MP-01077-VL Phase I.
- On-site staff will clear the accumulated weeds at the inlet of Sediment Pond C.
- New drums will be placed in the TSF to replace the recently discarded steel drums.
- Location coordinates will be obtained for the raptor perches and cover-study test pits installed (and backfilled) in July 2007.

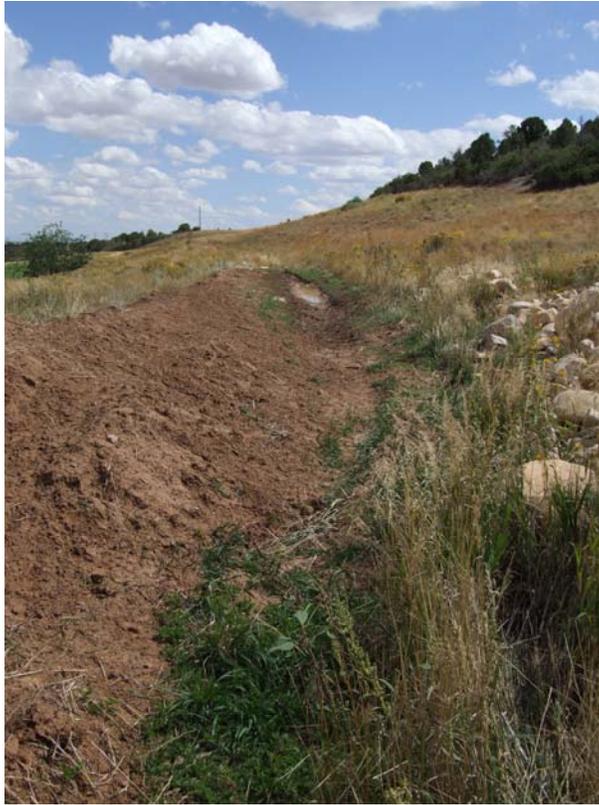
- The 2006 noted that a portion of the ditch along the northwest edge of MP-01077 Phase I (former haul road) had filled with sediment. This ditch is down slope of supplemental standards property MP-01077 Phase II. On-site staff had determined that the sediment was not radiologically contaminated. The City responded to land-owner concerns of potential damage to property MP-00179 by removing excess sediment from the ditch and improving the ditch in August 2007.

27. Repaired section of ditch separating properties MP-00179 and MP-01077 PH I.
