2007 Annual Inspection of the Monticello Mill Tailings (USDOE) and Monticello Radioactively Contaminated Properties Sites

December 2007

Office of Legacy Management

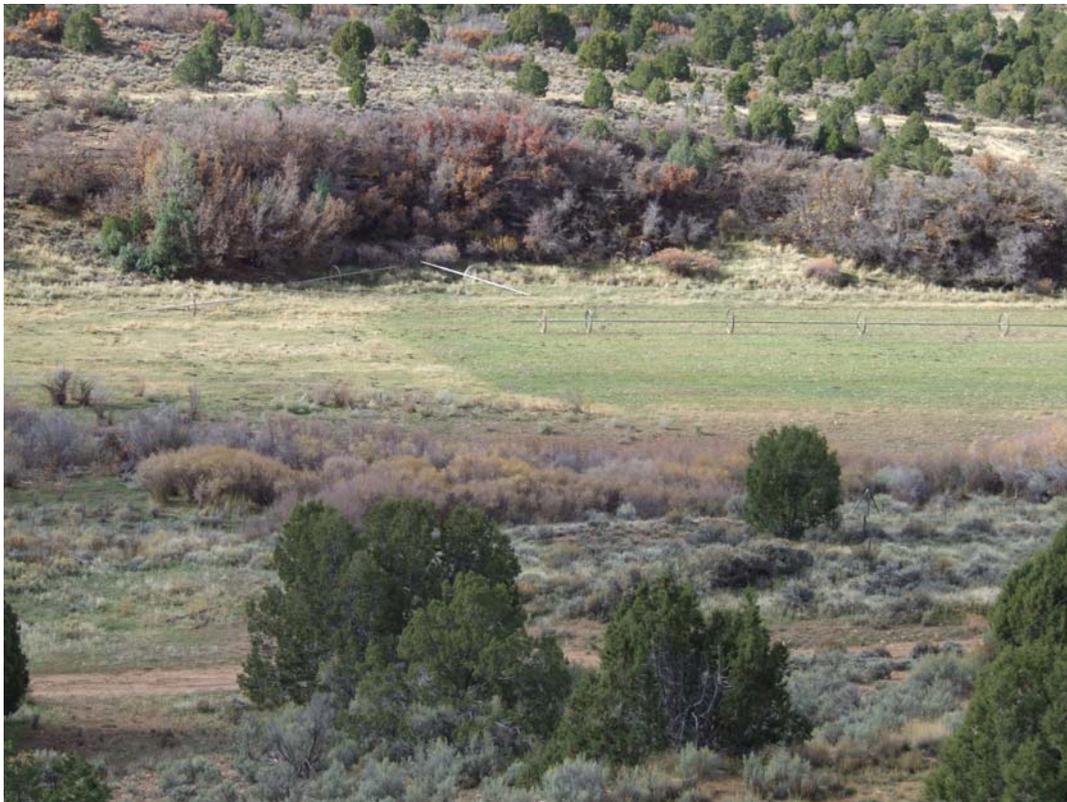
28. Montezuma Creek valley in supplemental standards area. Creek is willow lined in foreground.
