**2008 Annual Inspection of the  
Monticello Mill Tailings (USDOE)  
and  
Monticello Radioactively  
Contaminated Properties Sites**

**December 2008**

**U.S. DEPARTMENT OF  
ENERGY**

Office of  
Legacy Management

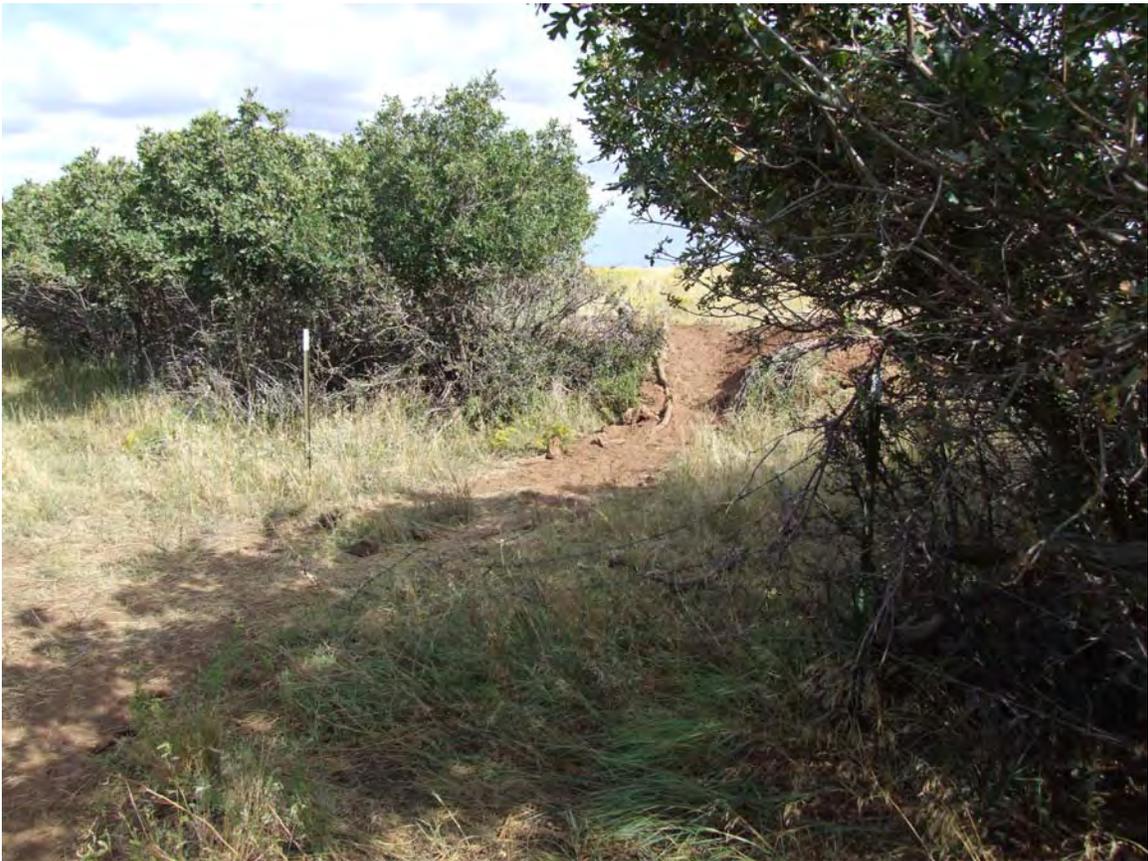
Approximately 25 percent of the perimeter fence, located along the south edge of the repository site, is damaged from winter snowfall and livestock activities (Photo 1). Cattle from the adjacent property have regularly crossed the broken fence onto the repository property (Photo 2). Because of the extent of the damage, replacement of this portion of the south perimeter fence is recommended. Between perimeter signs P25 and P26, a fence post appears sunken because of siltation. Replacing the fence will correct this problem, but the area will continue to be monitored. A slack area exists in the perimeter fence near perimeter sign P15 that also requires repair. A slack area also exists between perimeter signs P32 and P33 but does not compromise fence integrity at this time.

1. Damaged outer fence near perimeter sign P27; Cattle trail from adjoining Johnson property

**Action Item:** DOE will hire a subcontractor to replace portions of the perimeter fence along the south edge of the repository site. The new fence will be designed to better withstand livestock pressure. Minor fence repairs at perimeter sign P15 also will be performed.

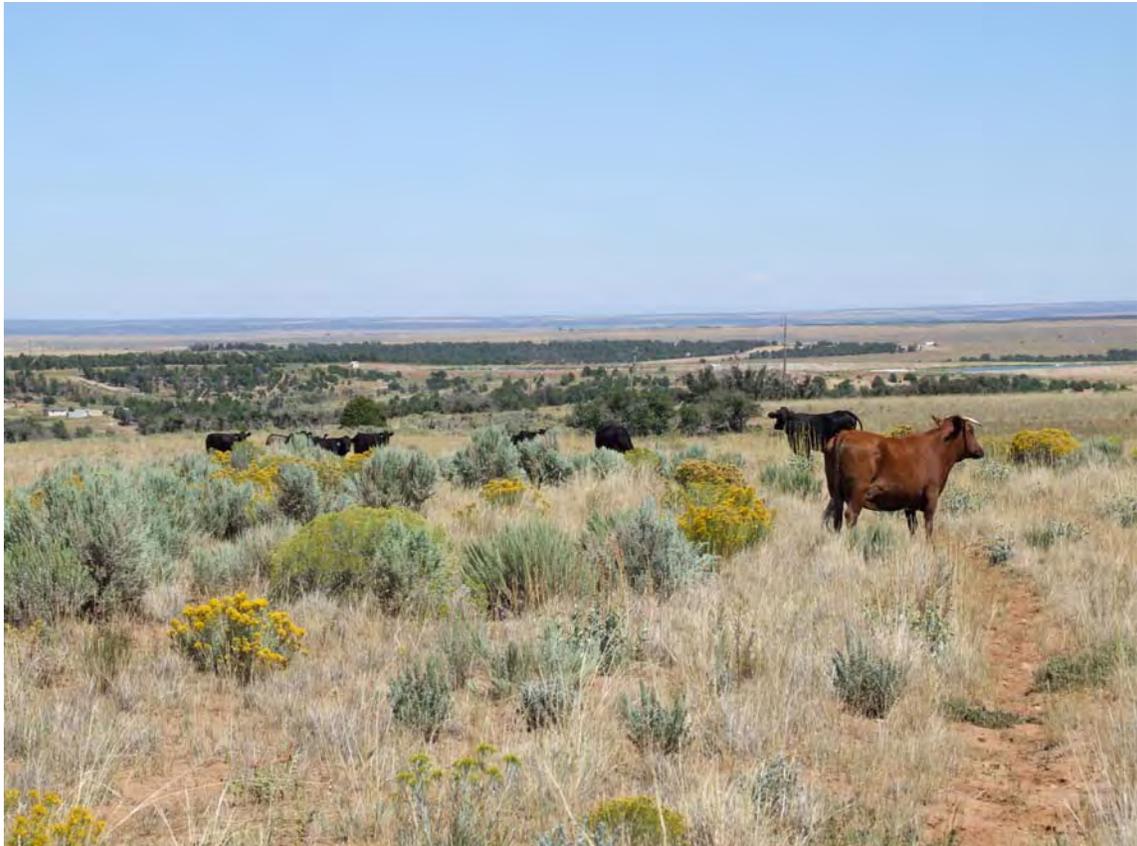
2. Cattle grazing (unsolicited) between outer and inner fences

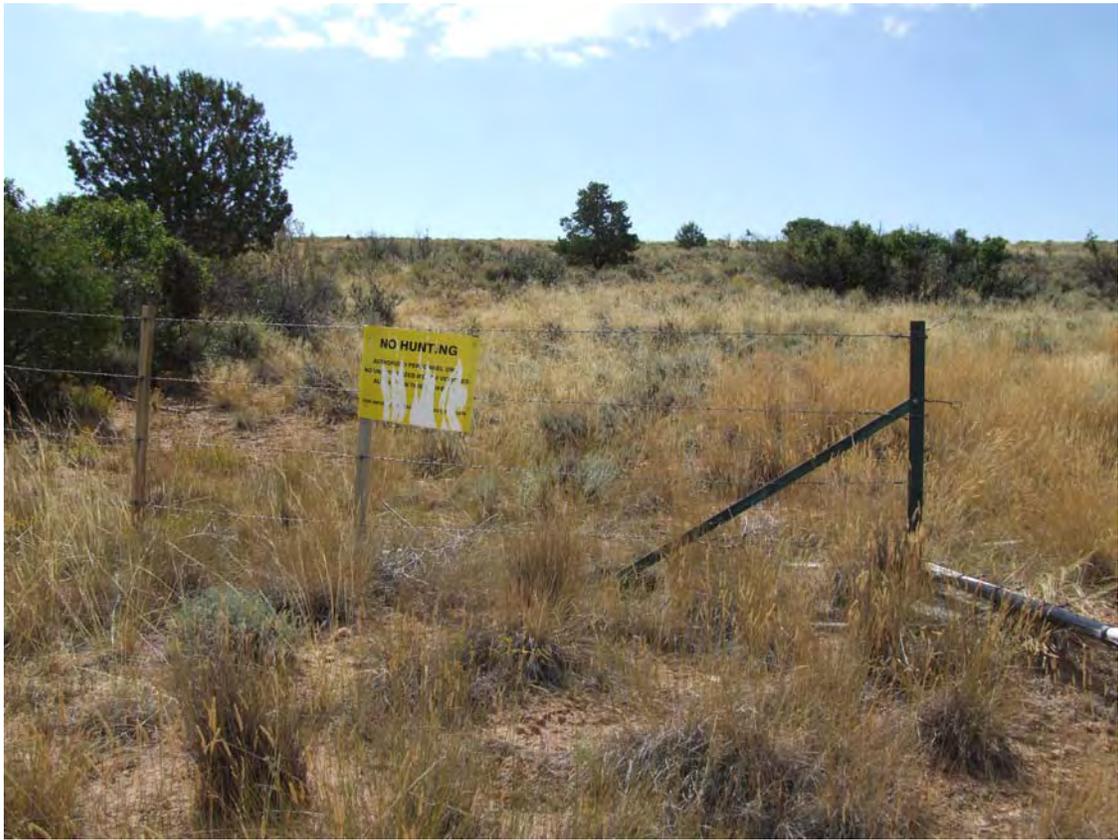
All perimeter gates are in good condition. However, it is recommended that the “No Hunting” signs posted at each gate be replaced, as they are generally illegible (Photo 3). No evidence of vandalism (e.g., bullet holes) is present.

3. Damaged “No Hunting” sign near Sediment Pond B

**Action Item:** “No Hunting” signs will be replaced at all perimeter gates.

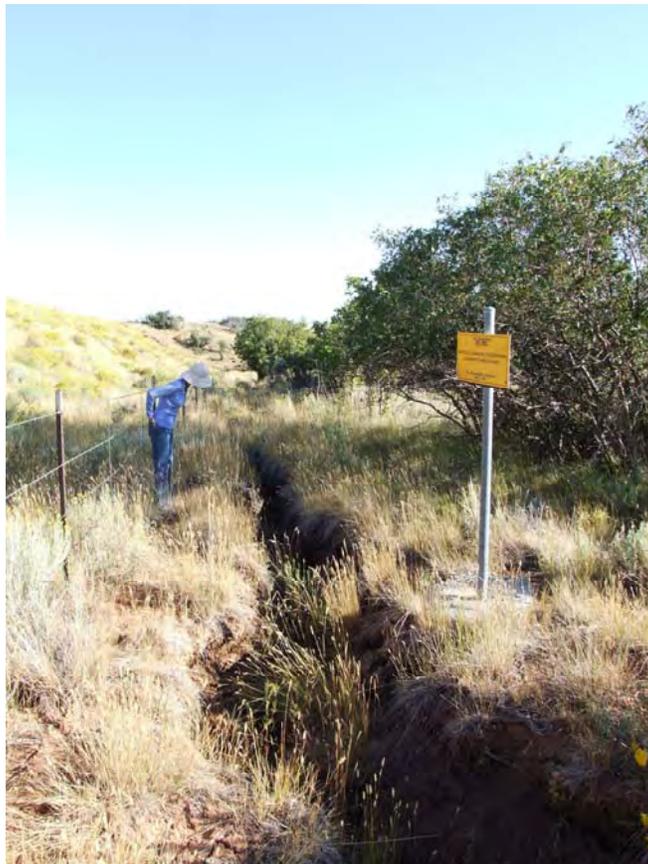
A gully between signs E and P2, described in the 2007 inspection report, has lengthened and deepened, and it continues to undercut fence posts (Photo 4). Relocating the affected posts is recommended to maintain the integrity of the perimeter fence. The gully is formed by storm runoff channeled along the Highway 191 right-of-way to North Draw. It has recently deepened from a water line break at the City of Monticello's manhole located near the site entrance. T. Moon repaired the break shortly after its discovery.

4. Gully in Highway 191 right-of-way along west outer fence

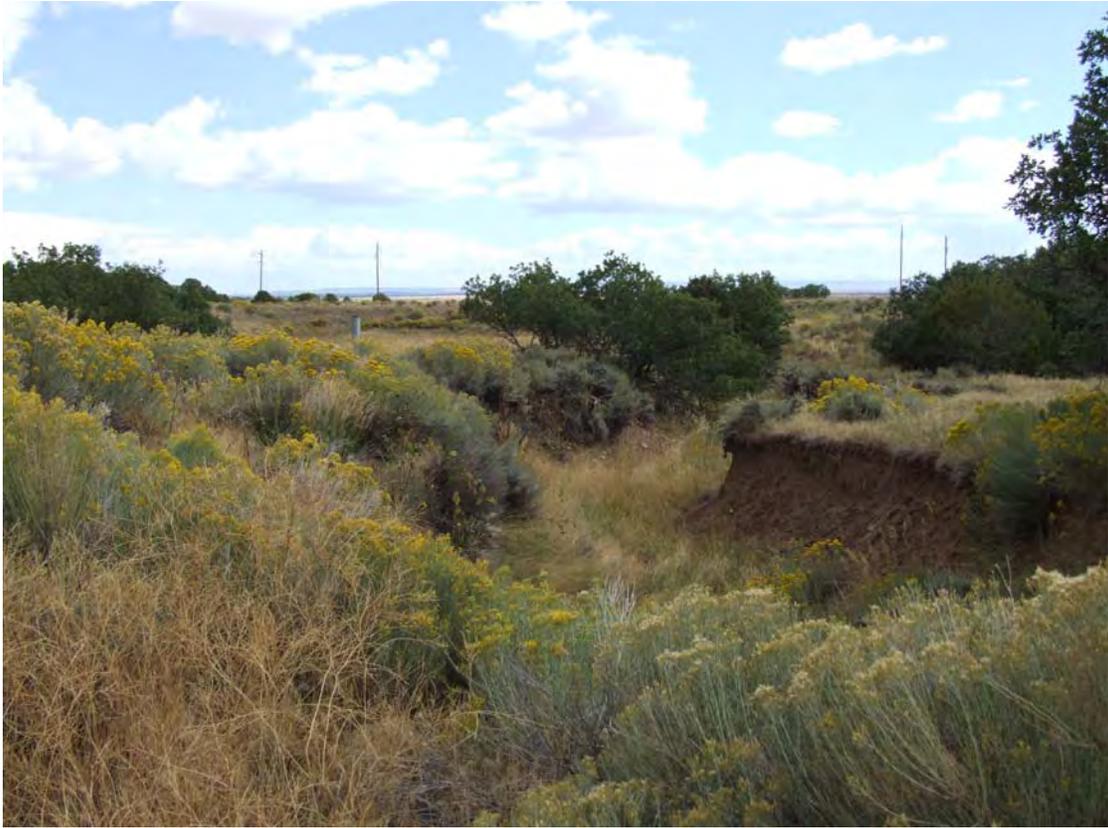
A large gully or small ravine (Photo 5) near sign P26, described in previous monitoring reports, shows signs of additional headcutting. This gully threatens portions of the fence line and it will continue to be monitored. Draws crossing the fence line between perimeter signs P15 and P16 and between signs P8 and P9 will be monitored. Potentially active headcutting was also noted near perimeter signs P31 and P7; these areas will also be monitored.

5. Ravine immediately south of the inflow channel to Sediment Pond C

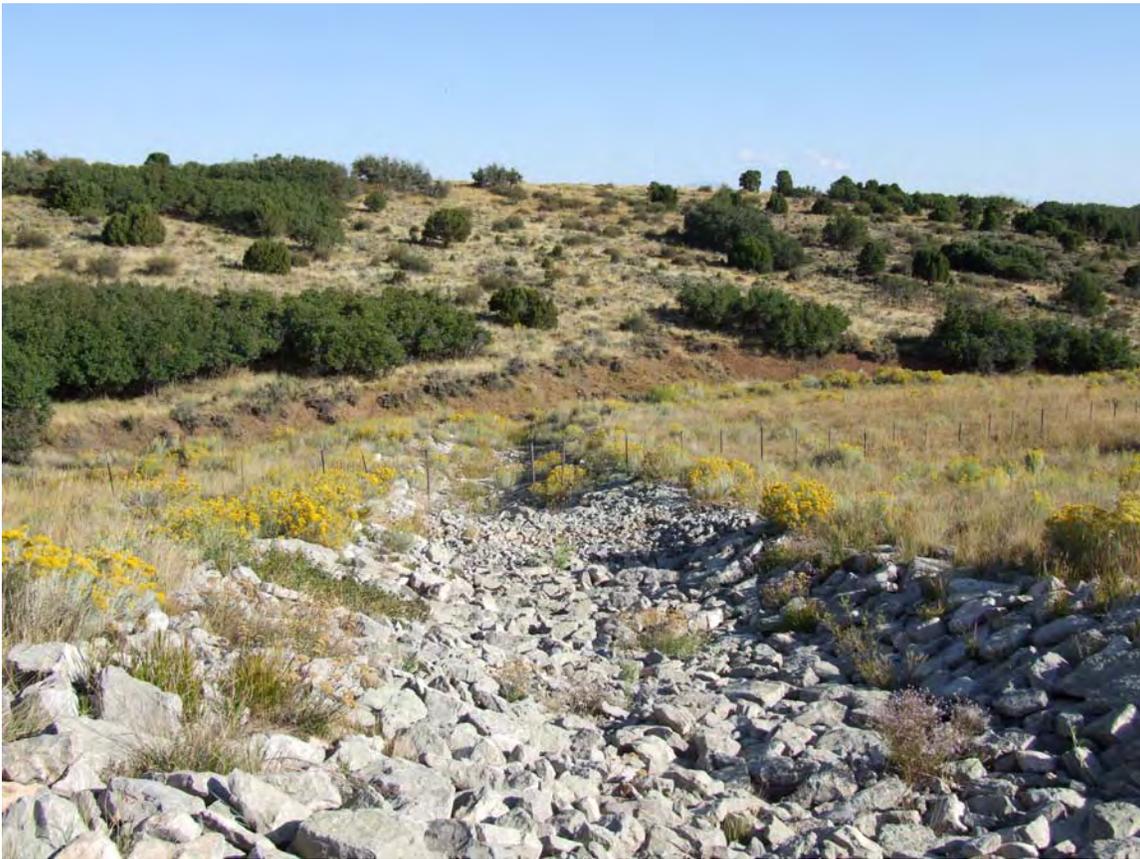
In 2002, eroded areas in the channel immediately north of the inner fence were repaired, and the channel was lined with rock all the way to North Draw (Photo 11). The West Drain Ditch and these repaired sections are in good condition. A small armored gully running into the west side of the West Drain Ditch shows fresh headcutting (Photo 12). It is recommended that this minor headcut be armored with rock to prevent continued erosion.

11. View from terminus of West Drain Ditch into North Draw

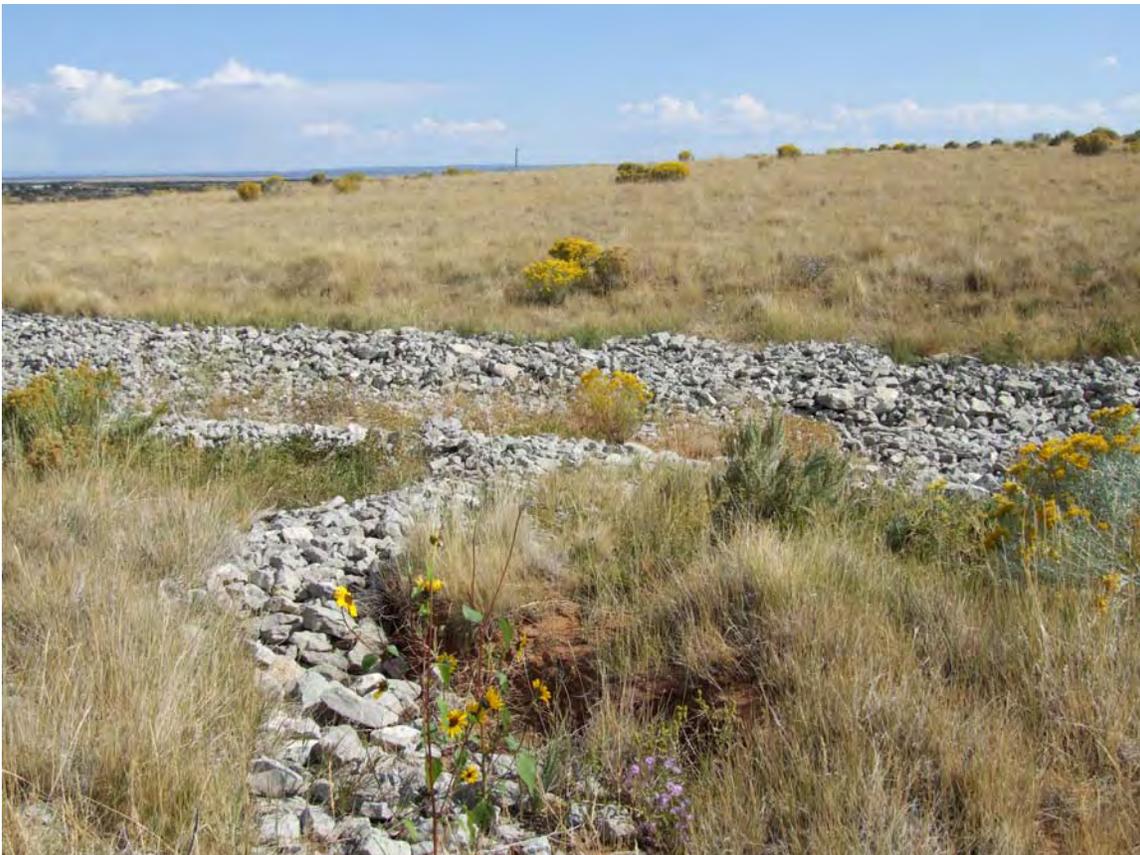
12. View down West Drain Ditch showing the minor headcut area identified during the 2008 inspection

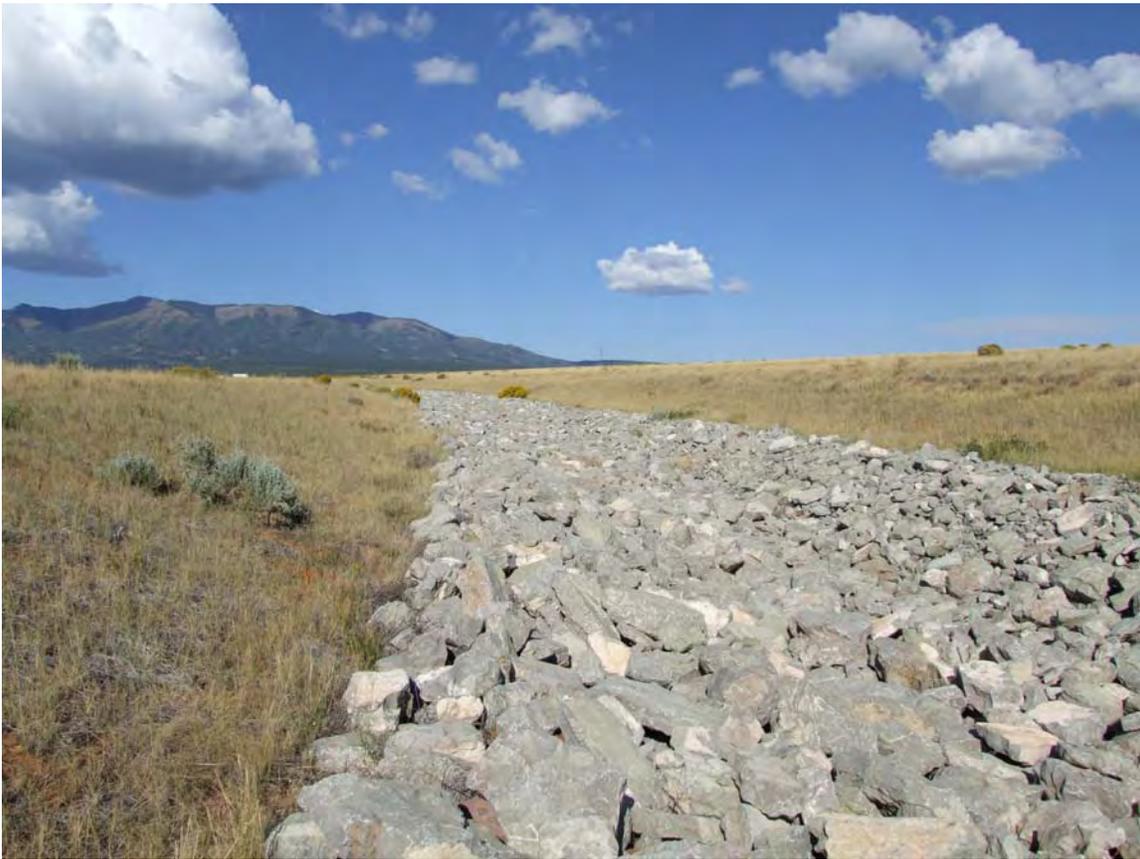
The South Drain Ditch (Photo 13) is in good condition. Erosion rills are present on the ditch's north side in places. Some rills have stabilized, and others appear fresh but remain small. These features do not require action other than continued monitoring.

13. View up South Drain Ditch

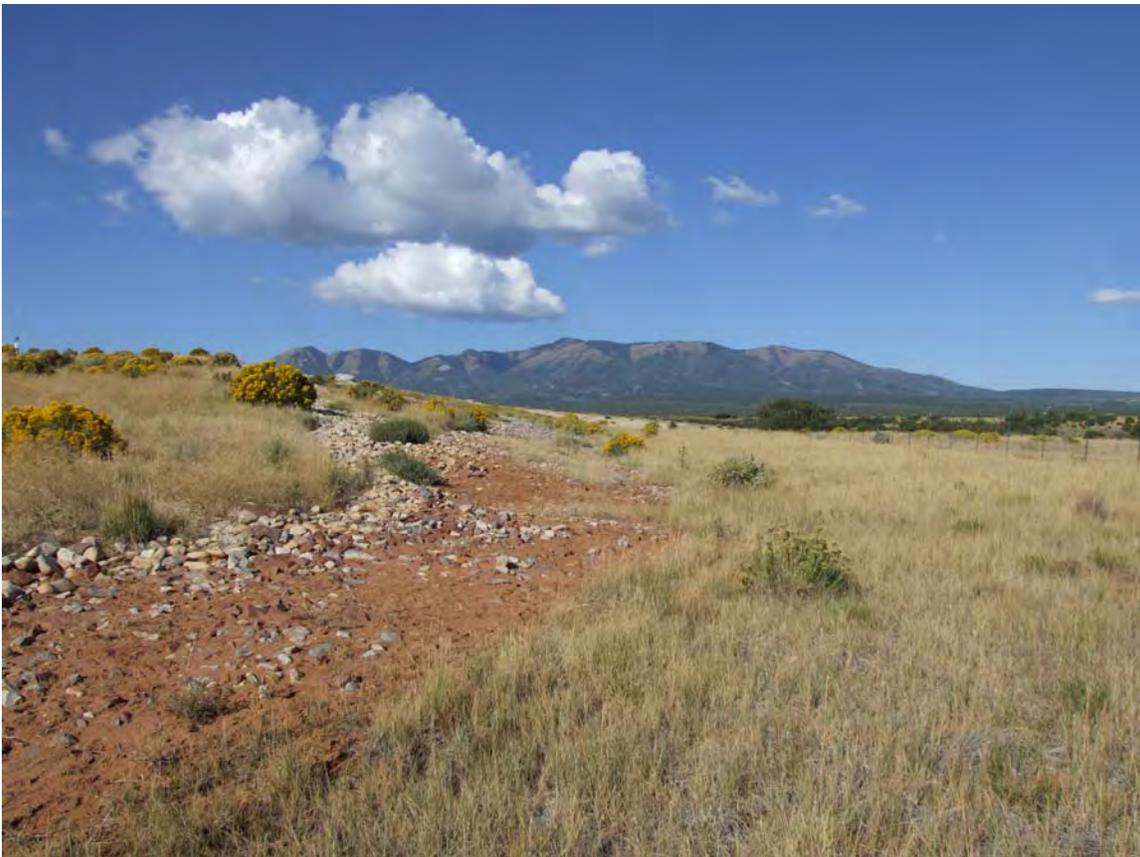
Some rock at the surface of both toe trenches is degrading; windblown sediment has accumulated at the surface, and in places, plants are becoming established (Photo 14). However, erosion or bypass of these trenches is not evident. Soils and vegetation have accumulated in the drainage downgradient from the East Toe Trench (Photo 15), but flows are not impeded. Soils and vegetation have also accumulated in the drainage downgradient from the North Toe Trench; some slopes in this area show evidence of minor sheet erosion.

14. View of the North Toe Trench showing sedimentation and vegetation

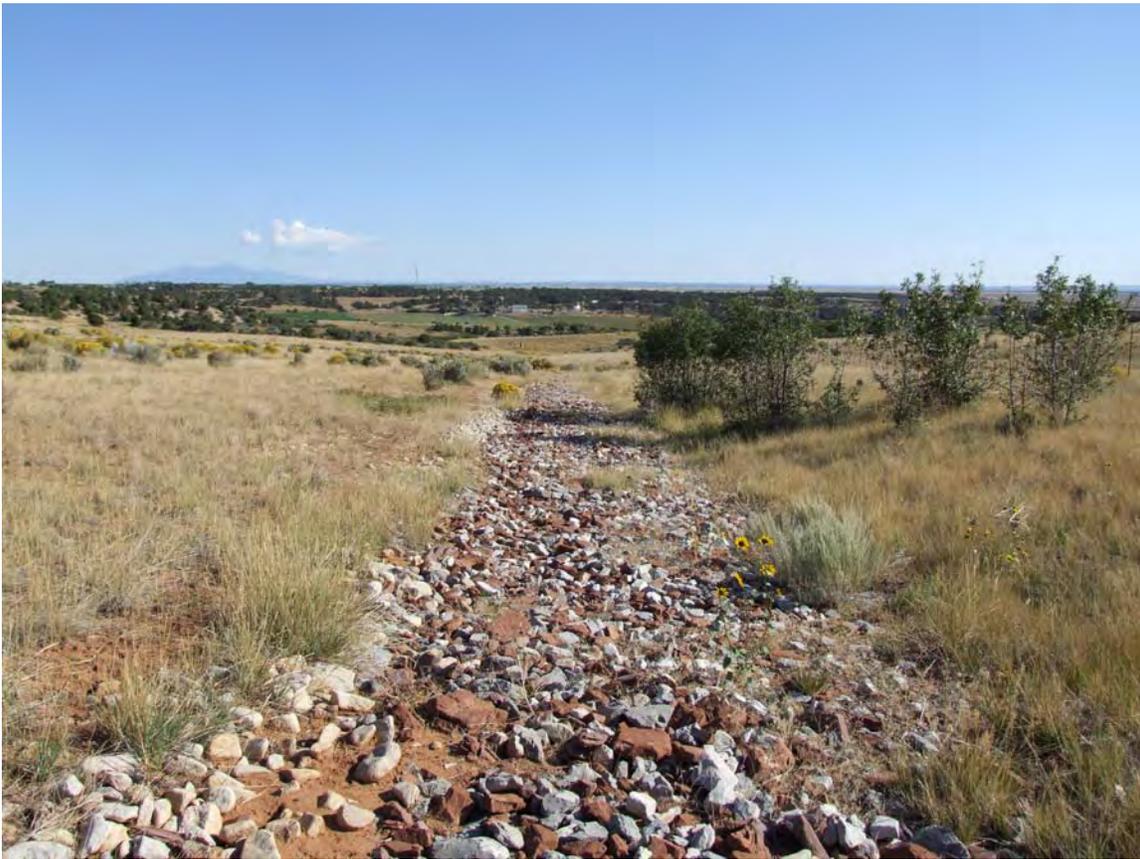
15. Drainage north of the East Toe Trench showing vegetation and soils accumulation

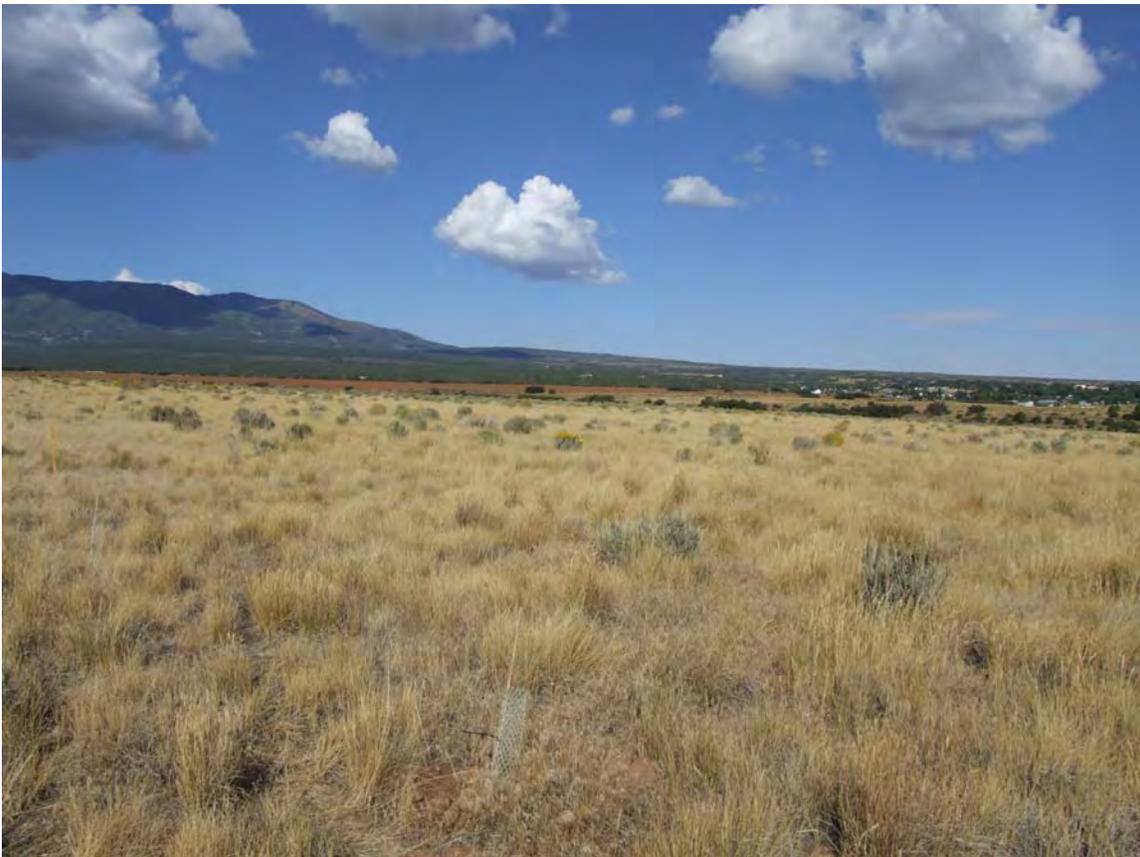
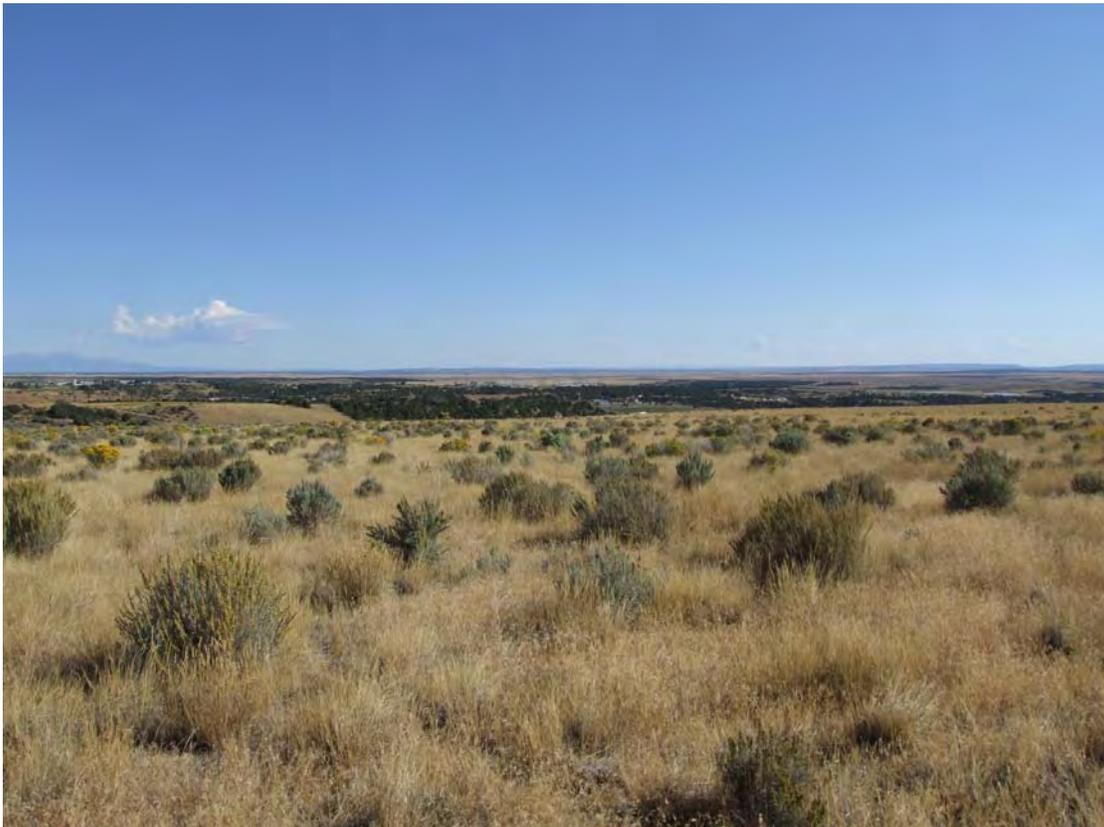
Desirable plants are well established on the cover, and no barren areas, eroded areas, or phreatophyte shrubs were identified (Photos 16 and 17). However, dead sagebrush plants are scattered across the cover. These shrubs were probably weakened by vole damage in 2006,

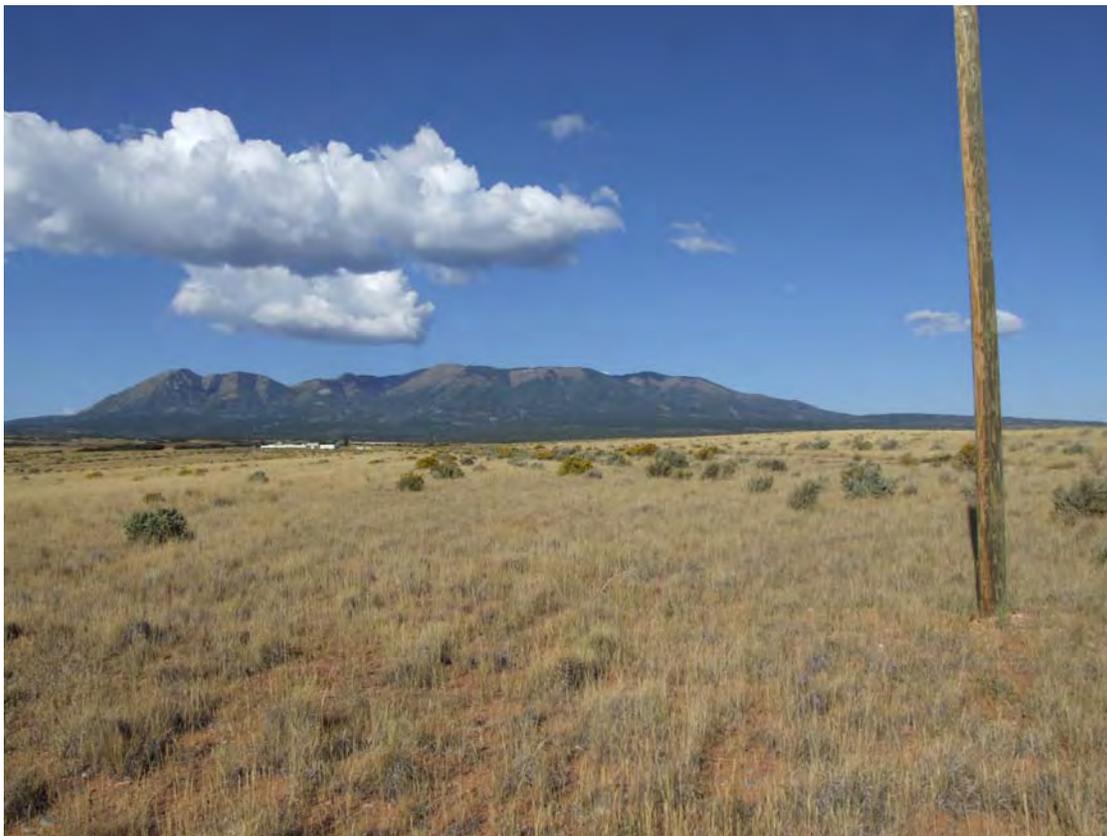
Vegetation on the repository's soil-covered side slopes and outlying areas is in good condition (Photo 18). Plants have also established on portions of the rock riprap armoring (Photo 19), mainly rabbitbrush (*Ericameria nauseosa*) and yarrow (*Achillea millefolium*), with occasional patches of oak brush (*Quercus gambelii*). None of this vegetation is of concern because it does not overlie tailings or threaten the integrity of the side slopes.

18. Repository side slope from a raptor pole at the northwest corner

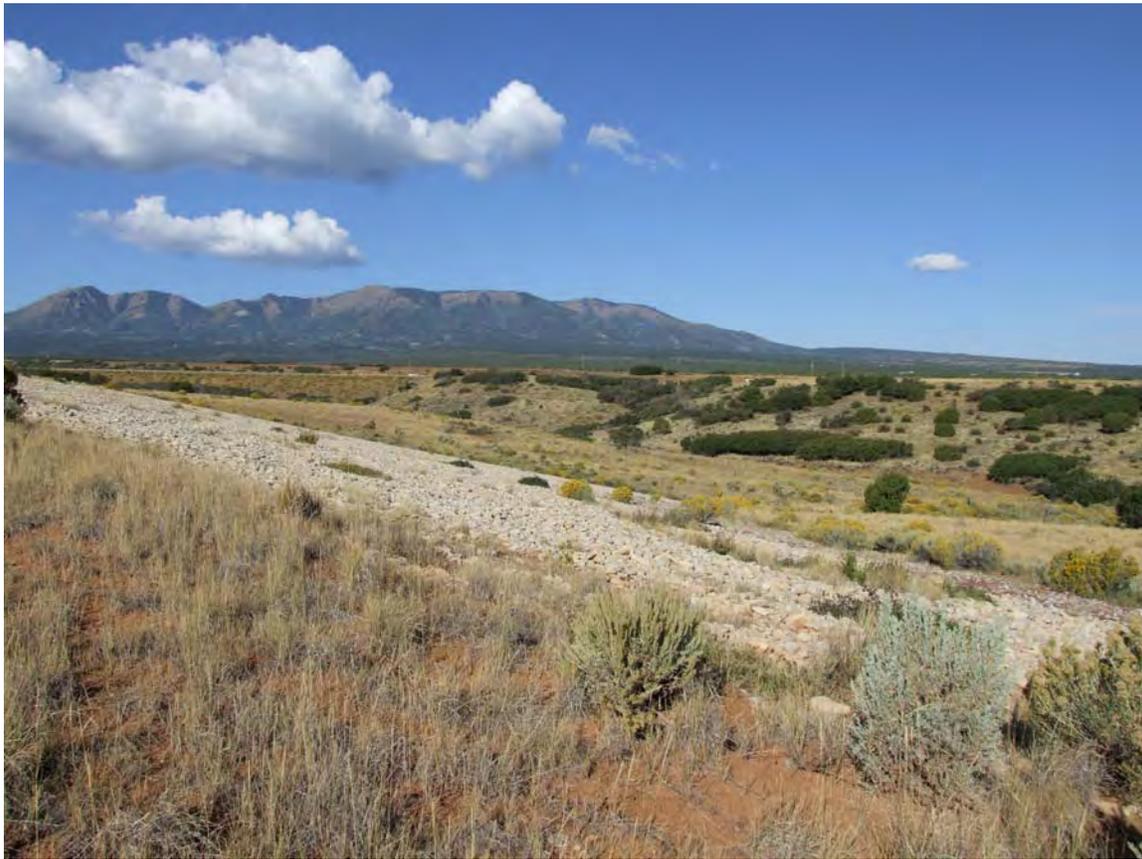
19. View across the western riprap cover facet showing vegetation growing in rock

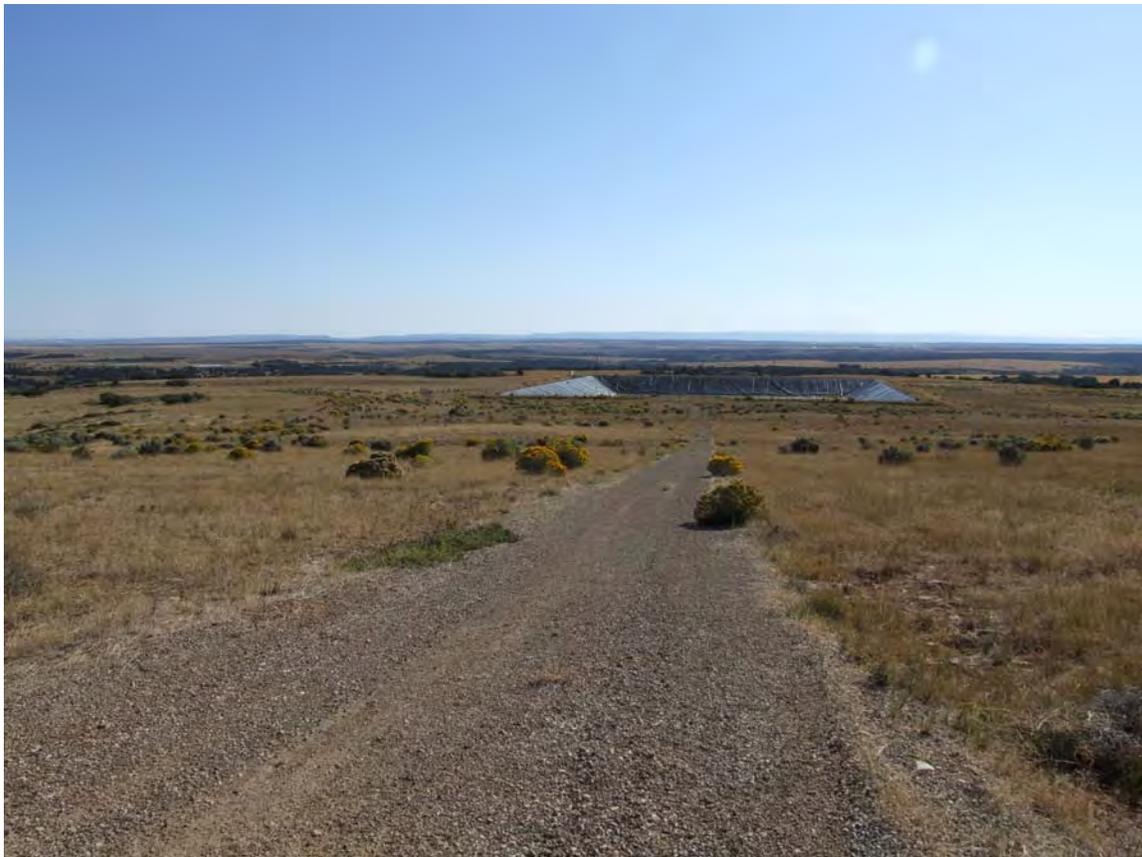
The graveled road surrounding the disposal cell and the road to Pond 4 (Photo 20) are in good condition. Weeds up to 18 inches high grow in places but do not impede travel.

20. Pond 4 and access road

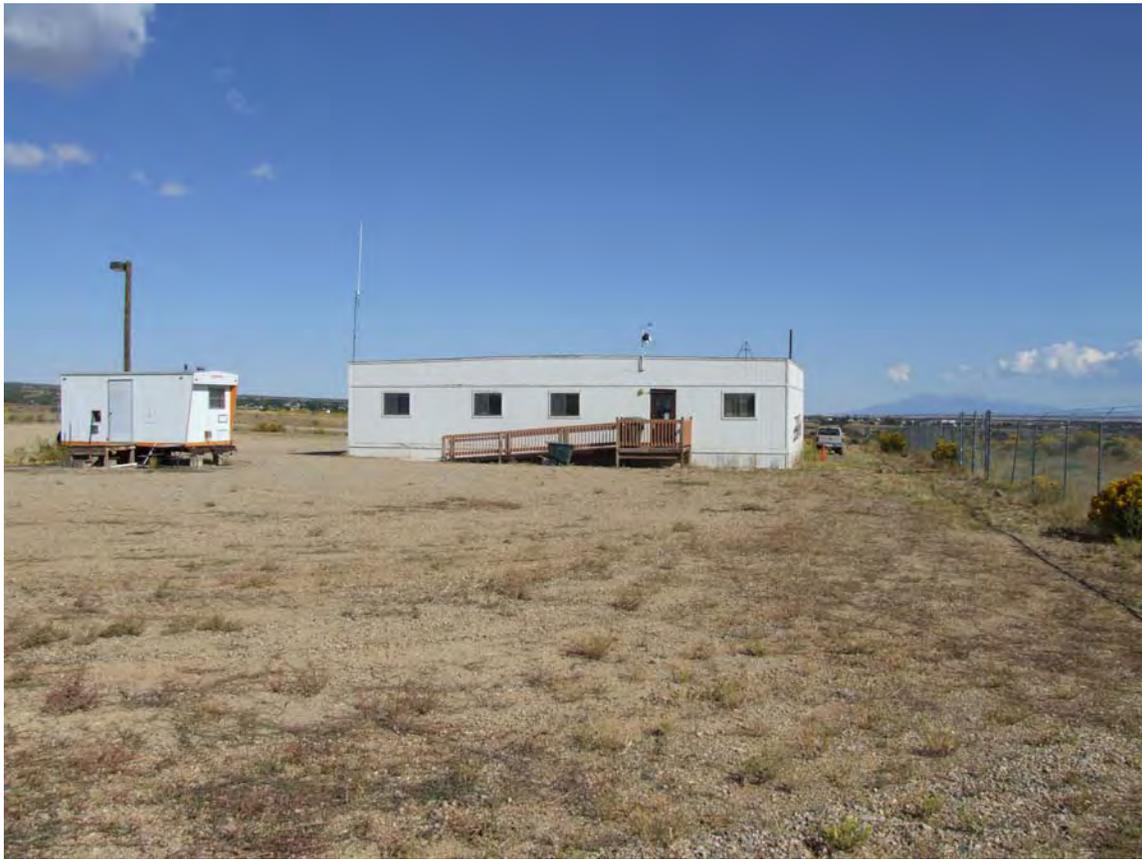
The Monticello field office buildings are in satisfactory condition (Photo 23). On-site personnel suggested some repairs and maintenance items, including replacement of skirting, roofing, and the building overhang, and installing a sidewalk. Several nonfunctional electrical panels on the northern fence of the support area (Photo 24) may also be removed. An infestation of Russian knapweed, a noxious species, was identified along the west fence of the support area. Herbicide has been purchased for on-site personnel to treat the infestation.

23. Support buildings at the Monticello field office

**Action Item:** Assess repairs and maintenance needs of field office buildings and support area and implement repairs as necessary.
