# 2012 Annual Inspection Report for the DOE Monticello, Utah, Mill Tailings Site and Monticello Vicinity Properties

December 2012

**2012 Annual Inspection Report for the  
DOE Monticello, Utah, Mill Tailings Site and  
Monticello Vicinity Properties**

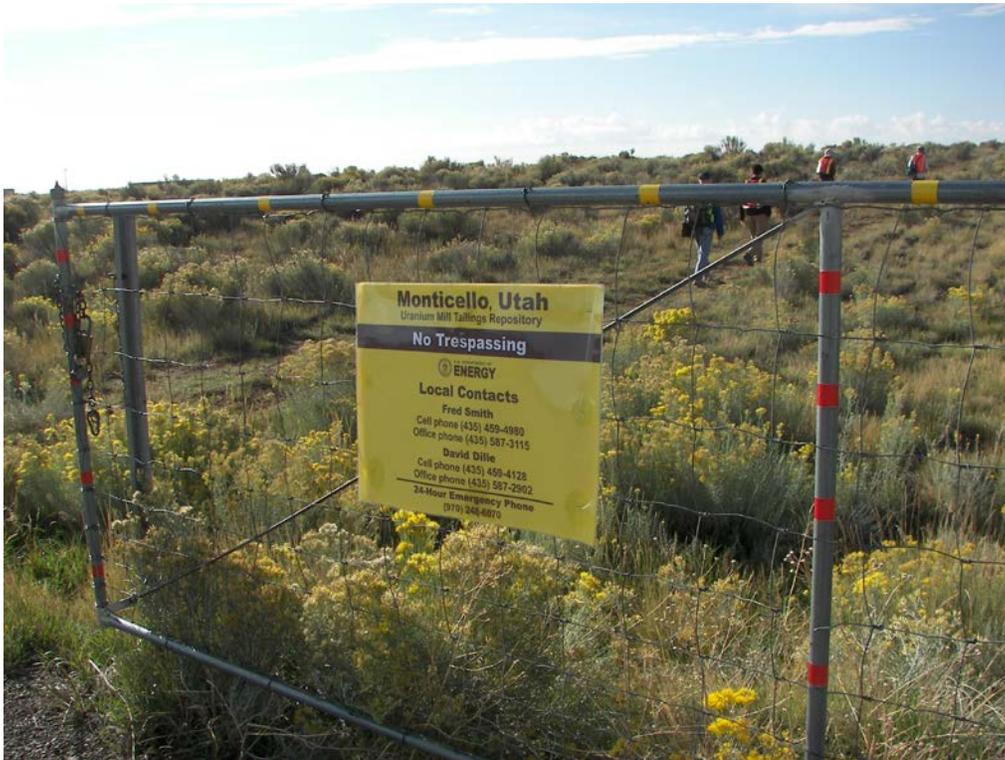
The Monticello field office buildings and associated structures were in excellent condition. Site access signs displaying contact information were current and visible (Photo 1). Small populations of two noxious weed species (Russian knapweed [*Acroptilon repens*] and spotted knapweed [*Centaurea diffusa*]) were identified near the field office buildings and entrance gate. Noxious weeds are regularly mapped and treated at the site. The site's paved access road was in good condition, with vegetation mowed along the margins.

Photo 1. Information sign on front access gate to the site.

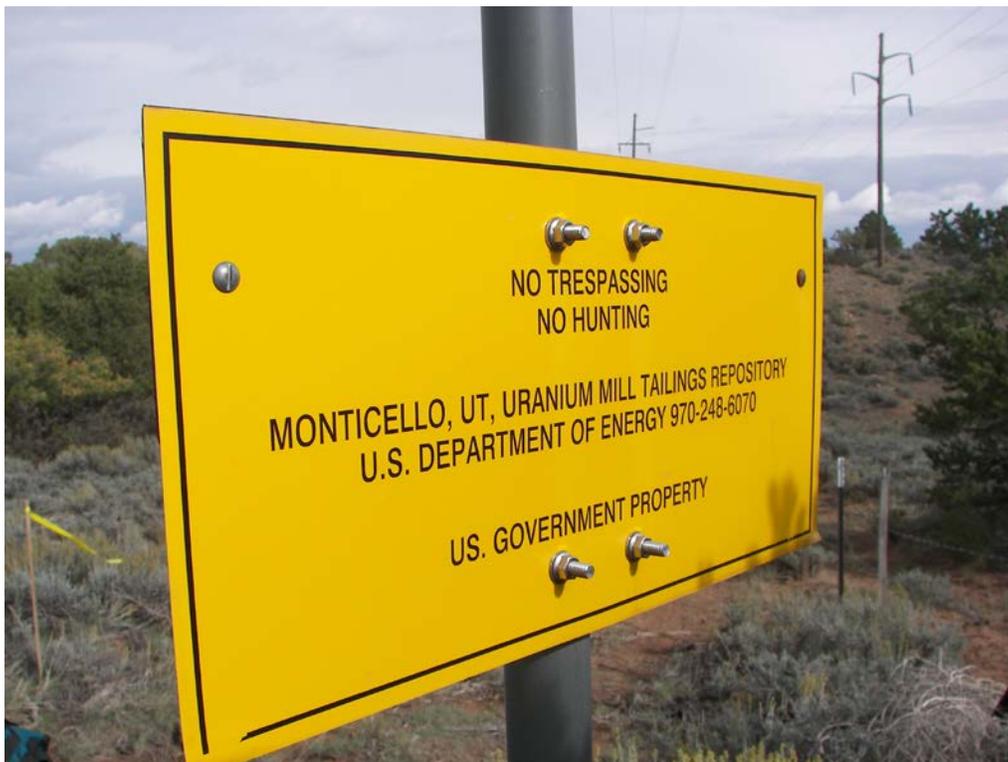
All perimeter signs were legible and in good condition (Photo 2), although perimeter sign P15 was scratched, and sign P5 contained a bullet hole along the edge. Weathered “No Hunting” signs, posted at all gates along the perimeter fence, were in need of replacement. New signs were ordered in October 2012 and will be installed in winter 2012.

Photo 2. Perimeter sign P24.

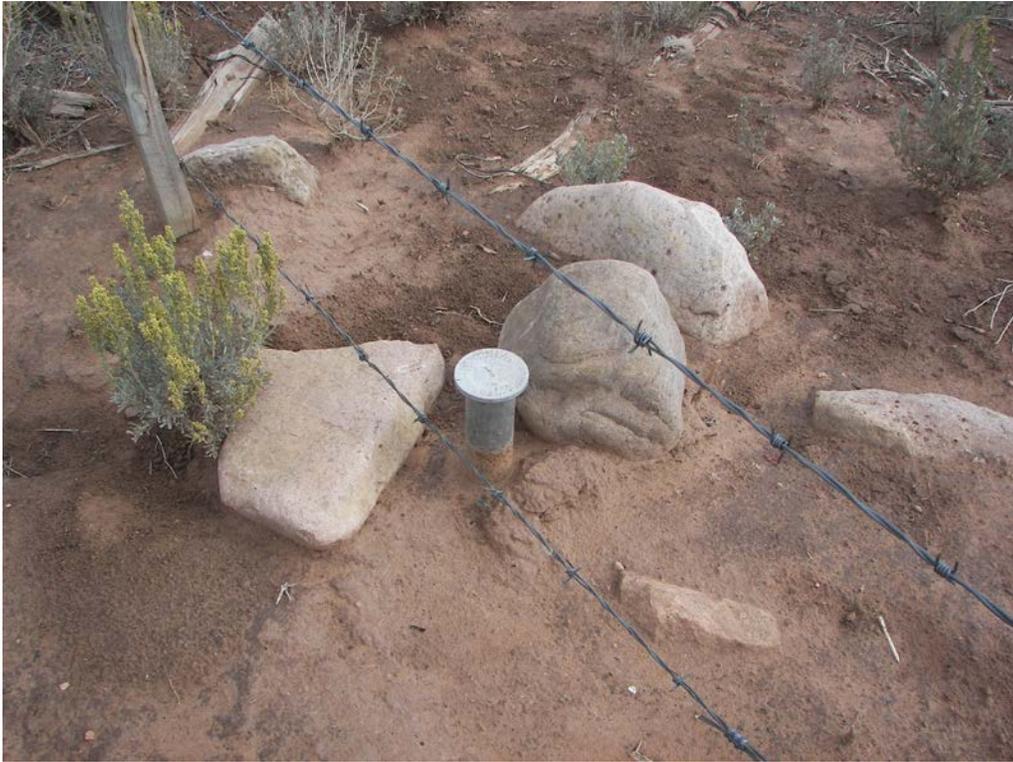
All six boundary markers were located during the inspection and were in good condition. Boundary marker 6, a representative marker, is shown in Photo 3.

Photo 3. Boundary Marker 6.

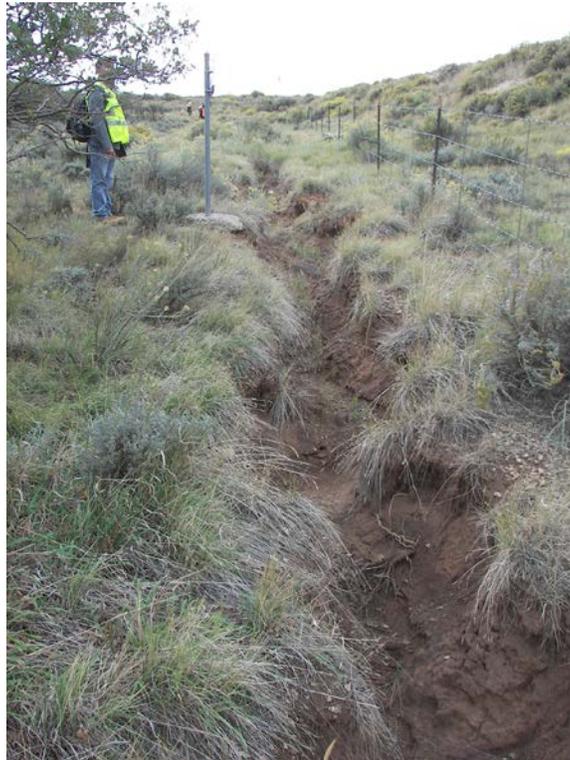
No new site erosion was apparent during the 2012 inspection. Previous inspection reports describe a gully between perimeter signs E and P2. Because sources of water to the gully have been rerouted or repaired by UDOT, no action was taken by DOE to fill the gully or to move the perimeter fence. The gully was still present in 2012, but soil deposition has continued, slowly filling in washout areas (Photo 4). This process will likely continue to fill the gully over time.

Photo 4. Erosion channel at western fence line filling in with sediment over time.

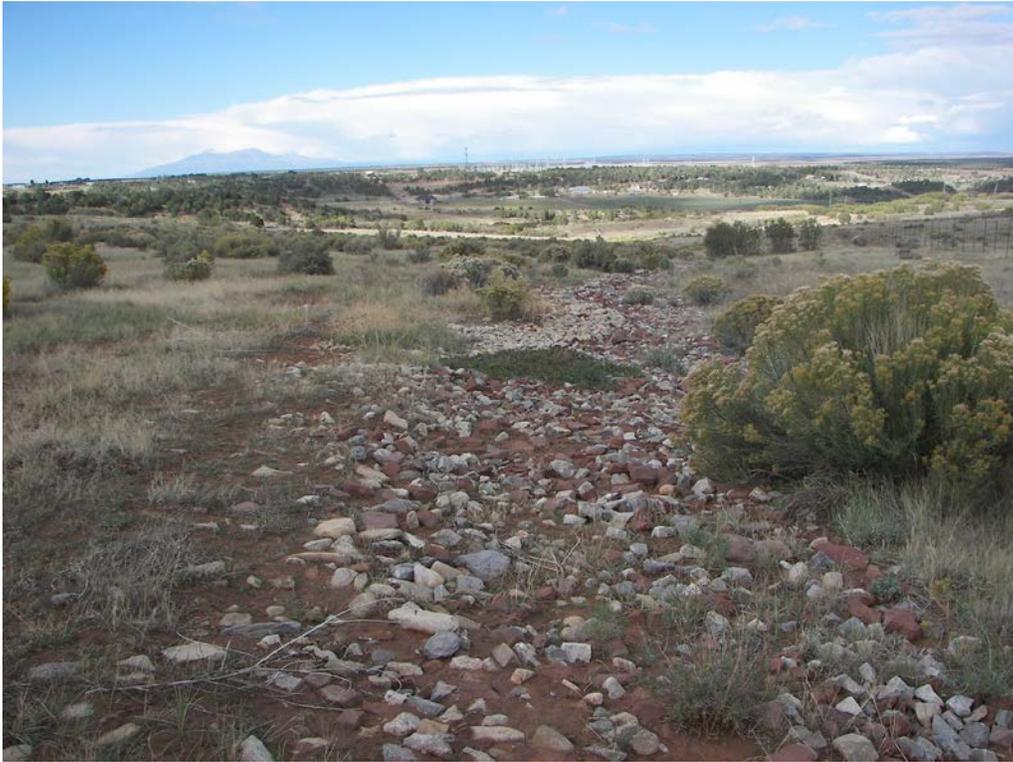
Photo 5. East Toe Trench, view to the north.

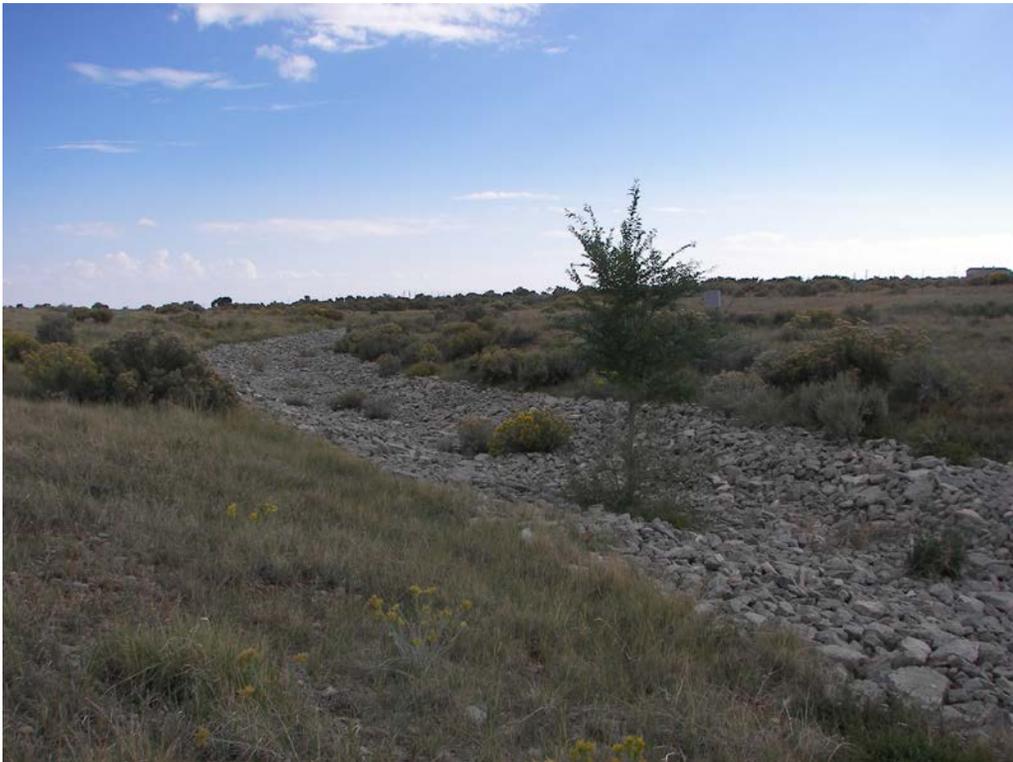
Photo 6. Siberian elm (*Ulmus pumila*) growing in West Drain Ditch, to be removed.

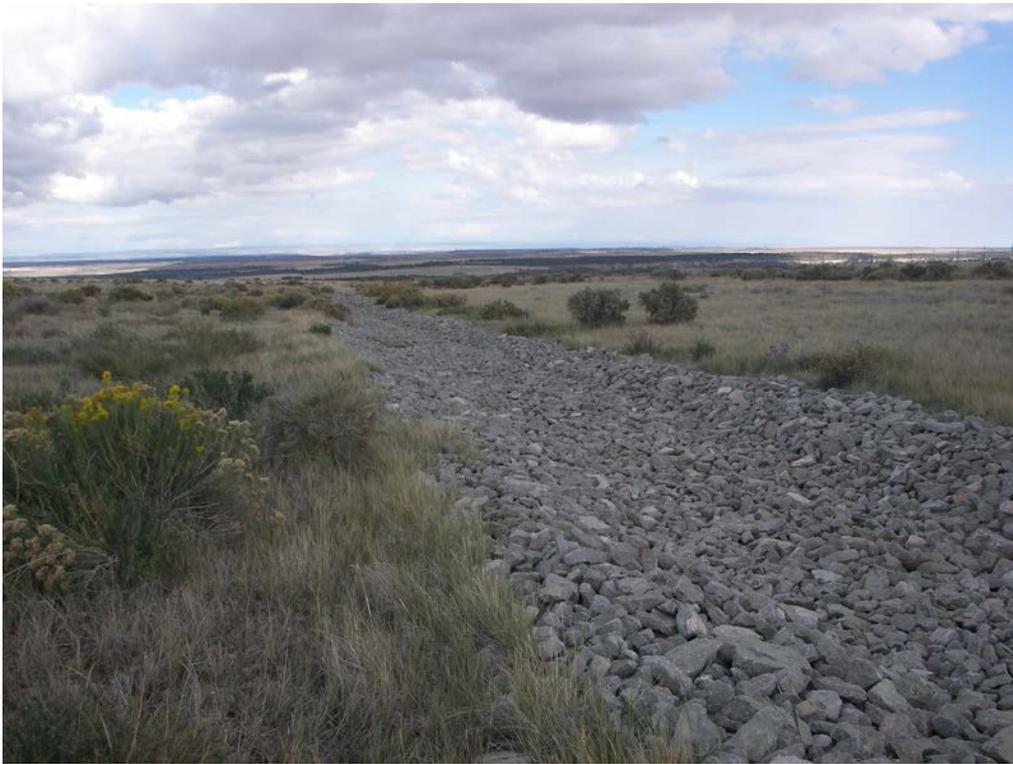
No evidence of new erosion was found in 2012 (Photo 7). Shrubs observed in portions of the South Drain Ditch do not block potential flow. Burrows from small rodents occurred in places along the margin of the ditch but do not threaten its integrity.

Photo 7. South Drain Ditch, view to the east.

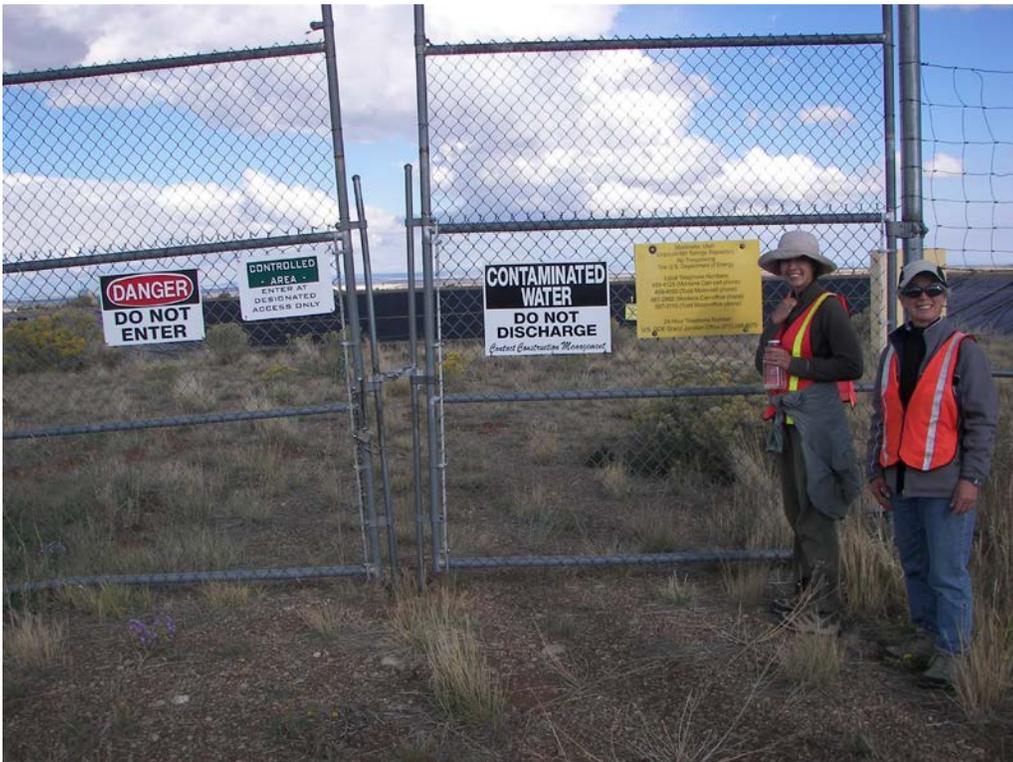
All gates were in good working condition. Warning signs on the perimeter fence were easily visible and legible (Photo 8). The following warning signs were posted on the perimeter fence and gates: "Danger Do Not Enter," "Controlled Area, Enter at Designated Access Only," "Contaminated Water, Do Not Discharge," "No Trespassing," and – on the vehicle access gate – a sign posting contact information. The contact information sign contained outdated names and phone numbers. There was no evidence of vandalism or trespass, but minor repairs to the security fence, noted on the site map (Figure 2), are necessary.

Photo 8. Personnel at gate to Pond 4.

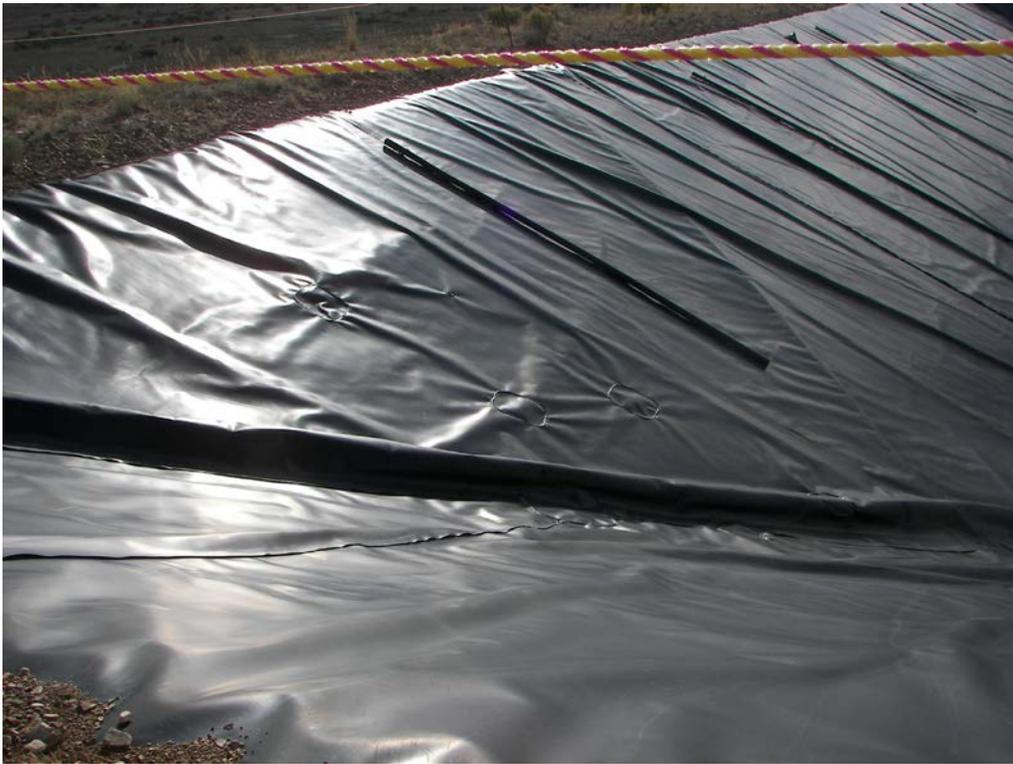
The pond liner was repaired in 2011 (Photo 9), and no visible evidence of holes or other damage to Pond 4 was observed during the 2012 inspection (Photo 10). Liner anchors, consisting of sand-filled polyethylene pipe, were in good condition. Several inches of water was standing in

Photo 9. Recent repairs in lining of Pond 4.

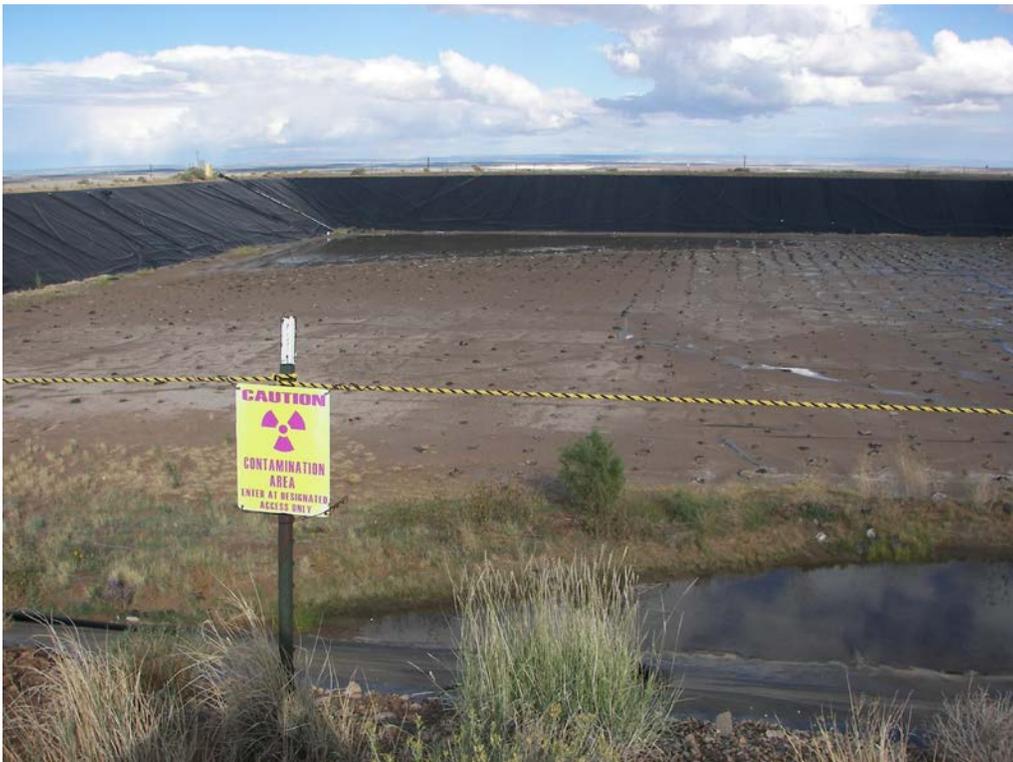
Photo 10. Pond 4, view to the east.

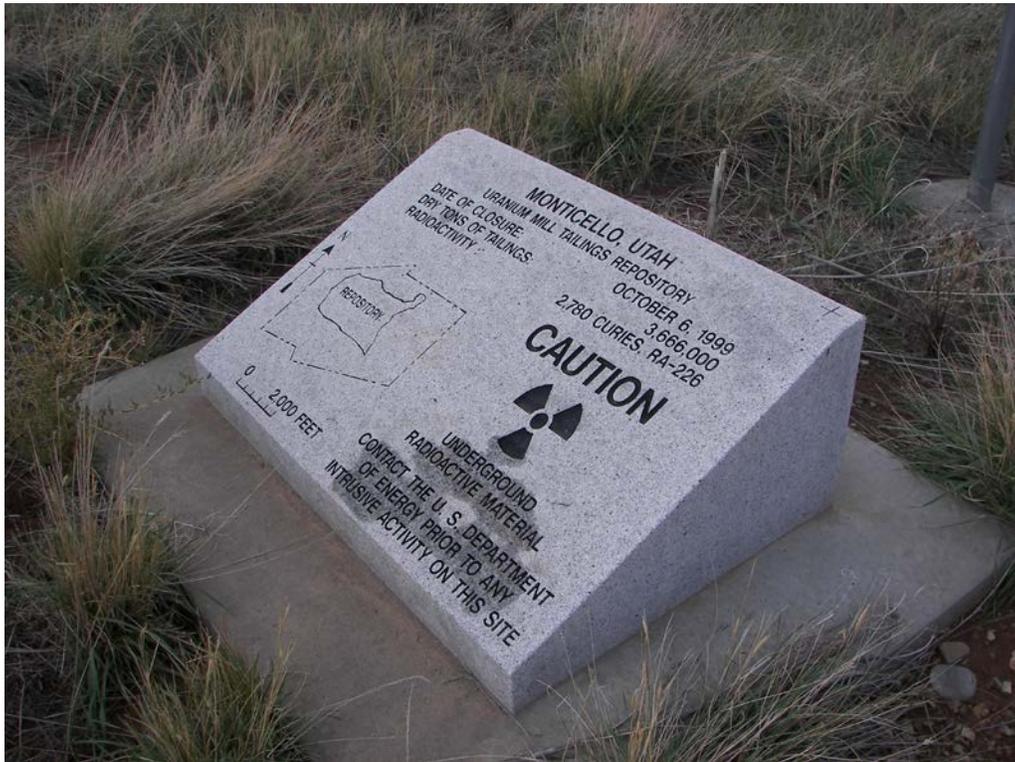
Photo 11. Site Monument 2 on top of disposal cell.

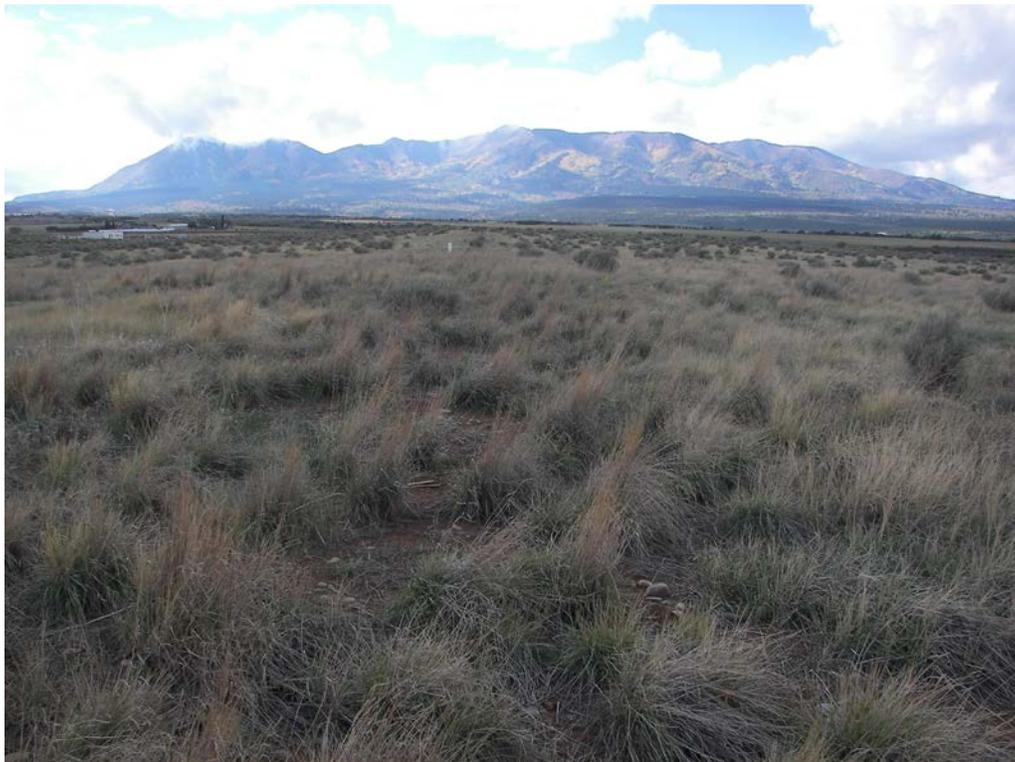
Photo 12. Vegetated disposal cell cover, view west from Site Monument 2.

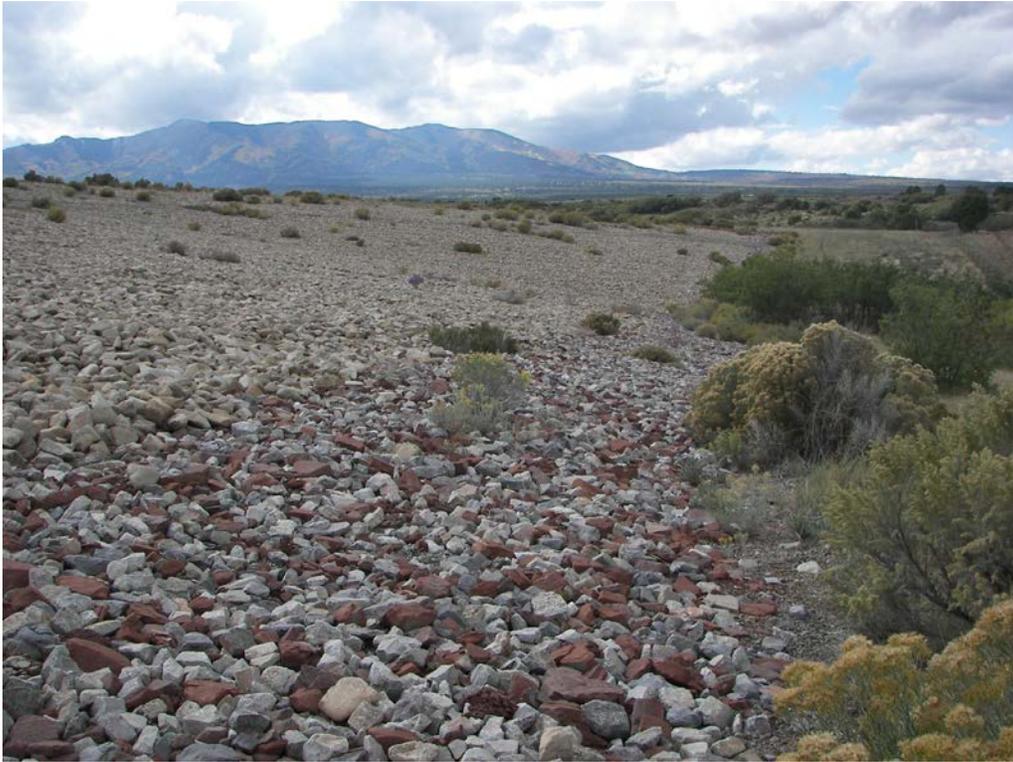
have established on portions of the rock riprap that have no soil cover (Photo 13). Some sagebrush, antelope bitterbrush (*Purshia tridentata*), Cicer milkvetch (*Astragalus cicer*), and purple aster (*Machaeranthera canescens*) were also found. Weeds were not common but included Russian thistle (*Salsola tragus*), amaranth (*Amaranthus* sp.), and cheatgrass (*Bromus tectorum*). Because this vegetation does not overlie tailings or threaten the integrity of the side slopes, control is unnecessary. However, because they are a nuisance species, several Russian olive trees (*Elaeagnus angustifolia*) will be removed.

Photo 13. Rock-covered side slope of disposal cell showing volunteer vegetation.

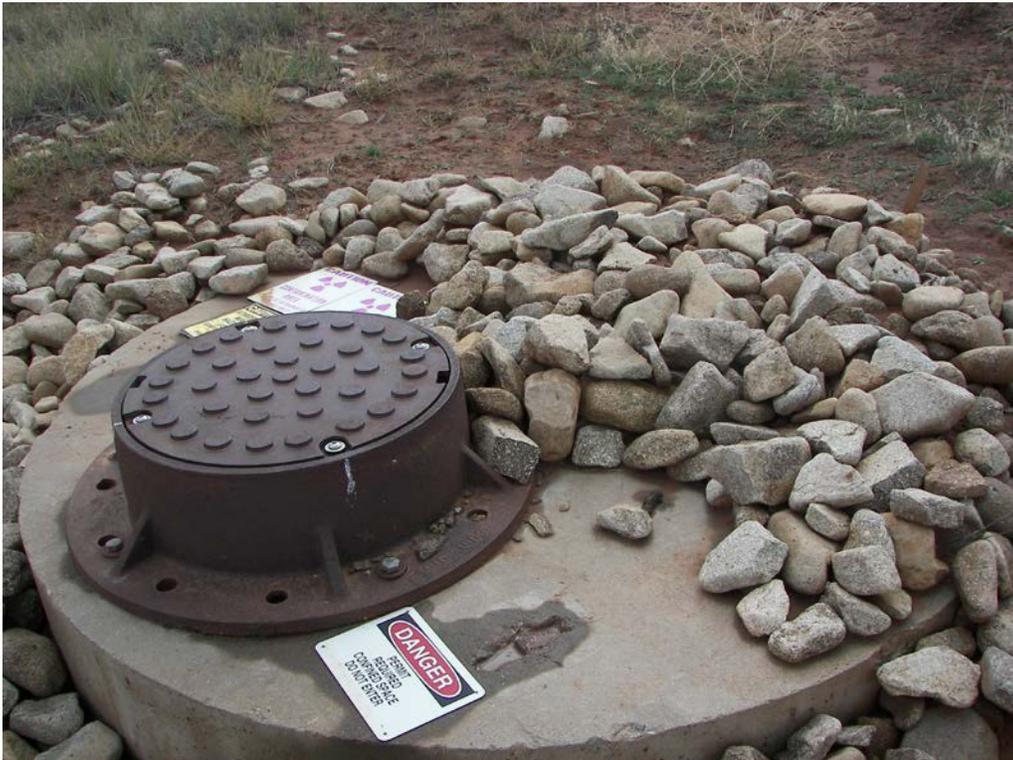
Photo 14. Manhole 4, showing health and safety postings.

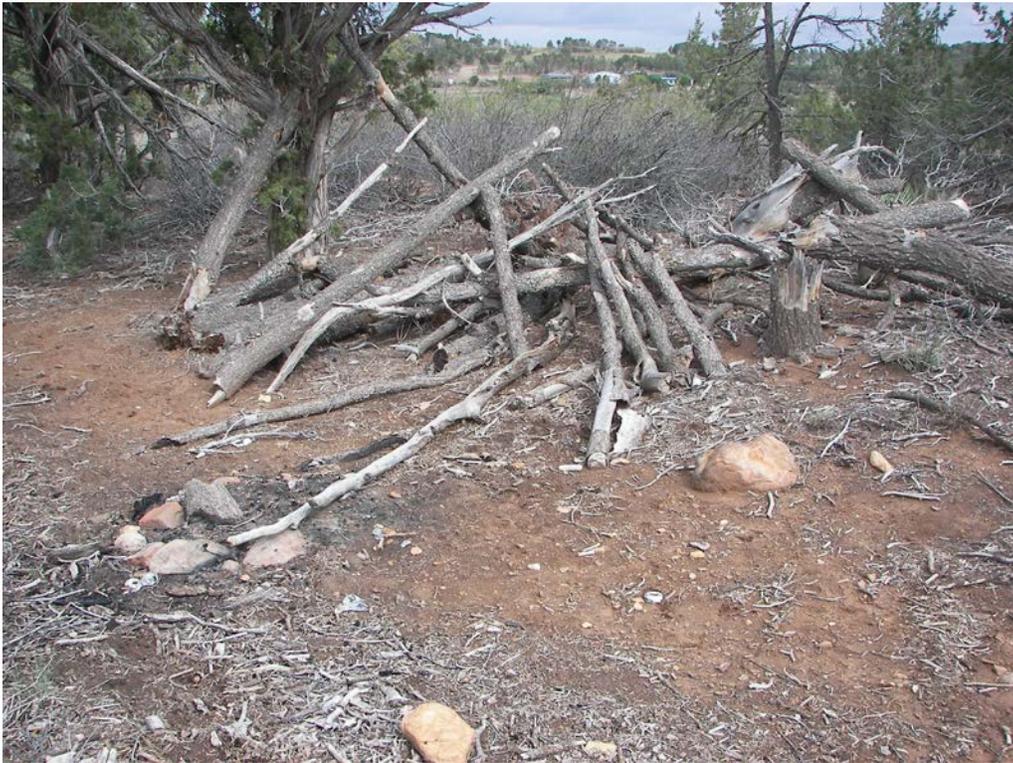
Overnight camping is not allowed on these properties. One area, previously determined to be a day camp on Property MP-01077, was monitored (Photo 18), and no evidence of recent use was observed. A fire pit previously identified on MP-01040 (North) was also monitored, with no evidence of recent use. A recently used fire pit was discovered on MP-01041 (Photo 19). This fire pit was not observed during previous inspections. Although it cannot be determined whether the fire pit was associated with a day camp or an overnight camp, the lack of debris and soil disturbance around the pit indicate that it was not associated with long-term camping. This fire pit will be monitored in the future.

Photo 18. Lean-to and fire pit discovered during previous inspections showing no evidence of additional use.

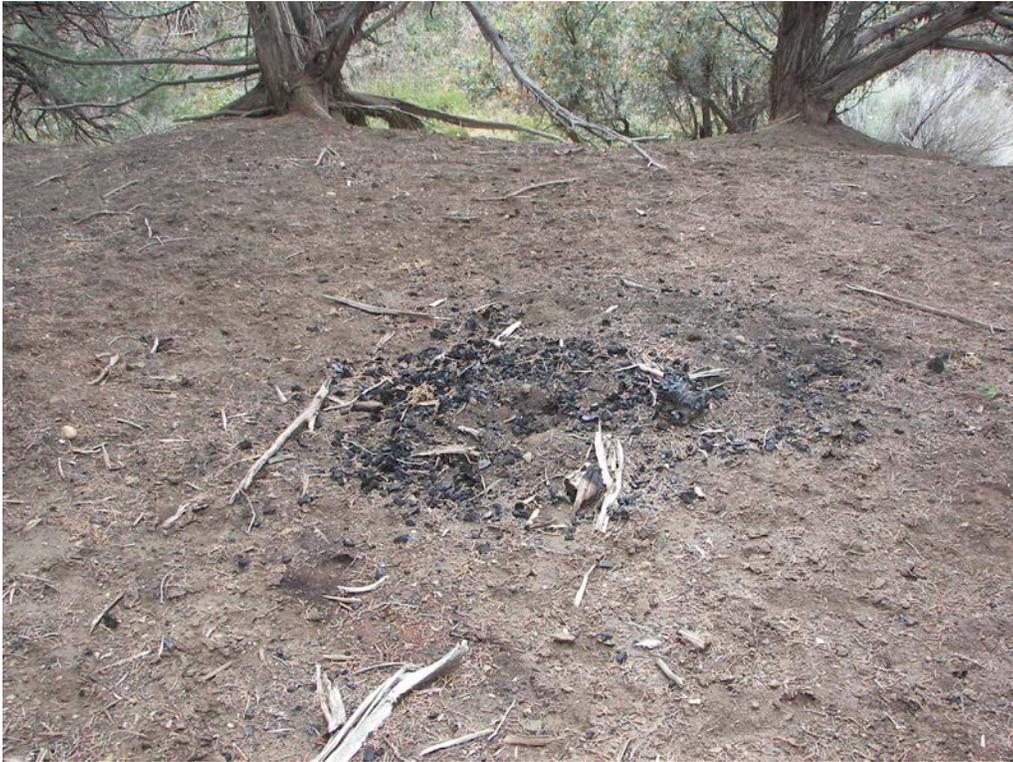
No significant violations of institutional controls that restrict land and water use were evident during the 2012 annual inspection. A recently used fire pit was discovered on MP-01041, which may relate to the land use restriction prohibiting overnight camping. This fire pit was not observed during previous inspections. While it cannot be determined whether the fire pit was associated with a day camp or an overnight camp, the lack of debris and soil disturbance around the pit indicate that it was not associated with long-term camping. It will continue to be monitored. Drainage and runoff control structures on the City-owned properties were in good condition. No remedy-related repair or maintenance items requiring action by the City of Monticello were observed. Although no land use restrictions apply to soil disturbance on Property MP-00181, utility-related construction on this property was properly monitored for radiological control by onsite personnel (LM contractor Site Operations Manager and Site Representative) in accordance with the LTS&M Plan. Wetlands were ecologically healthy, and no evidence of damage was apparent. No groundwater drilling applications were sought for the City-owned properties, and no drilling activities within the restricted area were noted or reported by onsite personnel.

Photo 19. Fire pit discovered during 2012 inspection on MP-01041.

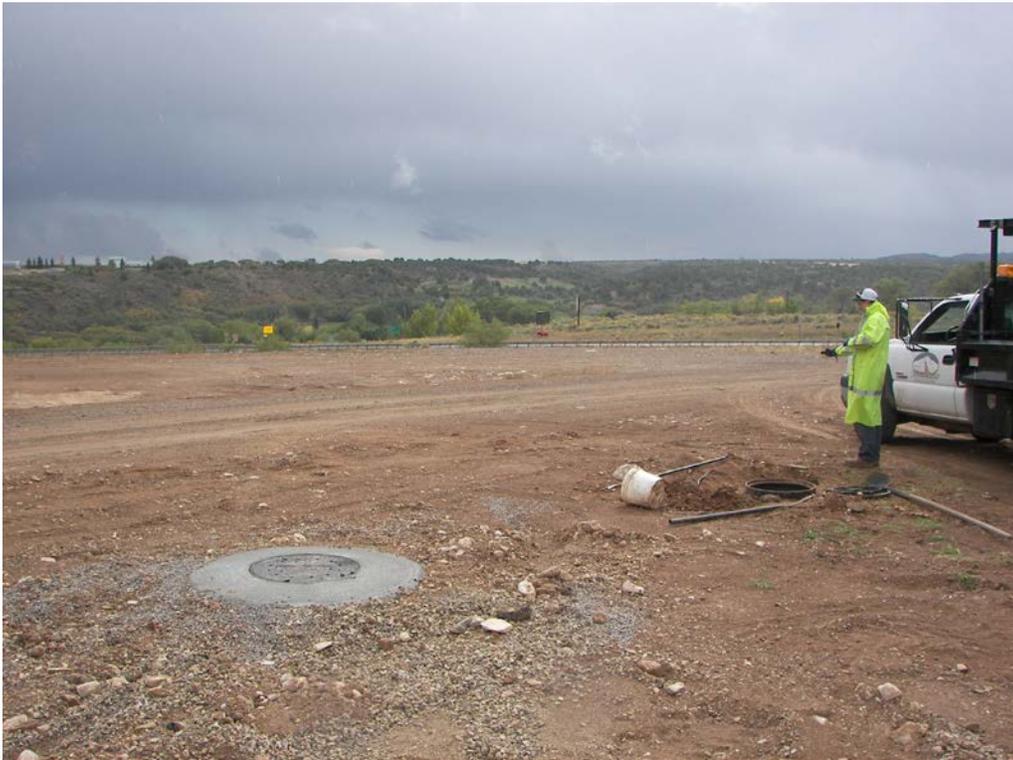
Photo 20. Area where contaminated material was removed during 2012 construction activities.

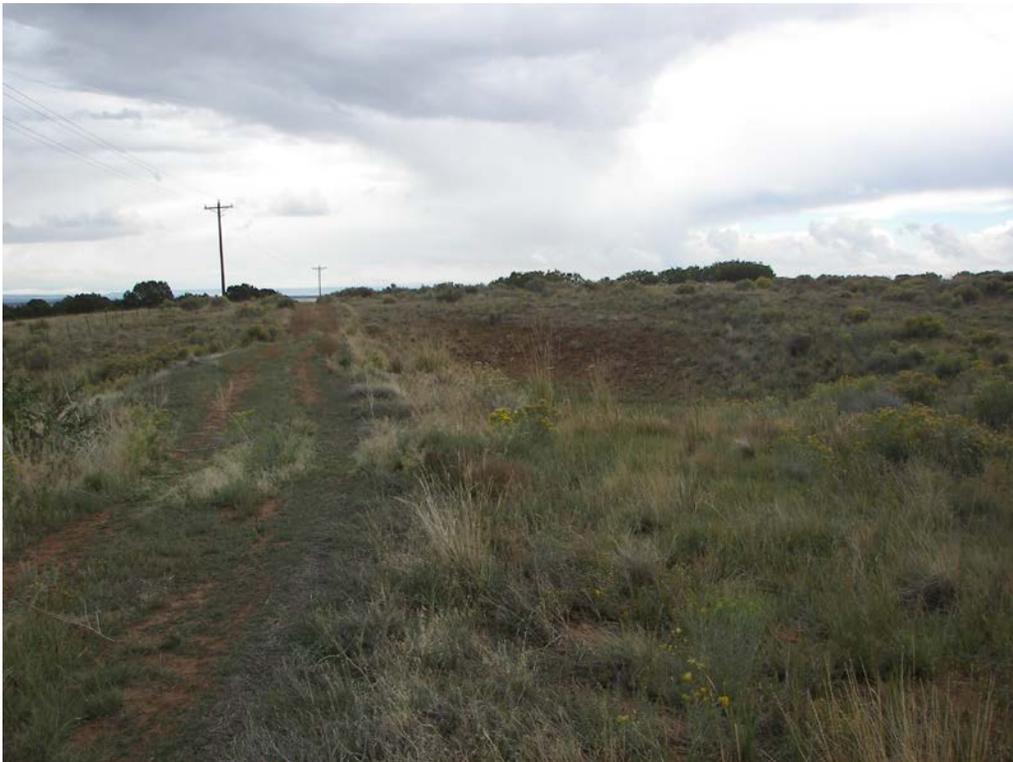
Although no land use restrictions apply to soil disturbance on Property MP-00181, utility-related construction on this property (a sewer line excavation) was properly monitored for radiological control by onsite personnel in accordance with the LTS&M Plan. During the summer of 2012, a small volume of material was identified and removed from the area surrounding a manhole on this property (Photo 20). All riprap-armored structures, dams, check dams, berms, and runoff control drainages (Figure 4) were intact and functional. No major erosion issues or evidence of recent erosion were noted during the 2012 inspection. One structure, Deer Draw Dam, is shown in Photo 21.

Photo 21. Deer Draw Dam, view to the east.

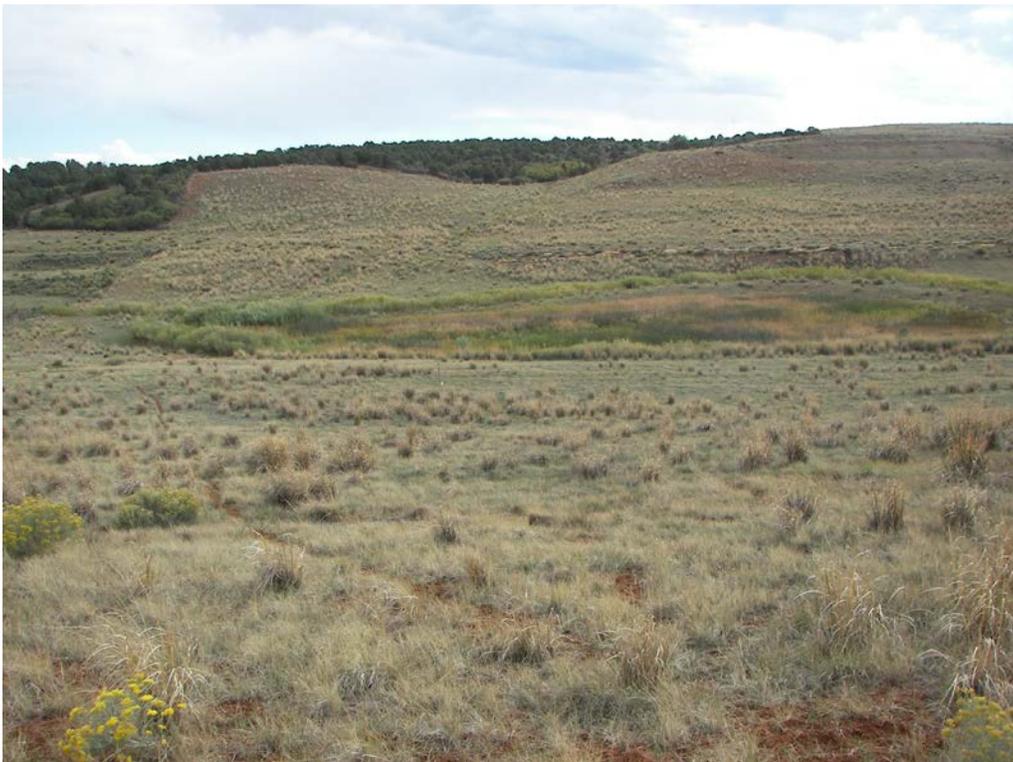
Wetlands on the former mill site were constructed according to EPA-specific criteria, and these wetlands are protected by cooperative agreement. Under this agreement, the City of Monticello will not disturb these areas without prior approval from appropriate state and federal agencies and is not responsible for repairing damage to these areas by natural causes. Montezuma Creek and three constructed marsh wetlands on the City-owned properties were ecologically healthy, and no evidence of damage by human activity or natural causes was observed during the 2012 inspection. Photo 22 shows Wetland 3 at the time of the 2012 inspection.

Photo 22. View of Wetland 3 from City access road.

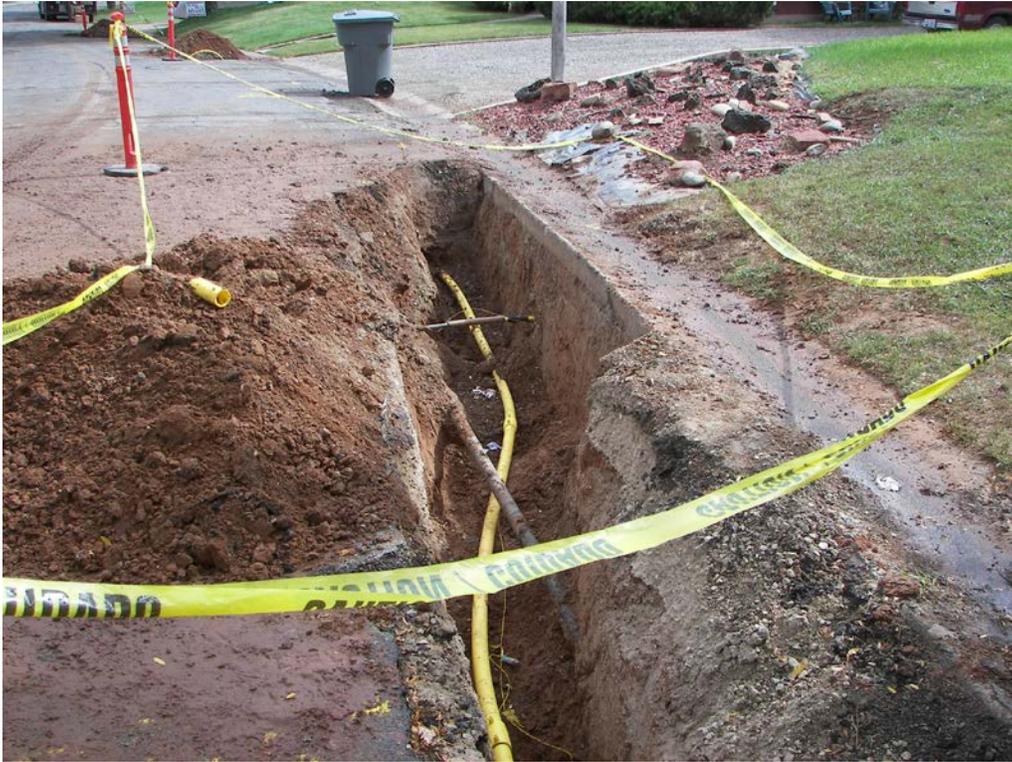
Photo 23. Monitored utility line excavation on City streets.

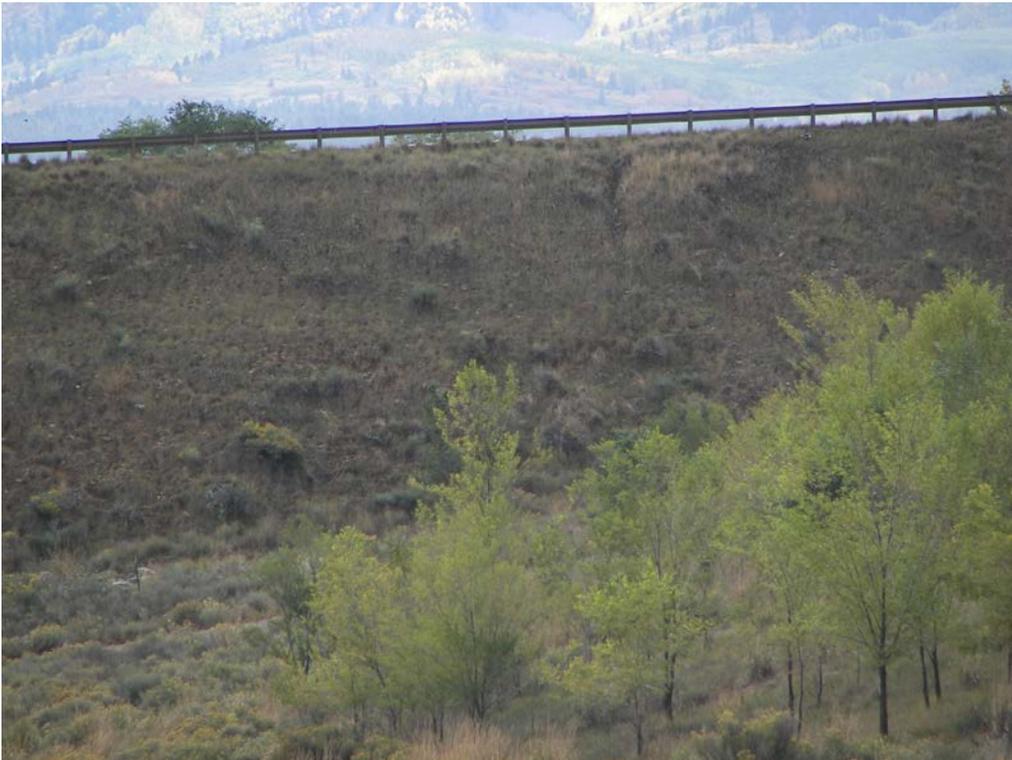
Results of the 2012 annual inspection of UDOT rights-of-way and City streets and utility corridors are found in Appendix A, Section VIII. No unmonitored or unplanned excavations were identified. Onsite personnel were aware of all planned excavations, and excavations were monitored in accordance with the LTS&M Plan. An example of an excavation is shown in Photo 23. Along the shoulders of Highways 191 and 491 and at the Highway 191 embankment at Montezuma Creek, no new excavations or new erosion were evident (Photo 24).

Photo 24. Previously eroded area along Highway 191 embankment.

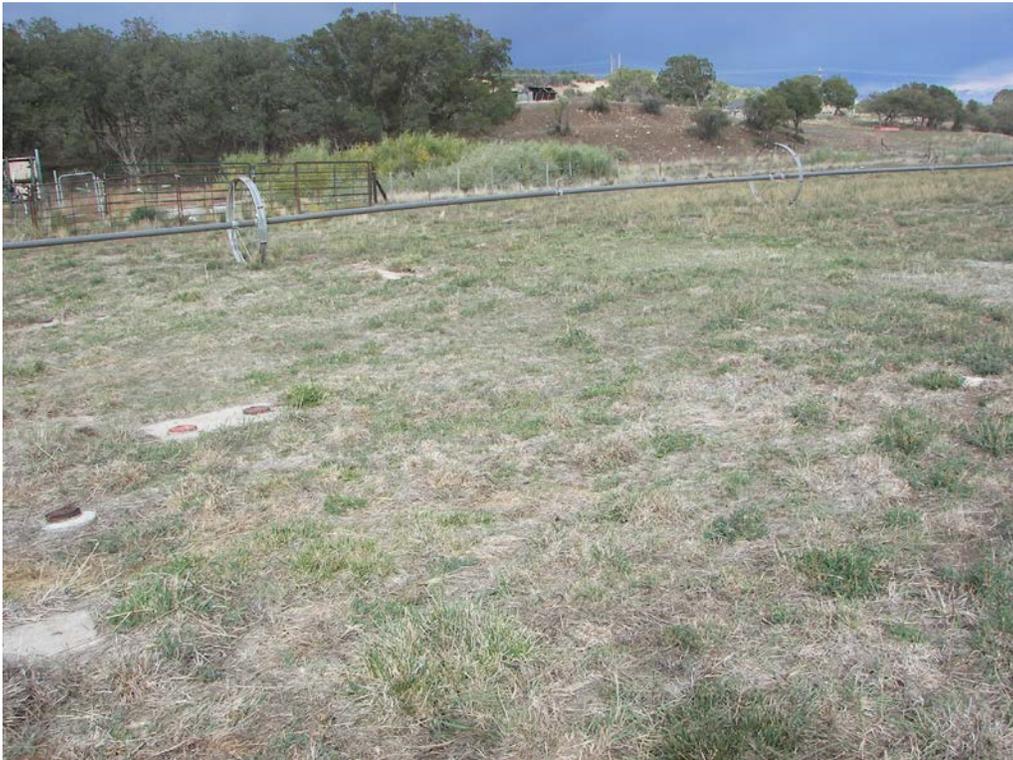
A groundwater treatment system comprising the PRB and treatment cells is on Property MP-00179 (private property) east of the former mill site. Features of these systems are inspected each year to ensure that the current land use, ranching, is not adversely affected. In 2012, the outside of the treatment cell structures was inspected, but the vaults were not opened, because the structures are regularly maintained by DOE Environmental Sciences personnel. Structures were in good condition, and there was no evidence of ponded water, saturated soil, surface disturbance, or stressed vegetation in the vicinity of the PRB or treatment vaults (Photo 26).

Photo 26. Permeable Reactive Barrier Area.
