# 2012 Annual Inspection Report for the DOE Monticello, Utah, Mill Tailings Site and Monticello Vicinity Properties

December 2012

**2012 Annual Inspection Report for the  
DOE Monticello, Utah, Mill Tailings Site and  
Monticello Vicinity Properties**

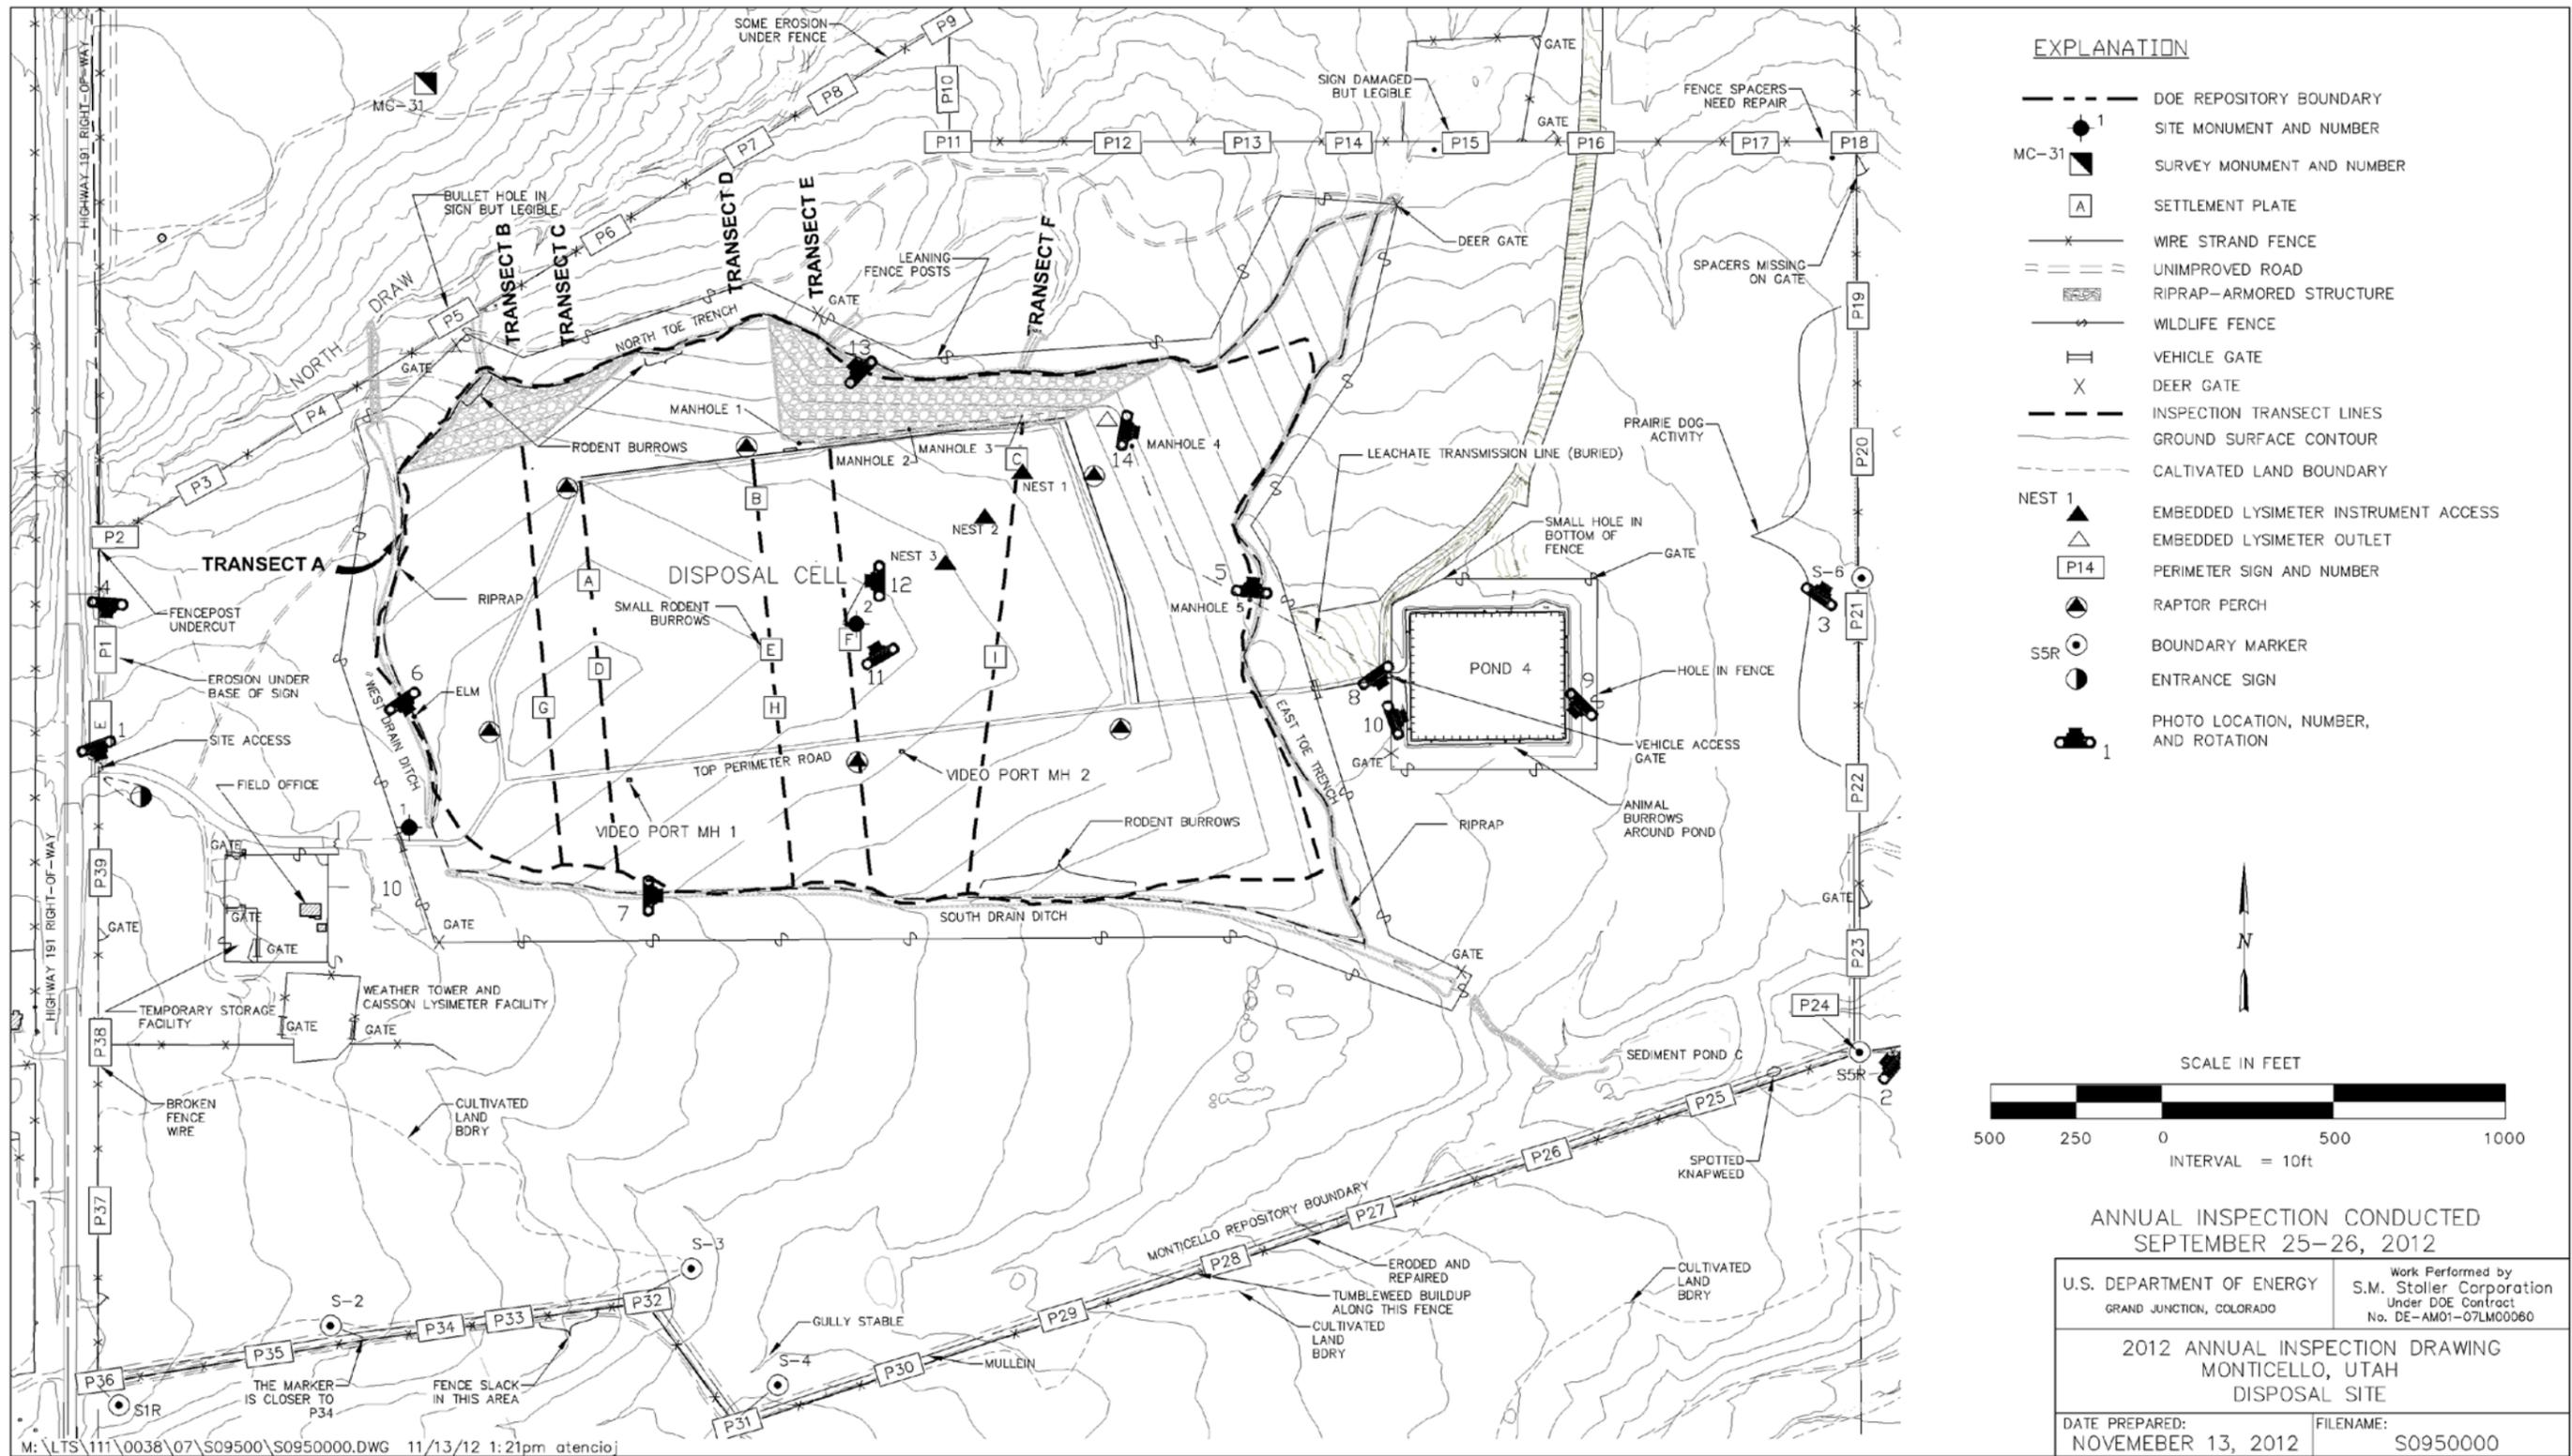
Figure 2. Monticello, Utah, Repository Site

The perimeter fence was in good condition and was functionally intact, but some sections were in need of minor repair, with broken or slack wires and broken or missing wooden spacers. These areas have been noted on the map (Figure 2). One gate at the northeast corner of the site near P18, damaged in 2011, was repaired and functional. It is recommended that tumbleweed buildup along some areas of the southern fence be removed to prevent potential damage from drifting snow in the winter. No evidence of vandalism was present.

All gates were in good working condition. Warning signs on the perimeter fence were easily visible and legible (Photo 8). The following warning signs were posted on the perimeter fence and gates: "Danger Do Not Enter," "Controlled Area, Enter at Designated Access Only," "Contaminated Water, Do Not Discharge," "No Trespassing," and – on the vehicle access gate – a sign posting contact information. The contact information sign contained outdated names and phone numbers. There was no evidence of vandalism or trespass, but minor repairs to the security fence, noted on the site map (Figure 2), are necessary.

**Maintenance Item:** Complete minor repairs to the perimeter fence (broken wires, slack wires, and broken or missing wooden spacers).

- Complete minor repairs to the perimeter fence (broken wires, slack wires, and broken or missing wooden spacers). Some repairs were completed in October and November 2012. All repairs are scheduled to be completed by July 31, 2013.
