2013 Annual Inspection Report for the DOE Monticello, Utah, Mill Tailings Site and Monticello Vicinity Properties

December 2013

Legacy
Management

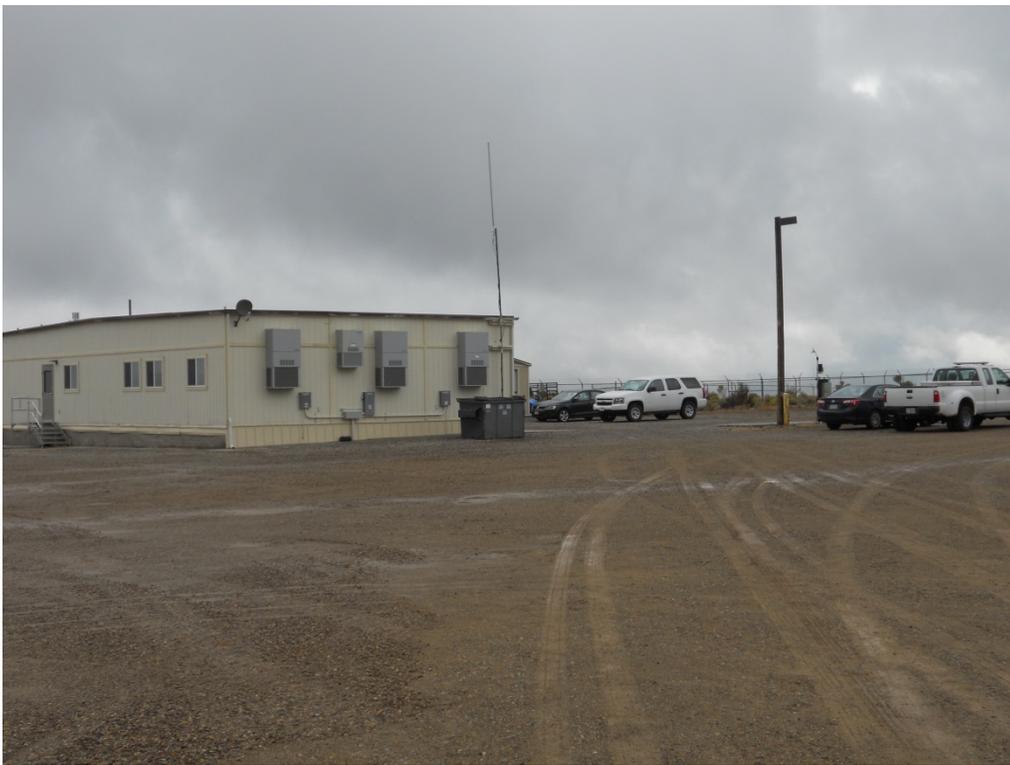
The Monticello field office buildings and associated structures were in excellent condition (Photo 1). Site access signs displaying contact information were current and visible. The site's paved access road was in good condition.

Photo 1. Office facility and parking lot.

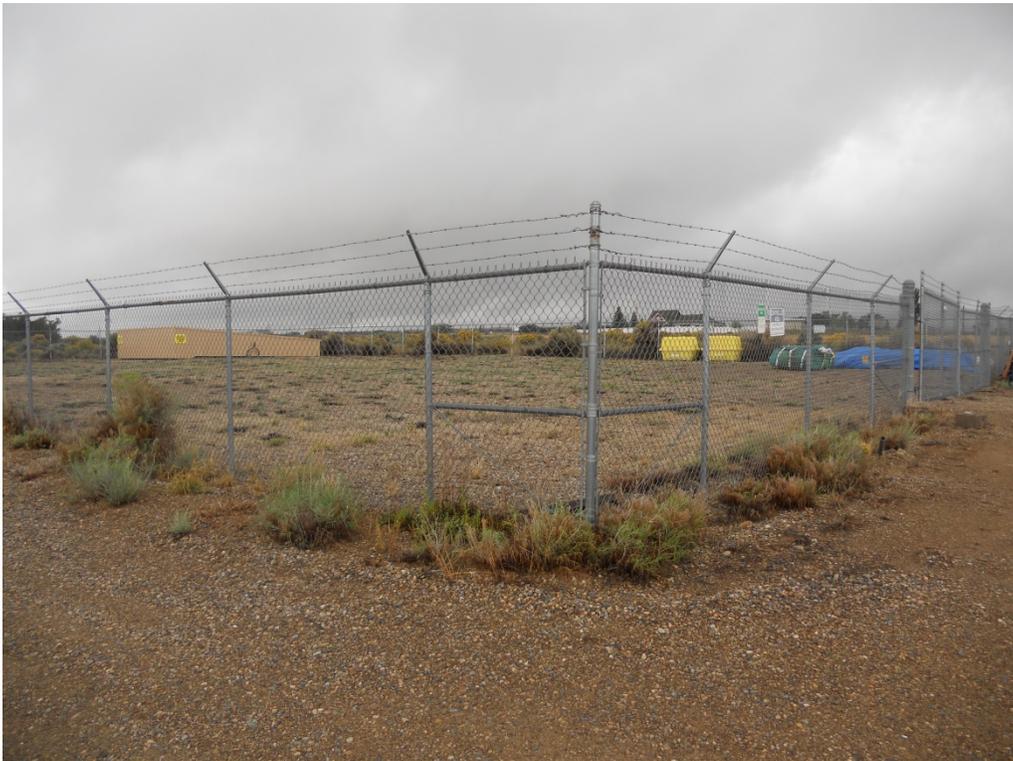
Photo 2. TSF yard and fence.

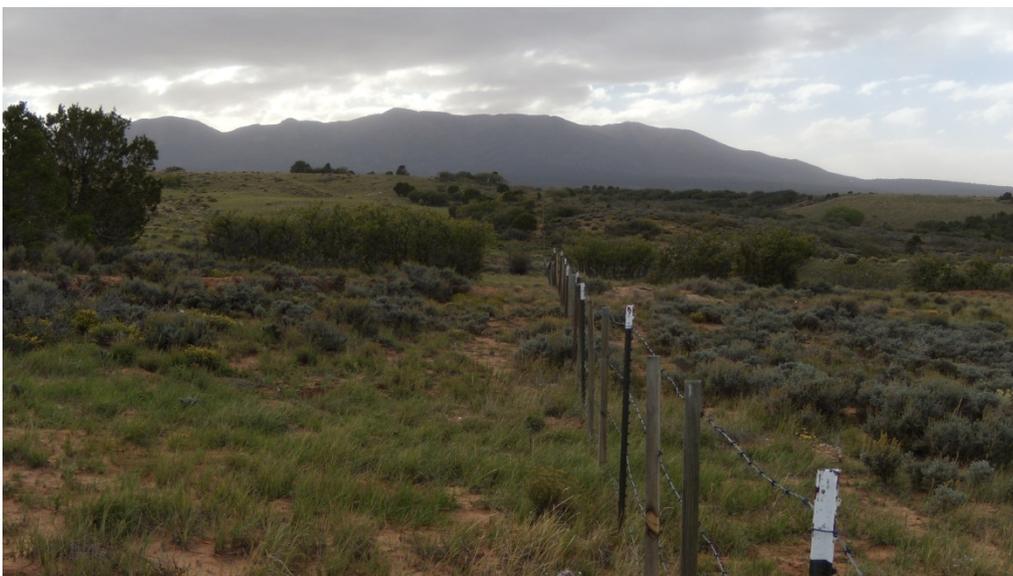
The perimeter fence was in good condition and was functionally intact. Repairs had been made to damaged areas reported in 2012 (Photo 3). No evidence of vandalism or areas of excessive tumbleweed buildup were present.

Photo 3. Section of perimeter fence with spacers repaired in 2013.

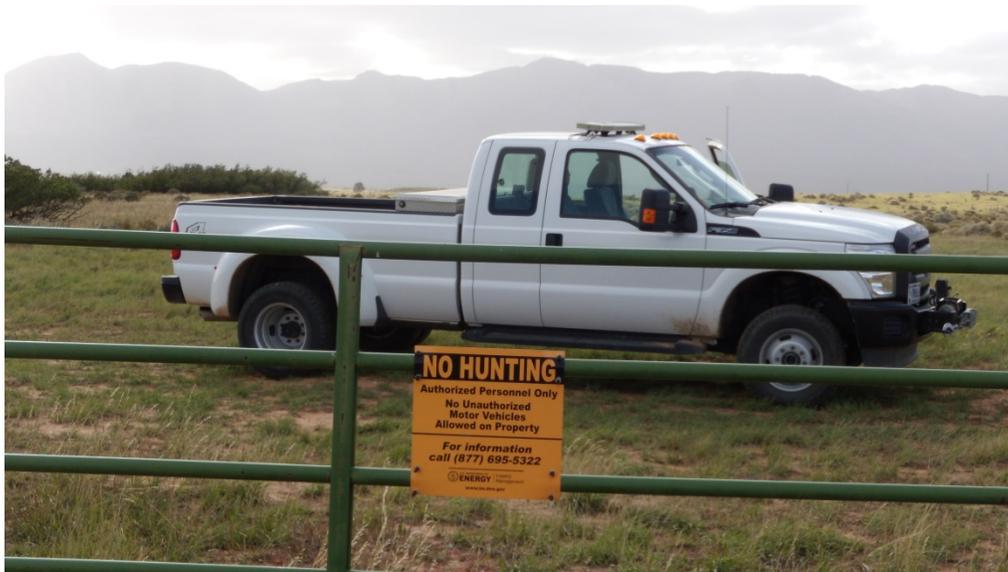
All perimeter signs were legible and in good condition, although perimeter sign P15 was scratched, and the designation “P15” was no longer readable. New “No Hunting” signs have been posted at all gates along the perimeter fence (Photo 4).

Photo 4. New "No Hunting" sign posted on a site access gate.

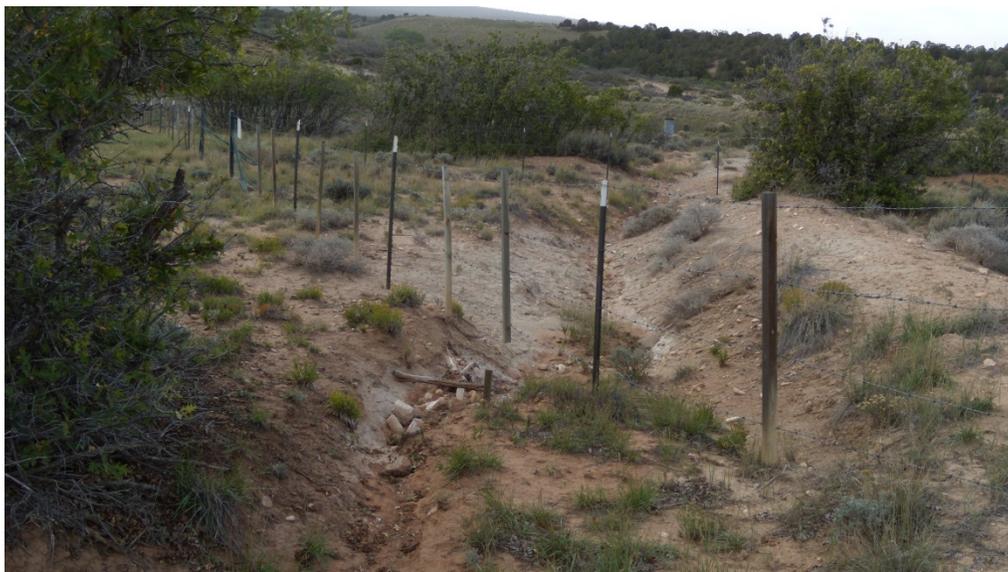
Photo 5. New erosion gully undercutting the fence between P16 and site access gate.

Notes for condition of repository perimeter (e.g., repairs needed, erosion areas, vandalism):
Spotted knapweed noted on map. Gully along west boundary filling in and stabilizing. New erosion area undercutting site boundary fence near perimeter sign P16. New erosion channels in previous remediation Haul Road near perimeter sign P16. Erosion repairs not recommended at this time, but monitoring will continue. Cows were observed grazing on Hammons property east of Pond 4, which may represent a land use change.

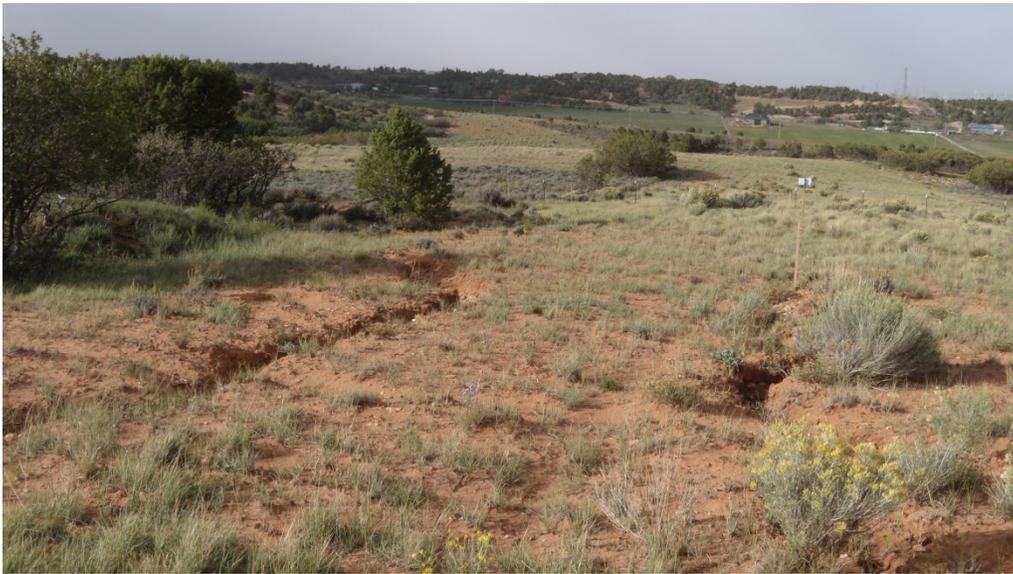
Photo 6. New erosion gully in former haul road corridor near P16.

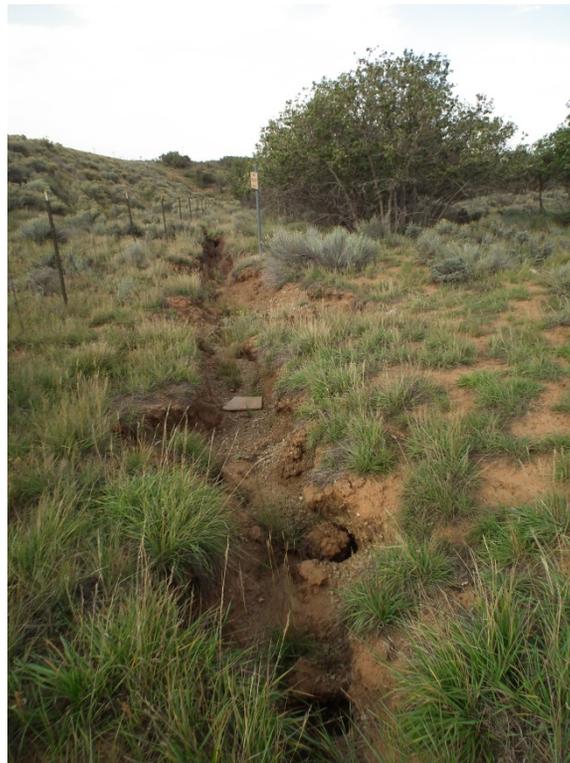
Photo 7. Erosion channel along west fence line near P1, continuing to fill in.

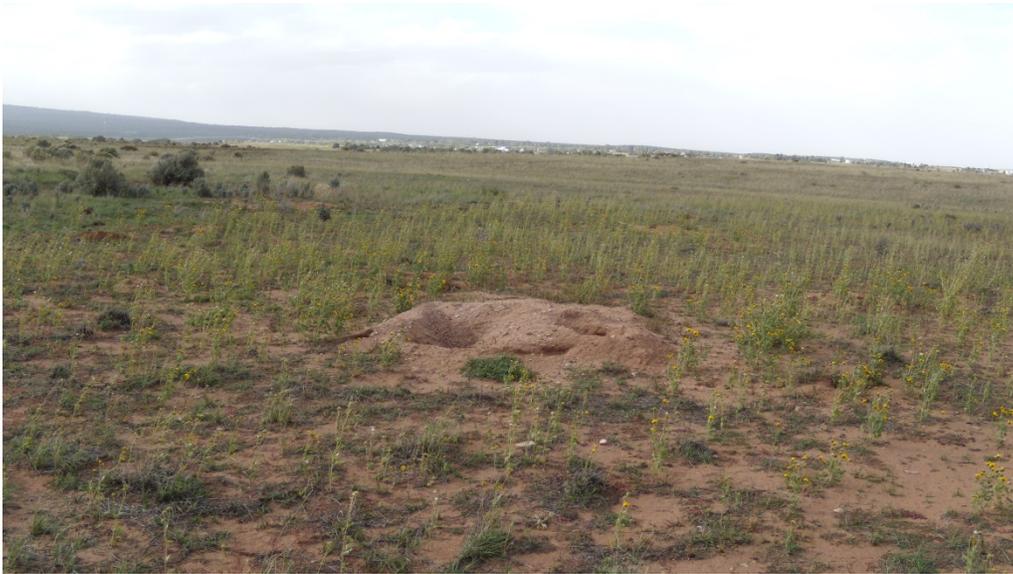
Photo 8. Prairie dog burrows and mound near the east perimeter fence.

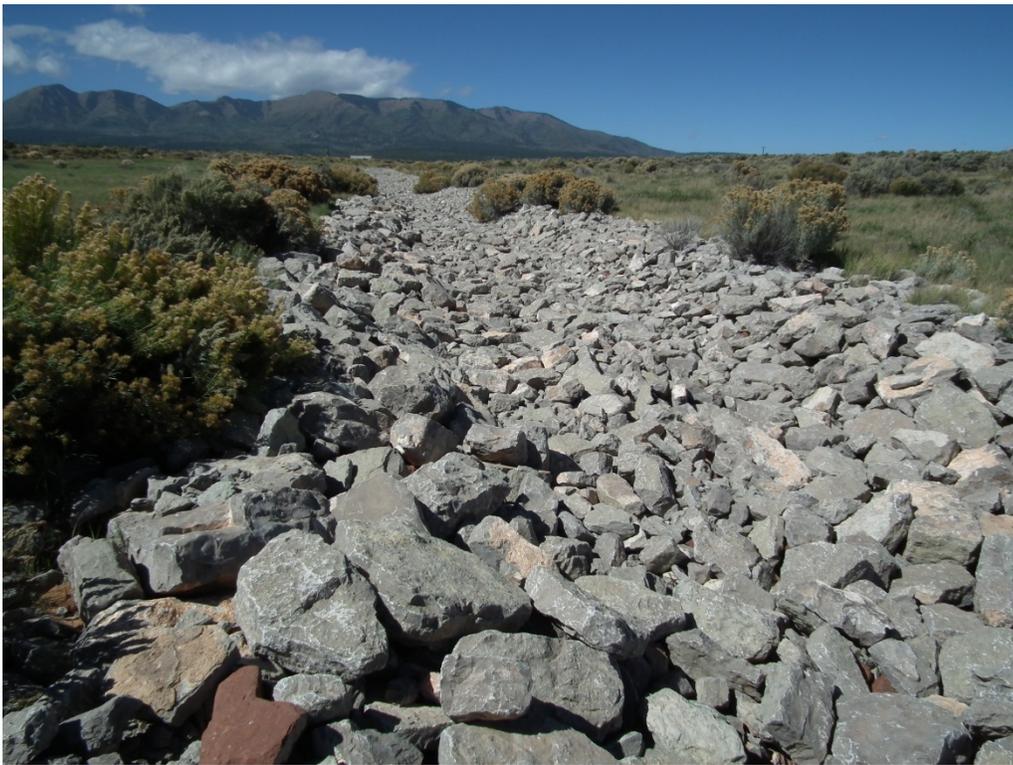
No evidence of new erosion was found in 2013 (Photo 9). Shrubs observed in portions of the South Drain Ditch do not block potential flow. Burrows from small rodents occurred in places along the margin of the ditch but do not threaten its integrity.

Photo 9. South Drain Ditch, view west.

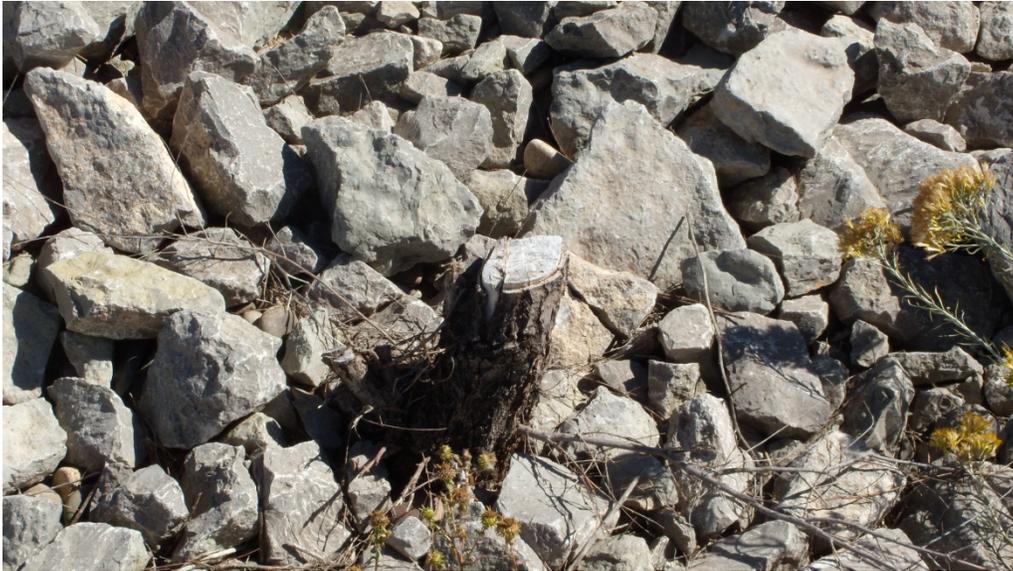
Photo 10. Elm stem cut and treated in West Drain Ditch.

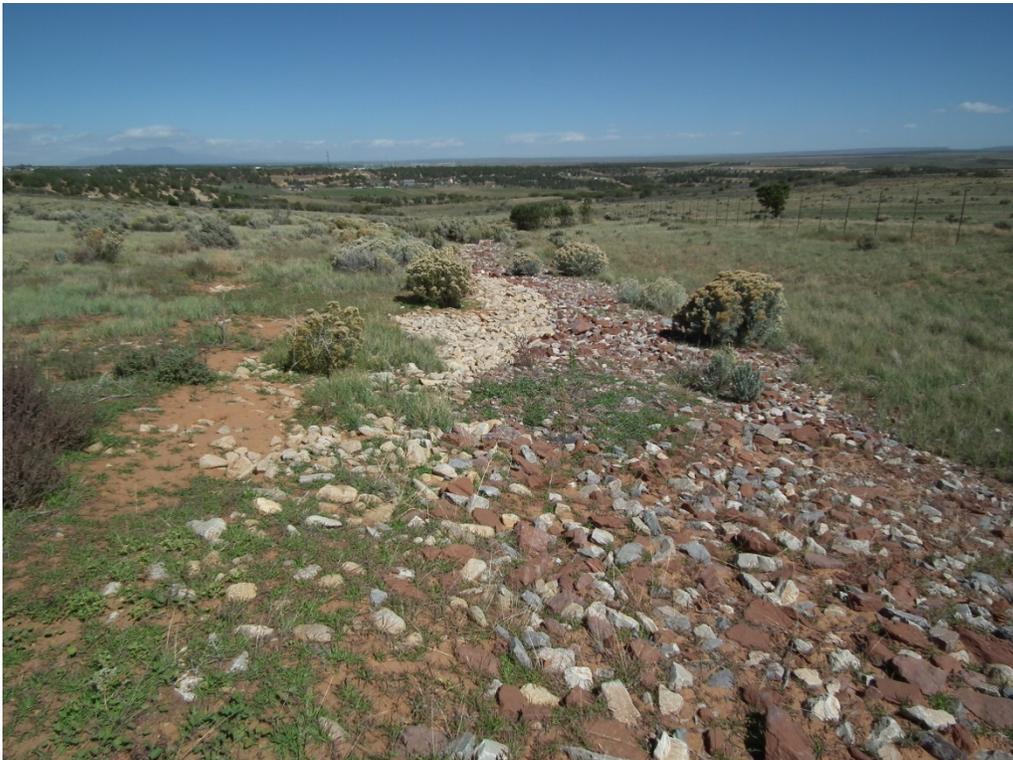
Erosion or bypass of these trenches was not evident. Soils and vegetation in the trenches are not expected to impede flows. After the recent large rainstorms, inspectors observed increased siltation and small amounts of surface riprap that had moved from the repository side slope (Photo 11). Monitoring of the toe trenches will continue to ensure that any material movement does not threaten the integrity of the disposal cell.

No area of the cover indicated settling, slumping, fracturing, seepage, ponding, or significant erosion. The steep, rock-lined slopes showed no evidence of rock degradation, settling, or slumping. As reported in Section 2.1.3, a small amount of rock riprap and soils have moved into the East and North Toe Trenches.

Photo 11. Northern portion of the East Toe Trench showing soil and riprap movement.

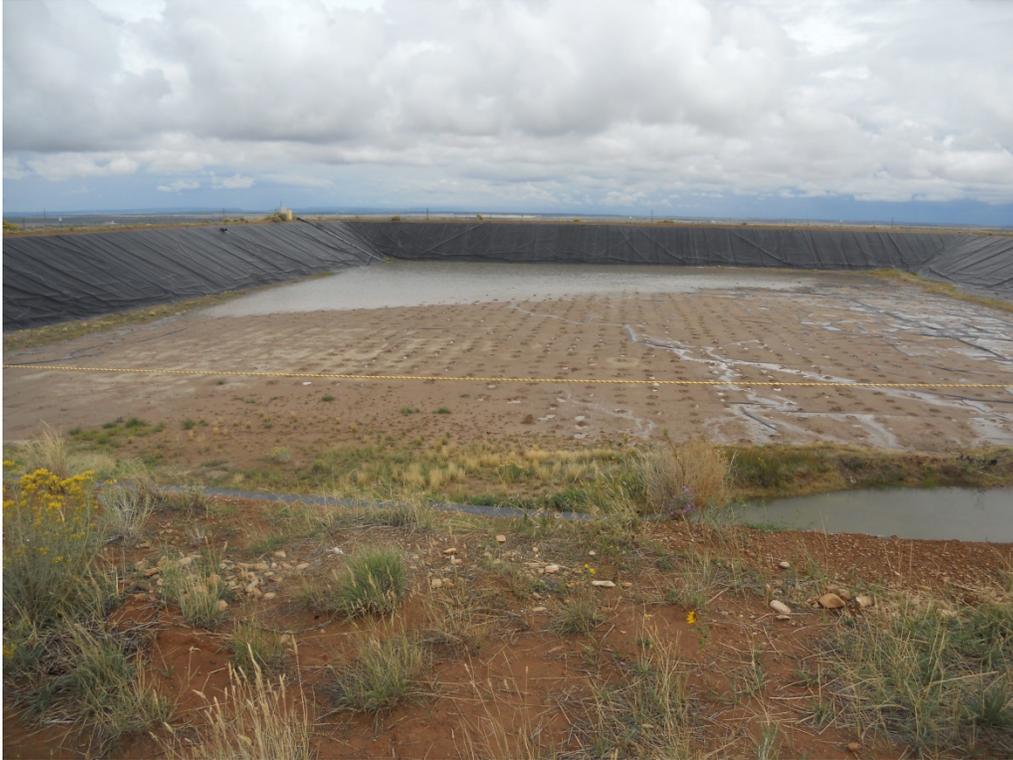
The pond liner was most recently repaired in August 2013, and no visible evidence of holes or other damage to Pond 4 was observed during the 2013 inspection (Photo 12). Liner anchors were also removed from the pond in 2013. Several inches of water was standing in the northeast and southwest corners of the pond. Saltcedar (*Tamarix ramosissima*) infestations reported in 2012 have been removed.

Photo 12. Barrier rope, standing water, sediment, and shallow-rooted vegetation at Pond 4.

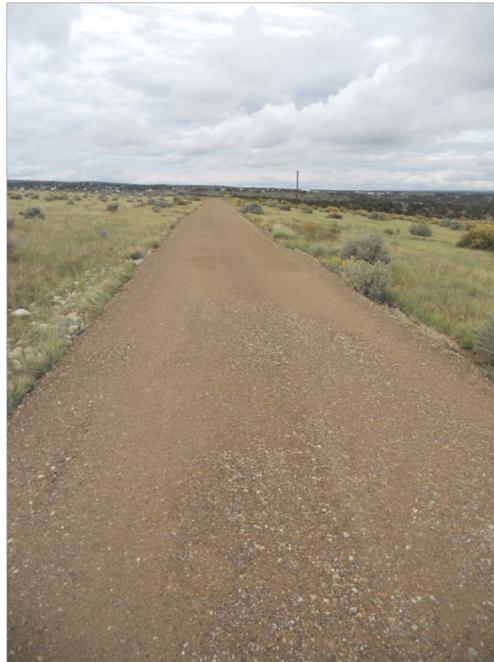
The gravel road surrounding the disposal cell and the road to Pond 4 were in excellent condition, and the disposal cell road had been recently repaired and resurfaced (Photo 13). The wildlife fence and gate apertures were functional and showed no evidence of vandalism. Both site monuments—one at the west access gate inside the wildlife fence and one at the apex of the disposal cell (Photo 14)—were present and intact. Six raptor perches, installed near the disposal cell cover in 2007, were also in good condition and continued to show evidence of use.

Photo 13. Newly repaired and resurfaced repository loop road.

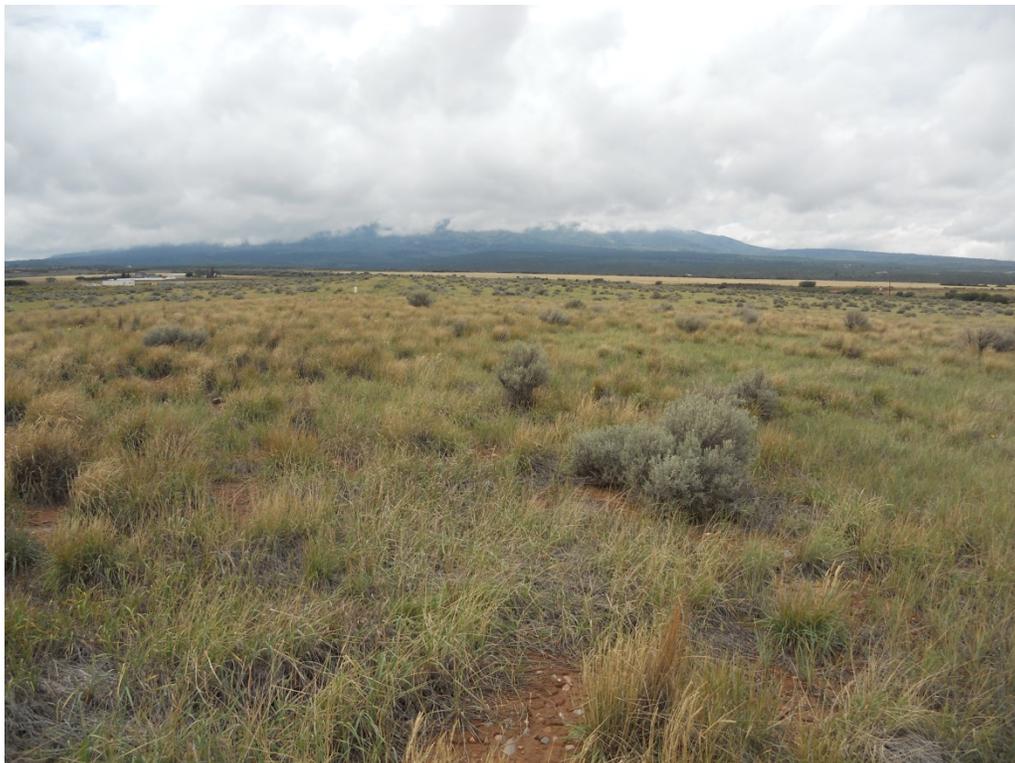
Desirable plants remained well established on the cover, and no significant barren or eroded areas were identified (Photo 15). No damage to vegetation or soils from the large, recent rainstorm was apparent. No species of phreatophyte shrubs were growing on the cover. A large number of healthy, desirable sagebrush (*Artemisia tridentata*) seedlings were apparent in 2013, as they were in 2012. Small quantities of field bindweed were growing on the cover, but because it is not spreading, control is unnecessary.

Photo 15. View west of the vegetated cell cover.

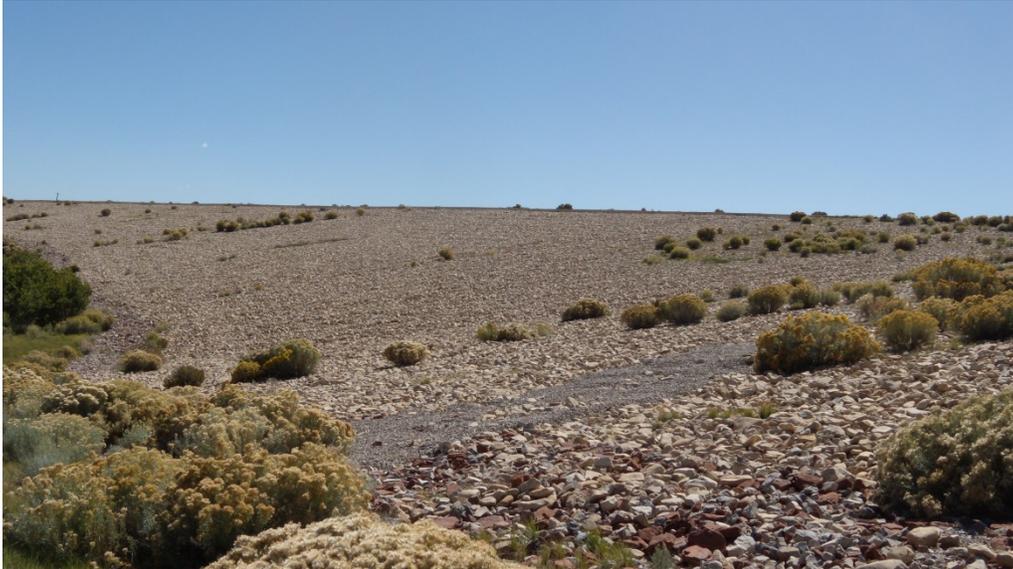
Photo 16. Repository side slope showing vegetation.

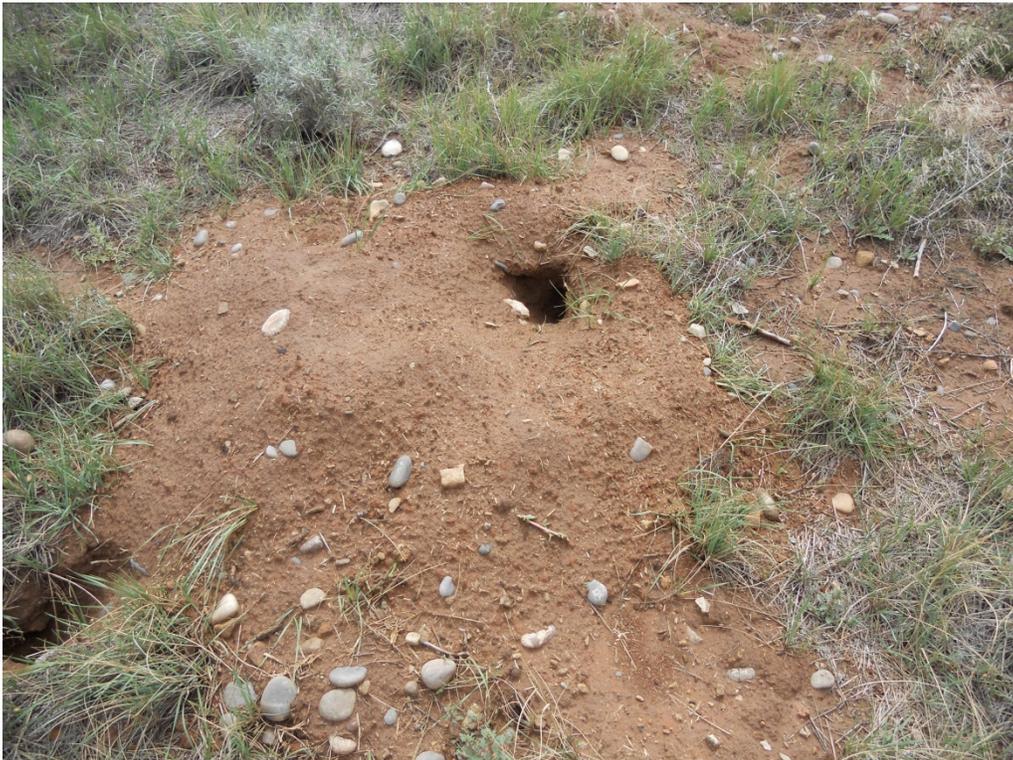
Small burrowing animals have been observed on the repository cover for years. Raptors and other predators have kept these populations at moderate levels since a vole outbreak occurred in 2006. In 2013, prairie dog burrows were found on the repository cover for the first time, and these burrows were monitored during the annual inspection (Photo 17). Because the repository cover was engineered to withstand prairie dog activity, populations are not a concern at this time. Burrows and the effect of prairie dog populations on the vegetation cover will continue to be monitored. Inspectors and onsite personnel will look for evidence of gray-colored soils being cast to the surface, as this would indicate excavation in the biointrusion layer. No such soils have been observed on the surface.

Photo 17. Prairie dog burrows on cell cover.

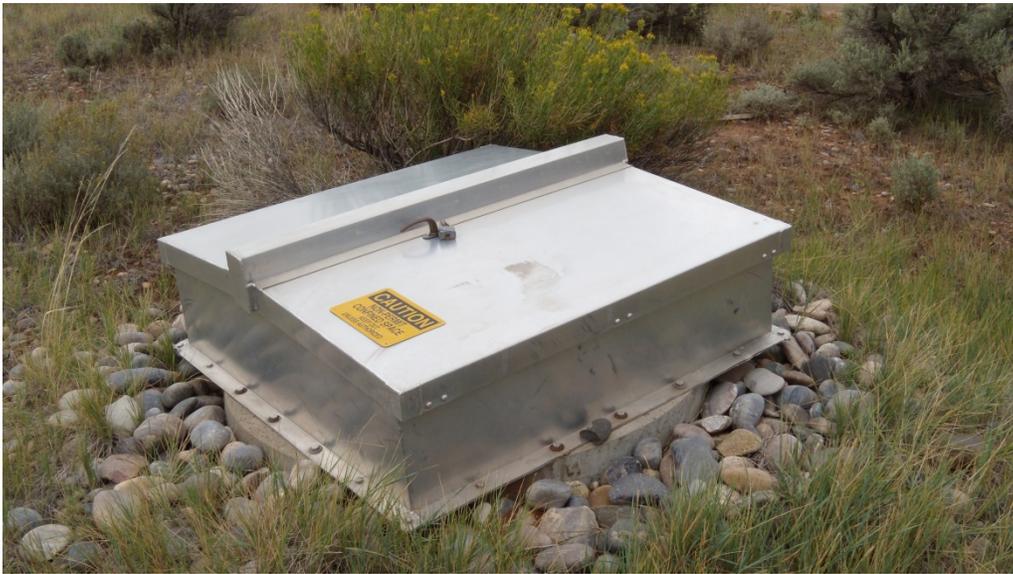
The manholes are restricted areas and were not entered during the annual inspection, but the exteriors were in good condition. All five manhole covers were secure and operable, and all of the bolts on the covers had been replaced. Manhole 4 will continue to be monitored, as soils have eroded on its uphill side, and rocks have been displaced to the top of the structure. Appropriate safety warnings and entry procedures were posted on the manholes, exterior pump access ports were undamaged, telemetry surface installations were in good condition, and no leakage or drainage was evident. Covers of the two inoperable video ports were locked and secure (Photo 18).

Photo 18. Video Port MH 1.

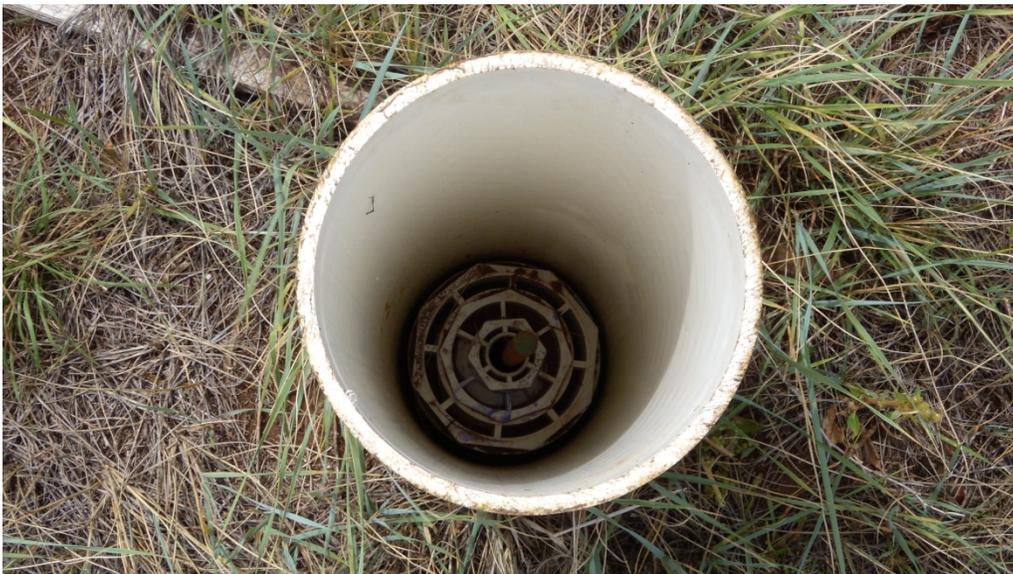
Photo 19. Interior of Settlement Plate E on cell cover.

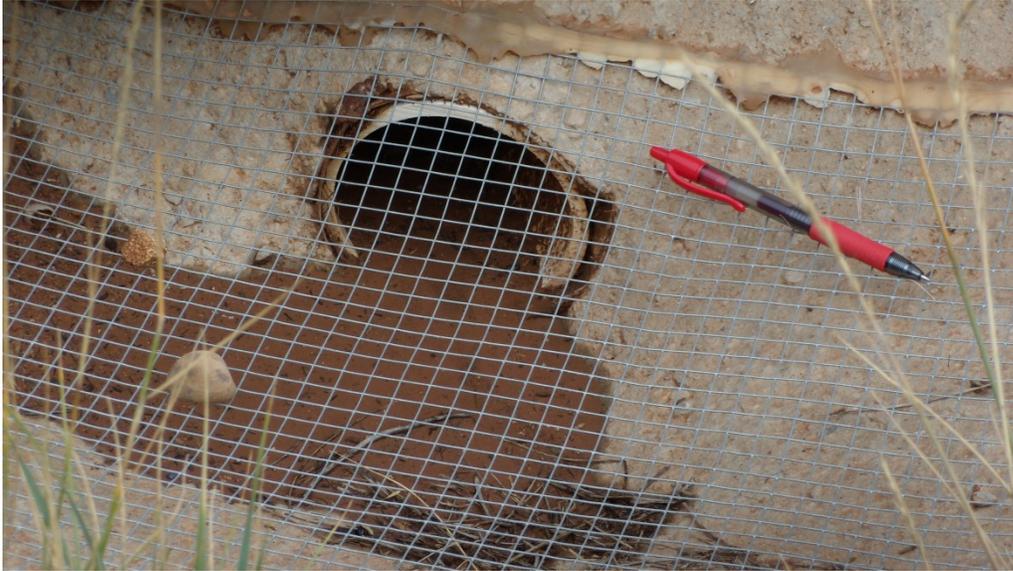
External features of the embedded lysimeter were inspected. Drainage and a small amount of siltation were detected at the outlet due to recent rainfall (Photo 20). Along cover penetrations, no seepage was evident. Instrumentation installations were in good condition.

Photo 20. Lysimeter outlet with minor siltation.

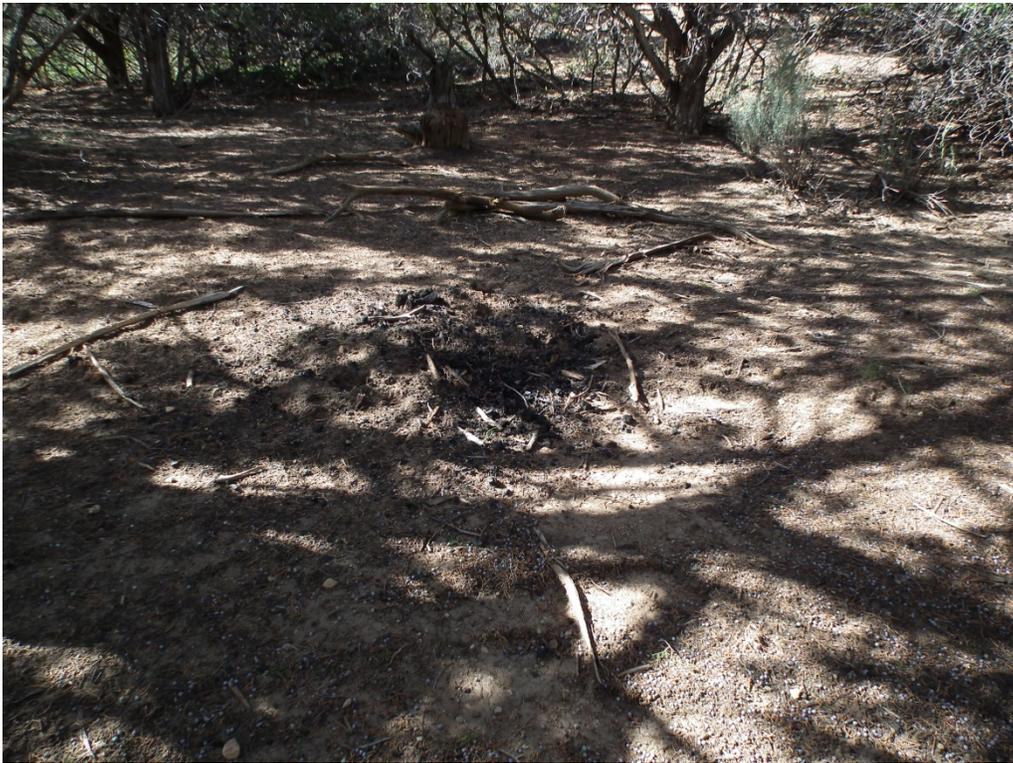
Overnight camping is not allowed on these properties. One area, previously determined to be a day camp on Property MP-01077, is routinely monitored by onsite personnel, and no evidence of recent use was observed. A fire pit previously identified on MP-01040 (North) was no longer apparent and will no longer be monitored. A fire pit discovered in 2012 on MP-01041 showed no evidence of additional use (Photo 23).

Photo 23. Discovered in 2012, this day camp area and fire pit show no evidence of additional use.

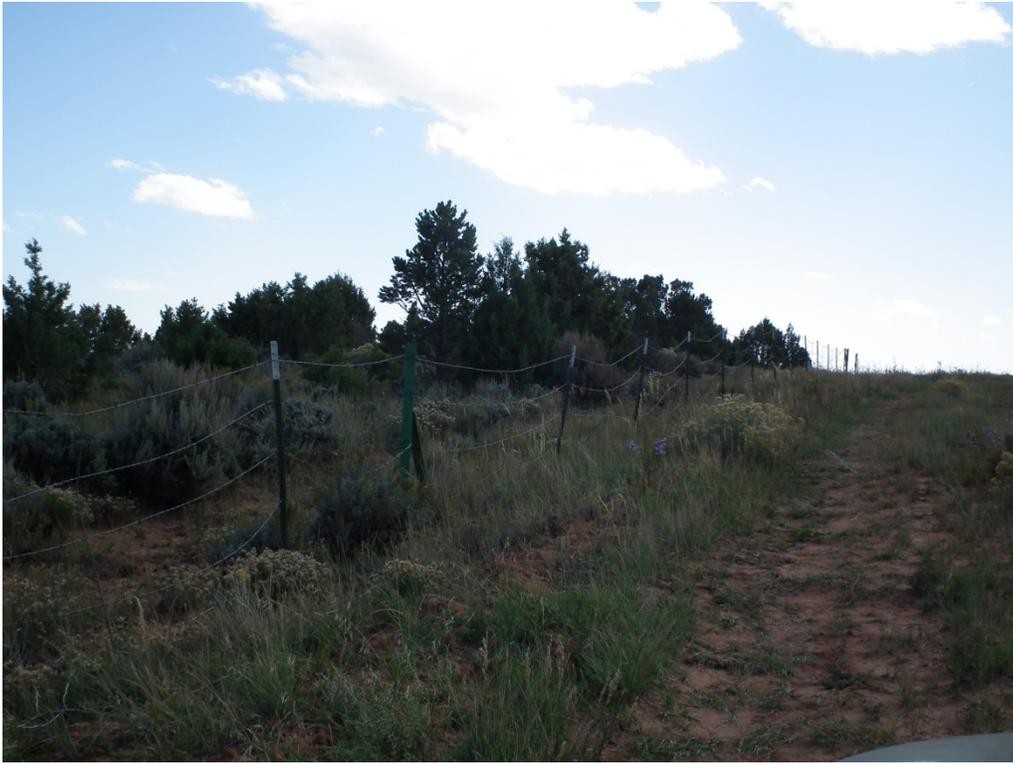
No evidence of new soil removal was noted on any of the Piñon/Juniper properties supplemental standards areas. However, recent rainstorms had eroded some soils on the hillsides. The supplemental standards areas are physically delineated by four-strand wire fences. The City of Monticello breached sections of these fences to accommodate mountain bike trails, and other sections of the fence have degenerated due to age (Photo 24). The bike trails and areas of eroded

Photo 24. Supplemental standards fencing showing deterioration over time.

Supplemental standards fence was breached years ago by the City for access to trails. Remaining fence is aging and deteriorating. Water wells are used to irrigate VMTE memorial tree plantings, and it is recommended that the water source be verified. To strengthen enforcement of ICs, it is recommended that "No Overnight Camping" signs be posted in supplemental standards areas.

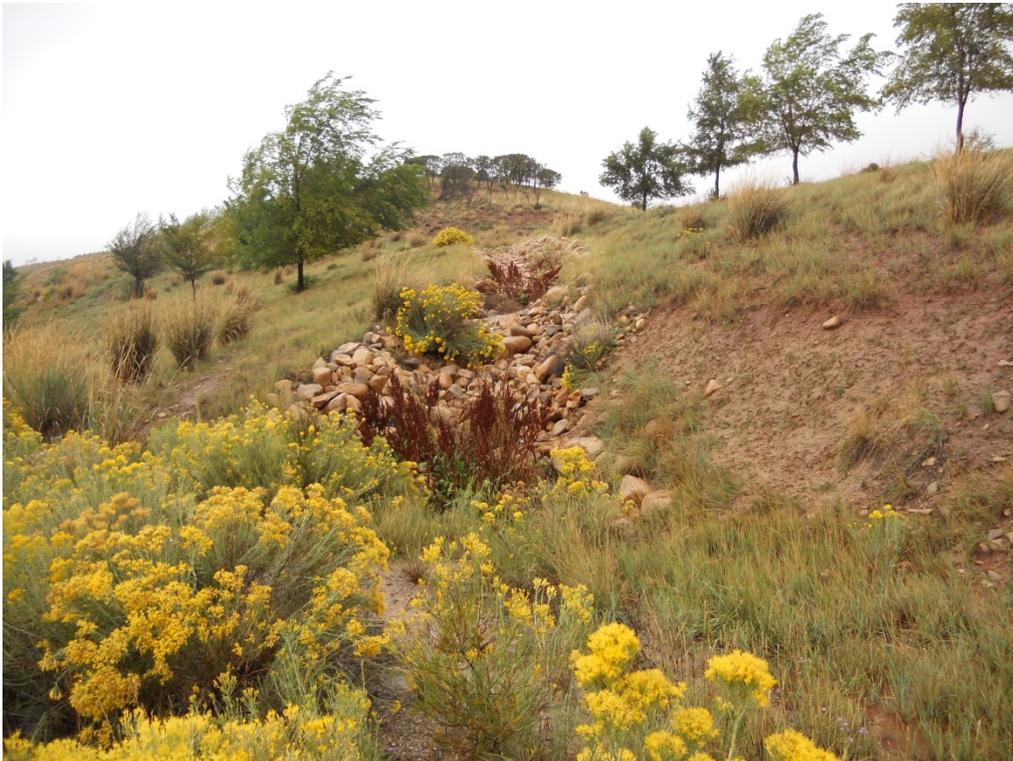
All riprap-armored structures, dams, check dams, berms, and runoff control drainages (Figure 4) were intact and functional. One riprap-armored structure below Steele's Pond on the former mill site was observed effectively carrying runoff during a significant rainstorm (Photo 25). Although all erosion structures were functional, erosion gullies have formed in portions of the access roads on several of the non-supplemental standards properties (Photo 26).

Photo 25. Rock-lined channel below Steele's Pond at former millsite, effectively carrying significant runoff.

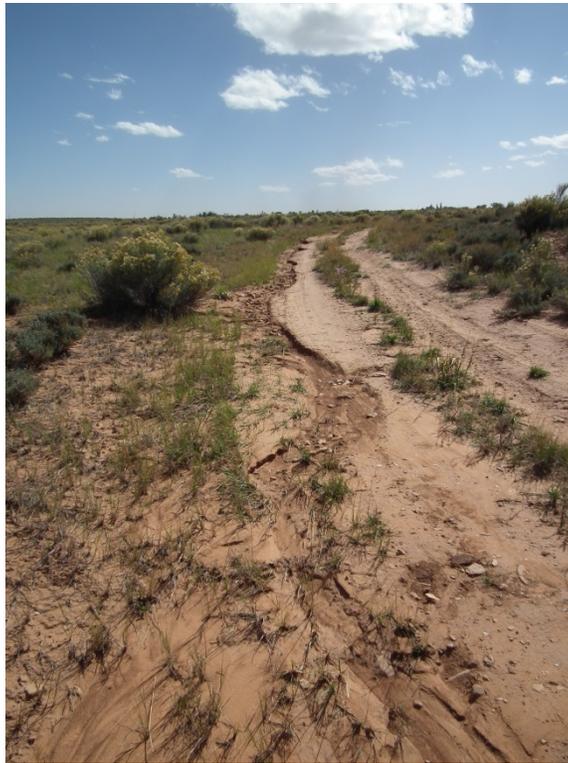
Photo 26. City-owned property MP-01040 with erosion channel in road.

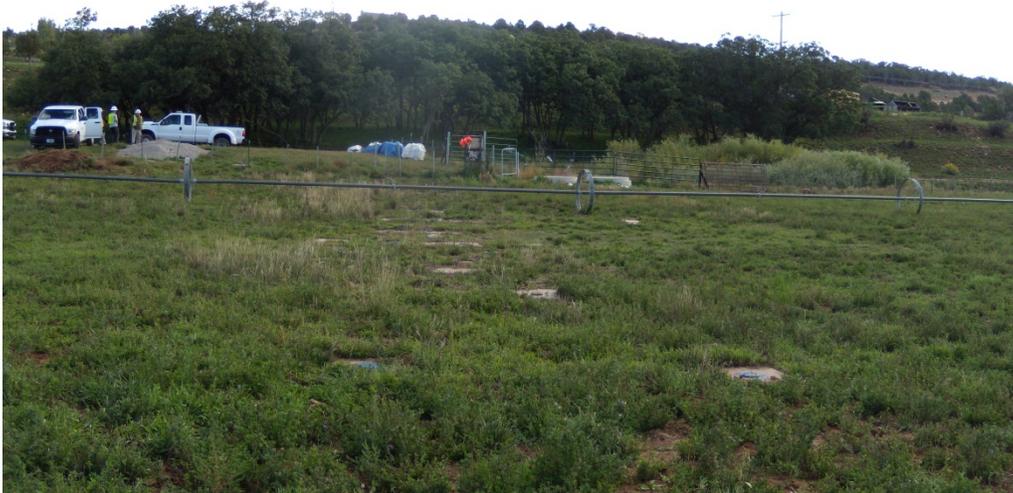
A groundwater treatment system comprising the PRB and treatment cells is on Property MP-00179 (private property) east of the former mill site. Although the structures are regularly maintained, features of these systems are inspected each year to ensure that the current land use, ranching, is not adversely affected. These features were inspected on September 17 and 18 in conjunction with the change-out of reactive media in the auxiliary treatment cells. All structures were in good condition, and there was no evidence of ponded water, saturated soil, surface disturbance, or stressed vegetation in the vicinity of the PRB or treatment vaults (Photo 29).

Photo 29. Wells in the vicinity of the auxiliary treatment cells.
