2009 Annual Inspection of the Monticello Mill Tailings (USDOE) and Monticello Radioactively Contaminated Properties Sites

December 2009

U.S. DEPARTMENT OF
ENERGY

Legacy
Management

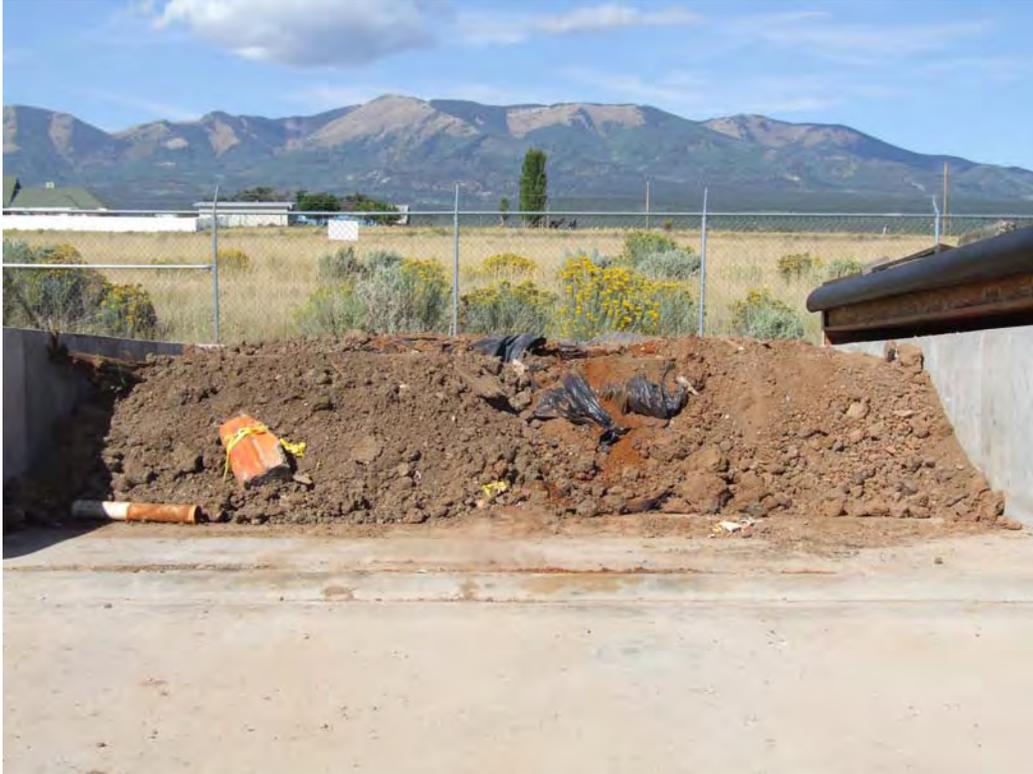
1. Material in TSF bin at the time of annual inspection.

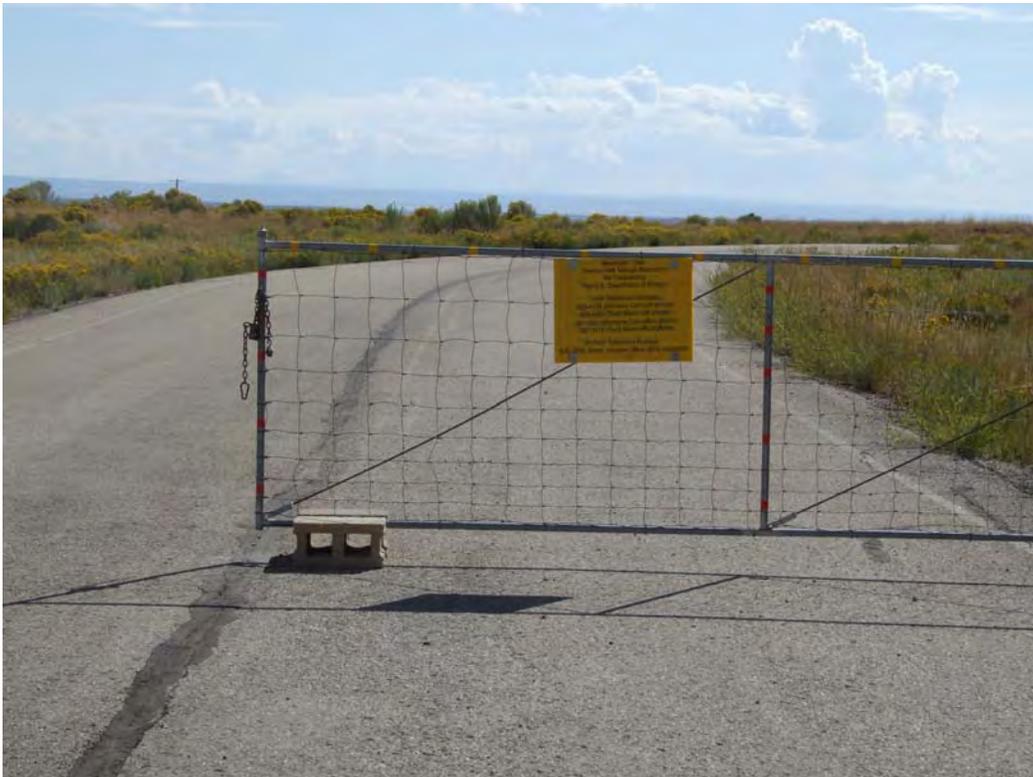
2. Repository site main access gate.

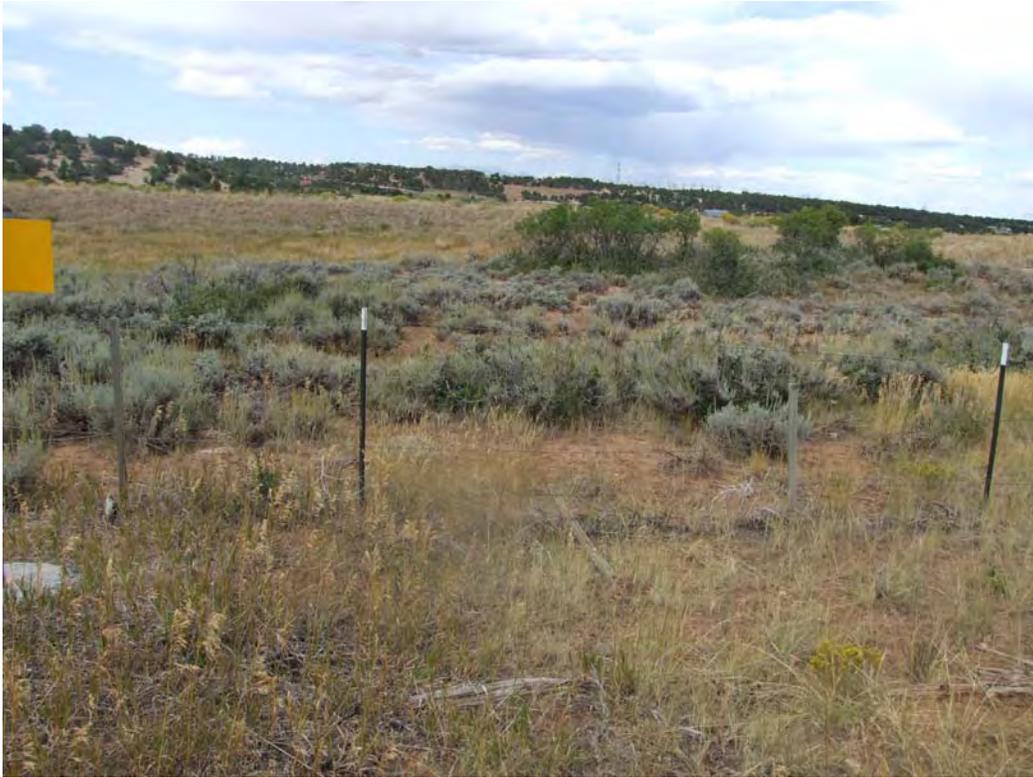
The perimeter fence along the south edge of the repository site was replaced in fall 2008, but snow and livestock damaged the fence again in winter 2008–2009. Damaged sections were repaired in spring 2009, and the perimeter fence was in working condition at the time of the annual inspection. A small section of fence is damaged near perimeter sign P15 and requires repair (Photo 3).

3. Damaged fence section near perimeter sign P15, view north.

Maintenance Item: Repair section of damaged fence near perimeter sign P15.

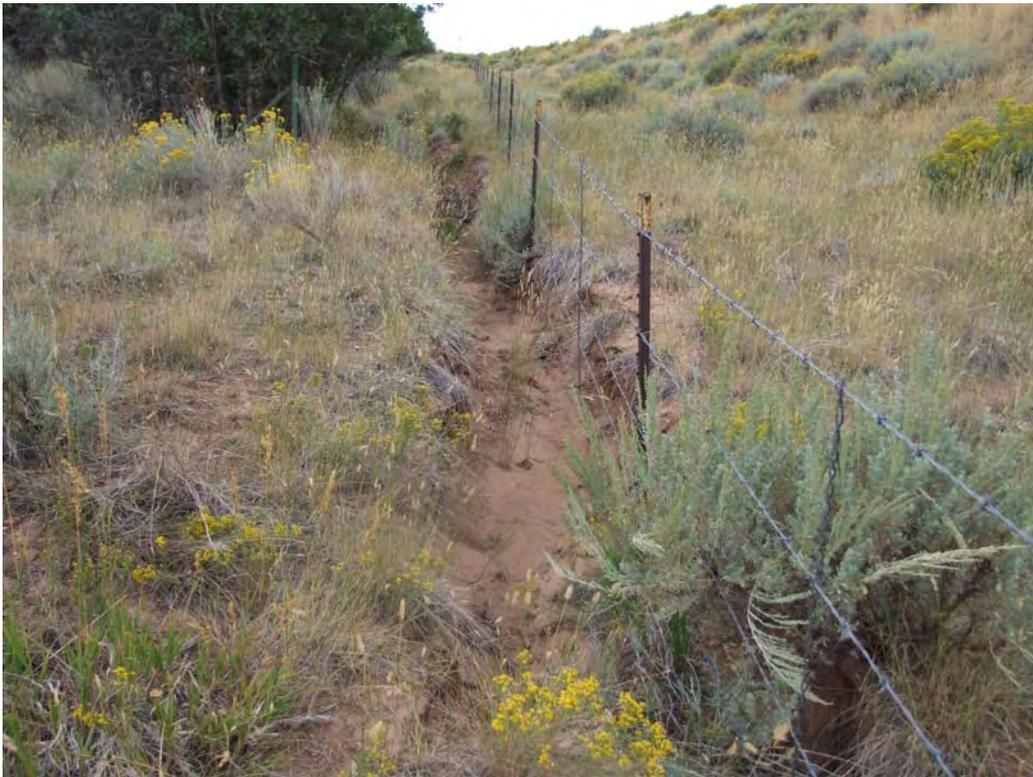
No new erosion was evident during the 2009 inspection. Previous inspection reports describe a gully between perimeter signs E and P2, which threatened portions of the fence line along the west boundary of the site. Because sources of water to the gully have been re-routed or repaired, no action was taken to fill the gully or to move the perimeter fence. In 2009, the gully was still present but had become shallower in places where walls had collapsed and materials were deposited (Photo 4). It is anticipated that this process will continue to fill the gully over time.

4. Gully between perimeter signs P1 and P2, view south.

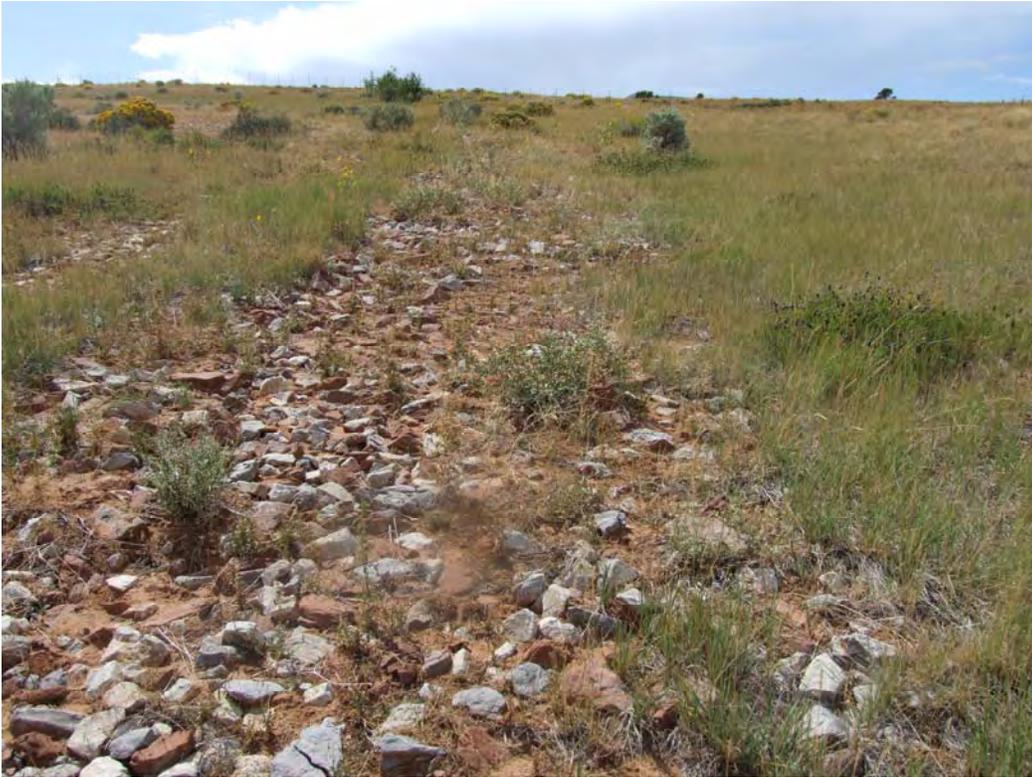
Some rock at the surface of the East and North Toe Trenches has continued to degrade; windblown sediment has accumulated at the surface, and in places, plants are becoming established. However, erosion or bypass of these trenches is not evident. Soils and vegetation have accumulated in the drainage downgradient from the East Toe Trench, but flows are not impeded. Soils and vegetation have also accumulated in the drainage downgradient from the North Toe Trench; some slopes in this area show evidence of minor sheet erosion.

5. Sediment and vegetation in East Toe Trench extension near wildlife gate.

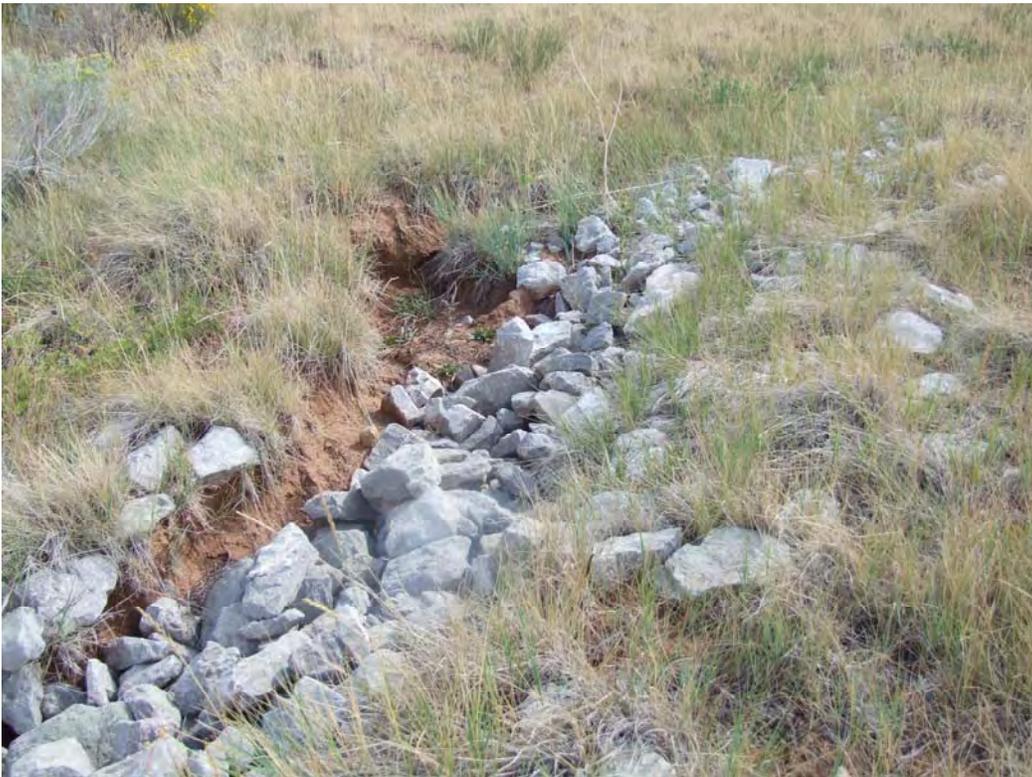
In 2002, eroded areas in the West Drain Ditch channel immediately north of the inner fence were repaired, and the channel was lined with rock all the way to North Draw. This repaired section is in good condition. Minor erosion is evident in a small armored gully noted during the 2008 annual inspection and will continue to be monitored (Photo 6).

6. Minor erosion area near West Drain Ditch.

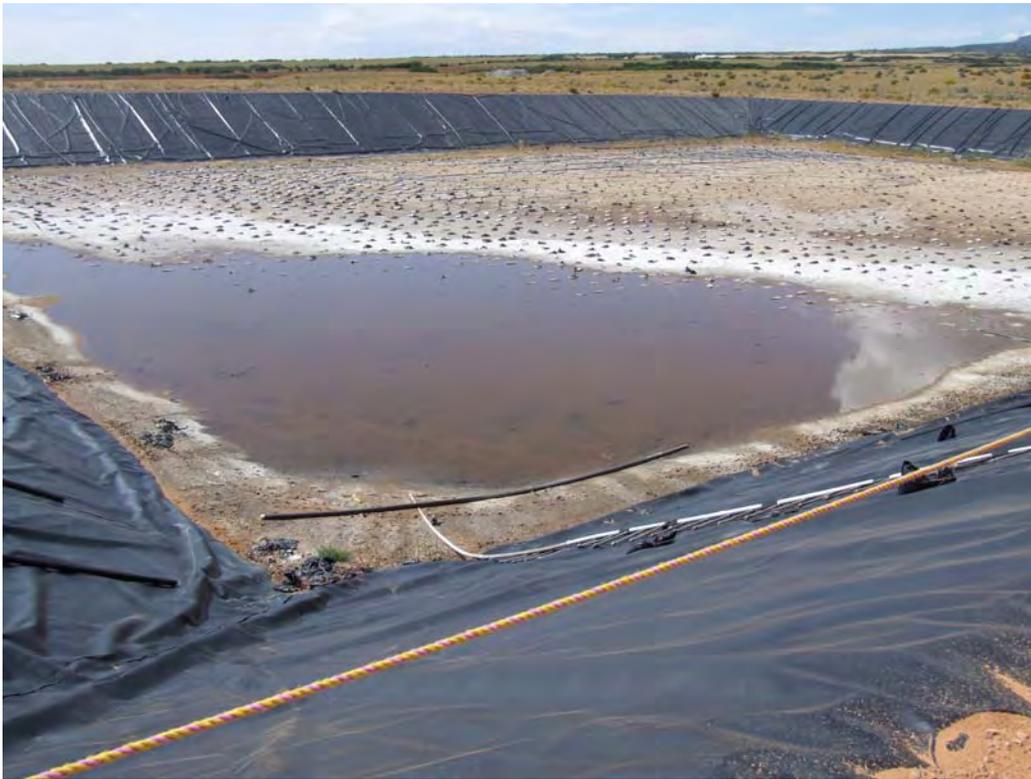
No evidence of holes in the pond liner was observed (Photo 7). Liner anchors, consisting of sand-filled polyethylene pipe installed in 2007, are in good condition. Approximately one foot of water is standing in the northeast corner of the pond. The pond also contains minor silt and vegetation. A doe deer was discovered in Pond 4 several weeks before the annual inspection. The fence was inspected at the time of the incident and no holes or breaches were observed. The liner was inspected at the time of the incident and also after the annual inspection, and no evidence of breaches, tears or damage was identified. The deer was chased out of the enclosure at the time of the incident and has not returned. Routine inspections continue to include looking for wildlife in the enclosure.

7. Pond 4 showing liner, water, vegetation, and silt.

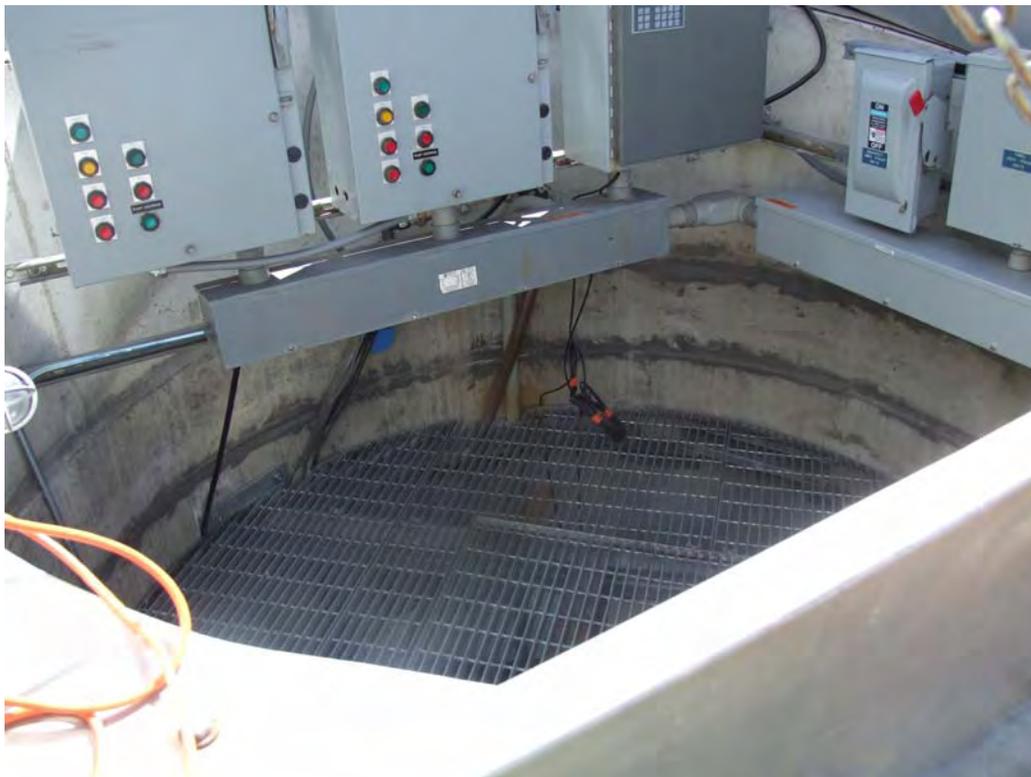
Manholes 1 and 3 enclose equipment for the disposal cell LCRS and LDS. They were not entered during the annual inspection, but the interiors of both manholes were observed from above ground (Photo 8 shows Manhole 3). All five manhole covers are secure and operable, appropriate safety warnings and entry procedures are posted, the exterior pump access ports are

8. View inside Manhole 3.

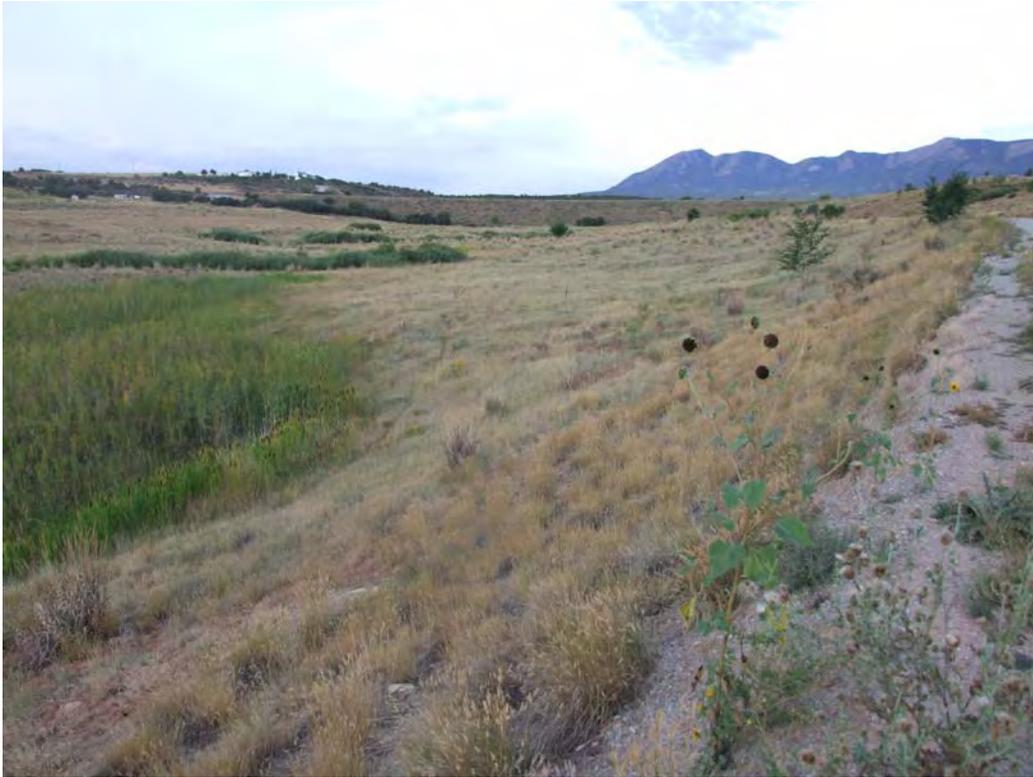
9. Former millsite, view southwest.

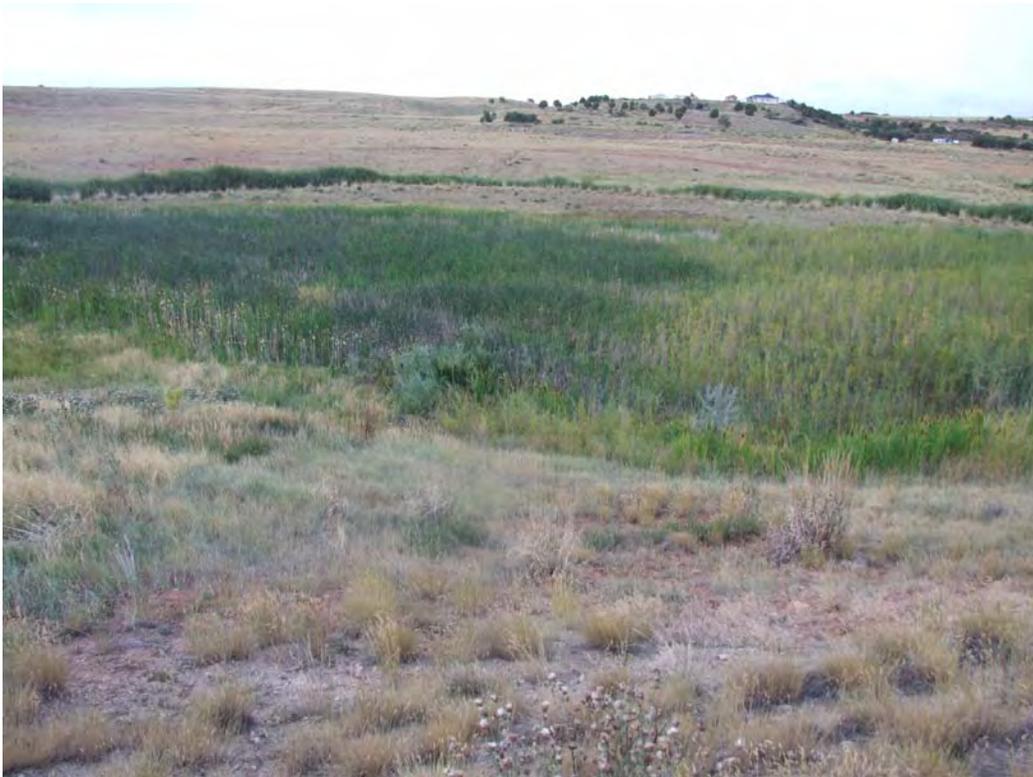
10. Former mill site, view south.

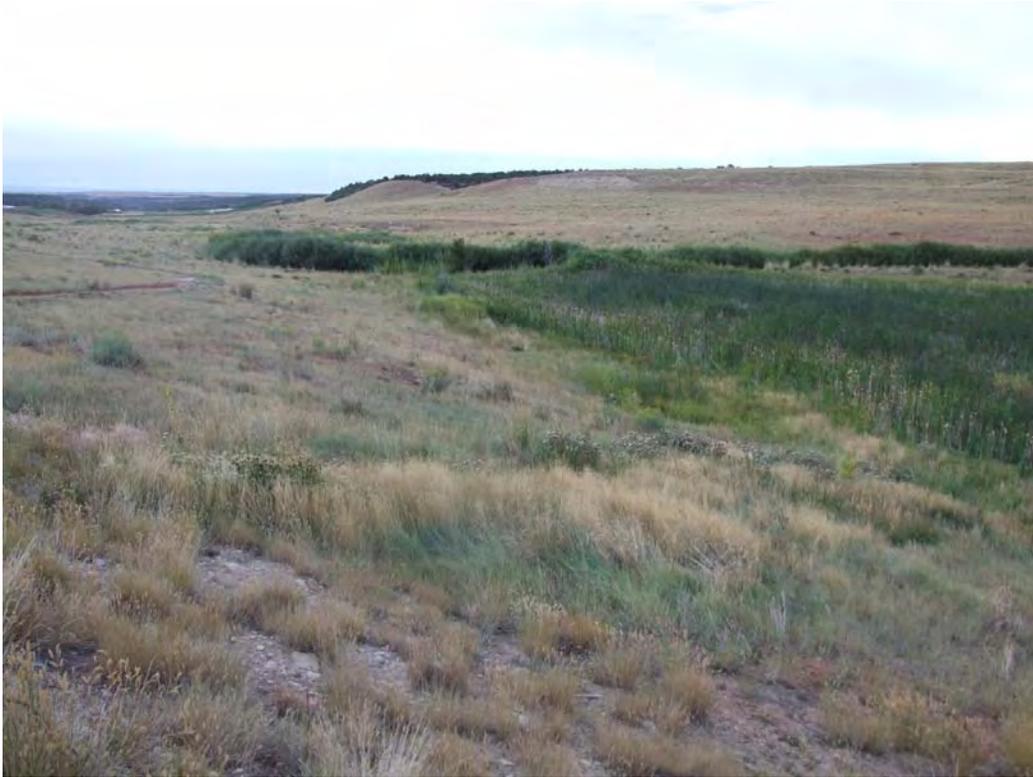
11. Former mill site, view southeast.

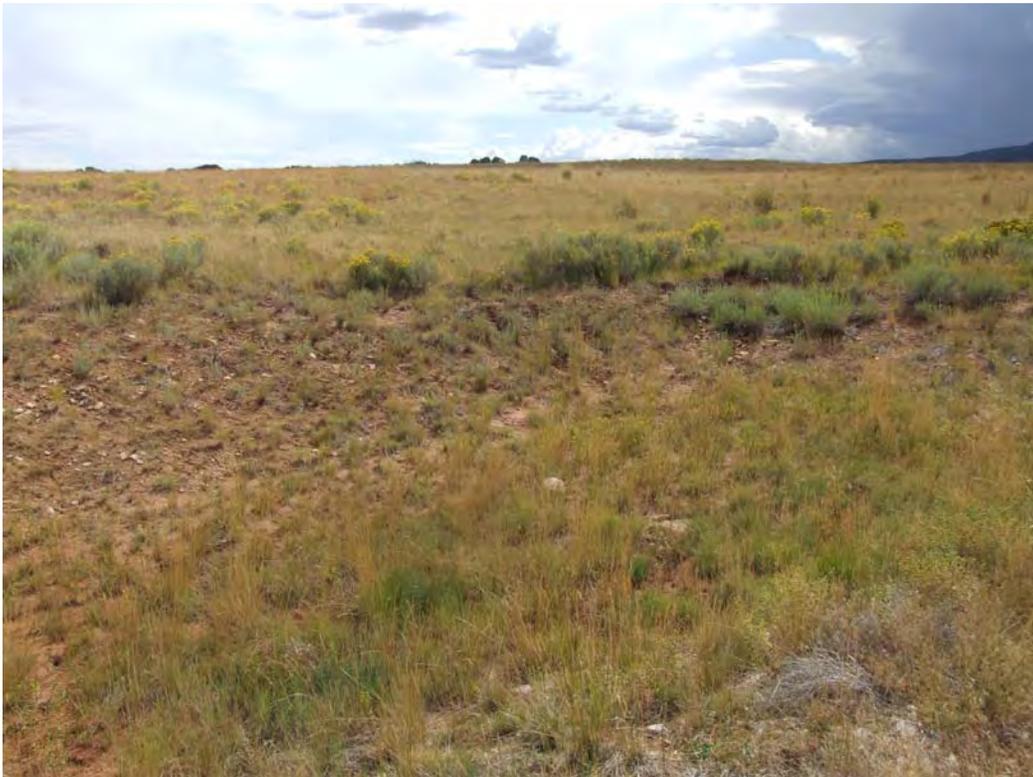
All riprap-armored structures, dams, check dams, berms, and runoff control drainages (see Figure 4) are intact and functional. No major erosion issues were noted during the 2009 inspection (for example, see Photo 12). A silted trench with reduced capacity was noted on Property MP-01077 by the adjacent landowner (Photo 13). The landowner indicated that the City of Monticello had partially repaired the trench, but more work was required to restore it to full capacity and prevent a possible breach by storm events. The landowner has reported this to the City of Monticello.

12. View southwest from Deer Dam showing vegetated check dams.

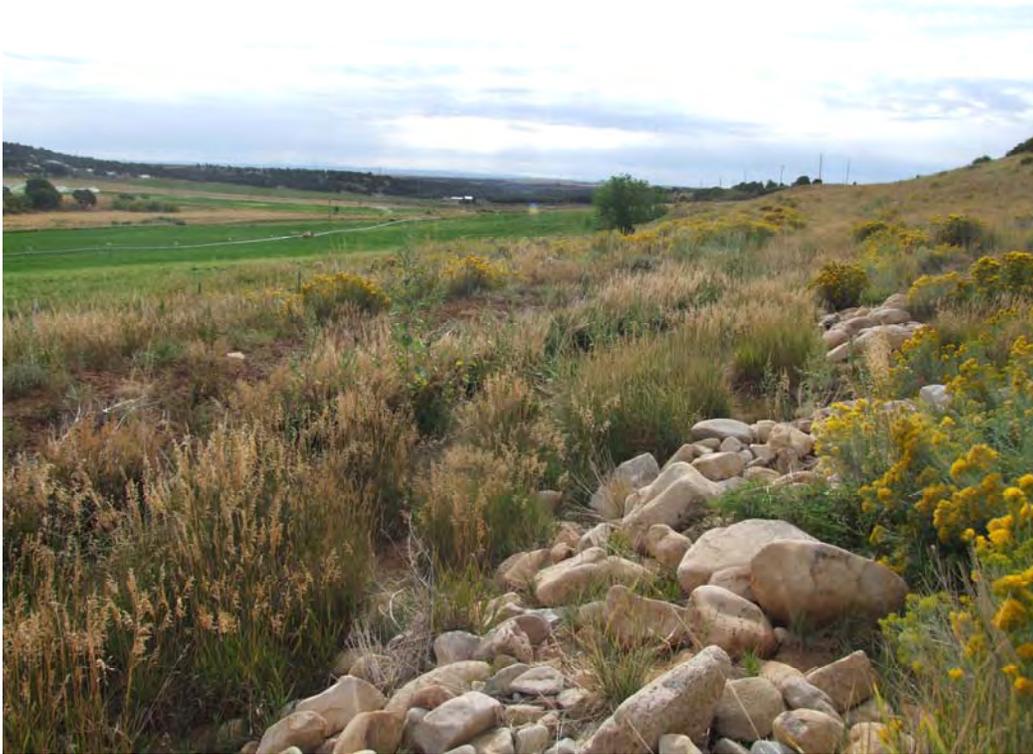
13. Silted trench on Property MP-01077, view east.

Siltation of trench on Property 1077 reported by downslope landowner; landowner has reported to City and some repairs had been performed, but trench still inadequate in places.

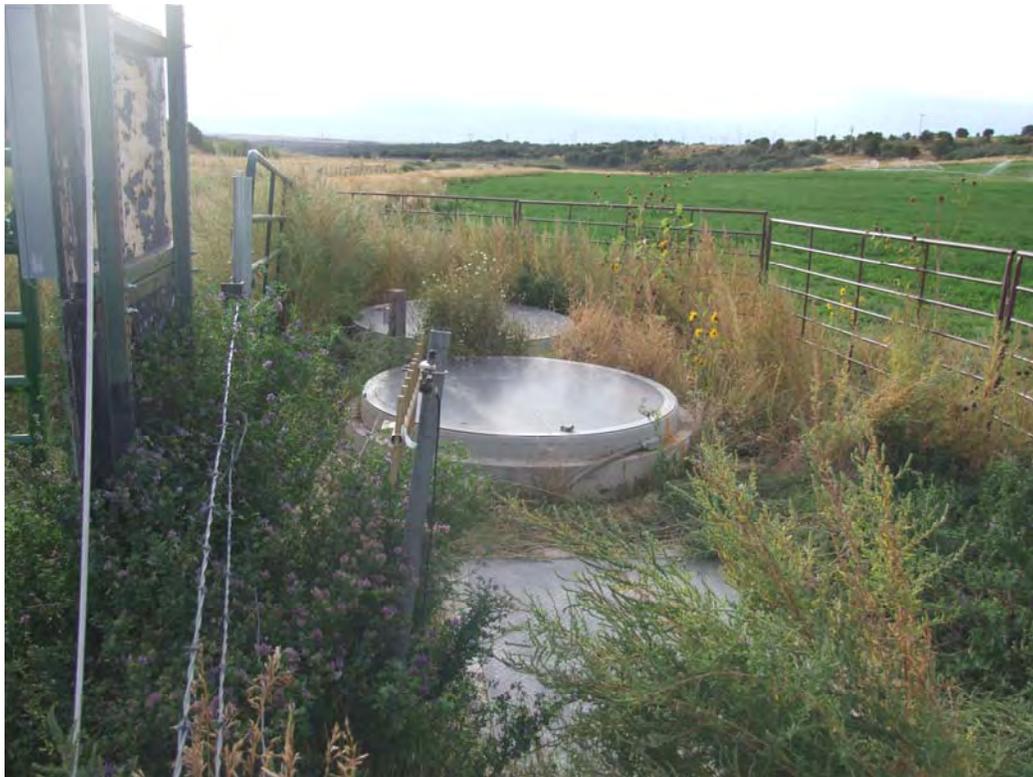
14. Auxiliary treatment cells, view east.
