2010 Annual Inspection of the DOE Monticello, Utah, Mill Tailings Site and Monticello Vicinity Properties

December 2010

Legacy
Management

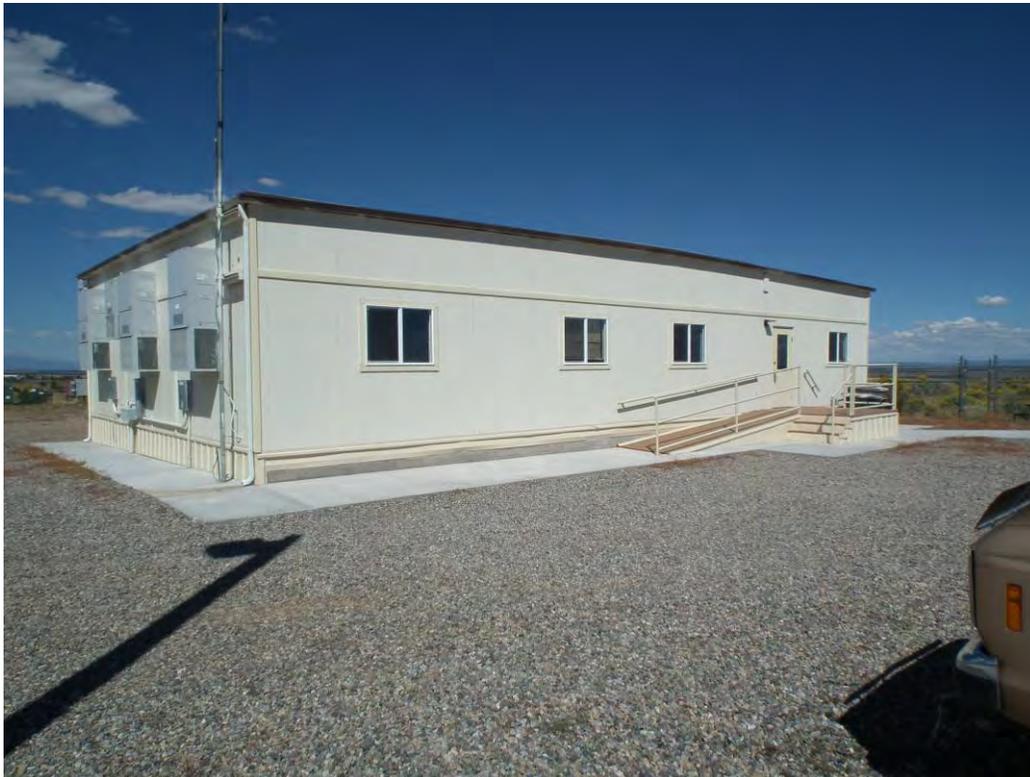
The Monticello field office buildings and associated structures are in very good condition. Repairs and upgrades to the field office building, described in the 2009 annual inspection report, were completed (Photo 1), and a new shed, with a concrete foundation, has been installed. Site access signs displaying contact information are current and visible. Two noxious weed species were identified and flagged by L. Sheader near the access area during field activities on September 8, 2010. Control of noxious weeds on Federal sites is required by law. Although weed treatment is not specified in the LTS&M Plan and is not an annual inspection activity, inspectors with expertise in identifying all stages of weed growth were present, and the weeds were at the appropriate stage for most effective control. Russian knapweed (*Acroptilon repens*) was treated with herbicide along the west fence of the support area. Diffuse knapweed (*Centaurea diffusa*) was also treated near the main access gate. Both infestations were smaller than in 2009. In response to a recommendation following the 2009 inspection, empty 55-gallon drums for storing potential mixed waste were no longer stored outside.

1. Monticello field office trailer showing 2010 improvements.

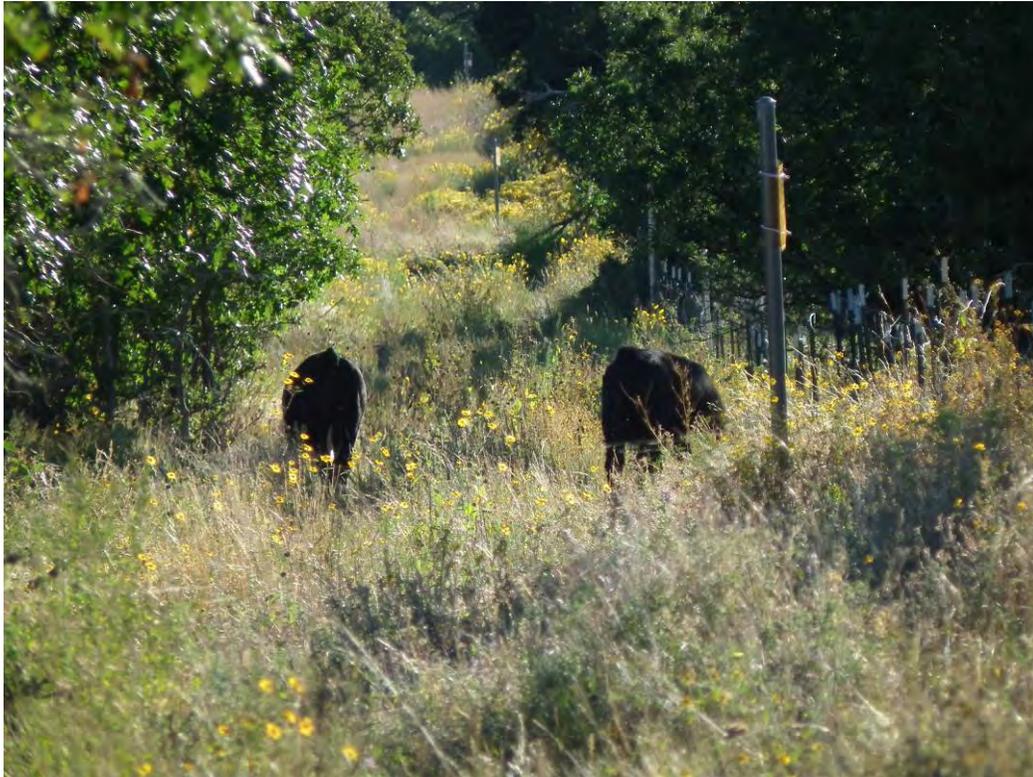
The perimeter fence along the south edge of the repository site was replaced in fall 2008, but since then, snow and livestock have damaged it severely. Many sections were broken, allowing livestock to enter the site. Fence repair was completed in November, 2010. Several head of cattle were on site during the annual inspection (Photo 3). Small sections of fence near perimeter signs P14 and P15 are also damaged. Because snow accumulation and livestock activities have repeatedly damaged the southern fence line, installation of a taller, sturdier fence is recommended in lieu of future repairs.

3. Cattle on site along south fence line between perimeter signs P28 and P29.

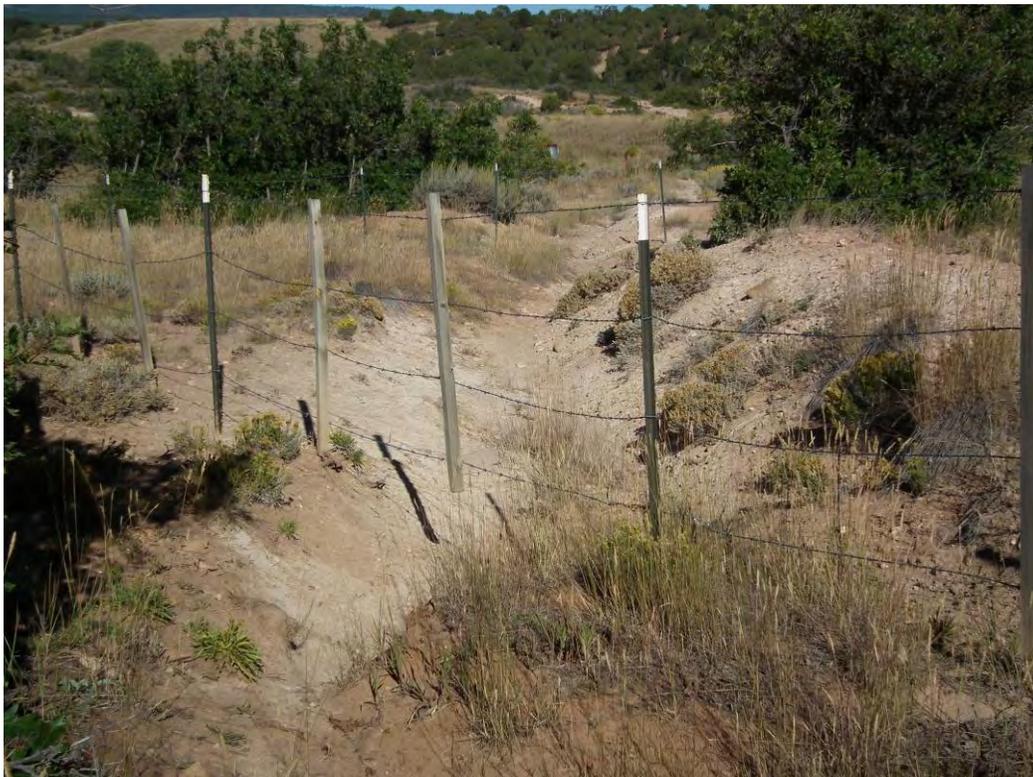
No new erosion was apparent during the 2010 inspection (Photo 4). Previous inspection reports describe a gully between perimeter signs E and P2, which threatened portions of the fence line along the west boundary of the site. Because sources of water to the gully have been rerouted or repaired by UDOT, no action was taken by DOE to fill the gully or to move the perimeter fence. In 2010, the gully was still present but deposition has continued, slowly filling in washout areas (Photo 5). This process will likely continue to fill the gully over time.

4. Erosion under north fence line near perimeter sign P16. No new erosion is evident.

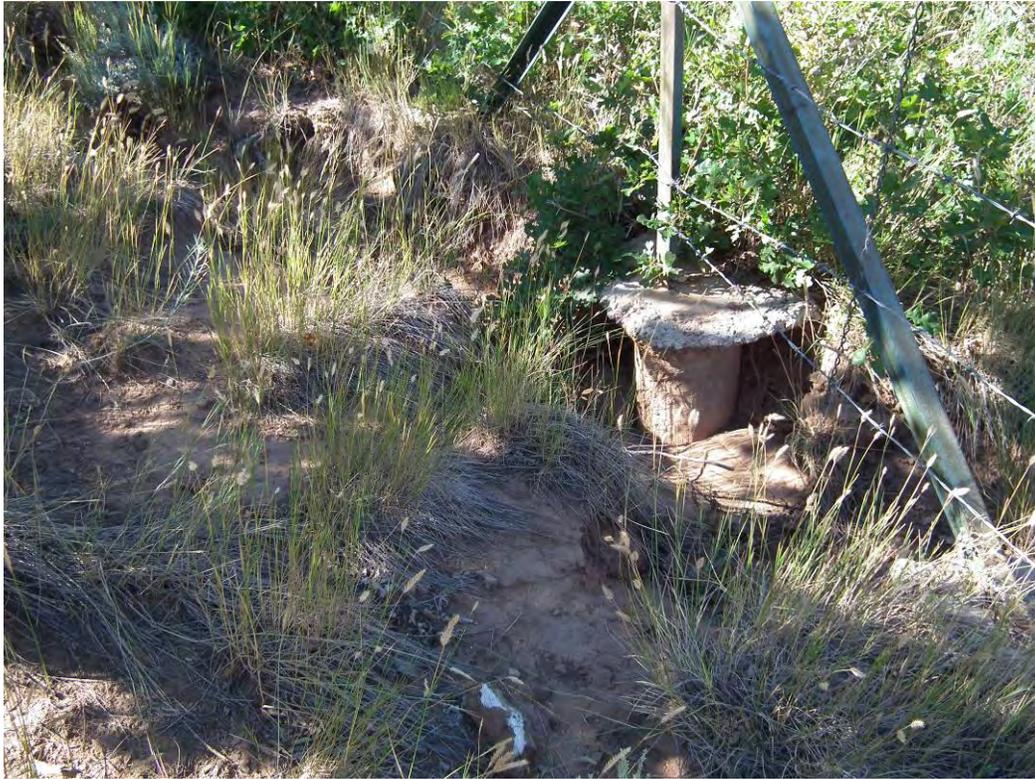
5. Erosion under fence line near perimeter sign P2. This area accumulated sediment in 2010.

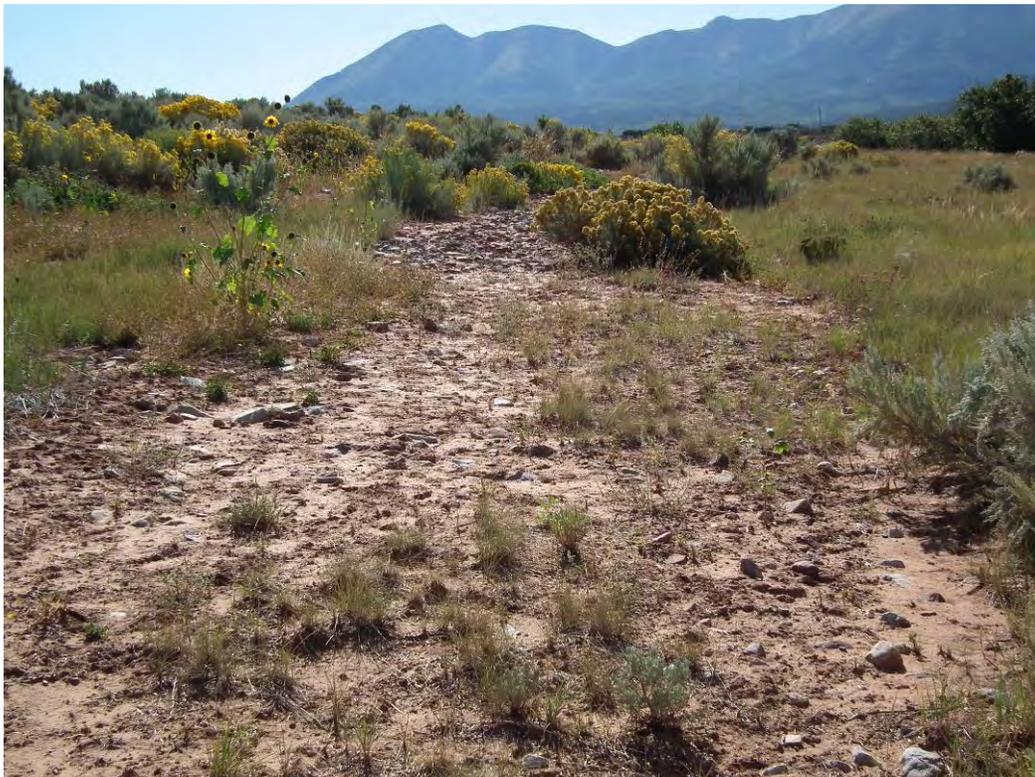
6. Siltation from previous years in North Toe Drain.

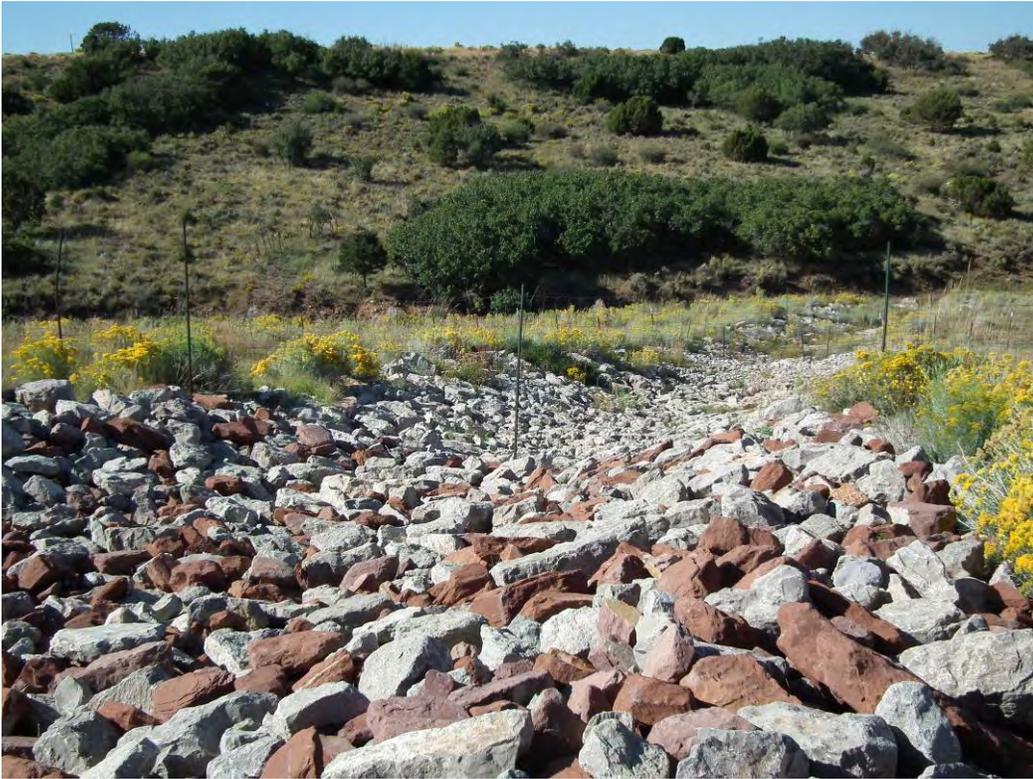
In 2002, eroded areas in the West Drain Ditch channel immediately north of the inner fence were repaired, and the channel was lined with rock all the way to North Draw. This repaired section is in good condition (Photo 7). Minor erosion was found in a small armored gully during the 2008 annual inspection; this area has not changed and will continue to be monitored (Photo 8).

7. Outlet of West Drain Ditch as it meets North Draw.

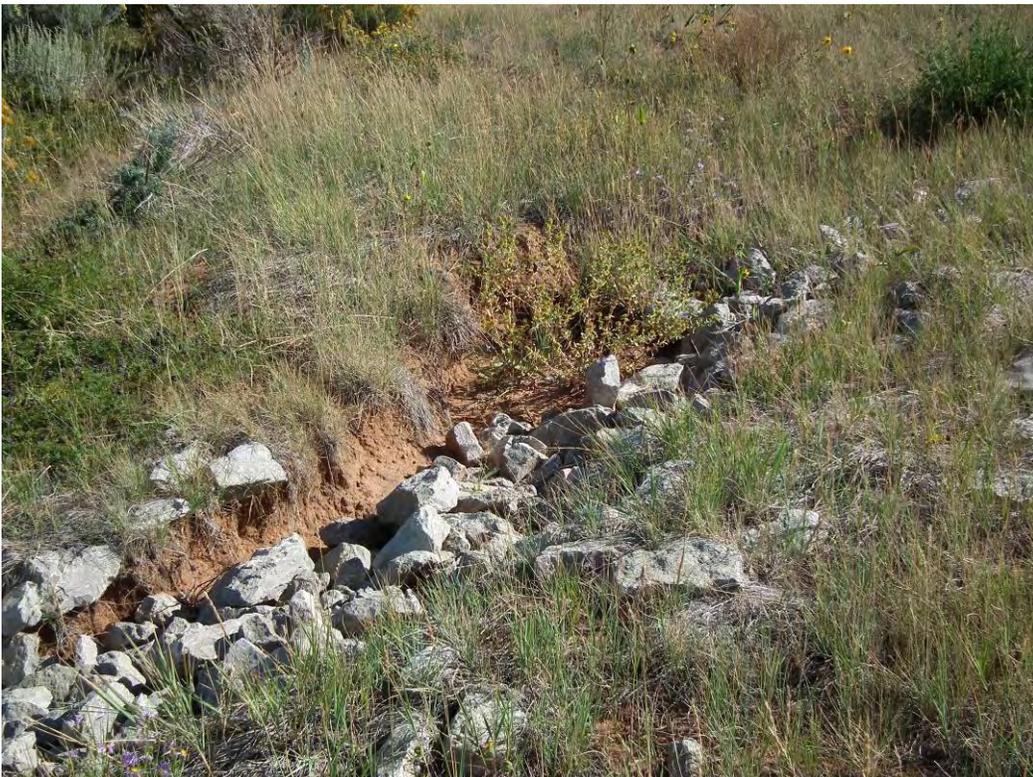
8. Eroded section near West Drain Ditch. No new erosion is evident.

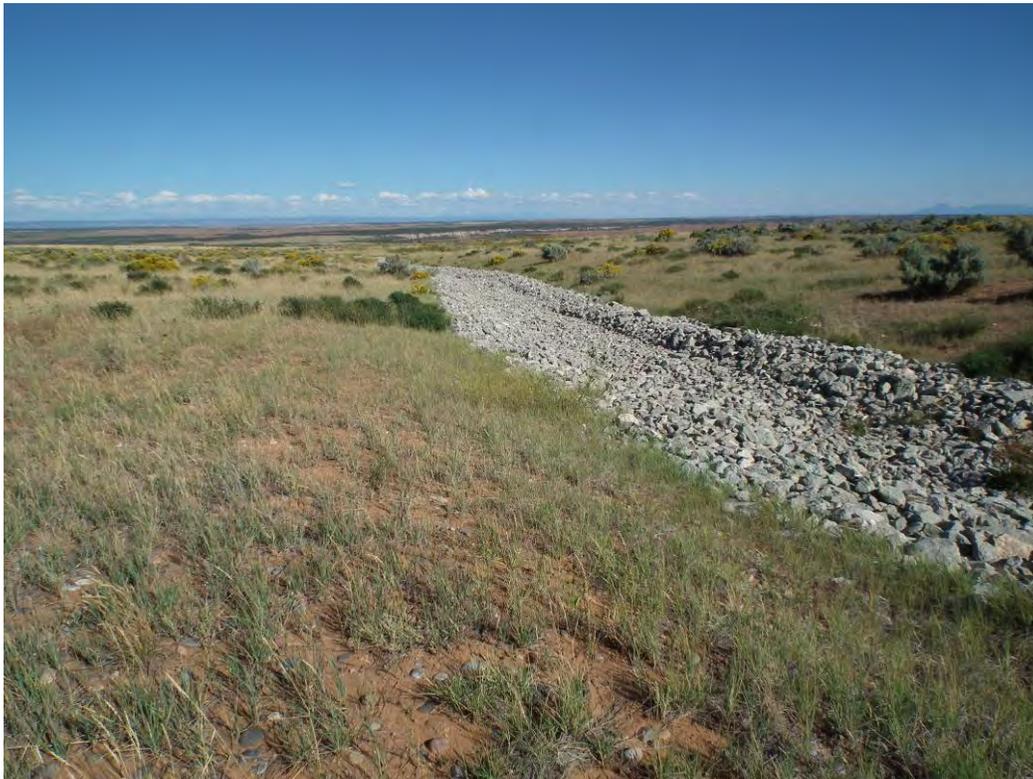
Erosion rills are present on the South Drain Ditch’s north side in places. These features do not require action other than continued monitoring. Rabbitbrush (*Ericameria nauseosa*) was observed in portions of the South Drain Ditch, but the ditch is mostly free of vegetation (Photo 9).

9. South Drain Ditch, west end, view to the east.

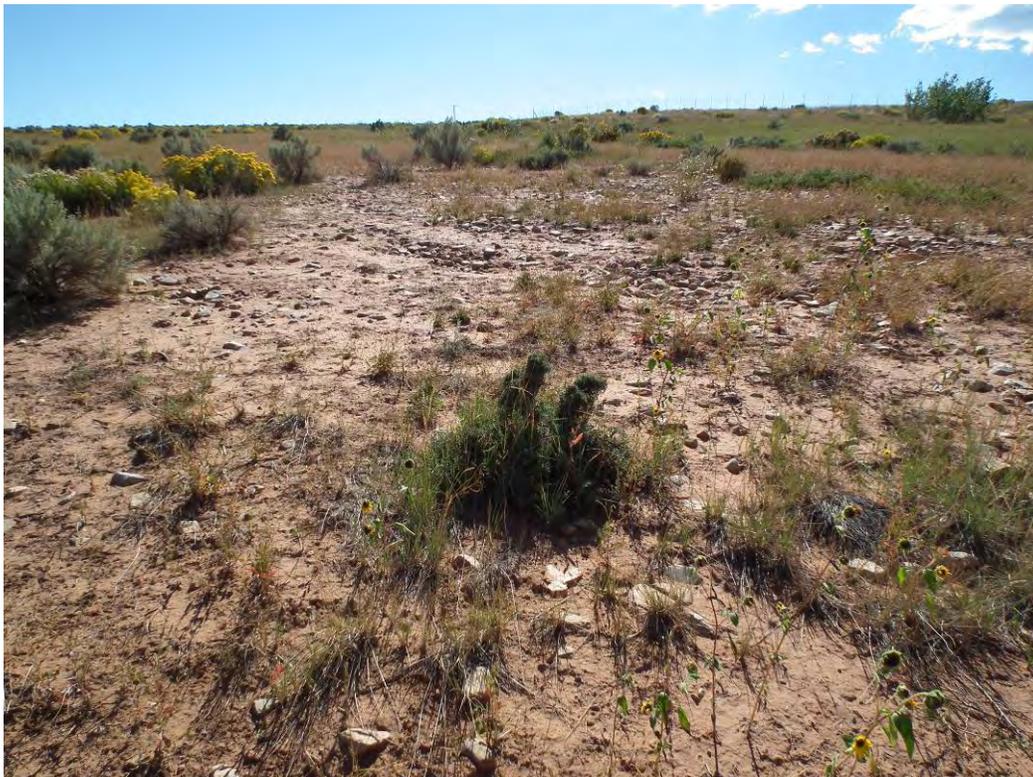
Some rock at the surface of the East Toe Trench and North Toe Trench has degraded in the past, but no new degradation was noted. Erosion or bypass of these trenches is not evident. Soils and vegetation have accumulated in the drainage downgradient of the East Toe Trench, but flows are not impeded. Soils and vegetation have also accumulated in the drainage downgradient of the North Toe Trench; some slopes in this area show evidence of minor sheet erosion (Photo 10).

10. Minor sheet wash area on slope where North Toe Drain and East Toe Drain converge.

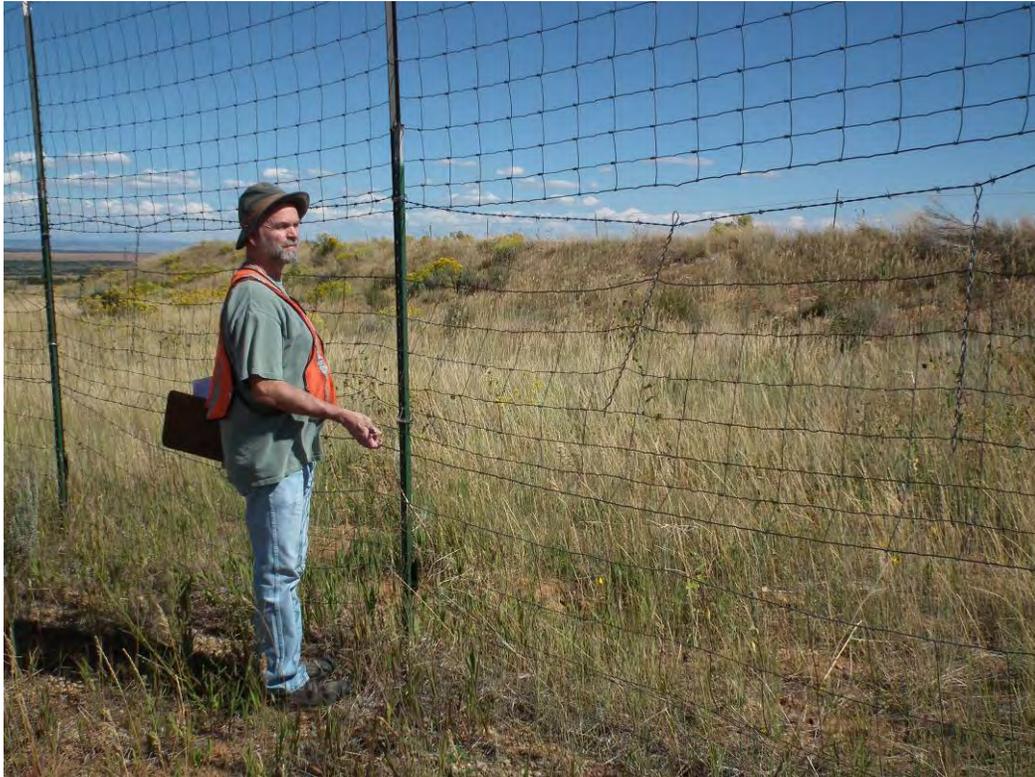
An 8-foot-high chainlink security fence surrounds Pond 4. Locked chainlink gates are present at the northeast and southwest corners, and a locked vehicle access gate is in the west fence. All gates are in good working condition. Warning signs on the perimeter fence are easily visible and legible. The following warning signs are posted on the perimeter fence: "Danger Do Not Enter," "Controlled Area, Enter at Designated Access Only," "Contaminated Water, Do Not Discharge," and a sign posting contact information, which includes a No Trespassing warning. Within the fence, around the perimeter of the pond, are Contamination Area postings and notices that life jackets are required. There is no evidence of vandalism or trespass. However, inspectors discovered a gap in the fence that could allow human or animal access to the Pond 4 area (Photo 11). This gap requires repair.

11. Open section of fence surrounding Pond 4.

Maintenance Item: Repair the gap in the fence section surrounding Pond 4.

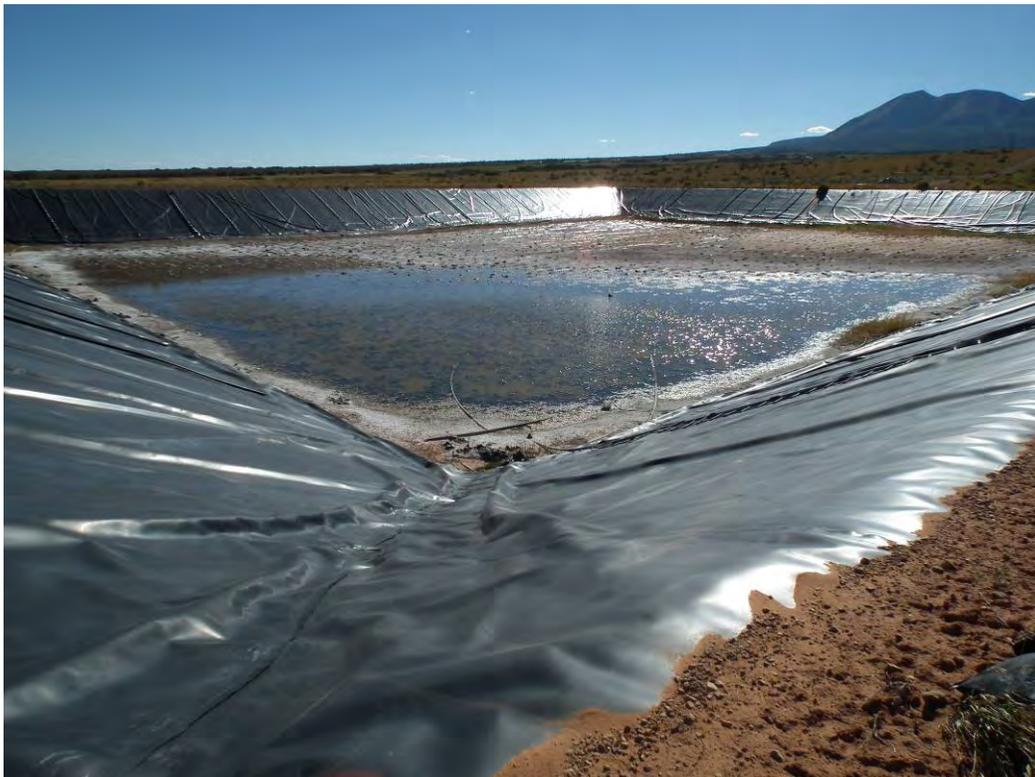
No evidence of holes in the pond liner was observed (Photo 12). Liner anchors, consisting of sand-filled polyethylene pipe installed in 2007, are in good condition. Less than 1 foot of water is standing in the northeast corner of the pond. The pond contains minor silt and vegetation.

12. Pond 4, view from the northeast corner.

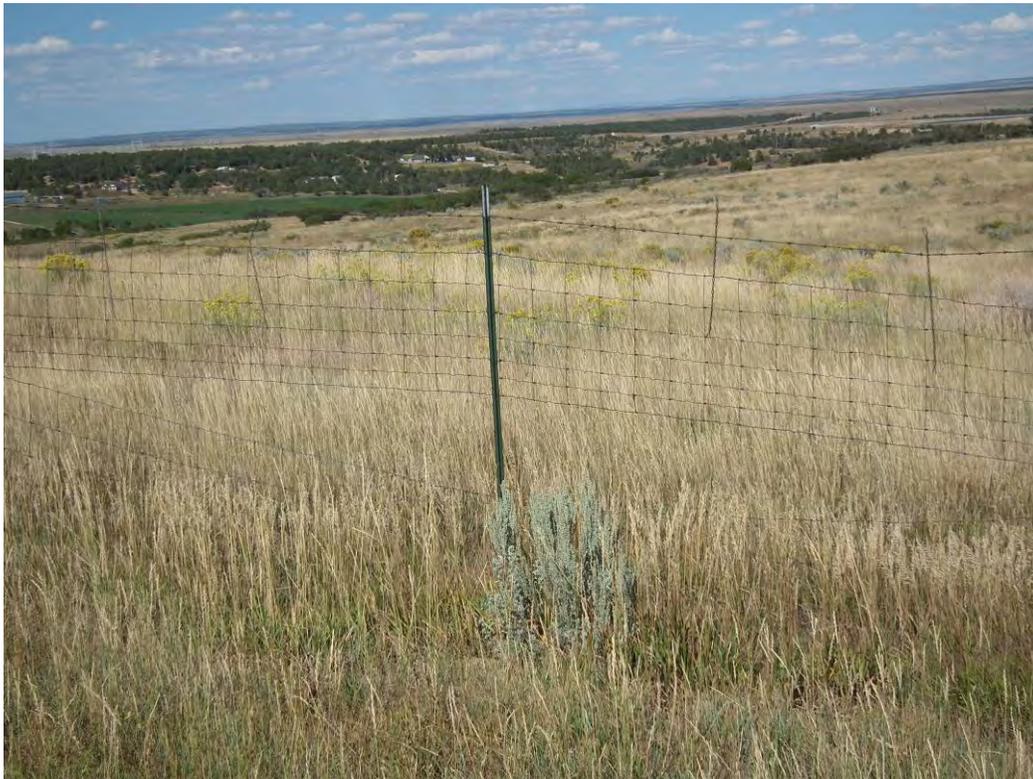
The graveled road surrounding the disposal cell and the road to Pond 4 are generally in good condition, but a small hole in the road bed liner was found between Manholes 2 and 3. This area will be monitored. One gap was discovered in the wildlife fence near Manhole 5 (Photo 13), and several fence posts along the north fence line are leaning (Photo 14). Other sections of the wildlife fence and gates, open at the time of the inspection, are in good condition and show no evidence of vandalism. Both site monuments, one along the access road inside the wildlife fence and one at the apex of the repository, are present and intact. Six raptor perches were installed near the disposal cell cover in 2007. All poles are in good condition, and site personnel occasionally observe raptors using the perches.

13. Gap in wildlife fence near Manhole 5, along east fence line.

Maintenance Item: Repair the gap in wildlife fence near Manhole 5 and repair the leaning fence posts along the northern section of the wildlife fence.

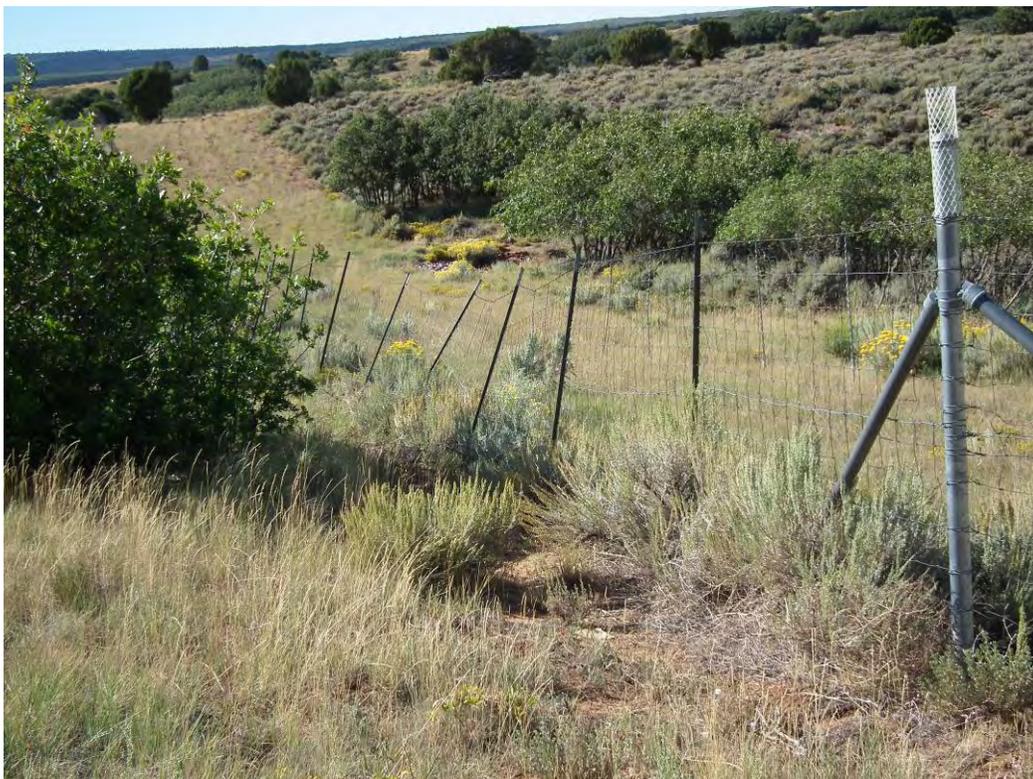
14. Leaning fence posts in wildlife fence along north fence line.

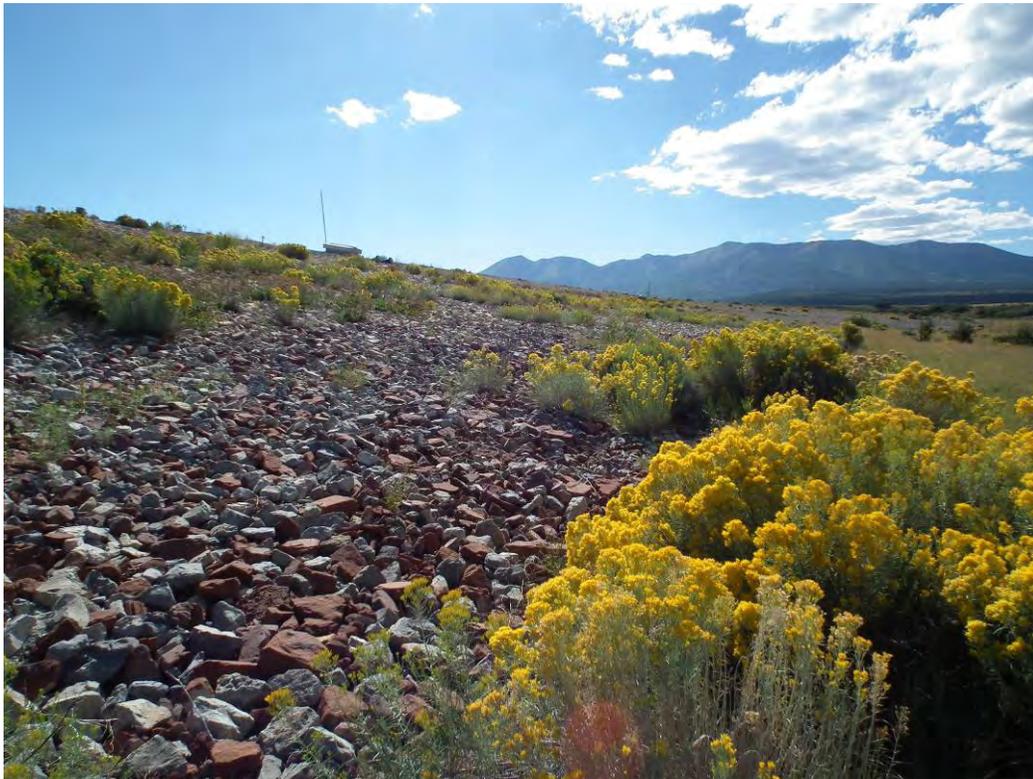
Vegetation on the repository's soil-covered side slopes and outlying areas is in good condition. Plants have also established on portions of the rock riprap armoring (Photo 15), mainly rabbitbrush and yarrow (*Achillea millefolium*), with occasional patches of oak brush (*Quercus gambelii*). Because none of this vegetation overlies tailings or threatens the integrity of the side slopes, it is not of concern.

15. North Toe Drain and repository slope with vegetation.

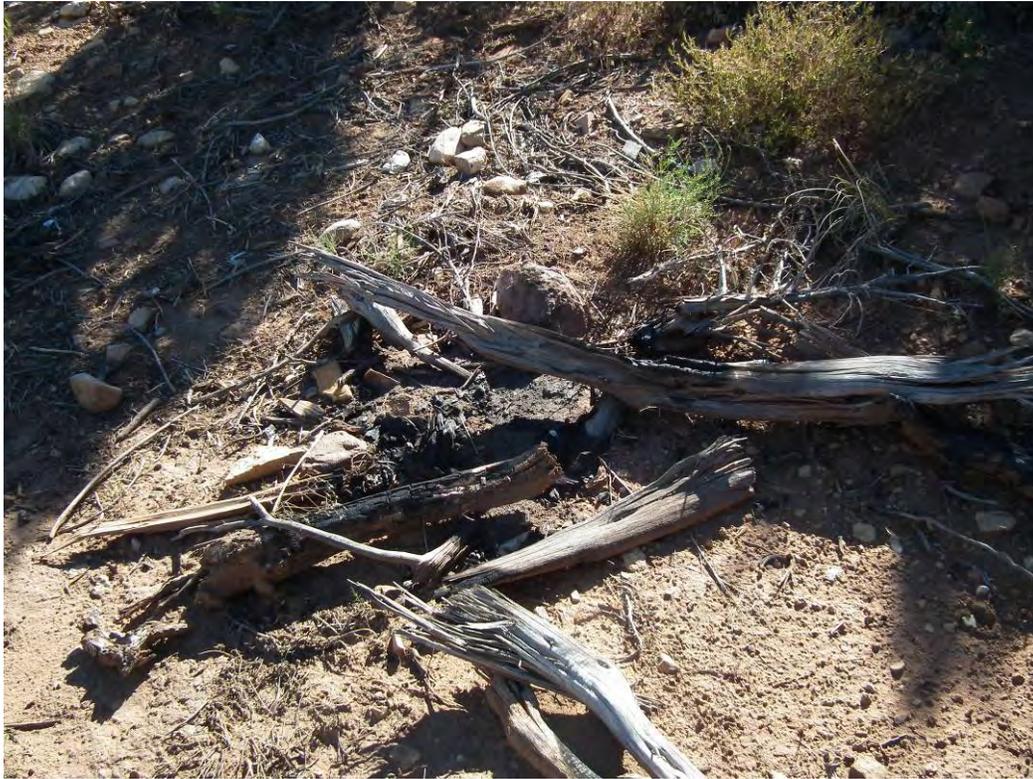
No evidence of new soil removal by human activity or natural processes was noted on any of the Piñon/Juniper properties supplemental standards areas during the 2010 inspection. The supplemental standards areas are physically delineated by four-strand wire fence. The City of Monticello has breached sections of this fence to accommodate mountain bike trails, and other sections of the fence have degenerated due to age. Radiological scans of the bike trails indicate no concerns, and survey records are available at the field office. DOE will continue to monitor these areas regularly. A small lean-to and fire pit were discovered on Property MP-01077 during GPS mapping of the bike trails. The area was radiologically scanned and investigated. Radiation levels were not above background levels, and the lean-to, constructed by a local youth, had not been used for overnight camping. The area will continue to be monitored.

19. Fire pit found on Property MP-01040. No evidence of camping was identified.

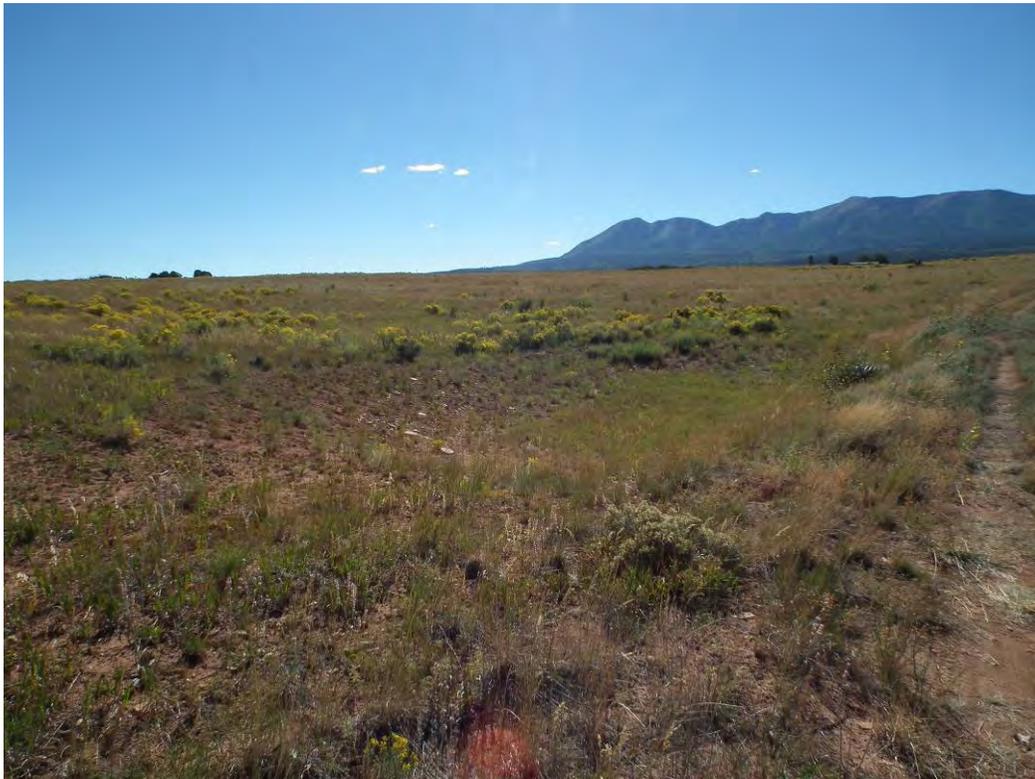
All riprap-armored structures, dams, check dams, berms, and runoff control drainages (see Figure 4) are intact and functional. No major erosion issues were noted during the 2010 inspection (for example, see Photo 21).

21. Deer Draw Dam area.
