2011 Annual Inspection of the DOE Monticello, Utah, Mill Tailings Site and Monticello Vicinity Properties

November 2011

U.S. DEPARTMENT OF
ENERGY

Legacy
Management

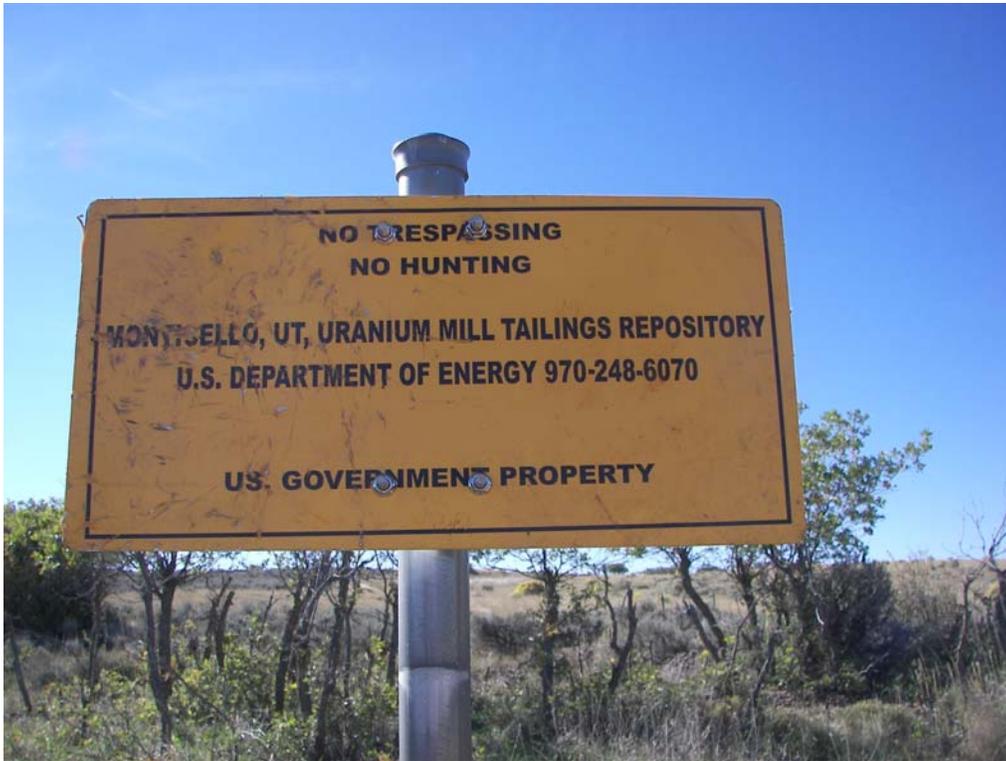
All perimeter signs were legible and in good condition, although perimeter signs P12 and P15 (Photo 1) were scratched. “No Hunting” signs, posted at all gates along the perimeter fence, were weathered and largely illegible. “No Hunting” signs may be particularly important along the eastern site boundary, where land use changes are likely to occur with the recent sale of the property. No evidence of bullet holes or other vandalism was present.

1. Perimeter sign P15, scratched but legible.

Maintenance Item: Replace “No Hunting” signs at all gates in the perimeter fence with sturdy metal signs.

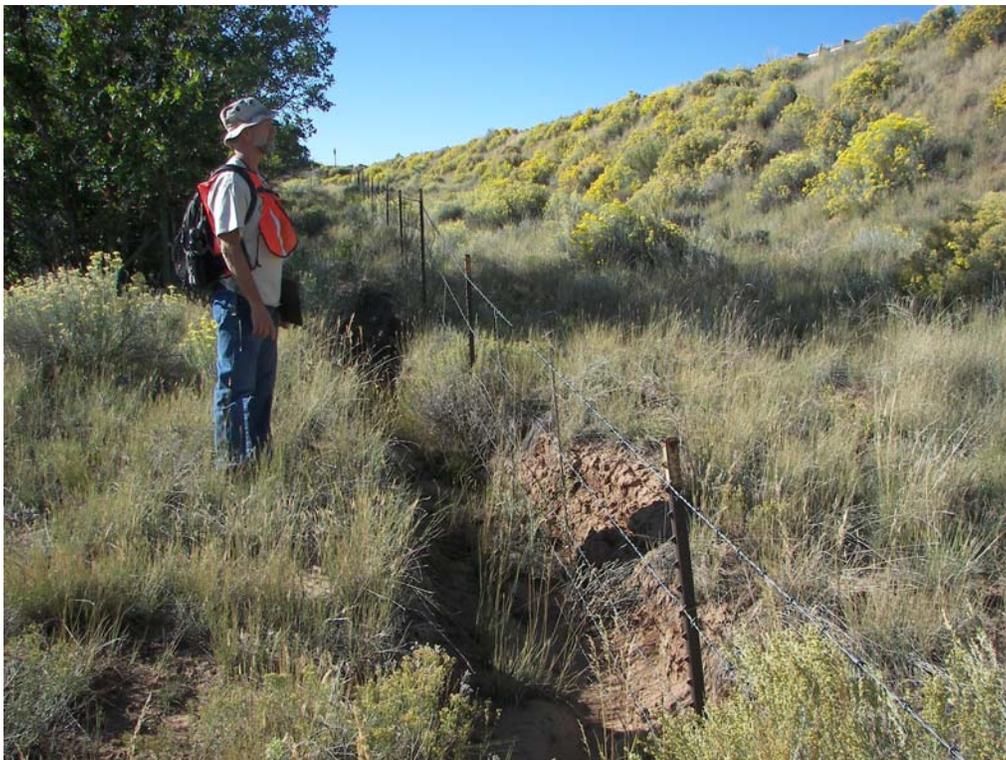
No new erosion was apparent during the 2011 inspection. Previous inspection reports describe a gully between perimeter signs E and P2, which threatened portions of the fence line along the west boundary of the site. Because sources of water to the gully have been rerouted or repaired by UDOT, no action was taken by DOE to fill the gully or to move the perimeter fence. As in 2010, the gully was still present in 2011. Deposition has continued, slowly filling in washout areas (Photo 2). This process will likely continue to fill the gully over time.

2. Gully along western perimeter fence.

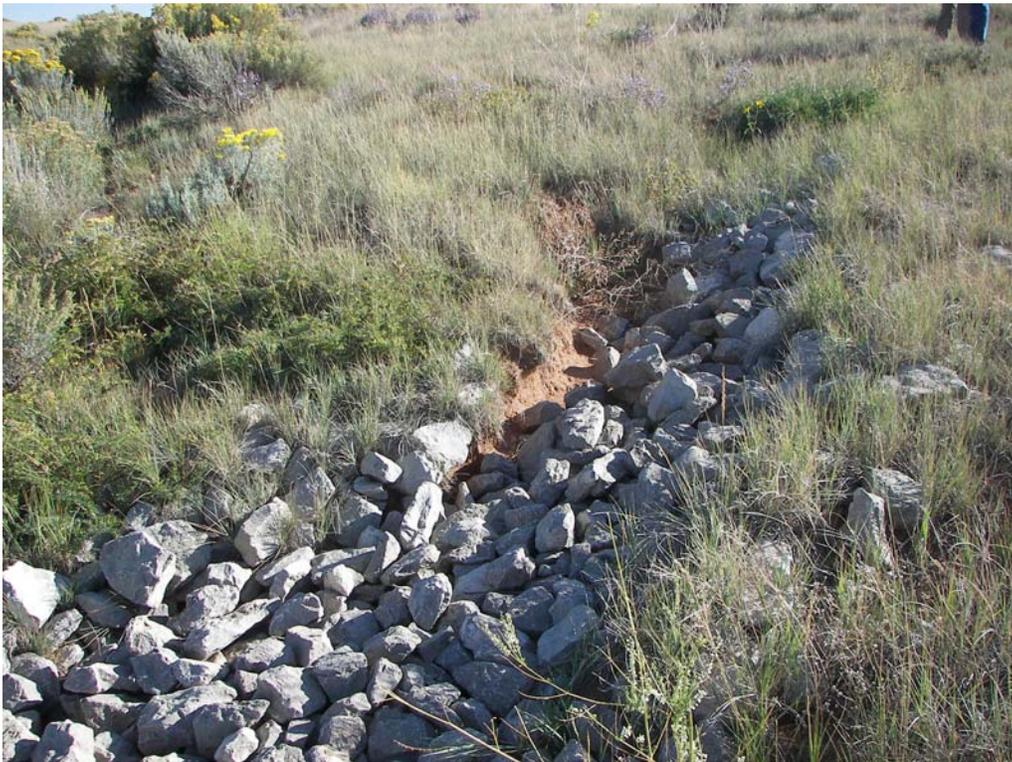
In 2002, eroded areas in the West Drain Ditch channel immediately north of the inner fence were repaired, and the channel was lined with rock all the way to North Draw. Erosion was also observed in a small gully connected to the West Drain Ditch during the 2008 inspection. No evidence of additional erosion in either area was apparent in 2011 (Photos 3 and 4). One small

4. Stabilized erosion area near the West Drain Ditch.

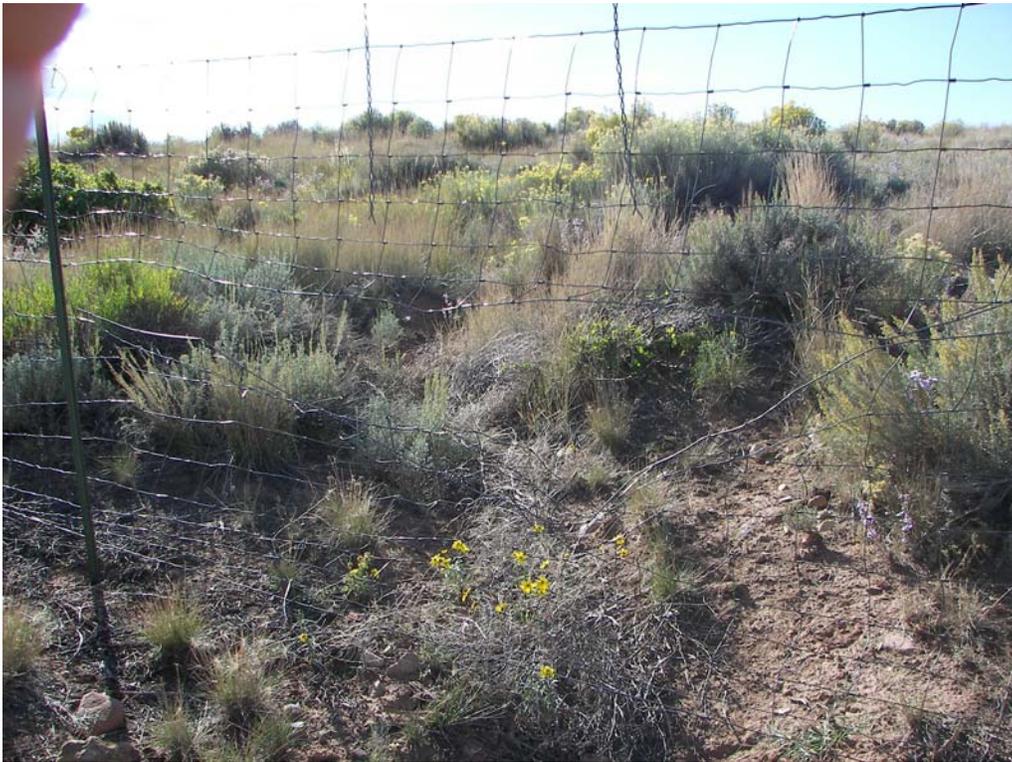
The unpaved road surrounding the disposal cell and the road to Pond 4 was recently graded and in very good condition (Photo 8). One hole was discovered in the wildlife fence in its northeast section (Photo 9). The hole, probably caused by snow damage, may present a hazard to wildlife and will be repaired. Other sections of the wildlife fence and gates, open at the time of the inspection, were in acceptable condition and showed no evidence of vandalism. Both site monuments, one at the west access gate through the wildlife fence (Photo 10) and one at the apex of the repository, were present and intact. Six raptor perches, installed near the disposal cell cover in 2007, were in good condition.

9. Hole in northeast section of wildlife fence.

Maintenance Item: Repair the hole in the wildlife fence in its northeast section.

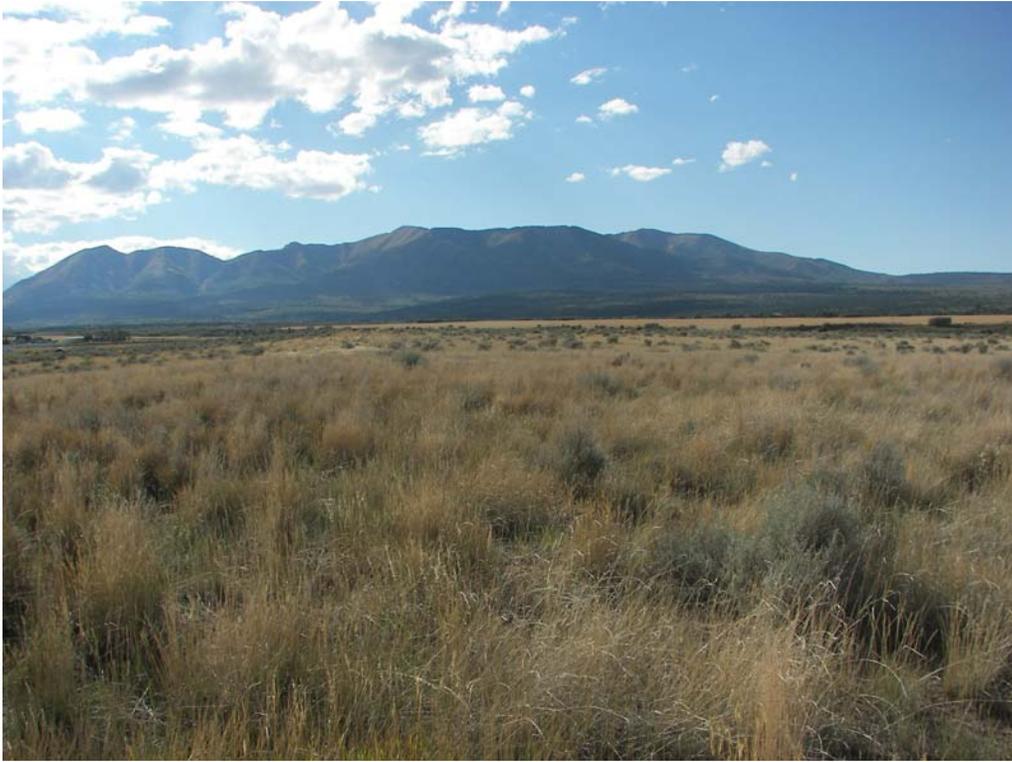
Desirable plants remained well established on the cover, and no significant barren areas, eroded areas, or phreatophyte shrubs were identified (Photo 11). Some dead sagebrush (*Artemisia tridentata*) and rabbitbrush (*Ericameria nauseosa*) plants—killed from a 2006 vole infestation—were still scattered across the cover. As in 2010, a large number of healthy, desirable shrub seedlings were apparent. Small quantities of field bindweed were found on the cover; because it is not spreading, control is not necessary.

11. Vegetated disposal cell cover, view to the west from center monument.

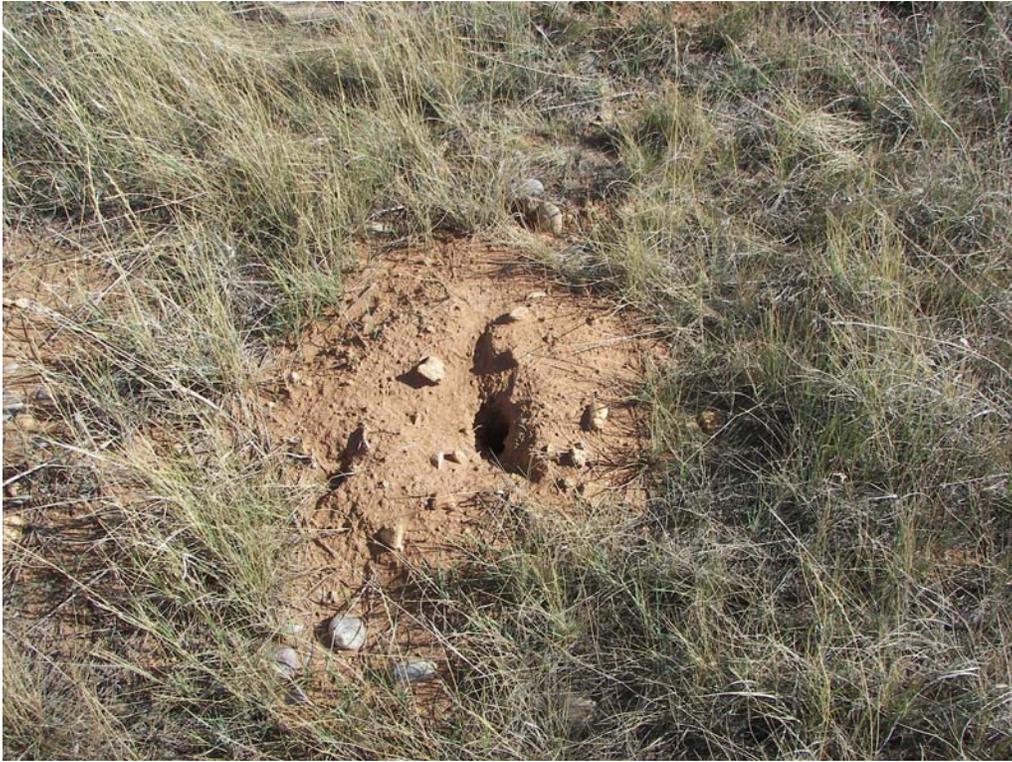
More active burrows (Photo 13) were observed during the 2011 inspection than in 2010, indicating that vole populations may be cyclically increasing at the site. However, the increased presence of raptors and recent decreases in standing dead vegetation due to heavy snowfall are expected to prevent widespread damage to the cover shrubs in 2011. There is no evidence that burrows penetrate beneath the cover's biointrusion layer.

13. Animal burrow on repository cover.

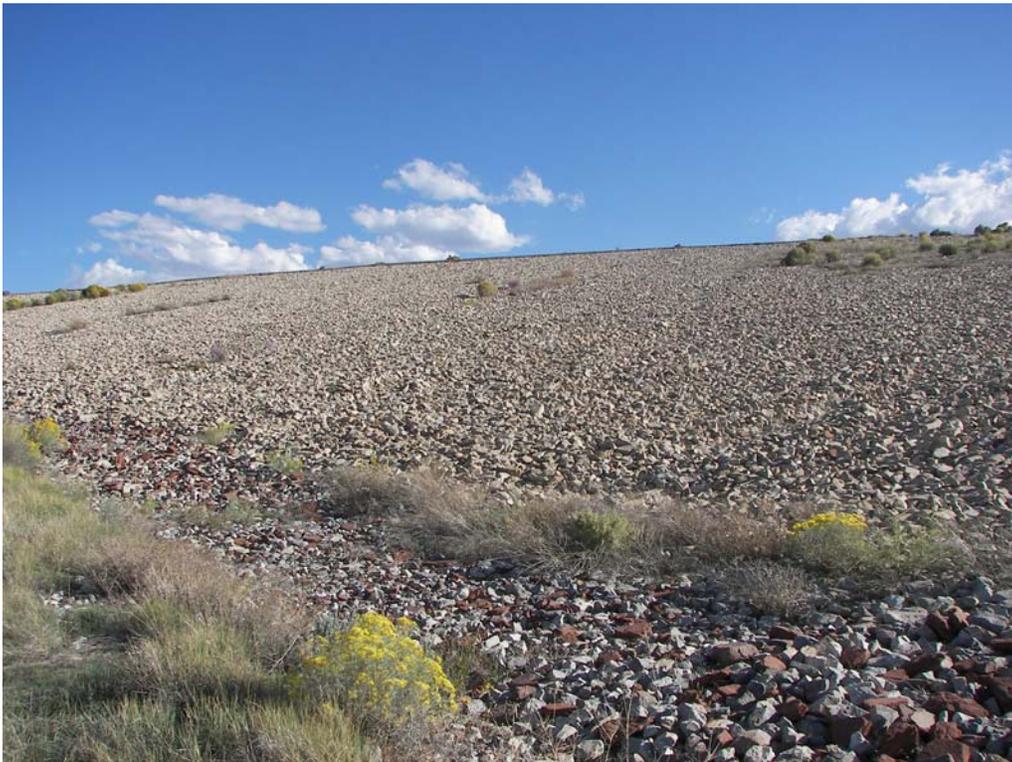
No area of the cover indicated settling, slumping, fracturing, seepage, ponding, or significant erosion. The steep, rock-lined slopes showed no evidence of rock movement or degradation, settling, slumping, or erosion (Photo 14).

14. Rock side slope of repository and North Toe Trench.

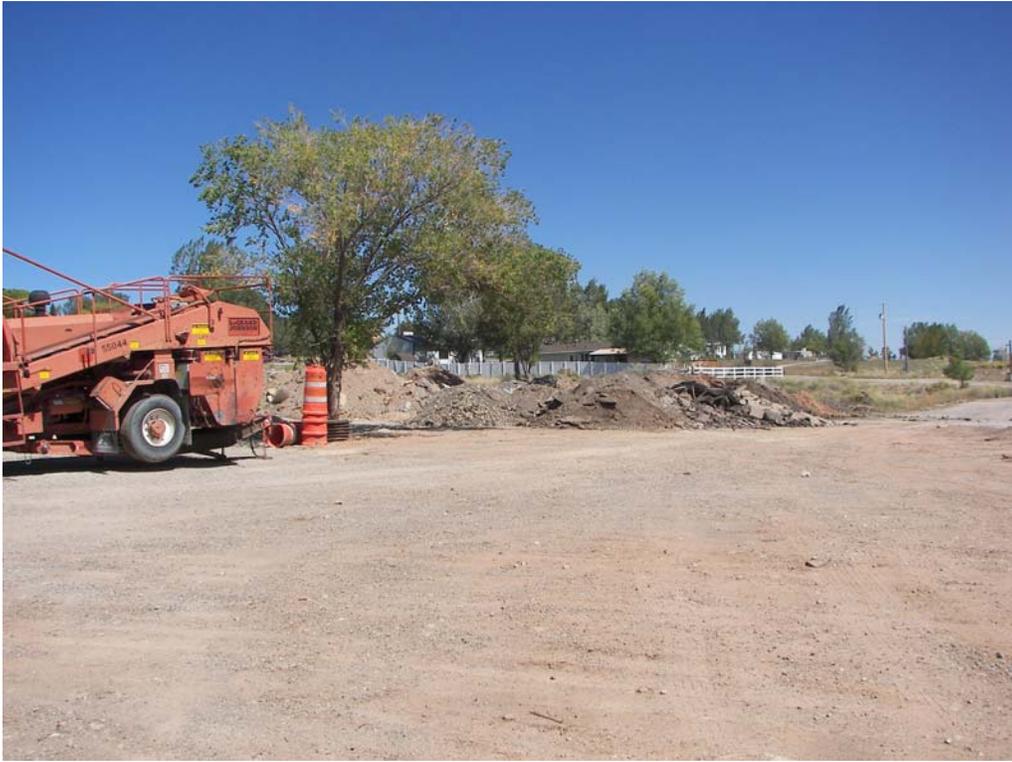
19. Fill materials at City-Owned Property MP-00211.

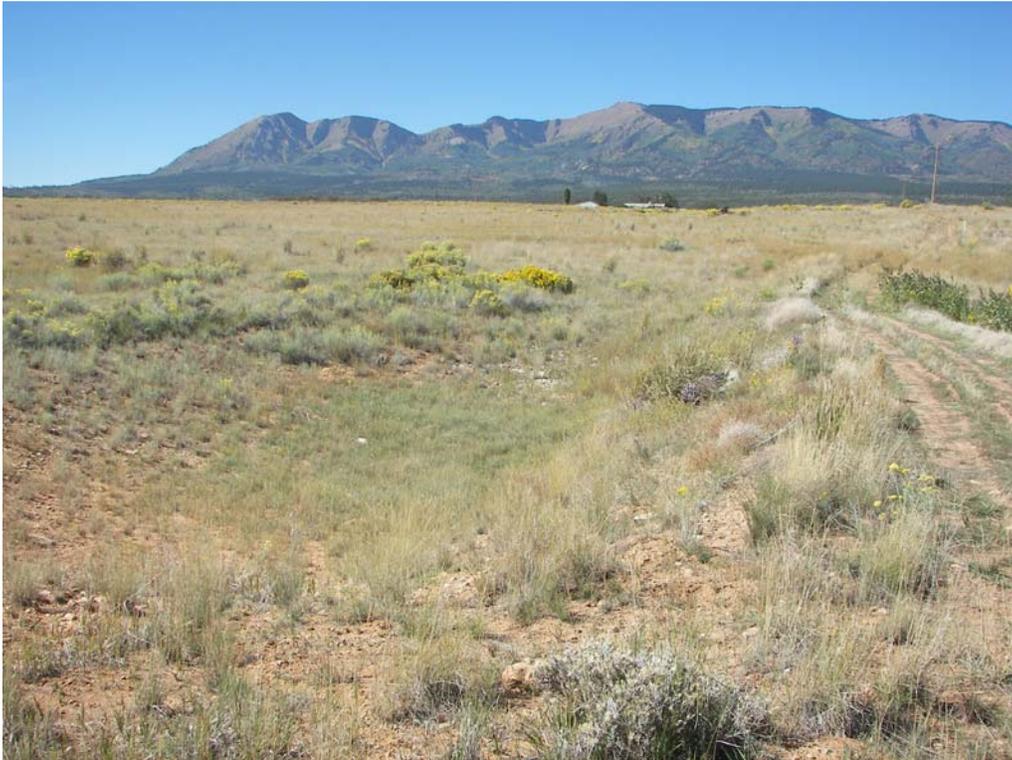
All riprap-armored structures, dams, check dams, berms, and runoff control drainages (see Figure 4) are intact and functional. One structure, Deer Draw Dam, is shown in Photo 20. No major erosion issues or evidence of recent erosion were noted during the 2011 inspection.

20. Runoff/drainage control structure, Deer Draw Dam.
