## Fourth Five-Year Review Report For Monticello Mill Tailings (USDOE) Site, San Juan County, Monticello, Utah

June 2012

U.S. DEPARTMENT OF  
**ENERGY**

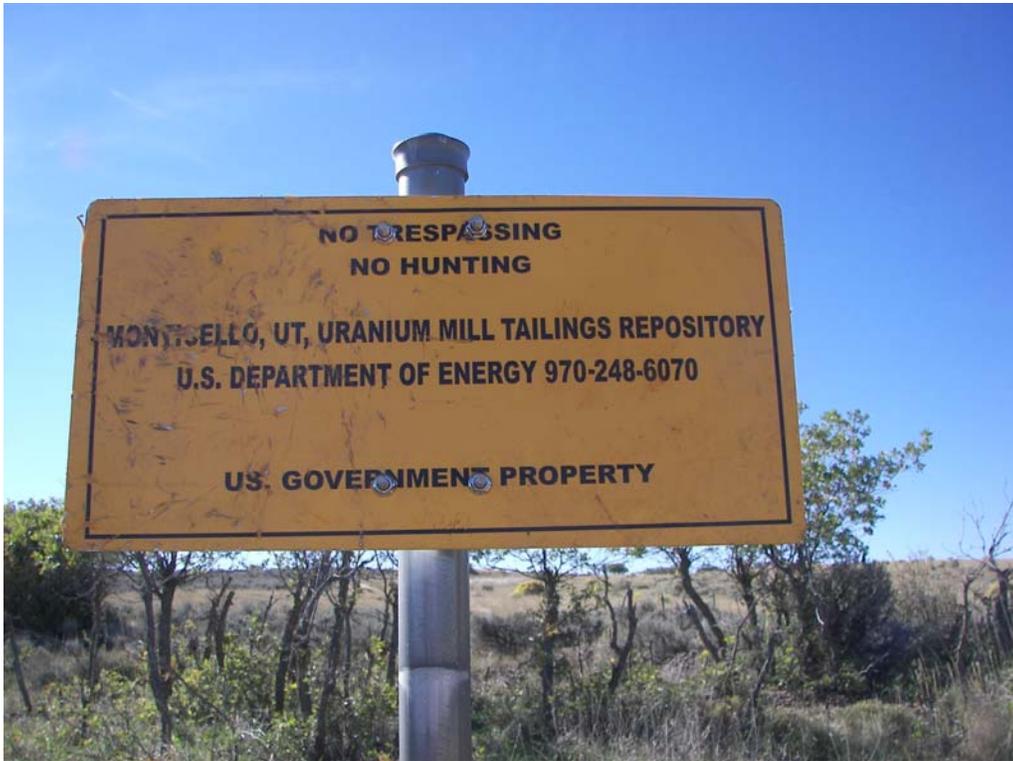
1. Perimeter sign P15, scratched but legible.

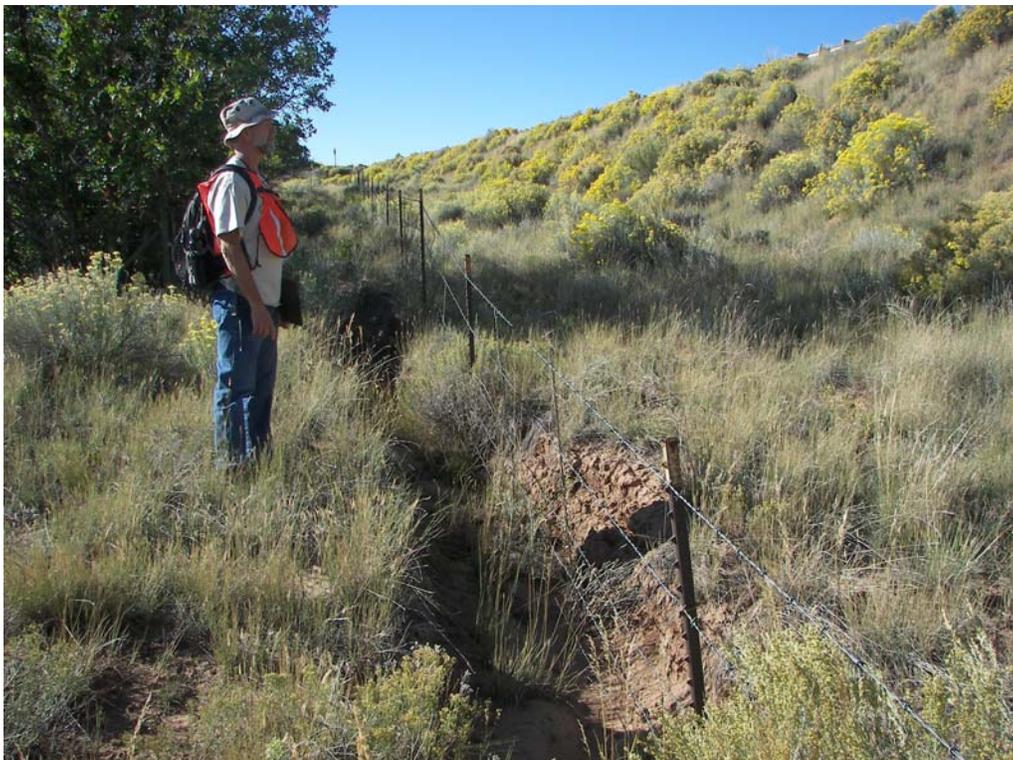
2. Gully along western perimeter fence.

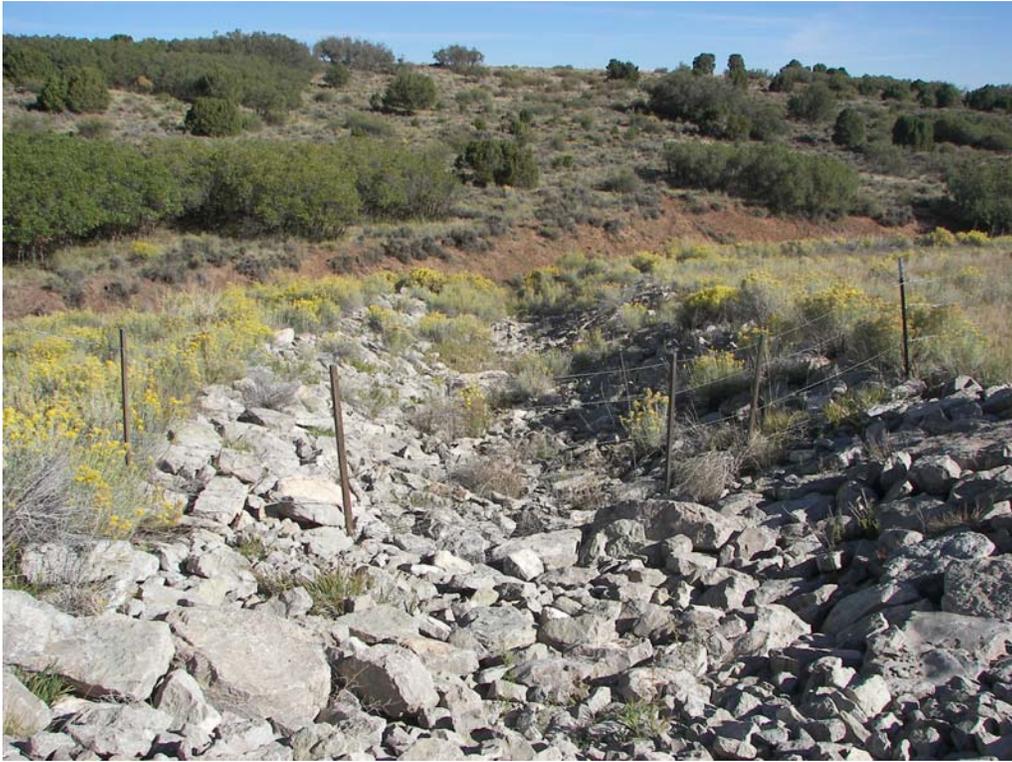
3. Rock-lined drainage between the West Drain Ditch and North Draw.

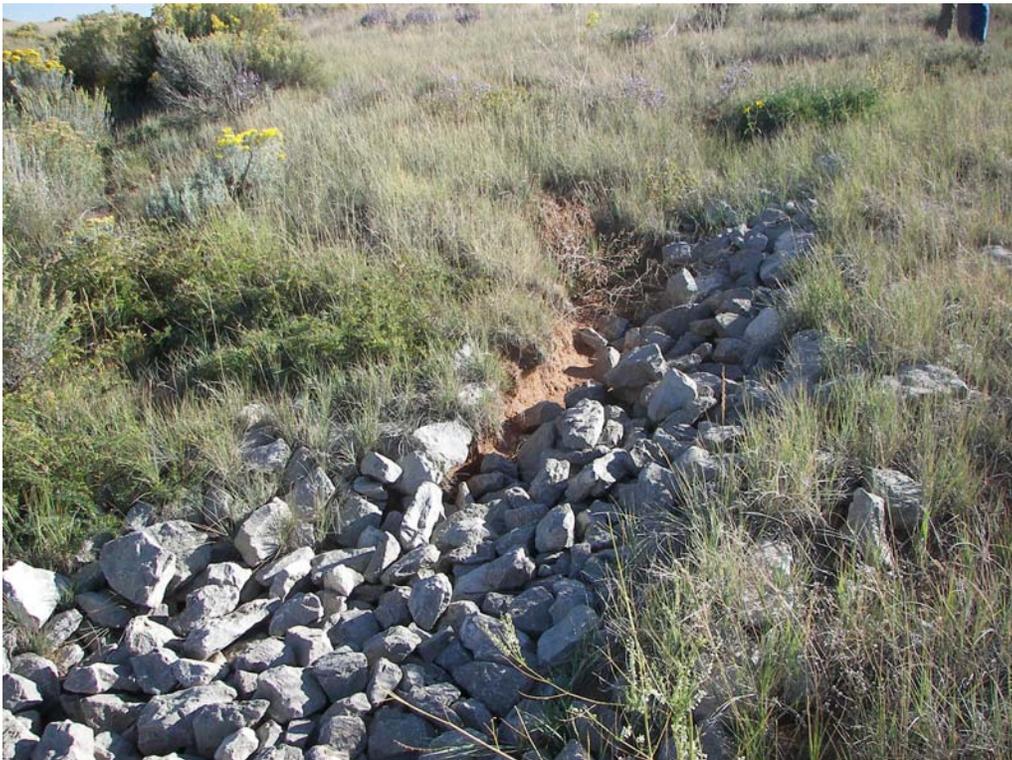
4. Stabilized erosion area near the West Drain Ditch.

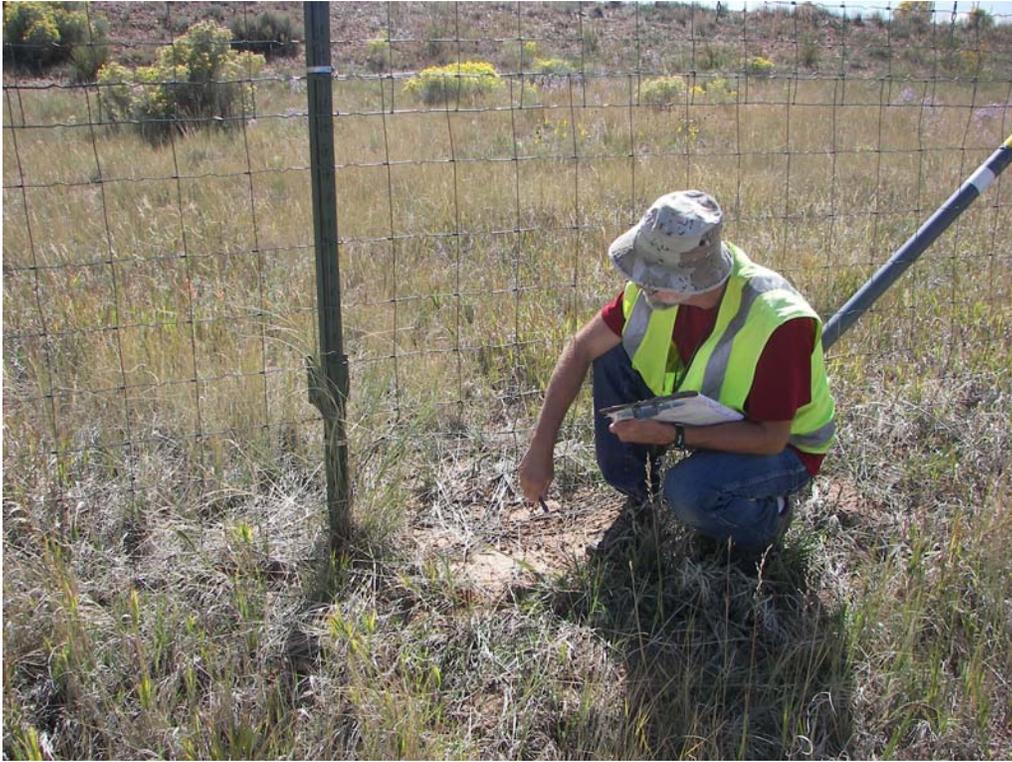
5. One of two holes discovered in the Pond 4 security fence.

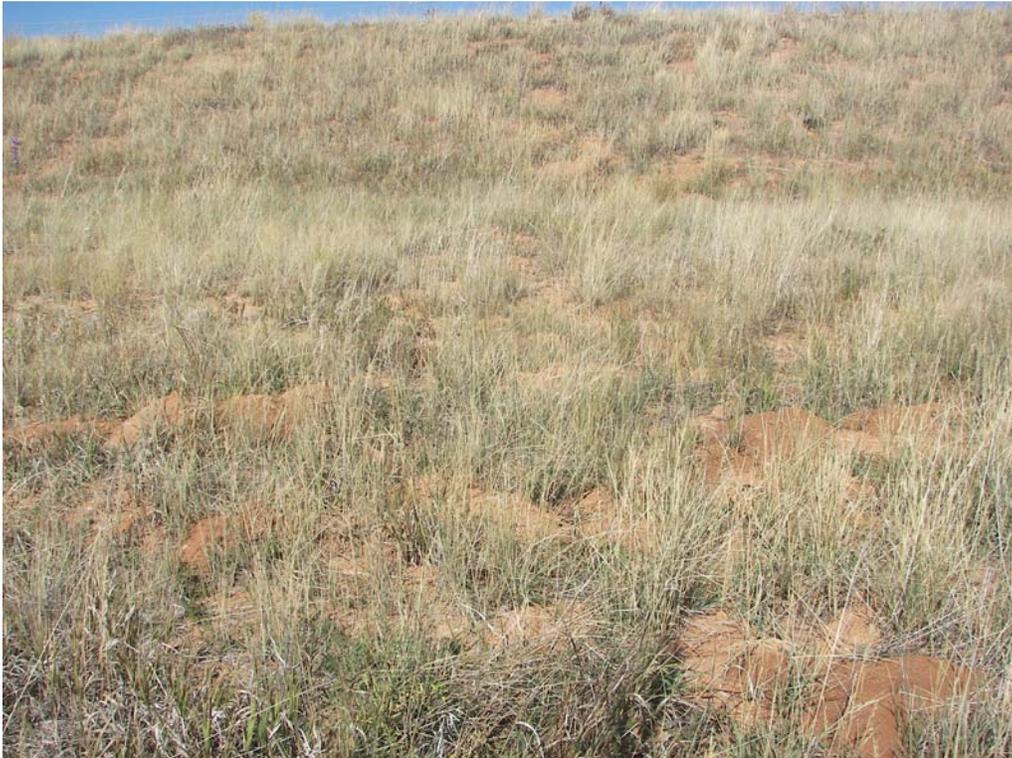
6. Animal burrows on and below the Pond 4 berm.

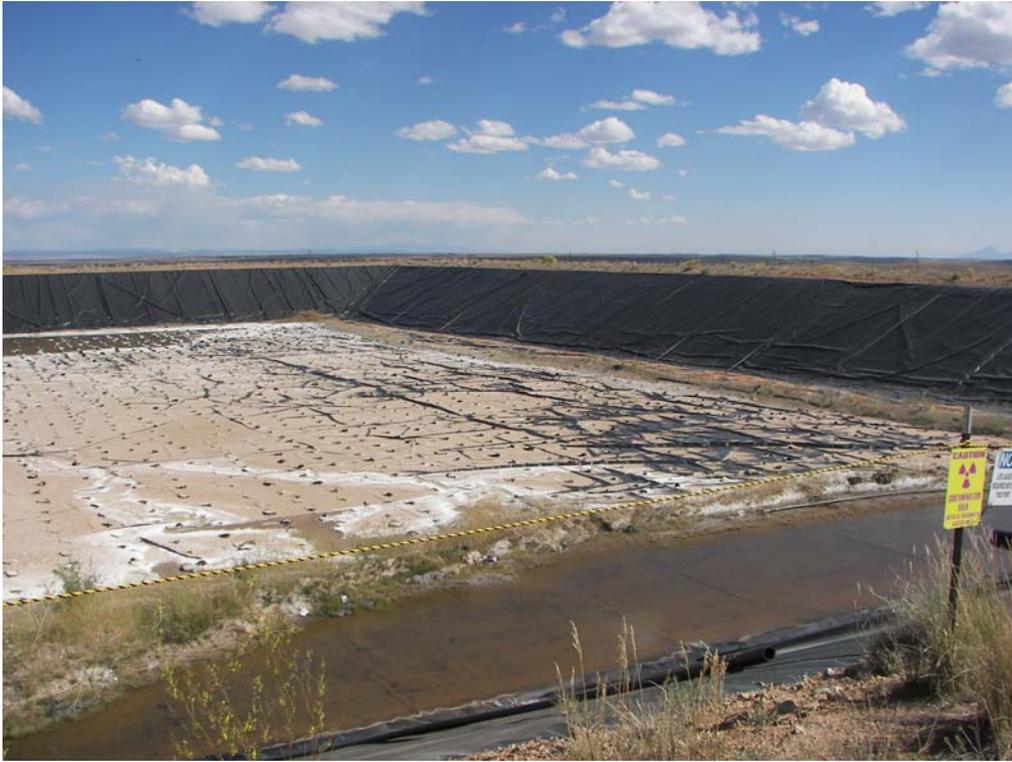
7. Pond 4 showing siltation, vegetation, and standing water.

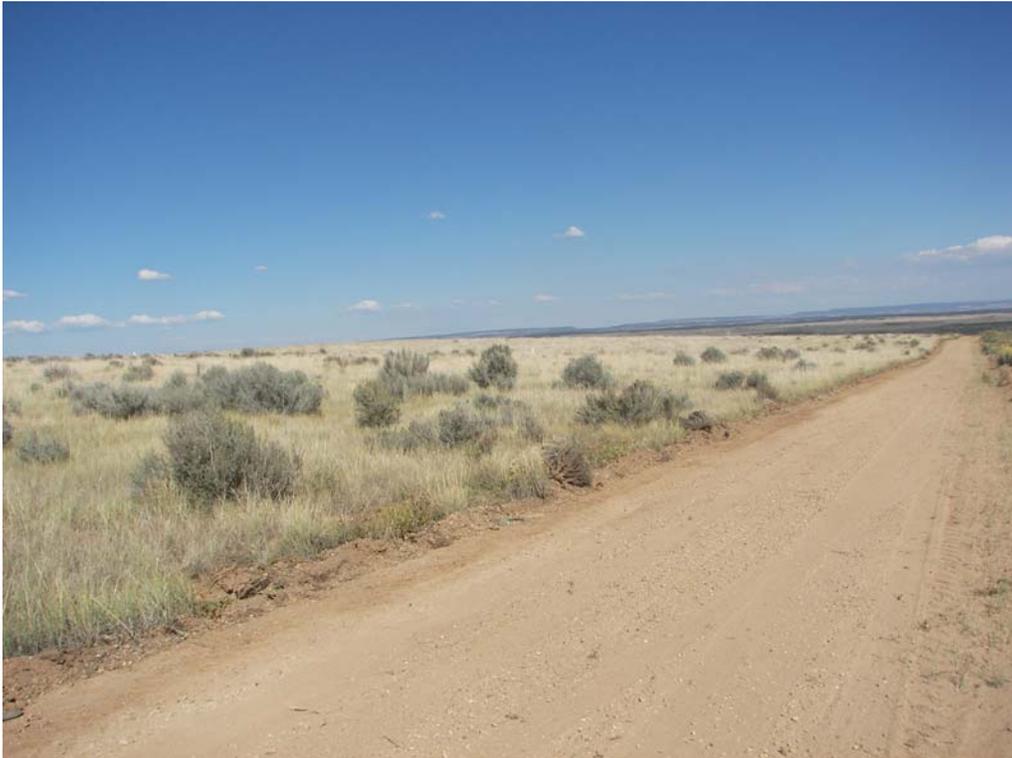
8. Repository cover and recently graded perimeter road.

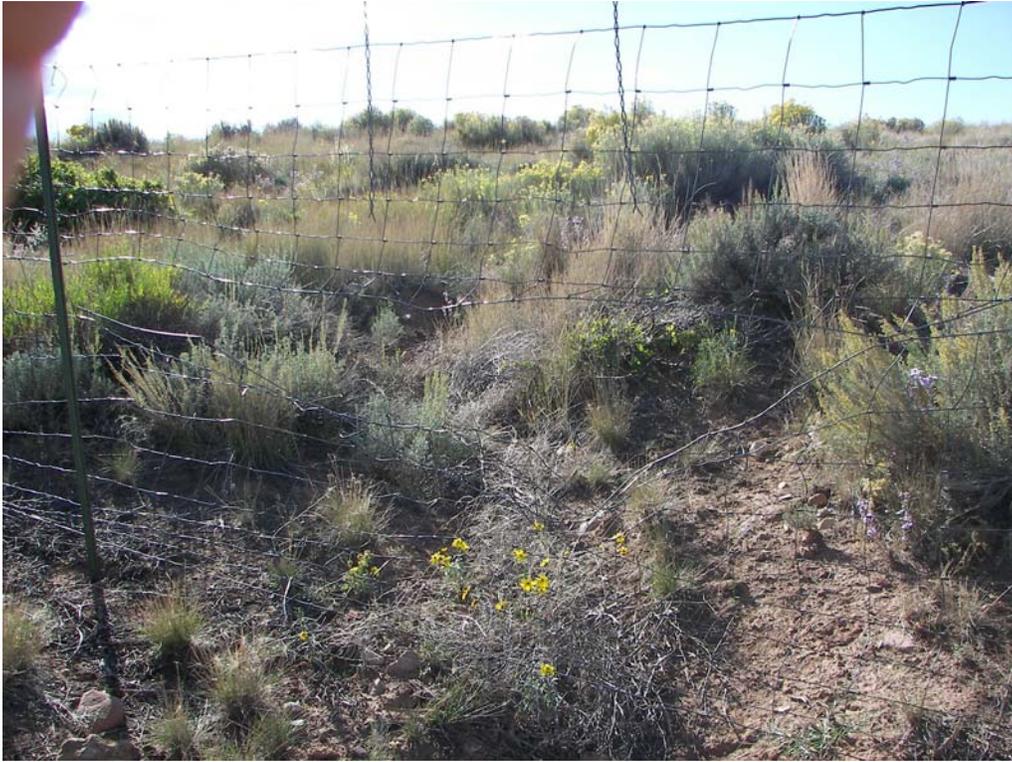
9. Hole in northeast section of wildlife fence.

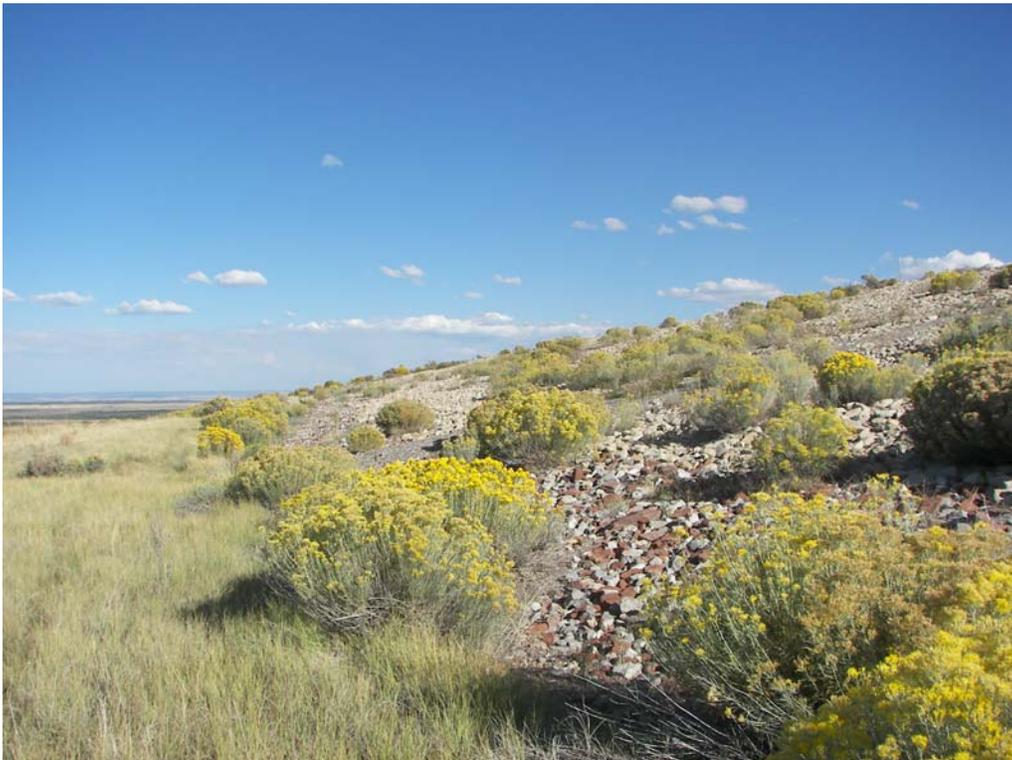
12. Vegetation on rock side slope of repository.

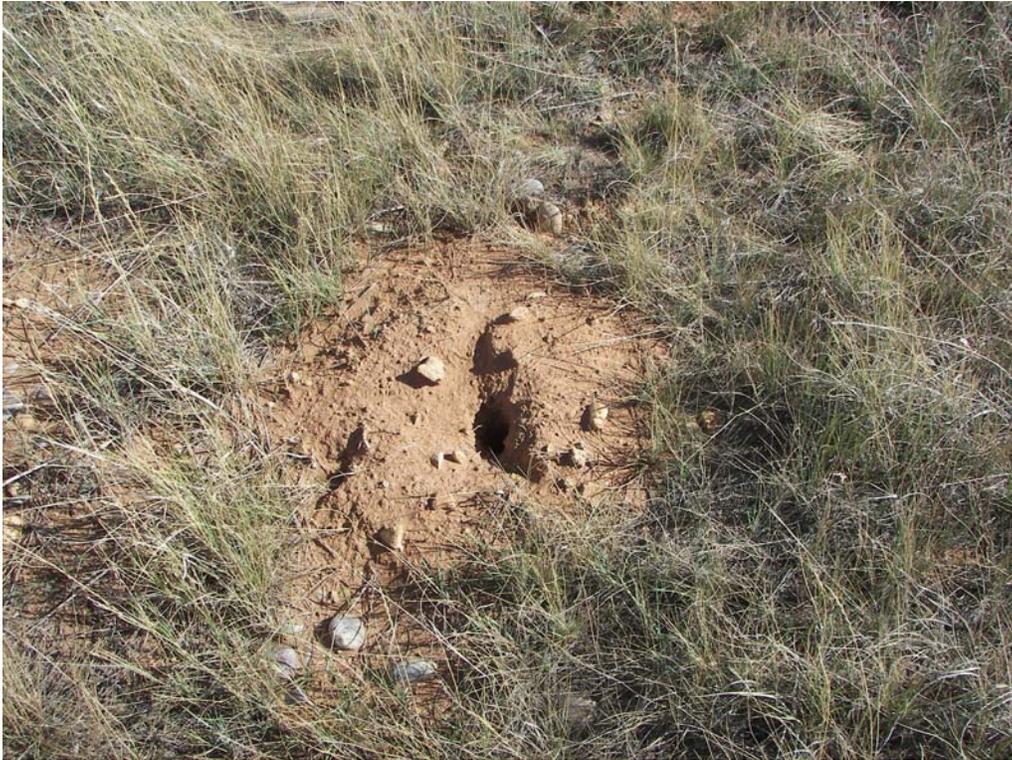
13. Animal burrow on repository cover.

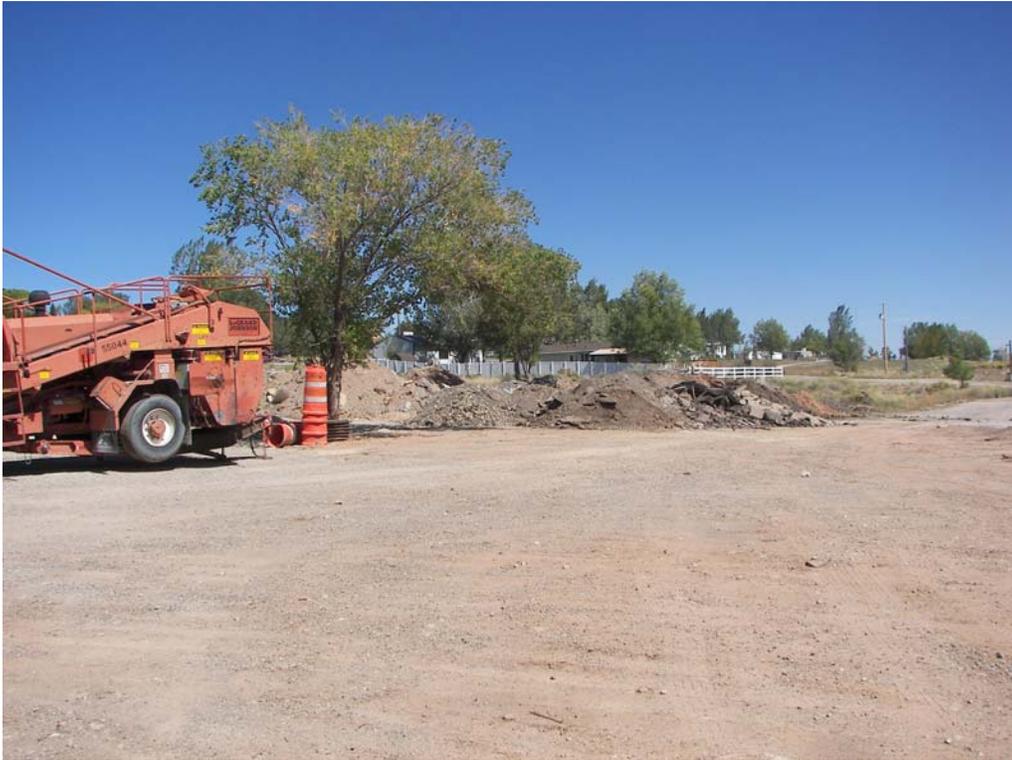
19. Fill materials at City-Owned Property MP-00211.
