2014 Annual Inspection Report for the DOE Monticello, Utah, Mill Tailings Site and Monticello Vicinity Properties

December 2014

U.S. DEPARTMENT OF
ENERGY

Legacy
Management

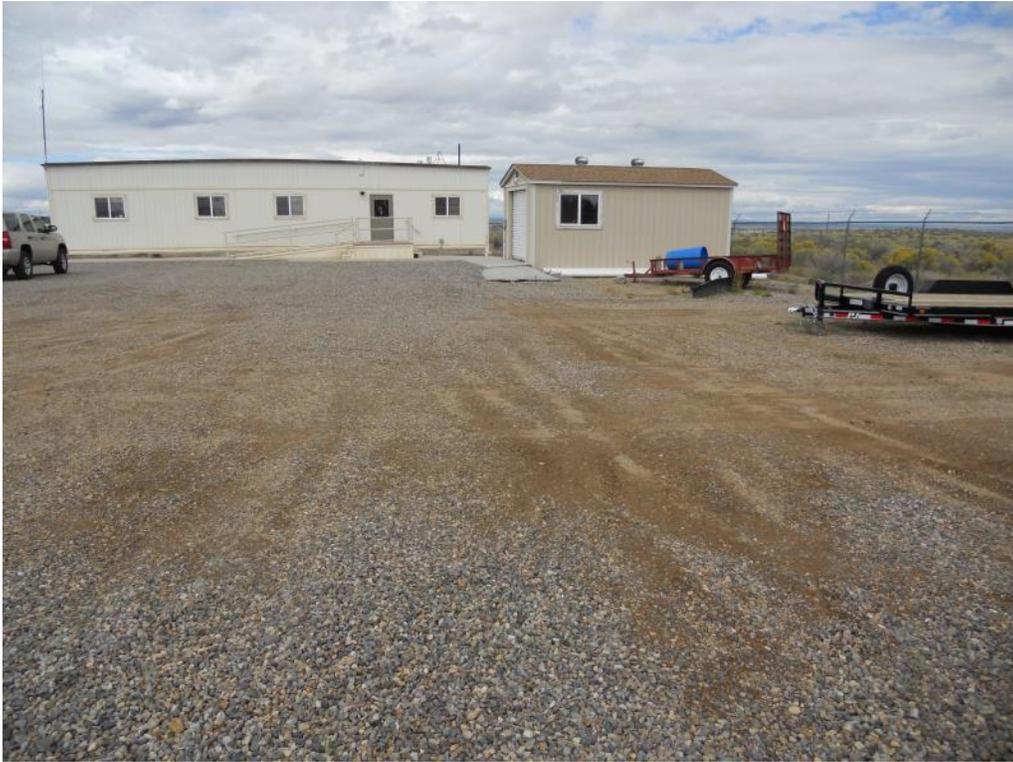
The Monticello field office buildings and associated structures were in excellent condition and are well maintained (Photo 1). Site access signs displaying contact information were current and visible (Photo 2). The site's paved access road was in very good condition.

Photo 1. Site Facilities (Buildings and Parking Lot)

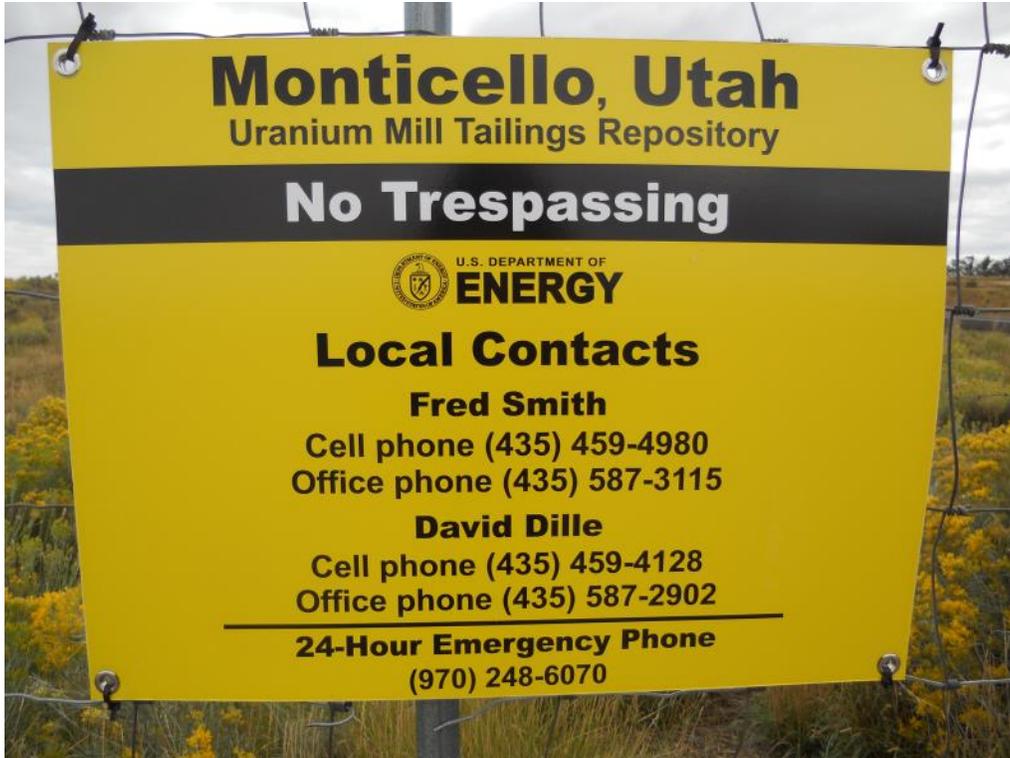
Photo 2. Site Information Sign Posted at Entrance

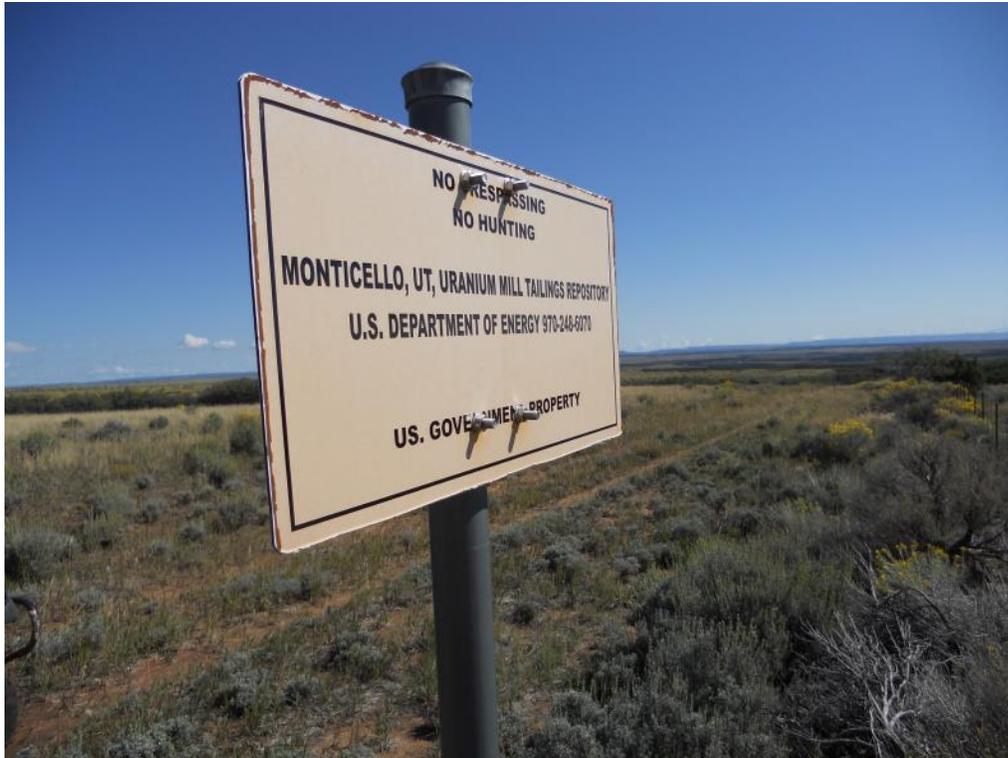
Most perimeter signs were legible and in good condition (Photo 4). Perimeter signs P5 and P15, as reported in previous years, were damaged but legible and will continue to be monitored. Perimeter sign P16 has been removed by construction activities (Photo 5) and will be replaced when construction is complete.

Photo 4. Perimeter Sign P34

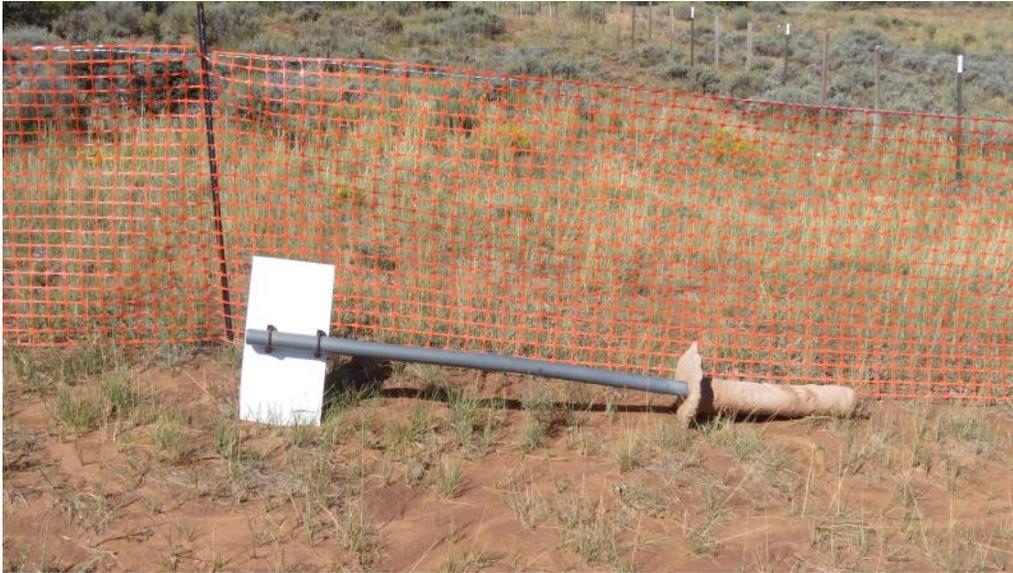
Photo 5. Perimeter Sign P16 Temporarily Removed by Construction

| Signs damaged but legible, requiring monitoring: P5 (bullet hole); P15 (damaged; missing "P15"); P16 sign missing (related to construction; to be replaced) | | |

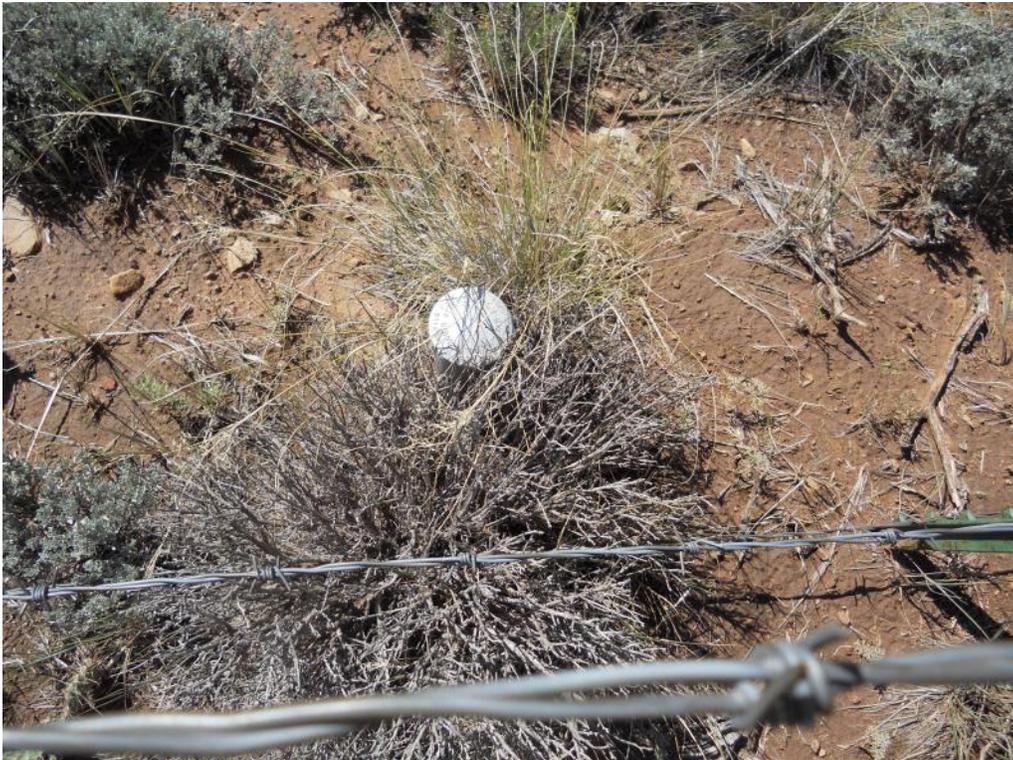
All six boundary markers were located during the inspection, and all markers were in good condition (Photo 6).

Photo 6. Boundary Marker S-2

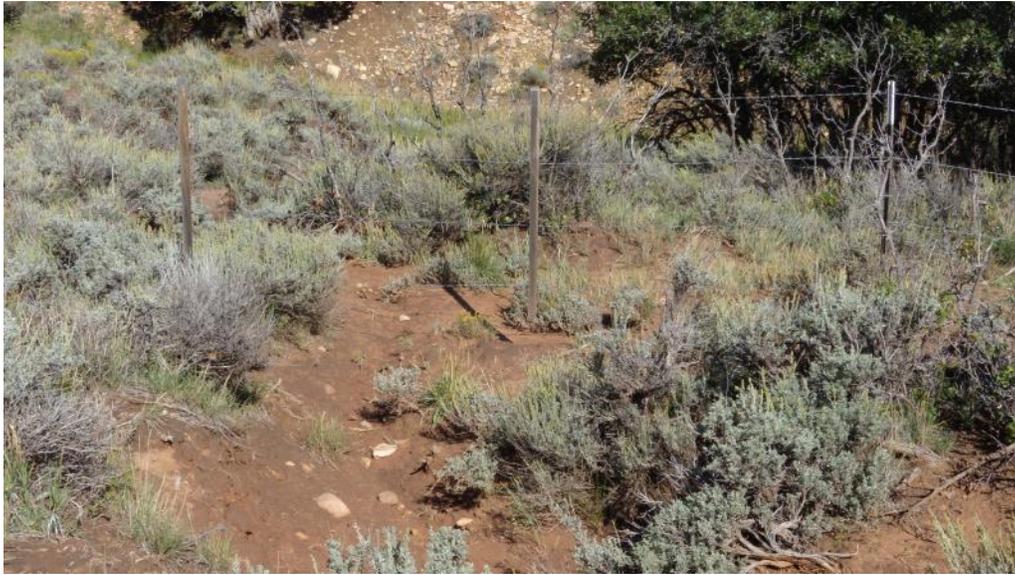
Photo 7. Erosion on Site Perimeter Near Perimeter Sign P7

Gully along west boundary continues to fill in and stabilize. Erosion repairs not recommended at this time, but monitoring will continue. Spotted knapweed and Russian knapweed infestations noted on map. Historical haul road under construction (transmission line installation).

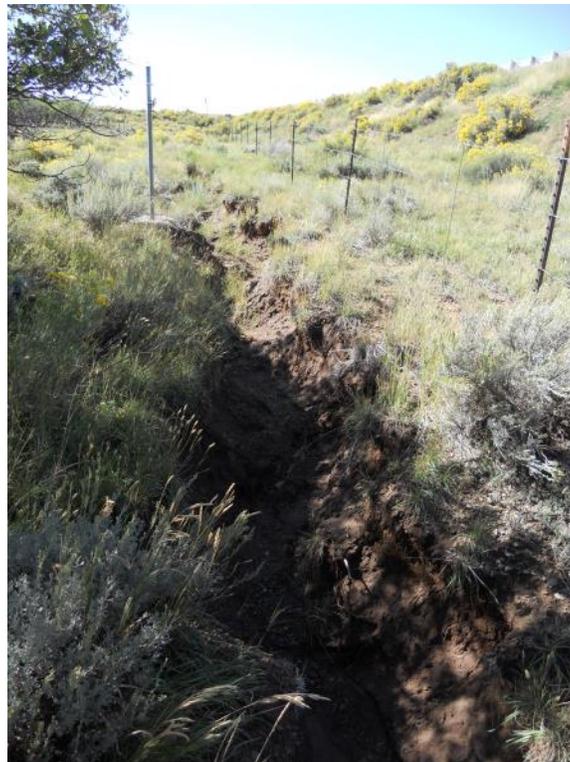
Photo 8. Erosion Channel Near Perimeter Sign P1

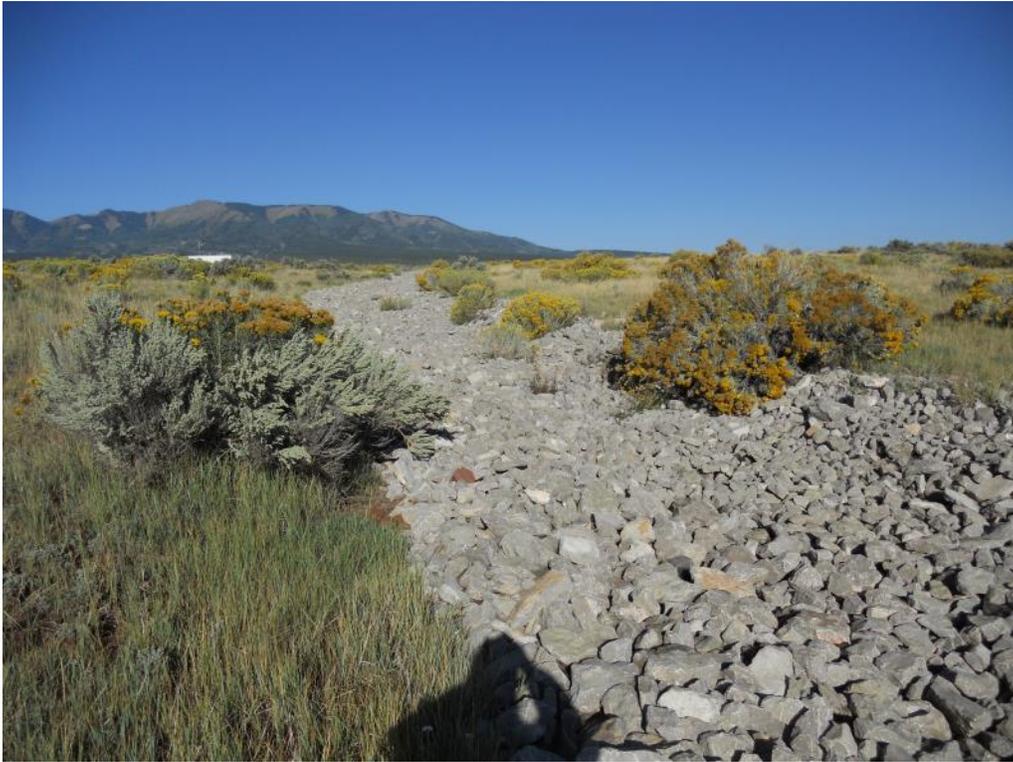
The South Drain Ditch and West Drain Ditch were in very good condition with no evidence of new erosion (Photo 9 and Photo 10). Shrubs observed in portions of the ditches do not block

Photo 9. South Drain Ditch

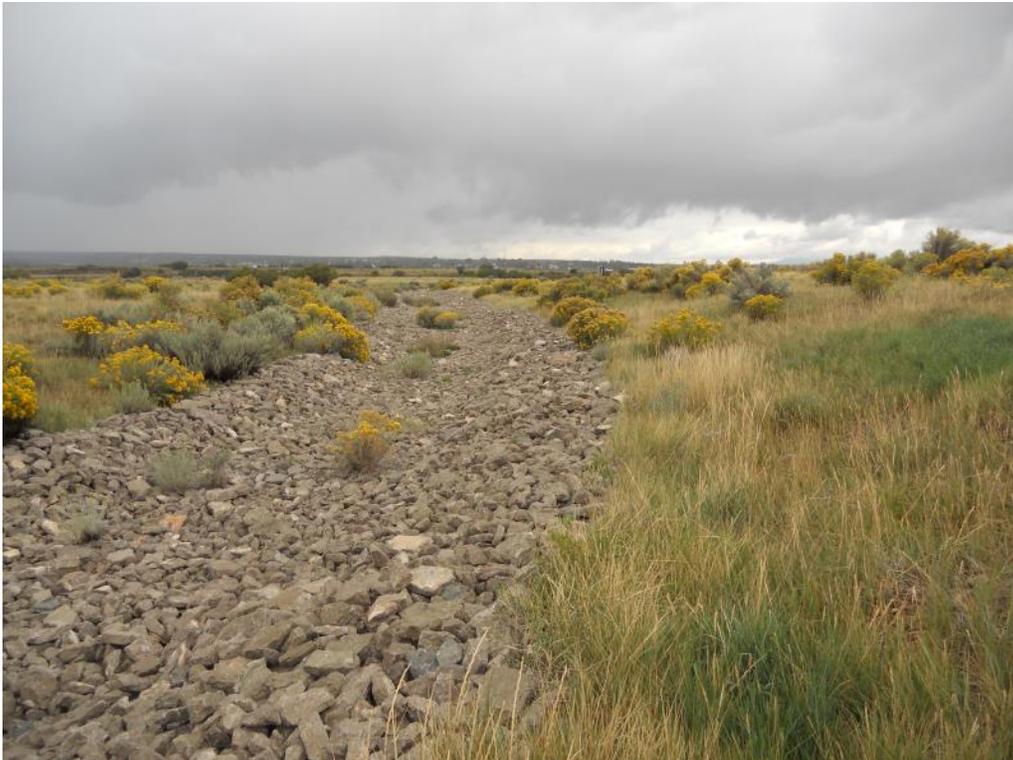
Photo 10. West Drain Ditch

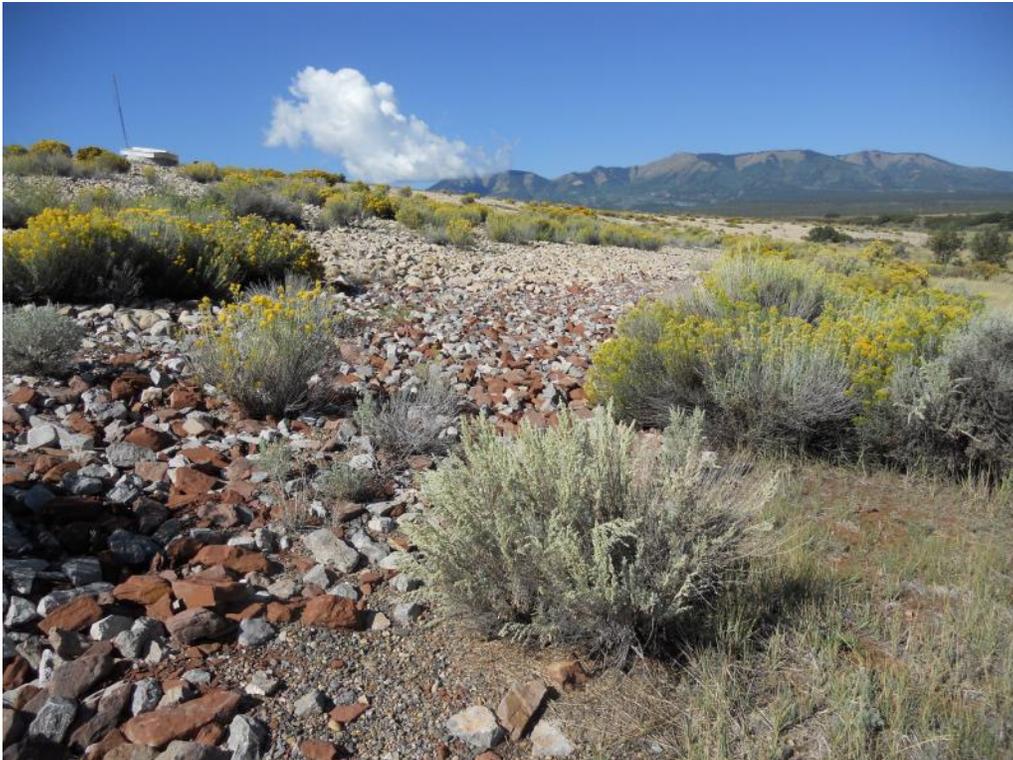
Erosion or bypass of these trenches was not evident. Soils and vegetation in the trenches are not expected to impede flows. Beginning in 2013, inspectors observed increased siltation and small amounts of surface riprap that had moved from the repository side slope into both trenches due to heavy rainfall events (Photo 11 and Photo 12). To ensure that any material movement does not threaten the integrity of the disposal cell, monitoring of the toe trenches will continue.

Photo 12. North Toe Trench

Degradation of rock in North Toe Trench relatively unchanged since 2011. Movement of materials into North and East Toe Trenches continues with heavy rainfall and will be monitored. Siltation in all drains and ditches is expected over time. Shrubs in ditches are not obstructing flow.

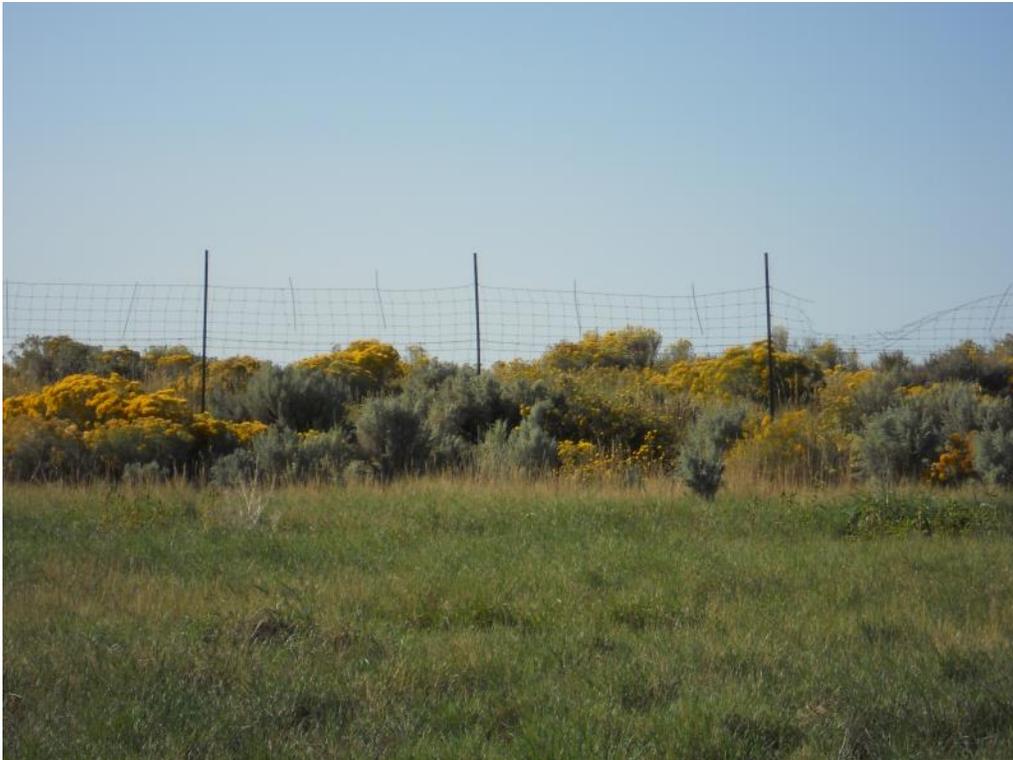
The gravel road surrounding the disposal cell and the road to Pond 4 were in excellent condition. The wildlife fence and gate apertures were functional and showed no evidence of vandalism. Damaged sections of the wildlife fence were apparent (Photo 14), but the fence remains functional, and repairs are not required. Both site monuments—one at the west access gate inside the wildlife fence (Photo 15) and one at the apex of the disposal cell—were present and intact. Six raptor perches, installed near the disposal cell cover in 2007, were also in good condition, although a supporting beam on one perch had become detached (Photo 16).

Photo 14. Damaged Section of Wildlife Fence

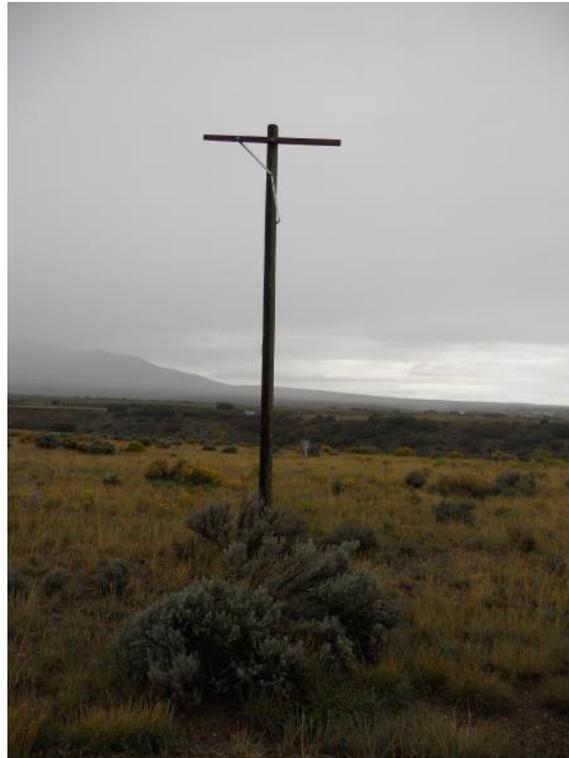
Photo 16. Raptor Perch with Damaged Support Structure

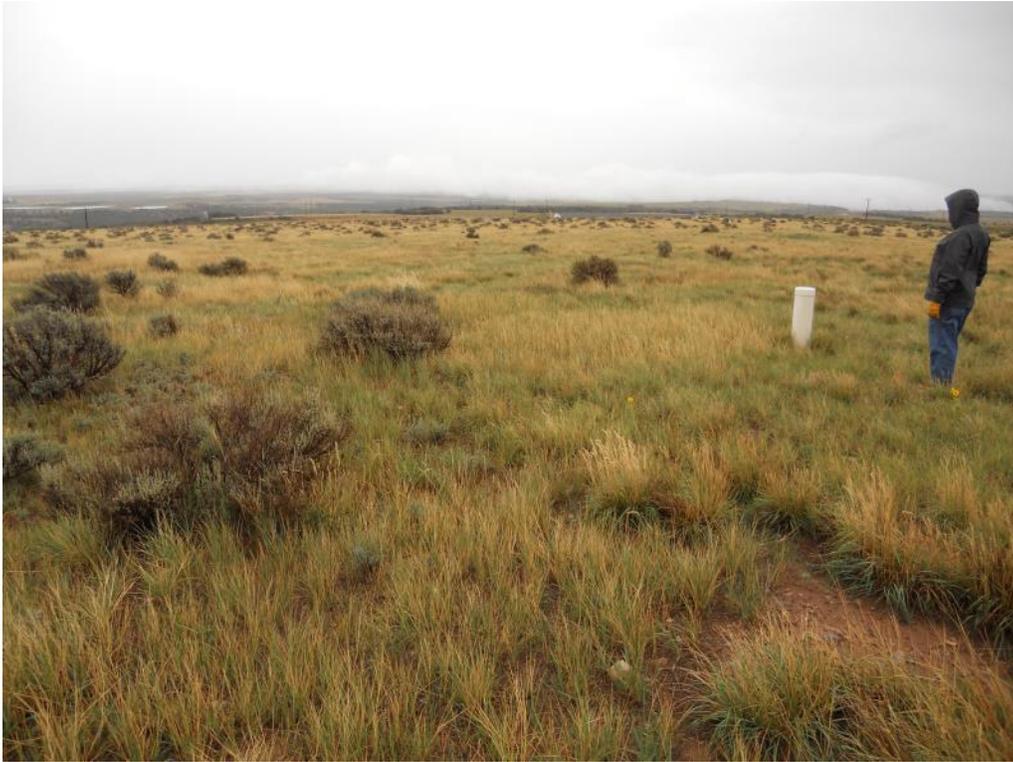
Desirable plants remained well established on the cover, and no significant barren or eroded areas were identified (Photo 17). No damage to vegetation or soils from large, recent rainstorms was apparent, and no species of phreatophyte shrubs were growing on the cover. As in recent years, there were a large number of healthy, desirable sagebrush (*Artemisia tridentata*) seedlings. Small quantities of field bindweed, a noxious species, were growing on the cover, but because it is not spreading, control is unnecessary.

Photo 17. Cover Vegetation, View East

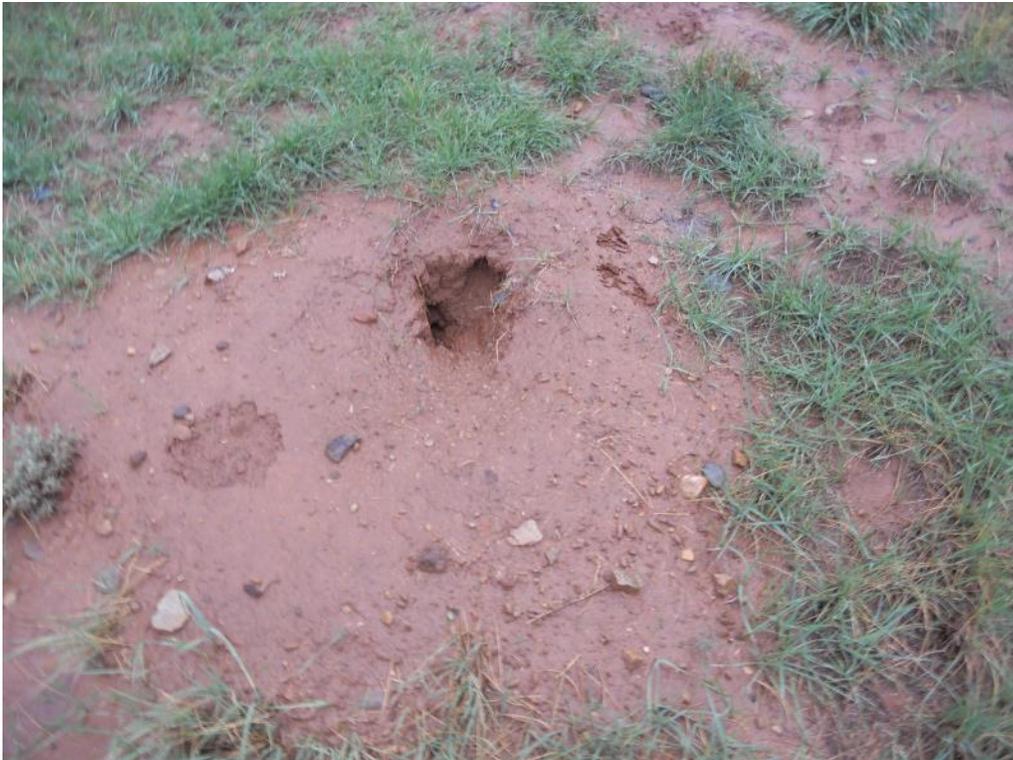
Evidence of small burrowing animals has been observed on the repository cover for years. Raptors and other predators have kept these populations at low to moderate levels since a vole outbreak occurred in 2006. In 2013, prairie dog burrows were found on the repository cover for

the first time, and these burrows were monitored during the 2014 annual inspection (Photo 18). Because the repository cover was engineered to withstand prairie dog activity, populations are not a concern, but burrows and the effect of prairie dog populations on the vegetation cover will continue to be monitored. Inspectors and onsite personnel will look for evidence of gray-colored soils being cast to the surface, as this would indicate excavation into the biointrusion layer. No such soils have been observed on the surface to date.

Photo 18. Prairie Dog Burrows on Repository Cover

Prairie dog burrows on cover. The cover was engineered to accommodate prairie dog activity. Burrows will be monitored and photographed as necessary during routine and annual inspections. Smaller rodent burrows (probably from voles) were also observed.

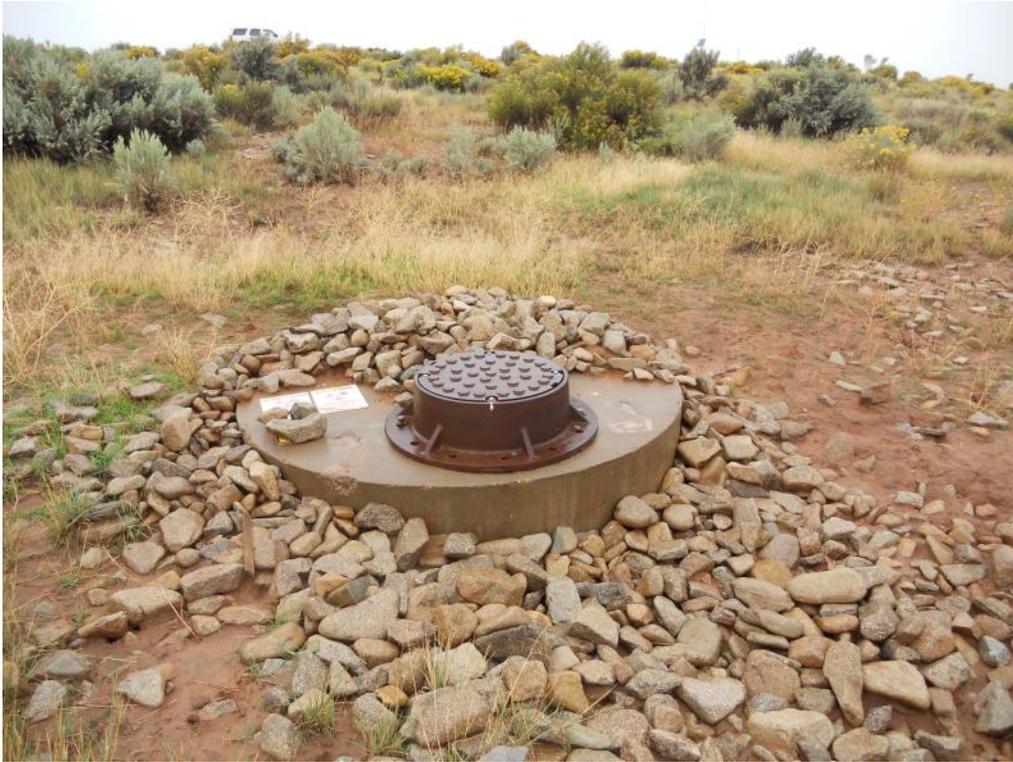
The manholes are restricted areas and were not entered during the annual inspection, but the exteriors were in good condition. All five manhole covers were secure and operable. Manhole 4 (Photo 19) will continue to be monitored, as soils have eroded on its uphill side, and rocks have been displaced to the top of the structure. Appropriate safety warnings and entry procedures were posted on all of the manholes, exterior pump access ports were undamaged, telemetry surface installations were in good condition, and no leakage or drainage was evident. Covers of the inoperable video ports were locked and secure (Photo 20).

Photo 19. Manhole 4

Notes for condition of manholes: **Rocks are piled up on the concrete cover penetration and against the manhole lid at Manhole 4. No damage was observed; monitoring of the area will continue.**

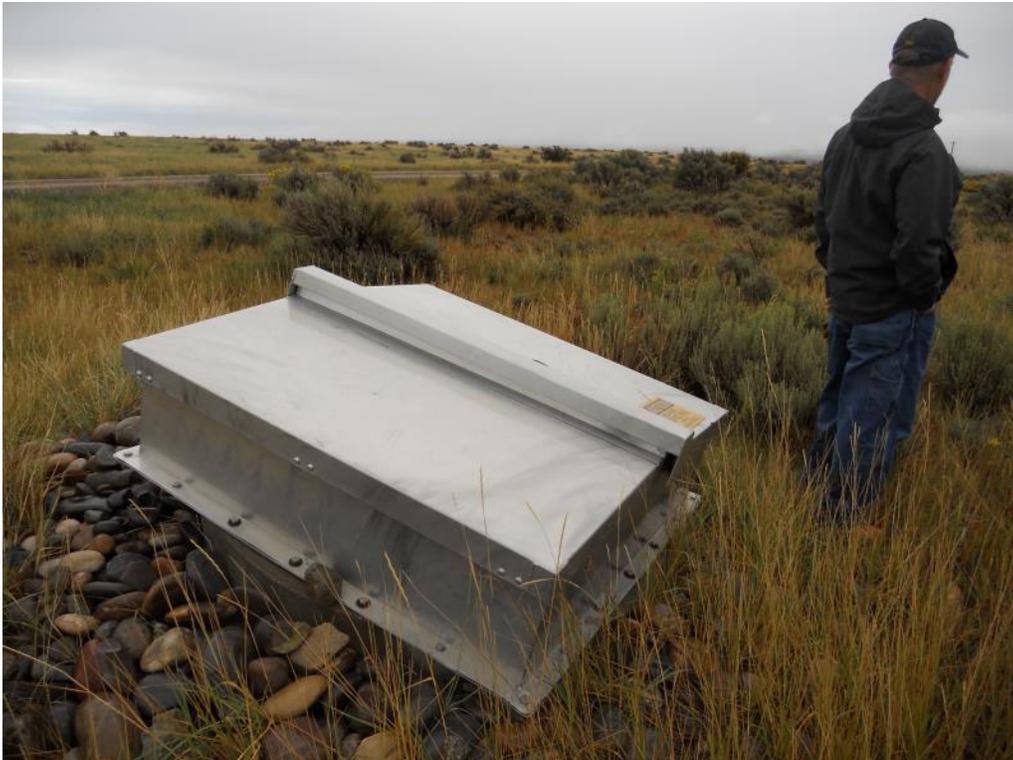
Photo 20. Video Port MH 2

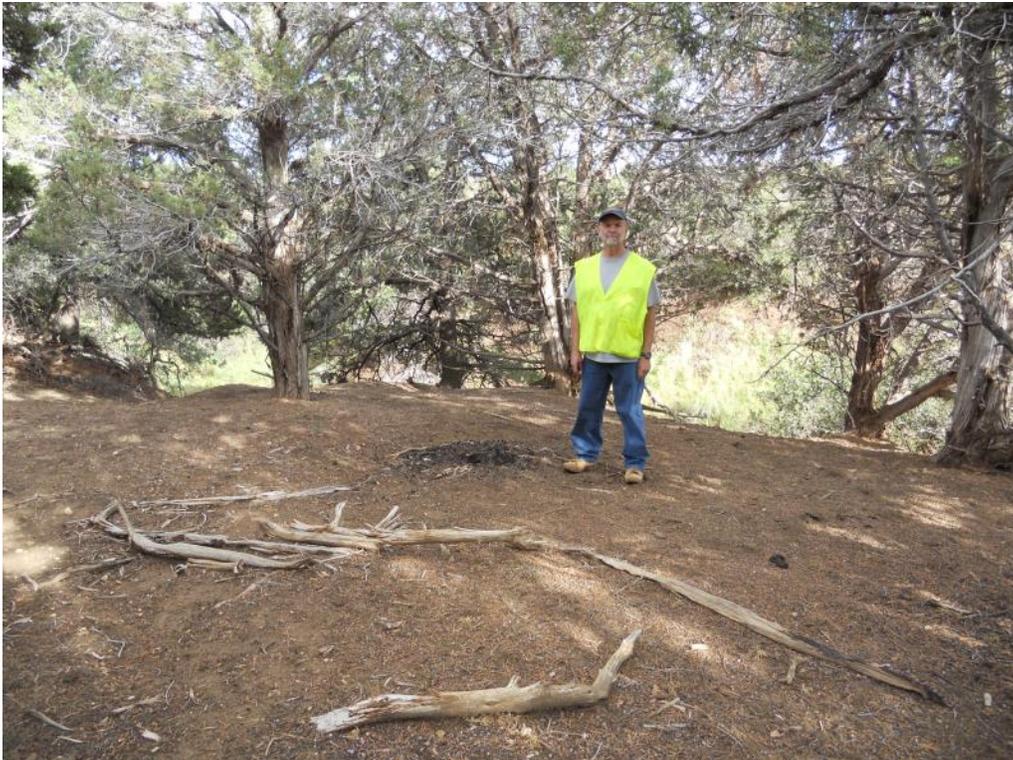
Overnight camping is not allowed on these properties. One area, previously determined to be a day camp on Property MP-01077, is routinely monitored by onsite personnel, and no evidence of recent use was observed. A fire pit previously identified on MP-01040 (North) was no longer apparent and will no longer be monitored. A fire pit discovered in 2012 on MP-01041 showed no evidence of additional use (Photo 24).

Photo 24. Old Fire Pit on MP-01041 Showing No Recent Use

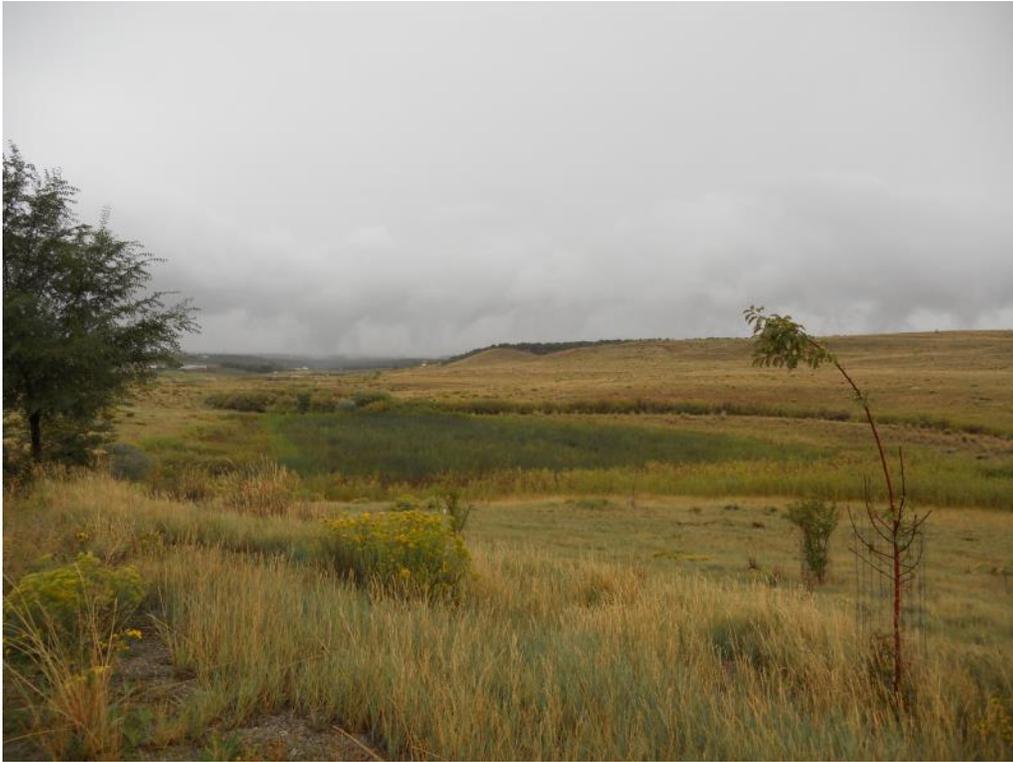
Wetlands on the former mill site (Photo 27) were constructed according to EPA-specific criteria, and these wetlands are protected by cooperative agreement. Under this agreement, the City of Monticello will not disturb these areas without prior approval from appropriate state and federal agencies but is not responsible for repairing damage to these areas by natural causes. Three constructed marsh wetlands (Wetlands 1–3, Figure 4) on the City-owned properties were ecologically healthy, and no evidence of damage by human activity or natural causes was apparent. However, outside of the constructed wetlands, significant damage to vegetation, probably from herbicide application by an unknown party, around the irrigation diversion structure on Montezuma Creek between Wetlands 2 and 3 was observed during the 2014 inspection. Inspectors also observed that repairs to the City road on the former millsite in 2014 disturbed small areas of wetland vegetation outside of the constructed wetlands.

Photo 27. Wetland 2

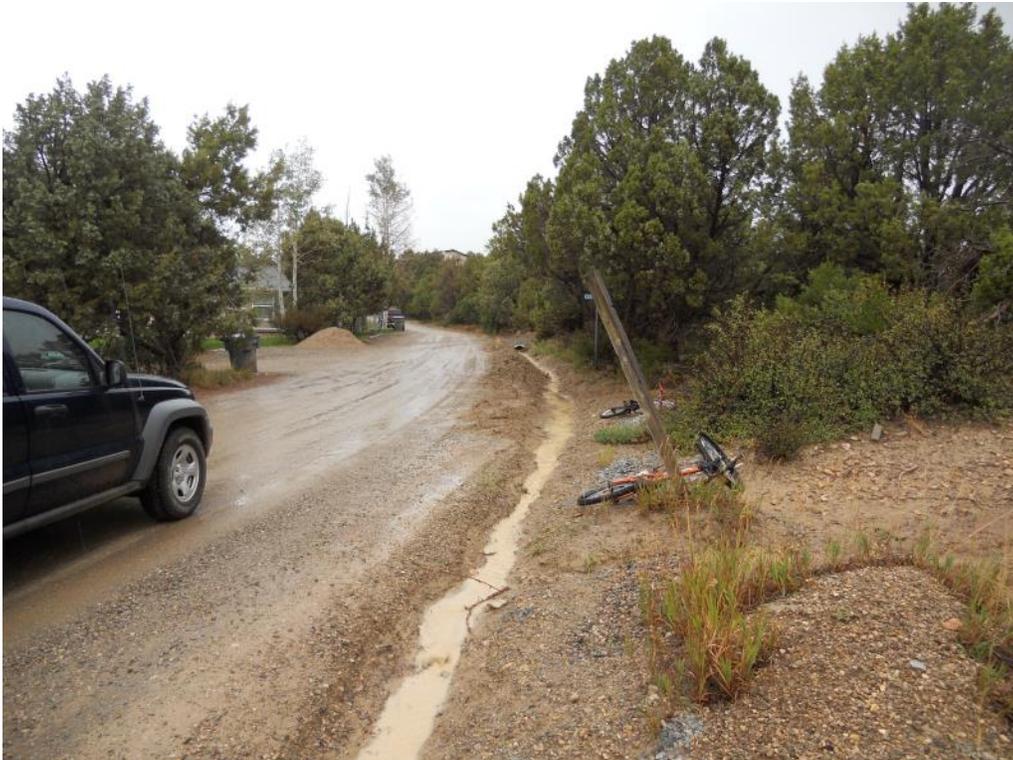
Photo 30. Drainage Ditch Below Property MS-00176, Scanned After Storm Events
