2015 Annual Inspection Report for the DOE Monticello, Utah, Mill Tailings Site and Monticello Vicinity Properties

December 2015

Legacy
Management

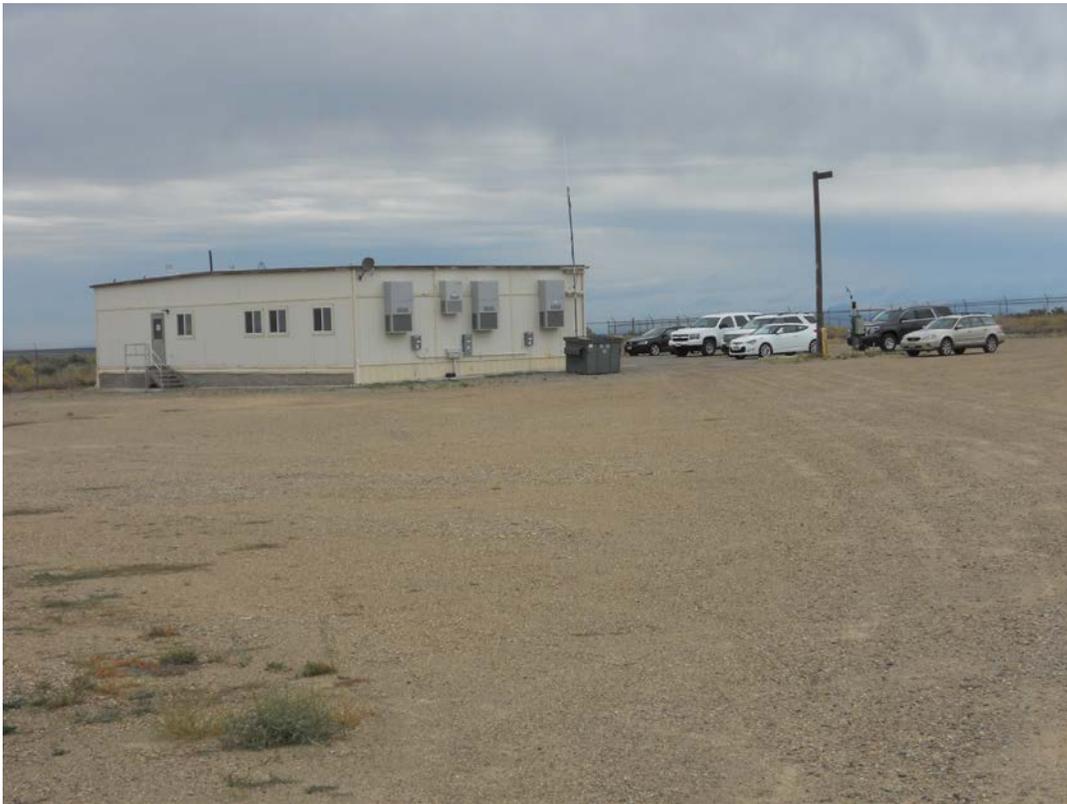
Photo 1. Field Office Facility and Parking Lot

The Monticello field office buildings and associated structures were in excellent condition and are well maintained (Photo 1). Site access signs displaying contact information were current and visible. The site's paved access road was in very good condition.

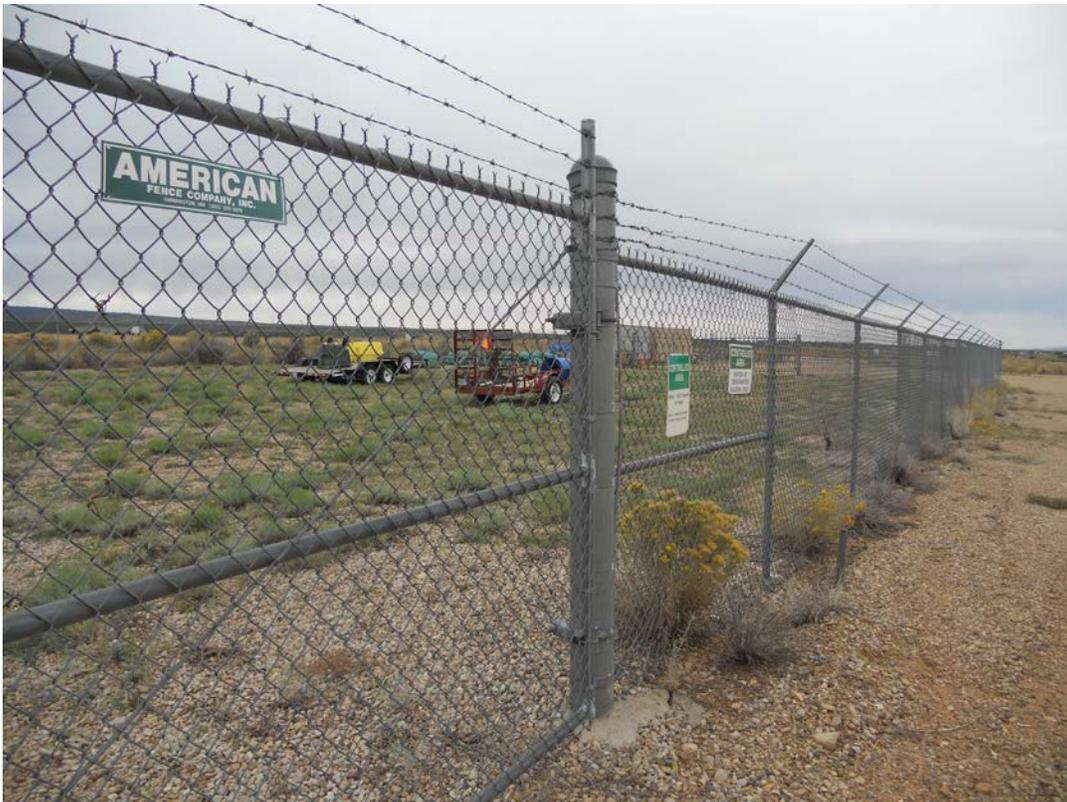
materials, mostly empty sand bags and minor debris removed from Pond 4, had been transferred to super sacks. The area containing the super sacks was appropriately posted. The TSF yard was well maintained. The lay-down area for potential mixed waste was in good working order, but no mixed waste was stored in the TSF. Clamshell containers, used for materials with activity below release levels, were in good condition.

Photo 2. Gate, Postings, and Equipment in TSF

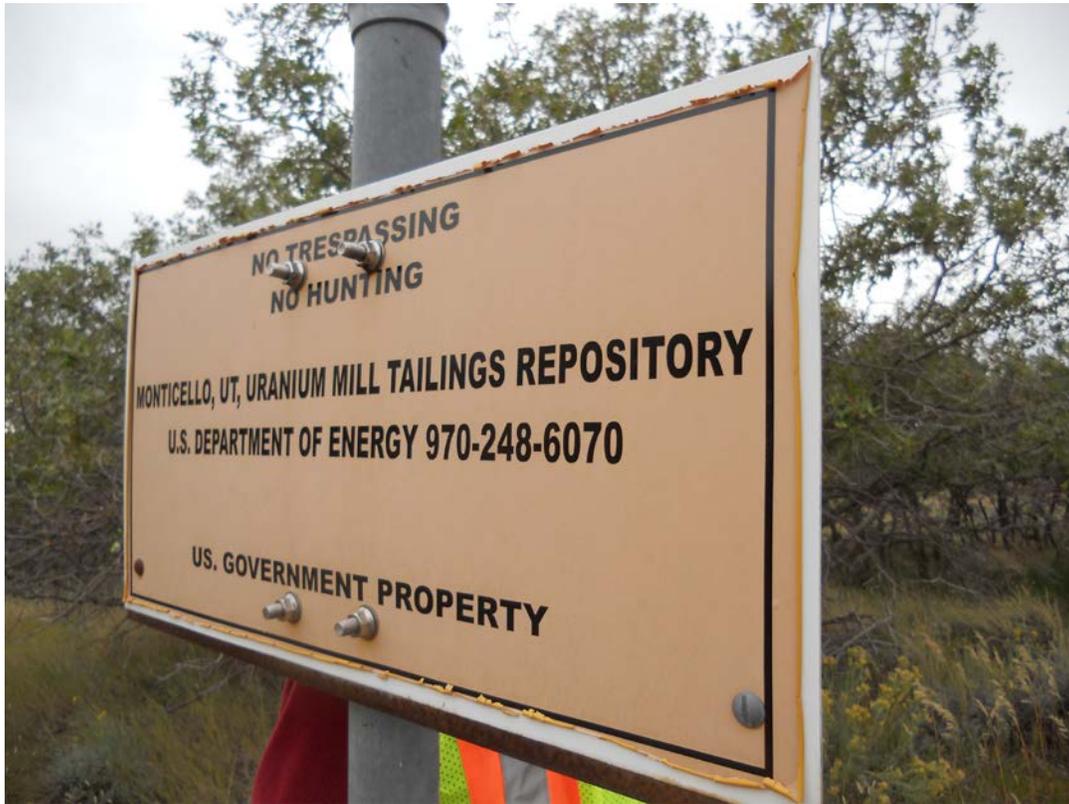
Most perimeter signs were legible and in relatively good condition (Photo 3). Perimeter signs P5, P15, and P20 were damaged but legible and will continue to be monitored.

Photo 3. Perimeter Sign P1

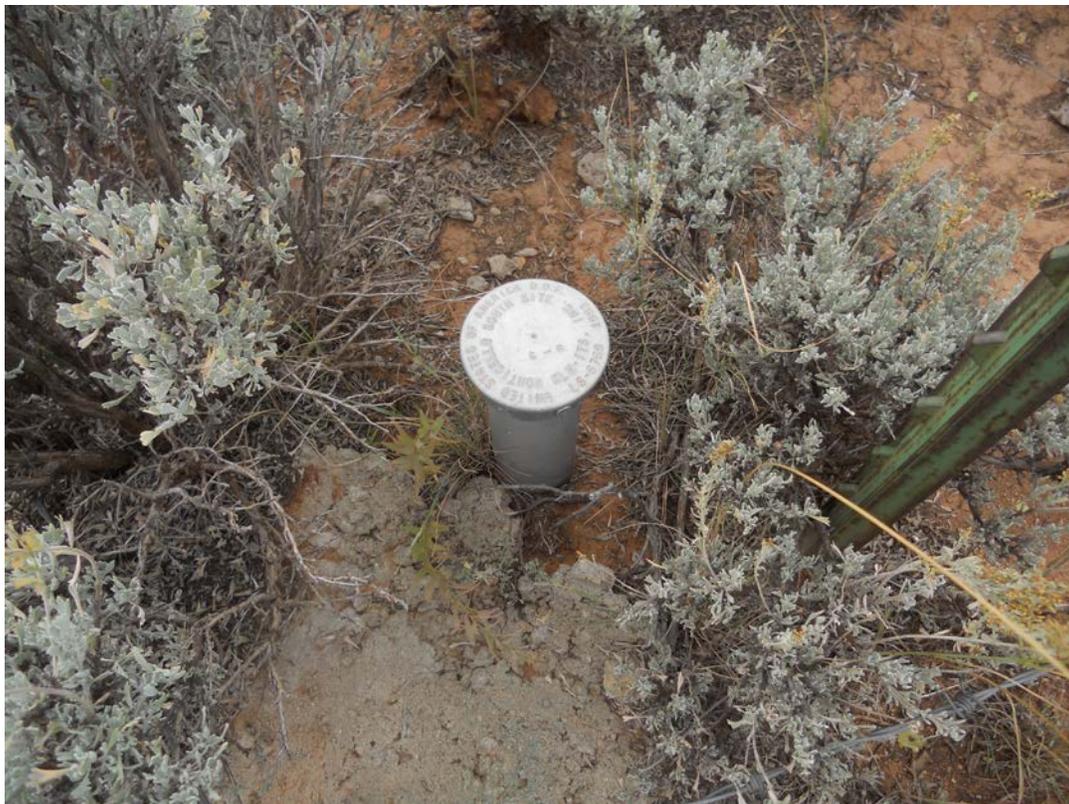
All six boundary markers were located during the inspection, and all markers were in good condition (Photo 4).

Photo 4. Boundary Marker S-3

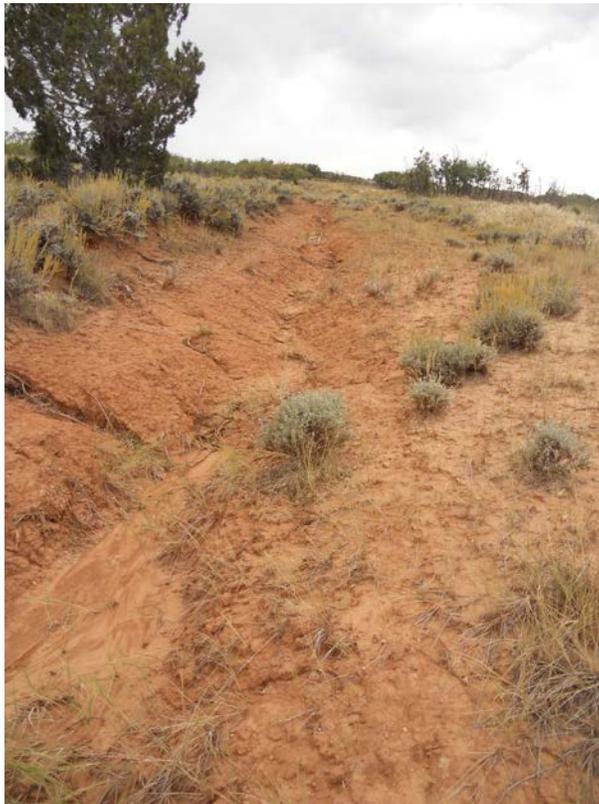
Most drainages around the site perimeter were well vegetated and were not significantly affected by recent heavy rainstorms (Photo 5). Erosion controls and revegetated areas related to the groundwater remedy optimization project were generally in very good condition, and no areas of major erosion were noted. The deep gully on the west edge of the disposal site north of the entrance gate (between perimeter signs E and P2) continued to fill in with sediment in most places (Photo 6). The gully still does not threaten the integrity of site features and will continue to be monitored.

Photo 5. Erosion Rill Above Perimeter Sign P6; No Significant New Erosion

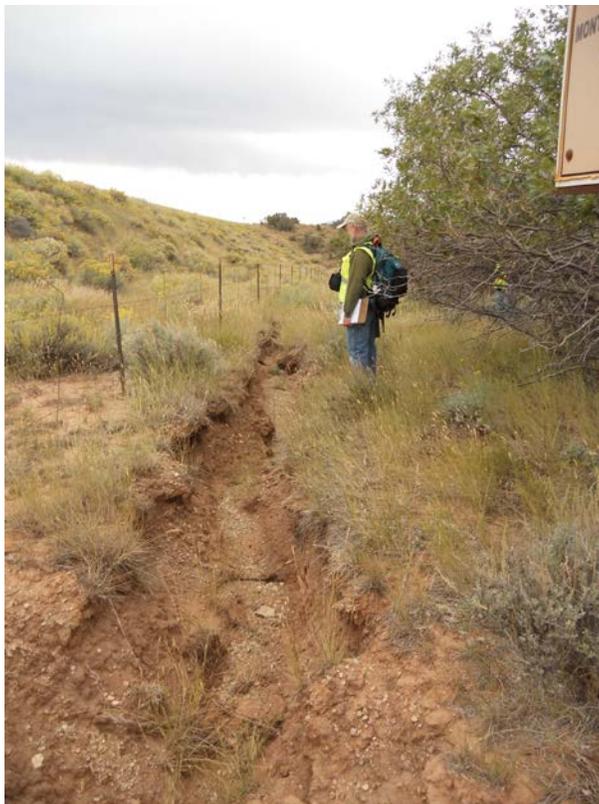
Photo 6. Erosion Rill Near Perimeter Sign P1

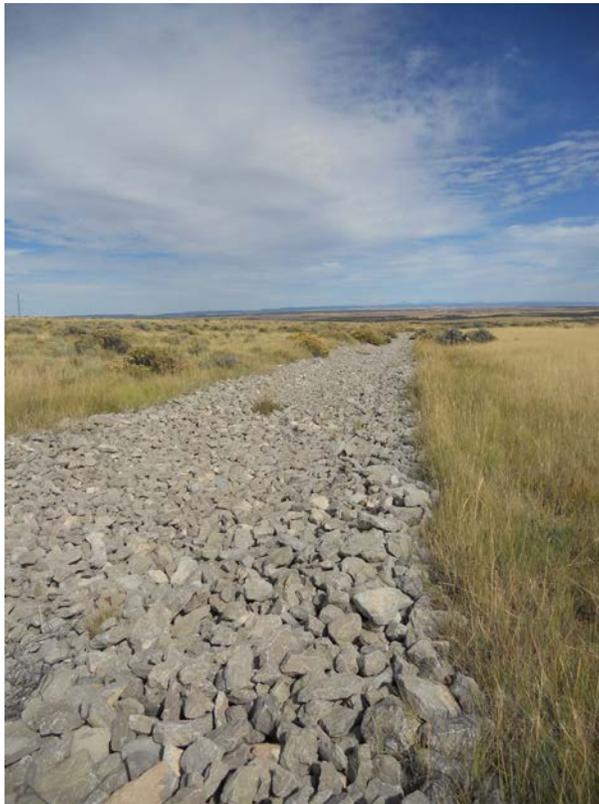
The South Drain Ditch and West Drain Ditch were in very good condition with no evidence of new erosion (Photo 7 and Photo 8). Shrubs observed in portions of the ditches do not block potential flow. Burrows from small rodents occurred in places along the margin of the South Drain Ditch but do not threaten its integrity.

Photo 7. South Drain Ditch

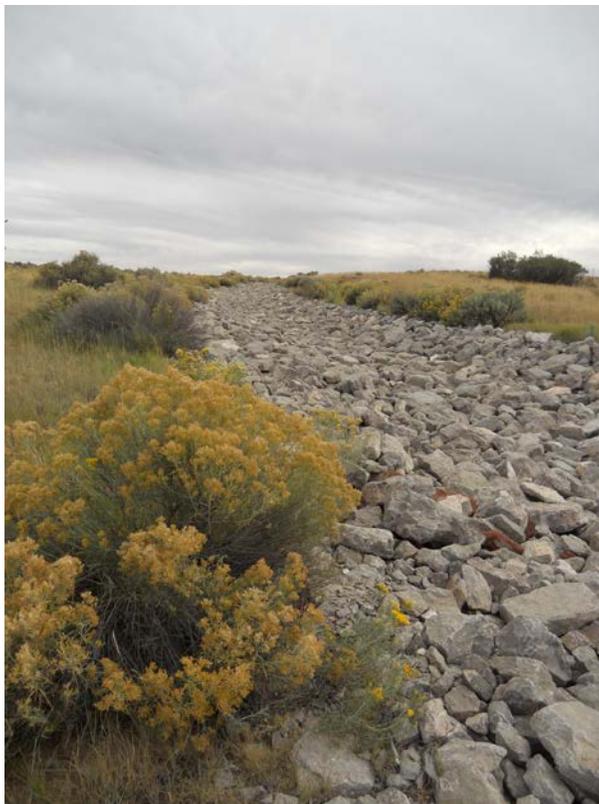
Photo 8. West Drain Ditch

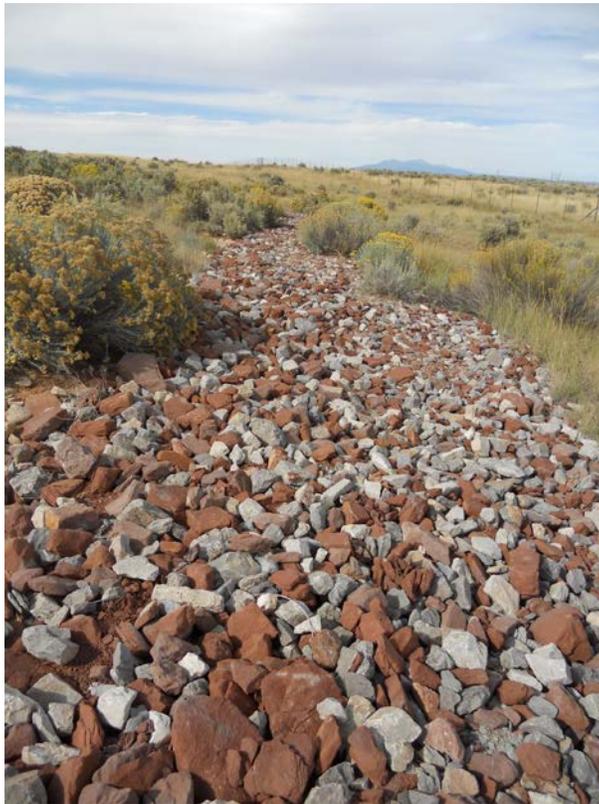
The East Toe Trench and North Toe Trench were in good condition. Erosion or bypass of these trenches was not evident. Soils and vegetation in the trenches are not expected to impede flows. Beginning in 2013, inspectors observed increased siltation and small amounts of surface riprap that had moved from the repository side slope into both trenches due to heavy rainfall events. Additional material movement was observed in 2015, but does not impair the functioning of the trenches (Photo 9 and Photo 10). To ensure that any material movement does not threaten the integrity of the disposal cell, monitoring of the toe trenches will continue.

Photo 9. East Toe Trench Showing Vegetation and Material Movement

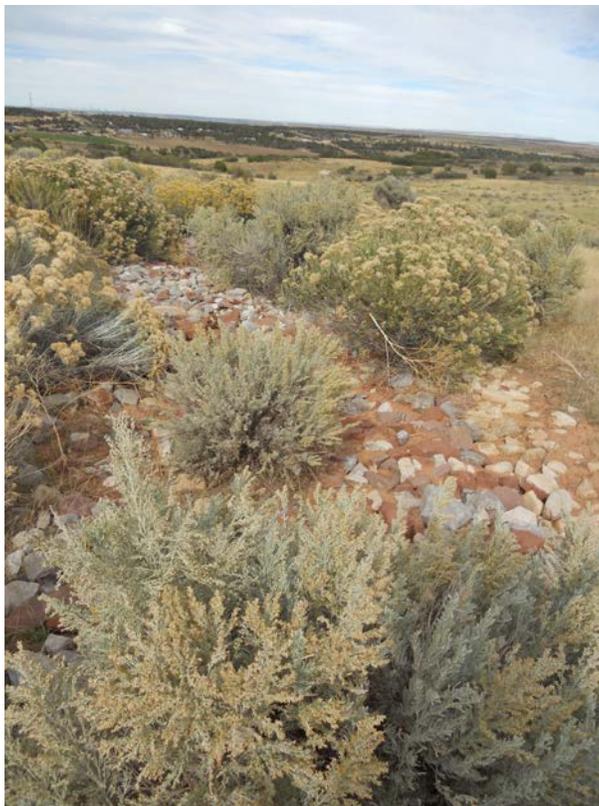
Photo 10. North Toe Trench Showing Vegetation and Material Movement

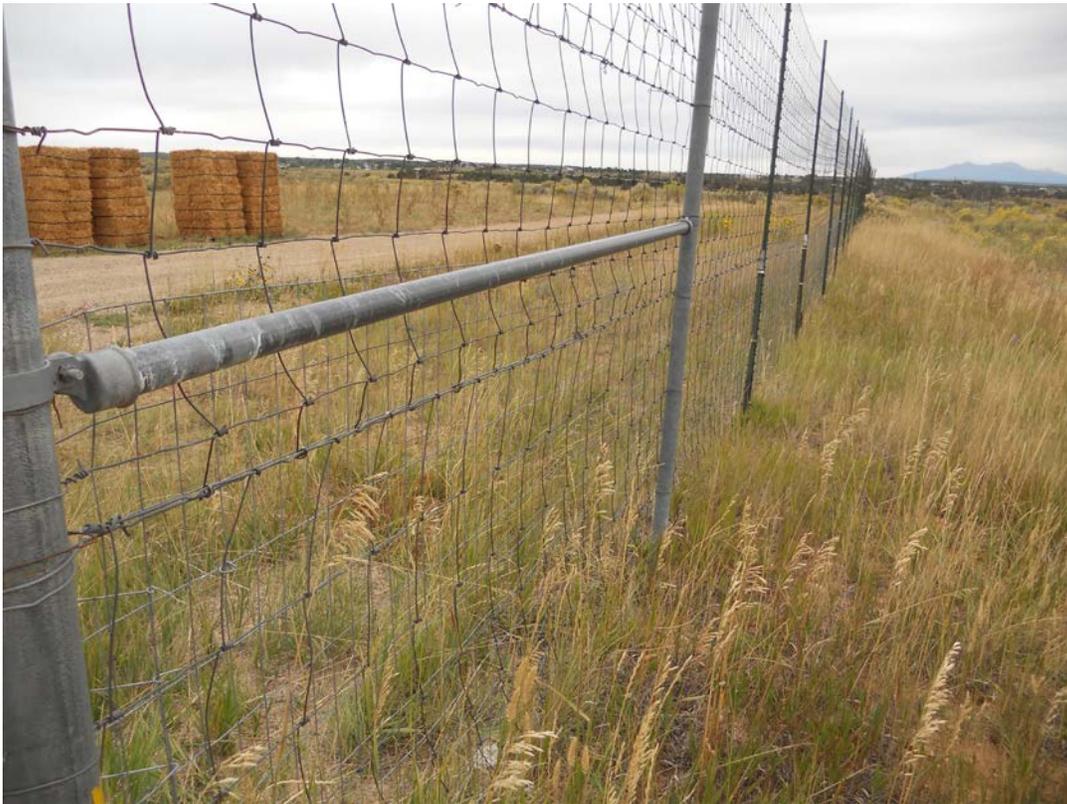
All gates were in good working condition. Warning signs on the perimeter fence were easily visible and legible. The following warning signs were posted on the perimeter fence and gates: “Danger Do Not Enter,” “Controlled Area, Enter at Designated Access Only,” “Contaminated Water, Do Not Discharge,” and “No Trespassing.” On the vehicle access gate there is also a sign posted with contact information. There was no evidence of vandalism or trespass, and all gates were found to be locked at the time of the inspection. Additional fencing was installed in 2015 to reduce access by small animals (Photo 11).

Photo 11. Pond 4 Fence Showing New Fencing Added in 2015

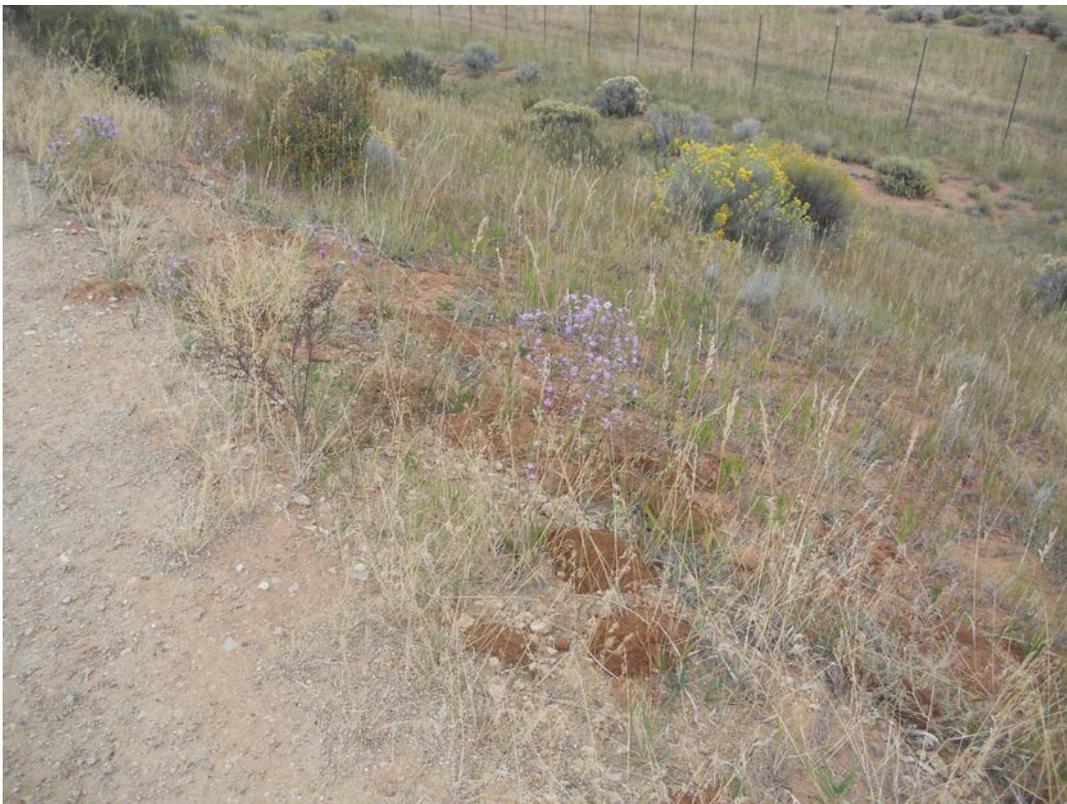
The pond’s rope barrier was intact and in good condition. Animal burrows made by voles and other small rodents were visible on and below the pond’s berm on all sides (Photo 12). No large burrows that might threaten the berm’s integrity were found. Animal burrows will continue to be monitored. Vegetation on the slopes of the berm was well established.

Photo 12. Pond 4 Berm Showing Animal Burrows

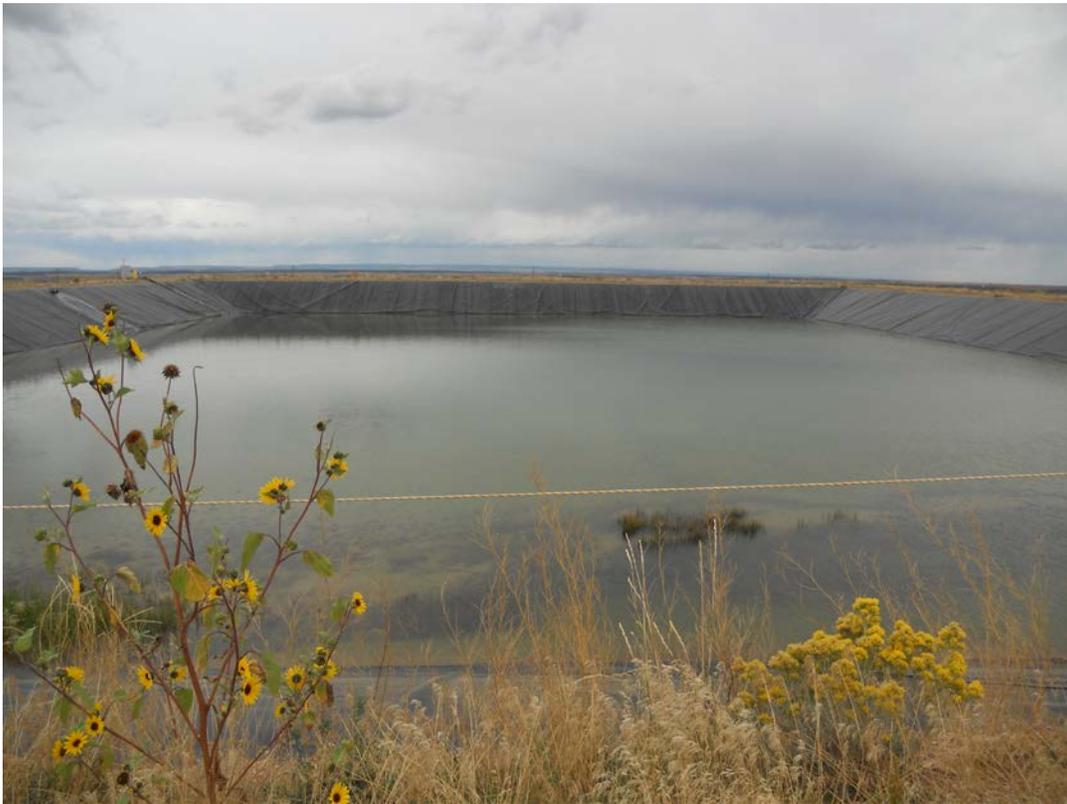
No visible evidence of holes or other damage to the pond liner was observed. Approximately 5 feet of water was in the pond at the time of the inspection (Photo 13), due in large part to operating the groundwater remedy optimization project.

Photo 13. Pond 4

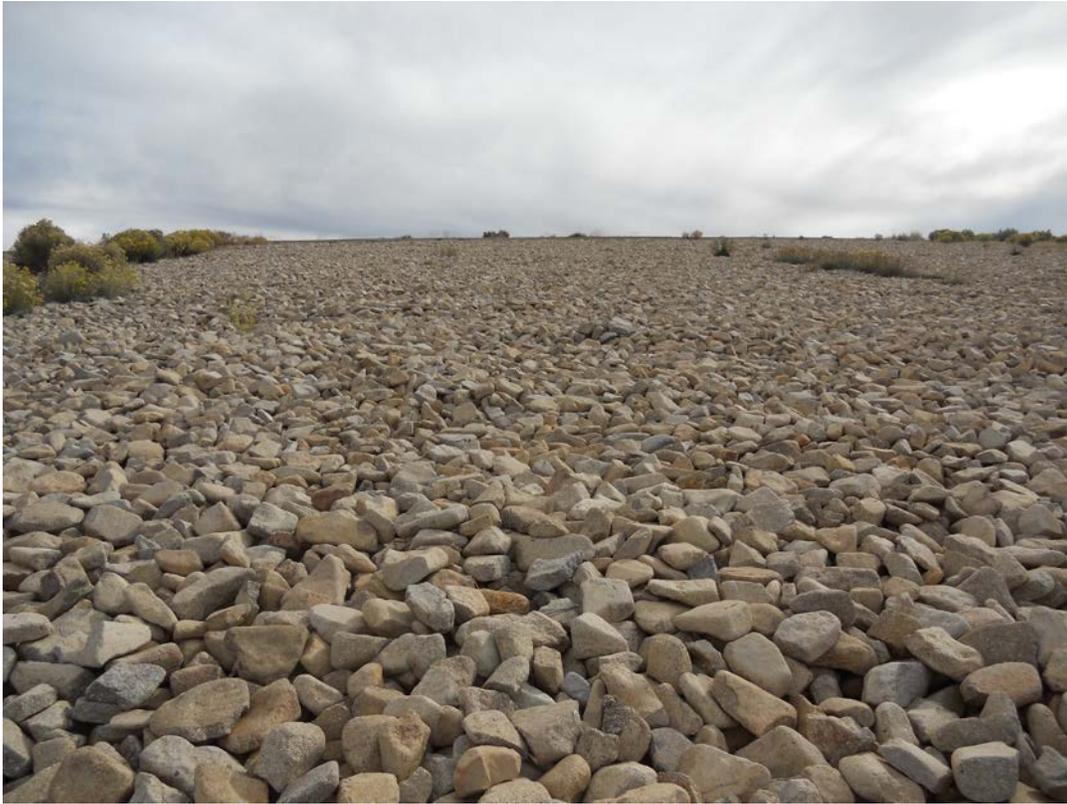
No area of the cover indicated settling, slumping, fracturing, seepage, ponding, or significant erosion. Some evidence of rock movement on the north disposal cell side slope was observed for the first time in 2015. Three observances were noted: (1) rock has moved, causing horizontal features on one portion of the side slope (Photo 15); (2) rock has moved downward and built up above the North Toe Trench in places (Photo 16); and (3) a channel-shaped feature has developed on the side slope (Photo 17). The location of these features is indicated by the respective photo locations on Figure 2. The movement of rock was probably due to runoff from large thunderstorms and affected areas are not large enough to indicate slope failure or the movement of anything other than surface rock. The side slopes will continue to be monitored, and affected areas will be compared to photographs taken annually.

Photo 15. Horizontal Line Features in Side Slope of Repository

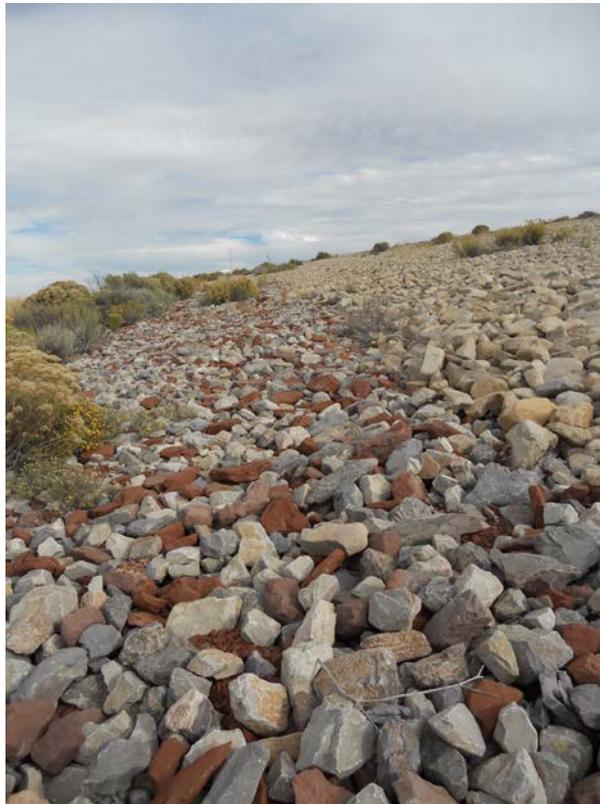
The steep, rock-lined slopes showed no evidence of rock degradation, settling, or slumping. As reported in Section 2.1.3, a small amount of soils continued to move into the East and North Toe Trenches. Soils were placed upslope on the surface over rock rip-rap, and movement of these soils into the trenches is not a significant concern.

Photo 16. Rock Accumulation Above the North Toe Trench

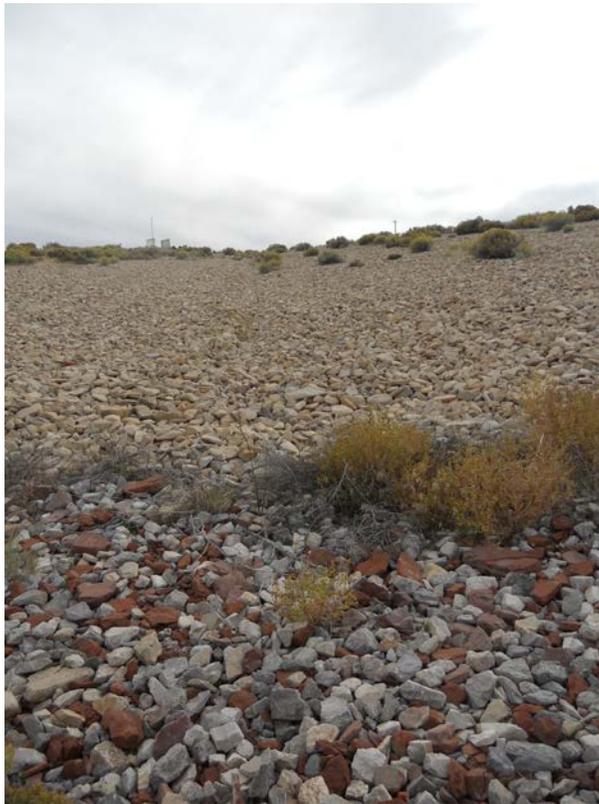
Photo 17. Channel-Shaped Area on Side Slope of Repository

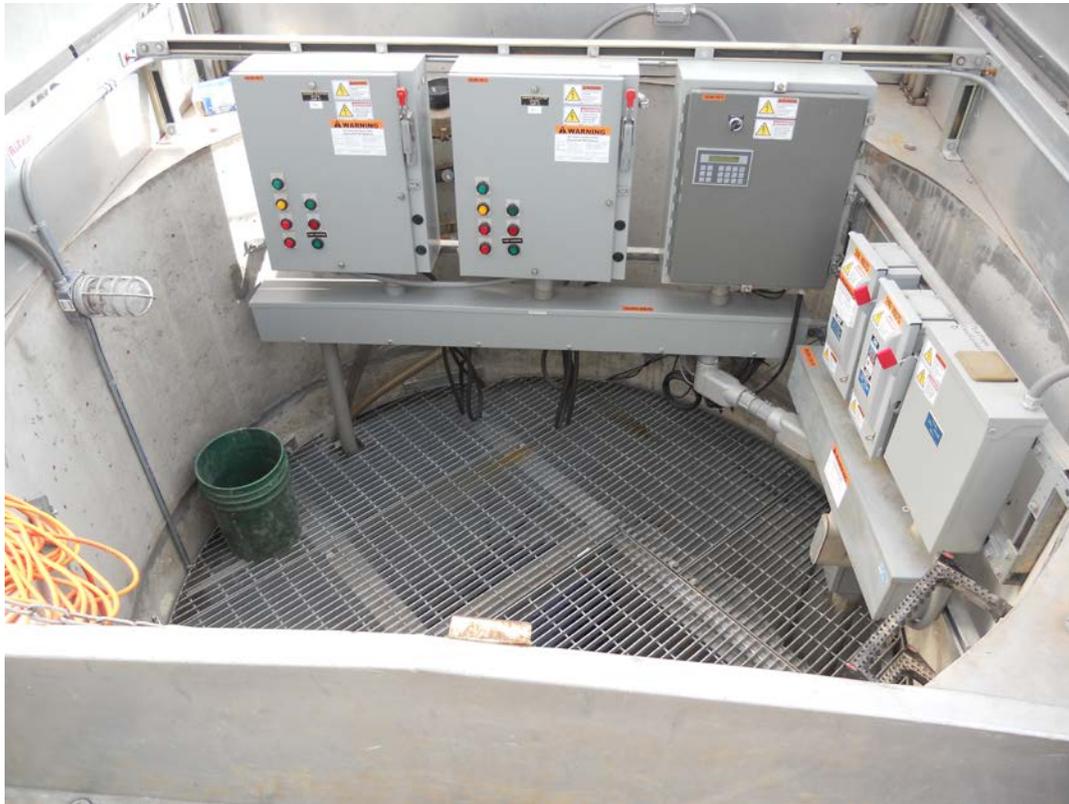
The manholes are restricted areas and were not entered during the annual inspection, but the interiors were observed without entering them and were in good condition (Photo 18). All five manhole covers were secure and operable. Manhole 4 will continue to be monitored, as soils have eroded on its uphill side, and rocks have been displaced to the top of the structure. Appropriate safety warnings and entry procedures were posted on all of the manholes, exterior pump access ports were undamaged, telemetry surface installations were in good condition, and no leakage or drainage was evident. Covers of the inoperable video ports were locked and secure.

Photo 18. Manhole 1 Showing Interior Equipment

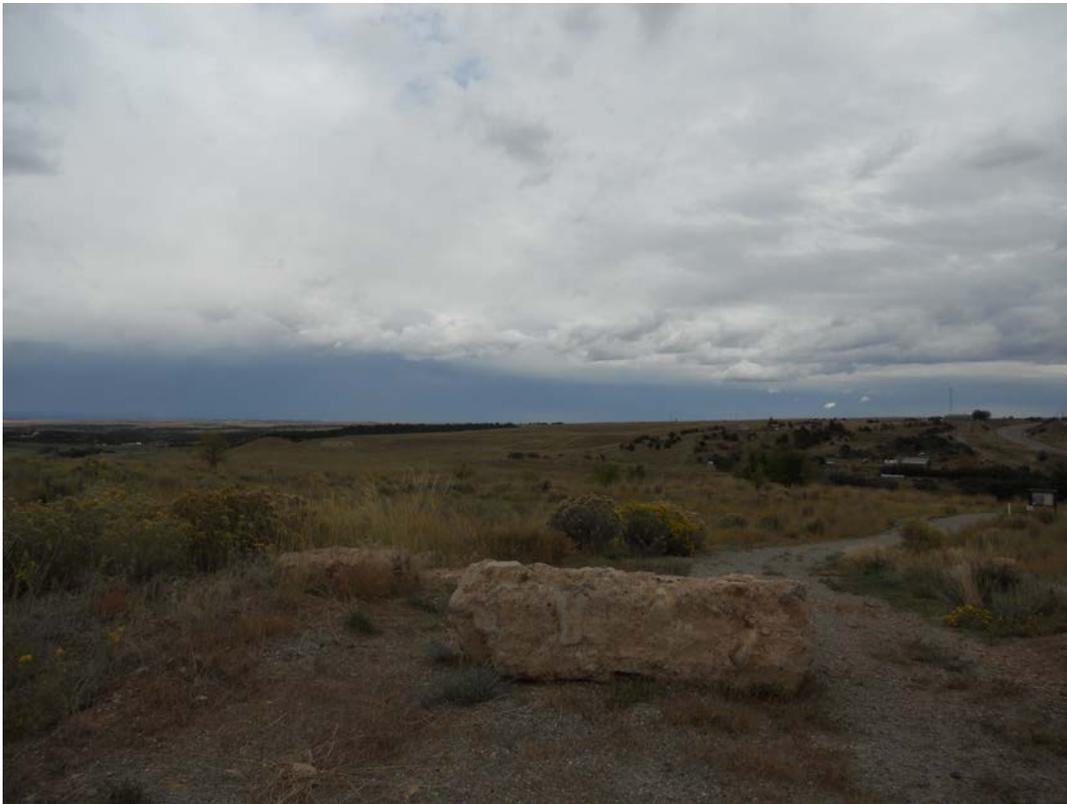
Photo 20. No Activity on Property MP-00211

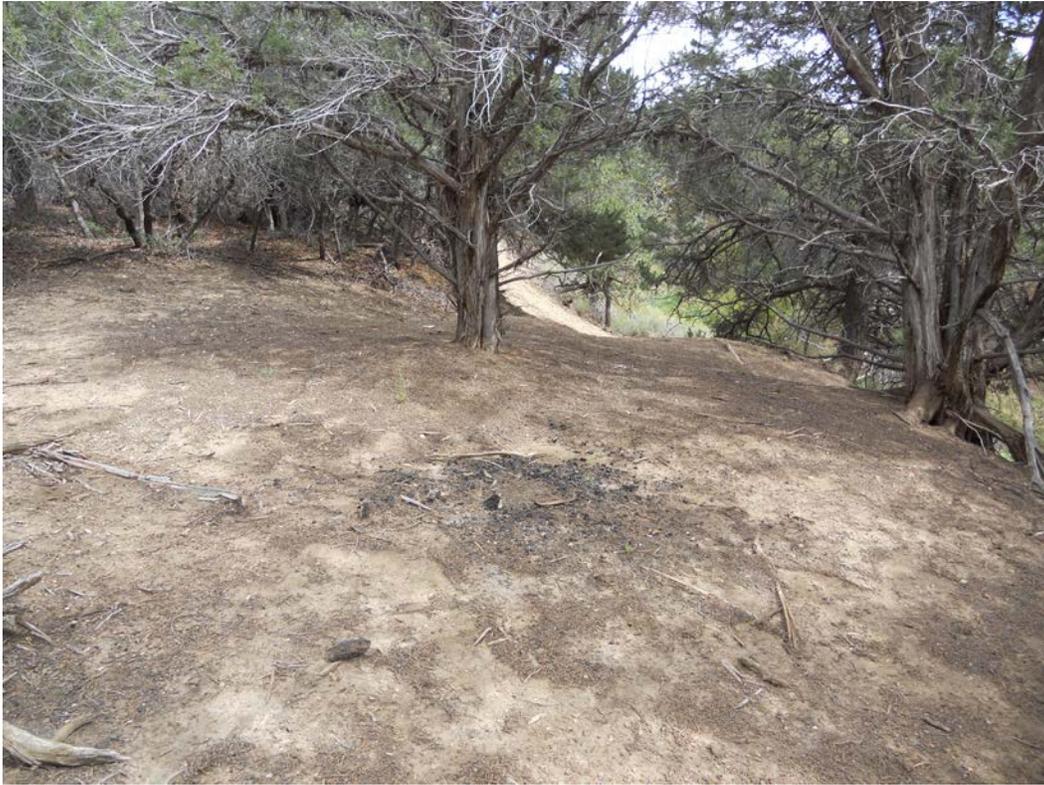
Overnight camping is not allowed on these properties. One area on Property MP-01077 previously determined to be a day camp is routinely monitored by onsite personnel, and no evidence of recent use was observed. A fire pit previously identified on MP-01040 (North Portion) was no longer apparent and will no longer be monitored. A fire pit discovered in 2012 on MP-01041 showed no evidence of additional use (Photo 21).

Photo 21. Campsite in Supplemental Standards Area on City-Owned Property MP-01041, No Signs of Recent Use

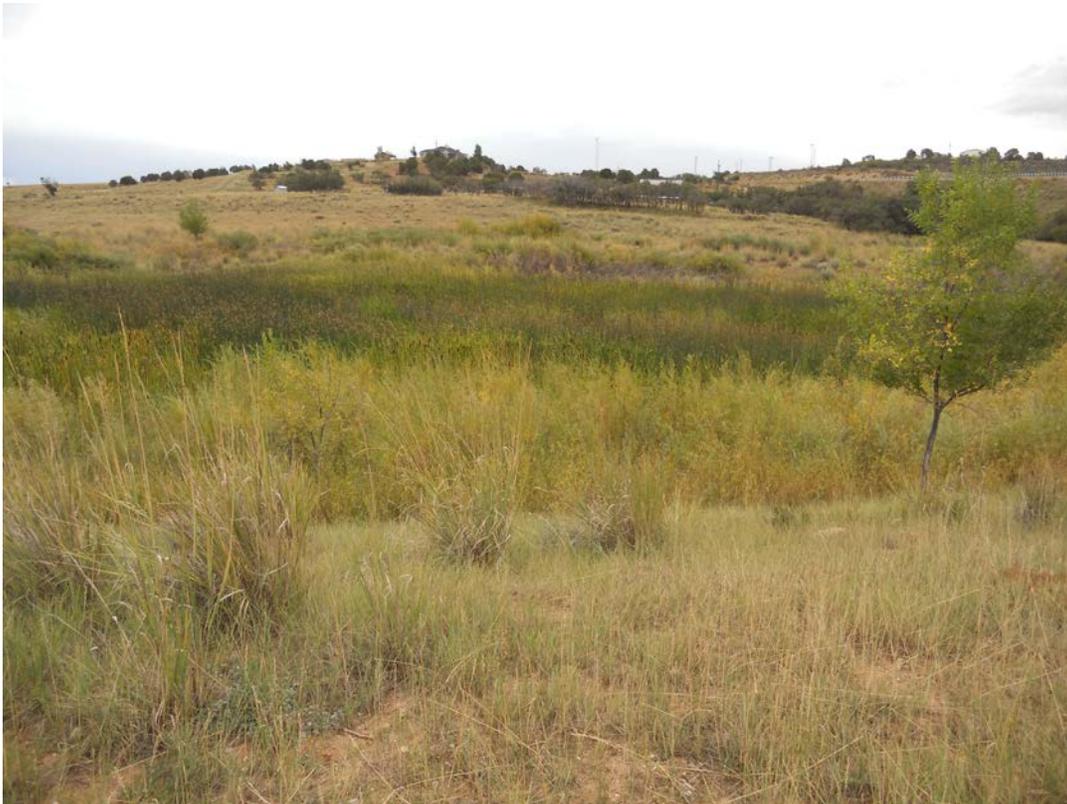
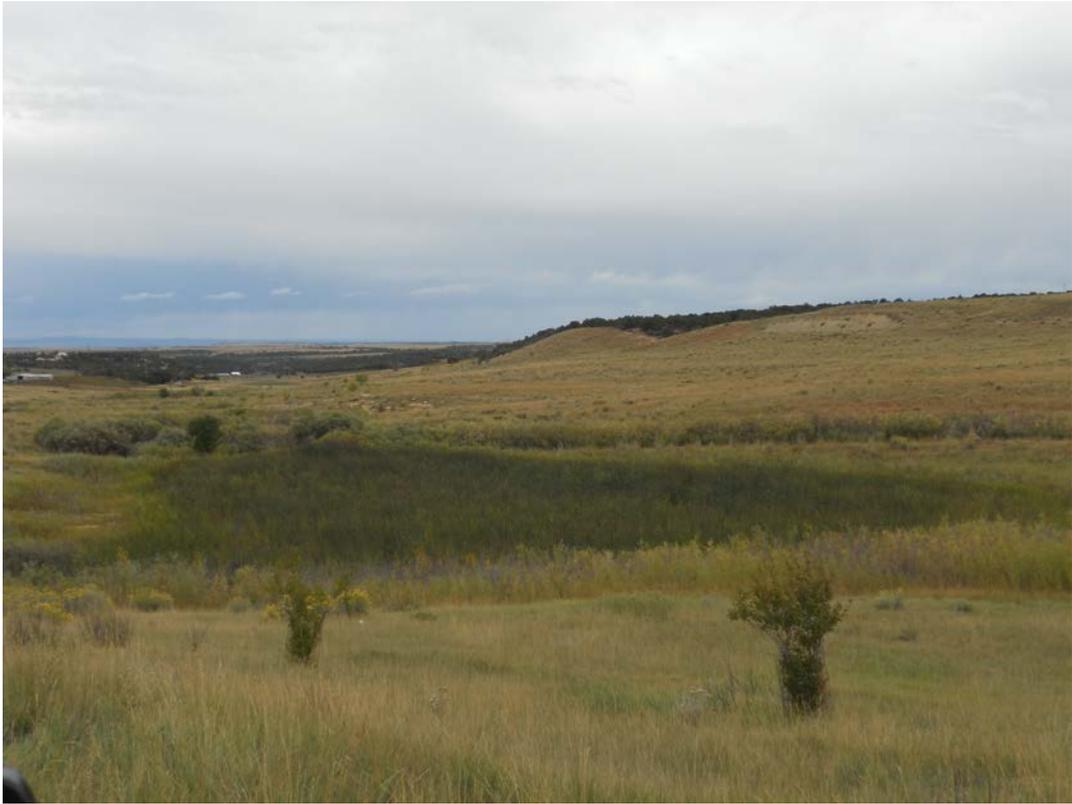
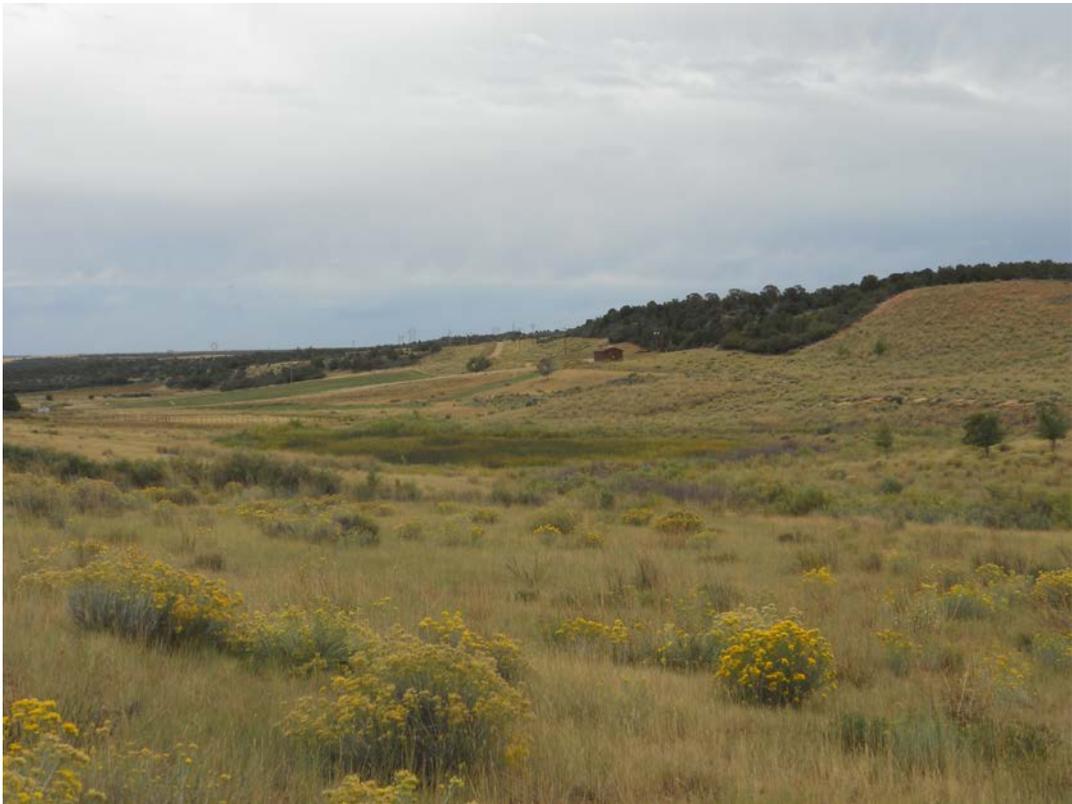
Wetlands on the former mill site (Photo 24, Photo 25, and Photo 26) were constructed according to EPA-specific criteria, and these wetlands are protected by cooperative agreement. Under this agreement, the City of Monticello will not disturb these areas without prior approval from appropriate state and federal agencies and is not responsible for repairing damage to these areas by natural causes. Three constructed marsh wetlands (Wetlands 1–3, Figure 4) on the City-owned properties were ecologically healthy, and no evidence of damage by human activity or natural causes was apparent.

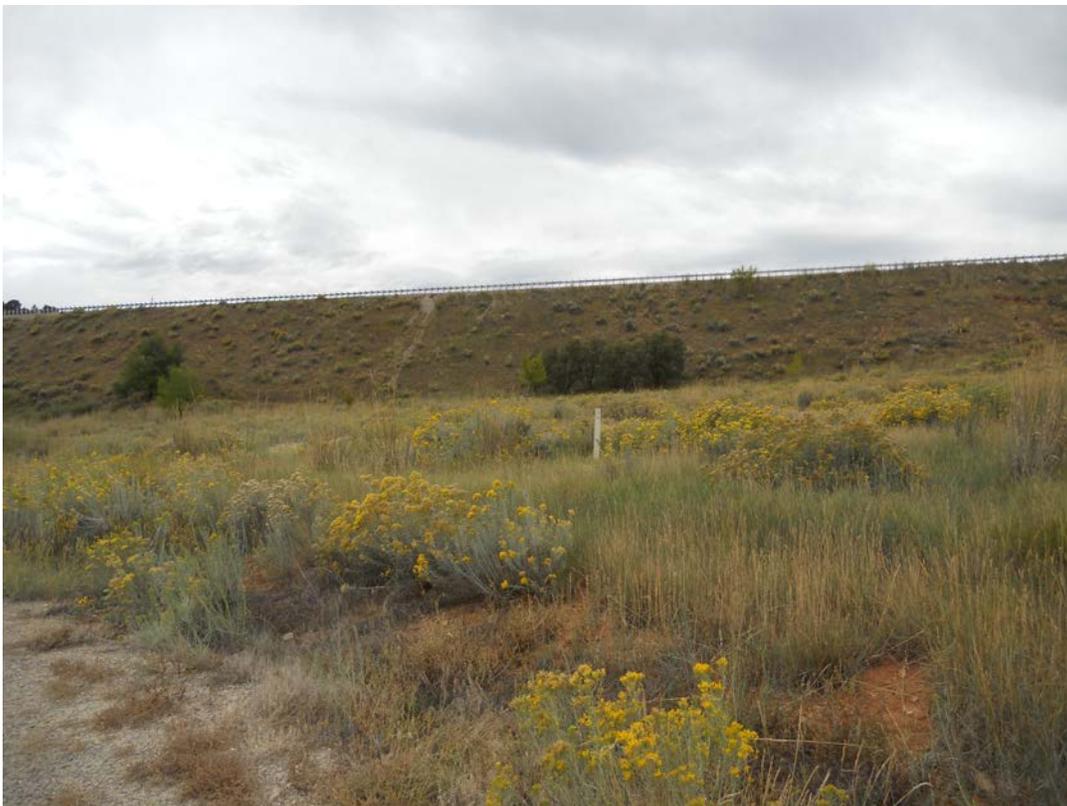
Photo 28. Highway 191 Embankment Showing No New Erosion

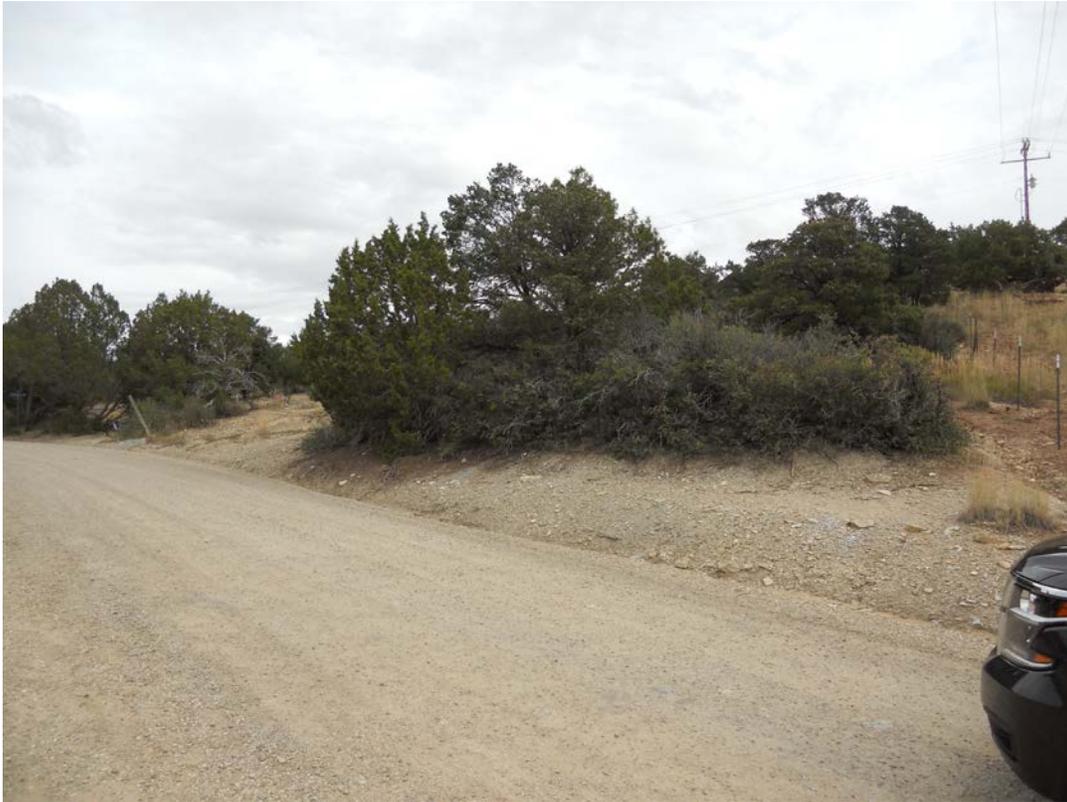
Photo 29. Private Property MS-00176; Drainage Ditch Scanned After Major Runoff Events
