2011 Annual Inspection for the Parkersburg, West Virginia, Nuclear Waste Policy Act Section 151(c) Disposal Site

Summary

3.0 Inspection Results

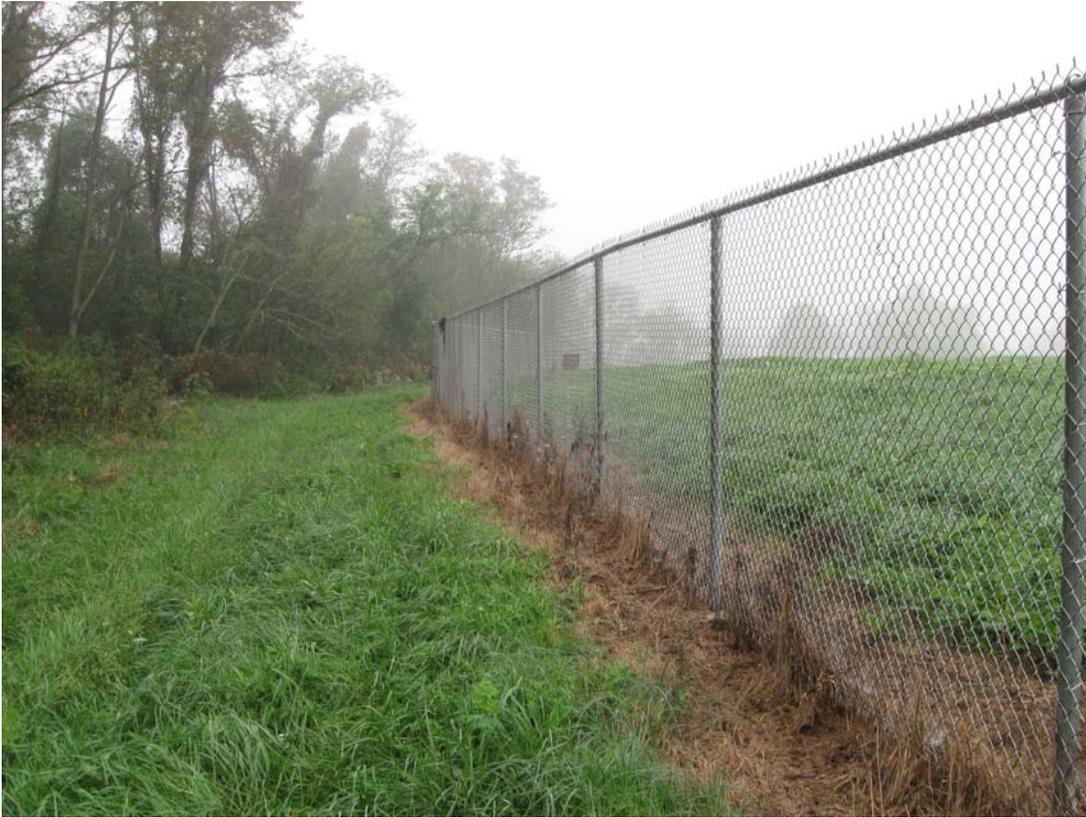
Vegetation management efforts along the fence are improved from last year. A vegetation free zone is being maintained along the base of the fence. (PL-1)

PKB 10/2011. PL-1. South corner of perimeter fence.

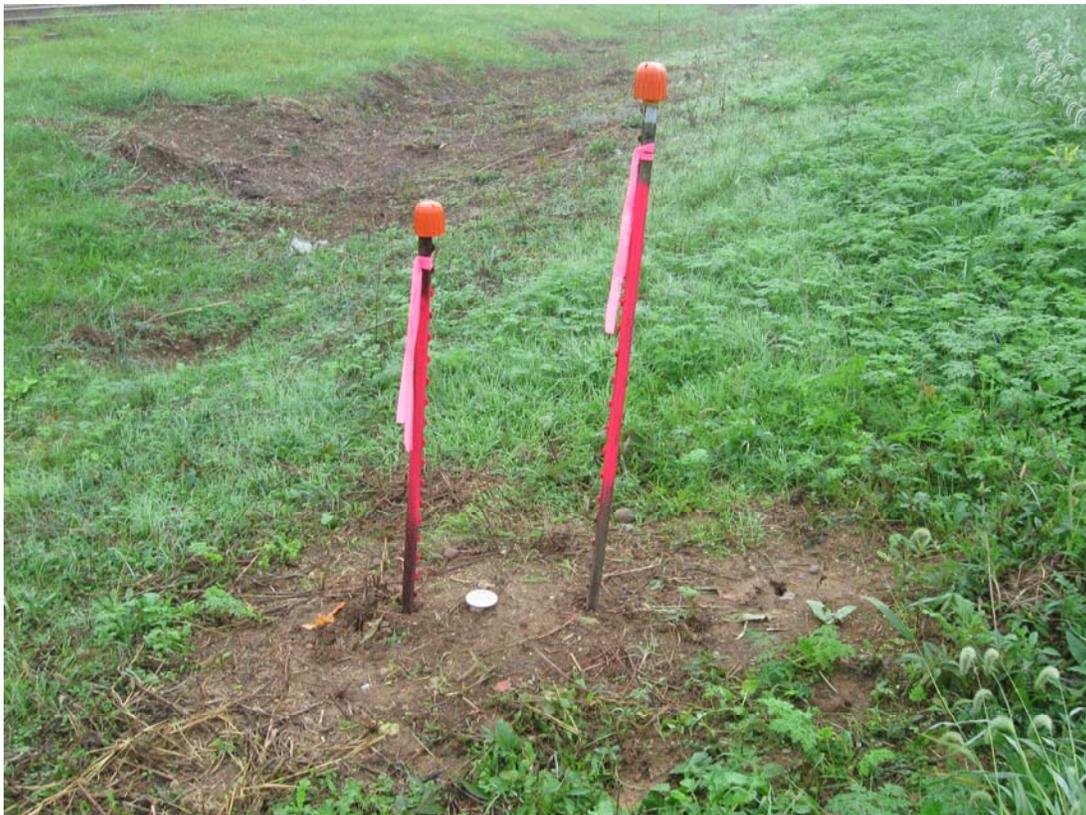
The site has six boundary monuments. All of the boundary monuments were located during the inspection and were in good condition. As a follow up to last year's inspection, boundary monument BM-2 was replaced (PL-2), and boundary monument BM-4 was raised, making it easier to locate (PL-3 and PL-4).

PKB 10/2011. PL-2. Boundary monument BM-2.

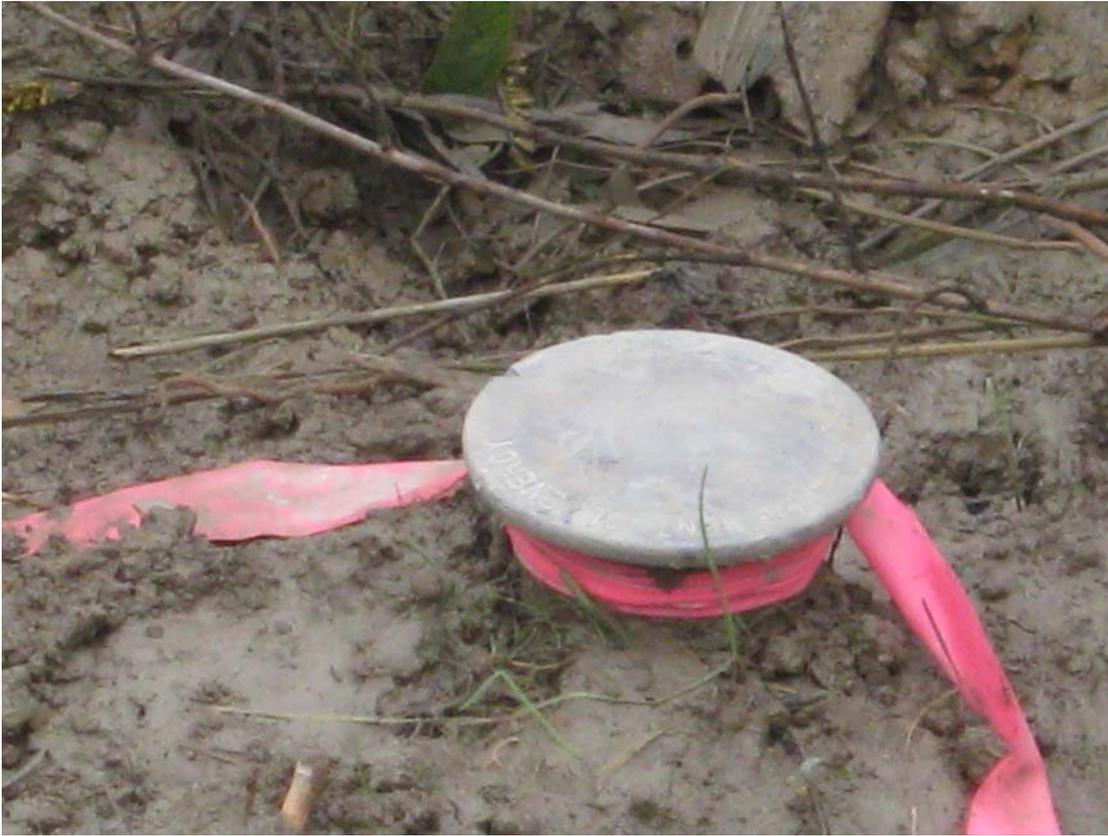
PKB 10/2011. PL-3. Boundary monument BM-4.

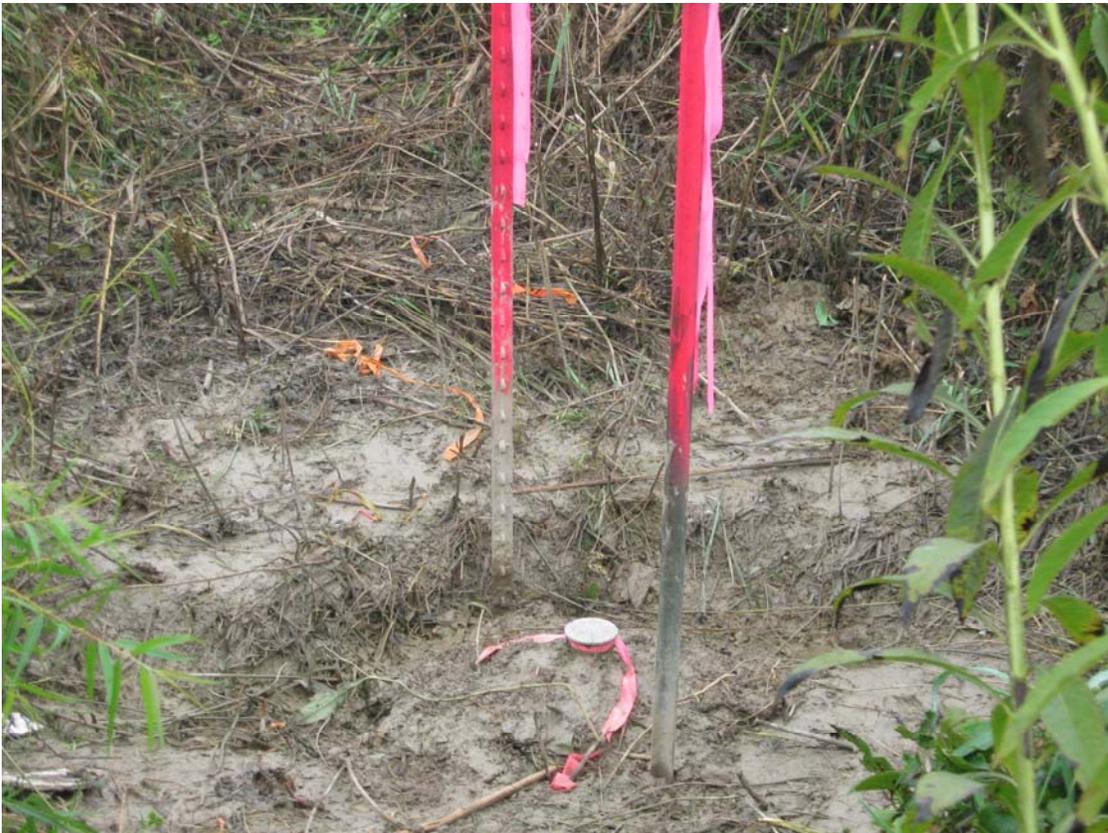
PKB 10/2011. PL-4. Boundary monument BM-4.

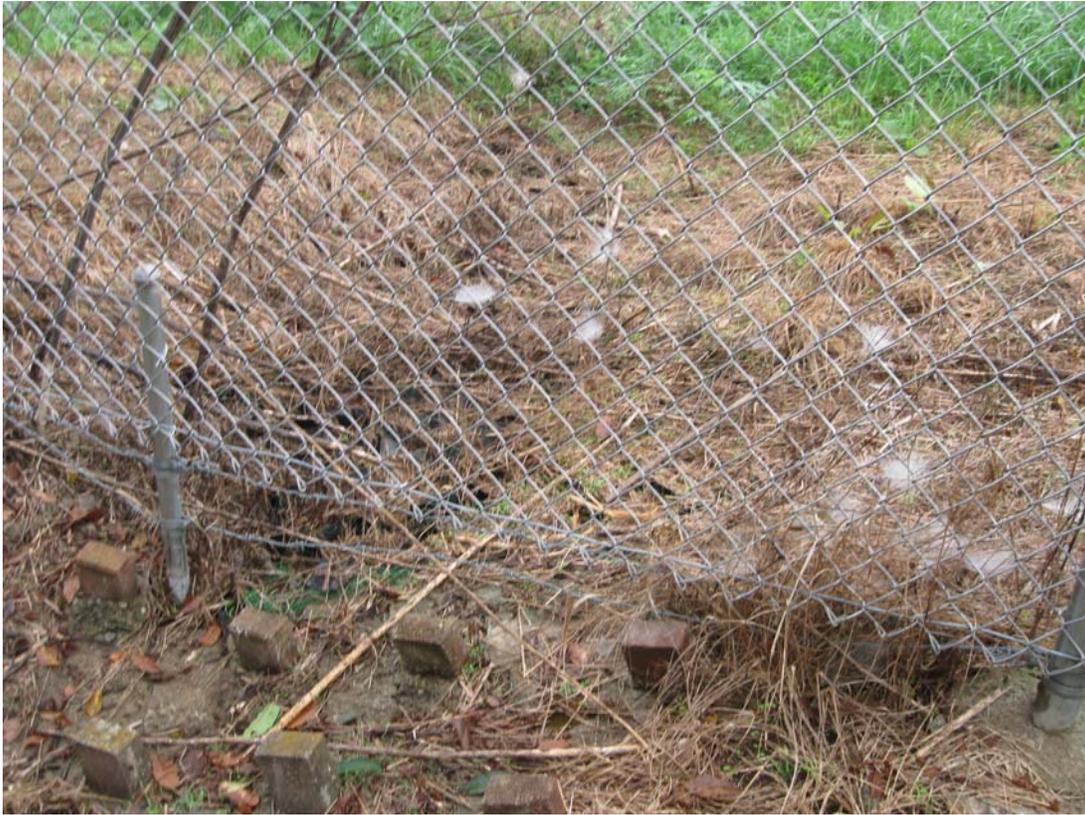
The drainage channel in the southwest corner of the site, lined with HDPE honeycomb baffles and brick energy dissipation baffles in August 1996, is in good condition and functioning as designed (PL-5). Additional erosion does not appear to be occurring.

PKB 10/2011. PL-5. Erosion control baffles.

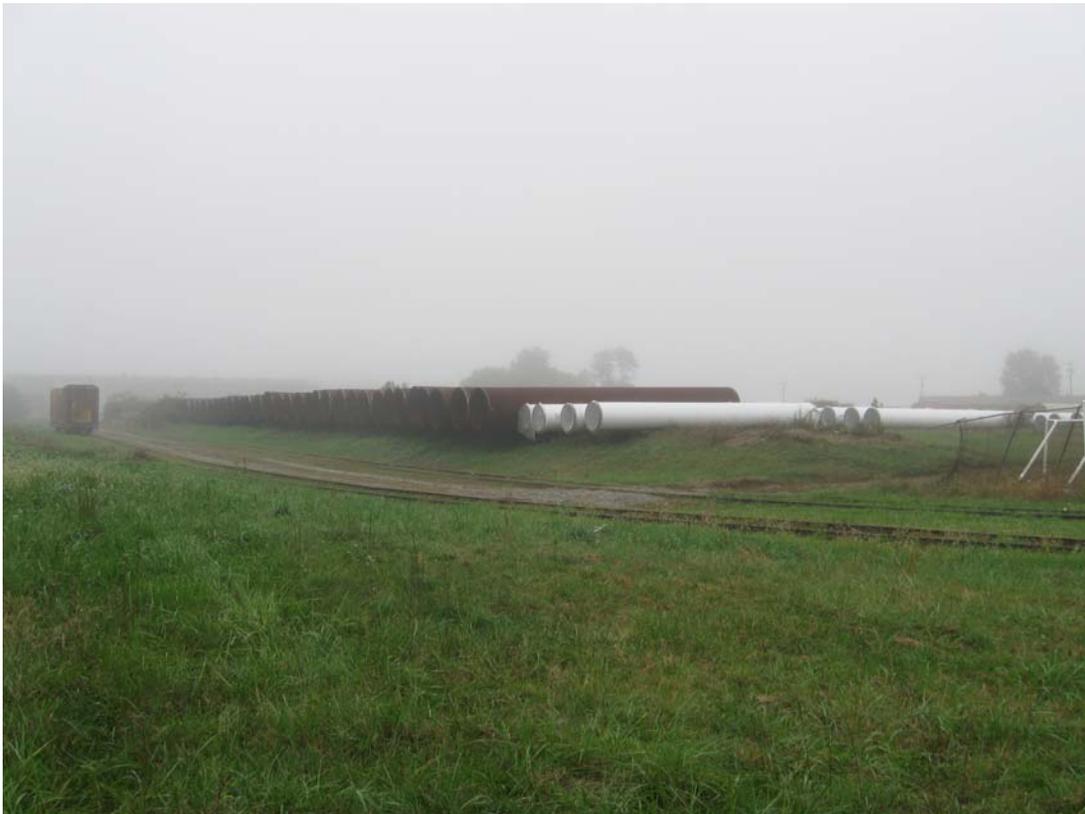
The Parkersburg site is in a developed industrial area. Inspectors observed that a pipe lay-down area next to the site has increased in size since last year's inspection (PL-6 and PL-7).

PKB 10/2011. PL-6. Pipe, off-property, northeast of site.

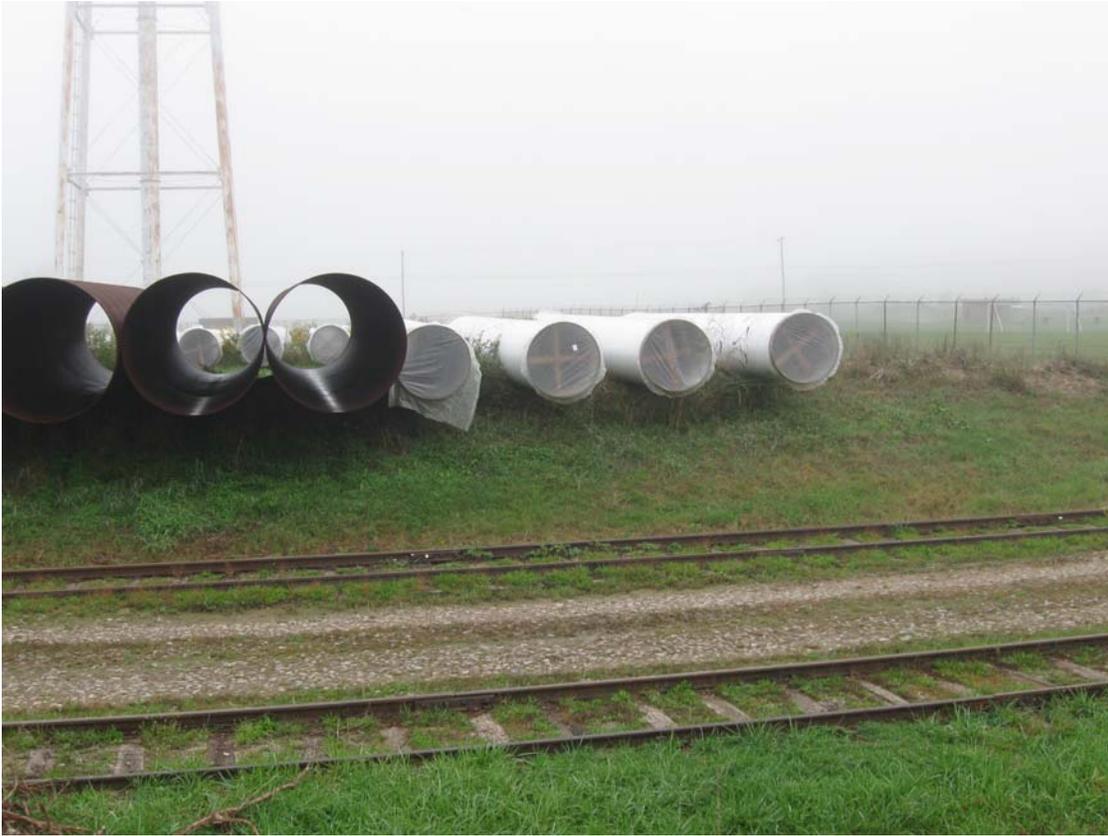
PKB 10/2011. PL-7. Pipe, off-property, northeast of site.

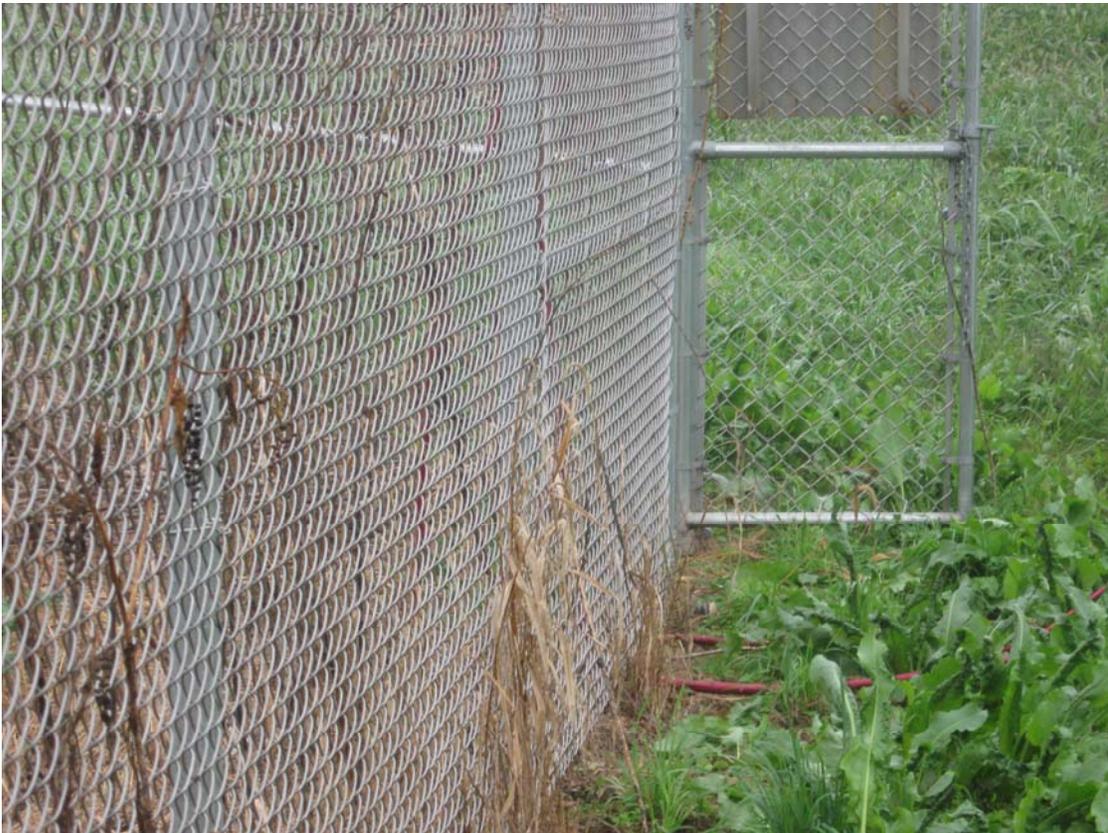
PKB 10/2011. PL-8. North corner of perimeter fence.

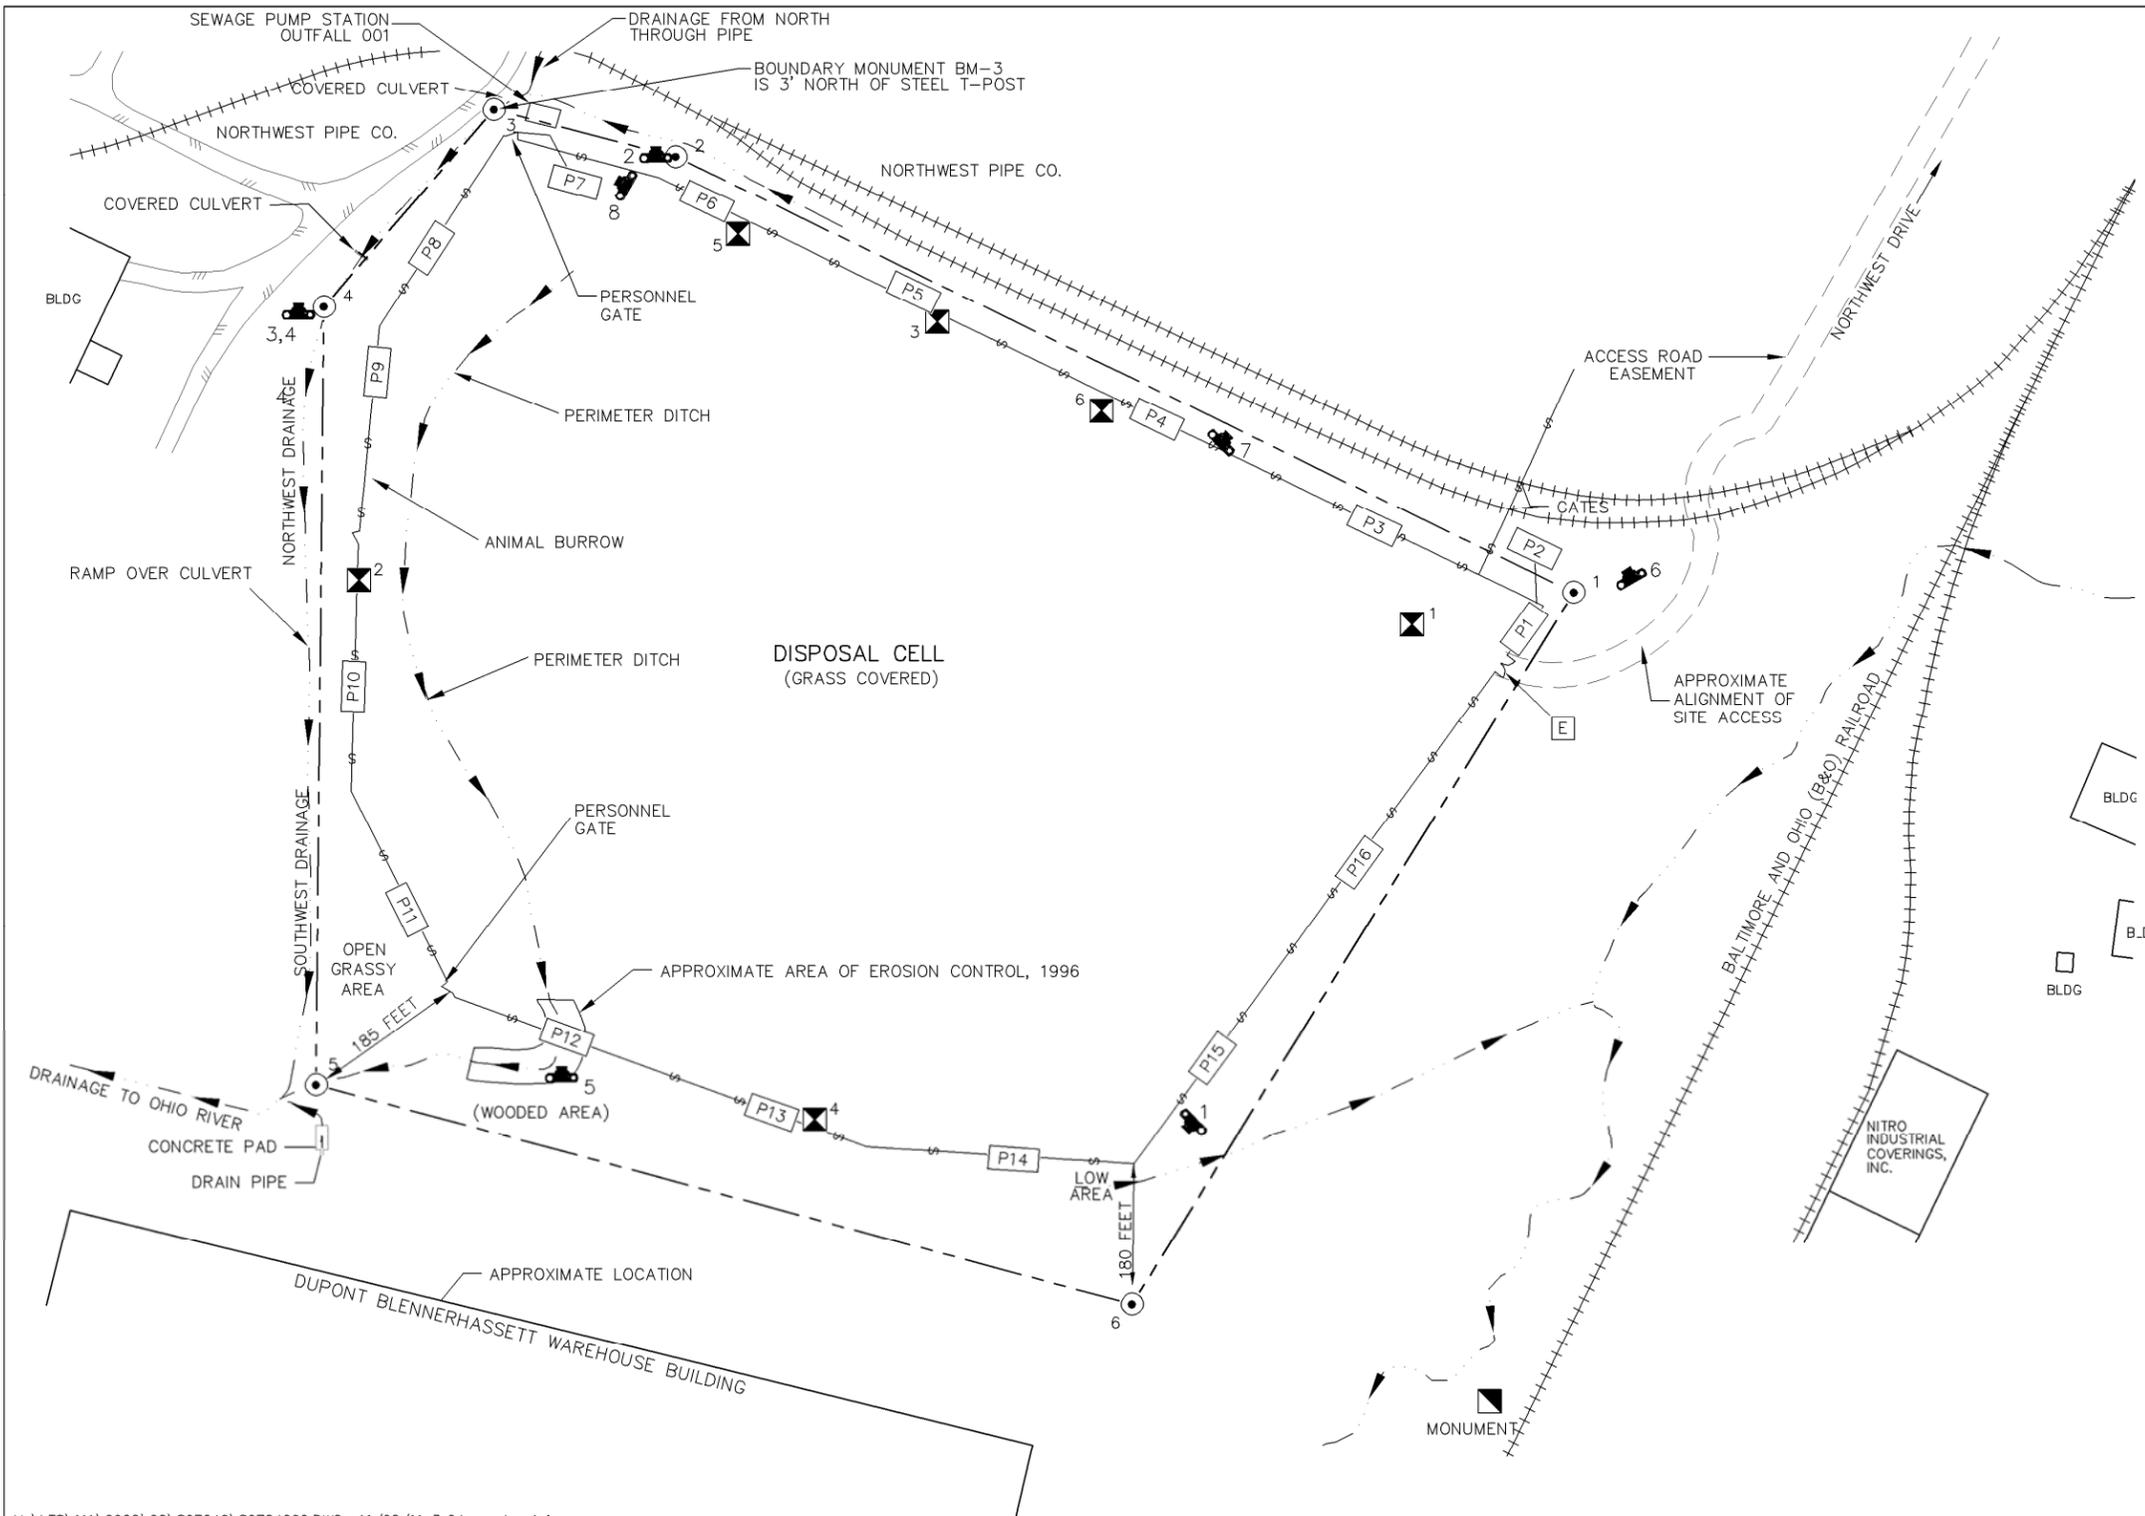
Animal burrows are present under the west perimeter fence. A couple of the burrows are quite large. The location of the burrows is noted on the site inspection map to alert future inspectors to potential tripping hazards.

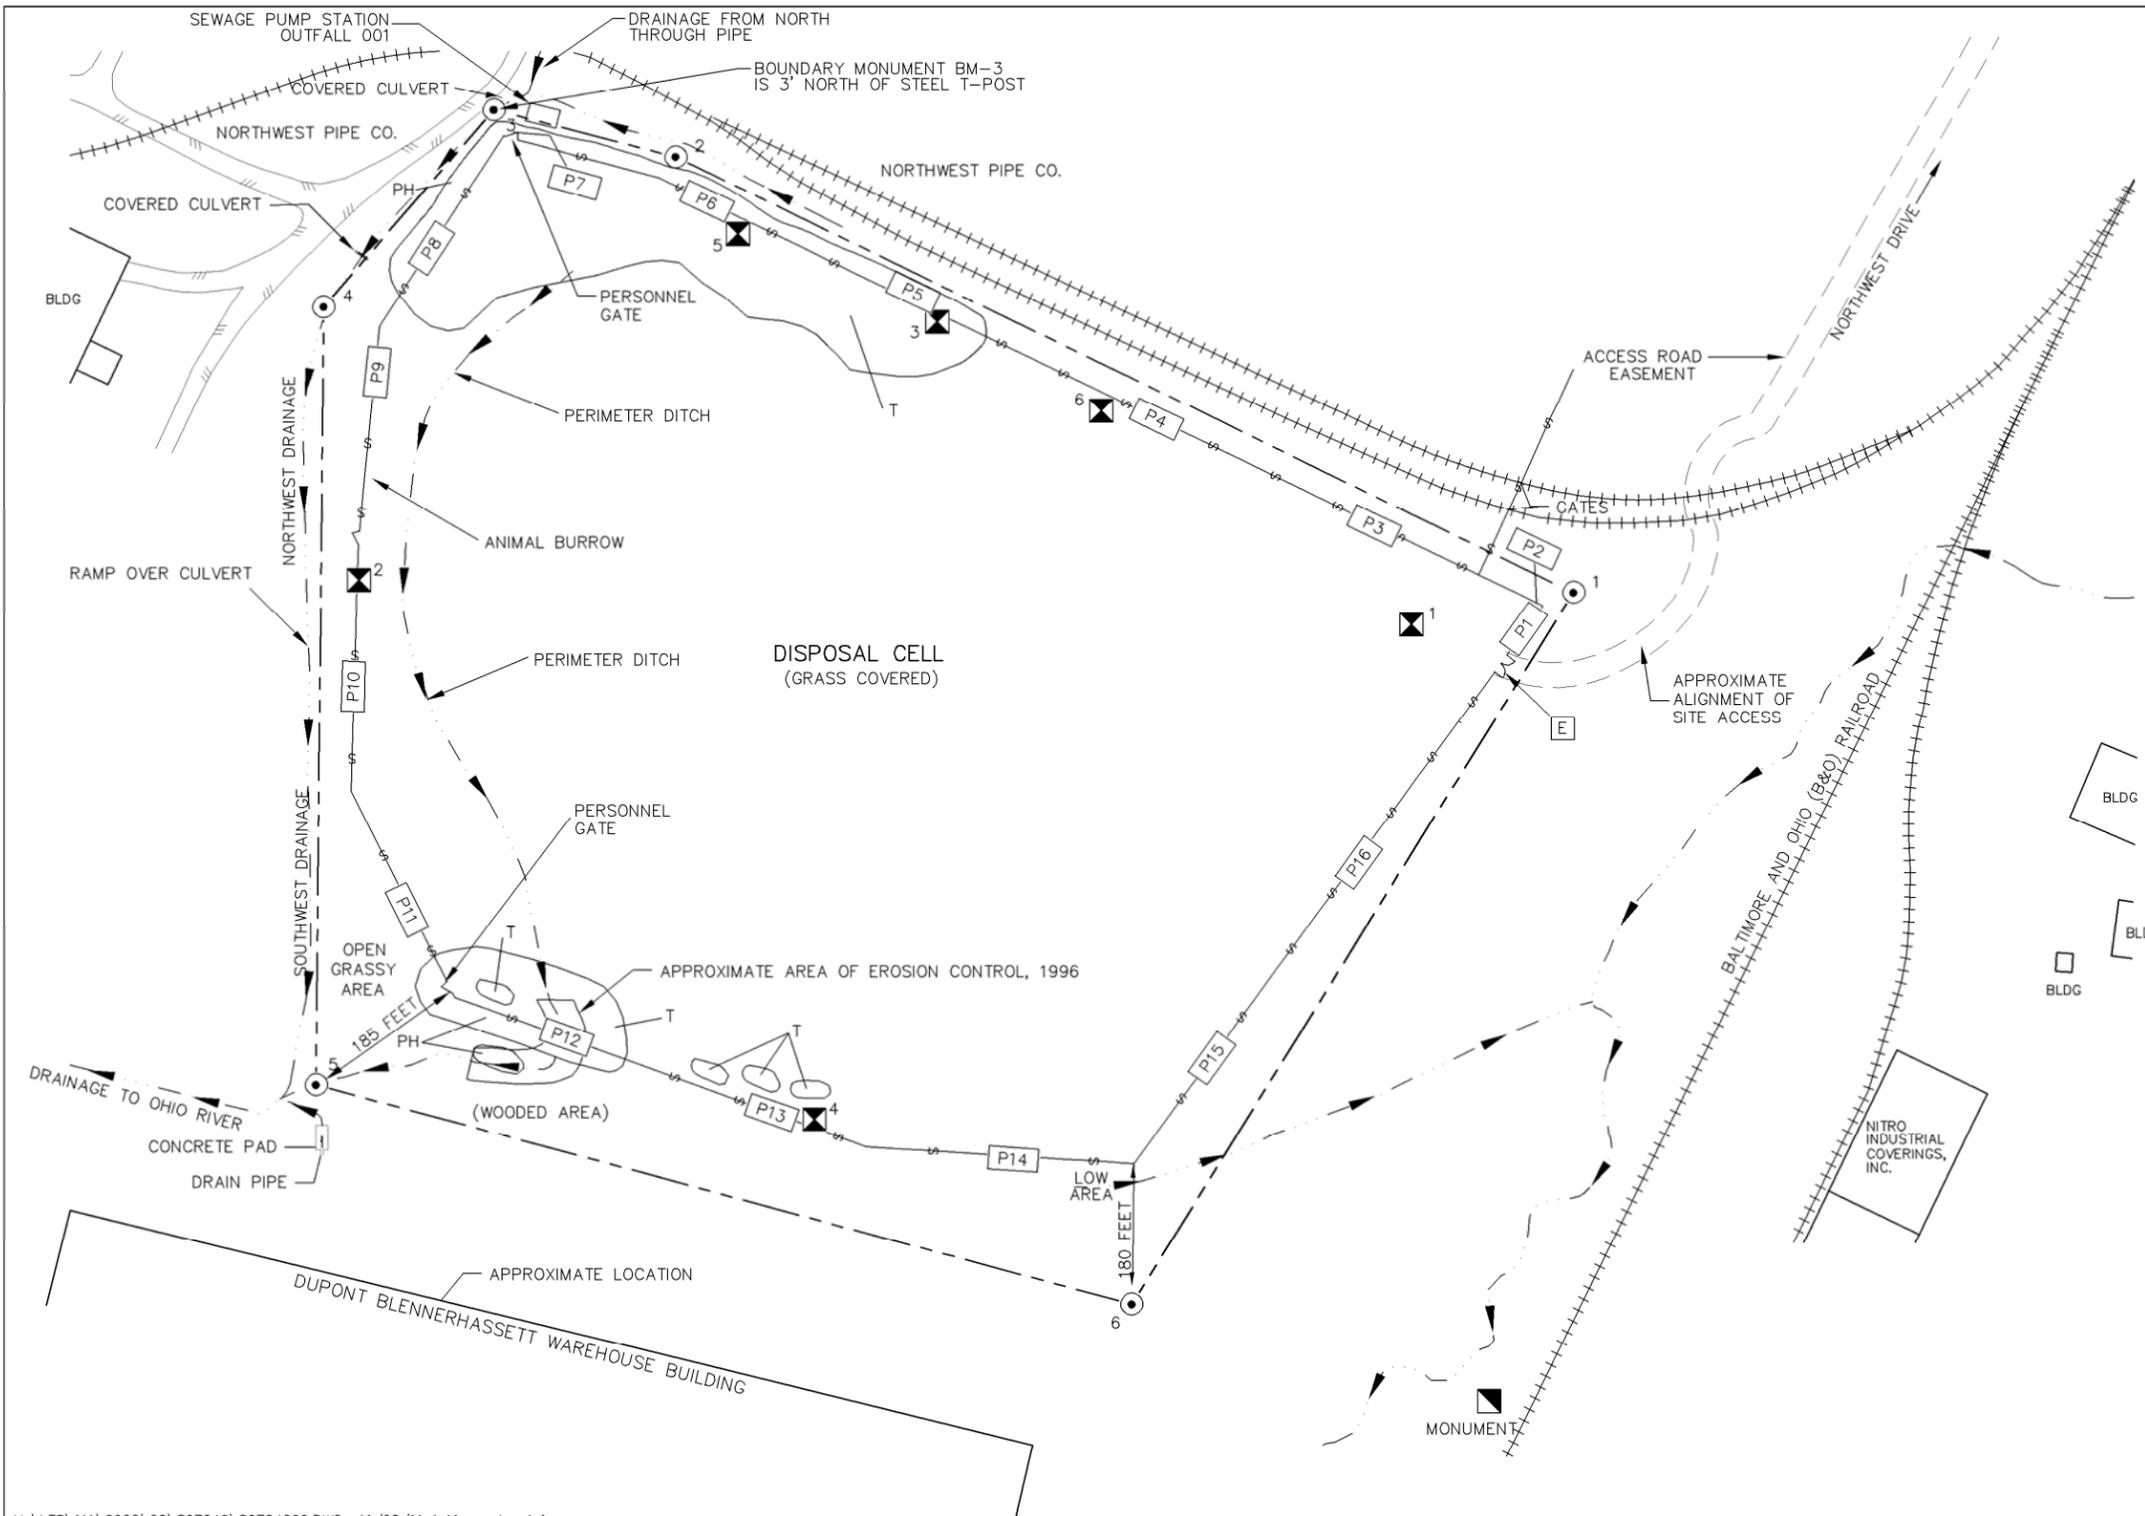
Poison hemlock was discovered on the site in 2003. In the past, plants had grown to heights of up to 10 feet and covered approximately 4 acres on and around the cell. Poison hemlock is a listed noxious weed species in West Virginia; and it poses a safety hazard to personnel who must walk through or work in infested areas, as all parts of the plant are poisonous. Poison hemlock poses a particular hazard to children, who often play in the soccer fields adjacent to the site. Spraying for poison hemlock this past year has allowed teasel to take hold in its place, especially in the northwest corner of the site (PL-8). It is recommended that the spraying program be amended next year to include spraying for teasel and that after areas are sprayed for teasel that they be seeded with a grass seed mixture..

- 1) Spraying for poison hemlock this past year has allowed teasel to take hold in its place, especially in the northwest corner of the site (page 3).

Recommendation: It is recommended that the spraying program be amended next year to include spraying for teasel and that after areas are sprayed for teasel that they be seeded with a grass seed mixture.
