# 2012 Annual Inspection Report for the Parkersburg, West Virginia, Disposal Site

## 1.0 Compliance Summary

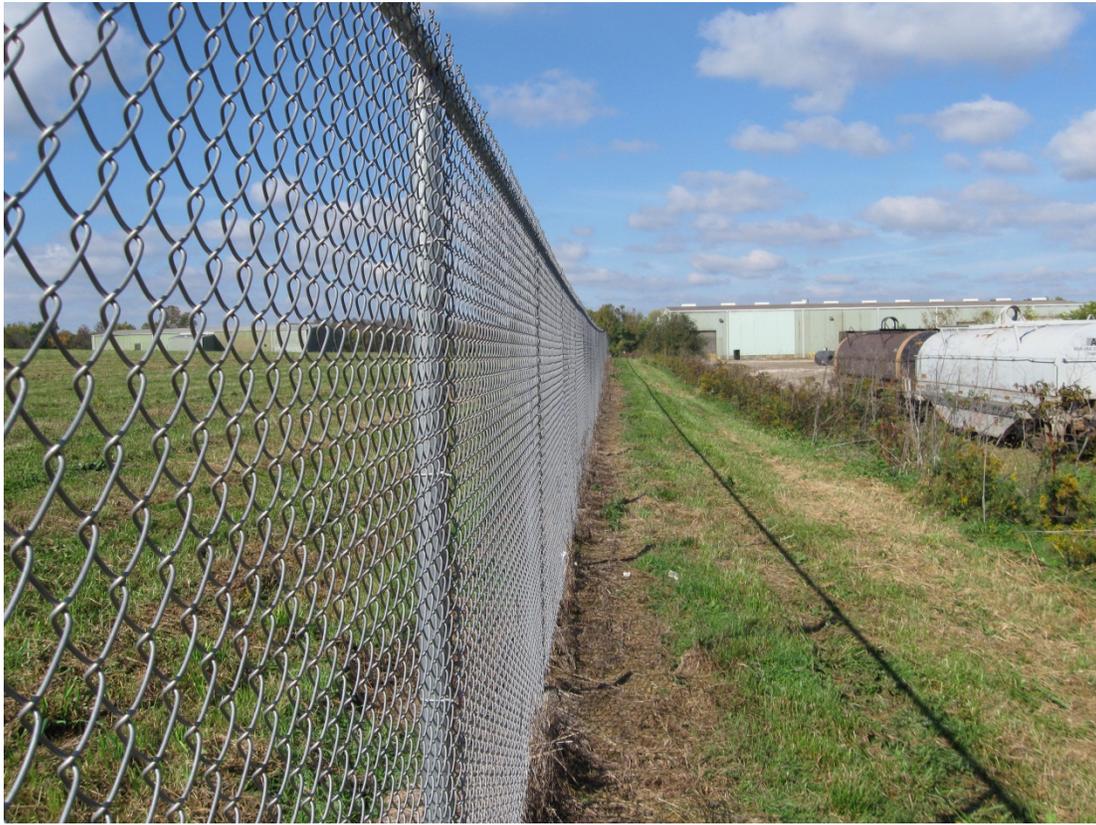
The perimeter fence was replaced in 2007 and was in excellent condition. Vegetation management efforts along the fence are improved from last year. A vegetation-free zone is being maintained along the base of the fence (PL-1).

PKB 10/2012. PL-1. View down northeast fence line.

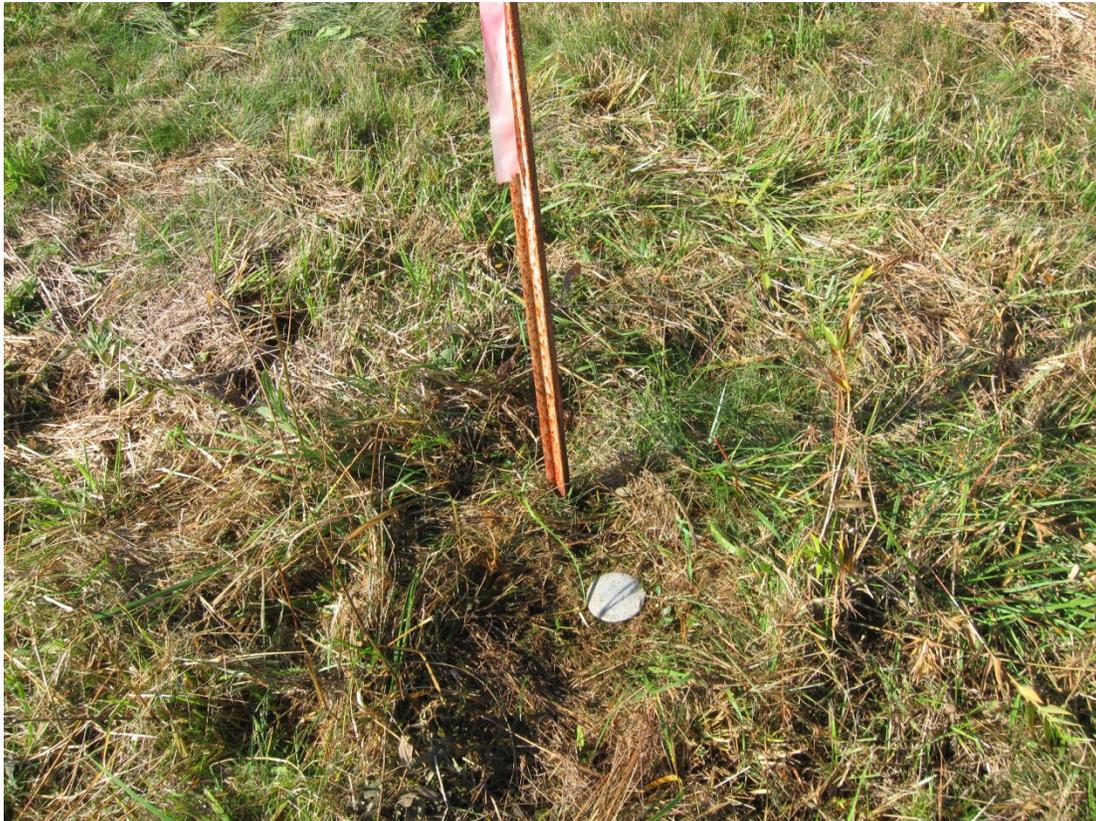
The Parkersburg site has 6 boundary monuments and one concrete survey monument. Five of the six boundary monuments were located during the site inspection and found to be in good condition (PL-2). The presence of dense vegetation around boundary monument BM-5 kept inspectors from finding it. Vegetation was also dense around boundary monuments BM-4 (PL-3) and BM-6 (PL-4). It is recommended that that greater effort be made by the site maintenance crew to clear vegetation from around the boundary monuments prior to inspections. Inspectors did not check the concrete survey monument during this year's inspection.

PKB 10/2012. PL-2. Boundary monument BM-2.

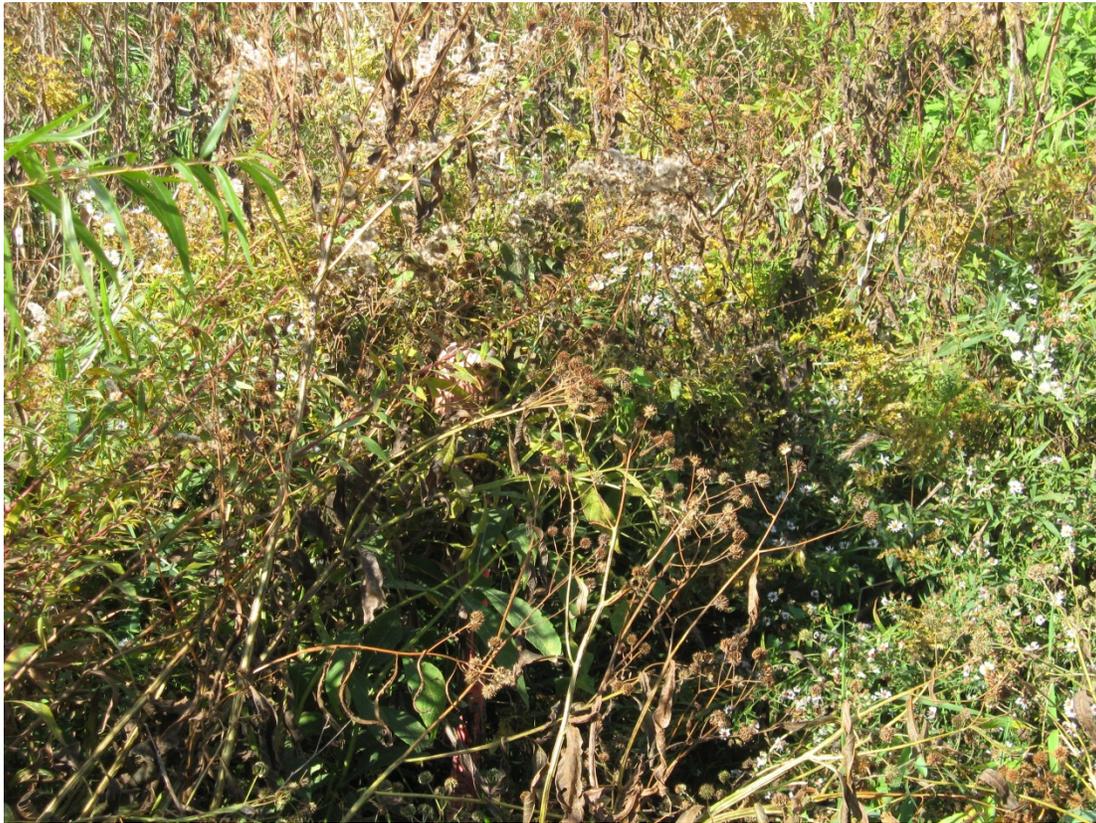
PKB 10/2012. PL-3. Vegetative growth around boundary monument BM-4.

All site monuments (with the exception of boundary monument BM-5) were located. All located site monuments were in good condition. Vegetation around boundary monument BM-5 was too dense to allow inspectors to find it. Vegetation was also very dense around boundary monuments BM-4 and BM-6. It is recommended that greater efforts be made by the site maintenance crew to clear vegetation from around the boundary monuments prior to inspections.

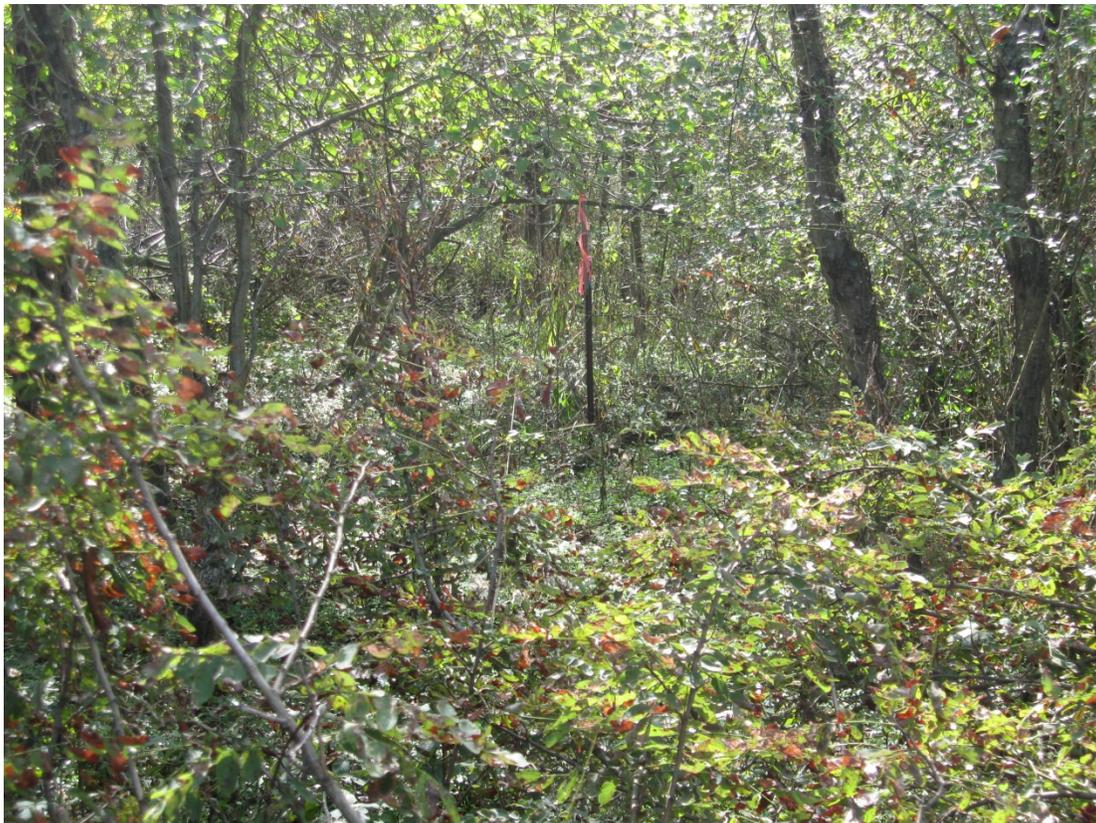
PKB 10/2012. PL-4. Vegetative growth around boundary monument BM-6.

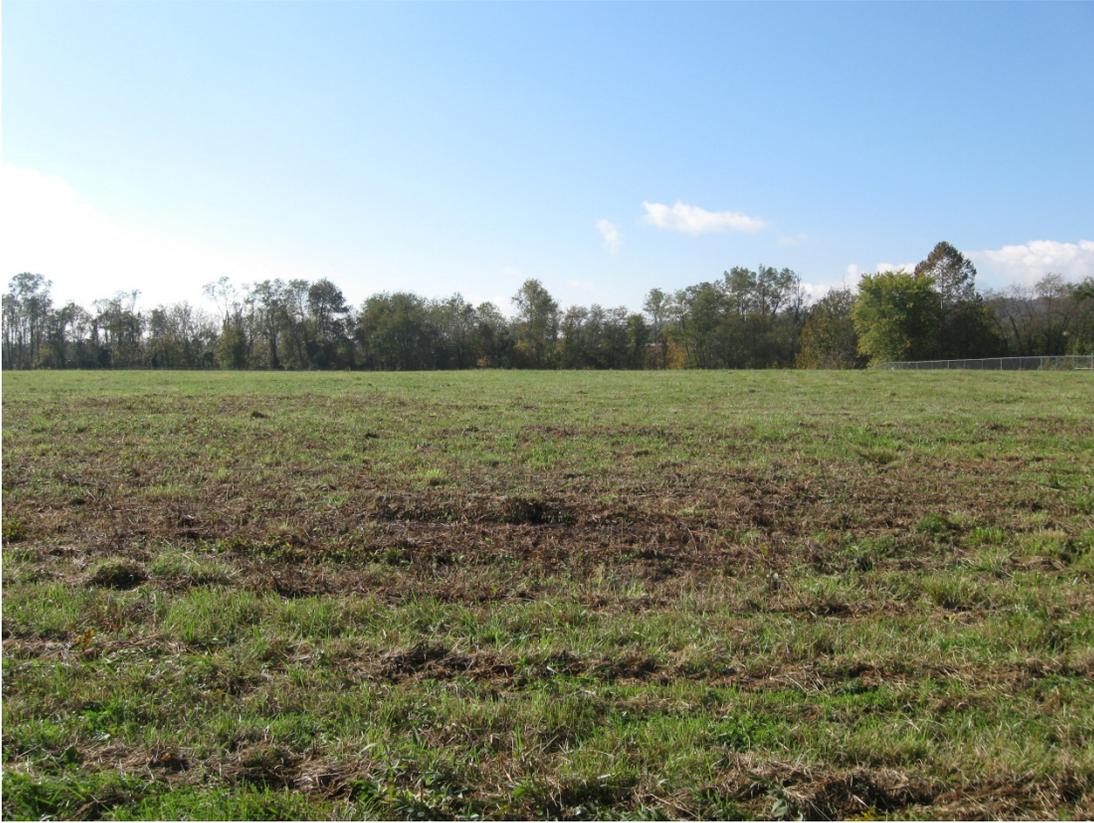
The grass covered disposal cell was in excellent condition (PL-5). No evidence of erosion or slope instability on the disposal cell was noted during the inspection. Dominant vegetation consists of fescue, crown vetch, and goldenrod. The vegetation on the disposal cell cover (essentially in the area inside the security fence) appeared healthy and vigorous. More attention needs to be given to cutting weeds and grass around some of the monitoring wells (PL-6).

PKB 10/2012. PL-5. Looking southwest across the disposal cell.

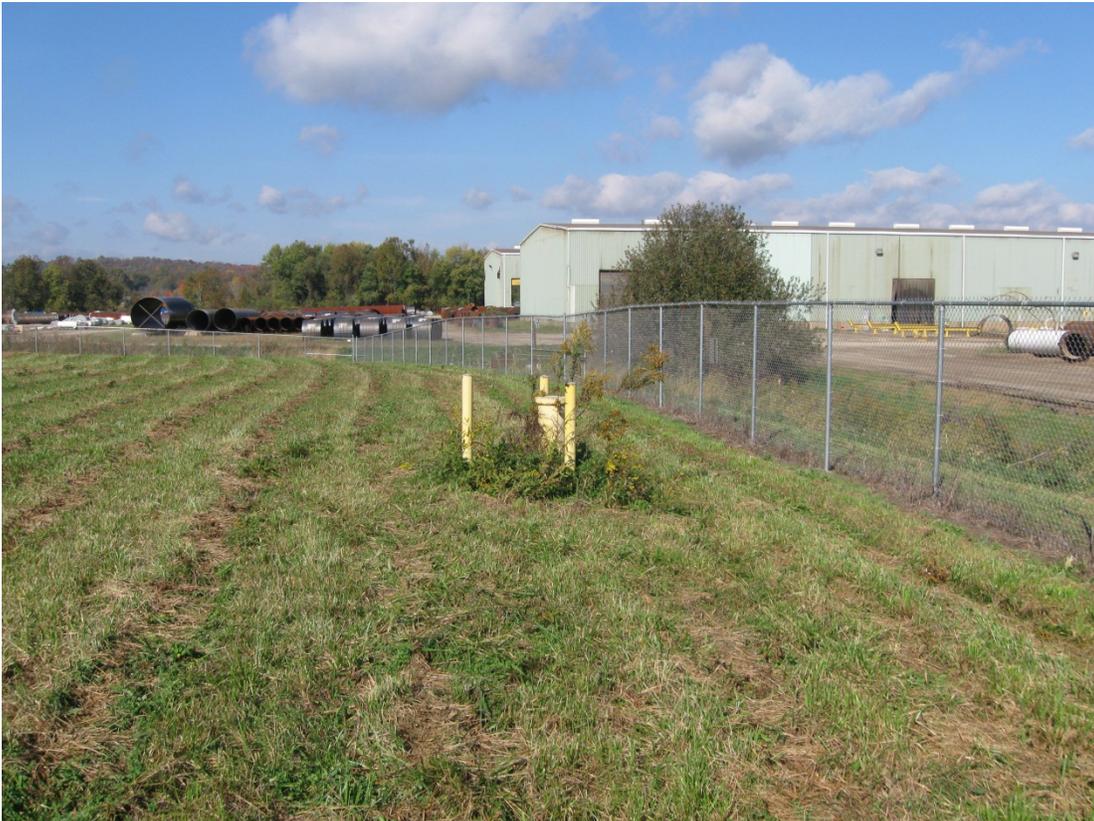
PKB 10/2012. PL-6. Vegetative growth around monitoring well MW-5.

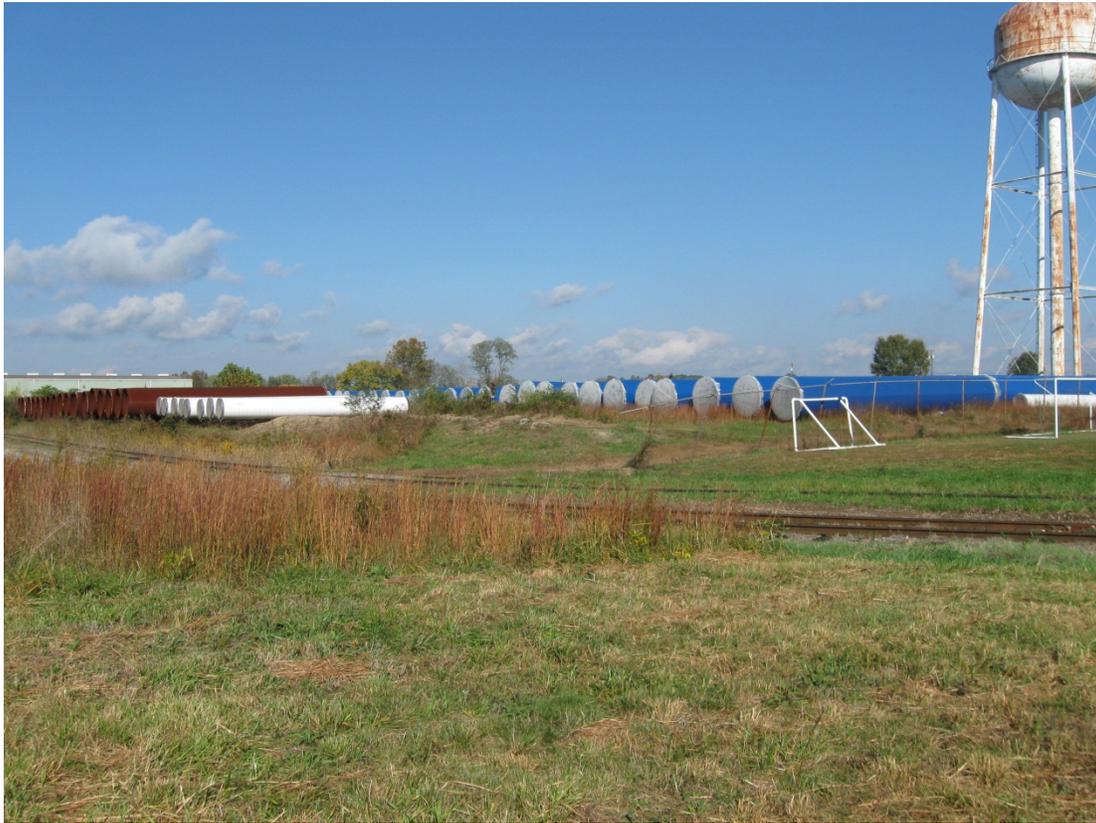
The Parkersburg site is in a developed industrial area. Inspectors observed that a pipe lay-down area next to the site has increased in size since last year’s inspection (PL-7).

PKB 10/2012. PL-7. Northwest Pipe Company lay-down area next to site.
