# Annual Inspection of the Parkersburg, West Virginia Disposal Site

## 1.1 Compliance Summary

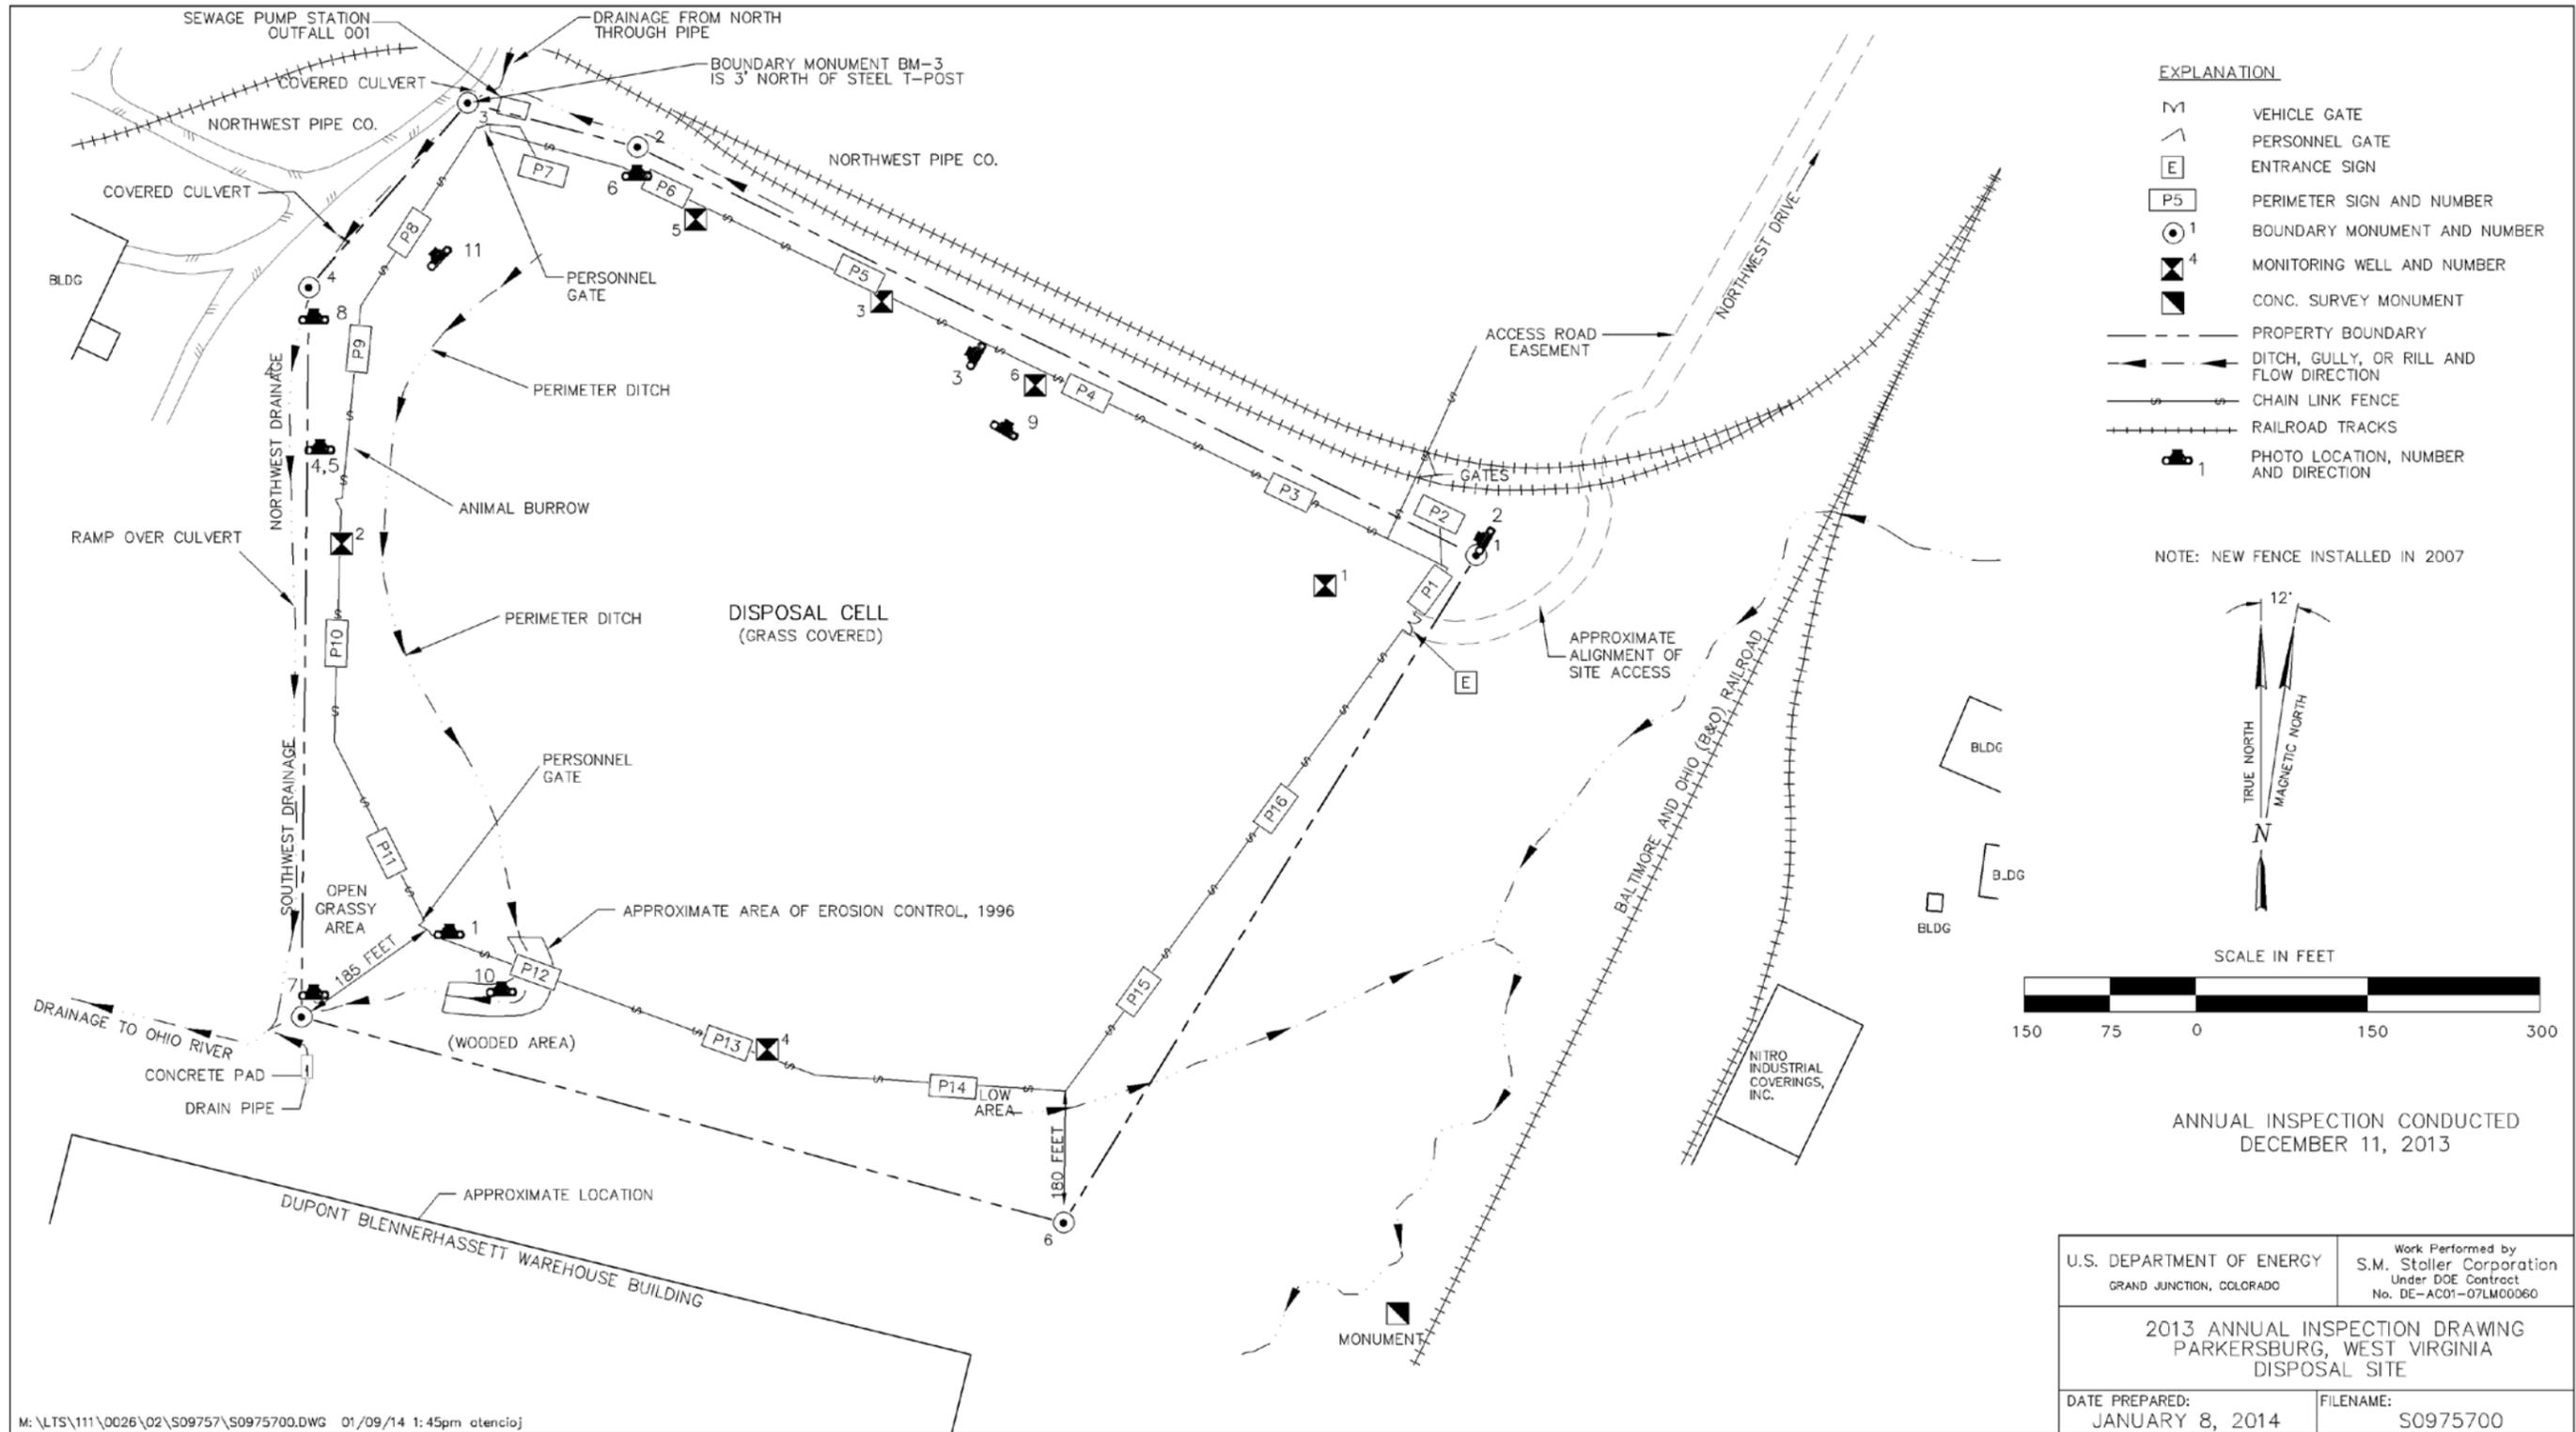
Figure 1. 2013 Annual Inspection Drawing for the Parkersburg Disposal Site

The locations of site surveillance features are shown in Figure 1. Inspection results and recommended maintenance activities associated with site surveillance features are included in the following subsections. Photographs to support specific observations are identified in the text and in Figure 1 by photograph location (PL) numbers.

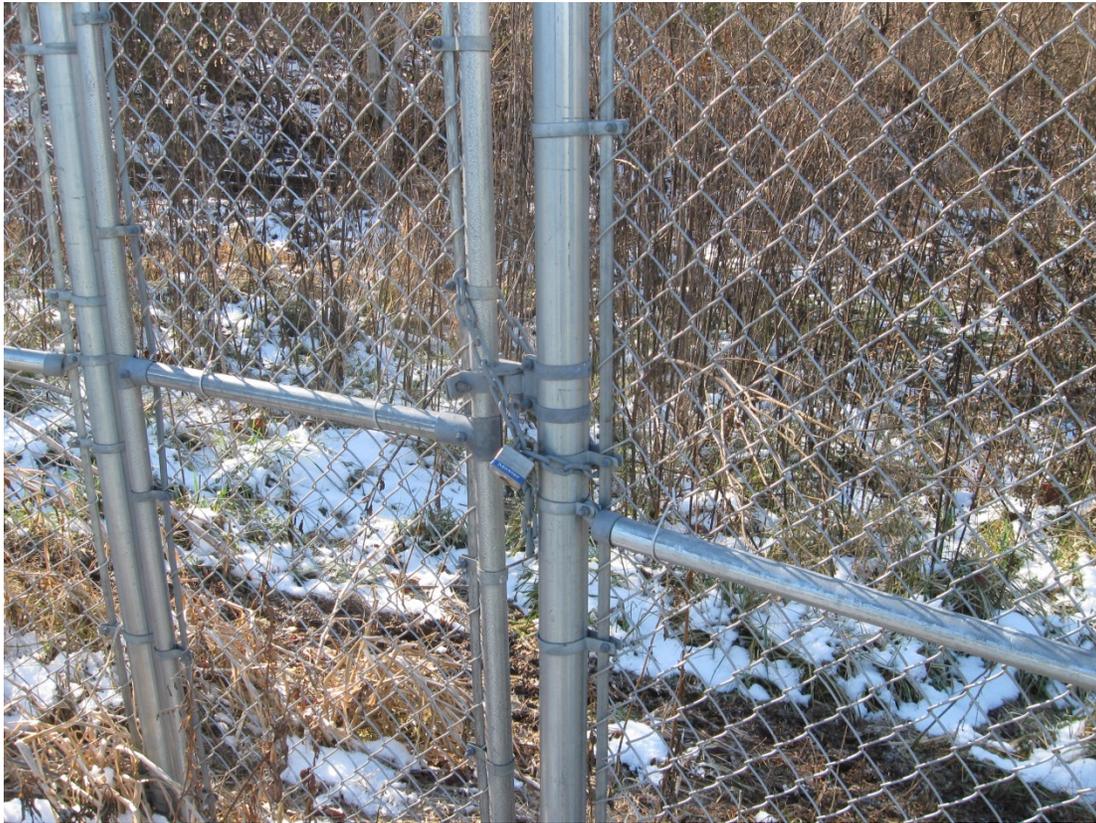
Entrance gates were replaced in 2007 and were in excellent condition. The two personnel gates were locked with non-DOE locks (PL-1). DOE replacement locks were secured next to the personnel gates during the inspection. The maintenance subcontractor will be asked to remove the non-DOE locks and replace them with the DOE locks.

PKB 12/2013. PL-1. Locks on personnel gate between Perimeter Signs P11 and P12.

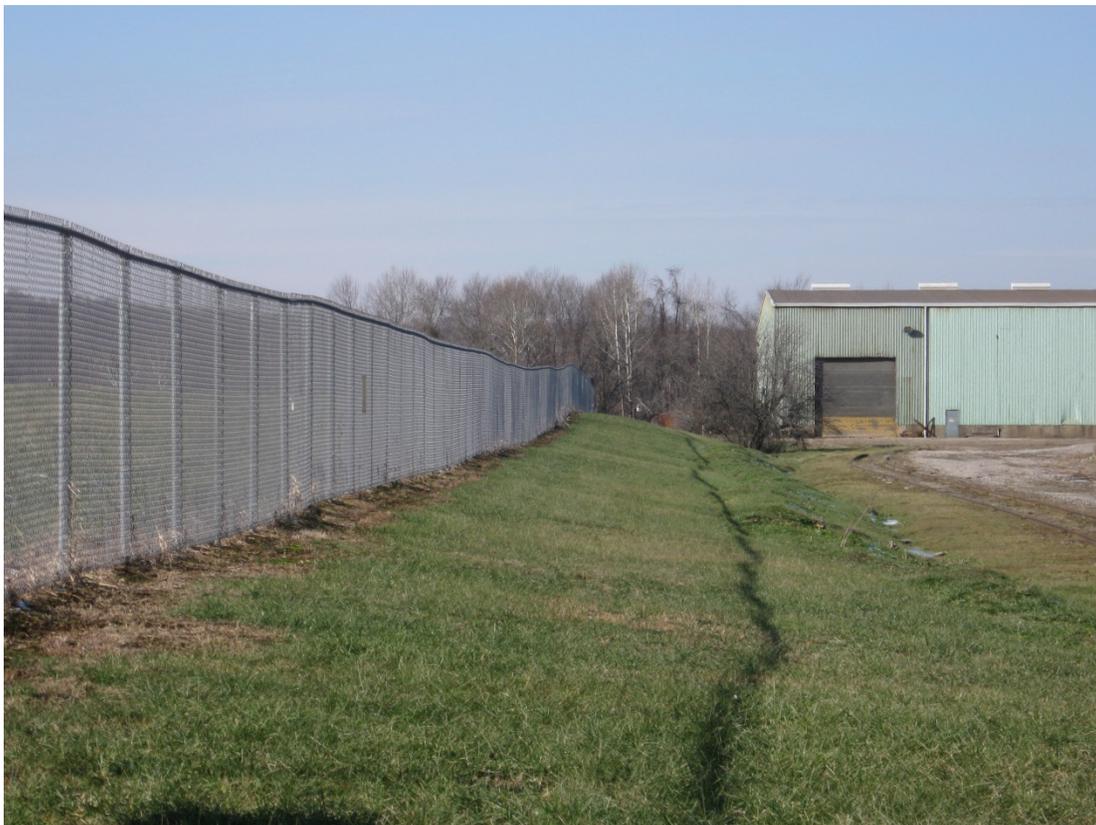
The perimeter fence was replaced in 2007 and was in excellent condition (PL-2). A vegetation free zone is being maintained along the base of the fence (PL-3).

PKB 12/2013. PL-2. View down northeast fence line.

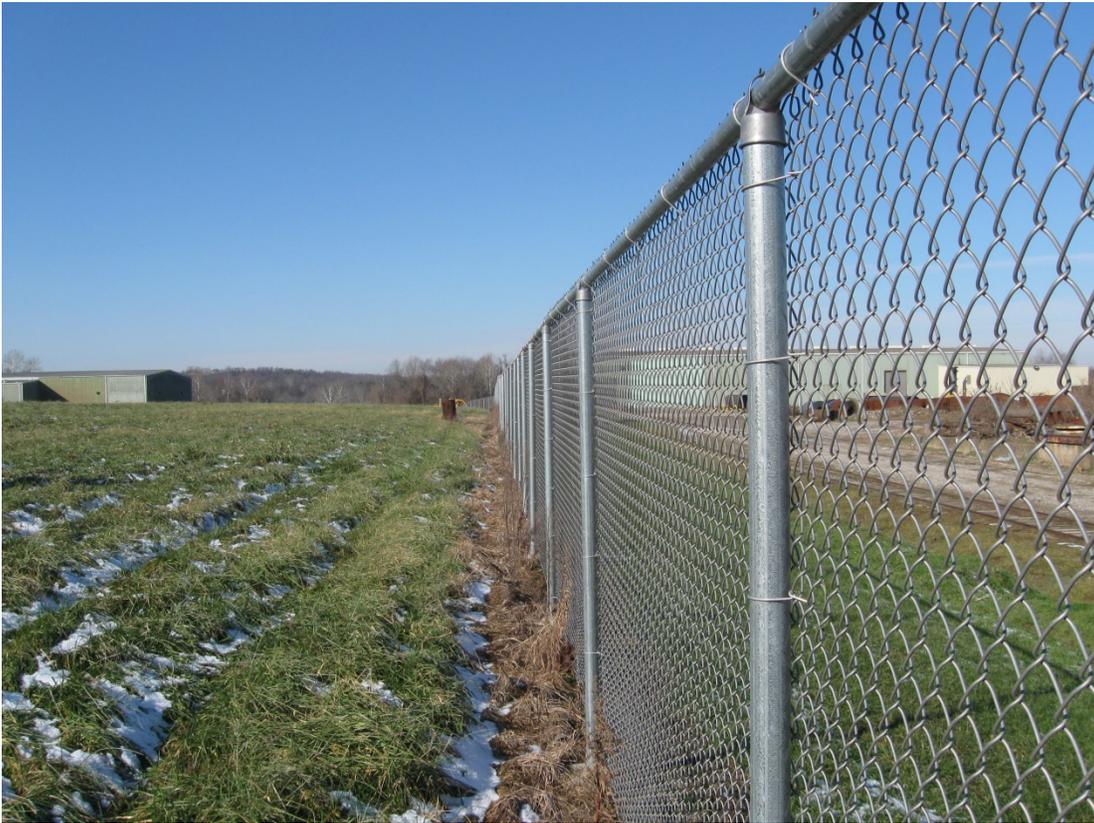
PKB 12/2013. PL-3. View down northeast fence line.

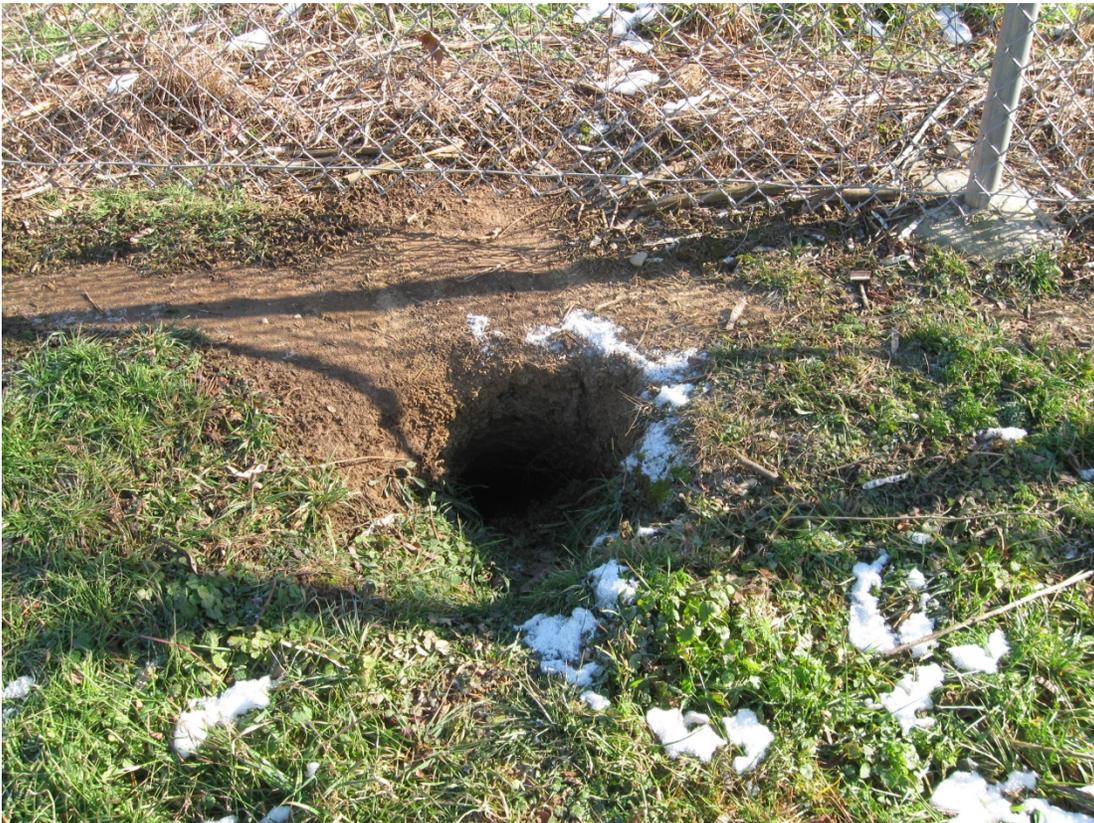
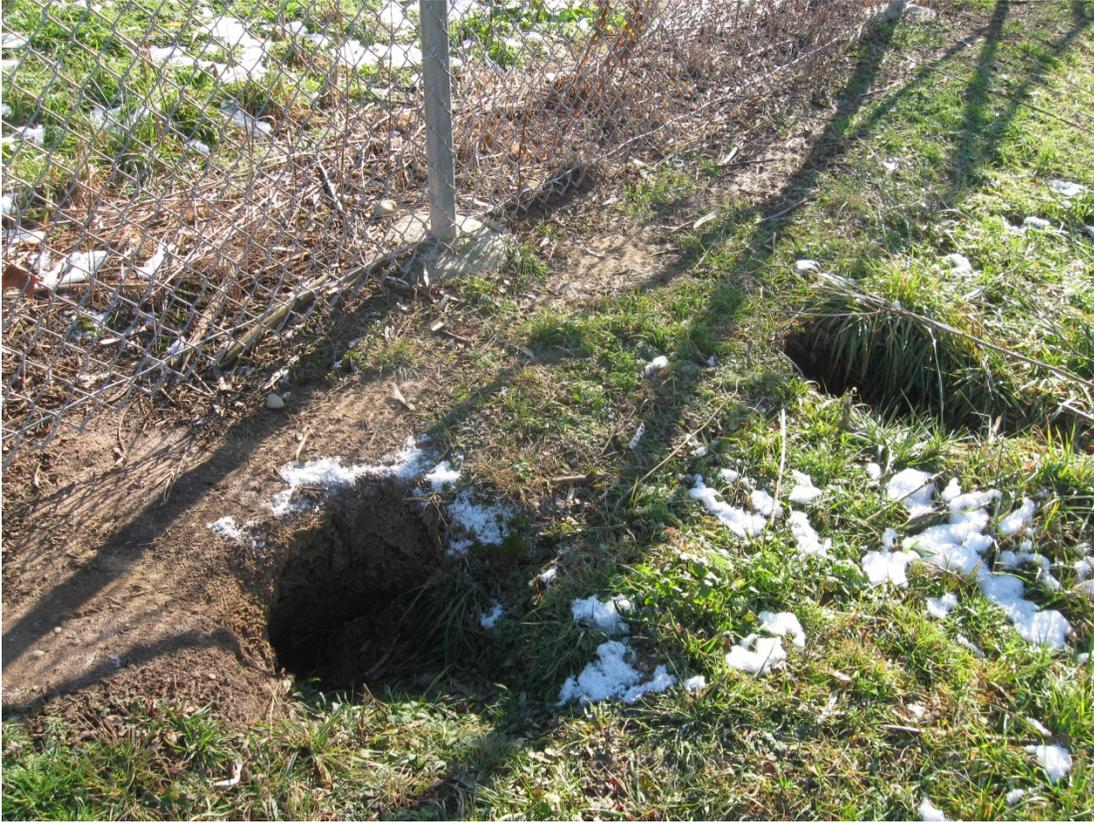
Animal burrows are present under the west perimeter fence (PL-4 and PL-5). A couple of the burrows are quite large. The location of the burrows is noted on the site inspection map to alert future inspectors to potential tripping hazards.

PKB 12/2013. PL-4. Animal burrows under west fence.

PKB 12/2013. PL-5. Animal burrows under west fence.

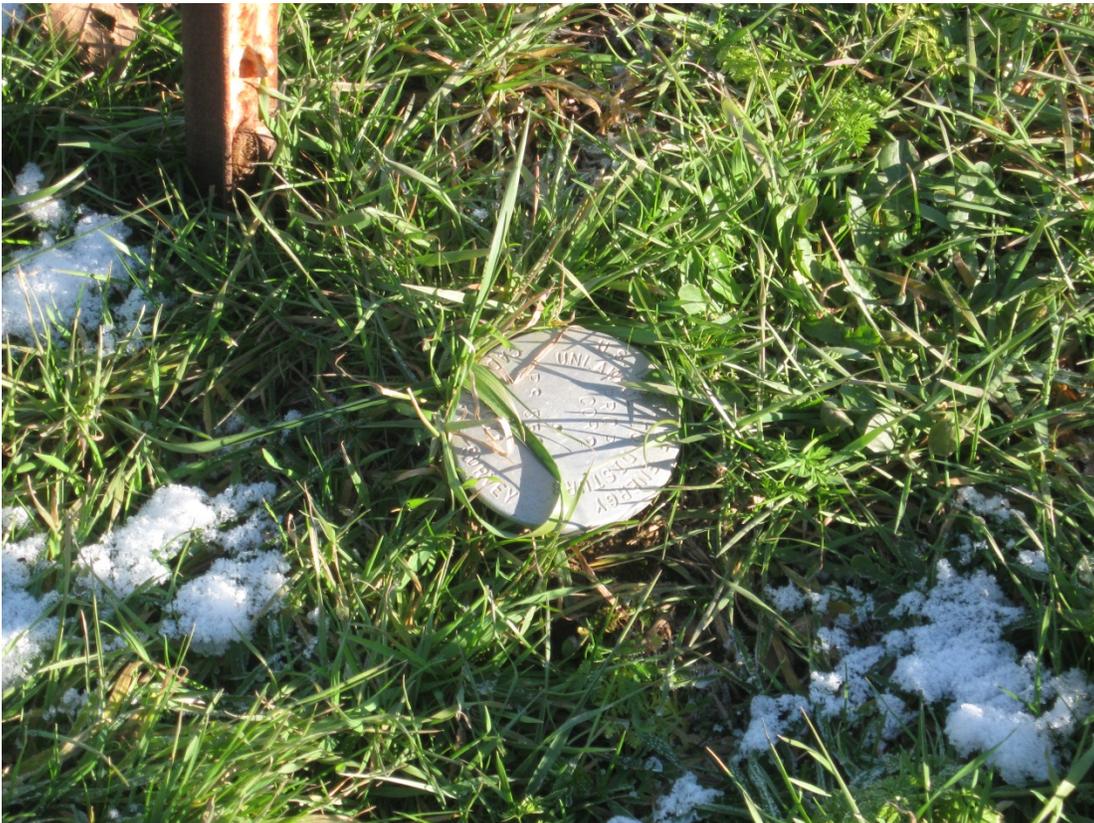
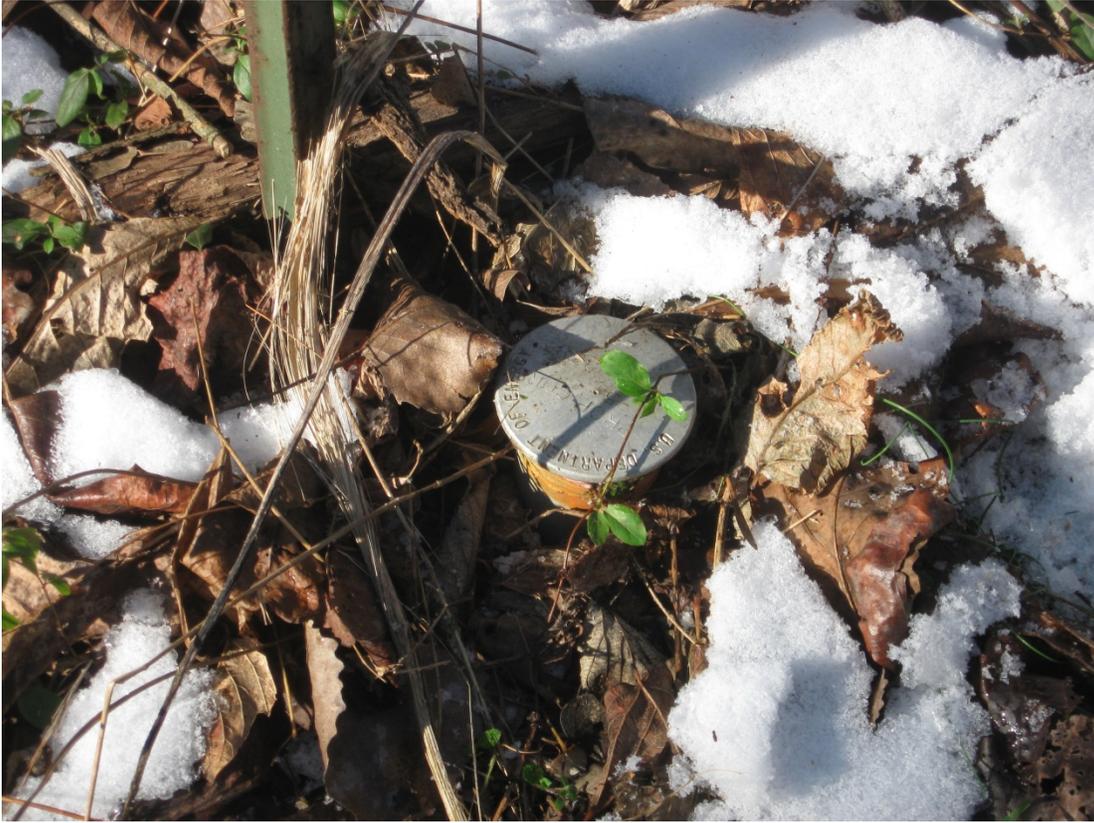
The Parkersburg site has 6 boundary monuments and one concrete survey monument. The presence of 4 of the 6 boundary monuments was verified during the site inspection; the monuments were in good condition (Boundary Monuments 1, 2, 5, and 6) (PL-6 and PL-7). Turf covered Boundary Monument 3, and ice covered Boundary Monument 4 (PL-8). Inspectors did not check the concrete survey monument during this year's inspection.

PKB 12/2013. PL-6. Boundary Monument 2.

PKB 12/2013. PL-7. Boundary Monument 5.

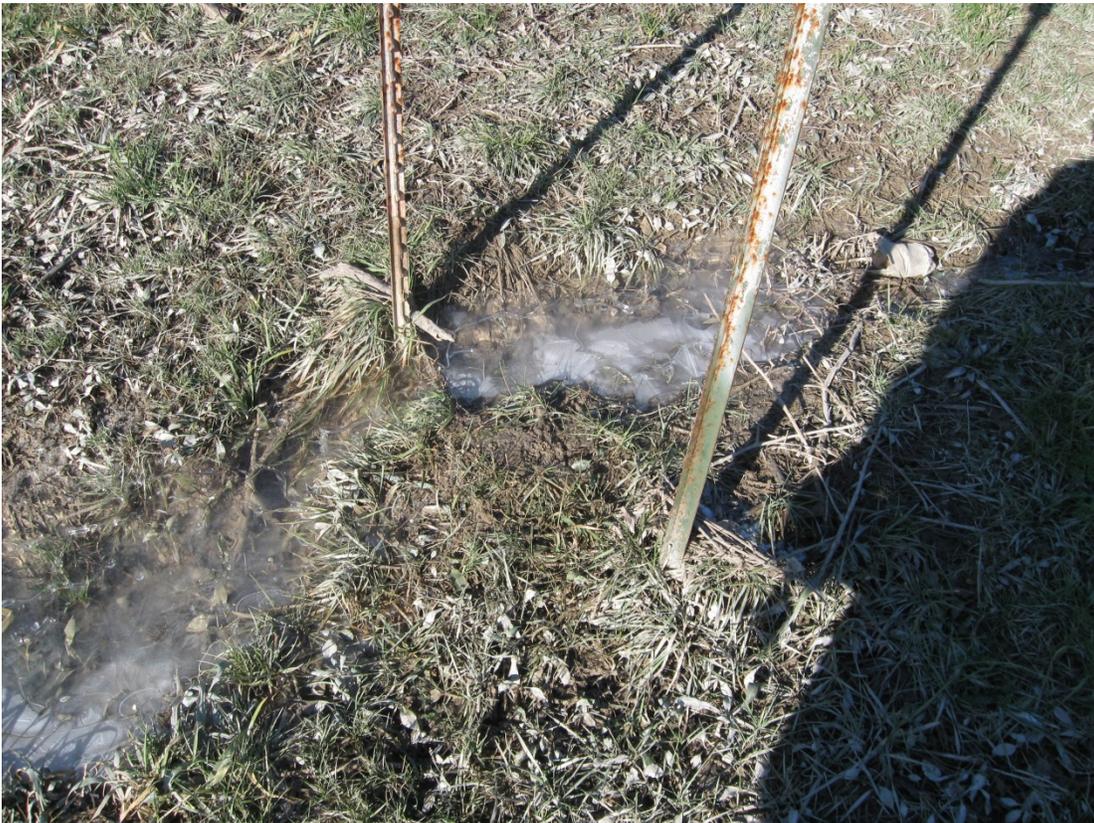
The presence of site monuments was verified during the inspection. All located site monuments were in good condition. The presence of Boundary Monument 3 could not be verified because it was covered with turf. The presence of Boundary Monument 4 could not be verified because it was covered by thick ice. The presence of both Boundary Monument 3 and Boundary Monument 4 was verified in 2012.

PKB 12/2013. PL-8. Boundary Monument 4 beneath the ice.

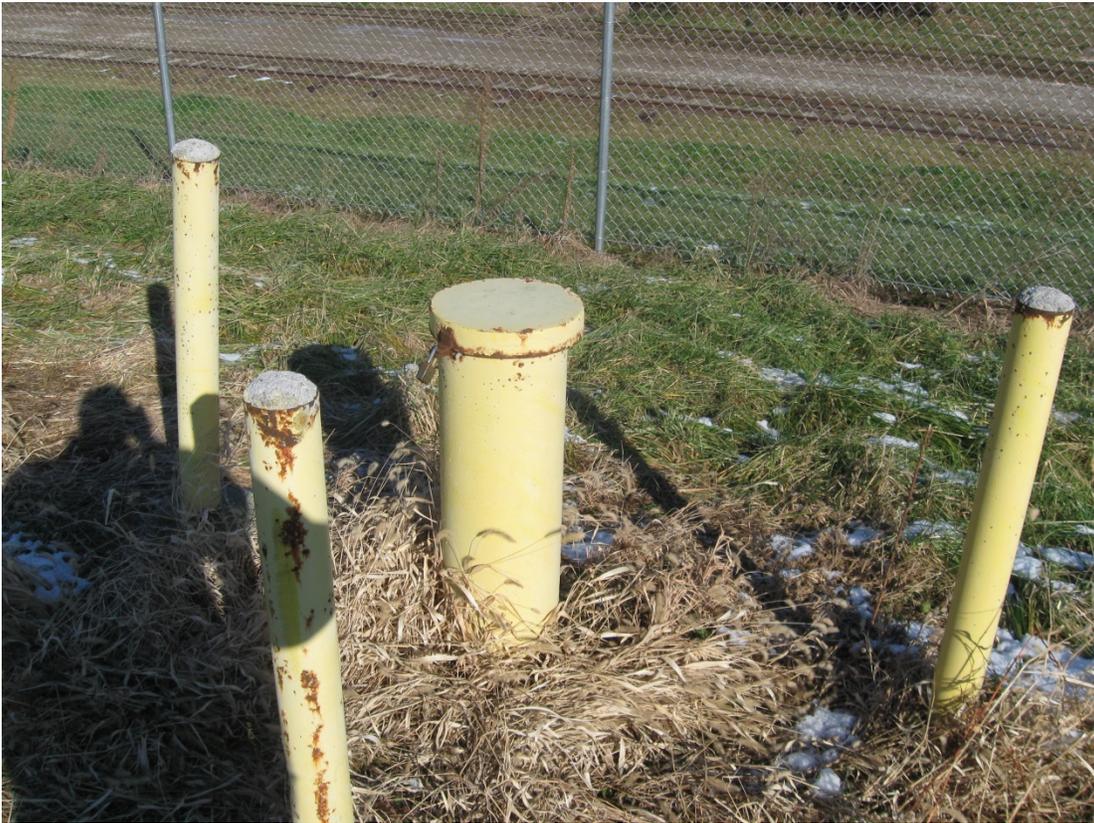
There are six groundwater monitoring wells at the Parkersburg site (PL-9). All six wells are located inside the security fence. The wells are numbered in the chronological order in which they were drilled and installed.

PKB 12/2013. PL-9. Monitoring well 6.

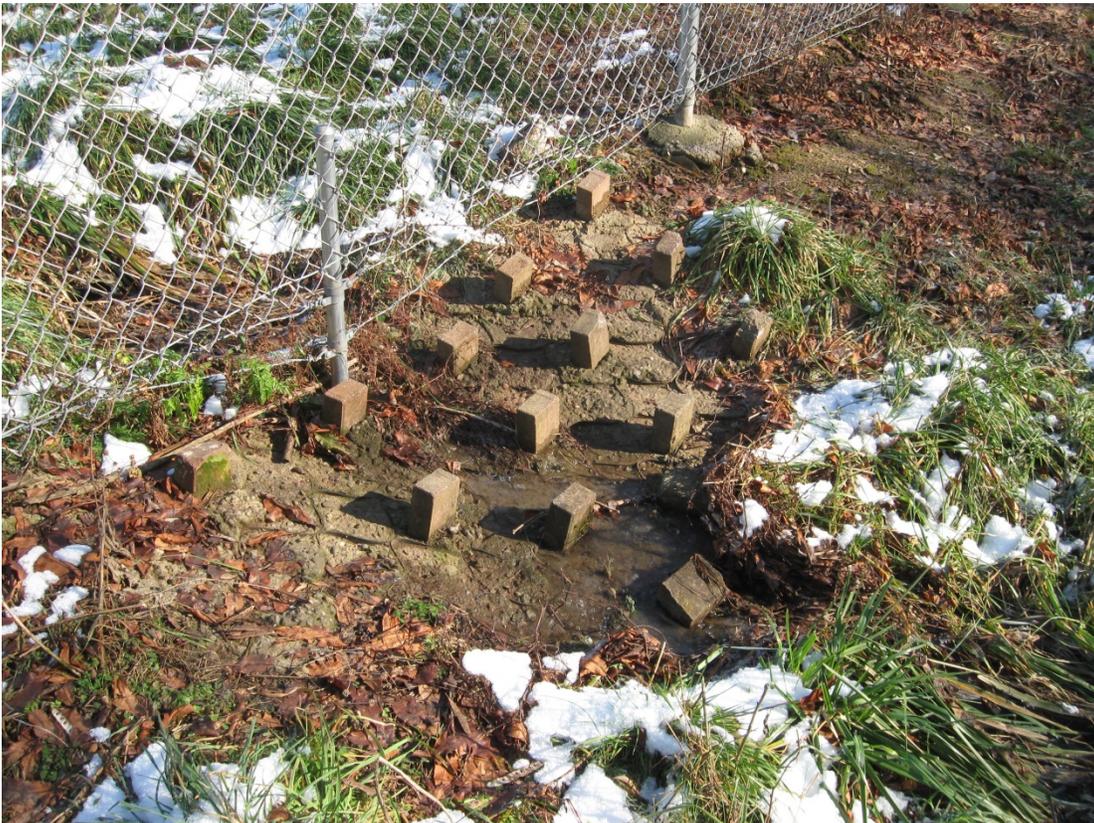
The drainage channel in the southwest corner of the site, lined with HDPE honeycomb baffles and brick energy dissipation baffles in August 1996, is in good condition and functioning as designed. Erosion in the channel appears to be unchanged from last year (PL-10).

PKB 12/2013. PL-10. Erosion control area.

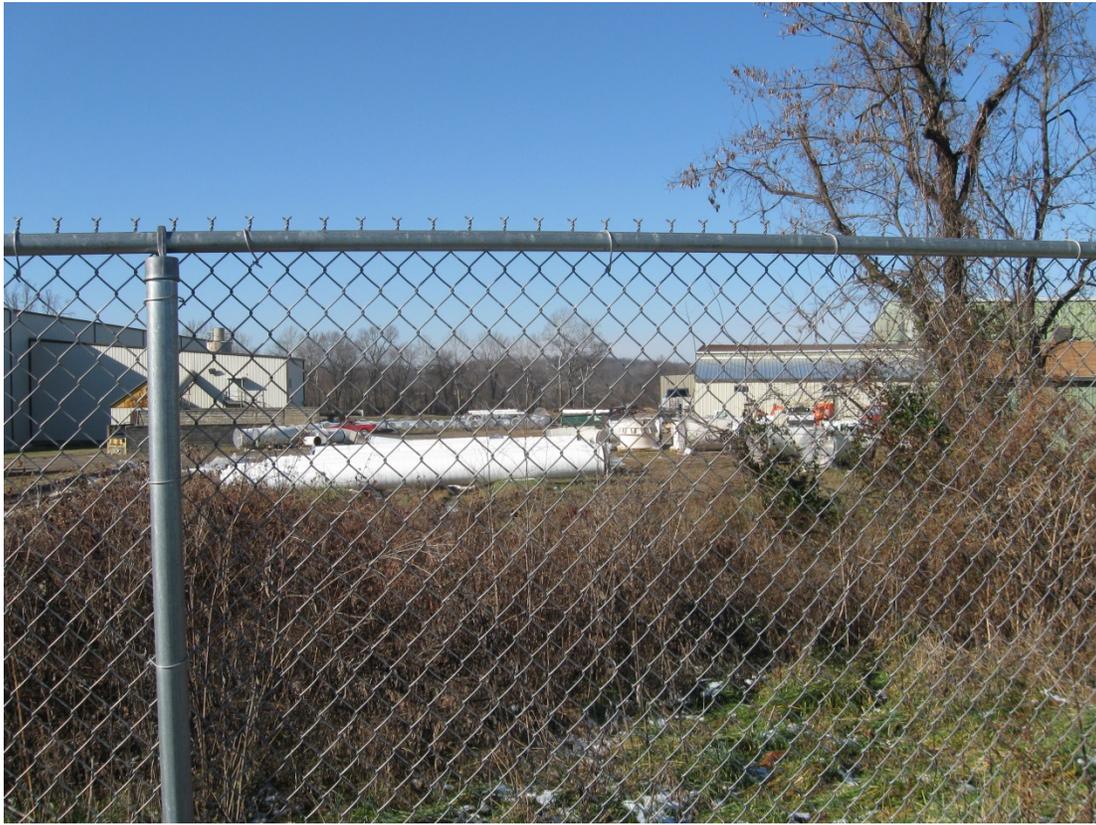
The Parkersburg site is in a developed industrial area. Inspectors observed that Northwest Pipe Company appears to remain very active (PL-11).

PKB 12/2013. PL-11. Looking toward Northwest Pipe Co. property.
