# 2014 Annual Inspection Report for the Parkersburg, West Virginia Disposal Site

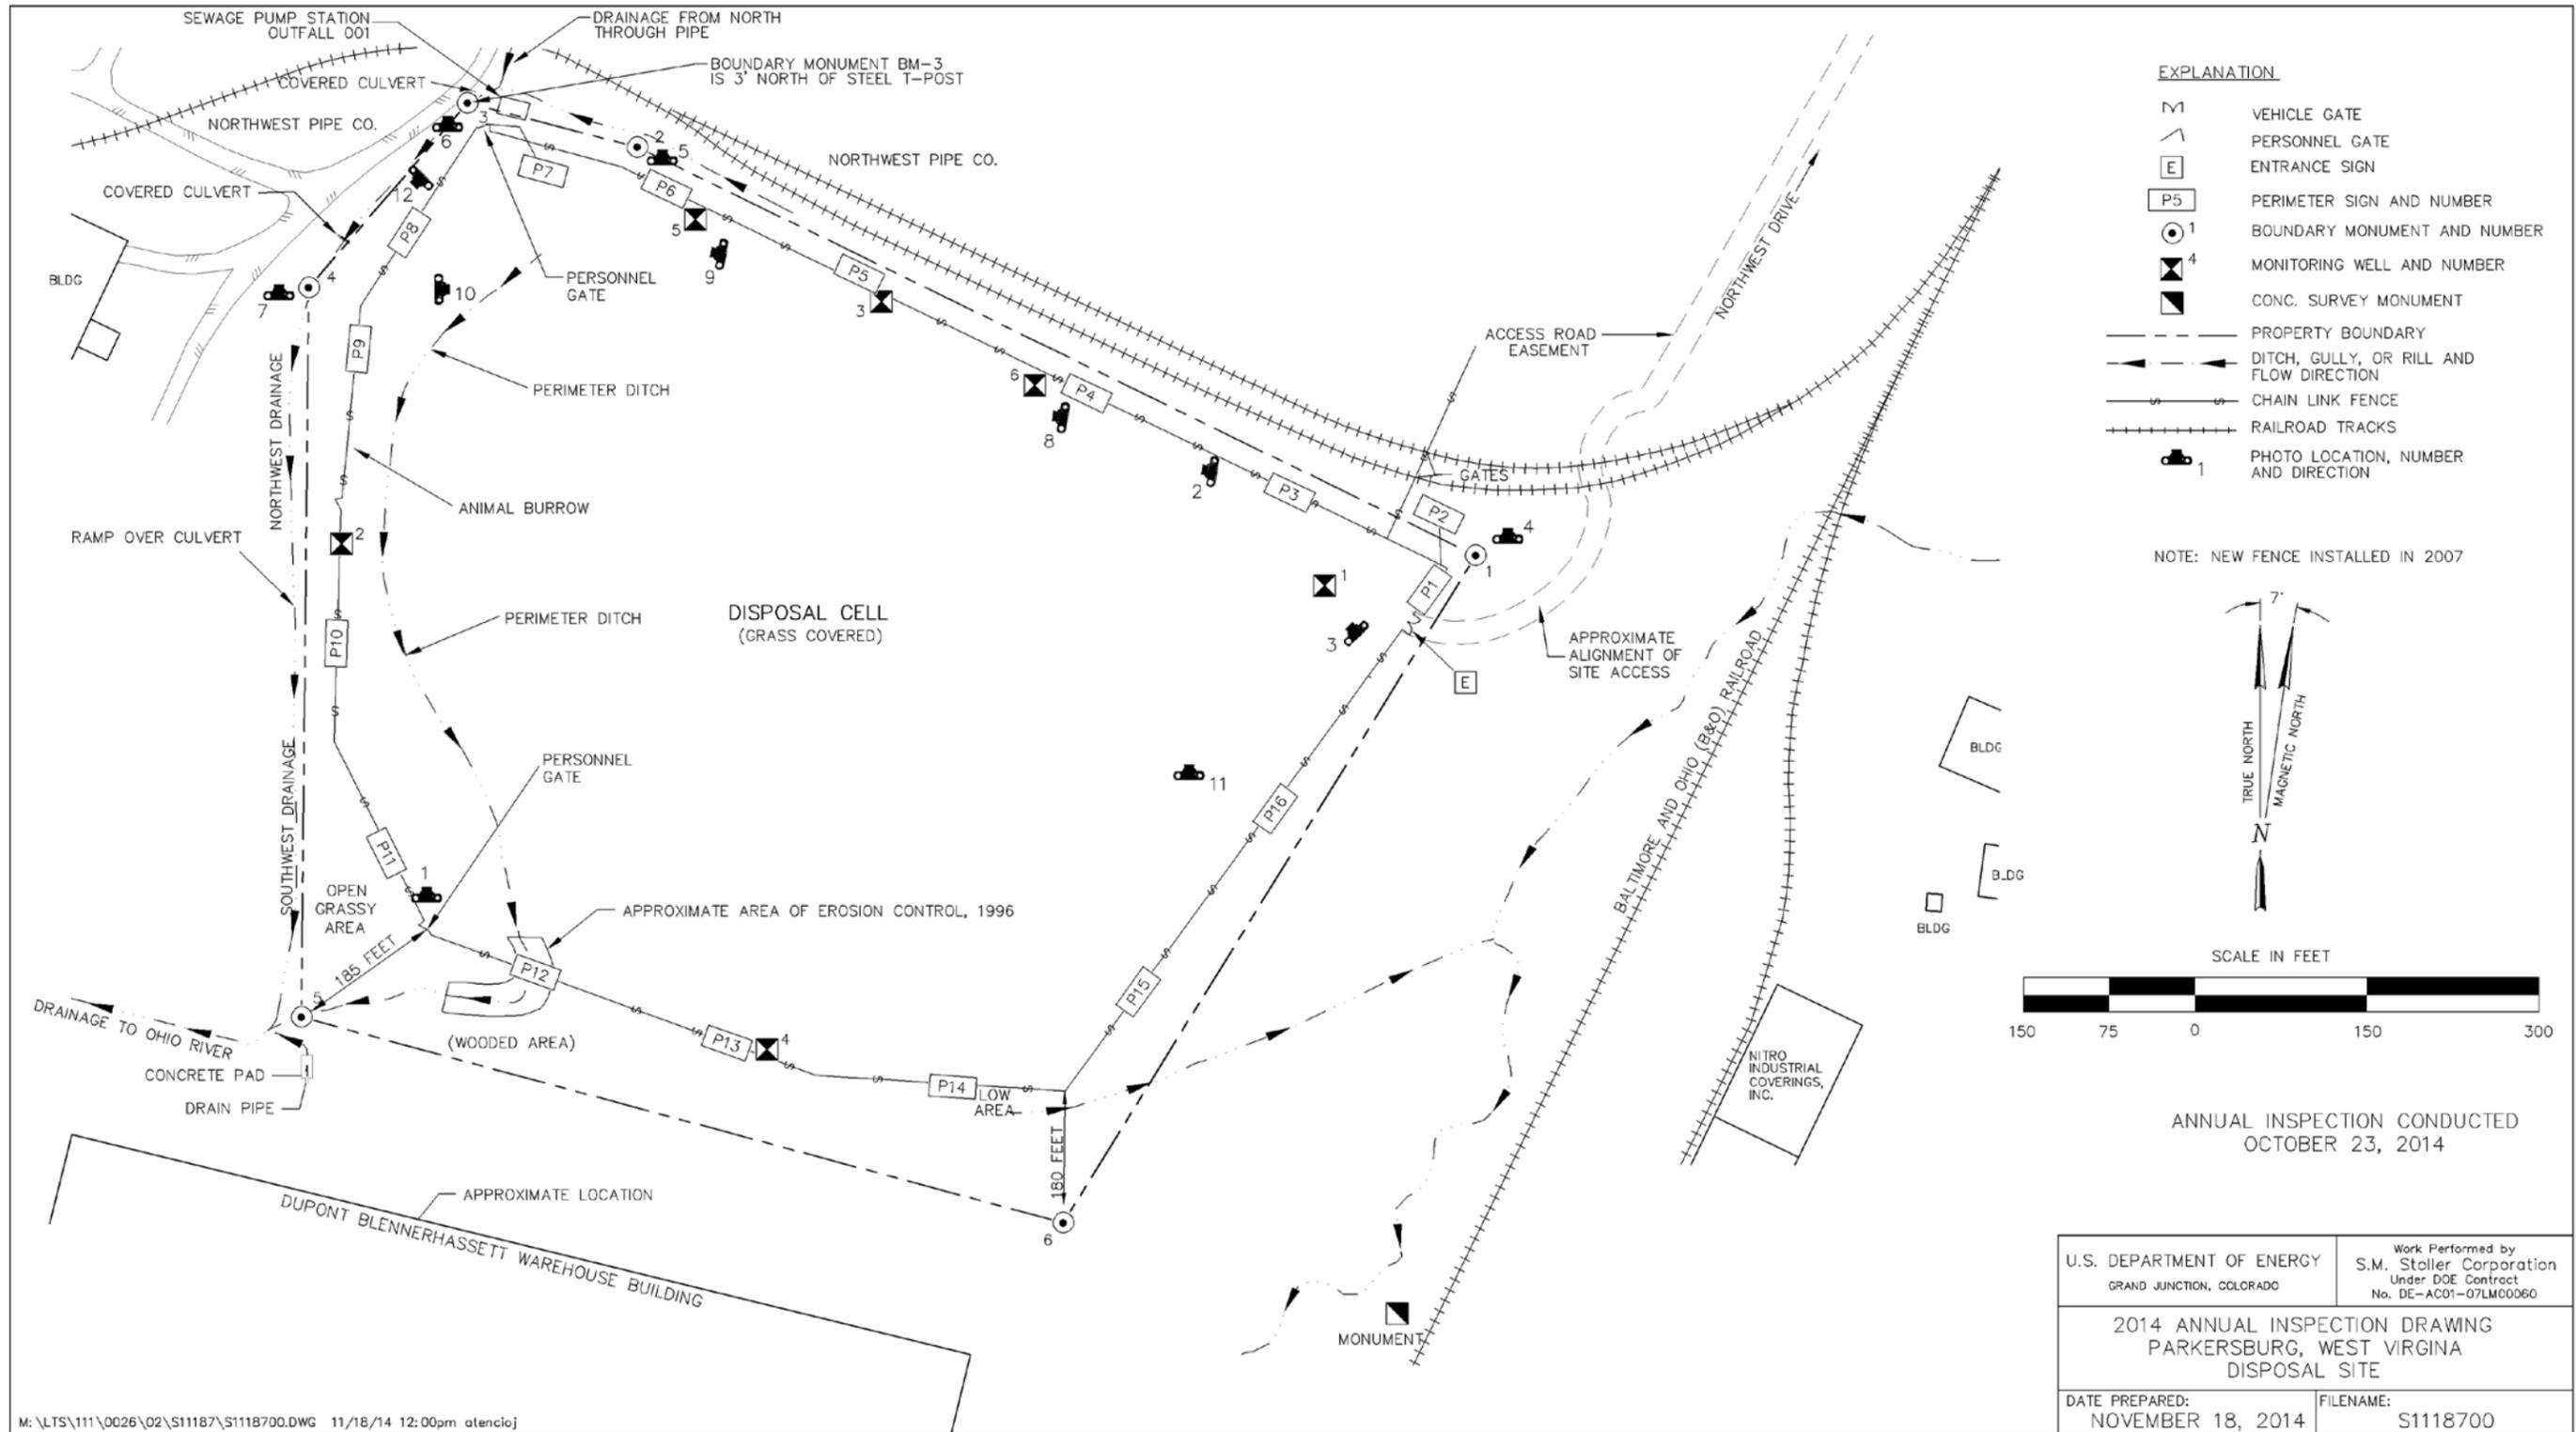
Figure 1. 2014 Annual Inspection Drawing for the Parkersburg Disposal Site

Animal burrows are present under the west perimeter fence. A couple of the burrows are quite large. The location of the burrows is noted on the site inspection map to alert future inspectors to potential tripping hazards.

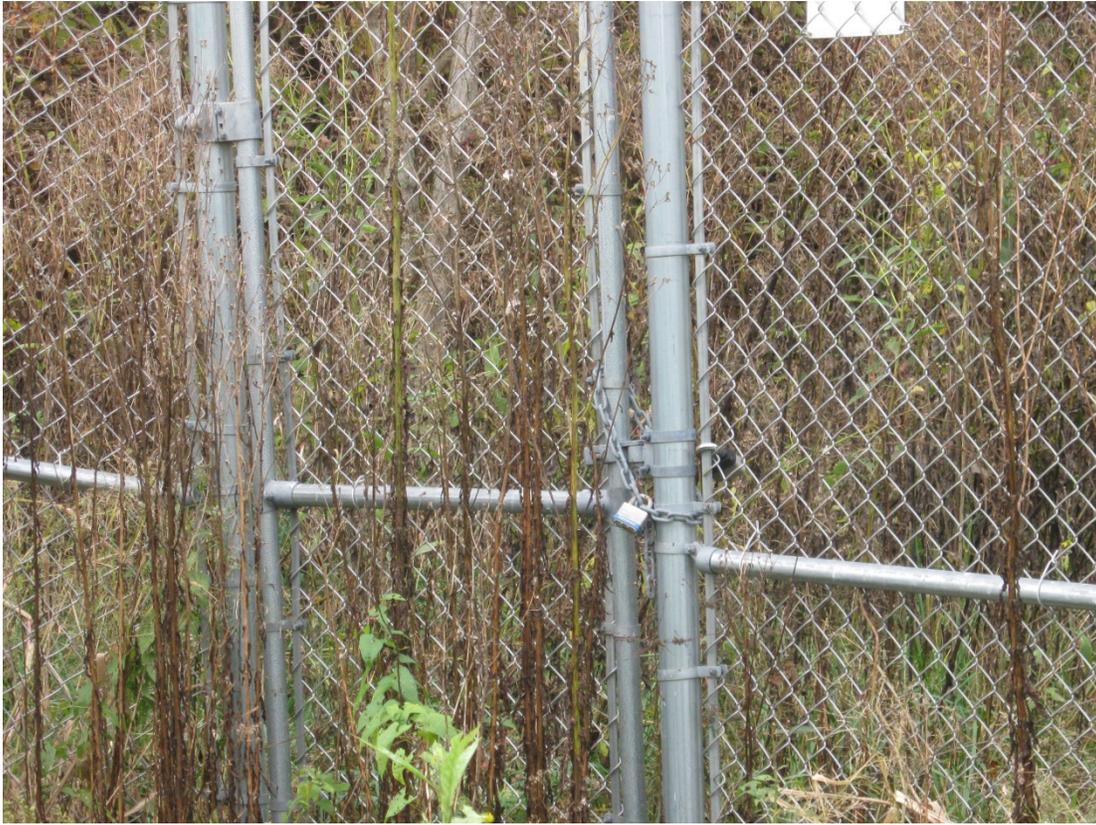
Entrance gates, replaced in 2007, were in excellent condition. The two personnel gates were found locked with non-DOE locks (PL-1). DOE replacement locks are secured next to the personnel gates. The maintenance subcontractor will be asked to remove the non-DOE locks and replace them with the DOE-approved locks.

*PKB 10/2014. PL-1. Weeds around southwest personnel gate and non-DOE approved lock.*

- Non-LM approved locks need to be removed from the personnel gates, and replaced with LM-approved locks.
- The t-post marking the location of Boundary Monument BM-3 should be moved closer to the actual monument.

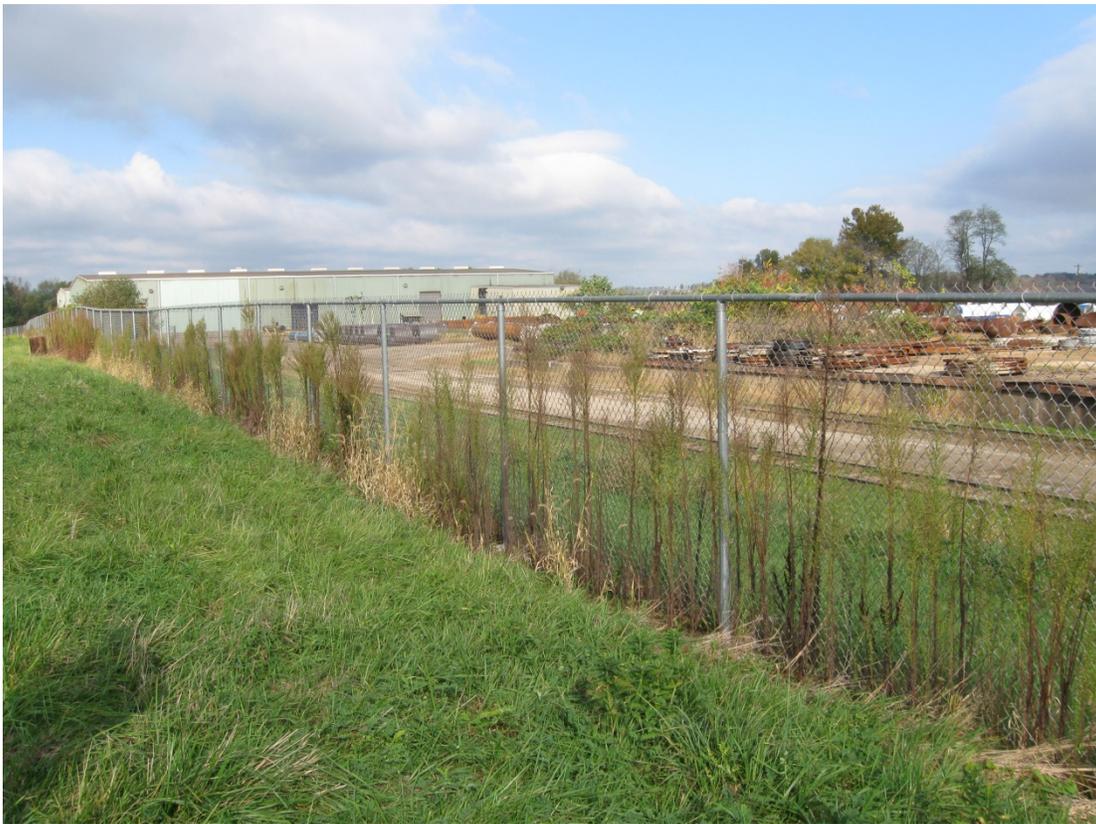
The perimeter fence, replaced in 2007, was in excellent condition. A vegetation free zone is to be maintained along the base of the fence. Although it is clear that the base of the fence is being sprayed, it is also clear that more effort needs to be made to keep the fence clear of vegetation (PL-2 and PL-3).

*PKB 10/2014. PL-2. Weeds along north perimeter fence.*

- The site maintenance contractor needs to do a better job keeping a vegetation clear zone around the base of the fence.
- The site maintenance contractor needs to do a better job keeping the vegetation trimmed around the monitoring wells.

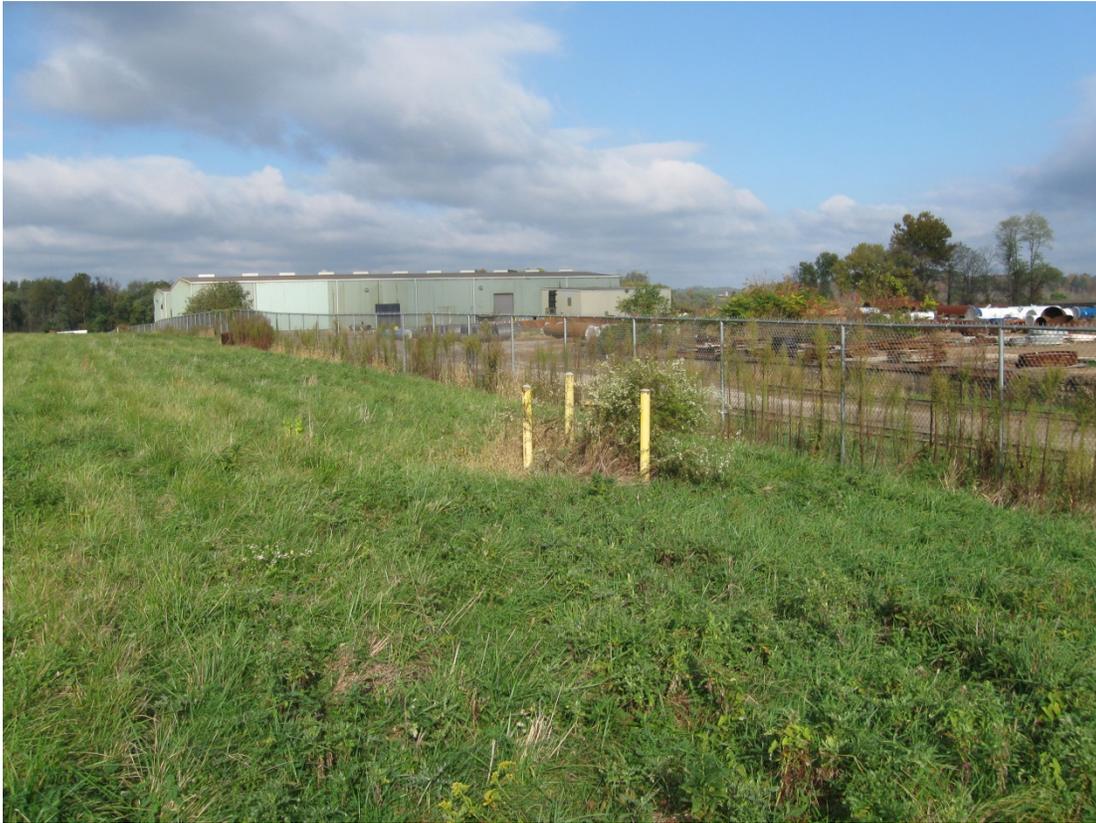
*PKB 10/2014. PL-3. Weeds around monitoring well 1*

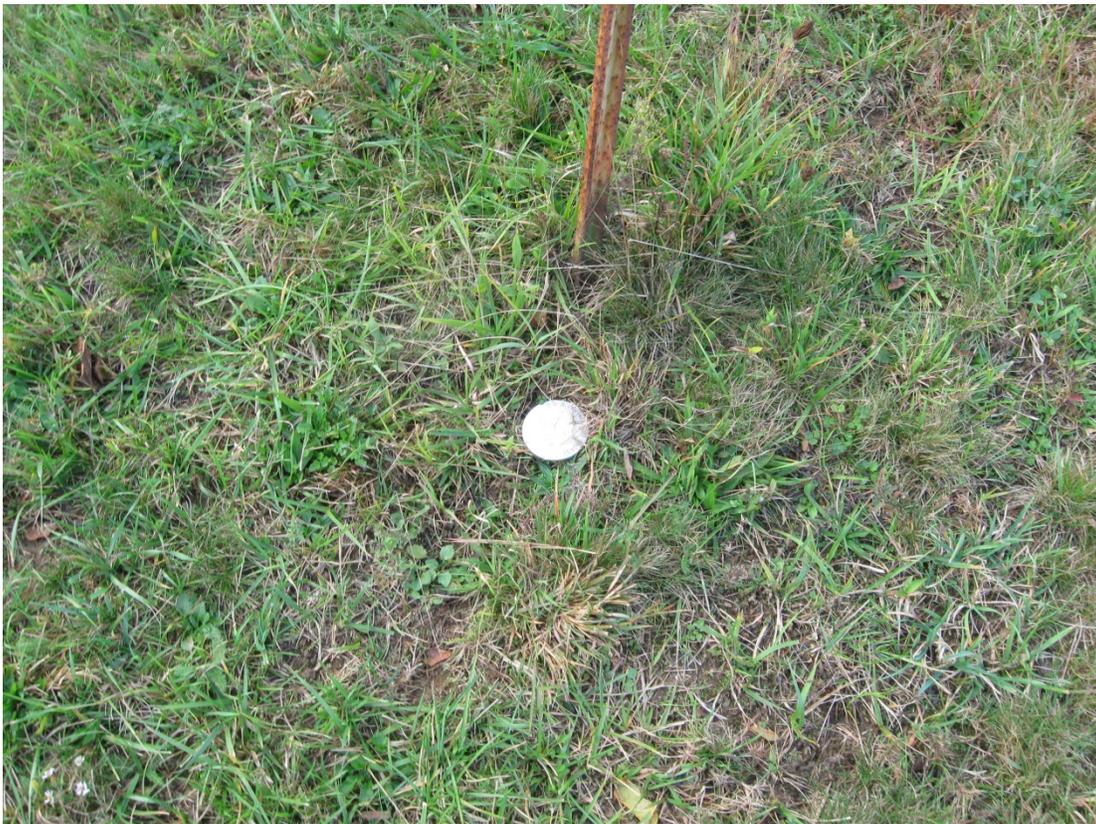
The Parkersburg site has 6 boundary monuments and one concrete survey monument. The presence of 4 of the 6 boundary monuments (Boundary Monuments 1, 2, 3, and 4) were verified during the site inspection and were in good condition (PL-4 thru PL-7). The t-post marking the location of Boundary Monument BM-3 should be moved closer to the actual monument (PL-6). The presence of Boundary Monuments BM-5 and BM-6 were not verified due to thick vegetation growth. Efforts will be made in 2015 to better clear vegetation around these two monuments. Inspectors did not check the concrete survey monument during this year's inspection.

*PKB 10/2014. PL-4. Boundary monument BM-1.*

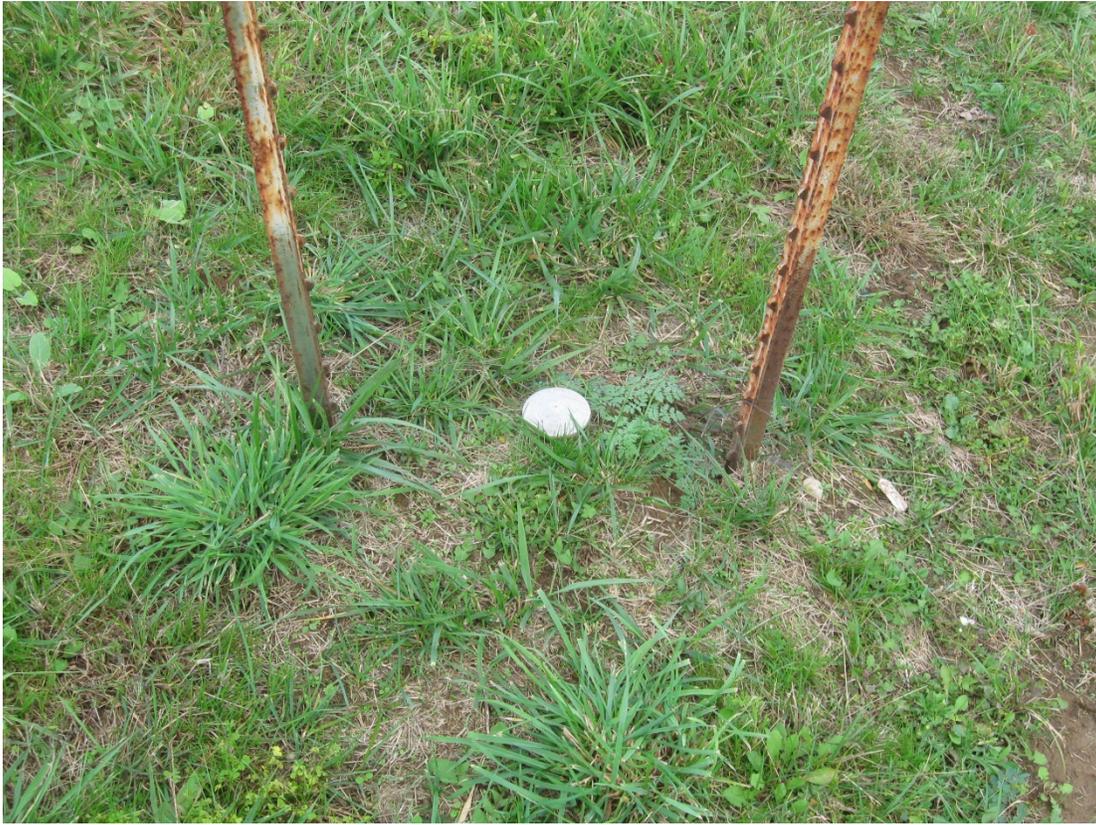
*PKB 10/2014. PL-5. Boundary monument BM-2.*

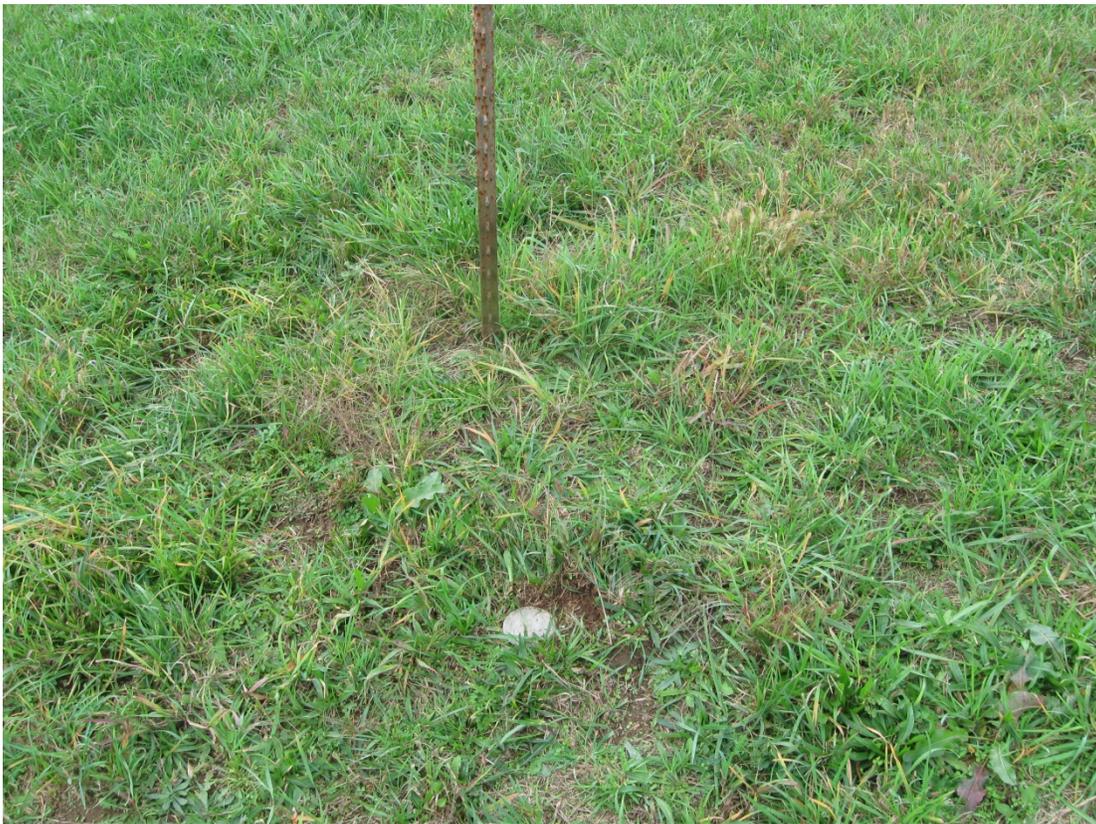
*PKB 10/2014. PL-6. Boundary Monument BM-3.*

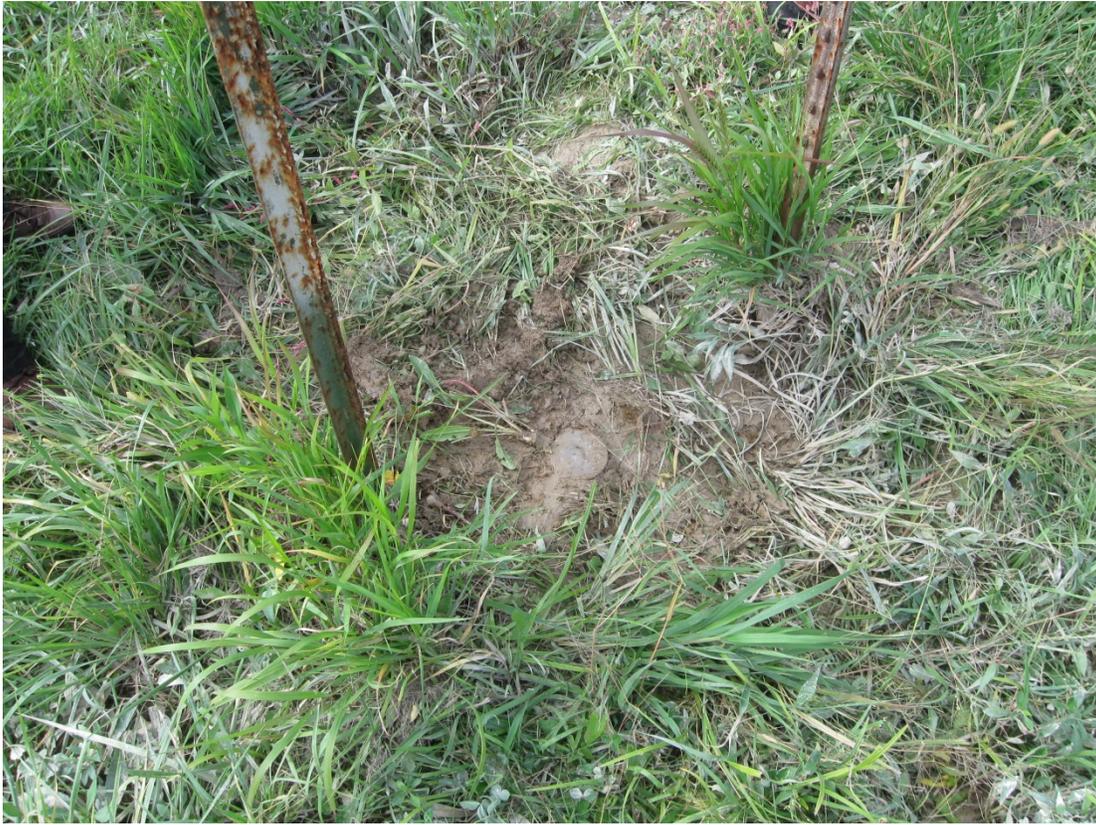
*PKB 10/2014. PL-7. Boundary Monument BM-4.*

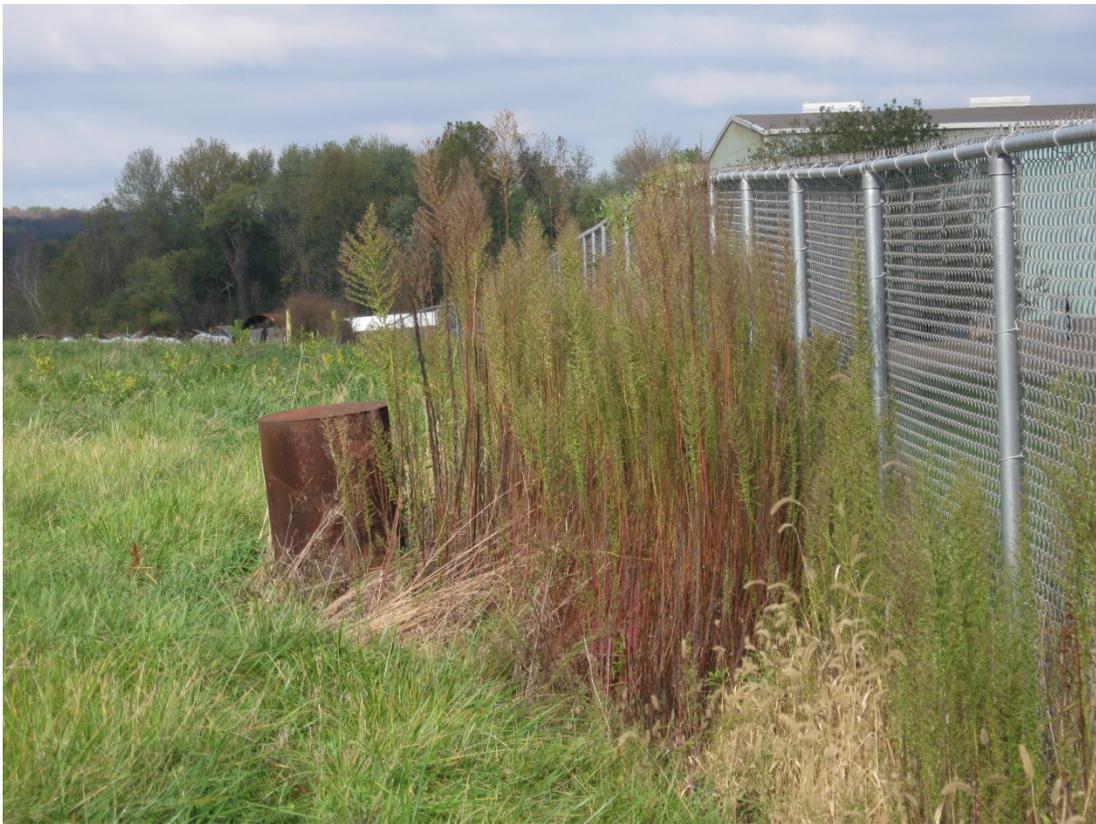
There are six groundwater monitoring wells at the Parkersburg site. All six wells are located inside the security fence. The wells are numbered in the chronological order in which they were drilled and installed. All 6 wells were properly locked. More effort is needed to control vegetation around the wells (PL-8 and PL-9).

*PKB 10/2014. PL-8. Weeds around monitoring well MW-6.*

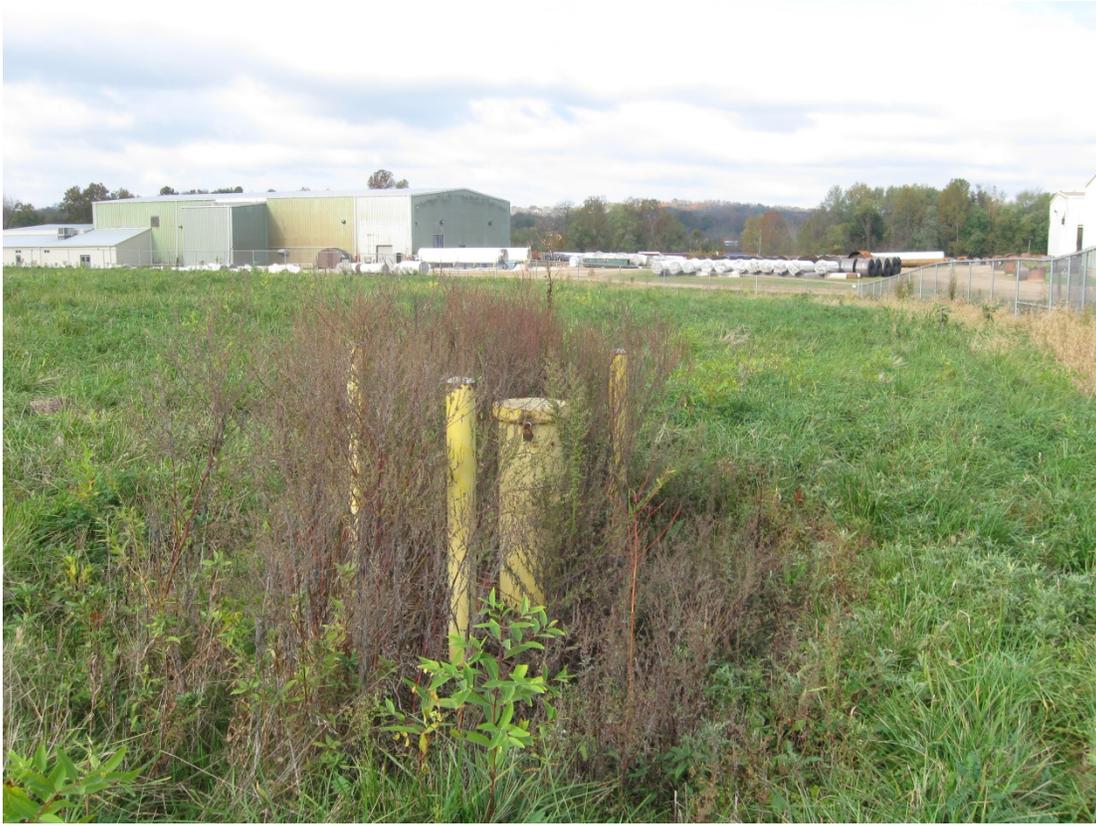
*PKB 10/2014. PL-9. Weeds around monitoring well MW-5.*

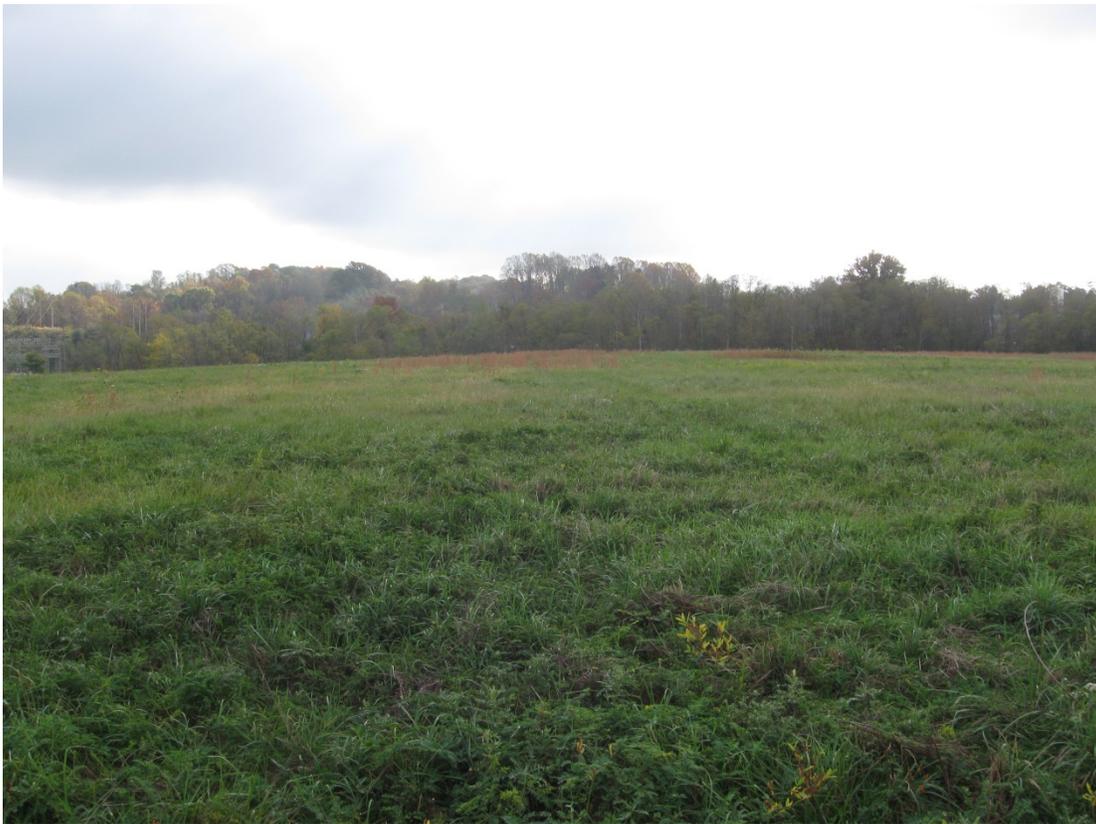
The grass covered disposal cell was in excellent condition (PL-10). No evidence of erosion or slope instability on the disposal cell was noted during the inspection. Dominant vegetation consists of fescue, crown vetch, and goldenrod. A lot of Indian hemp was observed growing in the fence area during the inspection (PL-11). Indian hemp is a common weedy species, not considered noxious or invasive. The vegetation on the disposal cell cover (essentially in the area inside the security fence) appeared healthy and vigorous.

*PKB 10/2014. PL-10. Grass covered mound.*

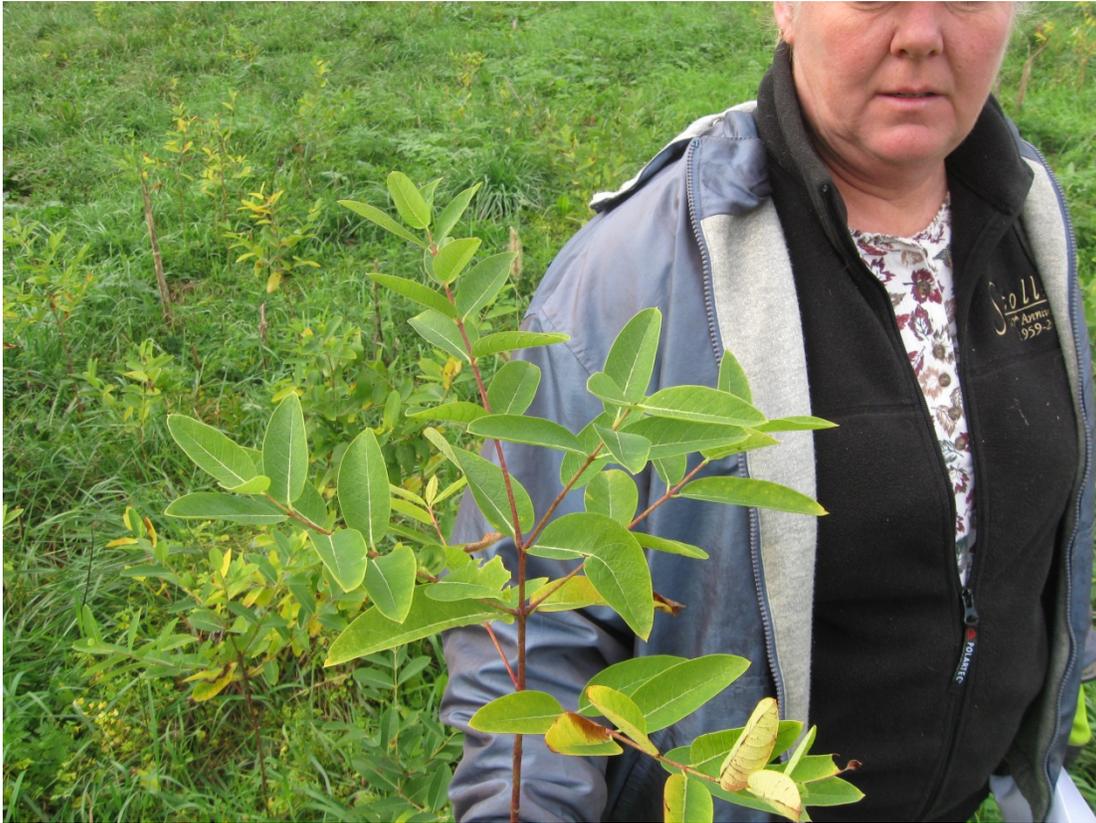
*PKB 10/2014. PL-11. Contractor holding Indian Hemp Plant.*

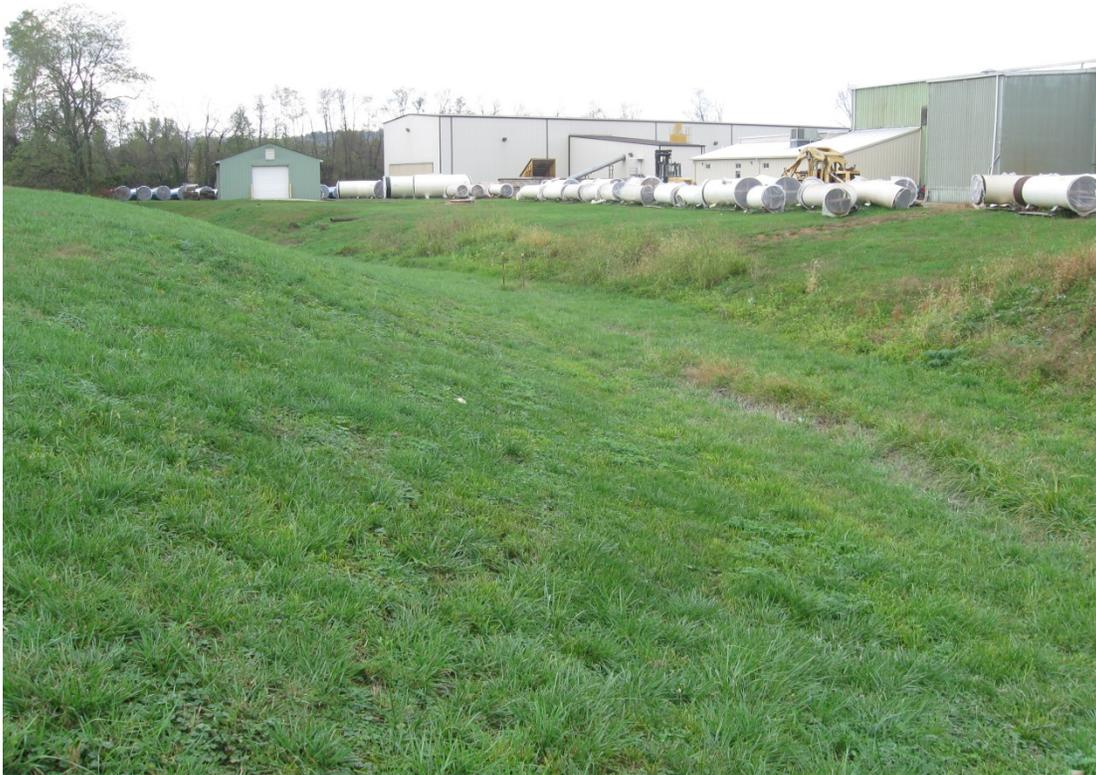
The Parkersburg site is in a developed industrial area. Inspectors observed that Northwest Pipe Company appears to remain very active. The area north of the perimeter fence, near Boundary Monument BM-4 had been cleared out and seeded with grass by the Northwest Pipe Company (PL-12).

*PKB 10/2014. PL-12. Swale located north of perimeter fence.*
