2004 Annual Inspection for the Parkersburg, West Virginia, Nuclear Waste Policy Act Section 151(c) Disposal Site

ANNUAL INSPECTION CONDUCTED
SEPTEMBER 23, 2004

U.S. DEPARTMENT OF ENERGY GRAND JUNCTION, COLORADO	Work Performed by S.M. Staller Corporation Under DOE Contract No. DE-AC01-02GJ79491
2004 ANNUAL INSPECTION DRAWING PARKERSBURG, WEST VIRGINIA, DISPOSAL SITE SHEET 1 OF 2 - PHYSICAL FEATURES	
DATE PREPARED: OCTOBER 12, 2004	FILENAME: S0099000

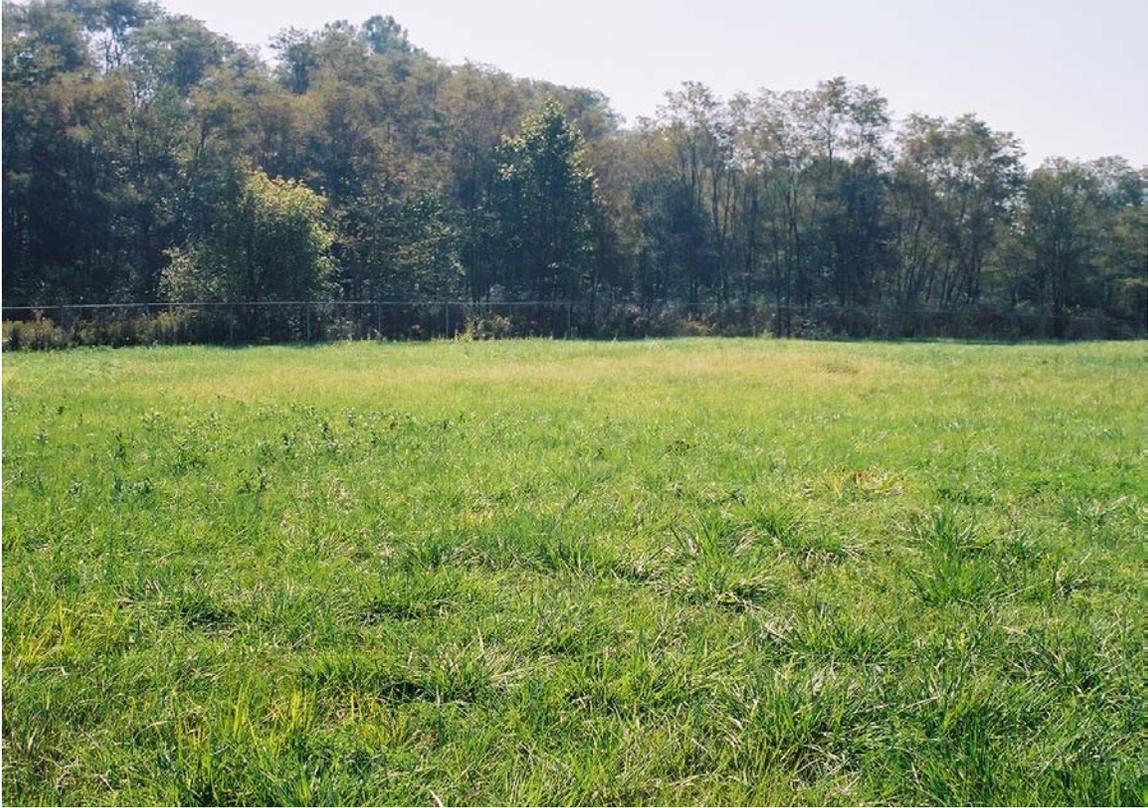
Inspectors walked a series of traverses inside the security fence to inspect the disposal cell top for signs of settlement, erosion, or other modifying process that would indicate a threat to cell integrity. No signs of instability were observed (PL-1 through PL-4).

PKB 9/2004. PL-1. View of disposal cell top.

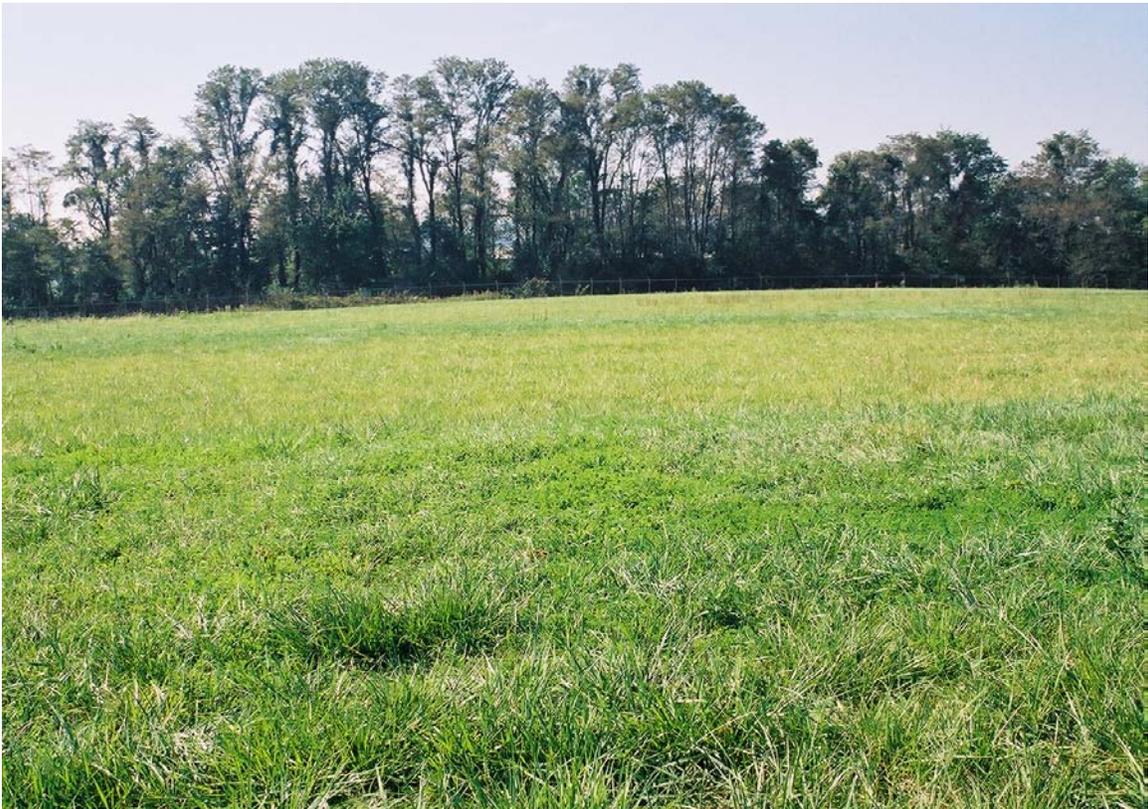
PKB 9/2004. PL-2. View of disposal cell top.

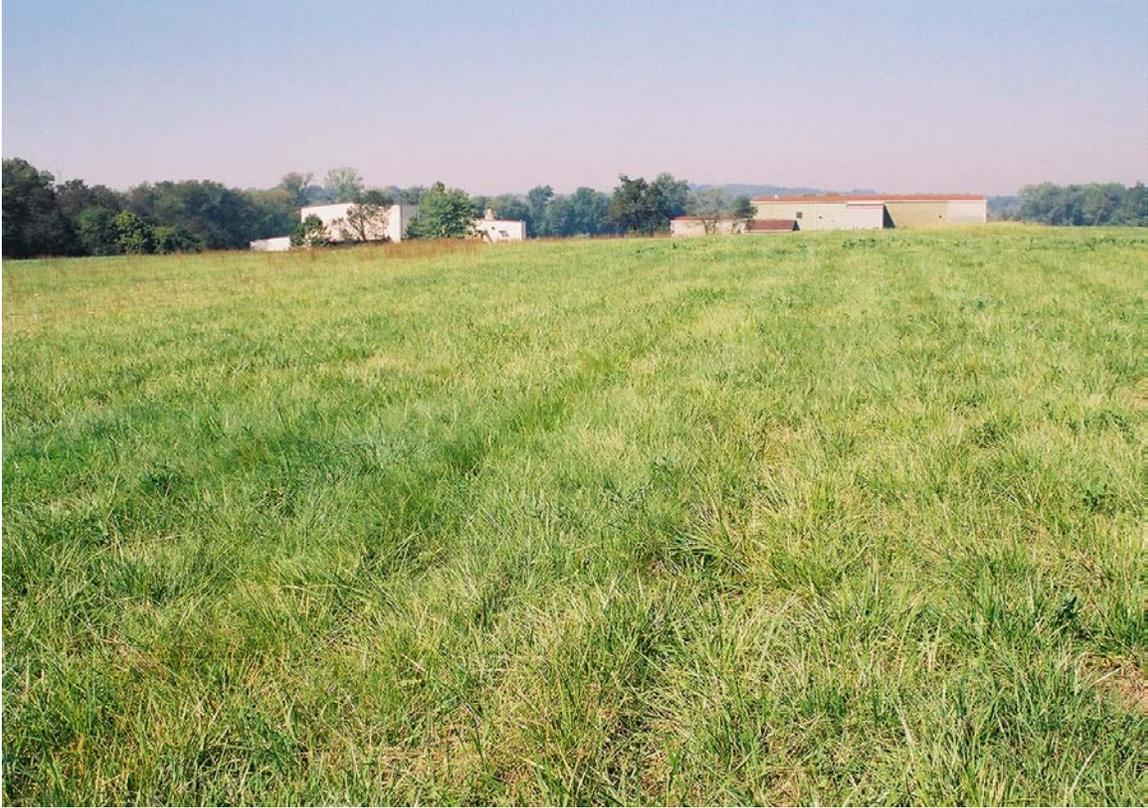
PKB 9/2004. PL-3. View of disposal cell top.

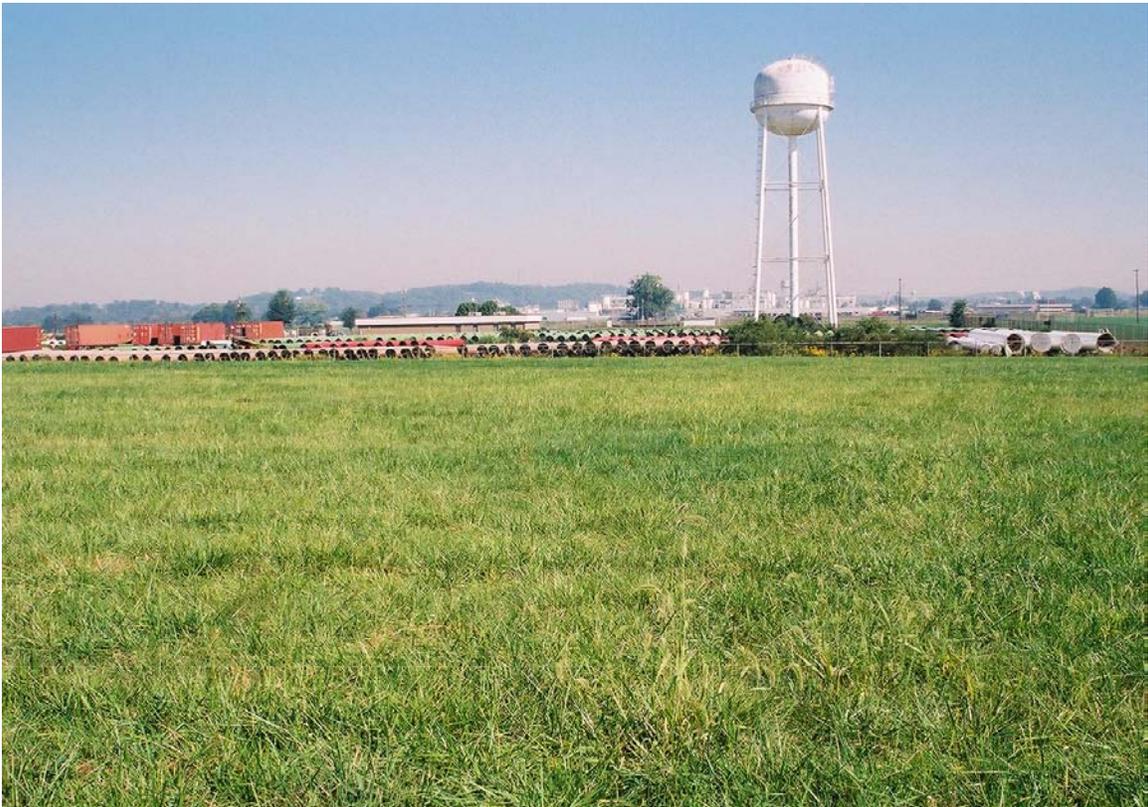
PKB 9/2004. PL-4. View of disposal cell top.

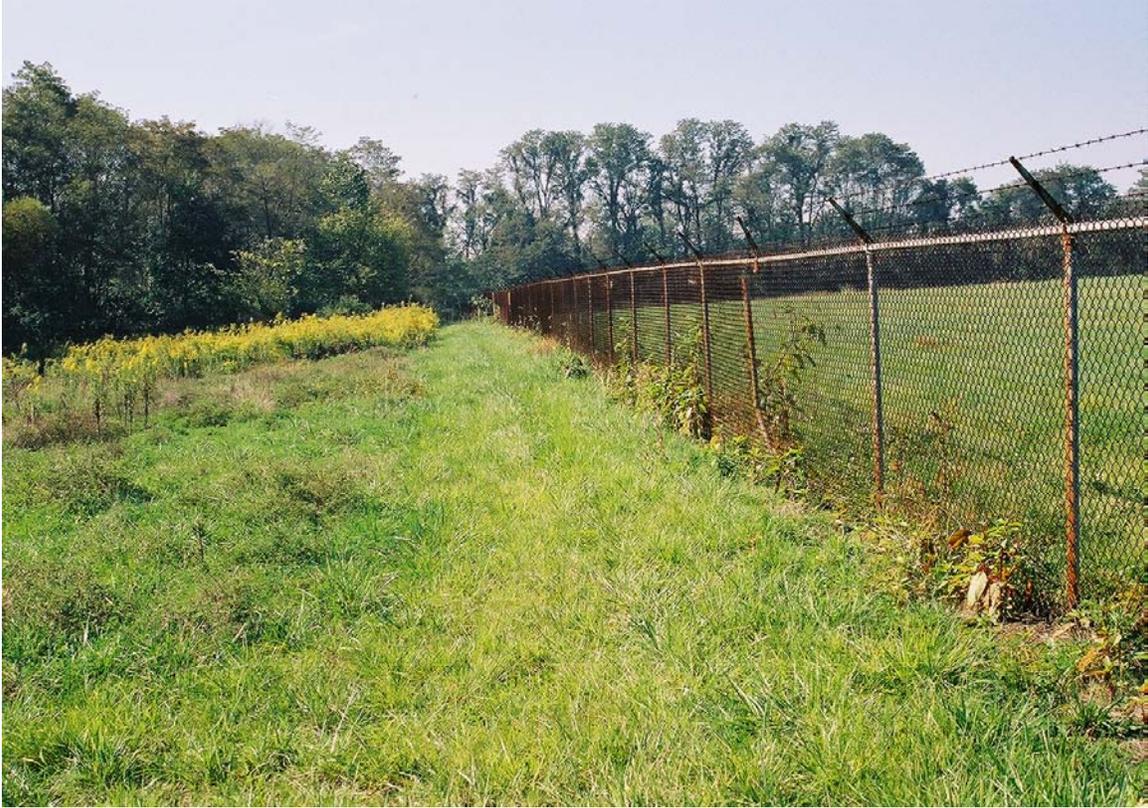
The security fence is in fair condition. Although the fence continues to function as designed, most of the chain link fabric is becoming heavily rusted due to the humid climate of the region. The chain link fence is now approximately 19 years old. The barbed wire attached to angle brackets along the top of the security fence is in poor condition. During the 2003 inspection, inspectors noted that the barbed wire was severely rusted in most areas and broken at three locations. Apparently, the life expectancy is shorter for the barbed wire than for the chain link fabric. DOE instructed the maintenance subcontractor to repair the broken strands in spring 2004 during a scheduled trip to the site, but inspectors noted that the repairs had not been made. DOE will make arrangements to complete this maintenance.

PKB 9/2004. PL-5. View of mowed area along eastern perimeter fence; note rusted condition of fence.

Recommendation: DOE will make arrangements to repair the broken barbed wire. At some time, the condition of the fence will be so degraded that the entire security fence system (i.e., posts, fabric, top railing, barbed wire, hardware, etc.) will require replacement. Inspectors will continue to monitor the overall condition of the fence to determine the optimal time for replacement and will request budget and scope for that activity when necessary.

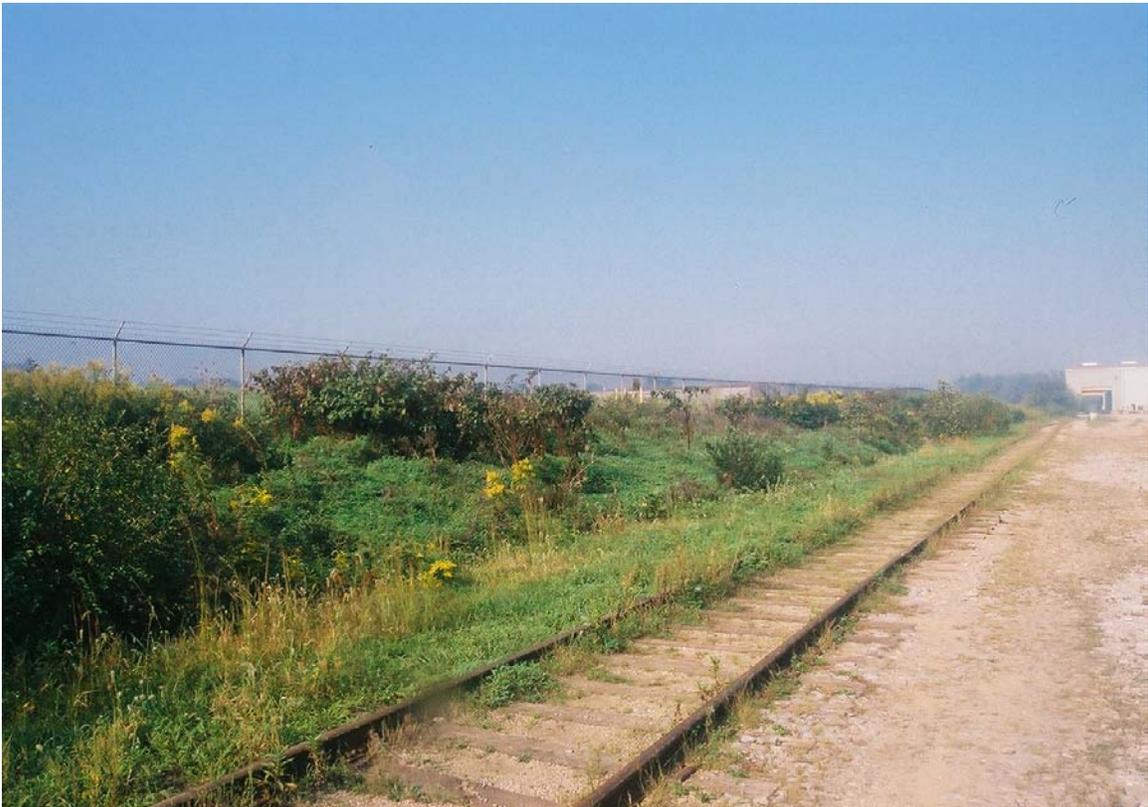
PKB 9/2004. PL-6. North side of site, looking westward.

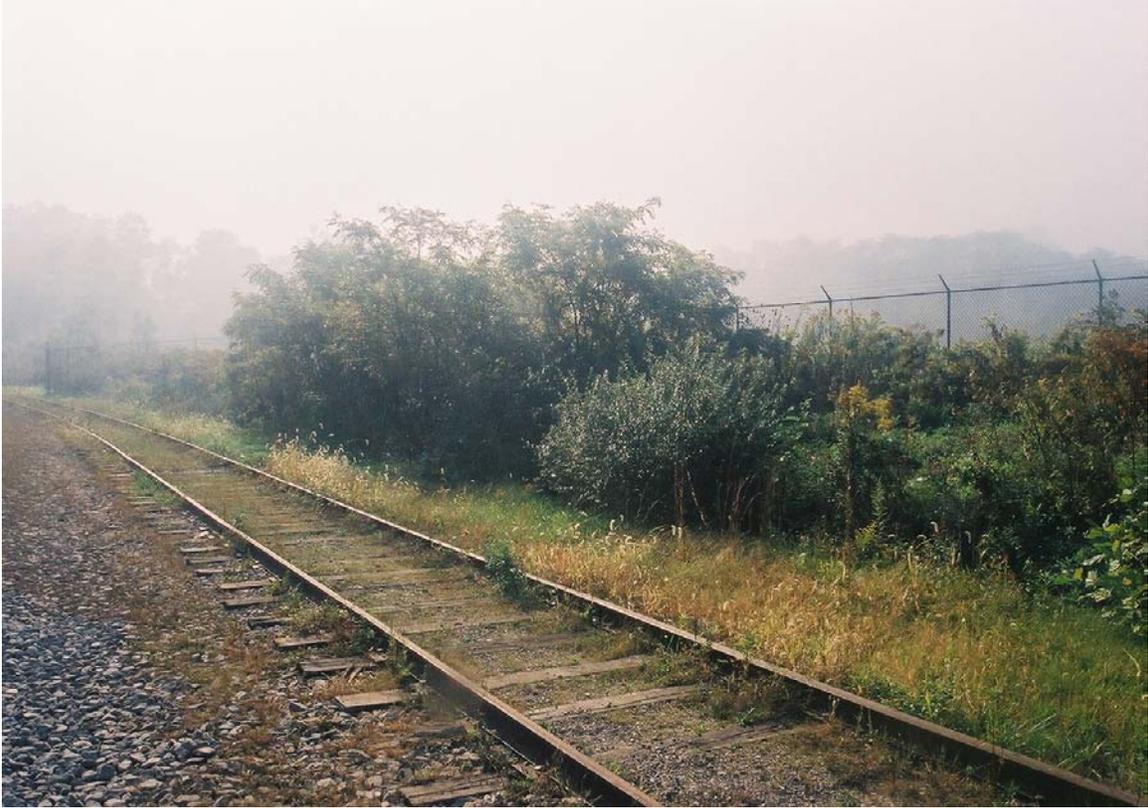
PKB 9/2004. PL-7. North side of site, looking eastward.

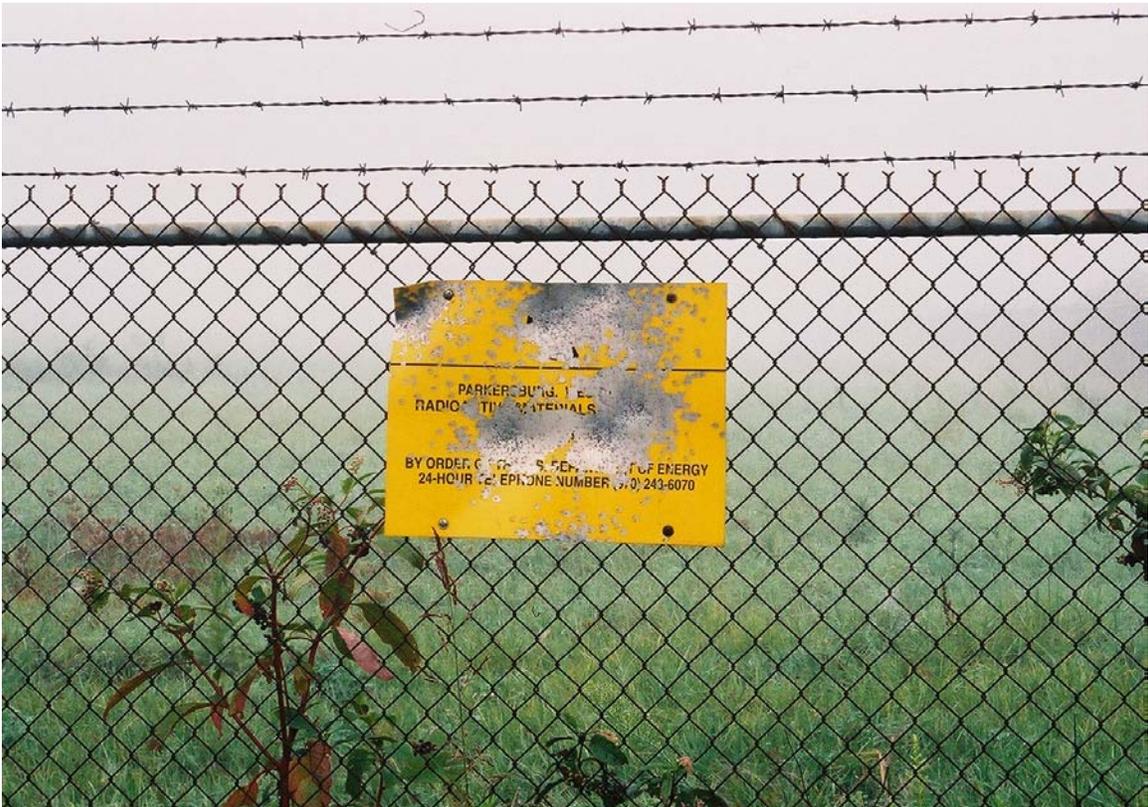
Perimeter signs were in good condition, with one exception. Perimeter sign P1 (PL-8), destroyed by shotgun blasts in 2003, had not been replaced in 2004 by the maintenance subcontractor as requested. DOE will instruct the subcontractor to complete this task. Adhesive overlays with the correct description of the cell contents were applied to perimeter signs in 2001. These remain in good condition.

PKB 9/2004. PL-8. Perimeter sign P1, damaged by shotgun blast.

Recommendation: DOE will instruct the maintenance subcontractor to replace the sign.

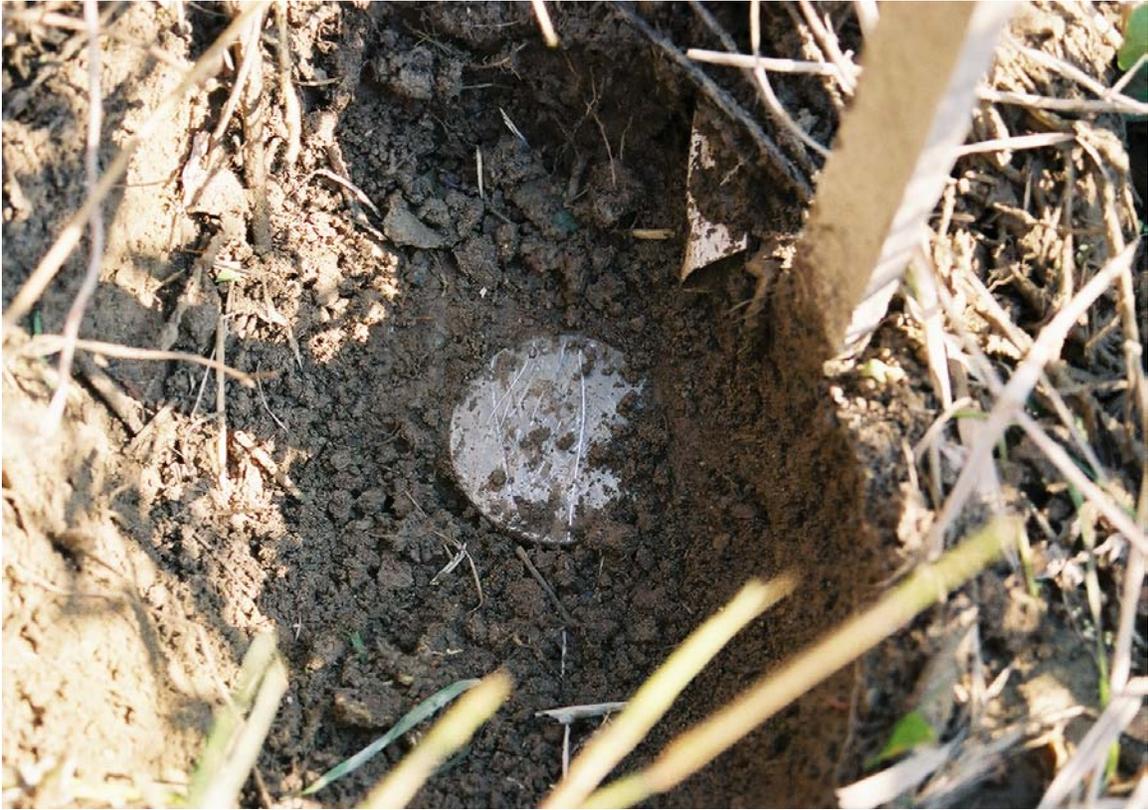
Inspectors could not find boundary monument BM-4 during the 2000 or 2001 site inspections. This monument is in the bottom of a drainage ditch that parallels the northern property boundary. In 2002, a local surveyor located BM-4 beneath more than 4 inches of sediment. In 2003 and 2004, inspectors again removed sediments to uncover the monument (PL-9). All other boundary monuments were located and are in excellent condition.

PKB 9/2004. PL-9. Boundary monument BM-4.
