# **2008 Annual Inspection for the Parkersburg, West Virginia, Nuclear Waste Policy Act Section 151(c) Disposal Site**

This report presents the findings of the annual U.S. Department of Energy (DOE) inspection of the Nuclear Waste Policy Act (NWPA) Section 151(c) disposal site at Parkersburg, West Virginia. M. Miller (Chief Inspector), K. Broberg (Assistant Inspector), both with S.M. Stoller Corporation, the DOE Legacy Management (LM) Contractor, conducted the inspection on October 16, 2008. J. Craig, DOE-LM also participated in the inspection.

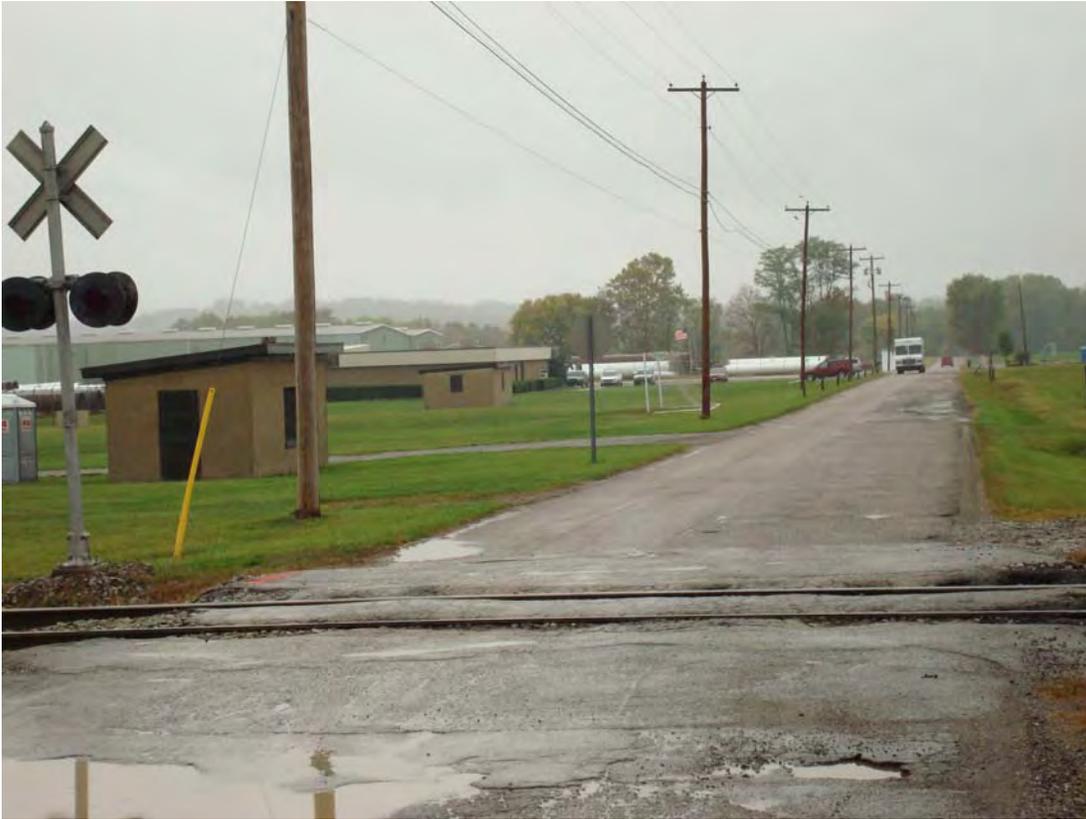
1. The grade over the railroad tracks provides adequate clearance for a passenger car, but gravel is needed to fill in low spots (PL-1) (page 2).

PKB 10/2008. PL-1. Gravel needed to fill in low spots in the grade going over the railroad tracks.

**Recommendation:** It is recommended that gravel be placed in the low spots in the grade over the railroad tracks. This is considered to be a low maintenance priority.

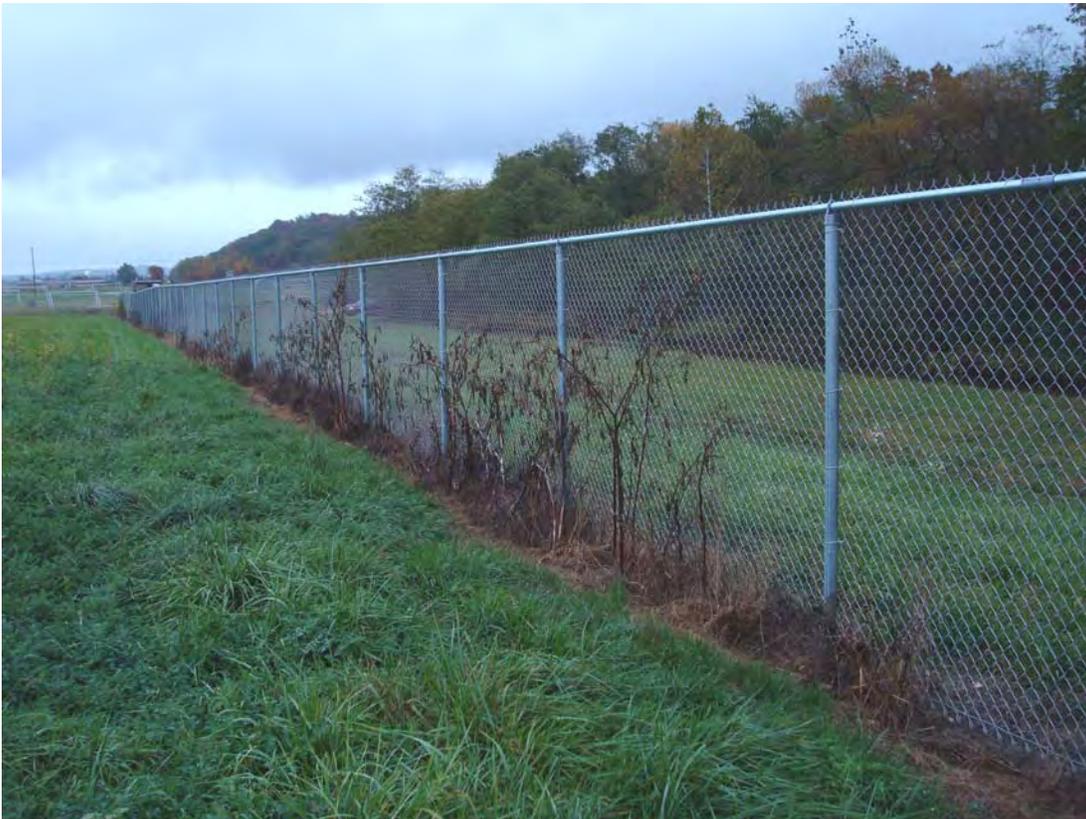
Both the entrance gate and security fence were replaced in 2007 and are in excellent condition. Vegetation management efforts are successful in keeping woody vegetation off the fence. Spraying along the fence line is taking place and is effective (PL-2).

PKB 10/2008. PL-2. Southeast fence line.

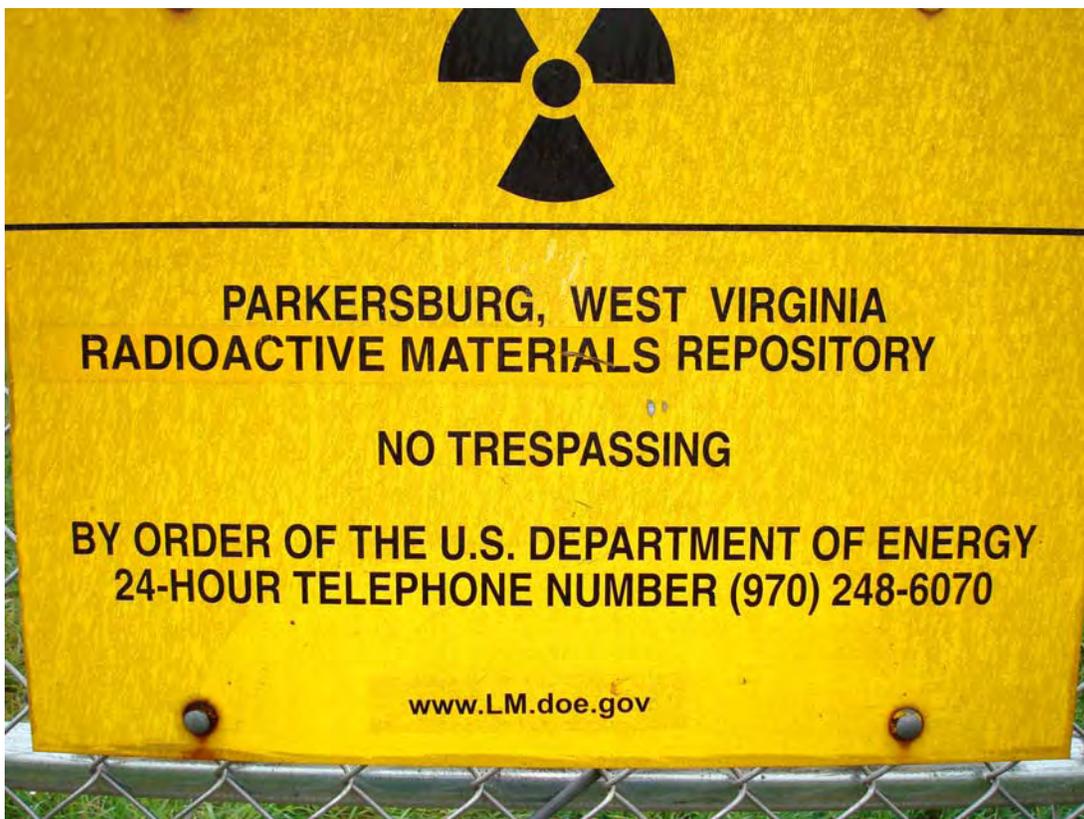
The entrance sign is in good condition. Website information was added to the entrance sign, and other key perimeter signs located close to access gates during this years inspection (PL-3).

PKB 10/2008. PL-3. Website information added to perimeter signs nearest the gates.

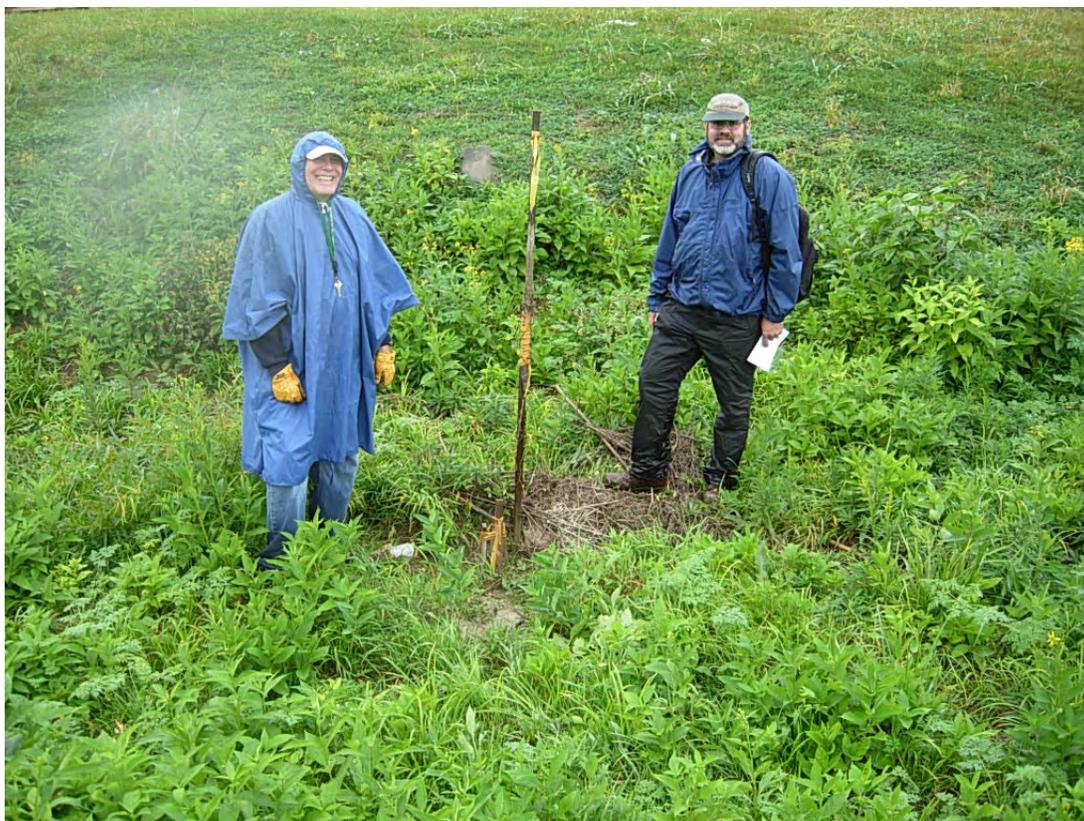
Five of the six boundary monuments were located during the inspection and were in good condition. Boundary monument BM-4 is located in the bottom of a drainage ditch that parallels the western property boundary. It is buried under approximately a foot of silt but its location is well marked with a steel post making it fairly easy to find (PL-4). The decision has been made not to spend resources raising this boundary monument unless locating it becomes a problem in the future.

PKB 10/2008. PL-4. Boundary monument BM-4.

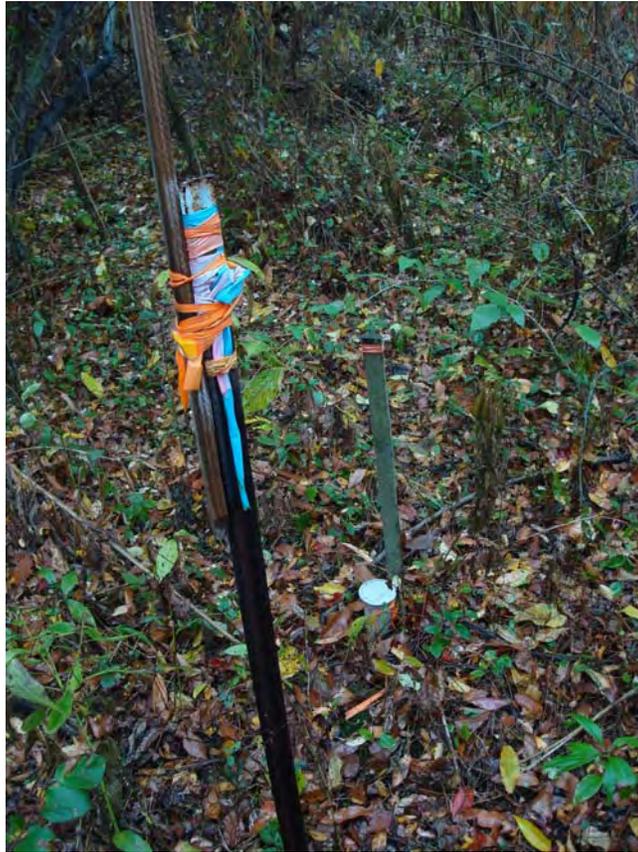
Boundary monuments BM-5 and BM-6 are both located in wooded areas. Previous inspectors have flagged adjacent trees and put measurements from fence posts on the inspection drawings to aid in locating these monuments (PL-5). It is helpful to carry a 100-foot measuring tape to facilitate locating these boundary monuments.

PKB 10/2008. PL-5. Boundary monument BM-5.

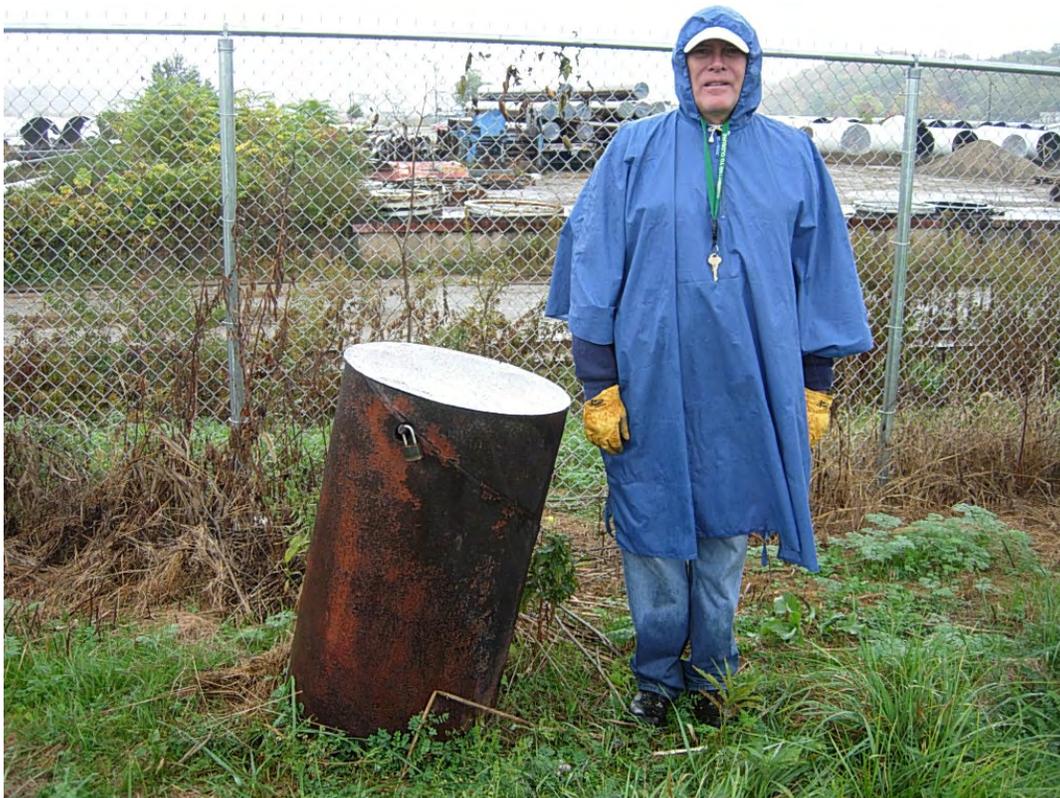
The protective casings of all 6 groundwater monitor wells are rusted but serviceable. Several of the protective casings are leaning and need to be straightened (PL-6). Although some protective casings are leaning, they are not leaning enough yet to impact the riser of the monitor well inside the protective casing (PL-7). Several of the monitor wells also still contain old, sampling equipment that is no longer serviceable (PL-7, PL-8, and PL-9). The bollard at monitor well 6 needs to be repaired (PL-10). It is recommended that old sampling equipment be removed from the wells, that leaning protective casings be straightened, painted, and properly labeled with the well number on the outside surface. It is also recommended that the bollard located at well 6 be repaired. This work is not considered to be urgent.

2. Several protective well casings are leaning and need to be straightened (PL-6). Although some protective casings are leaning, they are not leaning enough yet to impact the riser of the monitor well (PL-7). Several of the monitor wells still contain old sampling equipment that is no longer serviceable (PL-7, PL-8, and PL-9). The bollard located at monitor well 6 needs to be repaired (PL-10) (page 3).

PKB 10/2008. PL-6. Monitor well 3.

**Recommendation:** It is recommended that old sampling equipment be removed from the wells, leaning protective casings be straightened, painted, and wells properly labeled with the well number on the outside surface. It is also recommended that the bollard located at well 6 be repaired. This work is not considered to be urgent.

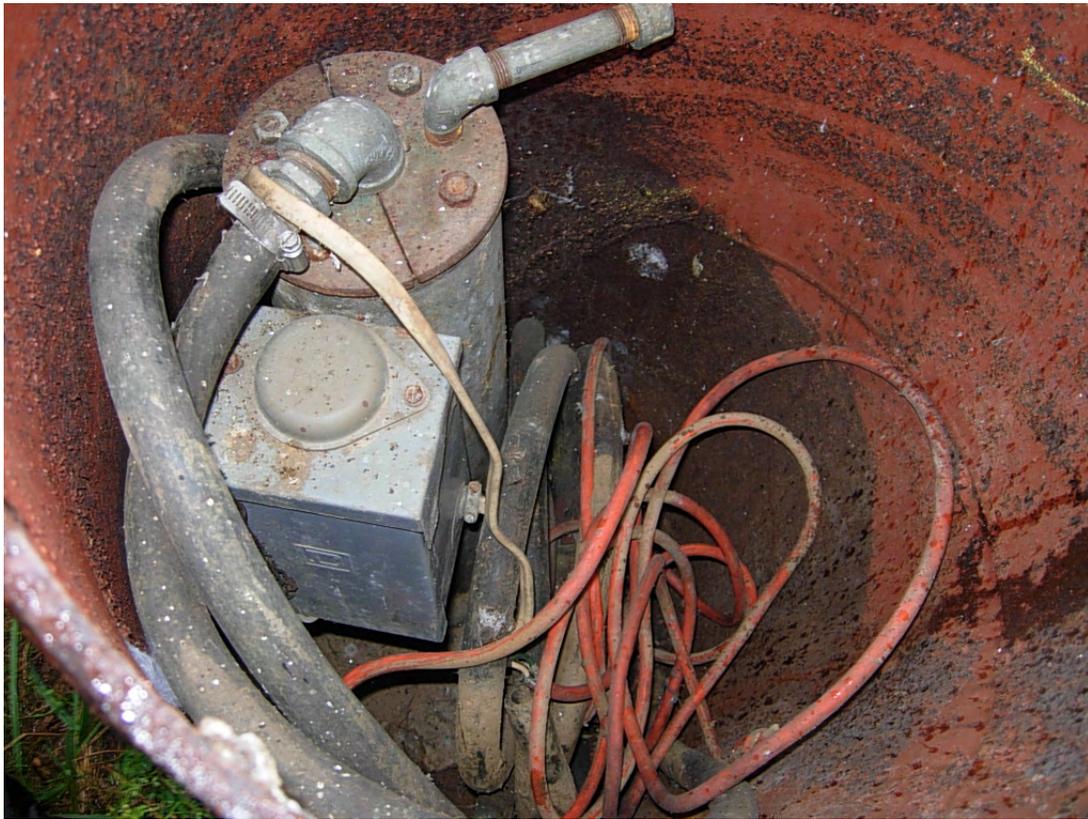
PKB 10/2008. PL-7. Inside of monitor well 3.

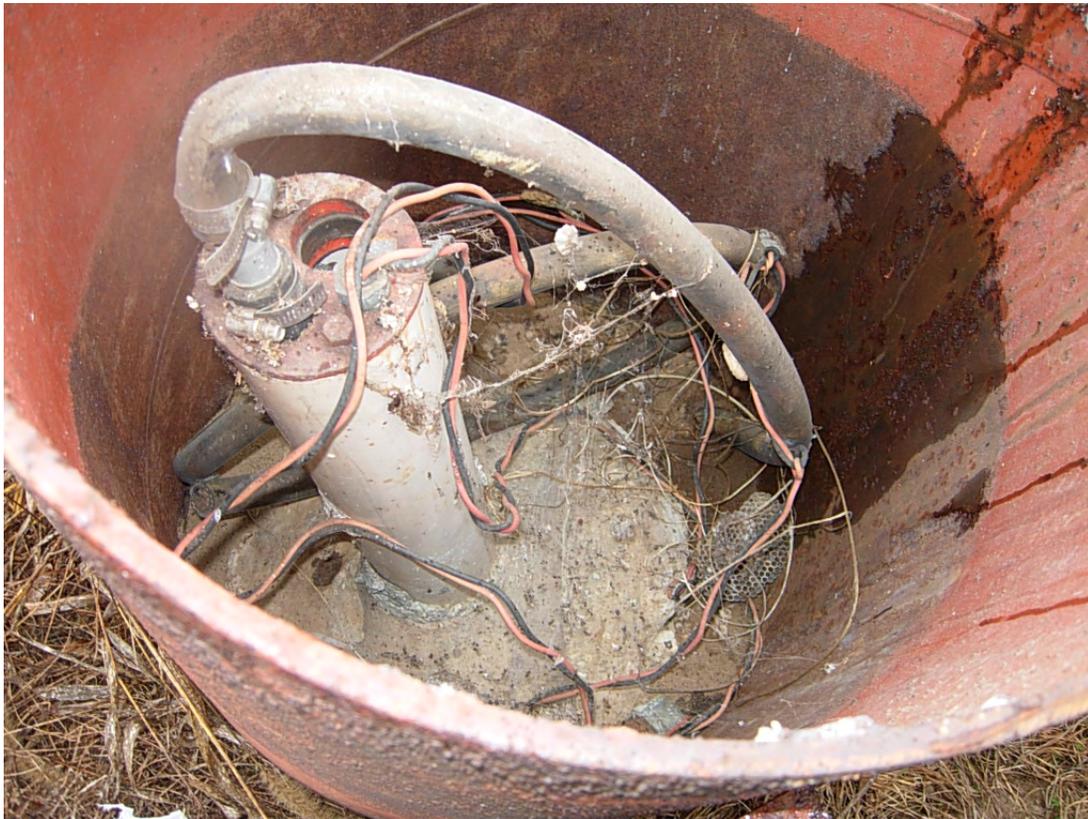
PKB 10/2008. PL-8. Inside of monitor well 2.

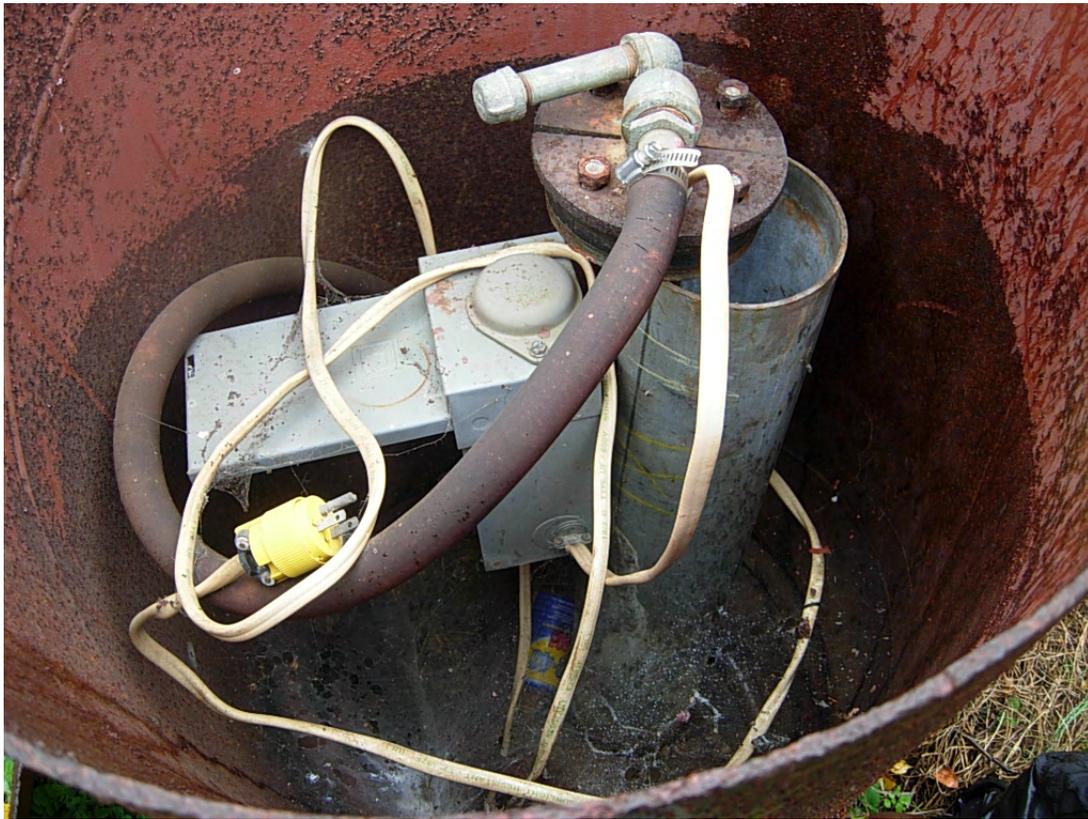
PKB 10/2008. PL-9. Inside of monitor well 4.

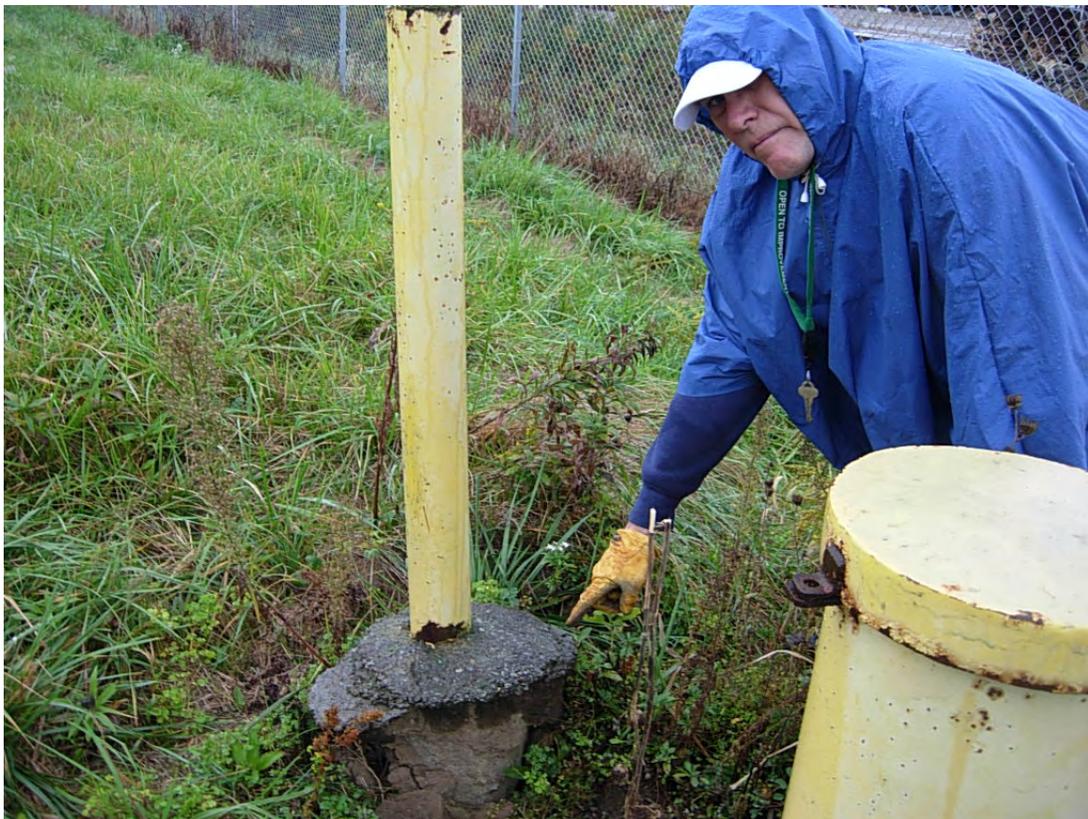
PKB 10/2008. PL-10. Loose bollard at monitor well 6.

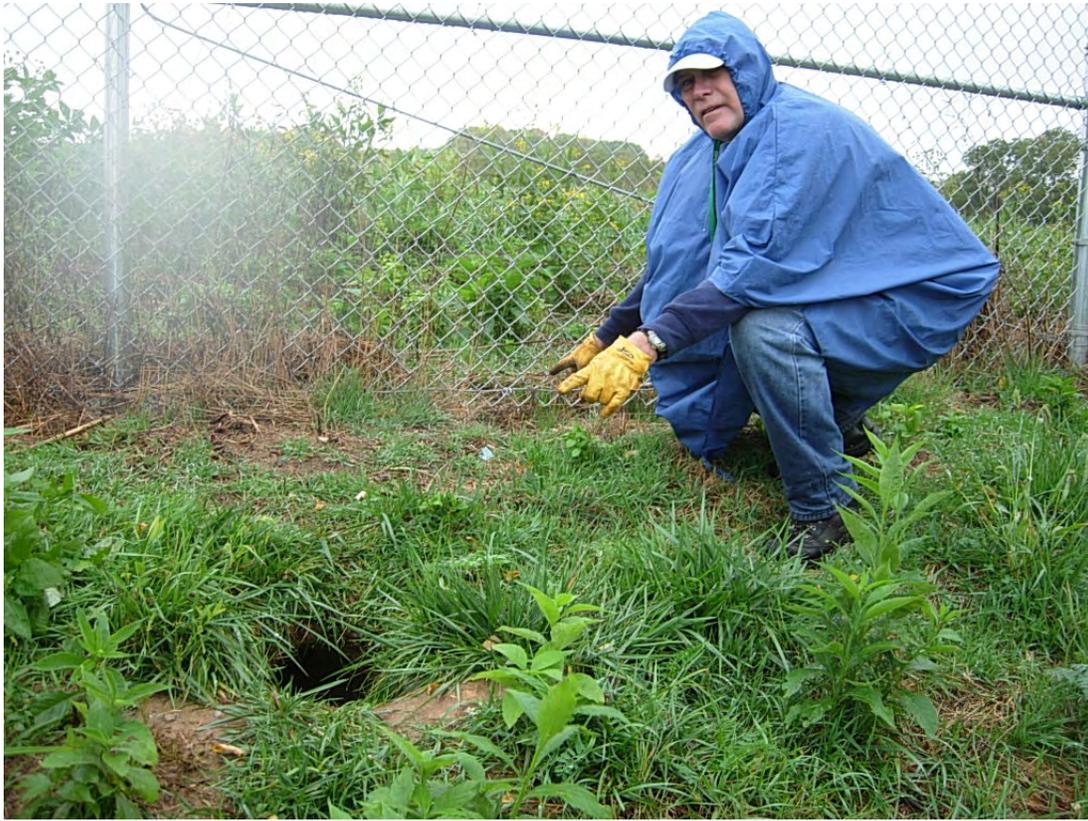
An animal burrow was discovered which appears to go beneath the west fence (PL-11). The location of this burrow is identified on page 1 of the site inspection map. The burrow does not pose a threat to the disposal cell, and does not need to be filled in at this time.

PKB 10/2008. PL-11. Animal burrow under fence.

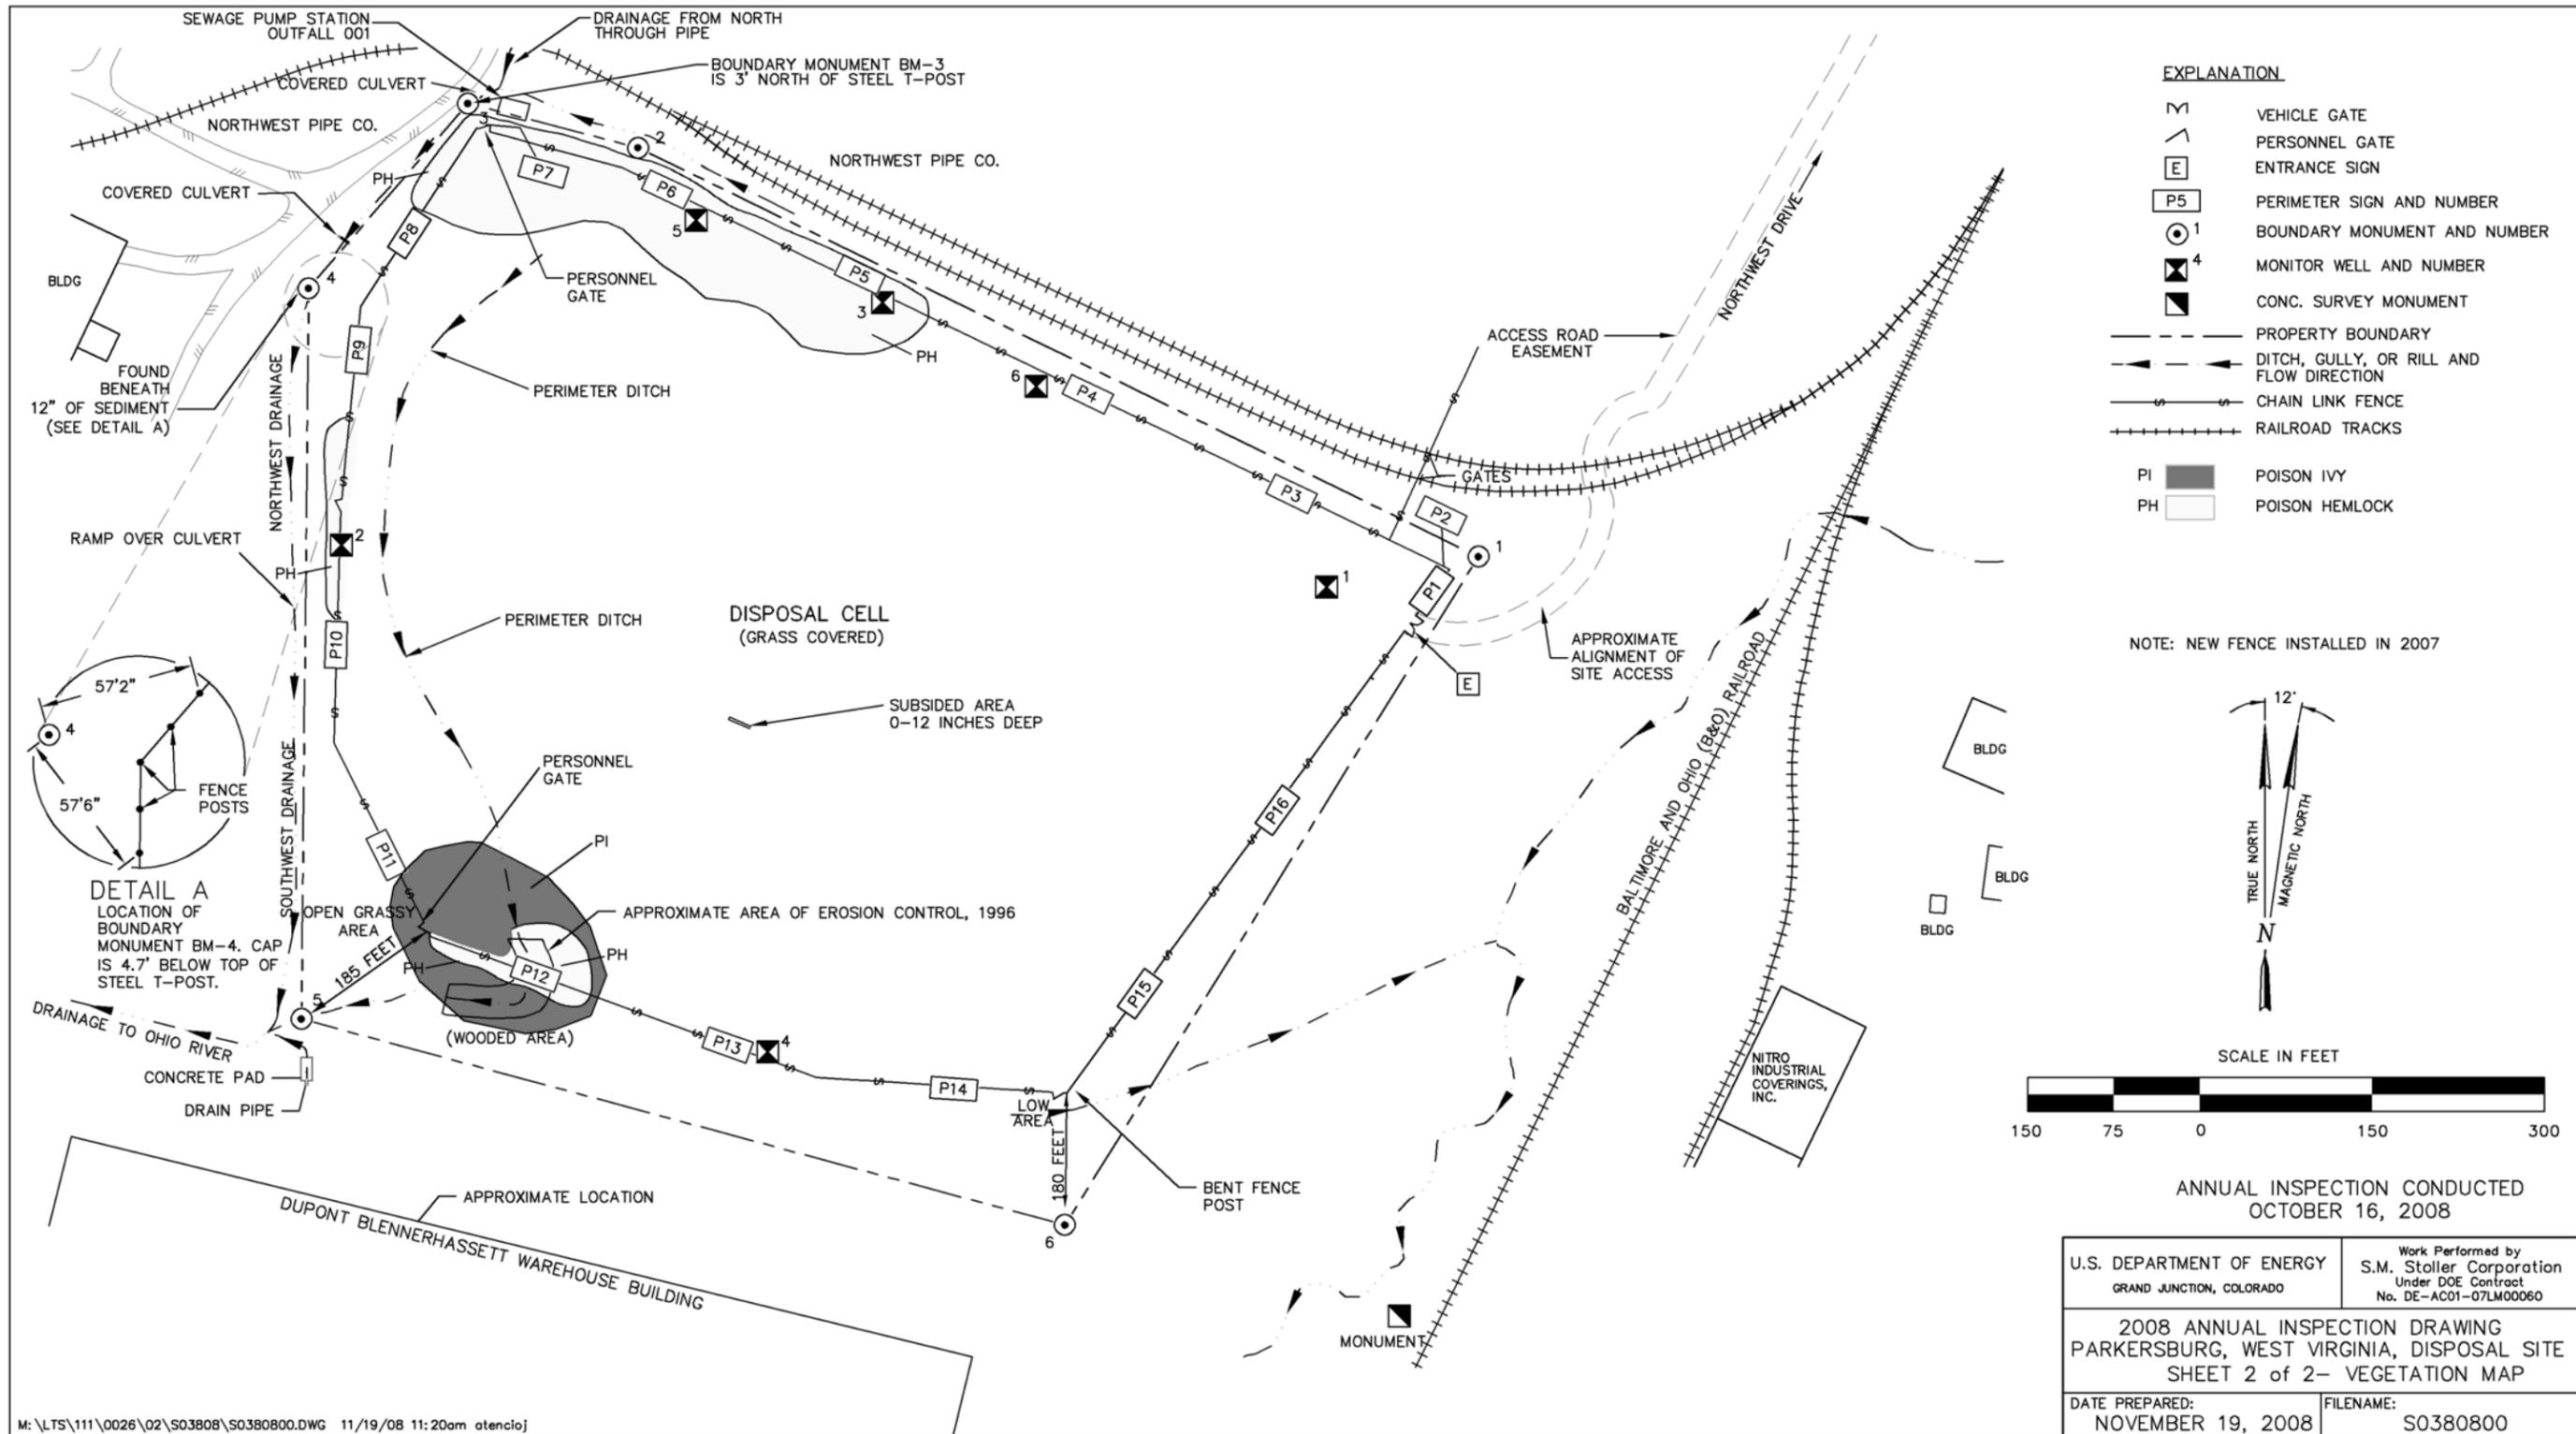
U.S. DEPARTMENT OF ENERGY GRAND JUNCTION, COLORADO	Work Performed by S.M. Stoller Corporation Under DOE Contract No. DE-AC01-07LM00060
2008 ANNUAL INSPECTION DRAWING PARKERSBURG, WEST VIRGINIA, DISPOSAL SITE SHEET 2 of 2- VEGETATION MAP	
DATE PREPARED: NOVEMBER 19, 2008	FILENAME: S0380800

Poison ivy was noticed this year in the southwest corner of the site near the erosion control area. The area is identified on page 2 of the site inspection map.
