2009 Annual Inspection for the Parkersburg, West Virginia, Nuclear Waste Policy Act Section 151(c) Disposal Site

U.S. DEPARTMENT OF ENERGY GRAND JUNCTION, COLORADO	Work Performed by S.M. Stoller Corporation Under DOE Contract No. DE-AC01-07LM00060
2009 ANNUAL INSPECTION DRAWING PARKERSBURG, WEST VIRGINIA, DISPOSAL SITE SHEET 1 of 2- PHYSICAL FEATURES	
DATE PREPARED: NOVEMBER 17, 2009	FILENAME: S0497800

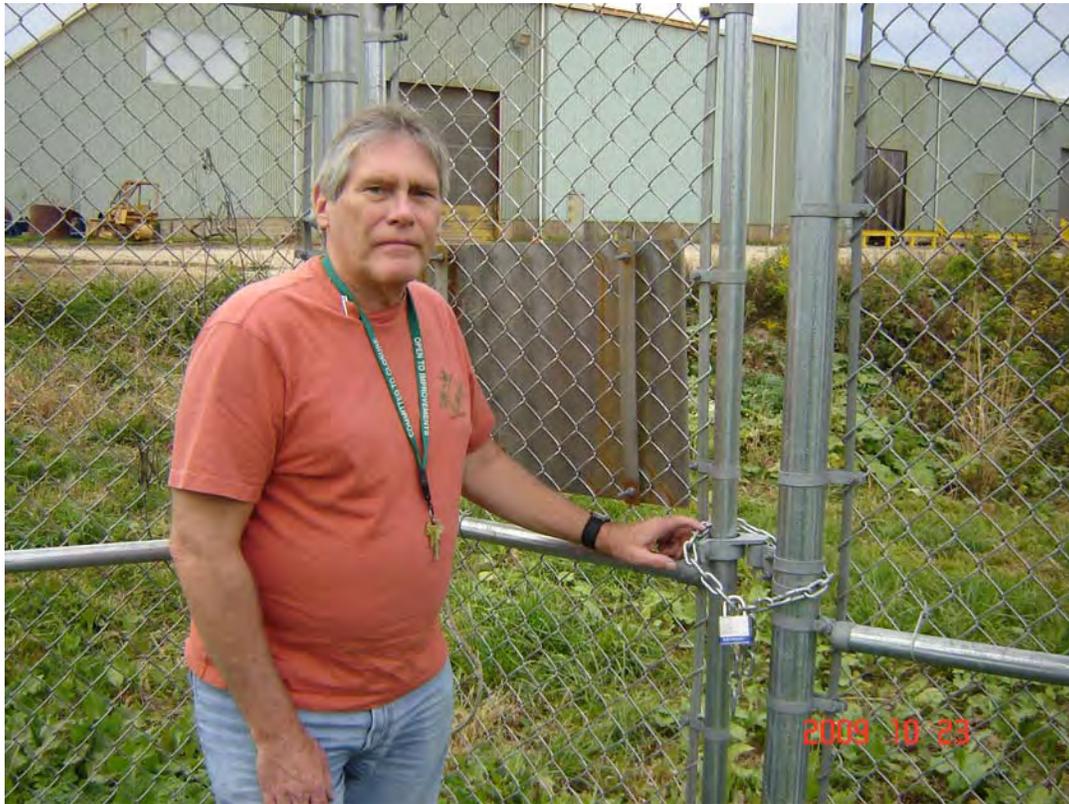
Both the entrance gate and security fence were replaced in 2007 and are in excellent condition. It was noted during the inspection that a bolt had been removed from the gate latch in the southwest corner of the site compromising the security of the gate. Inspectors installed a chain to re-secure the gate. A chain was also added to the other personnel gate located in the northwest corner of the site (PL-1). It is recommended that better latch mechanisms be installed at the two personnel gates.

PKB 10/2009. PL-1. Chain placed on personnel gate in northwest corner of the site.

Recommendation: It is recommended that better latch mechanisms be installed at the two personnel gates at the site.

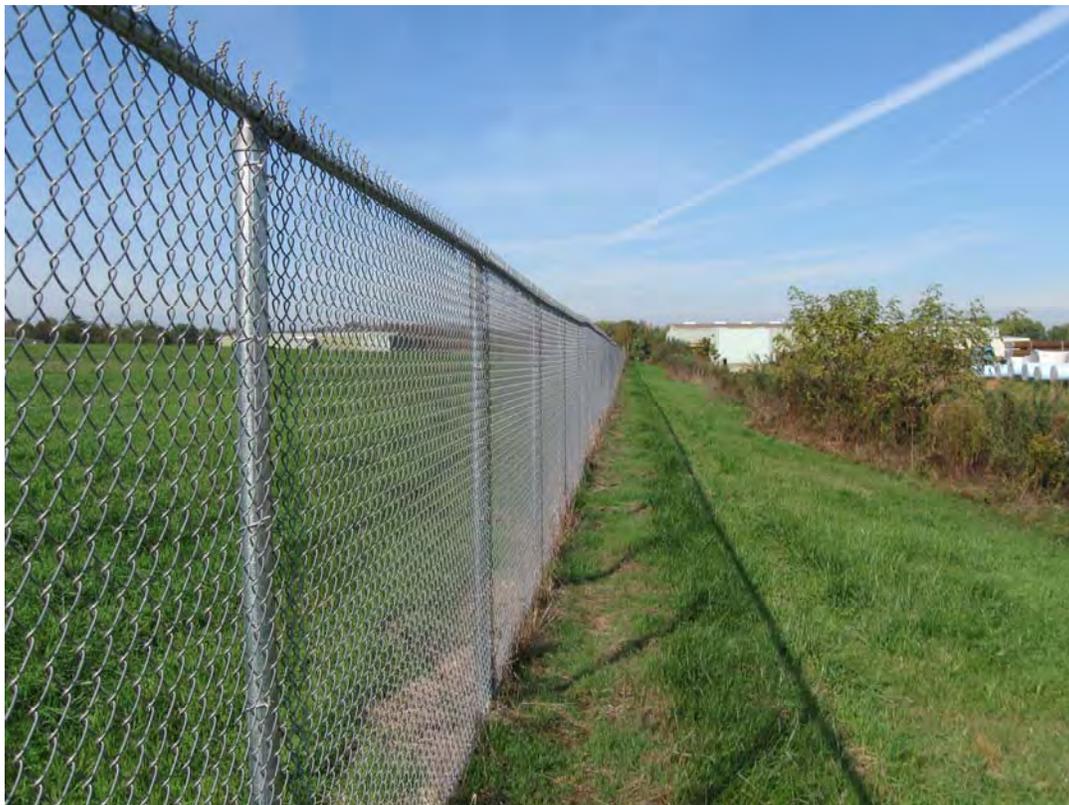
Vegetation management efforts are working to keep woody vegetation off the perimeter fence. Spraying along the fence line is taking place and is effective (PL-2). A large patch of poison hemlock is present along the fence in the northwest corner of the site, near boundary monument BM-3 (PL-3 and PL-4). It is recommended that spray/mow efforts be increased in this area in 2010 to address the poison hemlock.

PKB 10/2009. PL-2. View down the outside of the northeast fence line.

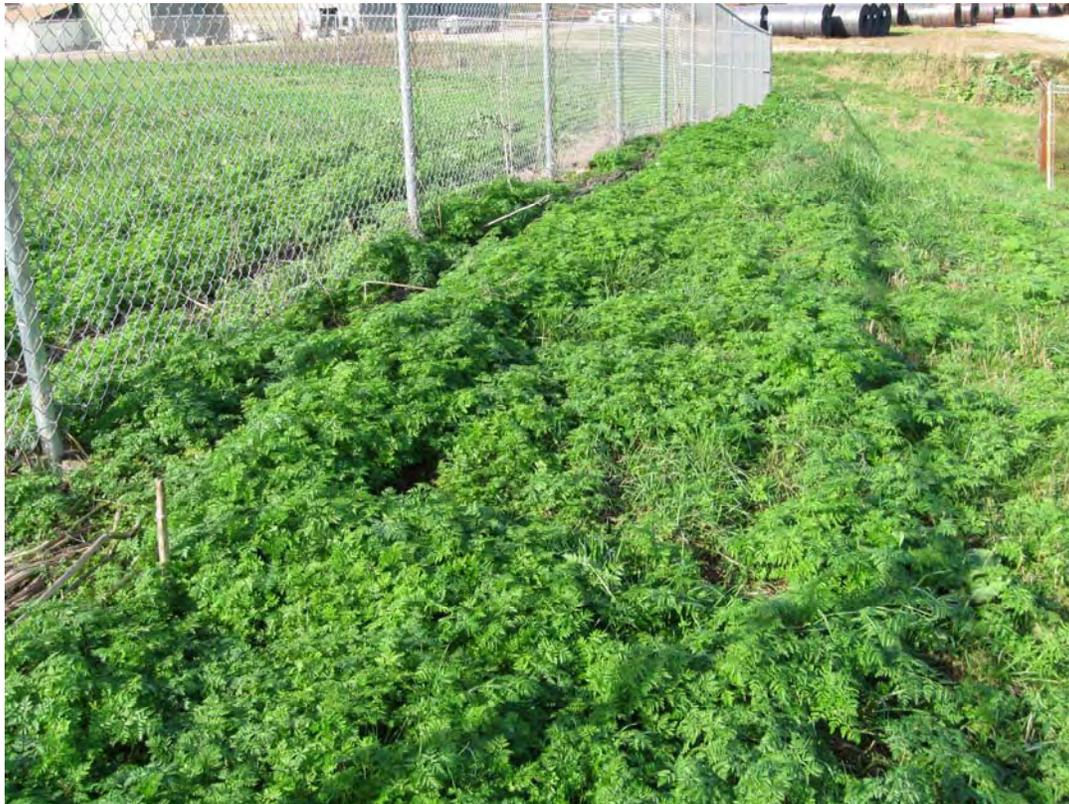
PKB 10/2009. PL-3. Poison hemlock thriving in northwest corner of the site along the perimeter fence.

Recommendation: It is recommended that spray/mow efforts be increased in these areas in 2010 to address the poison hemlock.

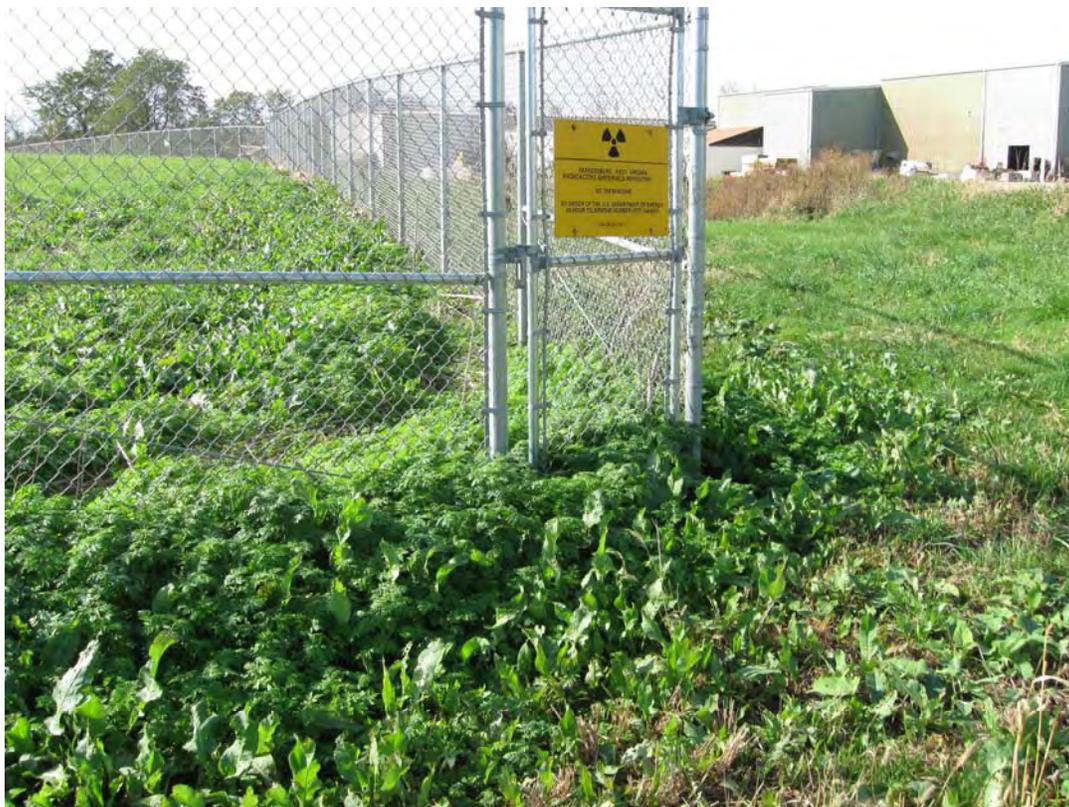
PKB 10/2009. PL-4. Poison hemlock thriving in northwest corner of the site along the perimeter fence.

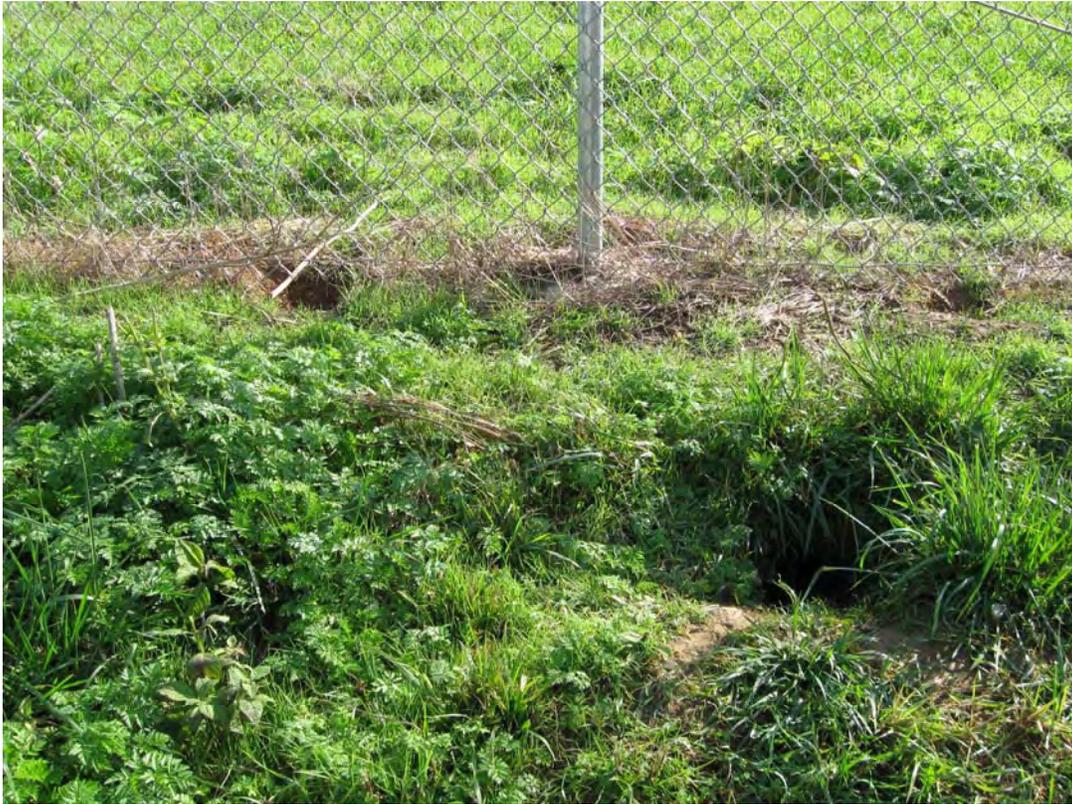
An area of several animal burrows is present under the west perimeter fence (PL-5). A couple of these burrows are quite large. Future inspectors need to be aware of trip hazards in this area.

PKB 10/2009. PL-5. Area of animal burrows outside of perimeter fence on west side of the site.

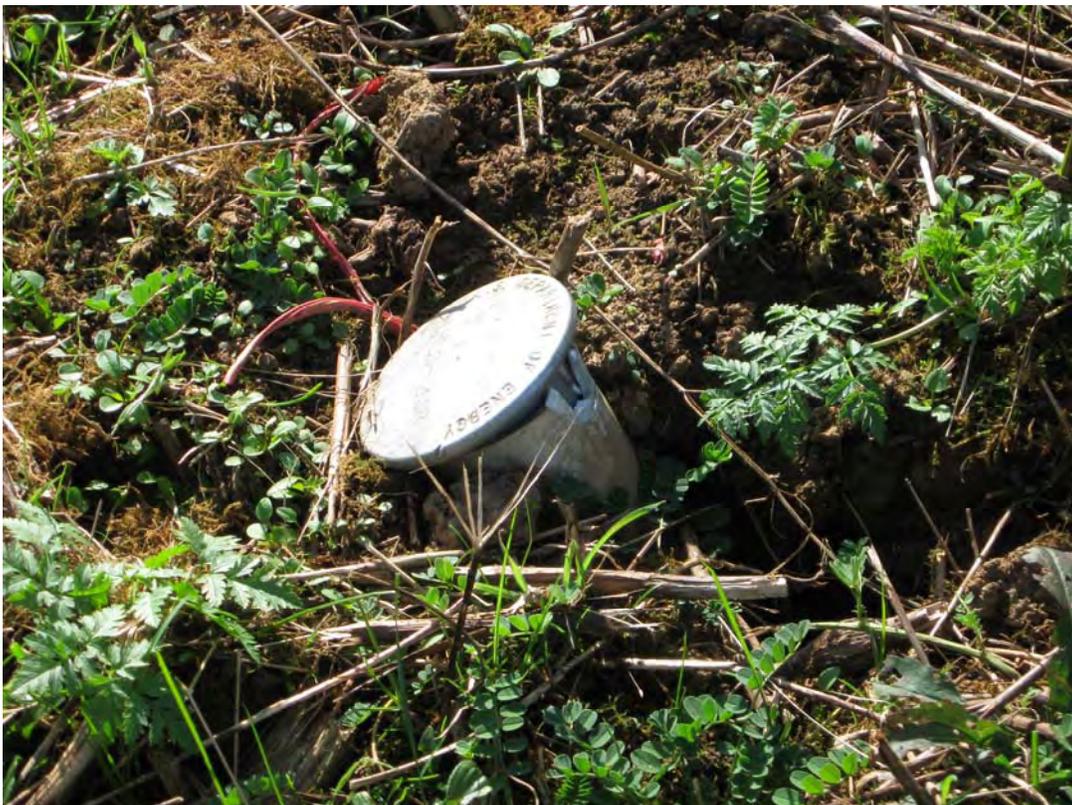
Boundary monument BM-2 is damaged and needs to be repaired (PL-6). It appears to have been hit by grounds maintenance equipment. Although a t-post was installed nearby to make the monument more visible to grounds maintenance personnel, it appears that the t-post was installed too far from the monument. It is recommended that each monument be identified with a minimum of two t-posts to make them more visible to grounds maintenance personnel.

PKB 10/2009. PL-6. Boundary monument BM-2 is damaged.

Recommendation: It is recommended that boundary monument BM-2 be repaired and that each boundary monument be identified with a minimum of two t-posts to make them more visible to grounds maintenance personnel.

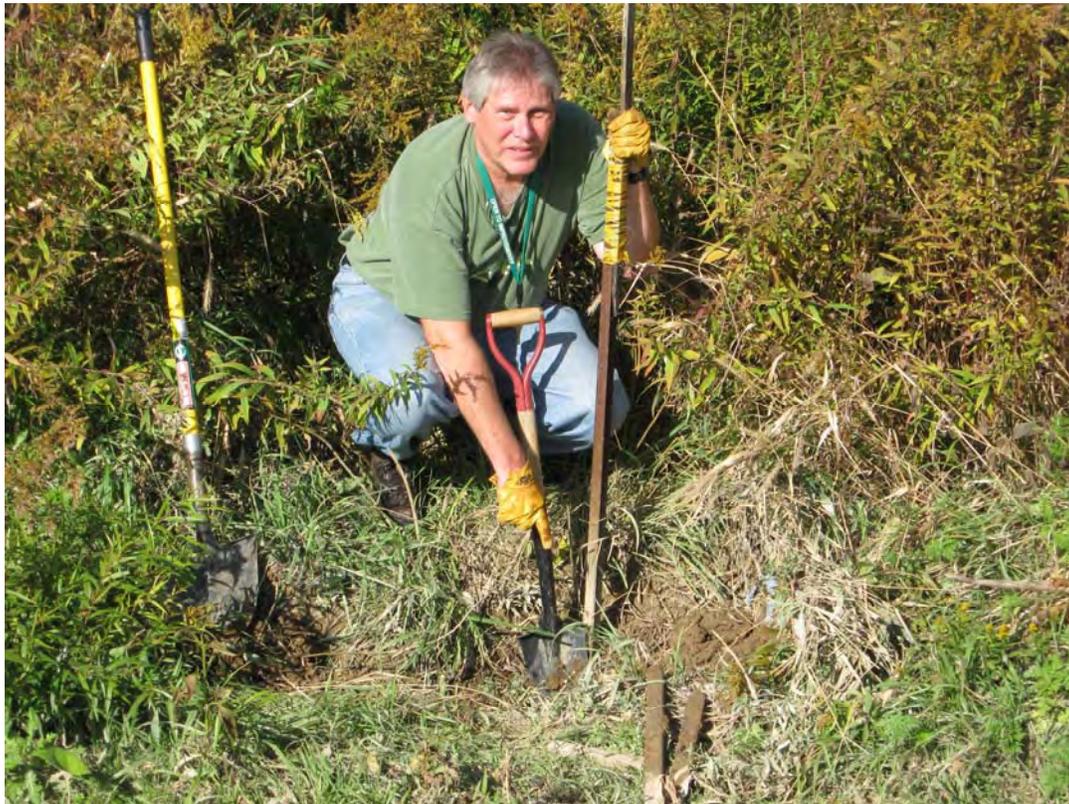
Boundary monument BM-4 is located in the bottom of a drainage ditch that parallels the western property boundary. It is buried under approximately a foot of silt but its location is well marked with a steel post making it fairly easy to find (PL-7 and PL-8). Given that BM-2 is damaged and needs to be repaired, it is recommended that BM-4 be raised at the same time to make it easier to locate in the future.

PKB 10/2009. PL-7. Location of boundary monument BM-4.

Recommendation: It is recommended that because BM-2 is damaged and needs to be repaired, that BM-4 be raised at the same time to make it easier to locate in the future.

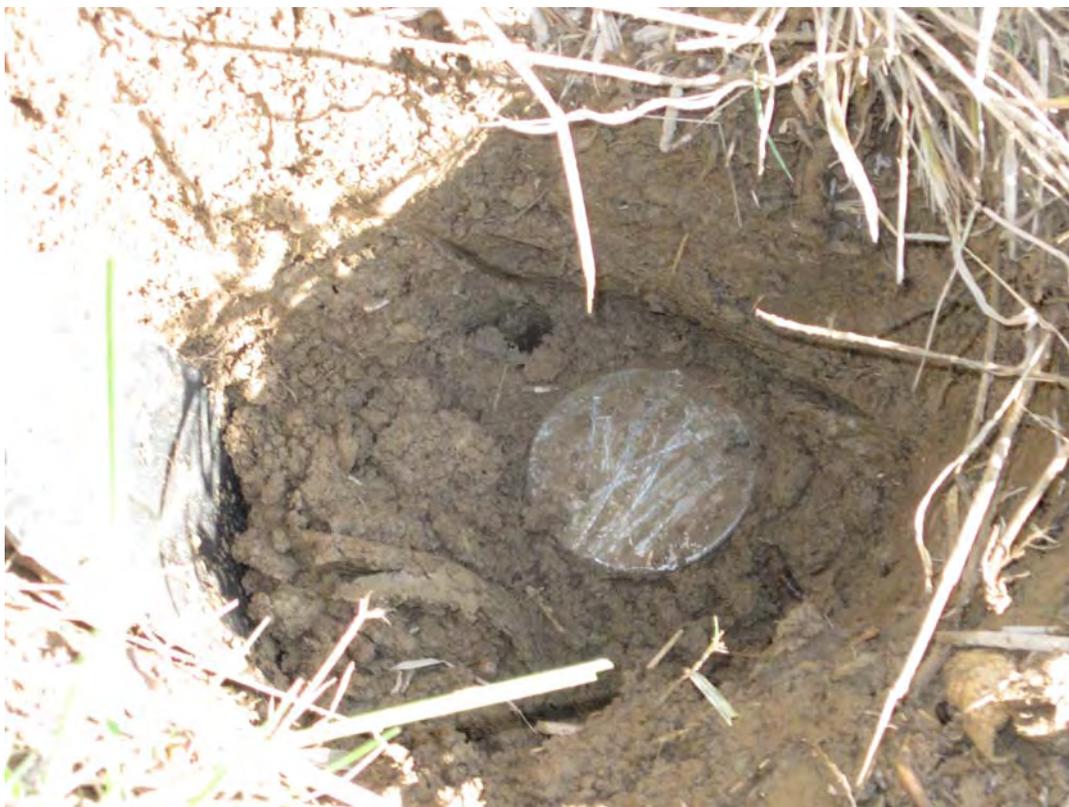
PKB 10/2009. PL-8. Boundary monument BM-4.

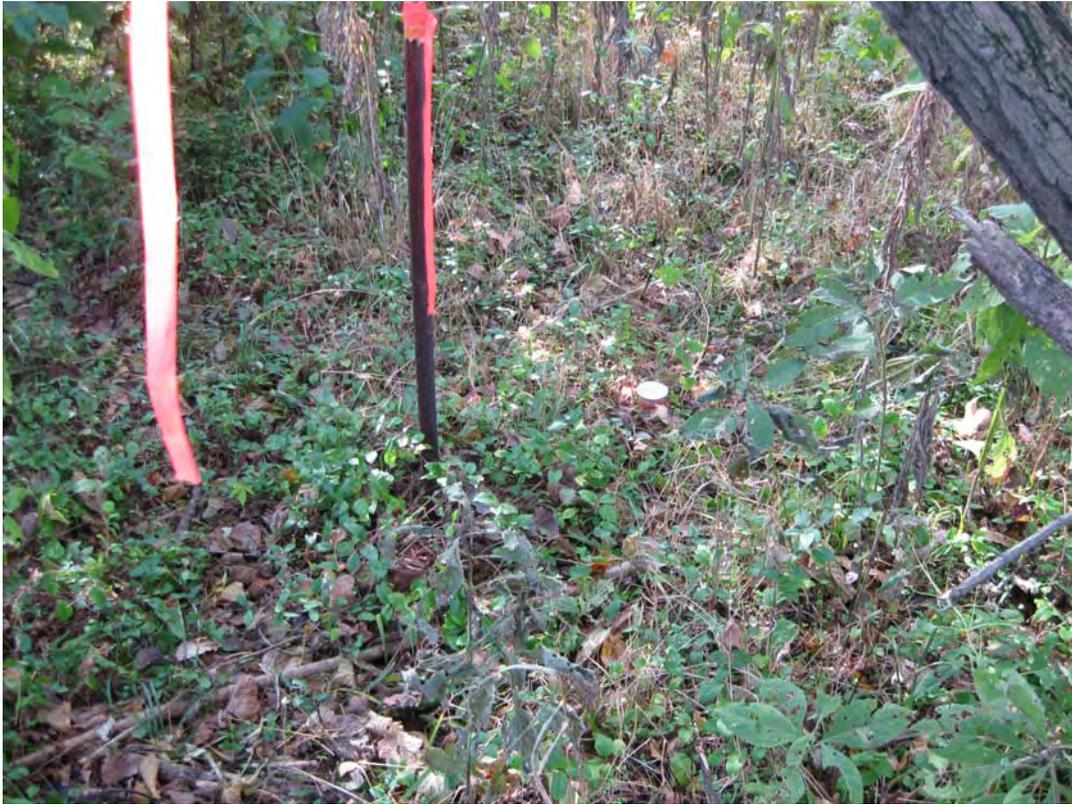
Boundary monuments BM-5 and BM-6 are both located in wooded areas (PL-9). Previous inspectors have flagged adjacent trees and put measurements from fence posts on the inspection

PKB 10/2009. PL-9. Boundary monument BM-5.
