2010 Annual Inspection for the Parkersburg, West Virginia, Nuclear Waste Policy Act Section 151(c) Disposal Site

This report presents the findings of the annual U.S. Department of Energy (DOE) inspection of the Nuclear Waste Policy Act (NWPA) Section 151(c) disposal site at Parkersburg, West Virginia. M. Miller (Chief Inspector), K. Broberg (Assistant Inspector), with S.M. Stoller Corporation, the DOE Legacy Management (LM) Contractor, conducted the inspection on October 21, 2010. C. Carpenter, DOE-LM also participated in the inspection.

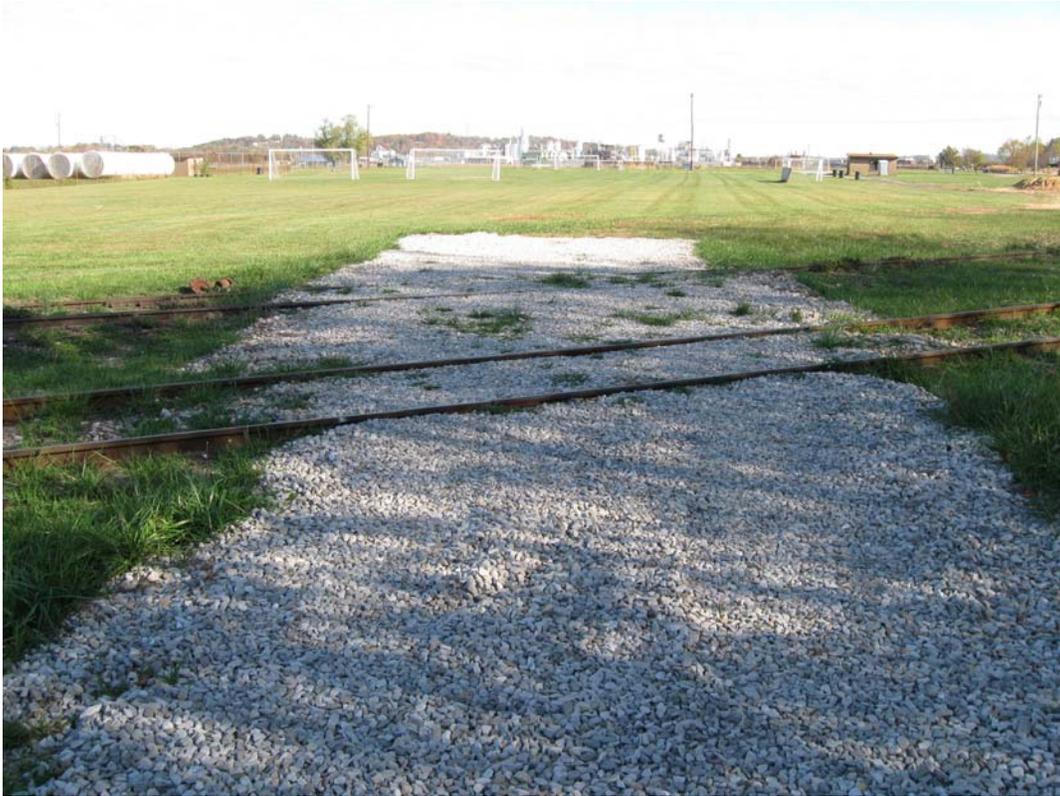
Earlier this year, low spots along the site access road, near the grade where the railroad tracks cross over the road, were filled in with gravel (PL-1, and PL-2). With placement of the gravel, the access road is now in excellent shape.

PKB 10/2010. PL-1. Fresh gravel on site access road by railroad tracks.

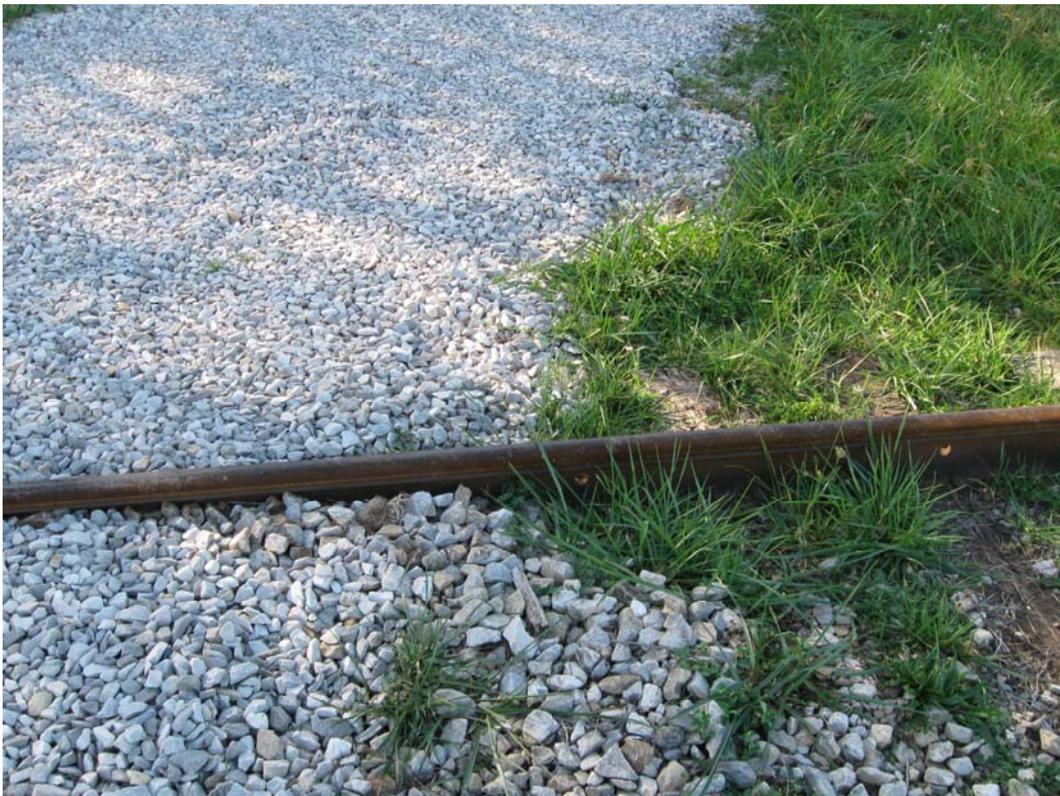
PKB 10/2010. PL-2. Fresh gravel on site access road by railroad tracks.

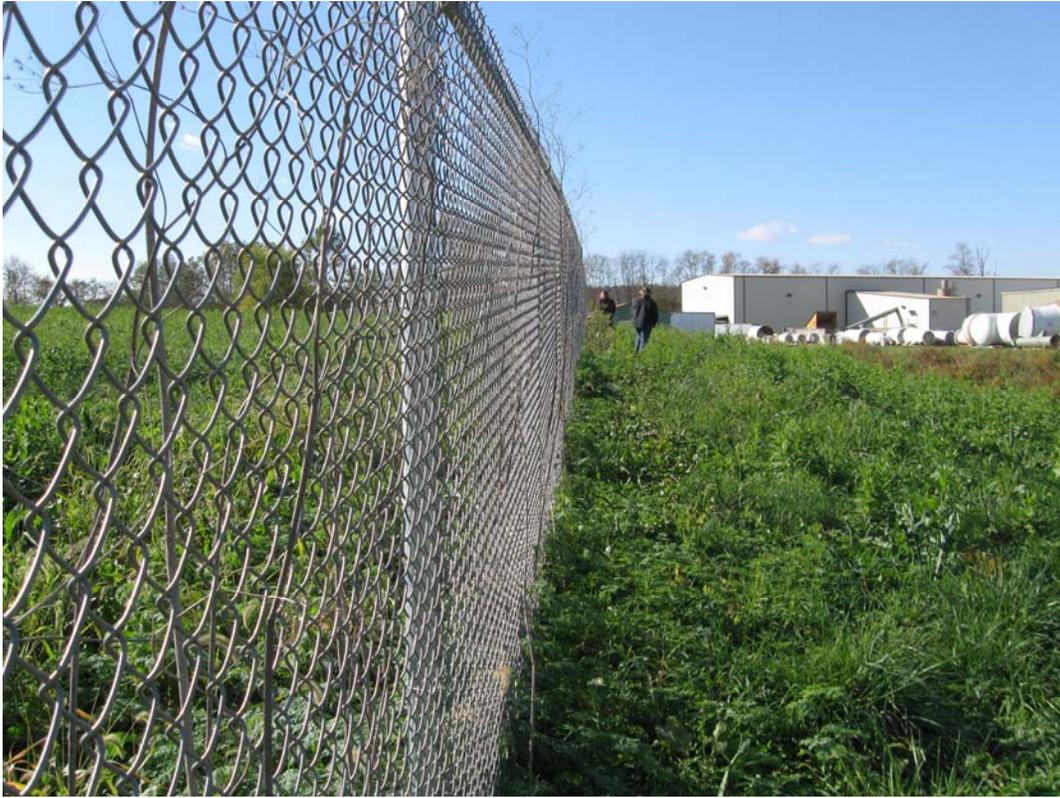
Vegetation management efforts along the fence need to be improved. A vegetation free zone needs to be maintained along the base of the fence, to keep vegetation off of the fence (PL-3). It is recommended that more effort be made to keeping a vegetation free zone along the base of the fence in the upcoming year.

PKB 10/2010. PL-3. Outside of north perimeter fence.

Recommendation: It is recommended that more effort be made to keeping a vegetation free zone along the base of the fence in the upcoming year.

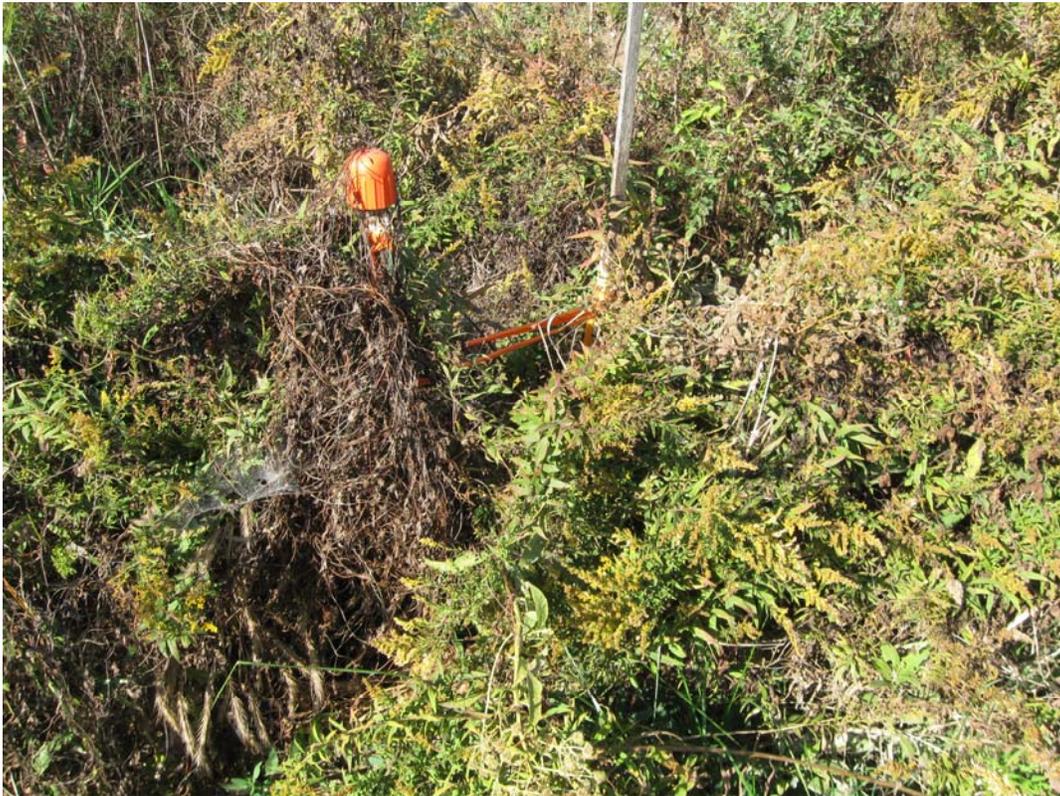
recommended that BM-4 be raised at the same time to make it easier to see in the future. Vegetation around boundary monument BM-4 has become rather dense (PL-4). It is recommended that additional attention be made to controlling vegetation around boundary monuments during the upcoming year.

PKB 10/2010. PL-4. Thick vegetation growth around boundary monument BM-4.

Recommendation: It is recommended that additional attention be made to controlling vegetation around boundary monuments during the upcoming year.

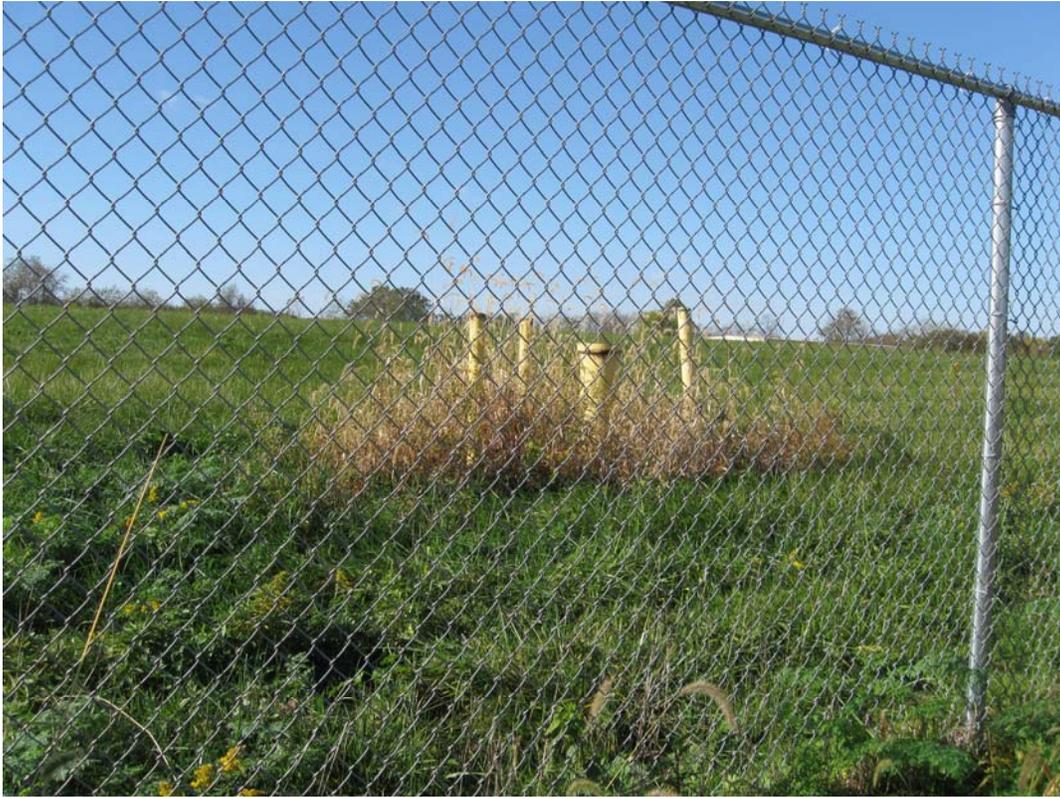
- 5) Vegetation growth around the monitoring wells was not being maintained as well as it should be (page 3).

PKB 10/2010. PL-5. Vegetation growth around monitoring well 6.

Recommendation: It is recommended that more effort be made this upcoming year to keep unwanted vegetation away for the monitoring wells.

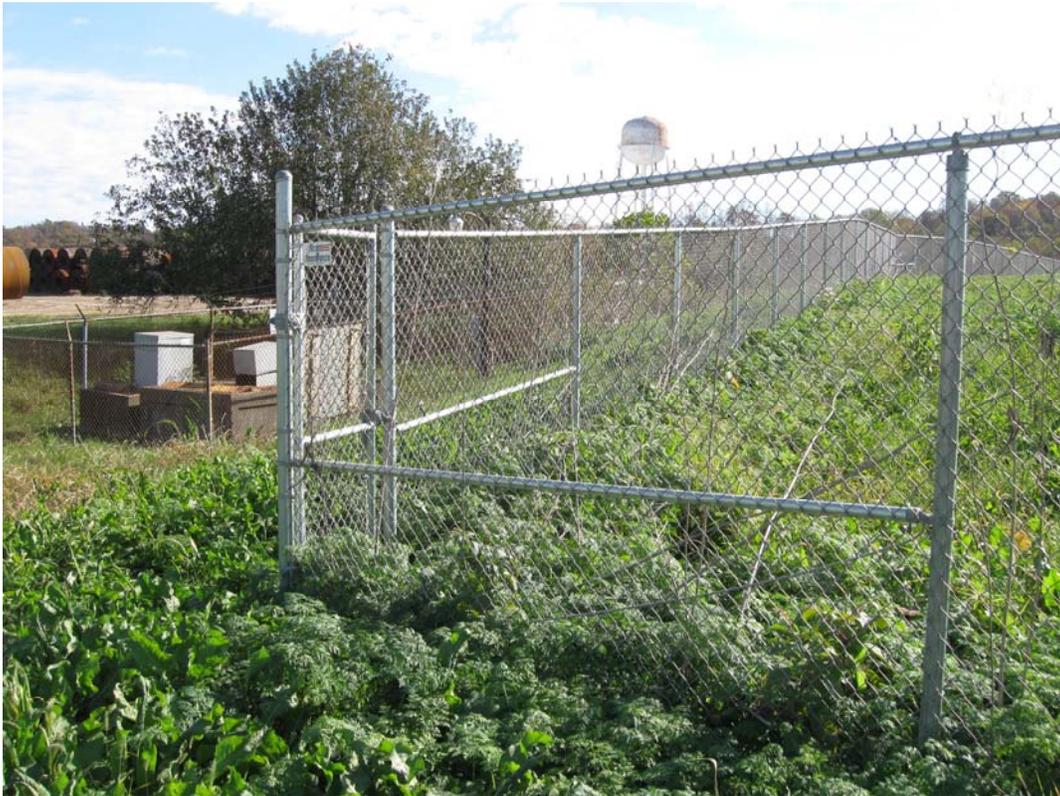
A few areas of poisonous and noxious weeds were identified during the inspection. Poison hemlock was thriving in the northwest corner of the site near the personnel gate leading to BM-3, (PL-6) and in the southwest corner of the site near the erosion control area (see sheet 2 of the inspection map) (PL-7). It is recommended that spray and mow efforts in the upcoming year continue and more attention placed on these two areas.

PKB 10/2010. PL-6. Poison hemlock growth in north corner of site near personnel gate.

Recommendation: It is recommended that spray and mow efforts in the upcoming year continue and more attention placed on these two areas.

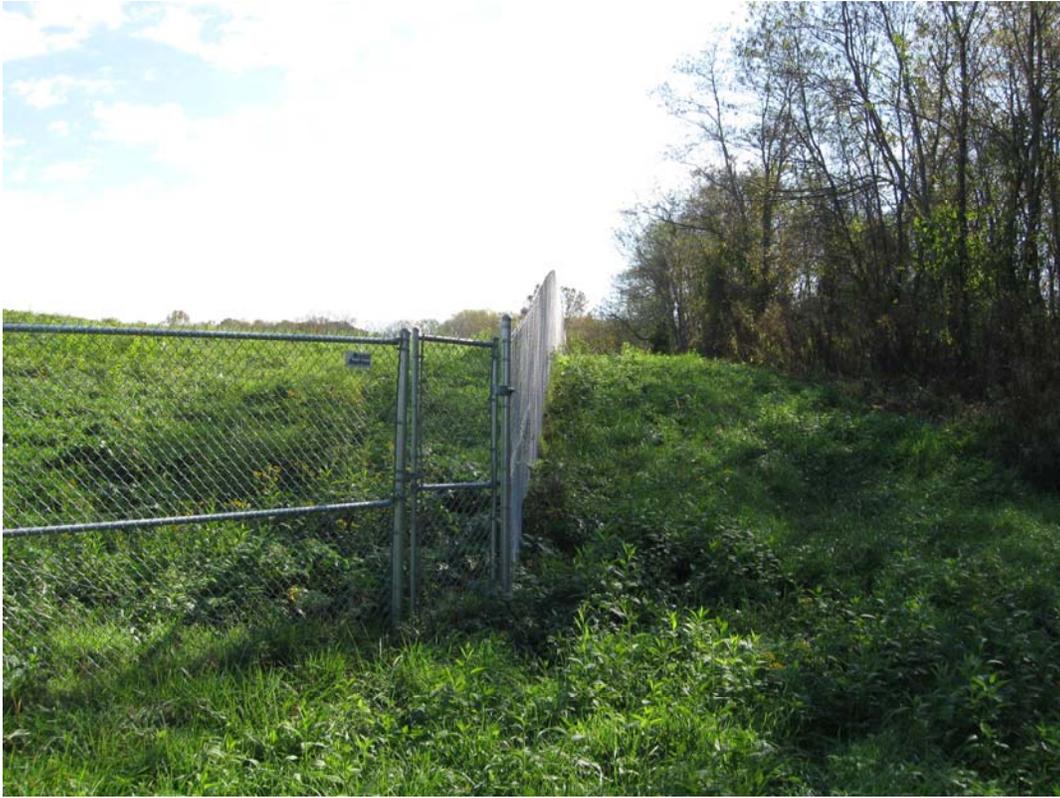
PKB 10/2010. PL-7. Southwest corner of perimeter fence, near personnel gate.

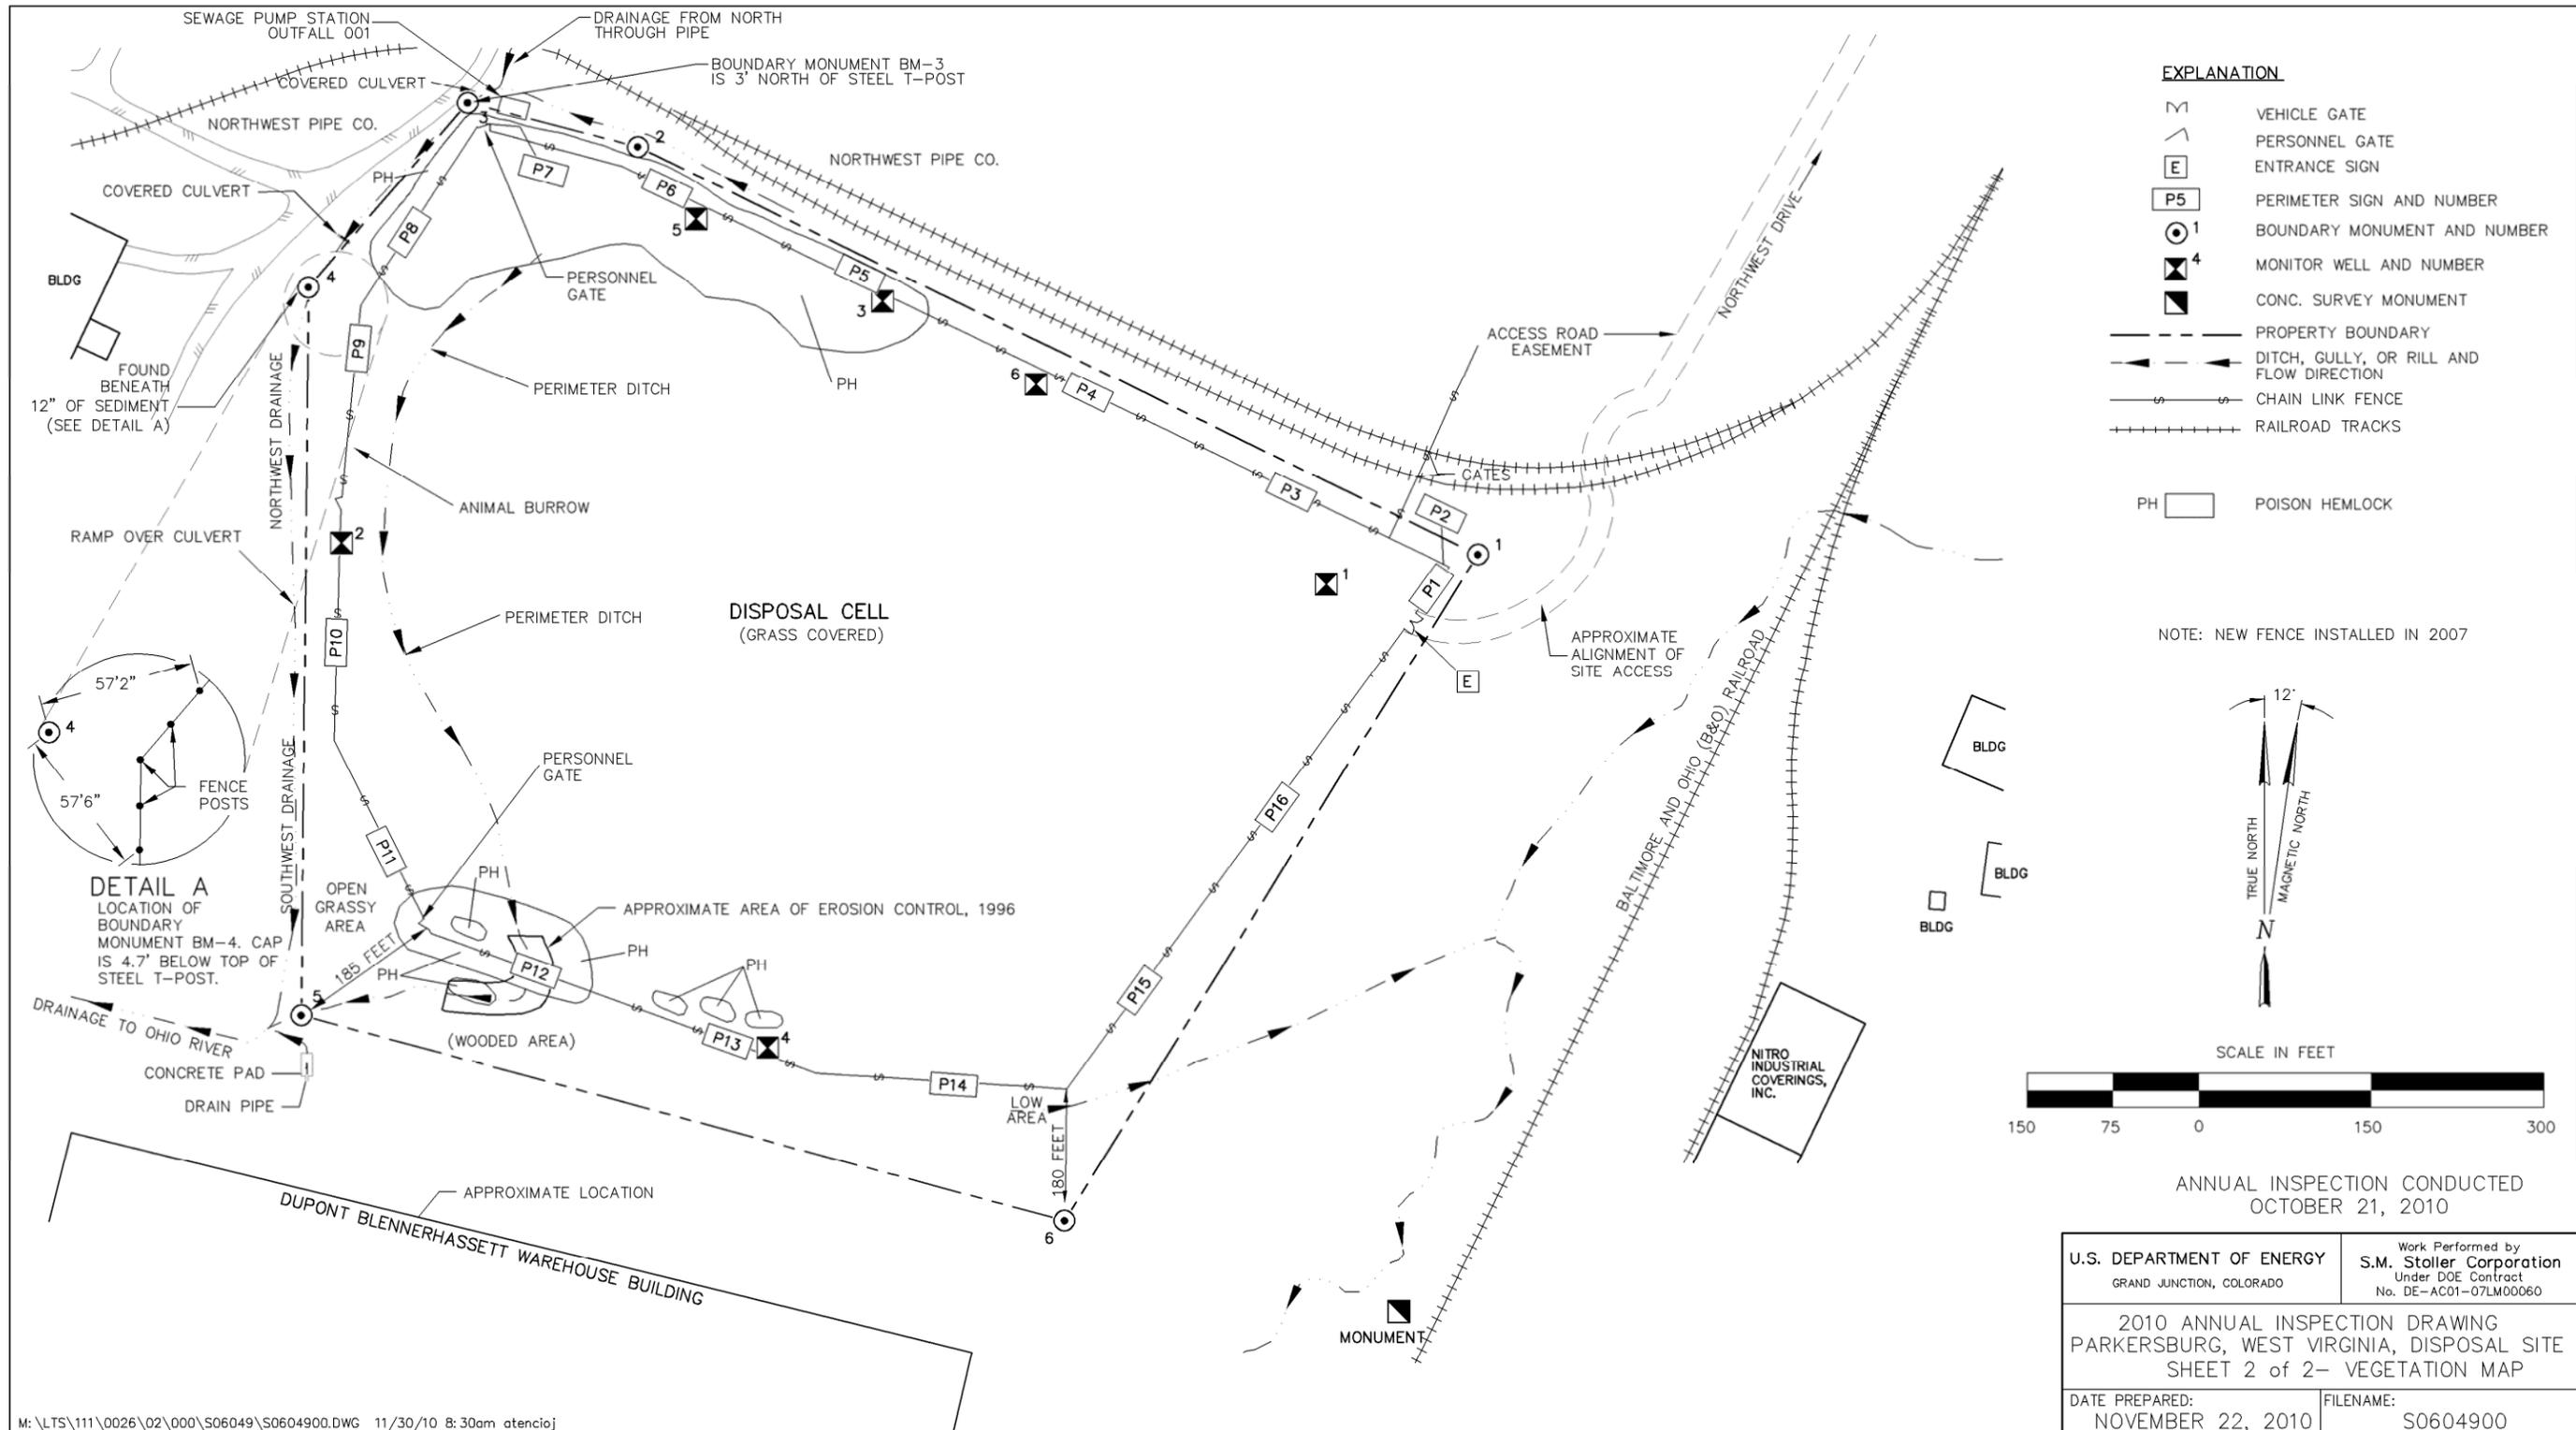
- 6) Poison hemlock was thriving in the northwest corner of the site near the personnel gate leading to BM-3, and in the southwest corner of the site near the erosion control area (see sheet 2 of the inspection map) (page 3).
