2015 Annual Inspection Report for the Parkersburg, West Virginia Disposal Site

1.0 Inspection Summary

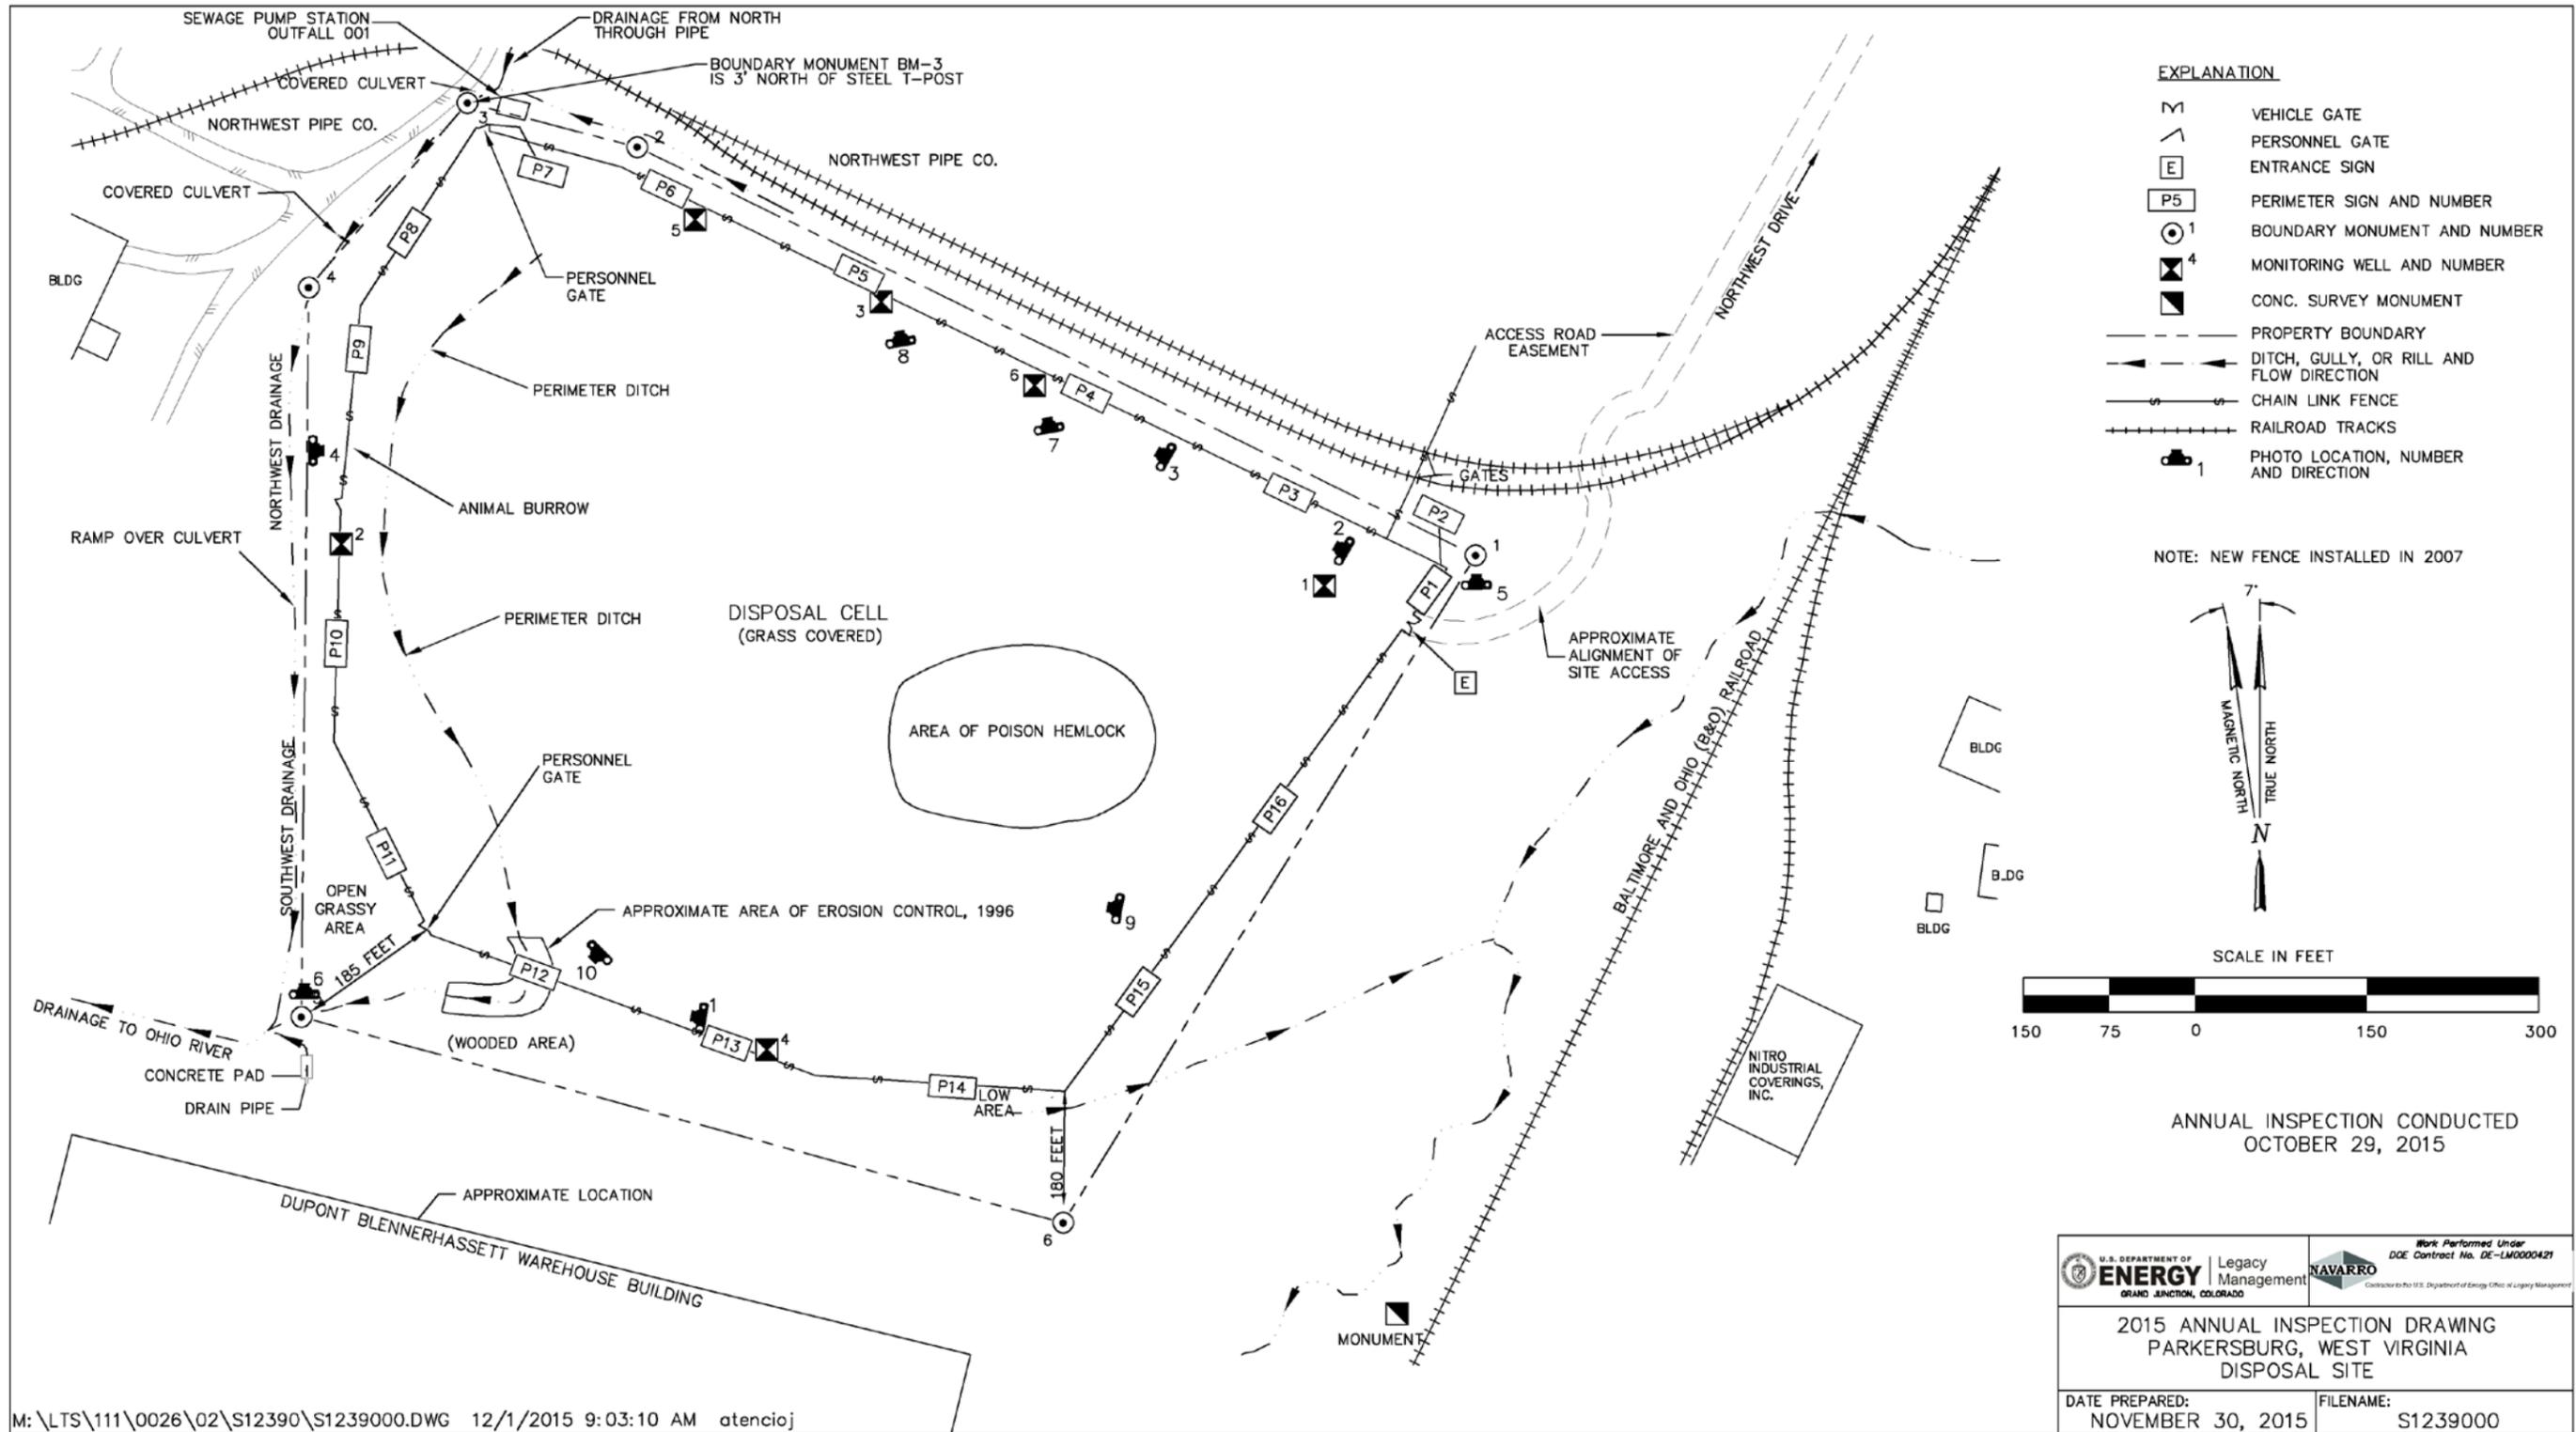
Figure 1. 2015 Annual Inspection Drawing for the Parkersburg Disposal Site

The locations of site surveillance features are shown on the attached drawing. Inspection results and recommended maintenance activities associated with site surveillance features are included in the following subsections. Photographs to support specific observations are identified in the text and on the attached drawing by photograph location (PL) number.

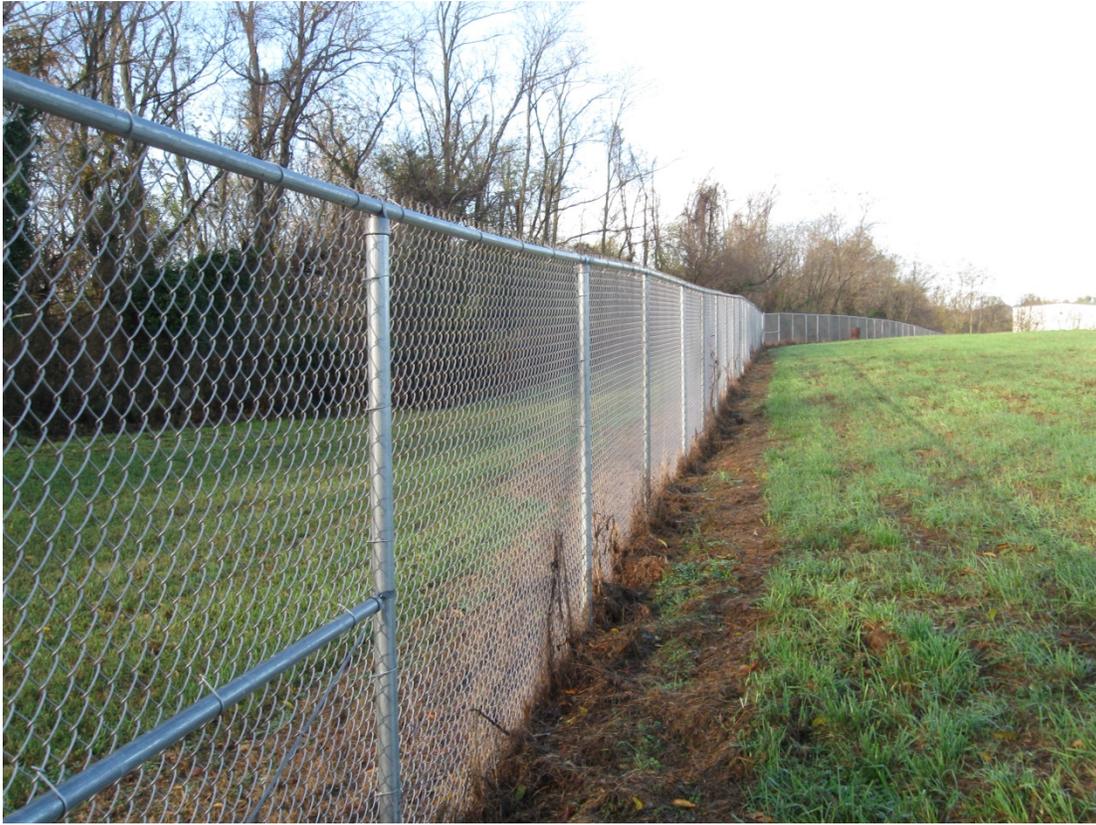
The perimeter fence was replaced in 2007 and was in excellent condition. It was noted last year during the 2014 inspection that the vegetation-free zone along the base of the fence line needed to be improved. Inspectors this year observed the zone to be much improved (PL-1, PL-2, and PL-3).

PKB 10/2015. PL-1. South fence line.

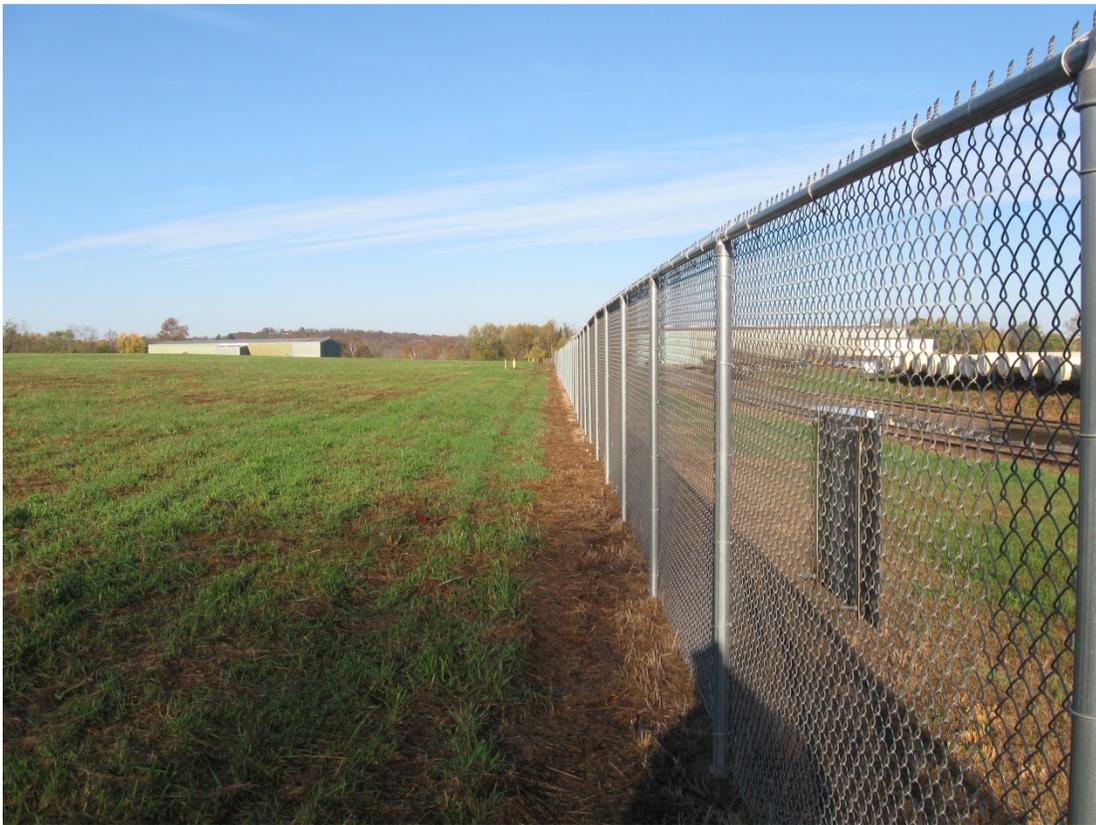
PKB 10/2015. PL-2. North fence line.

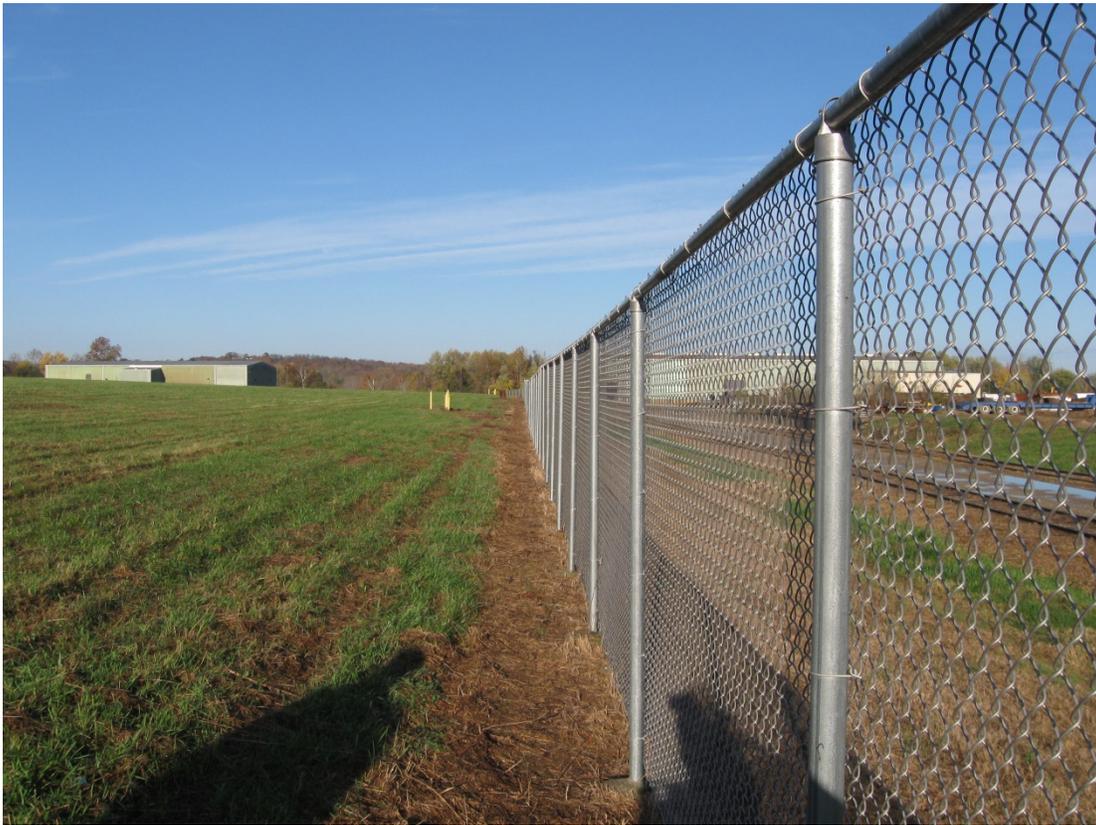
PKB 10/2015. PL-3. North fence line.

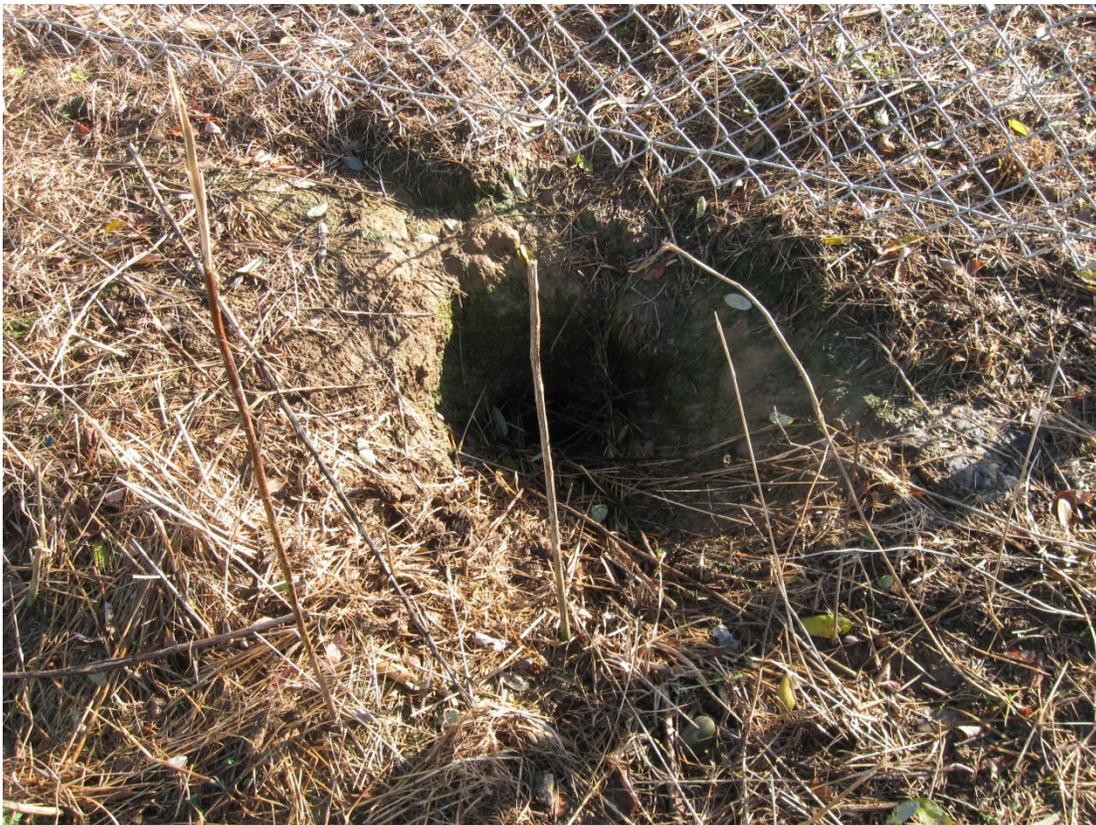
Animal burrows are present under the west perimeter fence. A couple of the burrows are quite large (PL-4). The location of the burrows is noted on the site inspection map to alert future inspectors to potential tripping hazards.

PKB 10/2015. PL-4. Animal burrows under fence.

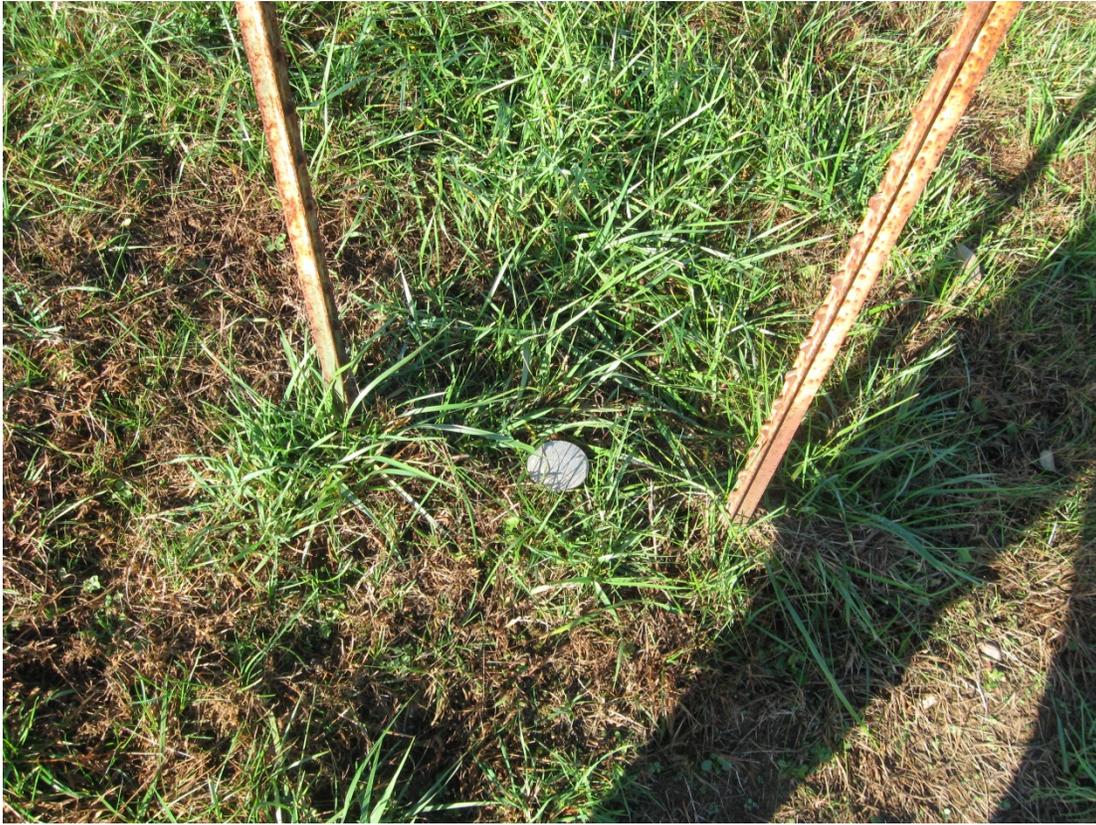
The Parkersburg site has 6 boundary monuments and one concrete survey monument. The presence of 3 of the 6 boundary monuments (Boundary Monuments 1, 2, and 5) were located during the site inspection and were in good condition (PL-5 and PL-6). Boundary Monuments 3, 4, and 6 could not be located. Efforts will be made in 2016 to locate these monuments.

PKB 10/2015. PL-5. Boundary monument BM-1.

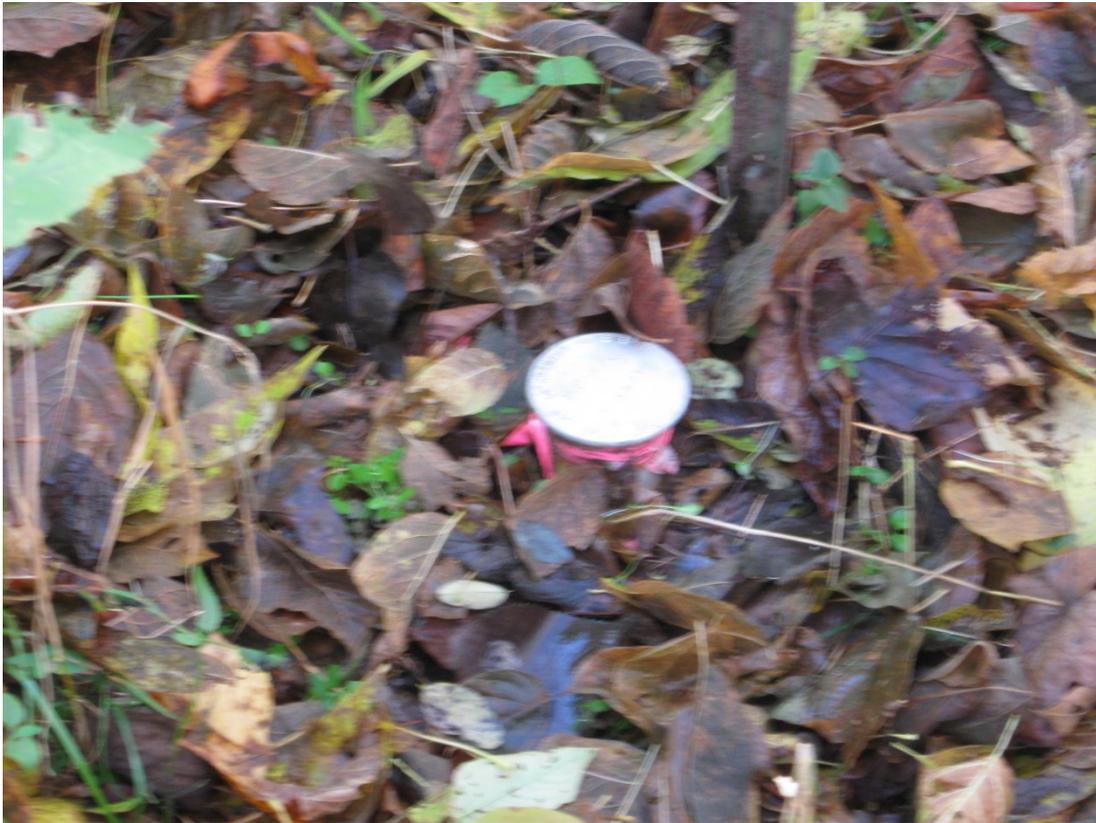
PKB 10/2015. PL-6. Boundary monument BM-5.

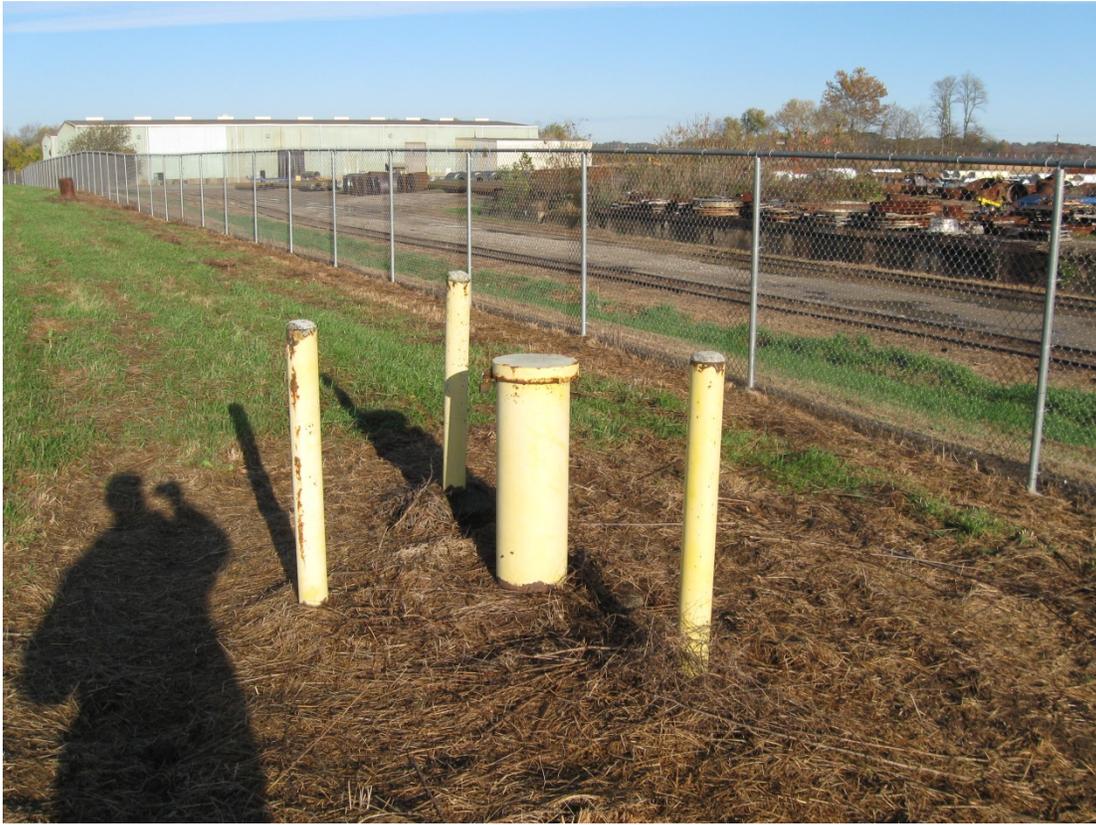
There are 6 groundwater monitoring wells at the Parkersburg site. All 6 wells are located inside the security fence. The wells are numbered in the chronological order in which they were drilled and installed. All 6 wells were properly locked. During the 2014 inspection it was noted that vegetation was not being properly cleared from around the monitoring wells. During the 2015 inspection the vegetation was properly cleared from around the monitoring wells (PL-7 and PL-8).

PKB 10/2015. PL-7. Monitoring well 6.

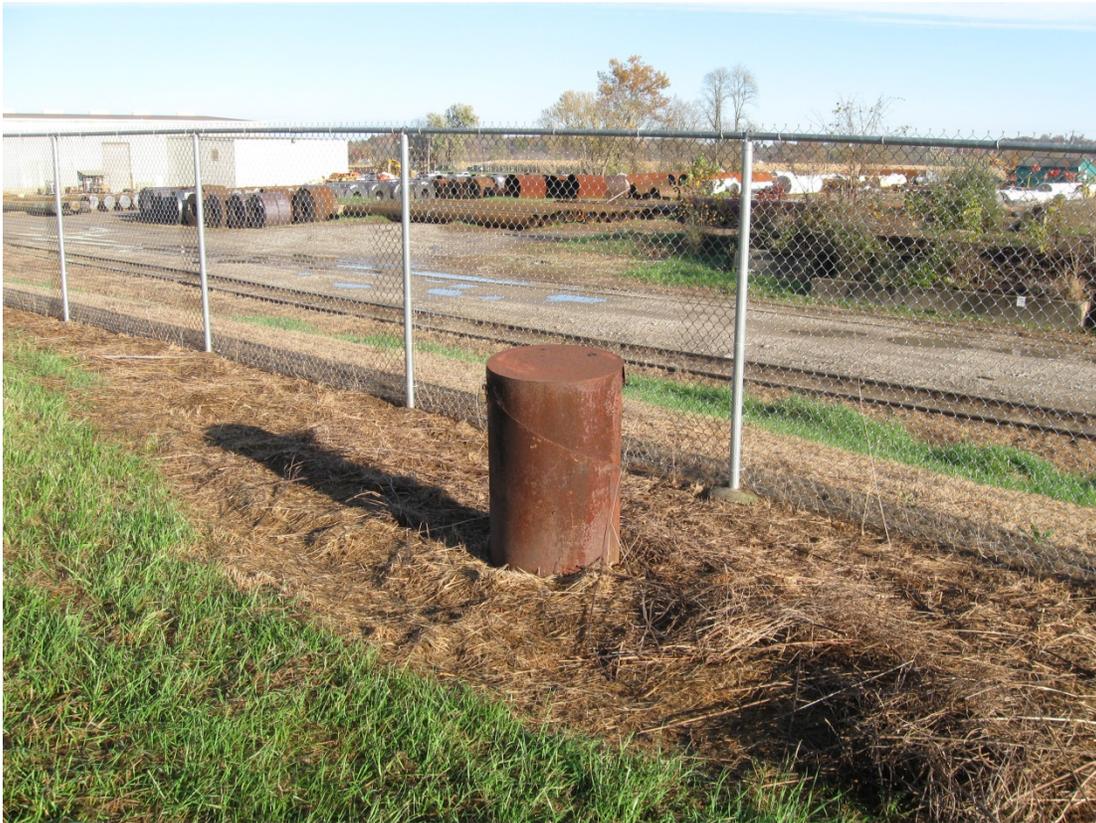
PKB 10/2015. PL-8. Monitoring well 3.

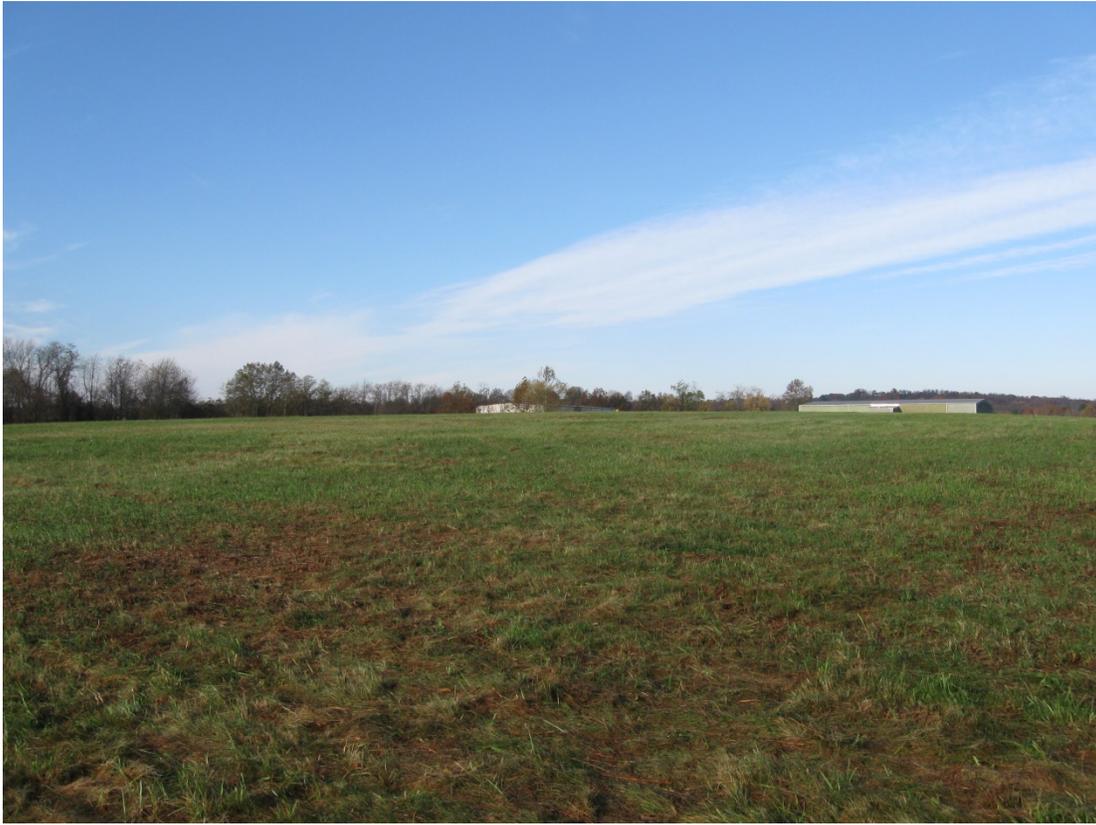
The grass covered disposal cell was in excellent condition (PL-9). No evidence of erosion or slope instability on the disposal cell was noted during the inspection. Dominant vegetation consists of fescue, crown vetch, and goldenrod. Poison hemlock is re-establishing itself on top of the disposal cell. The area of poison hemlock is identified on the site inspection map. The vegetation on the disposal cell cover (essentially in the area inside the security fence) appeared healthy and vigorous. Efforts will be made in 2016 to investigate using goats within the perimeter fence for the control of noxious weeds.

PKB 10/2015. PL-9. Grass covered disposal cell.

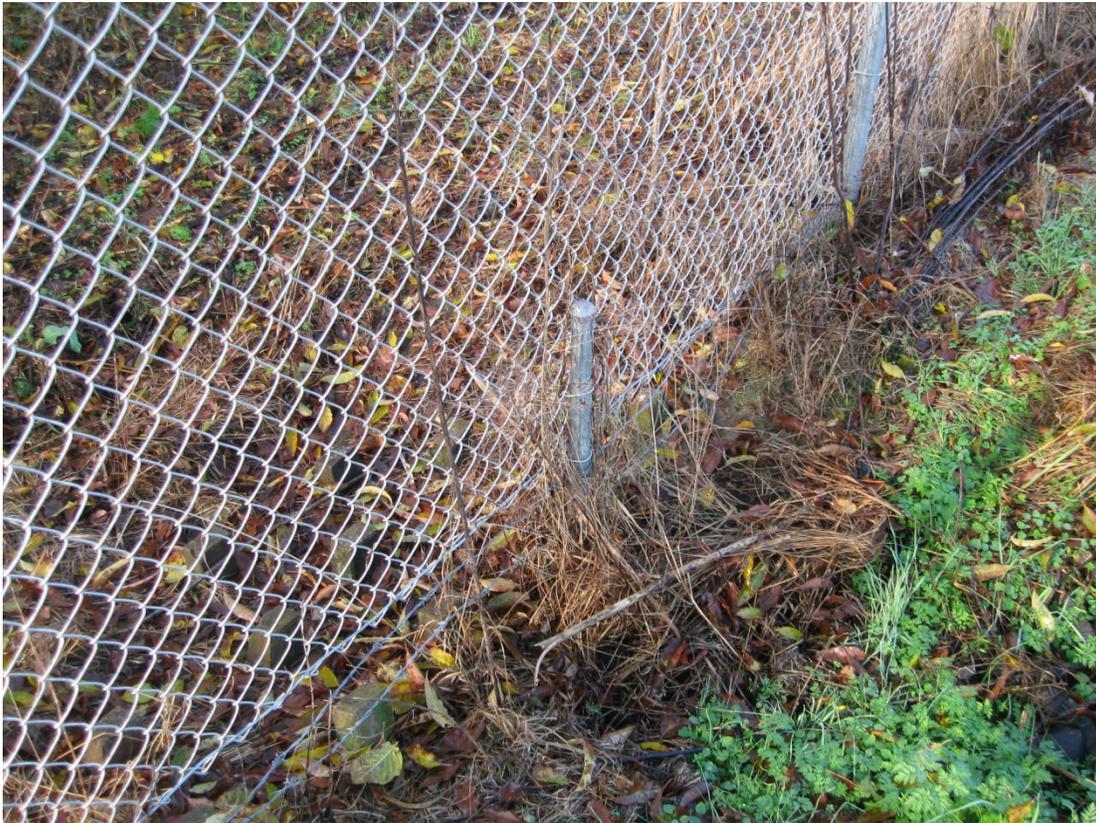
The drainage channel in the southwest corner of the site, lined with HDPE honeycomb baffles and brick energy dissipation baffles in August 1996, is in good condition and functioning as designed (PL-10). Erosion in the channel appears to be unchanged from last year.

PKB 10/2015. PL-10. Area of erosion control.
