2016 Annual Inspection and Radiological Survey Results for the Piqua, Ohio, Decommissioned Reactor Site

July 2016

U.S. DEPARTMENT OF
ENERGY

Legacy
Management

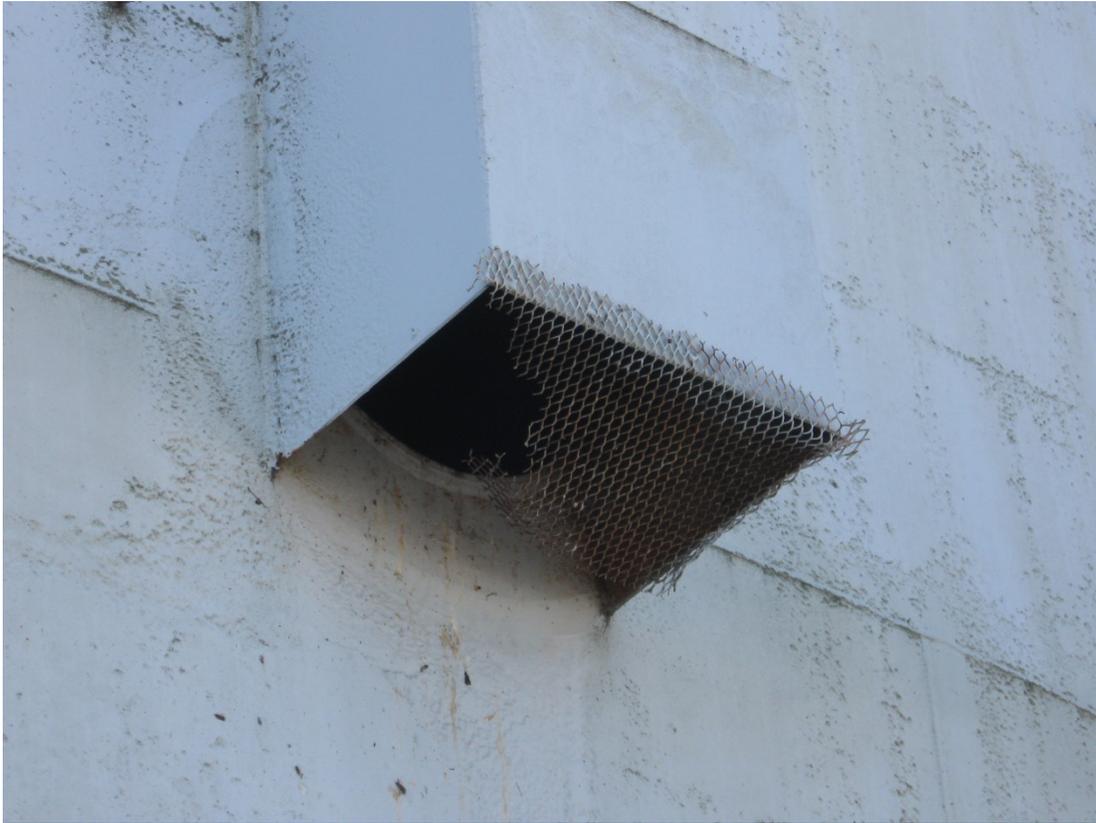
A new minor maintenance need was observed on the exterior north wall of the Containment Building. The screen covering an exterior vent was damaged (PL-1). Unless the screen is repaired, birds could enter the building through the vent. DOE requests that the City repair the screen prior to the next annual inspection.

- 1) A screen covering a vent on the exterior wall of the Containment Building is damaged (PL-1). Unless the screen is repaired, birds could enter the building through the vent.

PIQ 4/2016. PL-1. Missing vent screen.

Action Request: DOE requests that the City repair the screen prior to the next annual inspection.

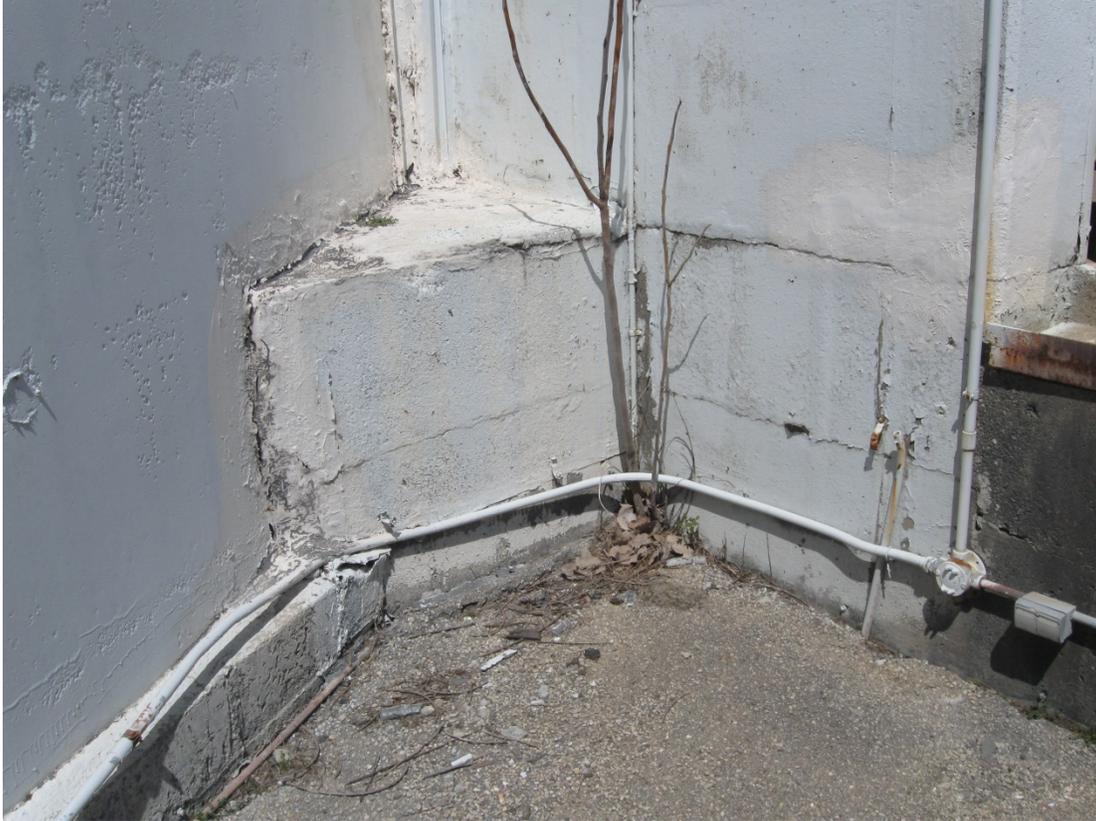
Vegetation around the outer base of the Containment Building continues to be a problem (PL-2 through PL-4). One area in particular has a tree growing out of the base of the building. If this vegetation is allowed to grow, it could compromise the building by enlarging cracks in the concrete, allowing water to possibly seep down into the entombment area. DOE requests that the City spray, kill, and remove this vegetation from the base of the Containment Building and properly seal the remaining cracks with a caulking compound prior to the next annual inspection.

- 2) Vegetation around the outer base of the Containment Building continues to be a problem (PL-2 through PL-4). One area in particular has a tree growing out of the base of the building. If this vegetation is allowed to grow, it will act to compromise the building by enlarging cracks in the concrete, allowing water to possibly seep down into the entombment area of the building.

PIQ 4/2016. PL-2. Small tree – base of Containment Building.

Action Request: DOE requests that the City kills and remove vegetation from the base of the Containment Building and properly seal the remaining cracks with a caulking compound prior to the next annual inspection.

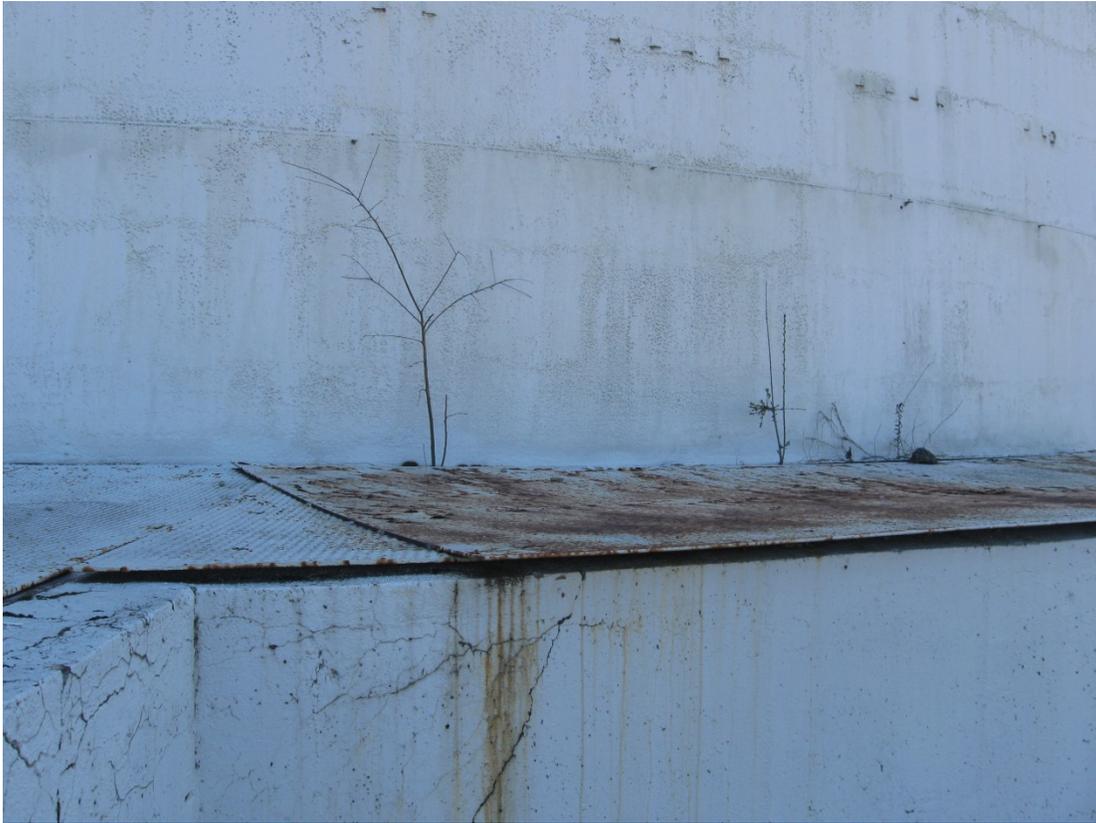
PIQ 4/2016. PL-3. Vegetation – base of Containment Building.

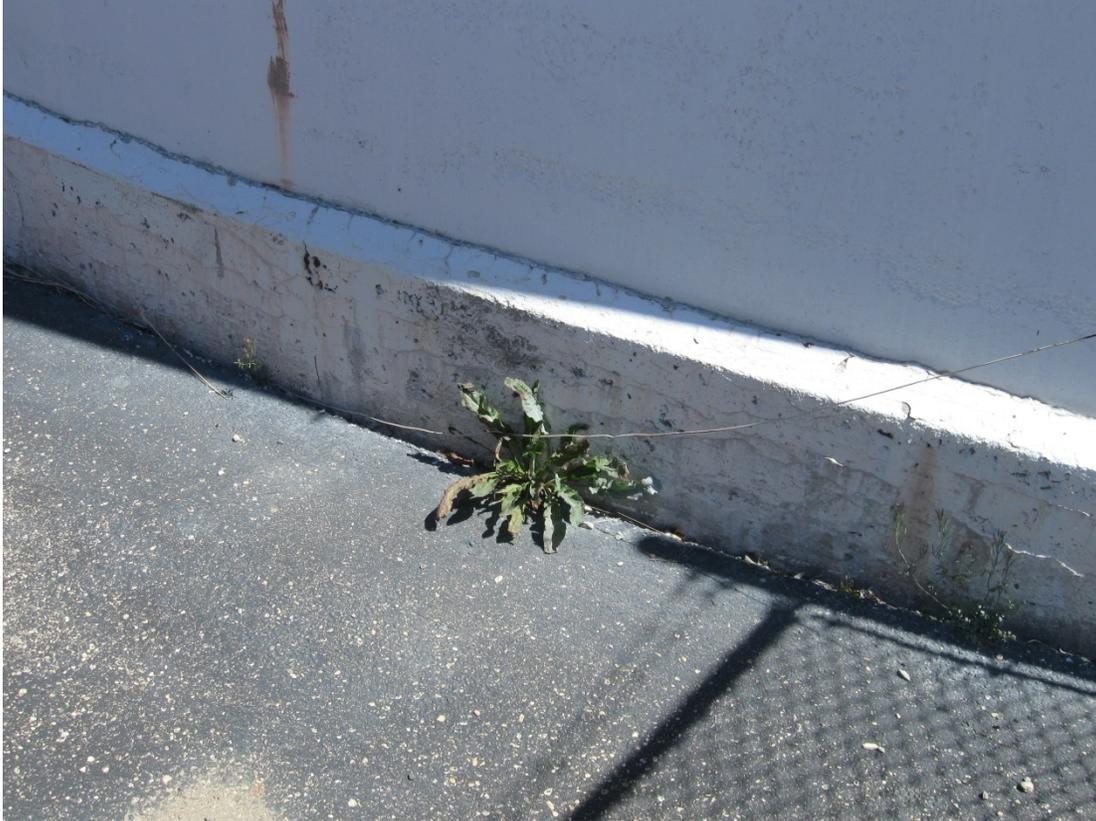
PIQ 4/2016. PL-4. Weeds – base of Containment Building.

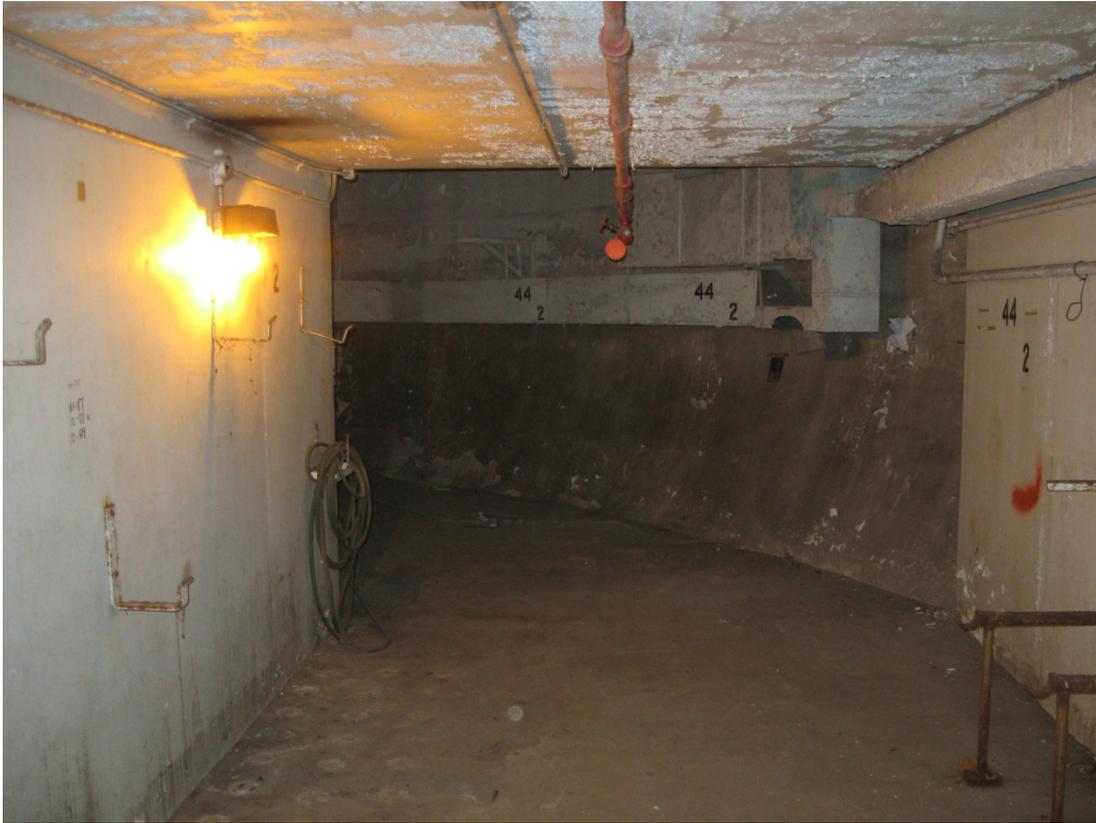
56-foot level: The 56-foot level is the lowest level of the Containment Building. The level is currently empty. The condition of peeling paint on the interior walls of the Containment Building remains unchanged from previous inspections (PL-5). Peeling paint (that is falling onto the floors) was analyzed in 2006 and found to contain 0.35 percent lead. The paint will probably continue to peel and fall to the floor. City personnel are aware of the presence of the lead-based paint. Abatement of the lead-based paint is being addressed in the Maintenance Assistance Plan.

PIQ 4/2016. PL-5. Peeling paint.

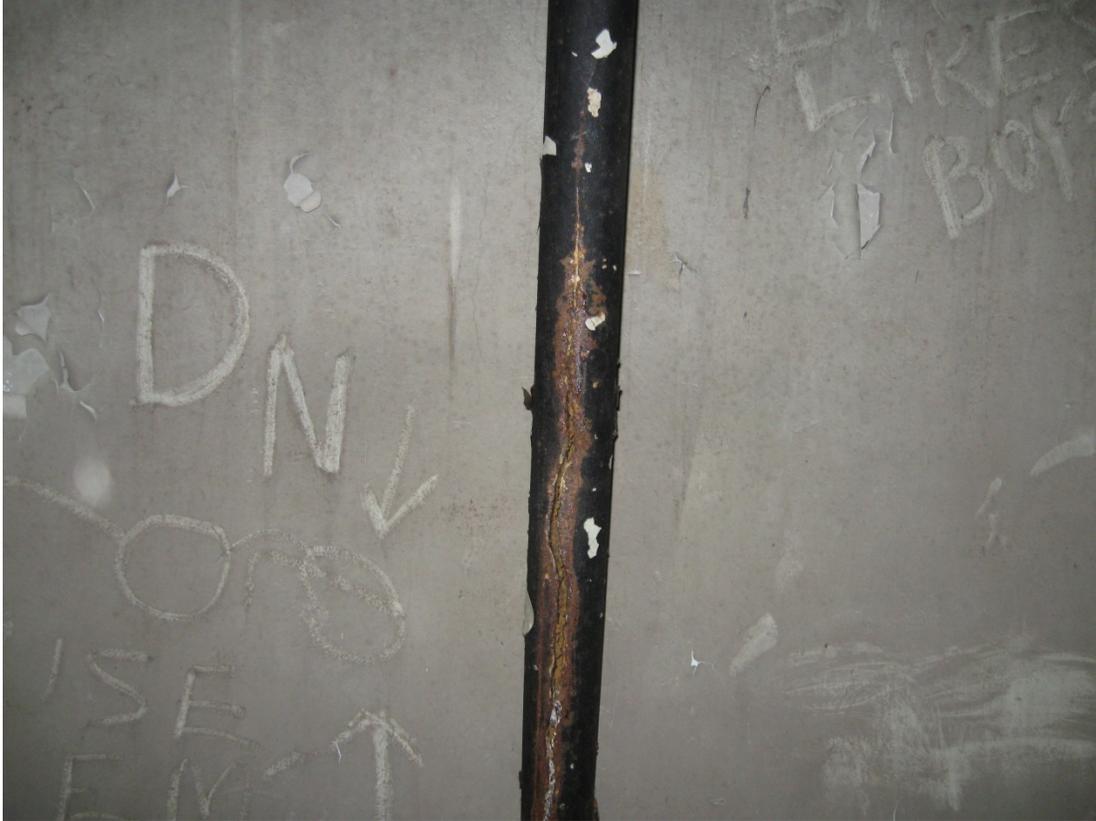
A vertical drain pipe, located on the northwest wall of the 56-foot level of the Containment Building, has developed a crack and split open (PL-6 and PL-7). Inspectors traced the pipe up to the 100-foot level where it is believed to be connected to a floor drain. DOE requests that the City assess the cracked drain line and repair it if necessary prior to the next annual inspection to keep water from entering the Containment Building on the 56-foot level.

- 3) A vertical drain pipe on the NW wall of the Containment Building on the 56-foot level has developed a crack and split open (PL-6 and PL-7). Inspectors traced the pipe up to the 100-foot level where it is believed to be connected to a floor drain.

PIQ 4/2016. PL-6. Cracked drain pipe.

Action Request: DOE requests that the City assess the cracked drain line and repair it if necessary prior to the next annual inspection to keep water from entering the 56-foot level.

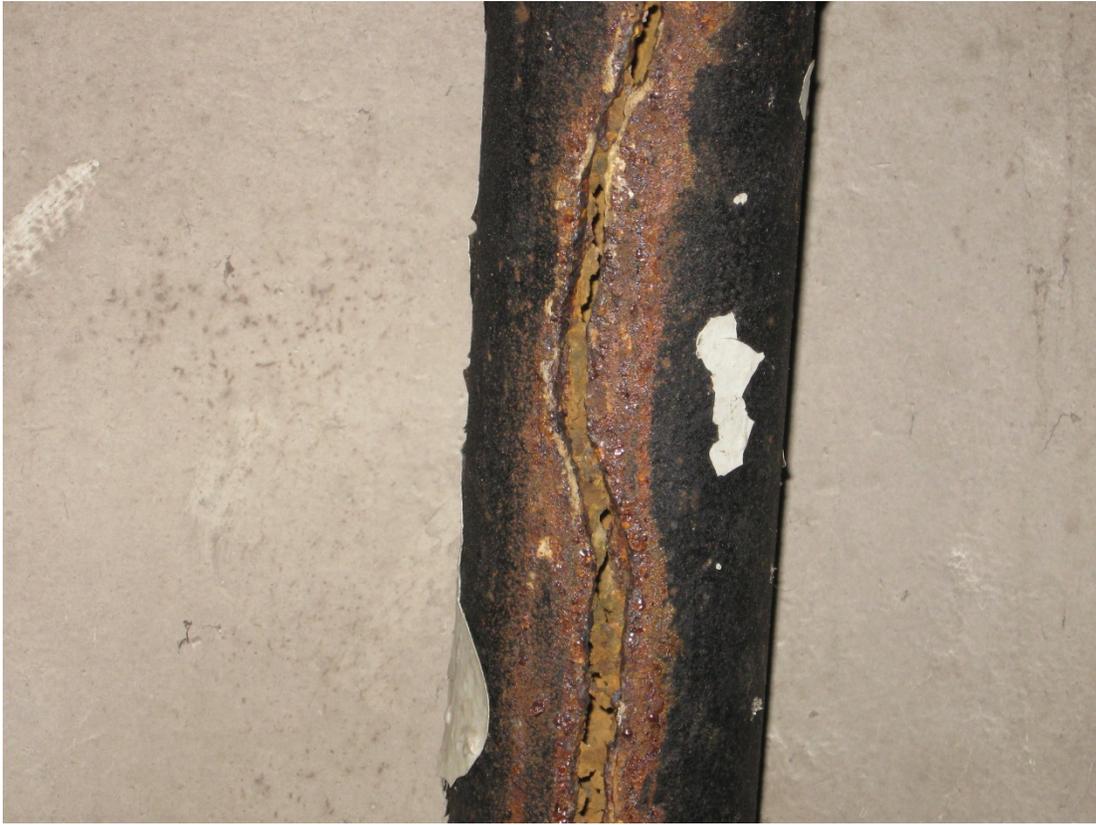
PIQ 4/2016. PL-7. Cracked drain pipe.

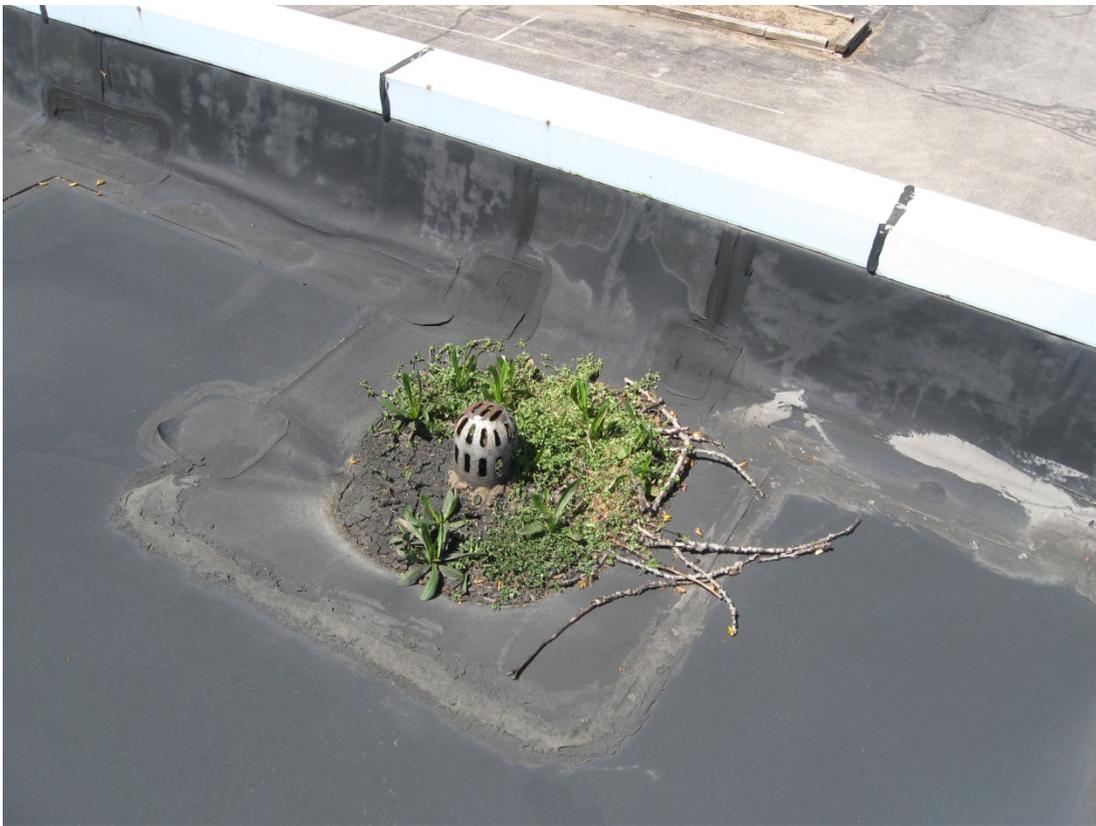
Roof drains were observed to be in much better condition this year than they were in 2015, but additional attention is needed. Vegetation is still growing around some of the drains (PL-8 and PL-9). Vegetation is also establishing itself in uncleaned corners of the roof (PL-10). DOE requests that the roof drains and roof areas be cleaned prior to next year's inspection and kept clean so that the roof can properly drain.

- 7) Roof drains on the Auxiliary Building were in much better condition this year than they were in 2015, but additional attention is needed. Vegetation is still growing around some of the

drains (PL-8 and PL-9). Vegetation is also establishing itself in uncleaned corners of the roof (PL-10).

PIQ 4/2016. PL-8. Roof drain.

Action Request: DOE requests that the roof drains and roof areas be cleaned prior to next year's inspection and kept clean so that the roof can properly drain.

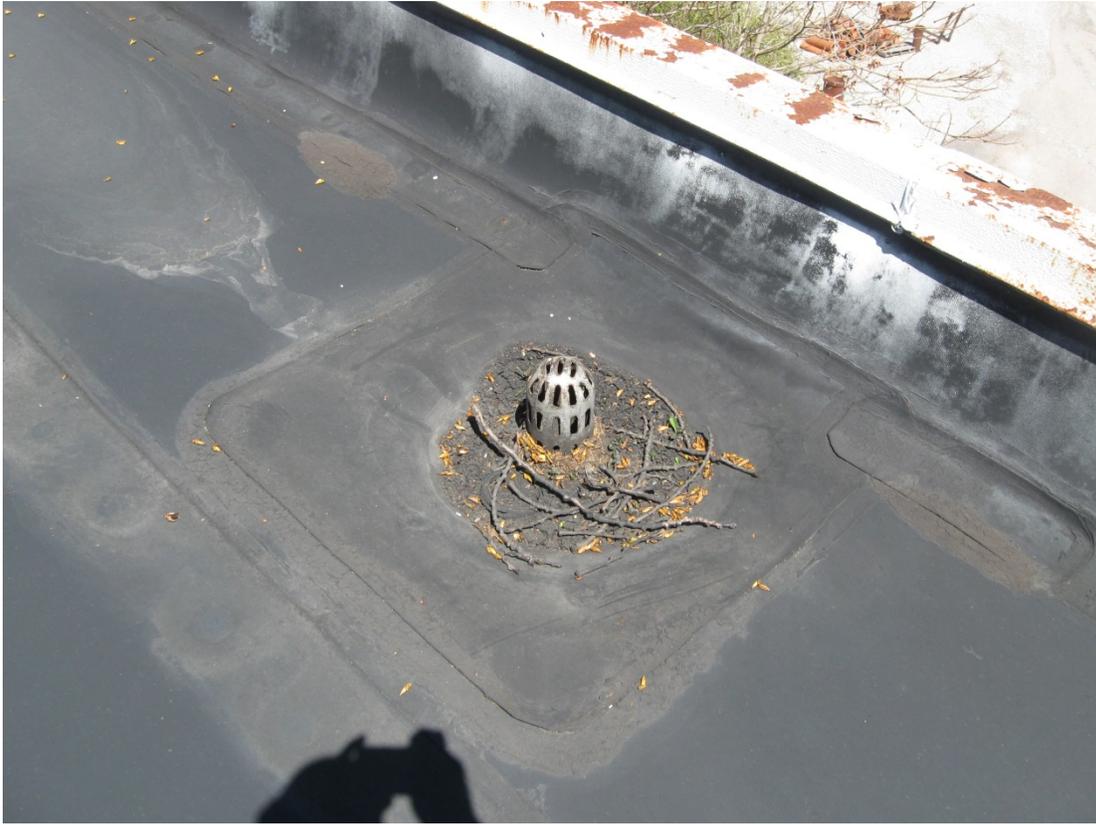
PIQ 4/2016. PL-9. Roof drain.

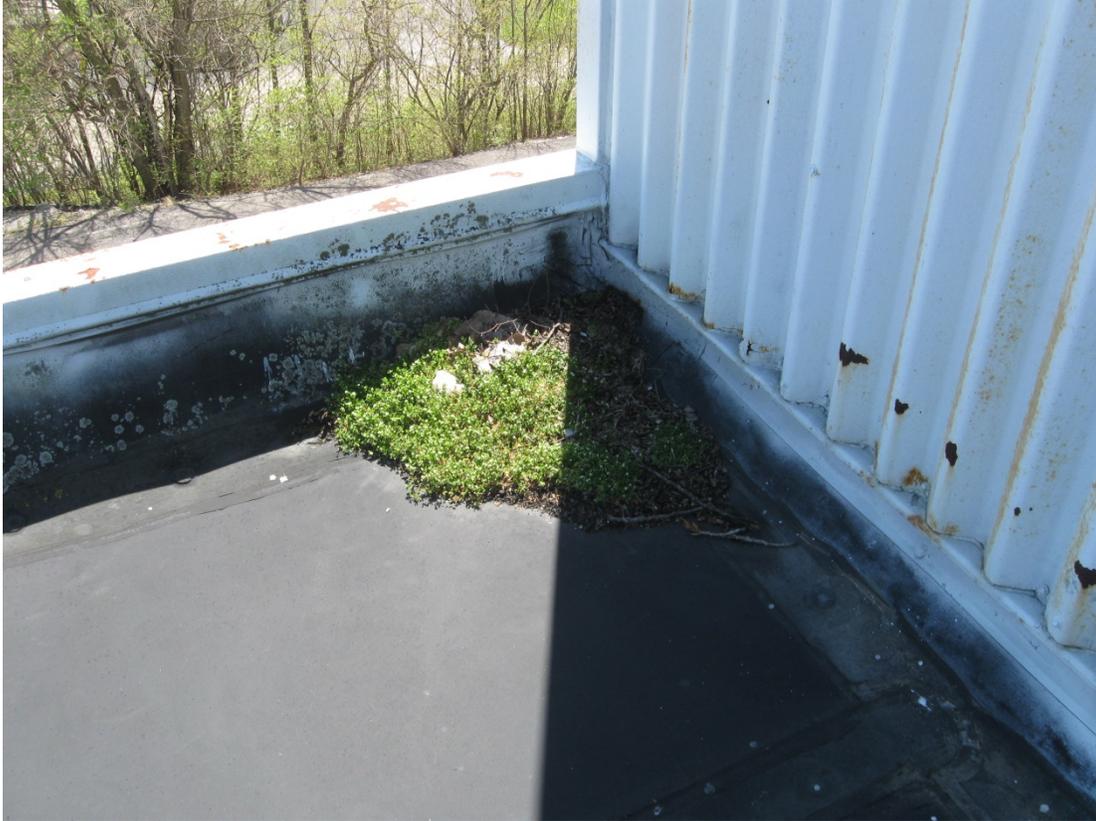
PIQ 4/2016. PL-10. Corner of roof.

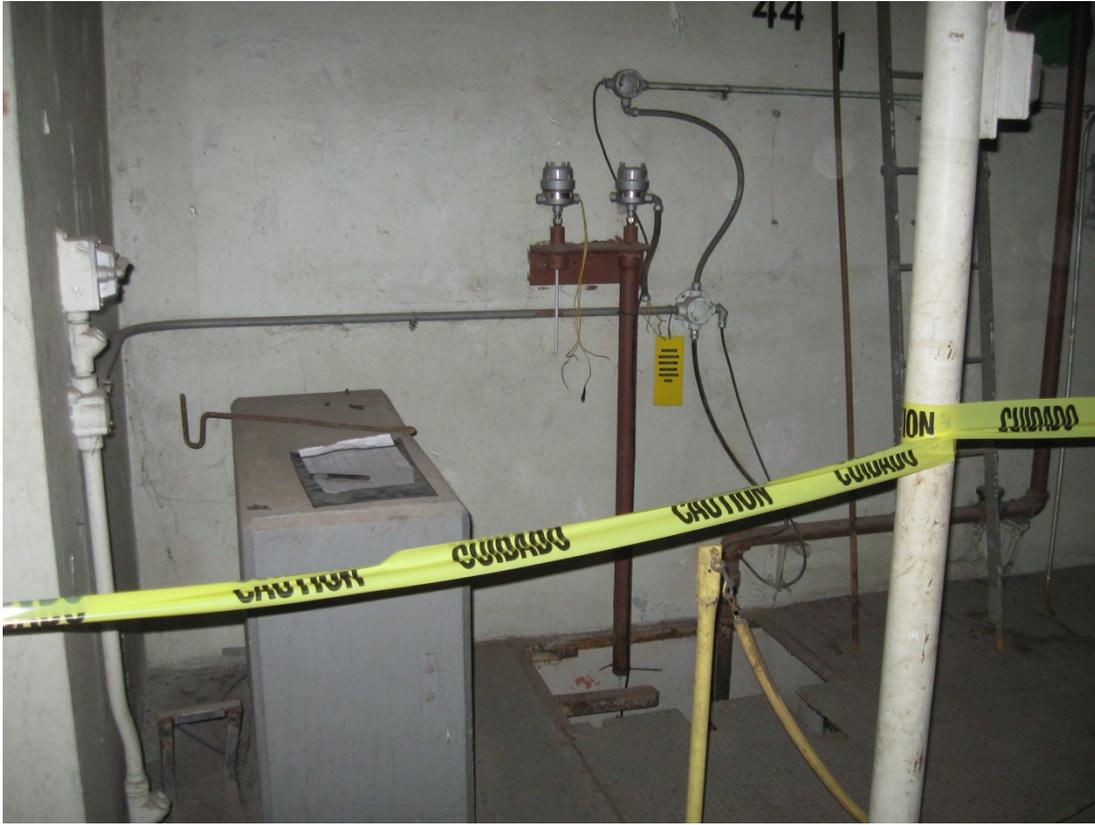
An alarm system is installed in the sump on the 56-foot level of the Containment Building to detect high water levels before they rise to the bottom of the entombed pressure vessel (PL-11). This system is designed to prevent immersion and accelerated corrosion of the pressure vessel. The alarm triggers when the sump fills to near overflow, alerting personnel to both high water and possible sump pump failure. The alarm registers in the Auxiliary Building on the Supervisory Control and Data Acquisition system, which is monitored 24 hours a day by an operator. The alarm system is included in the monthly building inspection. The Containment Building sump alarm test log indicates that the alarm is being tested monthly.

PIQ 4/2016. PL-11. Sump pump area.
