# **2012 Annual Inspection and Radiological Survey Results for the Piqua, Ohio, Decommissioned Reactor Site**

## **Summary**

This report presents the findings of the annual U.S. Department of Energy (DOE) inspection of the Piqua Nuclear Power Facility (PNPF) in Piqua, Ohio. This facility is assigned to the DOE Office of Legacy Management (LM) for long-term custody and care.

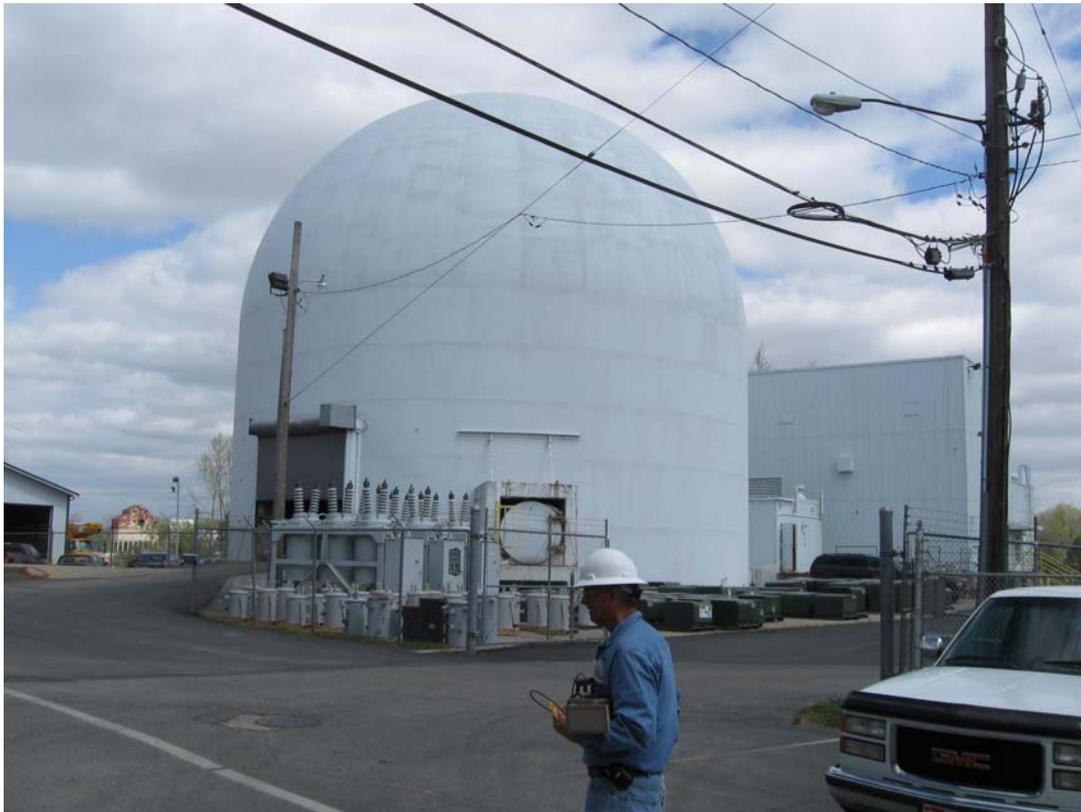
The Containment Building exterior was refurbished around 1995. The exterior of the reactor containment building was in good condition (PL-1).

PIQ 4/2012. PL-1. Exterior of the Piqua containment building.

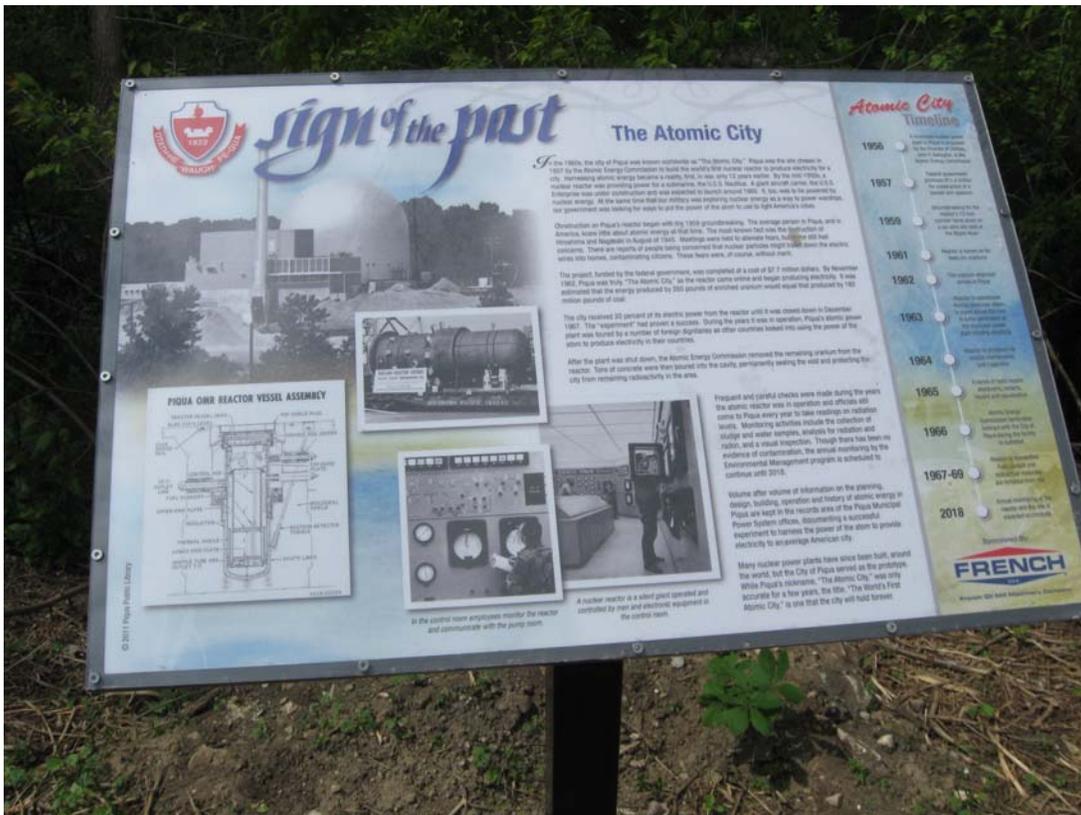
An informational sign concerning the former nuclear reactor was installed on a bike path that parallels the facility property (PL-2). The sign presents information on Piqua the “atomic city.”

PIQ 4/2012. PL-2. Historic sign on nearby bike path.

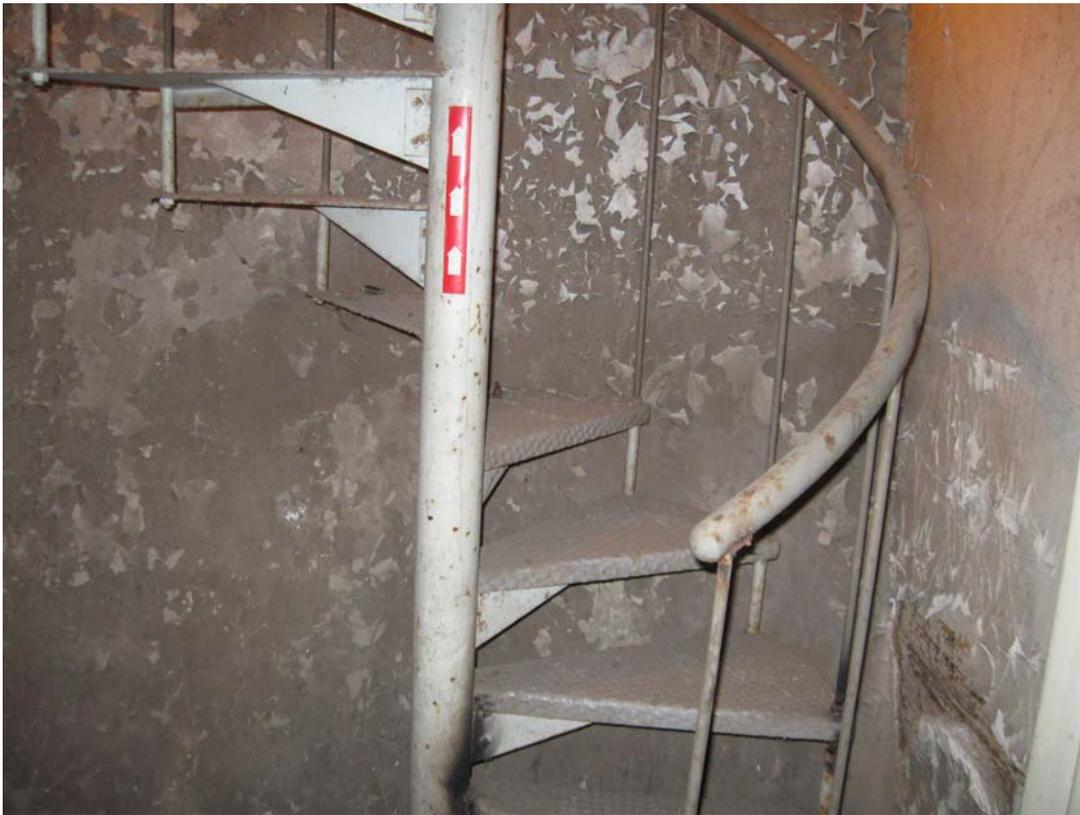
A spiral staircase is present in the containment structure (PL-3). Plaster is falling off the walls of the staircase enclosure and cable spools have rolled into the wall damaging the plaster at the entrance to the spiral staircase on the 56-foot level. This damage has been noted in previous inspection reports.

PIQ 4/2012. PL-3. Base of spiral staircase.

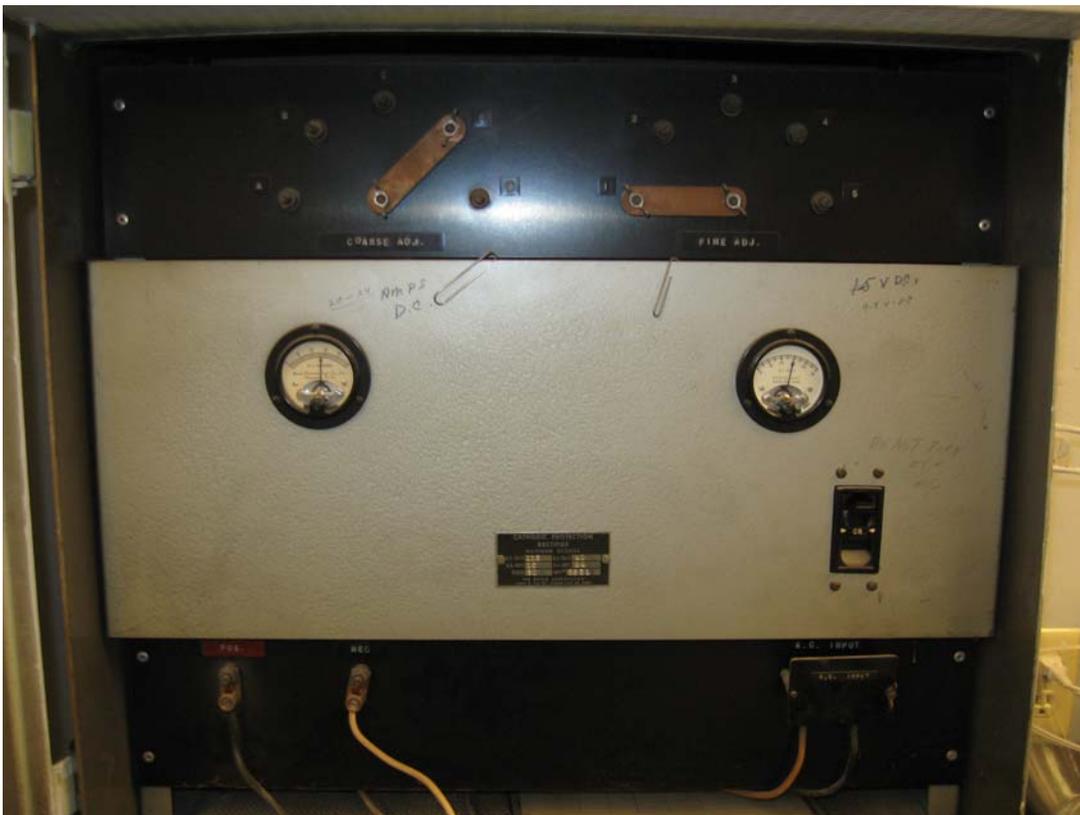
The entire system was checked by a qualified service provider in April 2010, resulting in the replacement of one of the header cables. According to the maintenance log kept with the unit, the system is being checked by plant personnel, but the December 2011 log entry was missing. Piqua plant personnel were notified of the missing log entry following the inspection. It was explained that even though the on site log book failed to report a monthly check, the system was being checked remotely through a computer link and that a computer printout would be provided as evidence that the system is being checked monthly.

PIQ 4/2012. PL-4. Rectifier Unit.

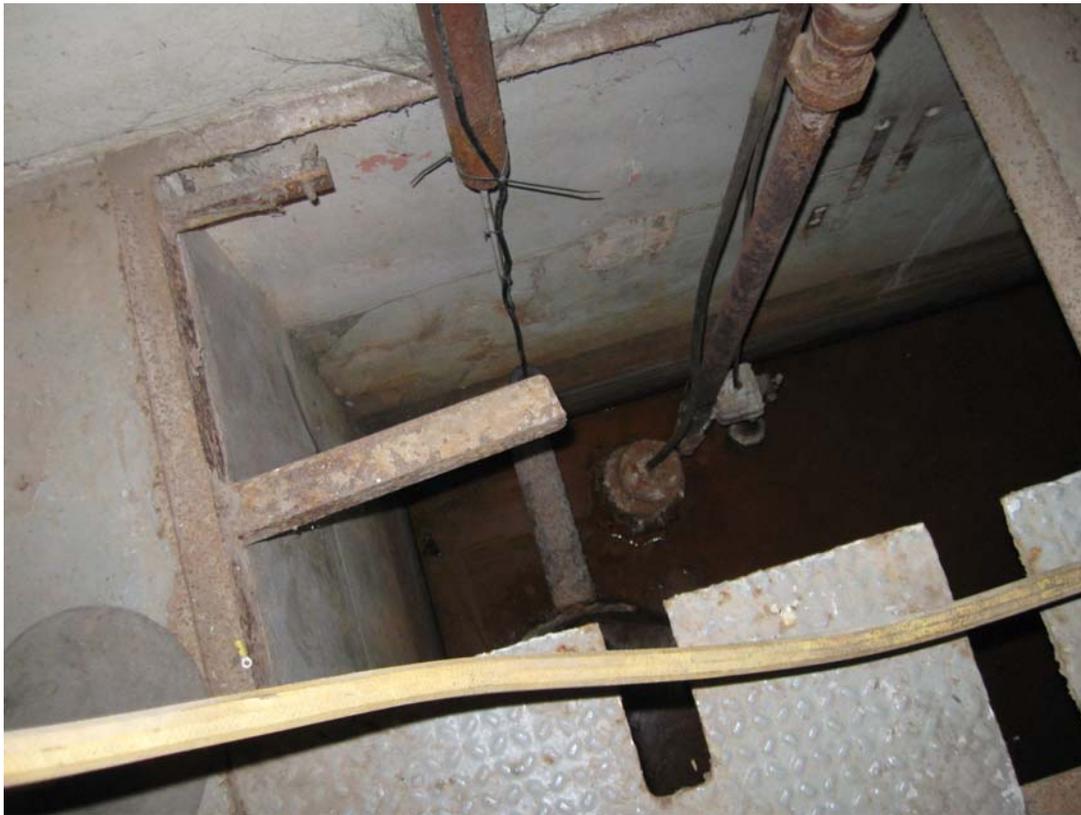
An alarm system is installed in the sump on the 56-foot level to detect high water levels before they rise to the bottom of the pressure vessel (PL-5). This system is designed to prevent immersion and accelerated corrosion of the pressure vessel. The alarm triggers when the sump fills to near overflow, alerting personnel to both high water and possible sump pump failure. The alarm registers in the auxiliary building on the Supervisory Control and Data Acquisition system, which is monitored 24 hours a day by an operator. The alarm system is included in the monthly building inspection. The reactor sump alarm test log indicates that the alarm is being tested monthly, but the entries for the December 2011 and the February 2012 checks were missing from the log (PL-6). Piqua plant personnel were notified of the missing log entries following the inspection. It was explained that even though the on site log book failed to report a few monthly checks, the system was being checked remotely through a computer link and that a computer printout would be provided as evidence that the system is being checked monthly. Very little water was present in the base of the sump during the inspection.

PIQ 4/2012. PL-5. Sump in floor.

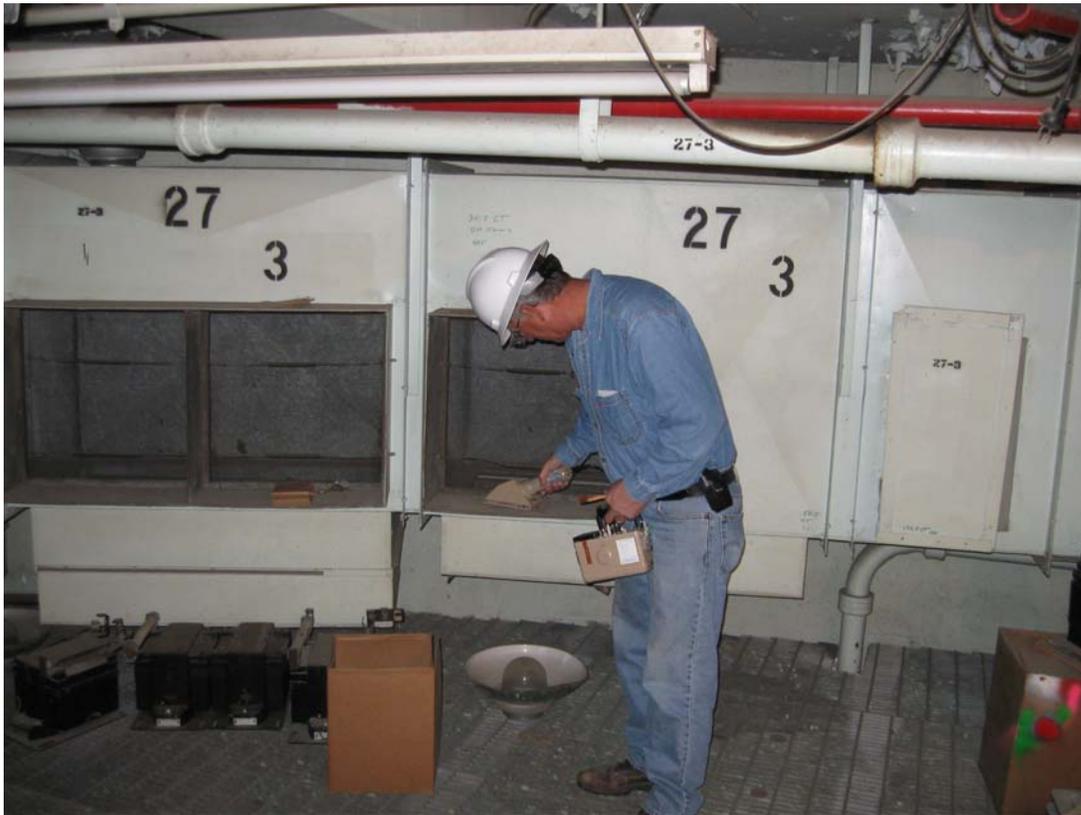
S.M. Stoller staff performed the annual radiological survey on the interior of the reactor containment building, auxiliary building, and exterior areas (PL-7). A total of 106 sample locations were checked for both removable and surface contamination using direct measurements

PIQ 4/2012. PL-7. Radiation survey.

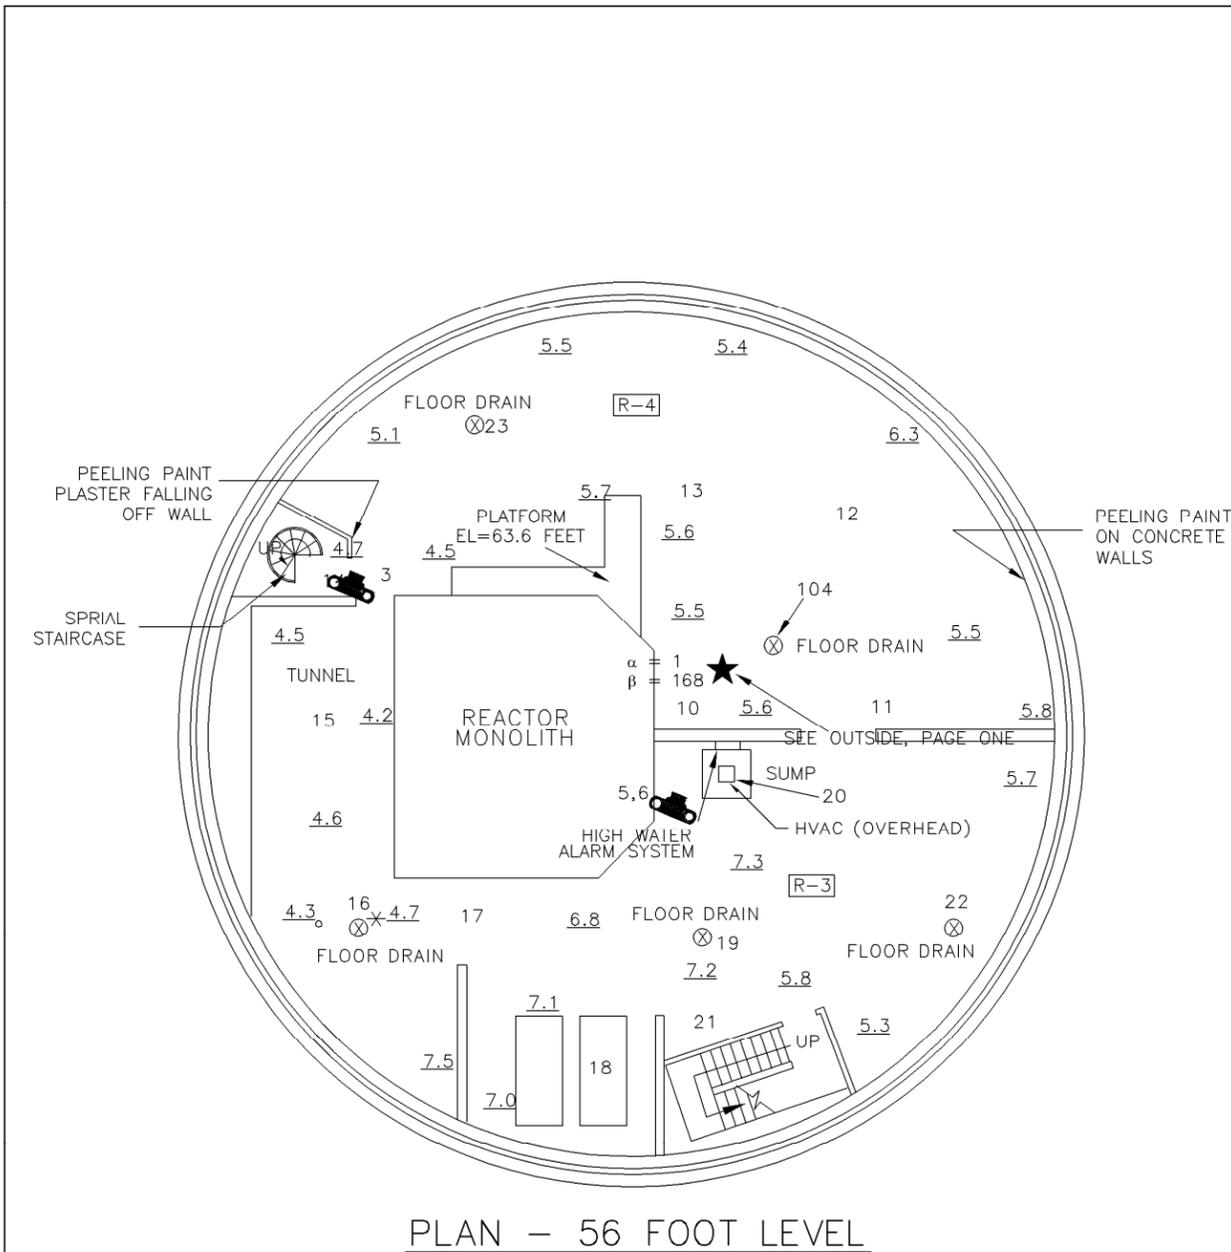
SMEAR/DIRECT LOCATIONS ON THE 56-FOOT LEVEL

Table 2 presents direct surface and removable activity results. Direct surface measurement results indicate the floor drain at the lowest level of the containment building exhibited a direct beta activity of 1,576 disintegrations per minute per 100 square centimeters (dpm/100 cm<sup>2</sup>). The smear from this location indicated that no removable activity is present. This result is consistent with previous surveys. All other direct measurements were below the MDA.

NOTE: ALL 2012 GAMMA CONTACT AND GENERAL AREA READINGS WERE  $\leq$  BKGD ON THE 56-FOOT LEVEL.

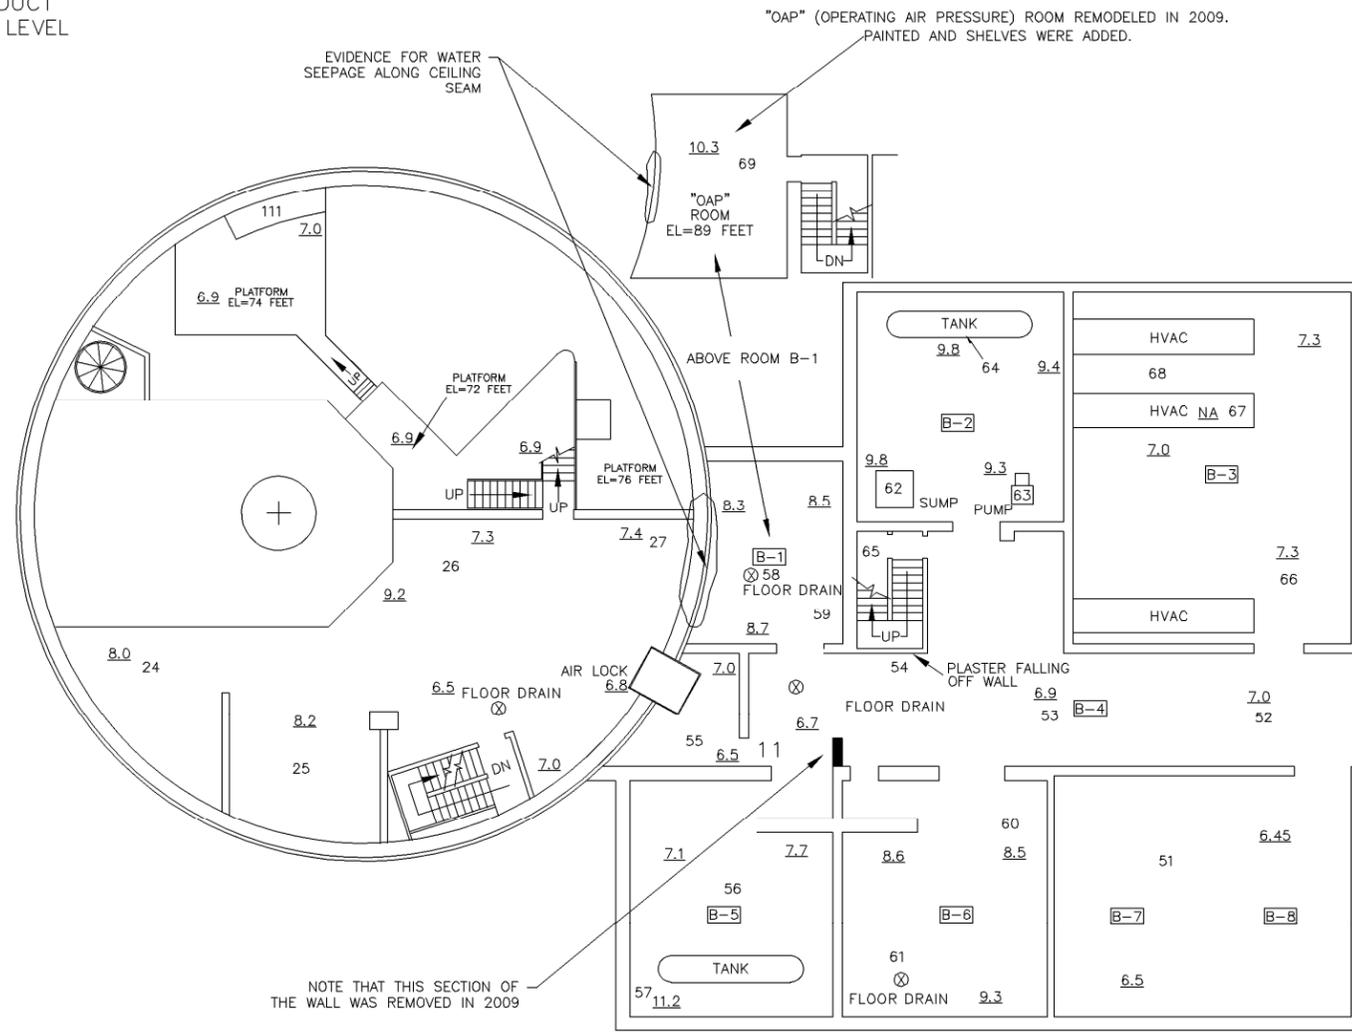
PLAN - 79 FOOT LEVEL

Evidence for water seeping along the ceiling seam of the OAP room remains unchanged from previous inspections (peeling paint and rust stains). This room is located directly above Room B1. Evidence for water seeping from the ceiling seam of Room B-1 also remains unchanged from previous inspections. The southwest wall of both rooms is the curved wall of the containment structure. Both rooms show evidence of water seeping along the same wall of the containment building. The condition is noted on the 79-foot level site inspection map and will continue to be monitored in future inspections.

HIGHEST GAMMA CONTACT READING  
WAS 0.7  $\mu$ rem/hr IN ROOM B-5

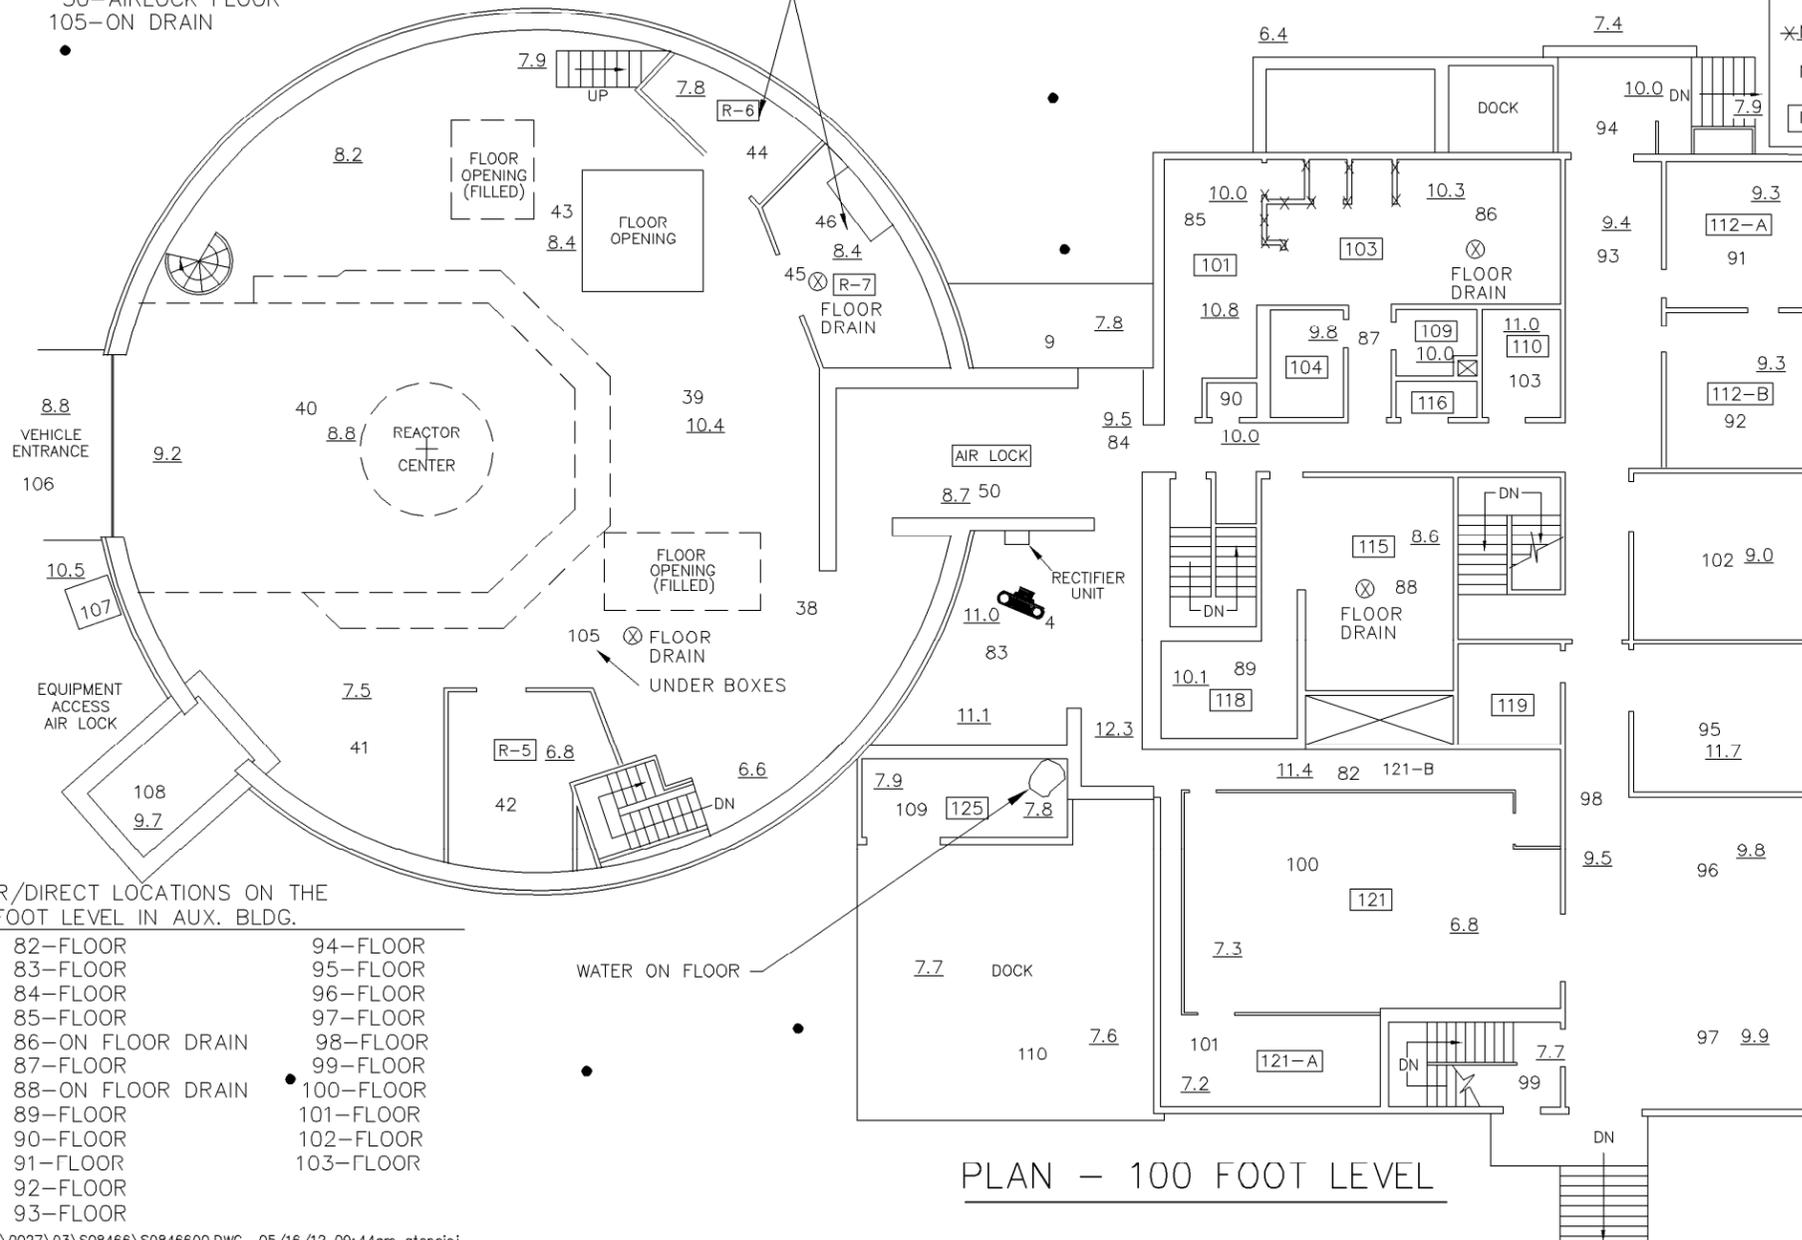
**PLAN - 100 FOOT LEVEL**

100-foot level: During the 2010 inspection, the roof above Room 125 had ponded water and was not properly draining, water was observed on the floor of Room 125, and the outside corner of the room was damaged. Room 125 is accessed from the loading dock. It is no longer used by Piqua personnel and is kept locked. Piqua personnel repaired the outside corner of the room and corrected the roof drainage problem above the room in 2010. The roof appears to be draining properly and no water was observed on the floor of Room 125 during this year’s inspection.

HIGHEST GAMMA READING ON THIS LEVEL IS 1.8  $\mu$ rem/hr > RECTIFIER ROOM
