14.0 Rifle, Colorado, Disposal Site

14.1 Compliance Summary

The Rifle, Colorado, Uranium Mill Tailings Radiation Control Act (UMTRCA) Title I Disposal Site was inspected on June 30, 2015. The disposal cell and all associated surface-water diversion and drainage structures were in good condition and functioning as designed. Vegetation on the site was in excellent condition. Minor fence repairs and perimeter sign maintenance will be conducted prior to the next inspection.

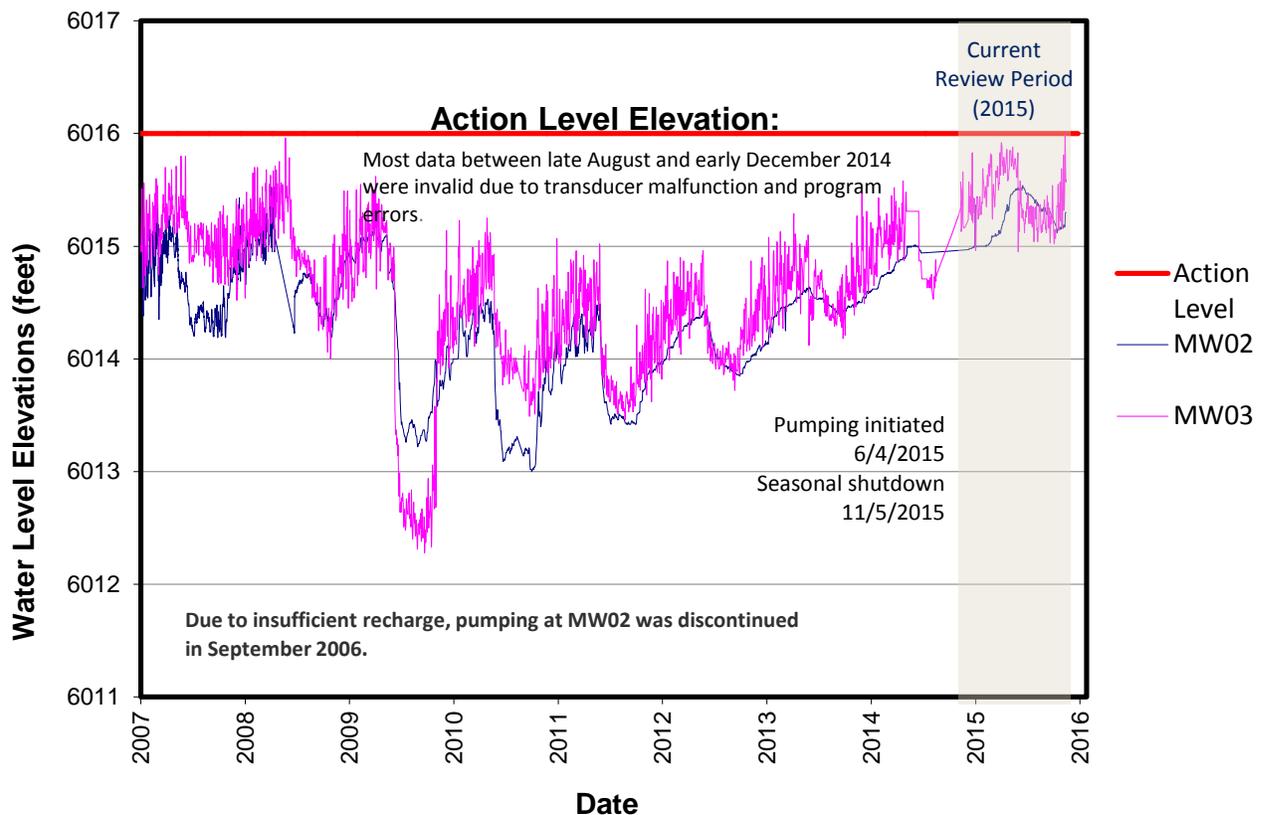
Figure 14-2. Disposal Cell Pore-Water Levels in Standpipes MW-02 and MW-03 at the Rifle Disposal Site

Datalogger information for the 2015 reporting period indicates that pore-water levels in both standpipes were always below the 6,016-foot action level (Figure 14-2). As observed historically, levels were highest during late fall and winter, when pumping is discontinued. In 2015, maximum water levels in MW-02 and MW-03 were 6,015.5 feet and 6,015.9 feet, respectively. Water levels declined to 6,015.1 feet and 6,014.9 feet, respectively, during pumping. According to the LTSP requirement, pumping will continue until the water levels in the standpipes stabilize at an elevation of 6,014 feet or lower.

This continued contingency operation has maintained the water level at an acceptable elevation (below the action level) and prevents water from overtopping the disposal cell liner. Dewatering of the cell will continue.

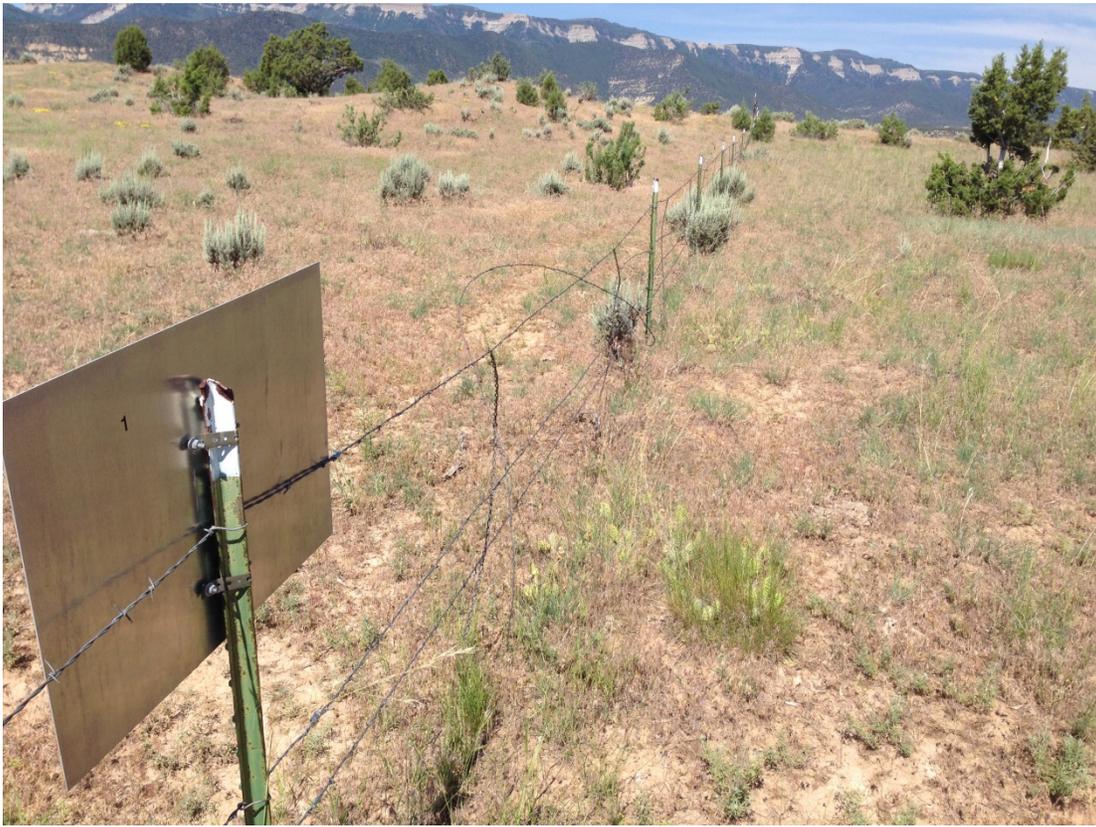
A barbed-wire fence, located at the south end of the site, extends to the edge of steep-sided arroyos that bound the site on the east and west and acts as a deterrent for easy access to the site. Fence damage was observed during the 2015 inspection including broken barbed wire (PL-1). Barbed-wire personnel gates at the southeast corner of the site were closed, which is a change from previous inspections where the gates have been found open (PL-2).

RFL 6/2015. PL-1. Broken barbed wire.

Minor fence repairs and hardware replacement for perimeter sign P4 will be performed before the next inspection.

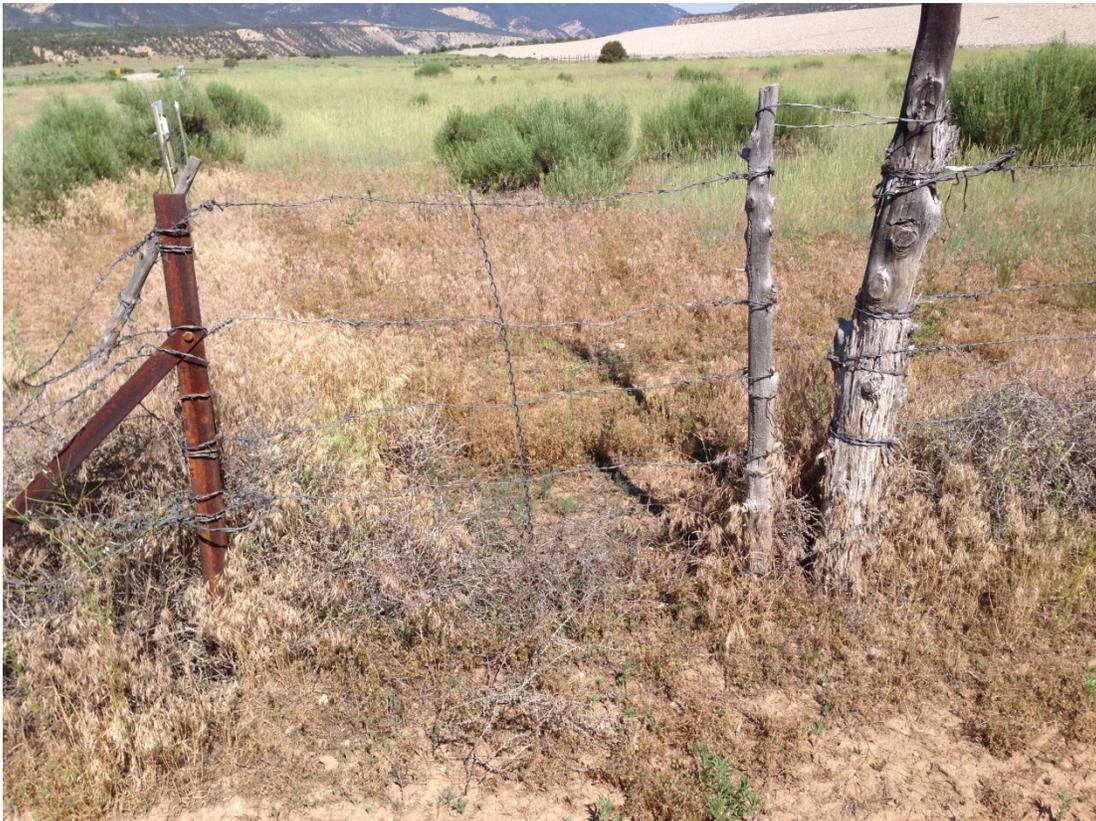
RFL 6/2015. PL-2. Closed fence gate.

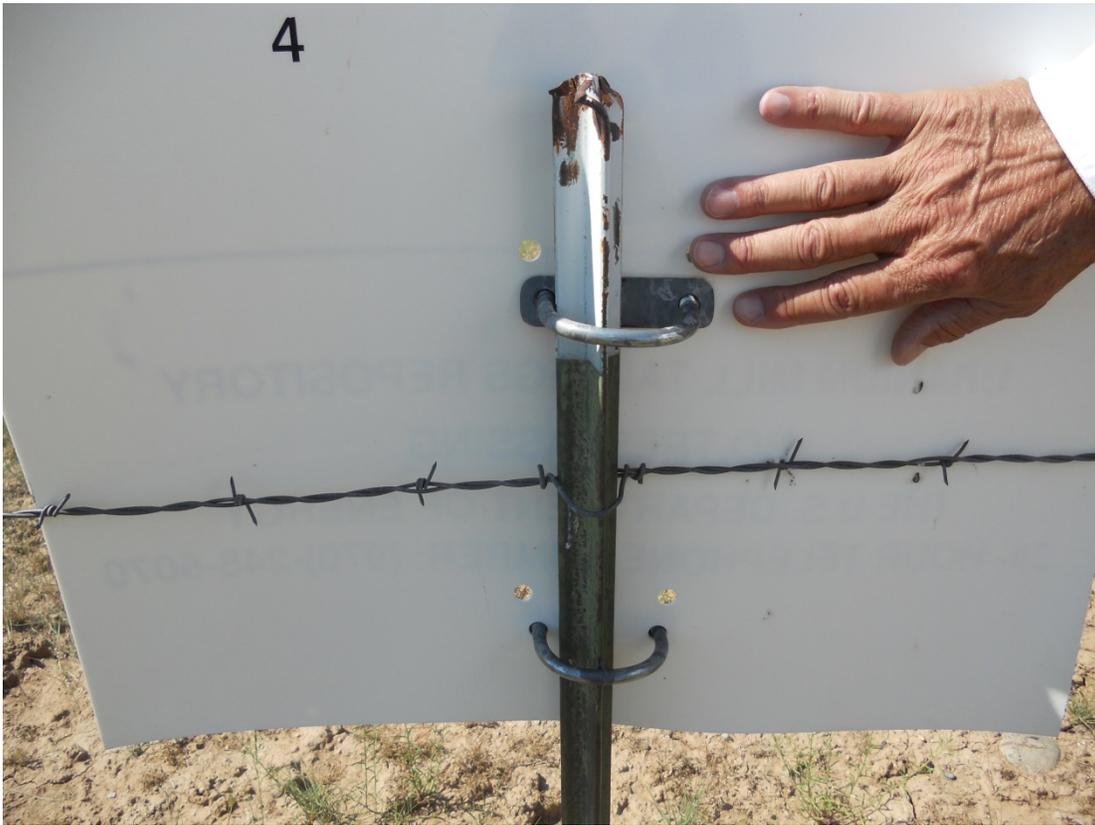
Perimeter signs are positioned along the fence and the edge of the disposal cell. A few signs have bullet damage but all were legible. The small-hole hardware used on perimeter sign P4 will be replaced (PL-3).

RFL 6/2015. PL-3. Perimeter sign P4.

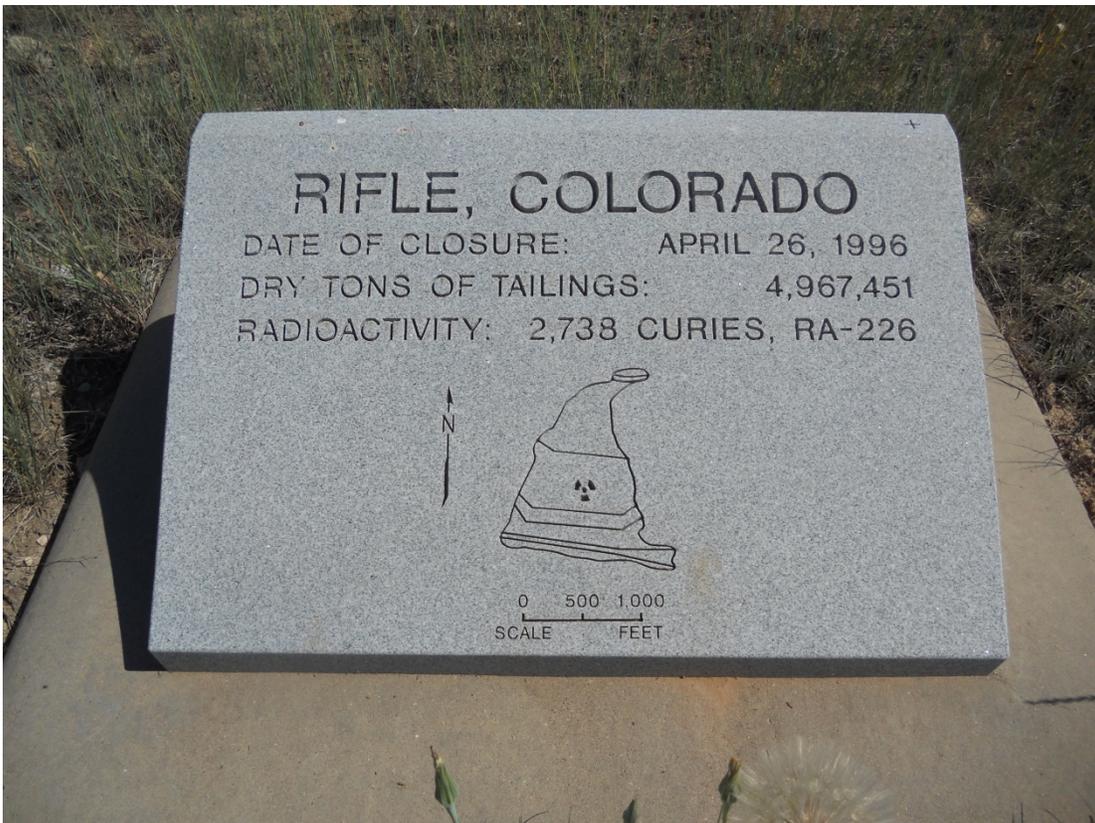
Two granite site markers, one just inside and left of the entrance gate (SMK-1; PL-4) and the other on the disposal cell (SMK-2), were in good condition.

RFL 6/2015. PL-4. Site marker SMK-1.

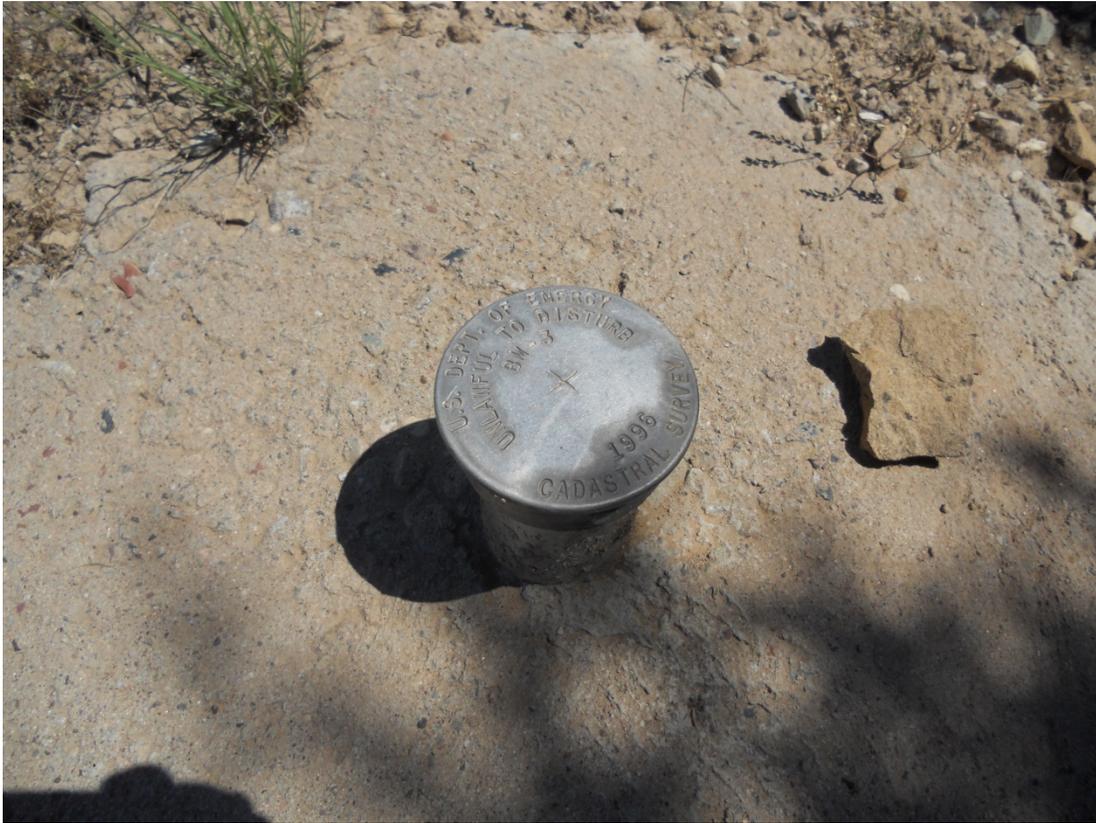
Three survey monuments and 15 boundary monuments delineate this site. Boundary monuments are set at corners along an irregular site boundary. According to the LTSP, 20 corner monuments were set along the site boundary; however, previous field investigations indicated that only 15 monuments were actually set because of the rough terrain. Consequently, boundary monument locations BM-8, BM-9, BM-13, BM-17, and BM-20 were only marked with wooden laths and are not included as part of the annual inspection. Several of the survey and boundary monuments at the site are difficult to locate because deadfall and underbrush obscure them, or steep terrain makes accessing them dangerous. All survey and boundary monuments inspected were in good condition (PL-5).

RFL 6/2015. PL-5. Boundary monument BM-3.

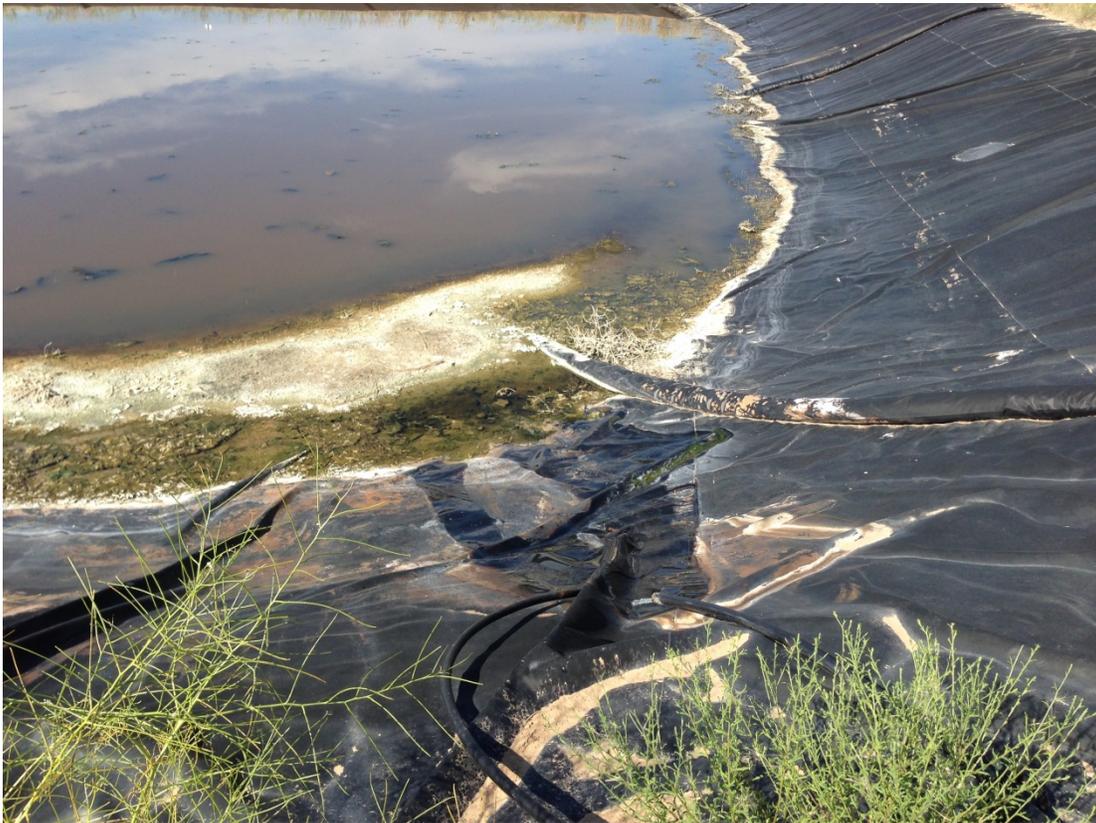
A synthetically lined evaporation pond was constructed adjacent to the cell in 2001 to receive water pumped from standpipes MW-02 and MW-03 (only MW-03 is currently pumped). Water was flowing into the pond at the time of the inspection (PL-6). A meteorological station was installed alongside the pond several years ago and is functioning normally.

RFL 6/2015. PL-6. Water entering evaporation pond.
