2.0 Site Operations and Maintenance

2.1 Annual Site Inspection

2.3 Pond Operations

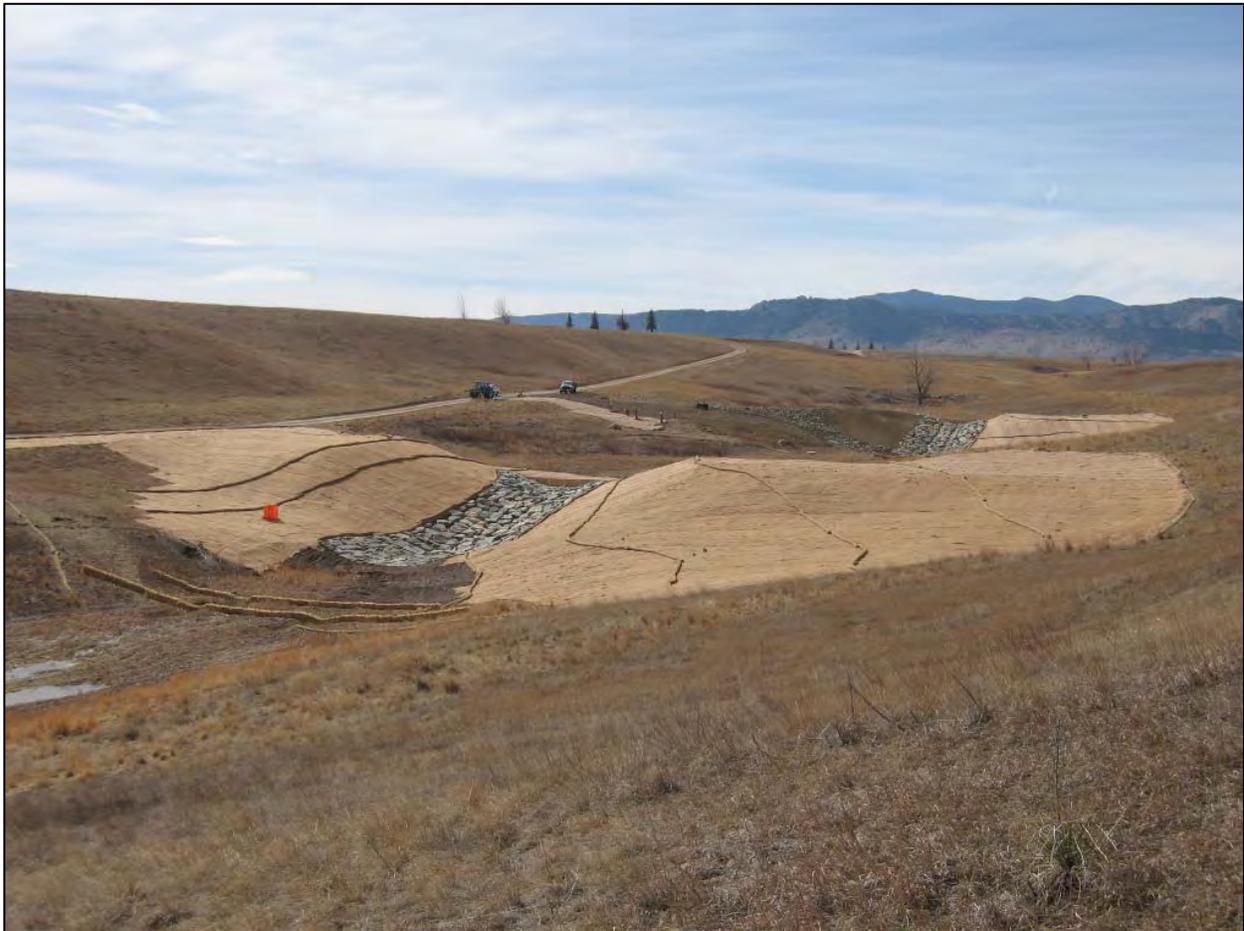
Figure 2–1. Completed Notch at Dam B-2

The breaching involved constructing grouted boulder-lined “notches” (Figure 2–1) with adjustable stoplog structures (Figure 2–2) that allow water to flow through the ponds or wetlands while still maintaining the wetland areas upstream. The ponds being modified include Ponds A-1

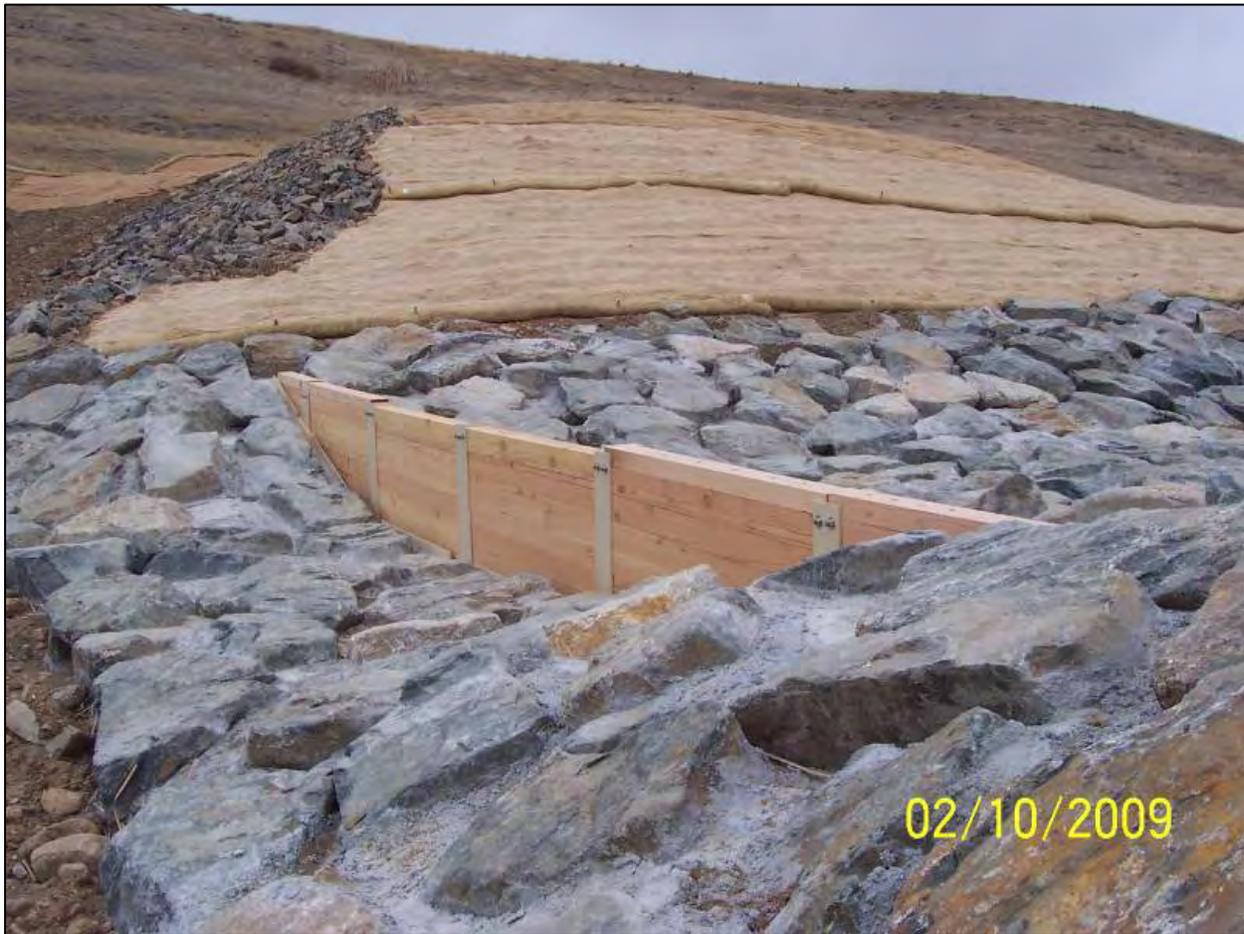
Figure 2–2. Completed Stoplog Structure at Dam A-2
