Overview of the Second Quarter 2009 Surveillance and Maintenance Report for the LM Rocky Flats Site

Legacy
Management

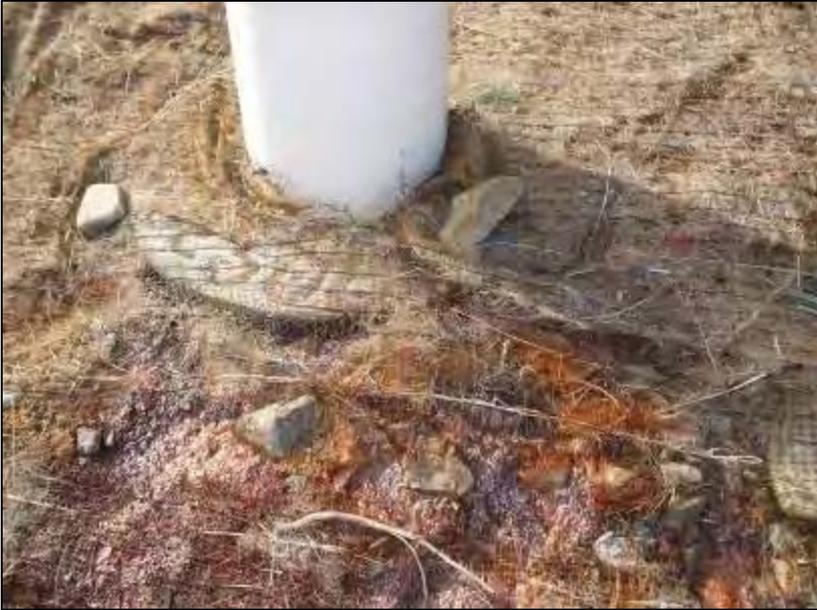
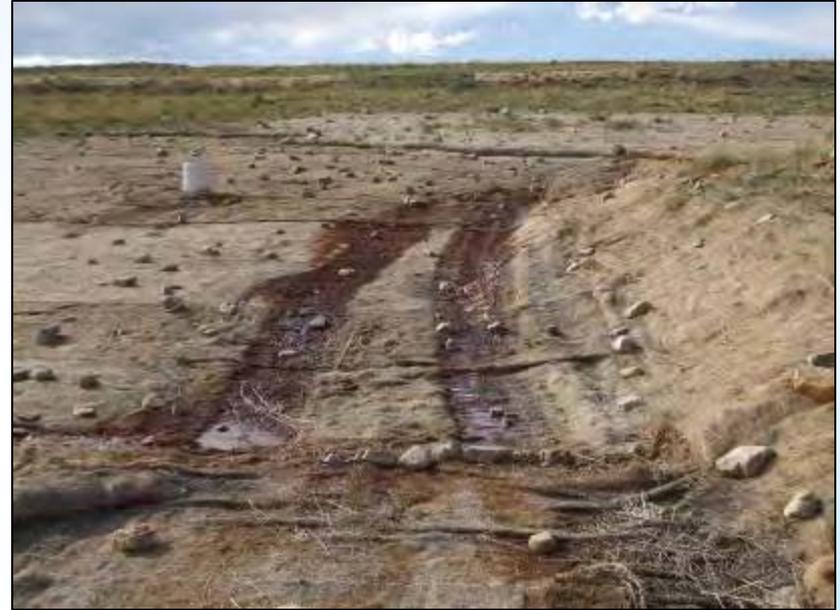
Seep 7 Expression in Spring 2009

- As part of the OLF geotechnical investigation, an extension to the original Seep 7 subsurface drain was installed in the OLF cover soil in September 2008
- No surface expression in the Seep 7 area until after precipitation events throughout second quarter CY 2009
 - Seep 7 showed surface flow during all three monthly inspections
- Flow observed along the approximate location of the eastern edge of the drain extension and south edge of casing for inclinometer 82508I
- Potholing on May 14 to evaluate the eastern edge of the drain and connection to the existing drain to determine whether water was flowing within the drain

- Geotextile fabric wrap not sufficiently porous to allow water to seep into the drain fast enough to carry the water away
- Seepage was surfacing in the vicinity of the eastern edge instead
- Water was freely flowing inside the drain extension and carrying water that enters the drain in the subsurface
- Small section of the geotextile wrapping edge replaced with more porous permanent erosion matting, which immediately resulted in the water entering the drain and the surface area quickly drying up at this location
- Additional sections along the edge adjusted in similar manner to allow water to enter the drain

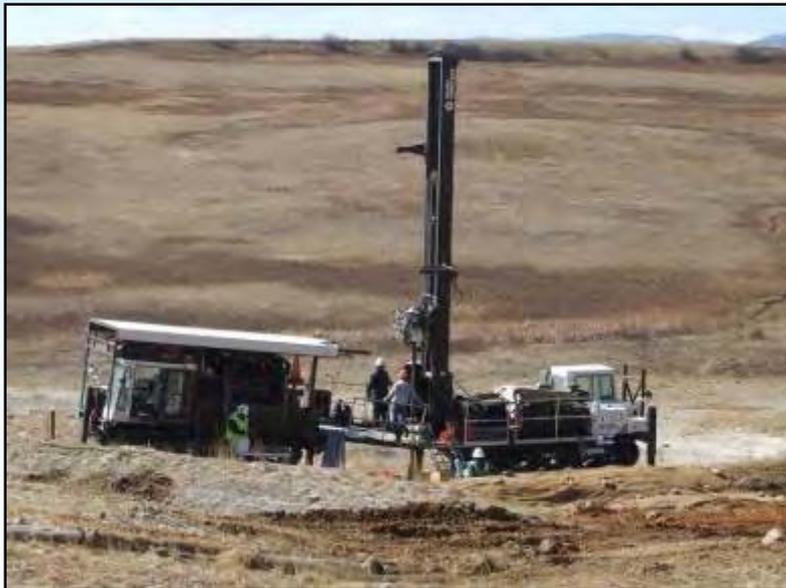
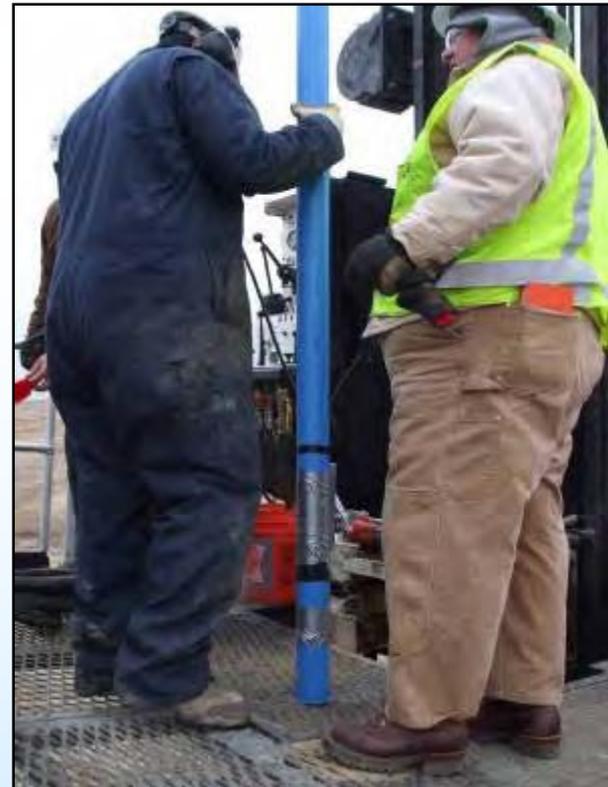
OLF Inclinator Deflection

- Settlement monuments were surveyed on June 23; data are within the expected range per the OLF Monitoring and Maintenance Plan
- Inclinometers were measured on April 29, May 13 and 14, and June 11 and 16, 2009
- Results showed higher deflection for several inclinometers, most noticeable for the three inclinometers on the west side of the OLF, between diversion Berms 1 and 3 (inclinometers 82208I, 82308I, and 82408I) where deflection was approximately 1.5 to 2.25 inches

- Seven inclinometers installed in boreholes in 2008 during OLF geotechnical investigation
 - Inclinometers deflect with lateral ground movement

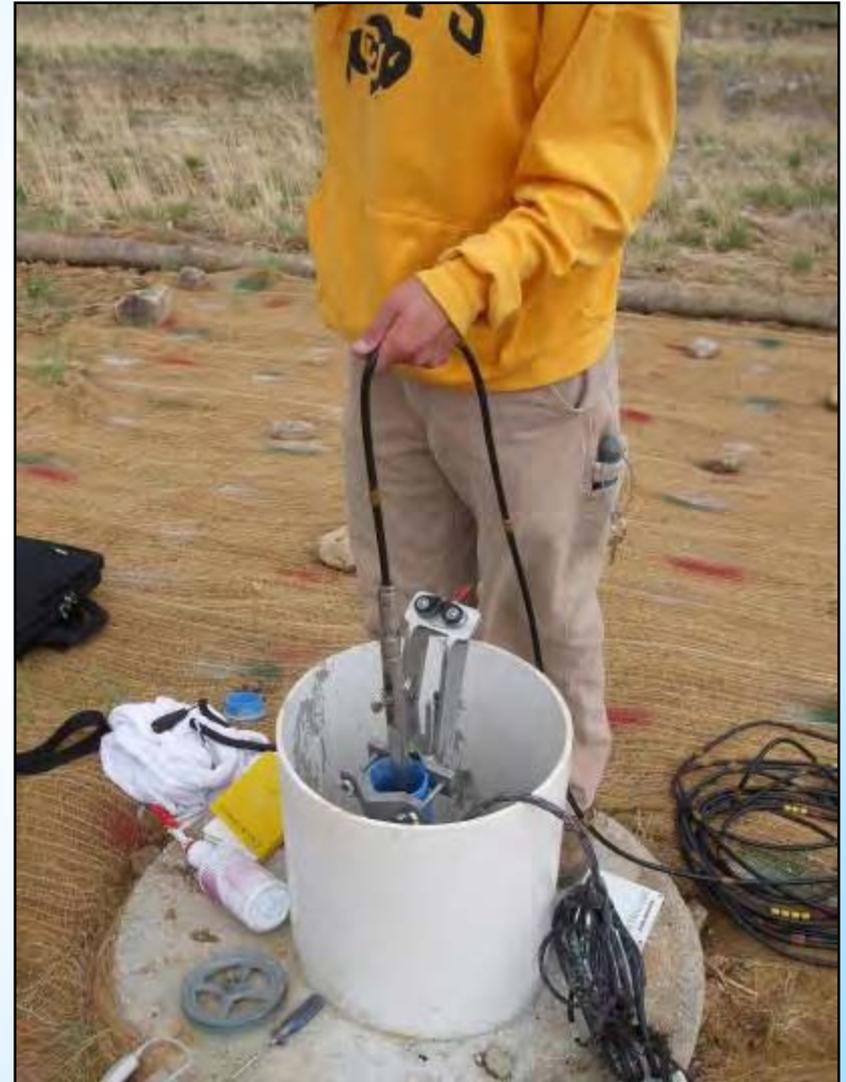
- Movement of the inclinometers has been monitored approximately monthly since installation

- Deflection occurred after a period of heavy precipitation events beginning in April 2009
- Deflection appears consistent with findings from geotechnical investigation: organic layer near bedrock creates weak zone for overlying soil. When lubricated by subsurface moisture from precipitation events, localized movement of the surface soil may occur.
- A qualified geotechnical engineer is evaluating further inclinometer data
- Indicated that signs of localized movement on the cover surface may occur – slumping noted

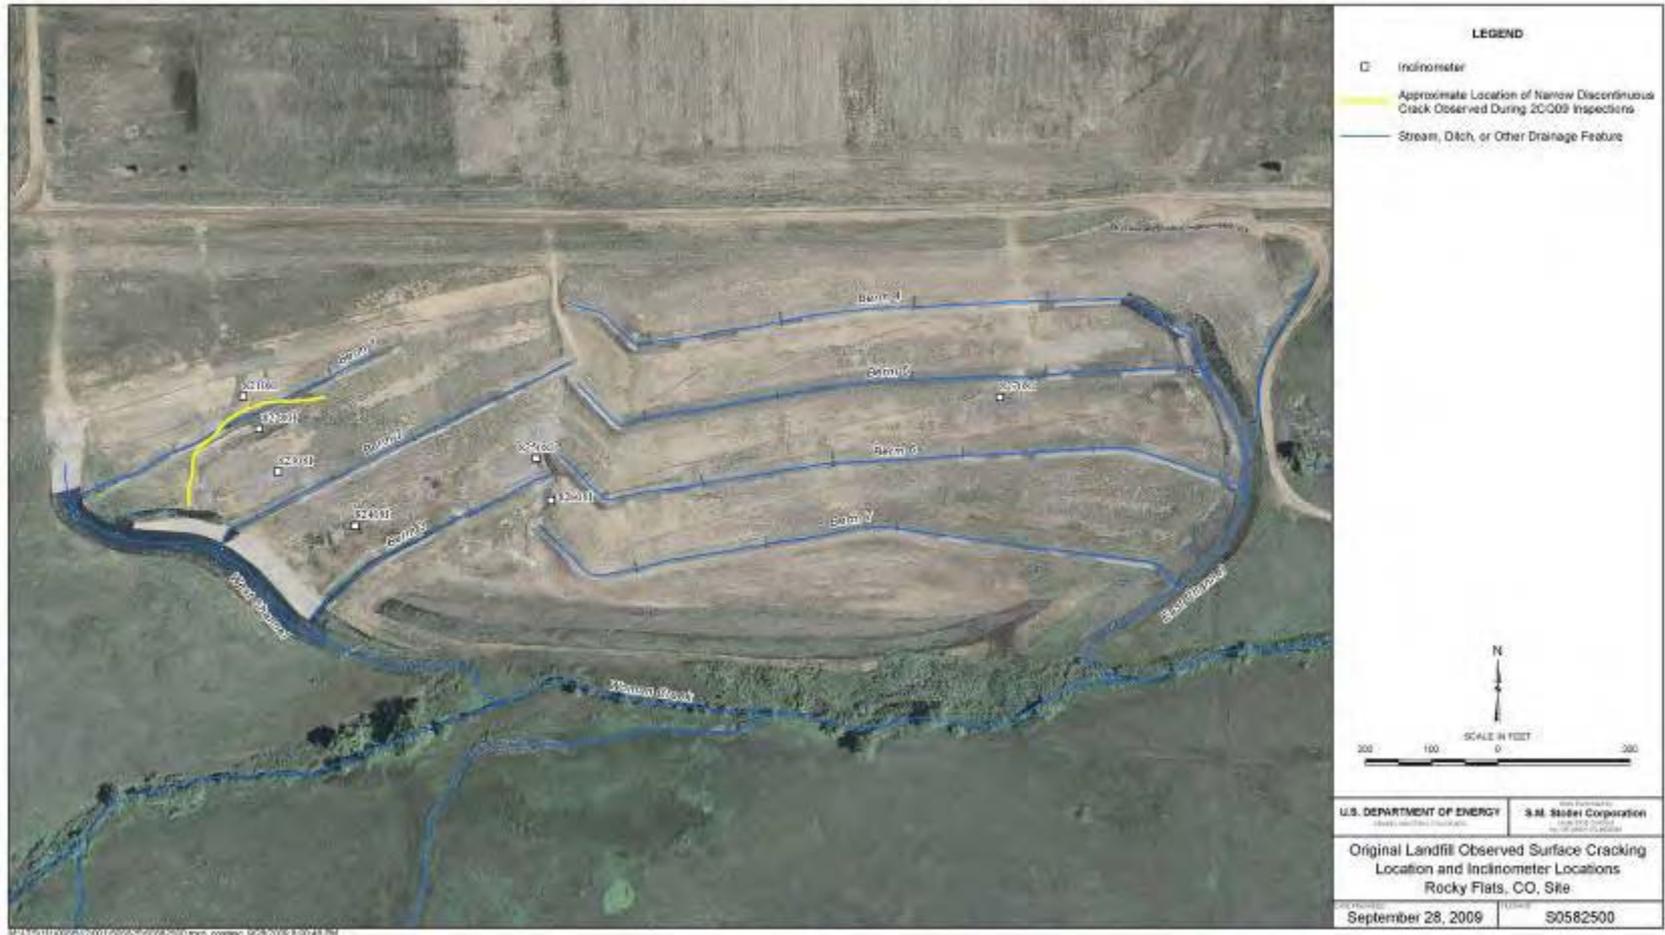
OLF Observed Crack Location

- Areas where the landfill cover is pushed up or rolling are noticeable on the western end of the OLF between Berms 2 and 3; however, the areas do not have any surface cracks at this time
- A new crack in Berm 1 was observed on April 4, 2009. The crack extended for a short distance through diversion Berm 1 to the north side of the berm and then back to the south side of the berm.
- These cracks were in the same general location of large cracks that appeared in 2006 and 2007
- Completed West Perimeter Channel regrading and channel drain in 2008 to improve stability. Slump not as severe as that noted in 2007.

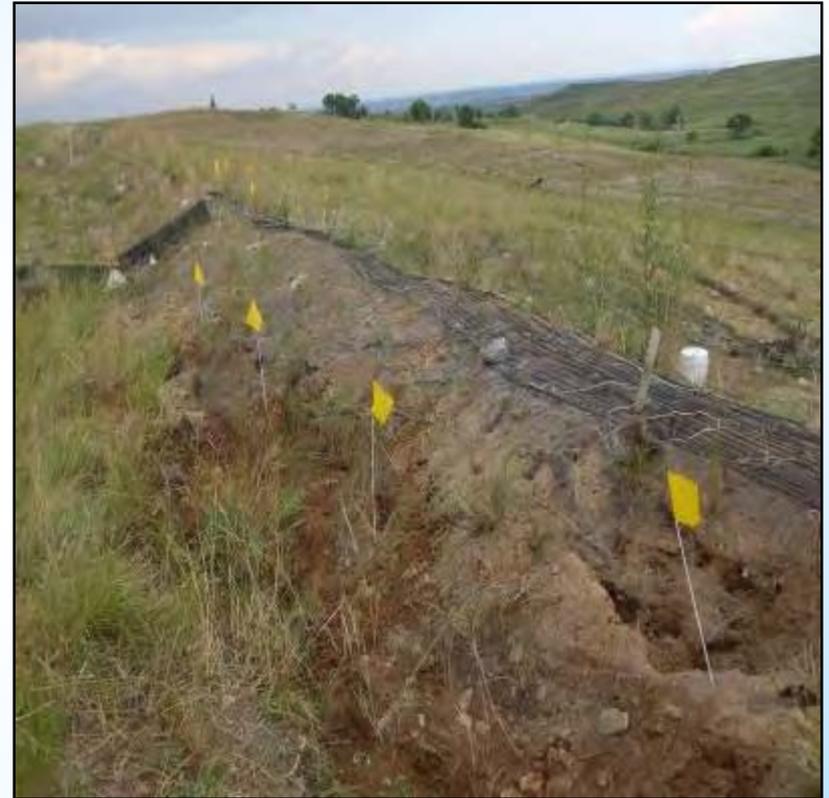
- Continue maintenance actions to fill cracking to minimize infiltration of precipitation
- The main crack in Berm 1 was observed again on June 20, 2009
- Site staff again repaired the crack with hand tools and the ATV bucket
- Subsequent nonroutine inspections have shown no new movement in the area where the crack was repaired
