Appendix C: Landfill Inspection Forms - Fourth Quarter CY 2011

C.1 Original Landfill

ORIGINAL LANDFILL – MONITORING AND MAINTENANCE PLAN INSPECTION FORM

Original Landfill October 2011 Monthly Inspection—Attachment 1

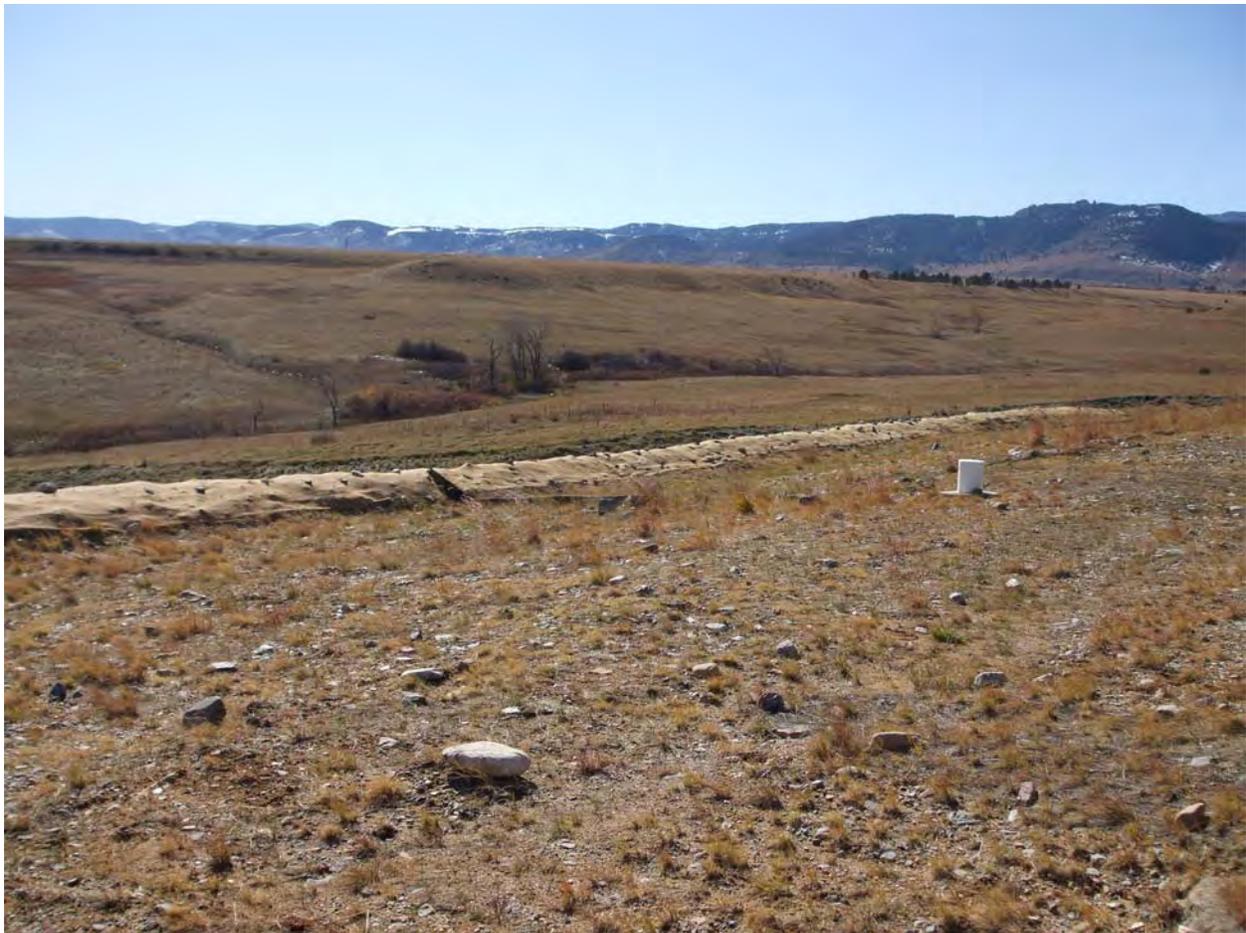
Berm 1

Berm locations that were re-graded during the OLF Maintenance 2011 Project remained in good condition. Vegetation in the West Perimeter Channel continues to establish slowly.

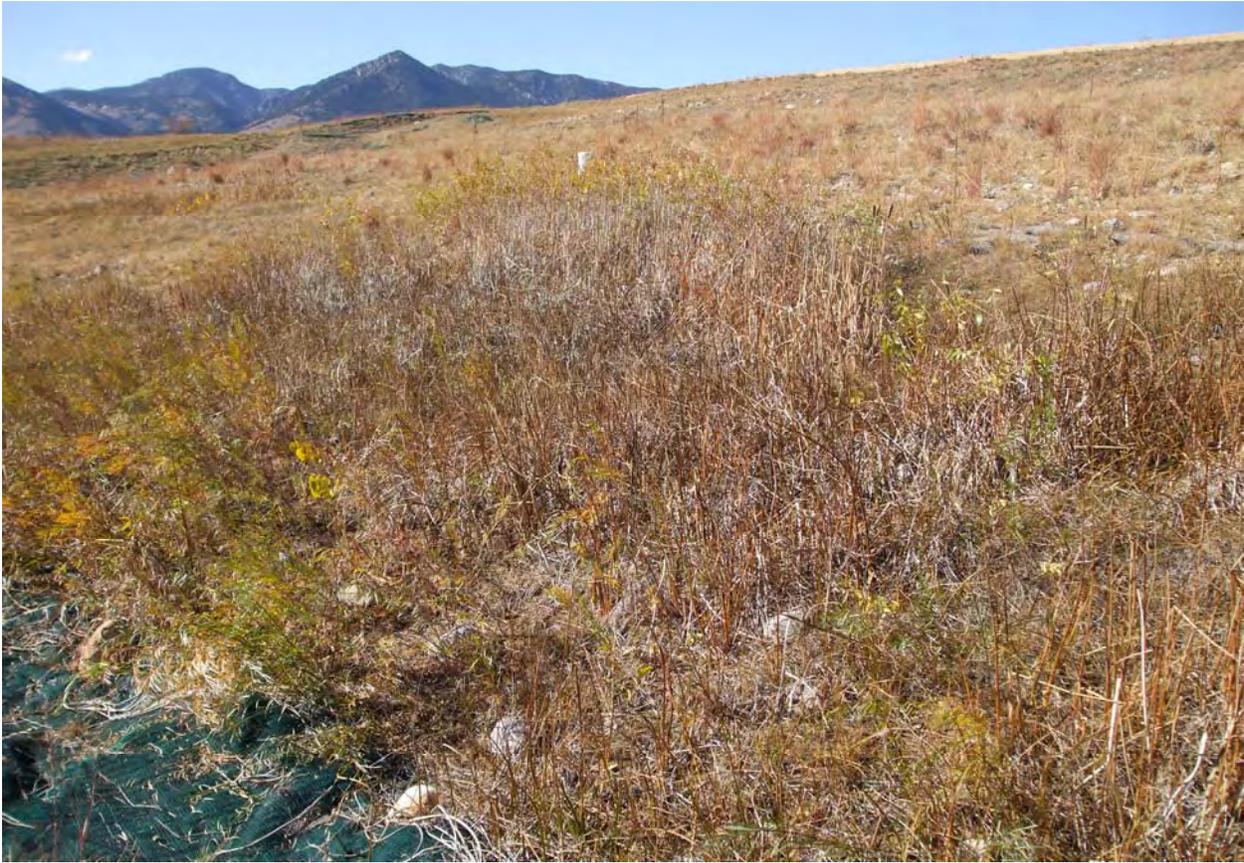
Seep 4 and 5 Area

The Seep 1 area was dry, as usual. The area around Seeps 2 and 3 were dry and showed no surface expression. The area around Seeps 4 and 5 had some surface expression that was draining through the berm 3 drain as designed. The Seep 6 area has three locations above berm 7 that were dry. The Seep7 area was saturated, but had no surface flow. Surface flow at Seep 8 continues at a rate of approximately 1 gpm. The seep locations continue to support small amounts of wetland vegetation even though drier conditions are present.

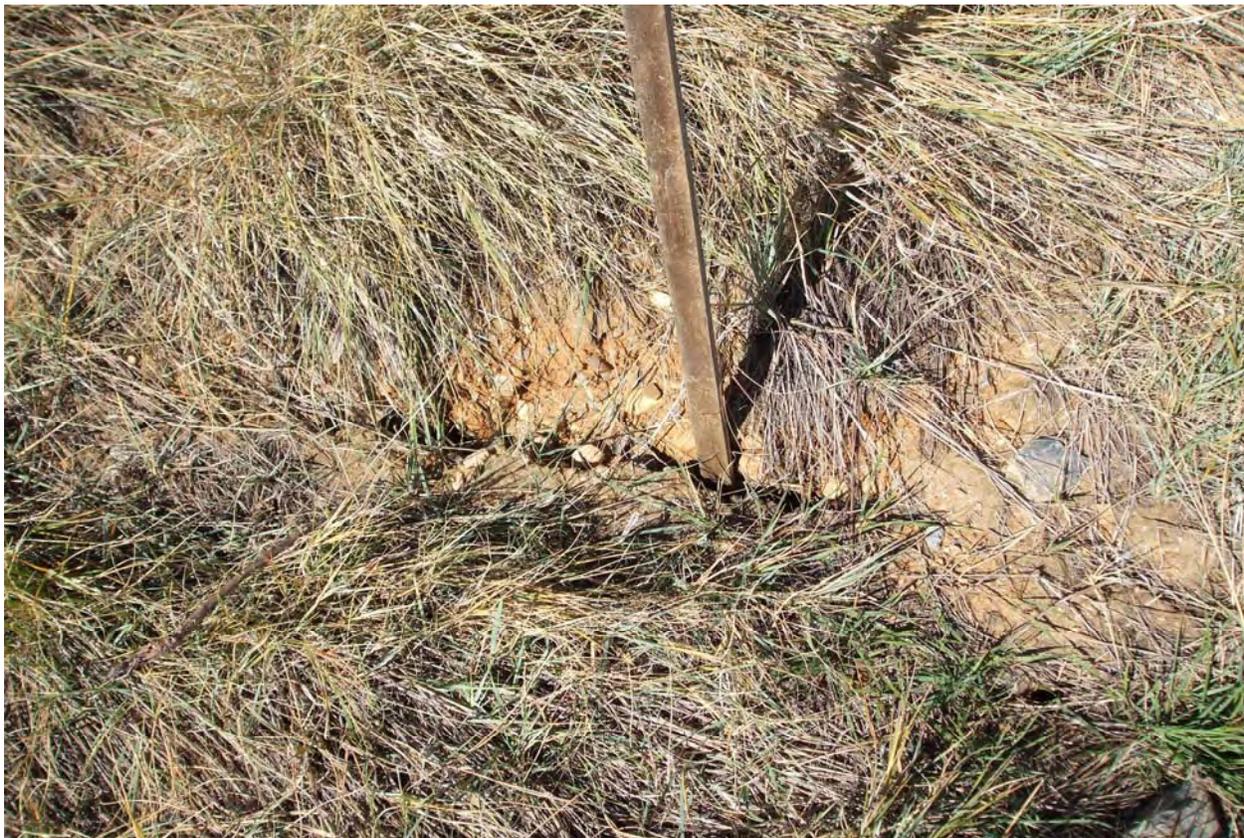
A few small cracks were observed on the OLF cover during the monthly inspection. One crack was located between berm 1 and berm 2 towards the middle of the landfill. This crack is in the area where the berm 1 subsidence was located and likely is associated with the movement of the slumping area. The crack was approximately 4 feet long and 2 inches wide.

Crack between Berm 1 and Berm 2

DEFICIENCY	DATE NOTED	ACTION	DATE COMPLETED	COMMENTS
Repair cracks below berm 1, above berm 4, and above berm 7 next to EPL.	10/31/11	Fill and compact cracks with RF Alluvium.	* Repairs will be completed by site staff ASAP.

All observed cracks will be filled with Rocky Flats Alluvium and compacted. These repairs prevent precipitation from entering the cracks which may cause further movement.

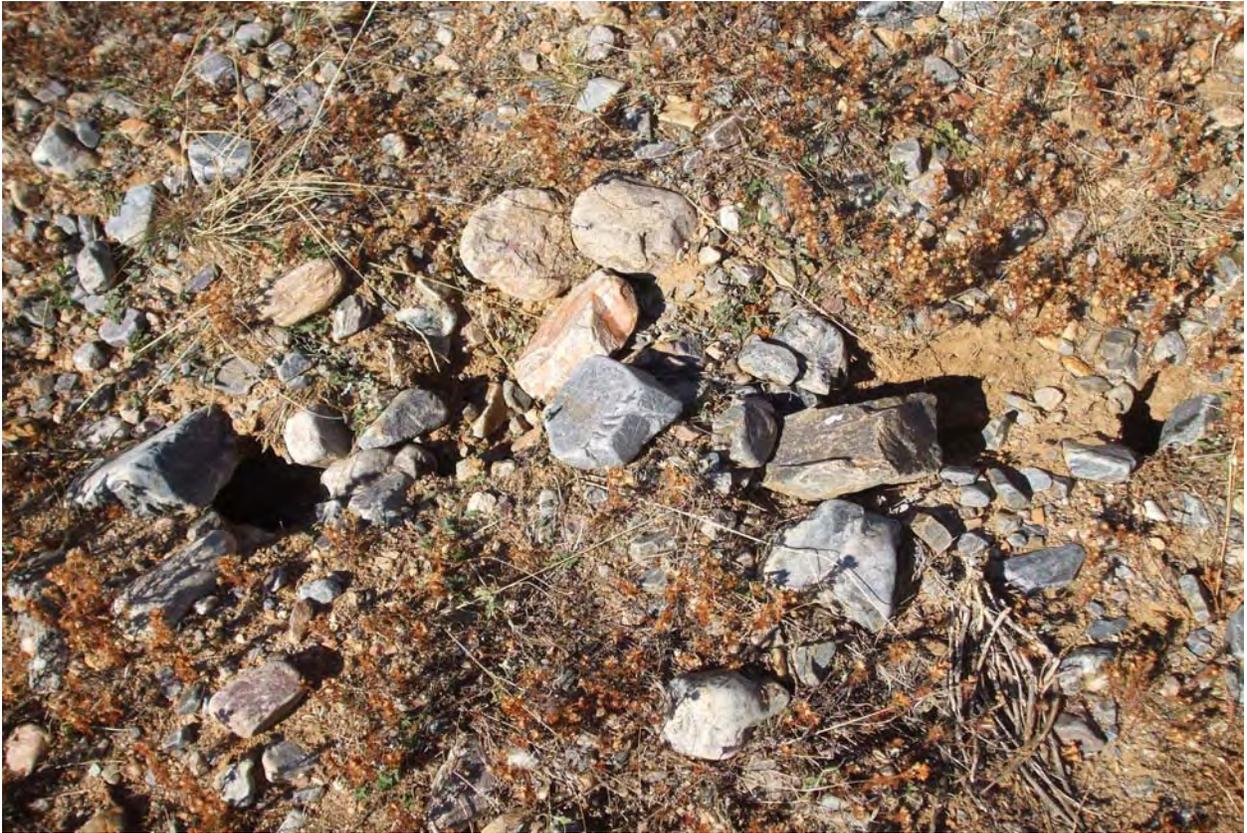
Another crack was observed above the EPC towards the end of berm 4. This crack is approximately 3 feet long and 2 inches wide. Cracks have been previously observed in this location. According to the geotechnical engineer, these cracks are attributed to the steep headwall at the top of the EPC.

Crack above EPC

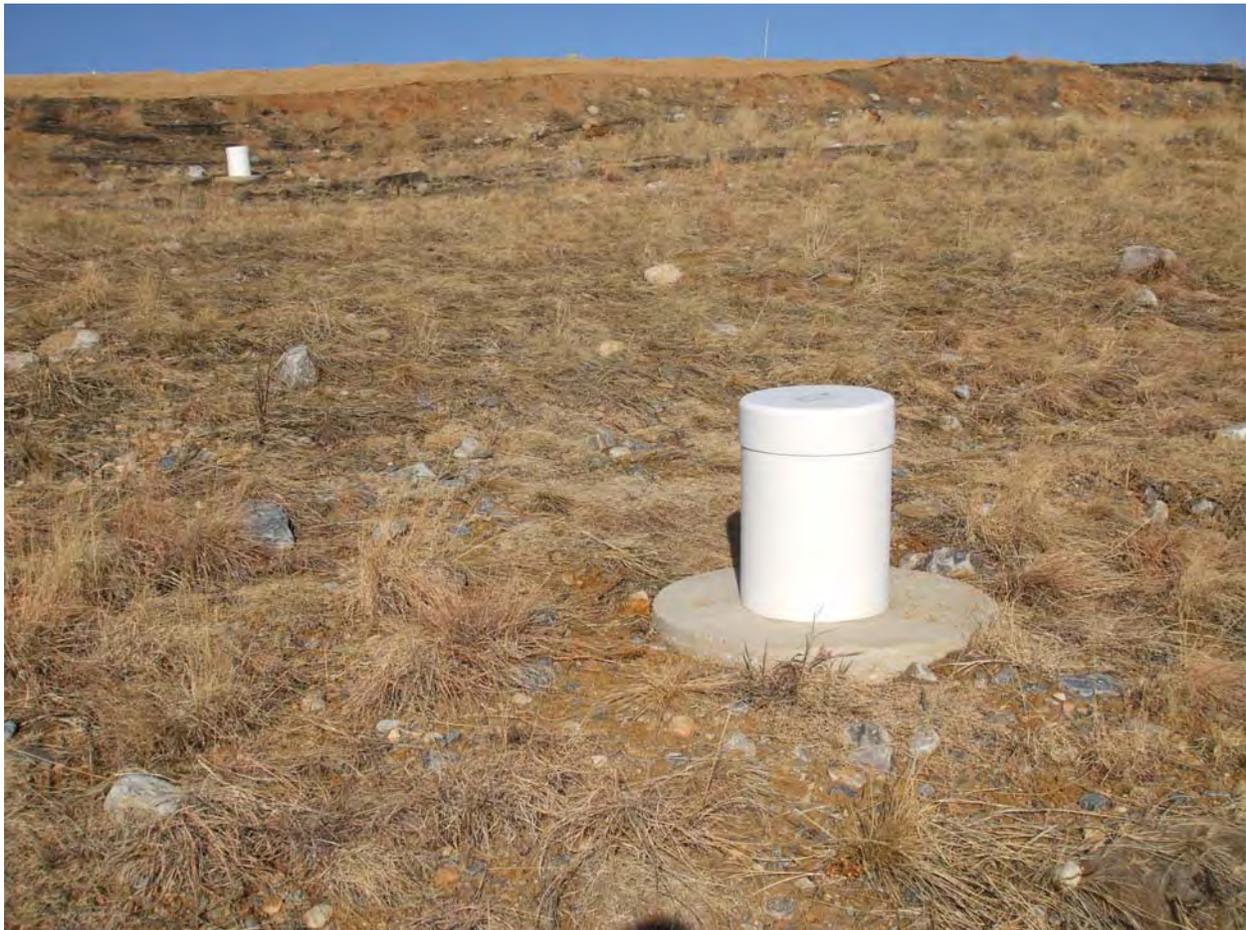
Inclinometers and Settlement Monuments are used to monitor movement on the landfill cover. Inclinometers are downloaded monthly and Settlement Monuments are surveyed quarterly. Very little movement has been observed on the OLF cover since December 2010.

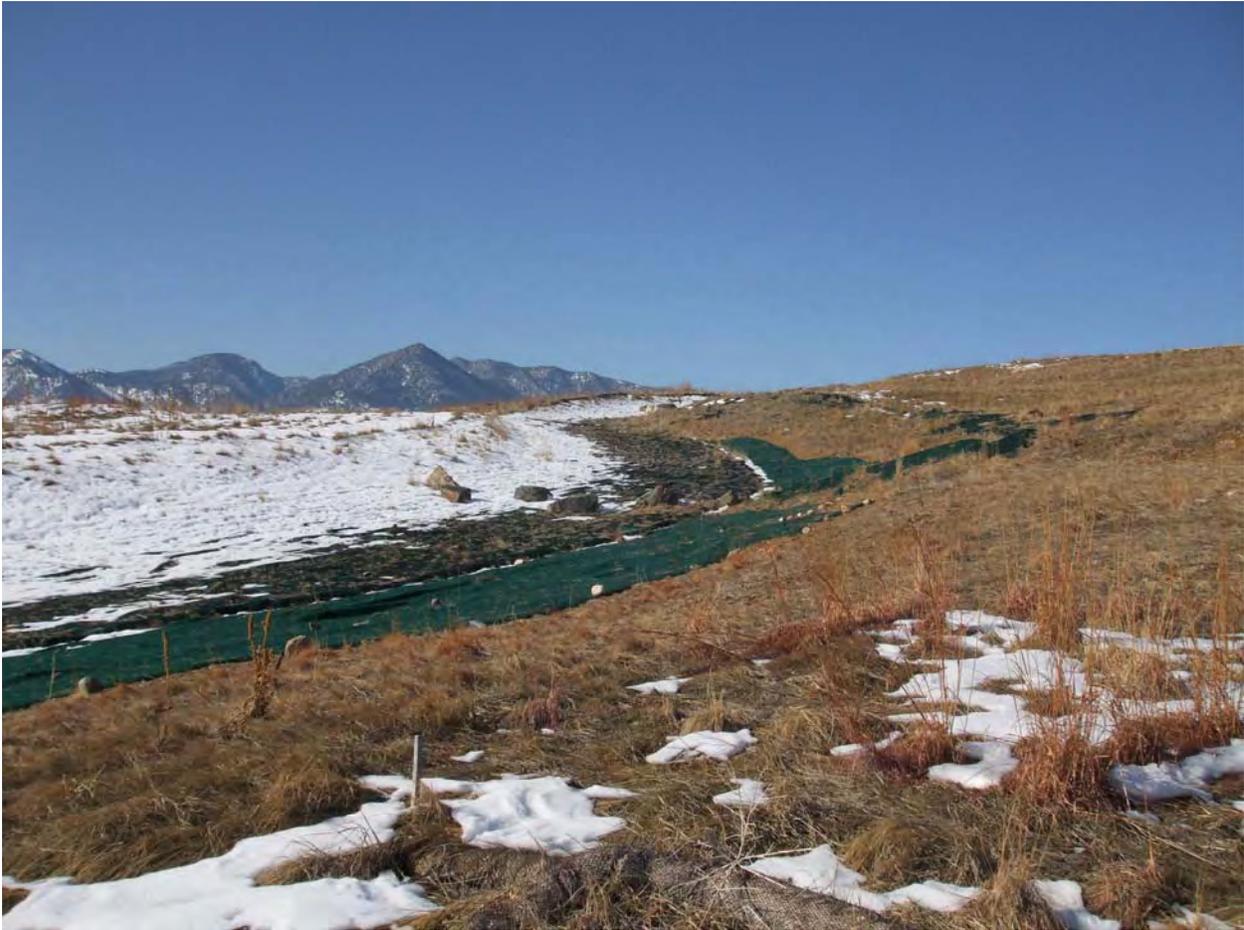
West Perimeter Channel

Berm locations that were re-graded during the OLF Maintenance 2011 Project remained in good condition. Vegetation on the landfill cover including the seep areas is now dormant.

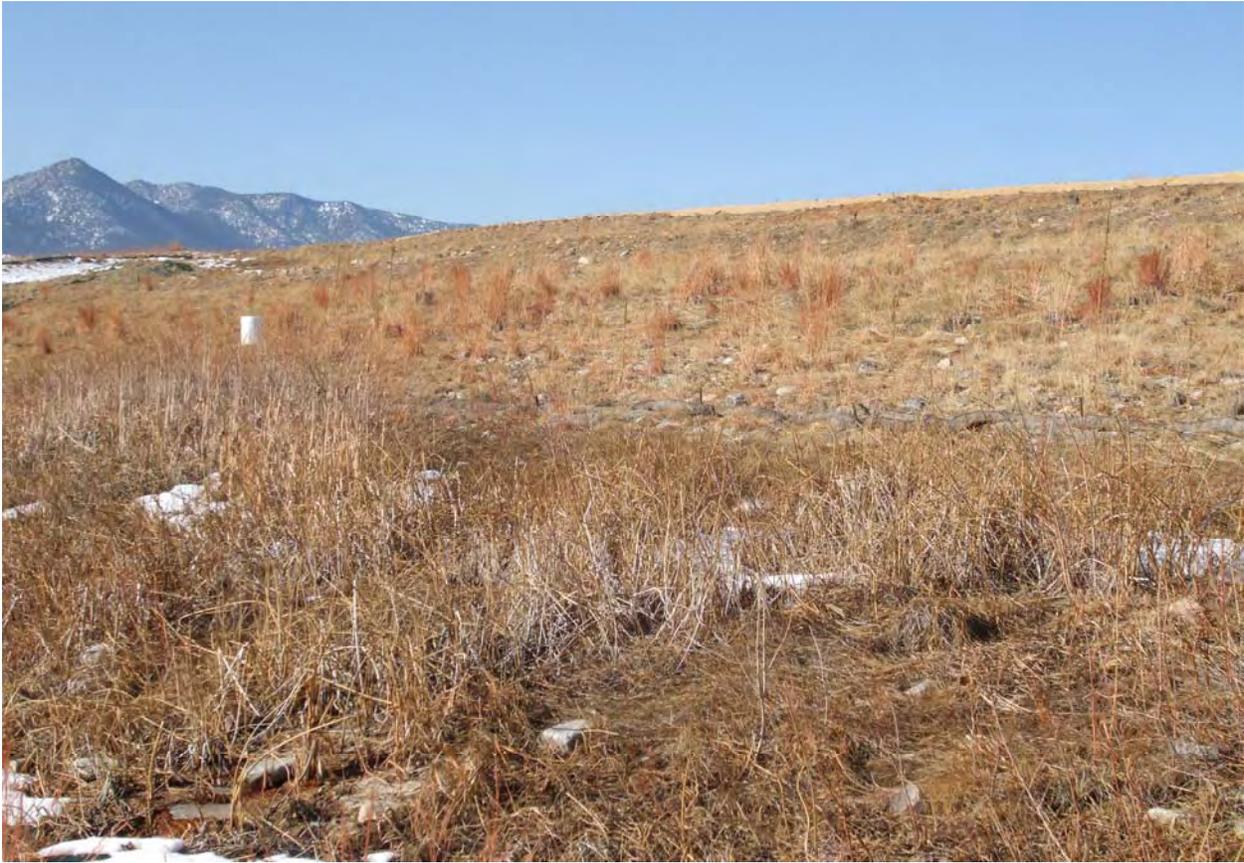
Seep 4 and 5 Area

All of the seep locations, except for seep 8, were dry at the time of this inspection. Seep 8 continues to flow at a rate of approximately 1 gpm.

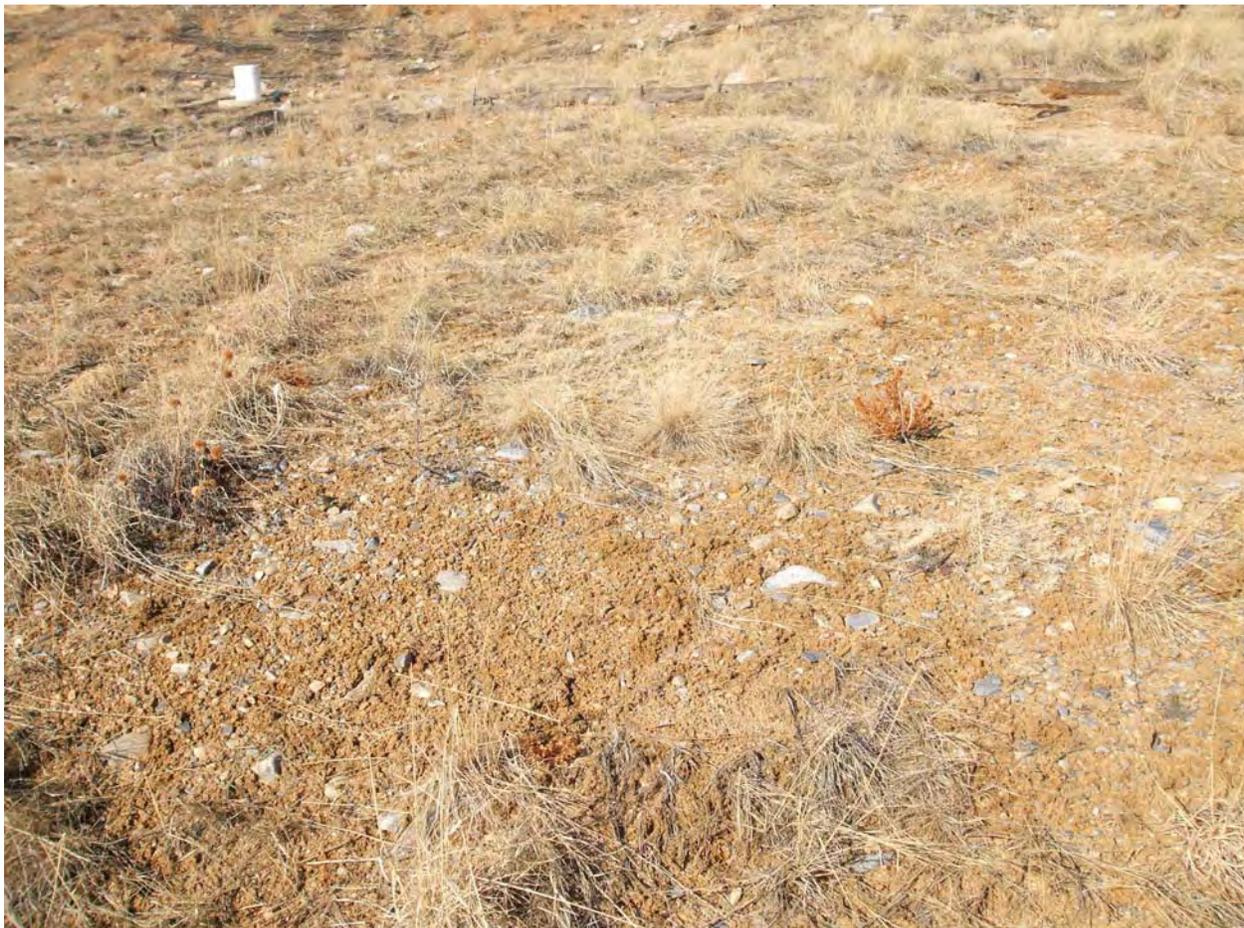
A few small cracks were observed on the OLF cover during the October monthly inspection. One crack was located between berm 1 and berm 2 towards the middle of the landfill. This crack is in the area where the berm 1 subsidence was located and likely is associated with the movement of the slumping area. The crack was approximately 4 feet long and 2 inches wide.

Repaired crack location below Berm 1

DEFICIENCY	DATE NOTED	ACTION	DATE COMPLETED	COMMENTS
Small cracks observed below berm 1, above berm 4, and above berm 7 next to EPC	10/31/11	Fill and compact crack locations	11/15/11	-
Clean-out Geo-ridges	11/15/11	Remove vegetation from geo-ridges	11/15/11	Routine maintenance

All observed cracks were filled with Rocky Flats Alluvium and compacted. These repairs prevent precipitation from entering the cracks which may cause further movement.

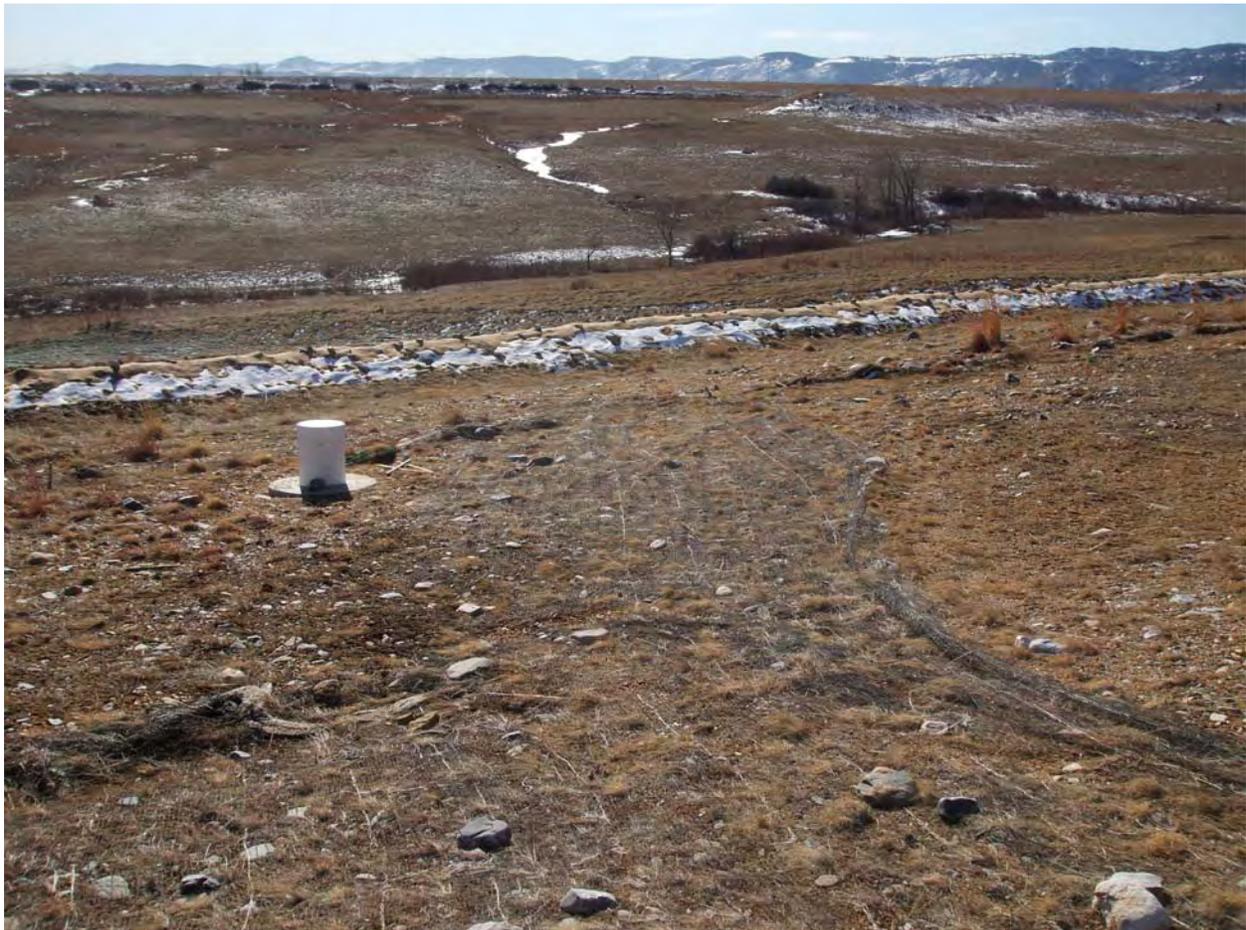
Berm 1 Area

Berm locations that were re-graded during the OLF Maintenance 2011 Project remained in good condition. Vegetation on the landfill cover including the seep areas remains dormant.

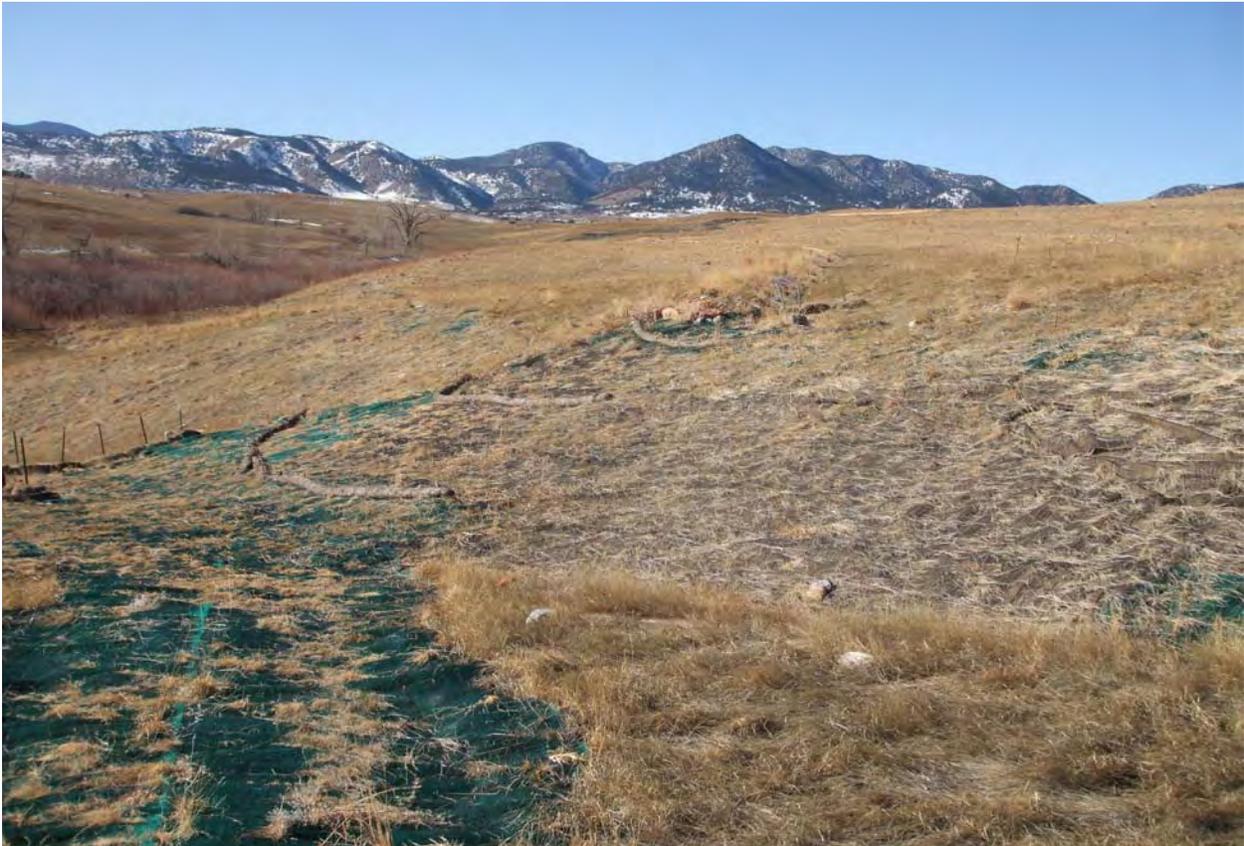
Berm 7 Outfall

STRUCTURE	CONDITION / SEDIMENT DEPTH
DIVERSION BERM OUTFALL 1	<i>Good condition / No sediment</i>
DIVERSION BERM OUTFALL 2	
DIVERSION BERM OUTFALL 3	
DIVERSION BERM OUTFALL 4	
DIVERSION BERM OUTFALL 5	
DIVERSION BERM OUTFALL 6	
DIVERSION BERM OUTFALL 7	
WEST PERIMETER CHANNEL OUTFALL	
EAST PERIMETER CHANNEL OUTFALL	
FRENCH DRAIN OUTFALL (SID)

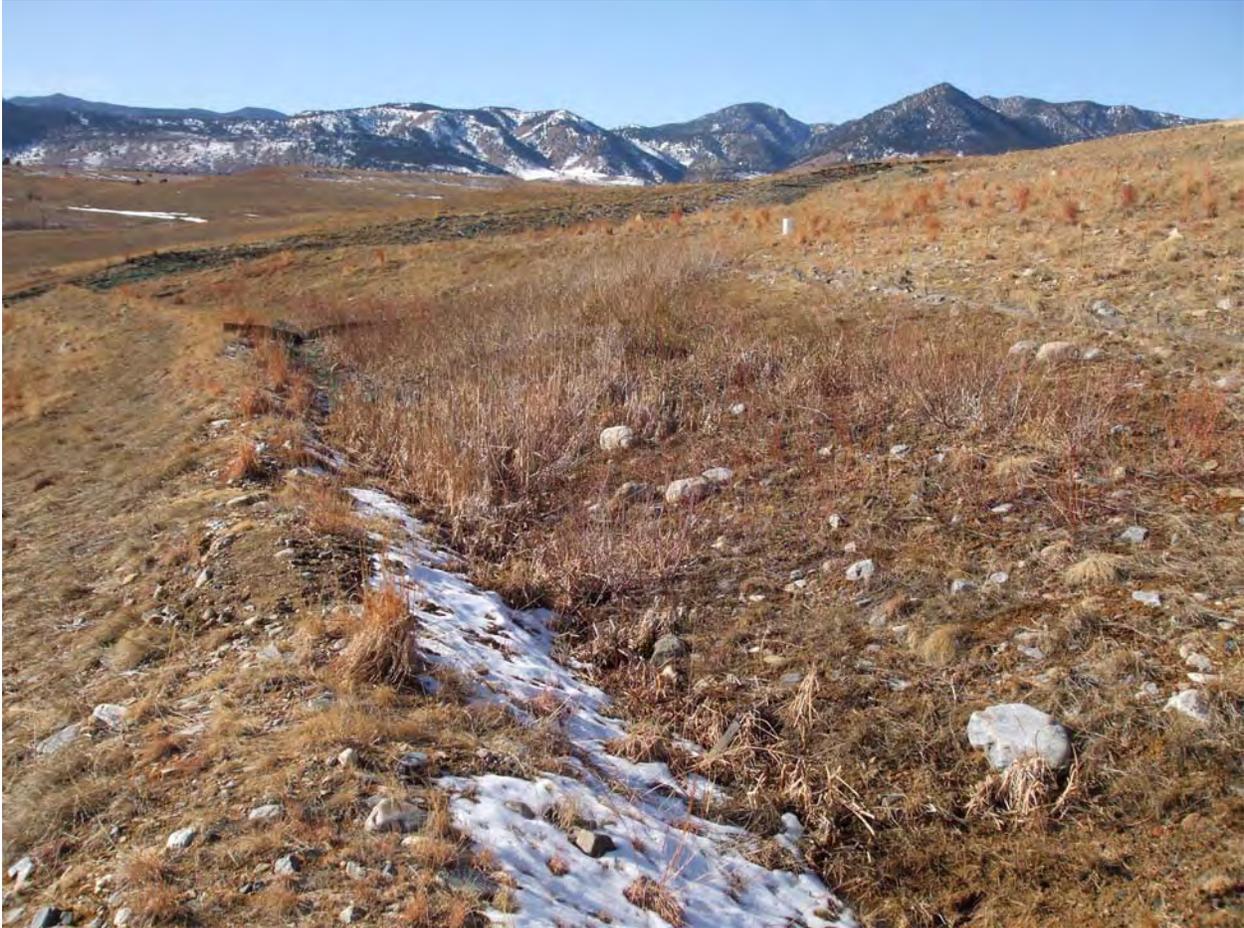
Seep 4 and 5 Area

All of the seep locations were saturated at the time of this inspection due to the melting of a recent snowfall. Seep 7 was flowing at a rate of approximately .5 gallons per minute (gpm). Seep 8 was flowing at 3-5 gpm. No other seeps produced any surface flow.

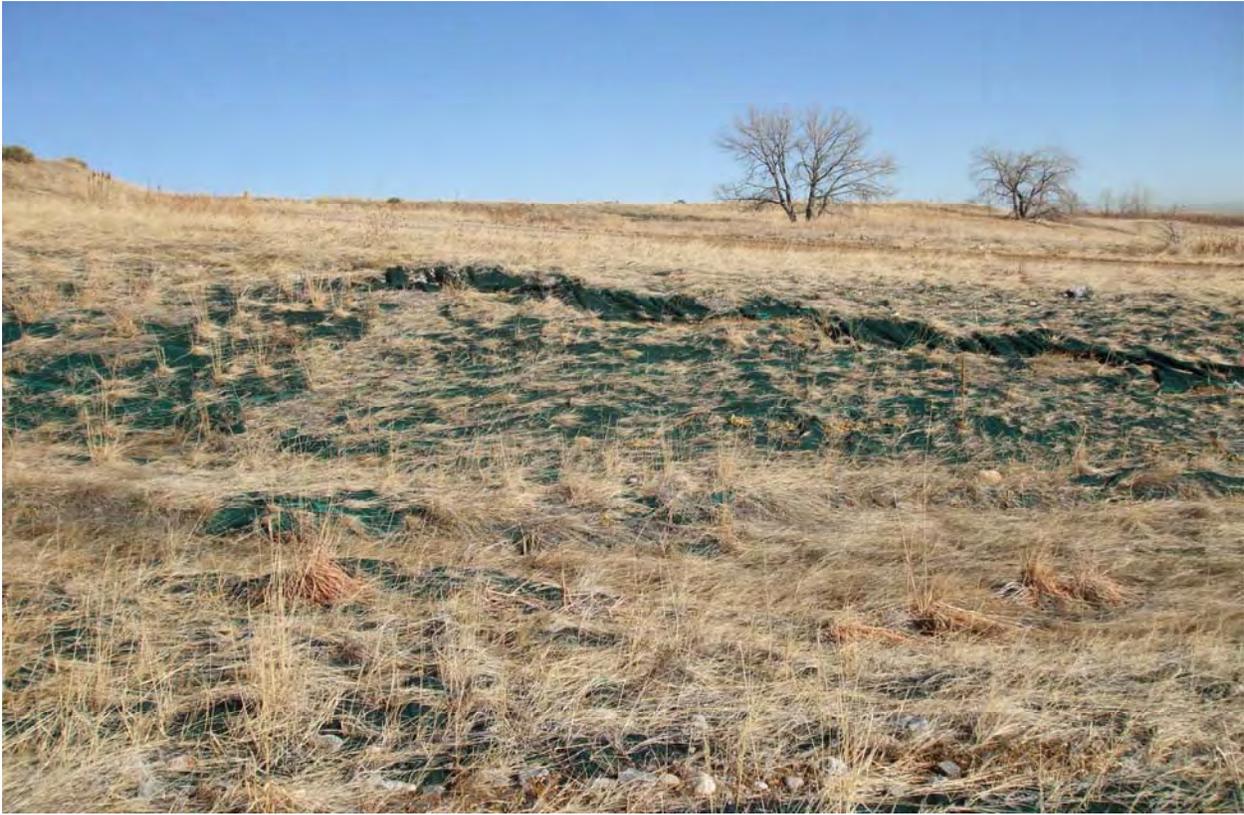
EPC Slump

The slump that was observed on the eastern slope of the EPC toward the top of the channel remains unchanged. The wooden stakes that were installed around the perimeter of the slumping area have not moved. No vertical displacement is apparent. We will continue to monitor the slumping area for any changes during routine and nonroutine inspections of the OLF.

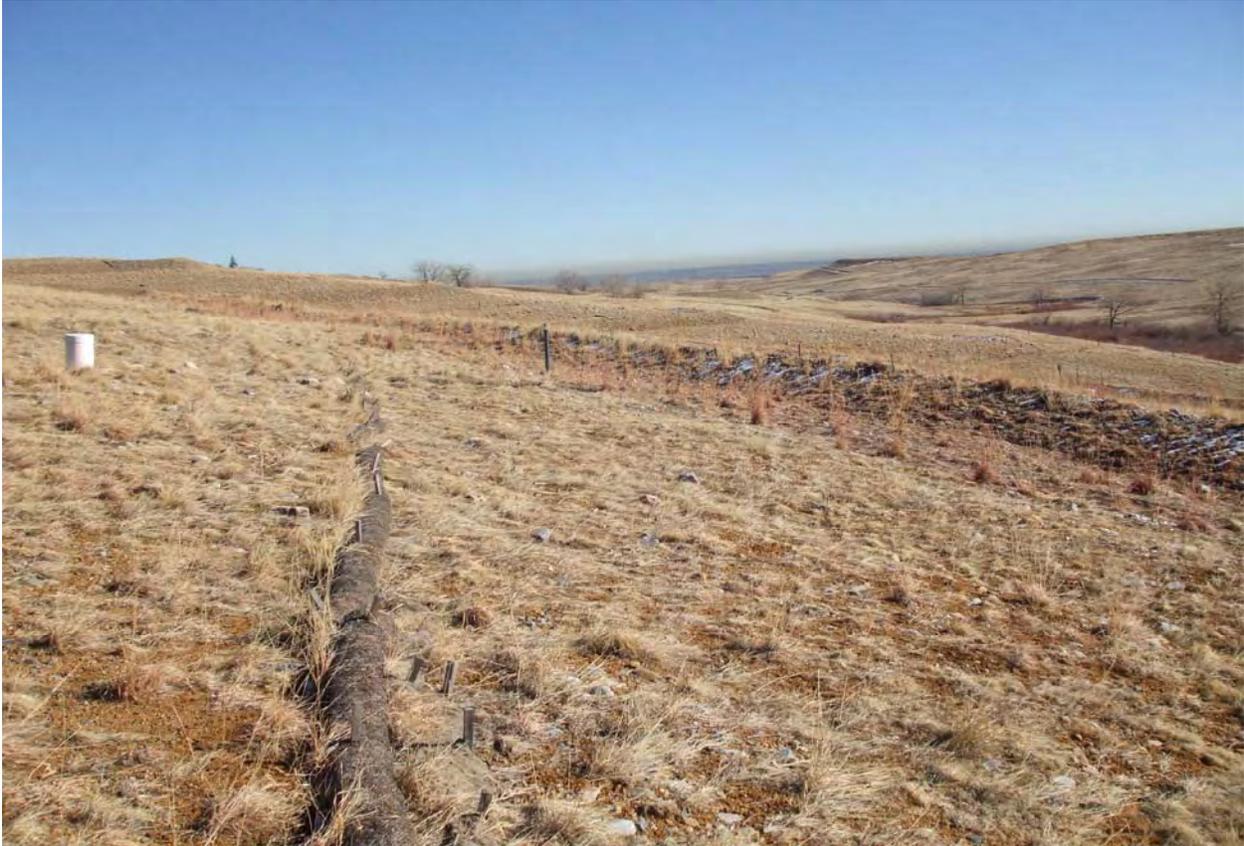
OLF Cover

The monthly inspection of the OLF was completed on December 23. The Rocky Flats Site received almost 1 inch of precipitation during the month of December. The cover was saturated at the time of the inspection and no new cracks were observed. The slump in the East Perimeter Channel (EPC) remained unchanged.
