Appendix C: Landfill Inspection Forms - Fourth Quarter CY 201&

C.1 Original Landfill

ORIGINAL LANDFILL – MONITORING AND MAINTENANCE PLAN INSPECTION FORM

Original Landfill October 2012 Monthly Inspection—Attachment 1

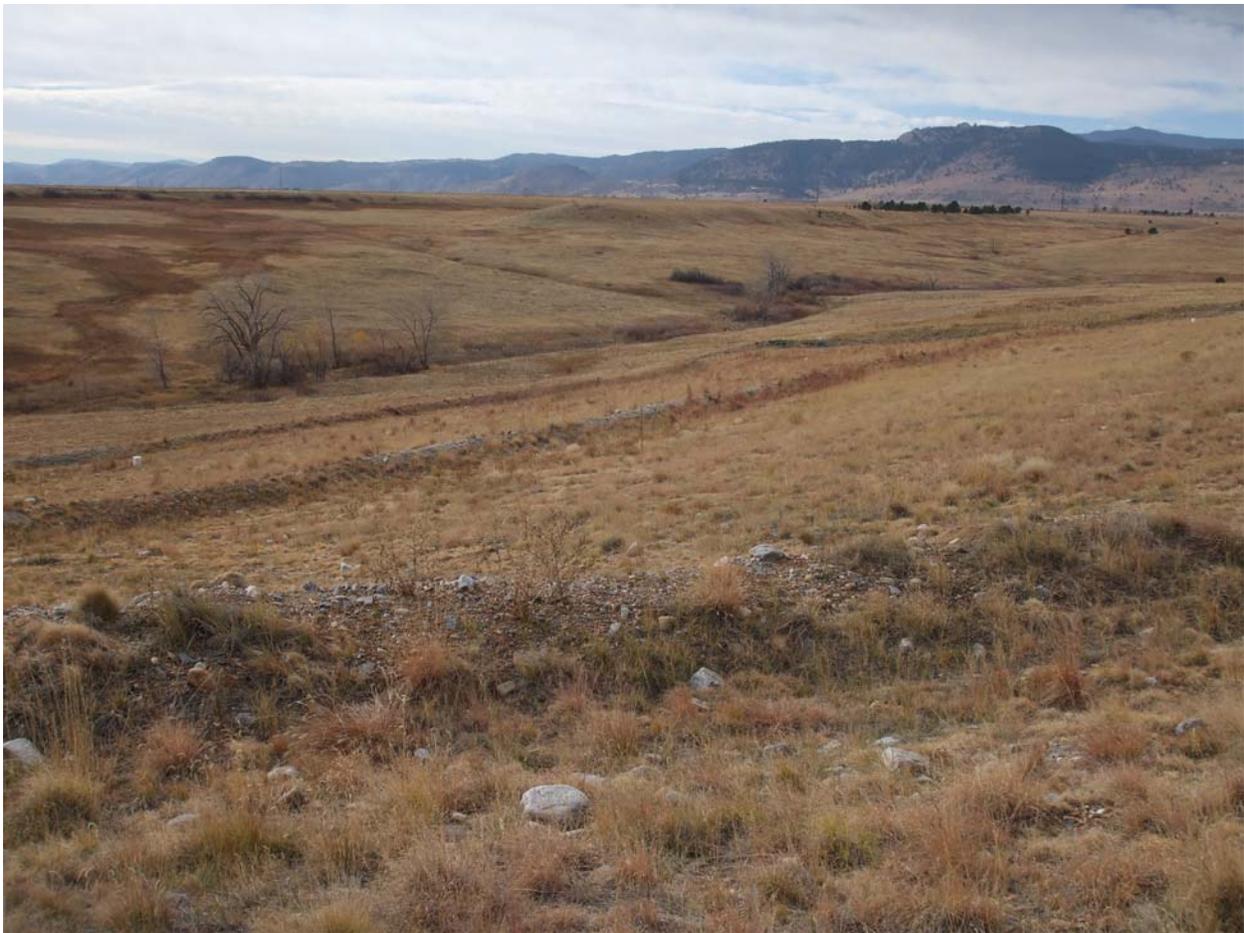
OLF Cover Facing Southwest

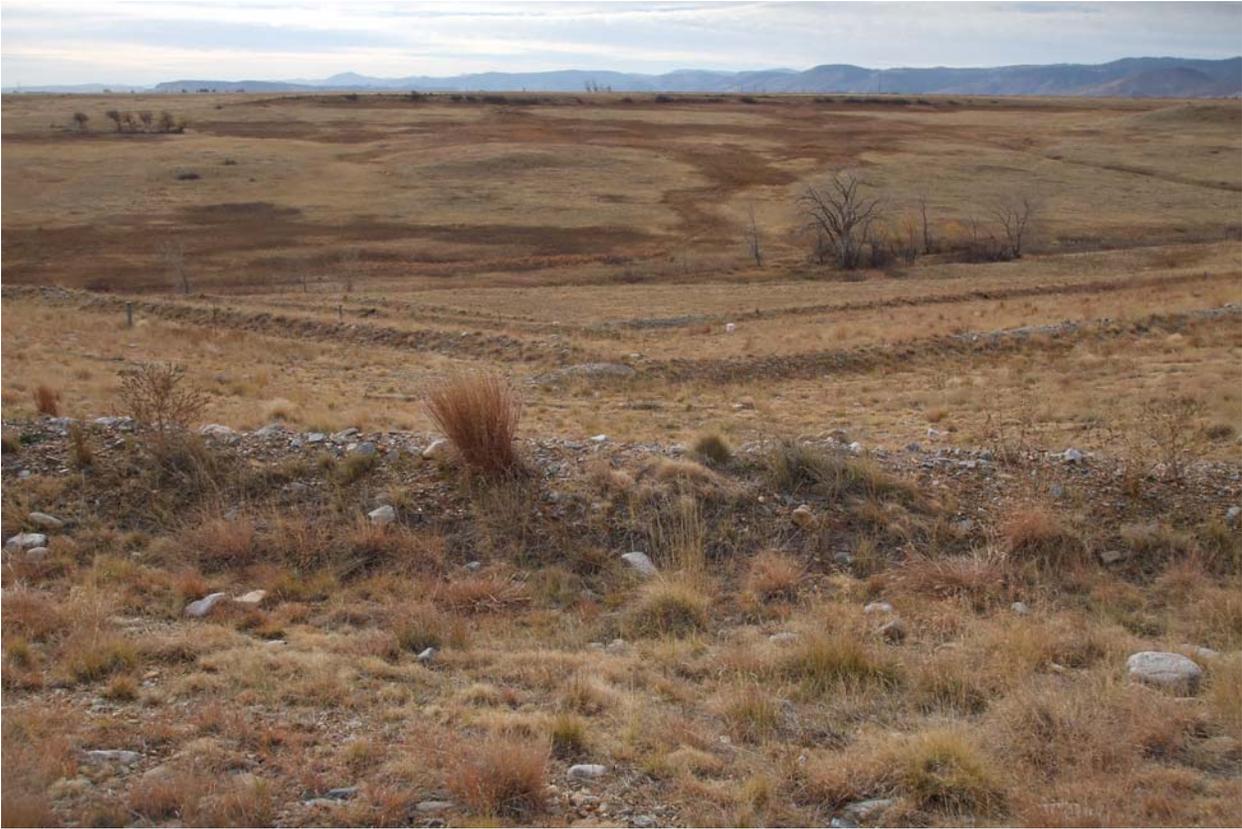
OLF Cover Facing South

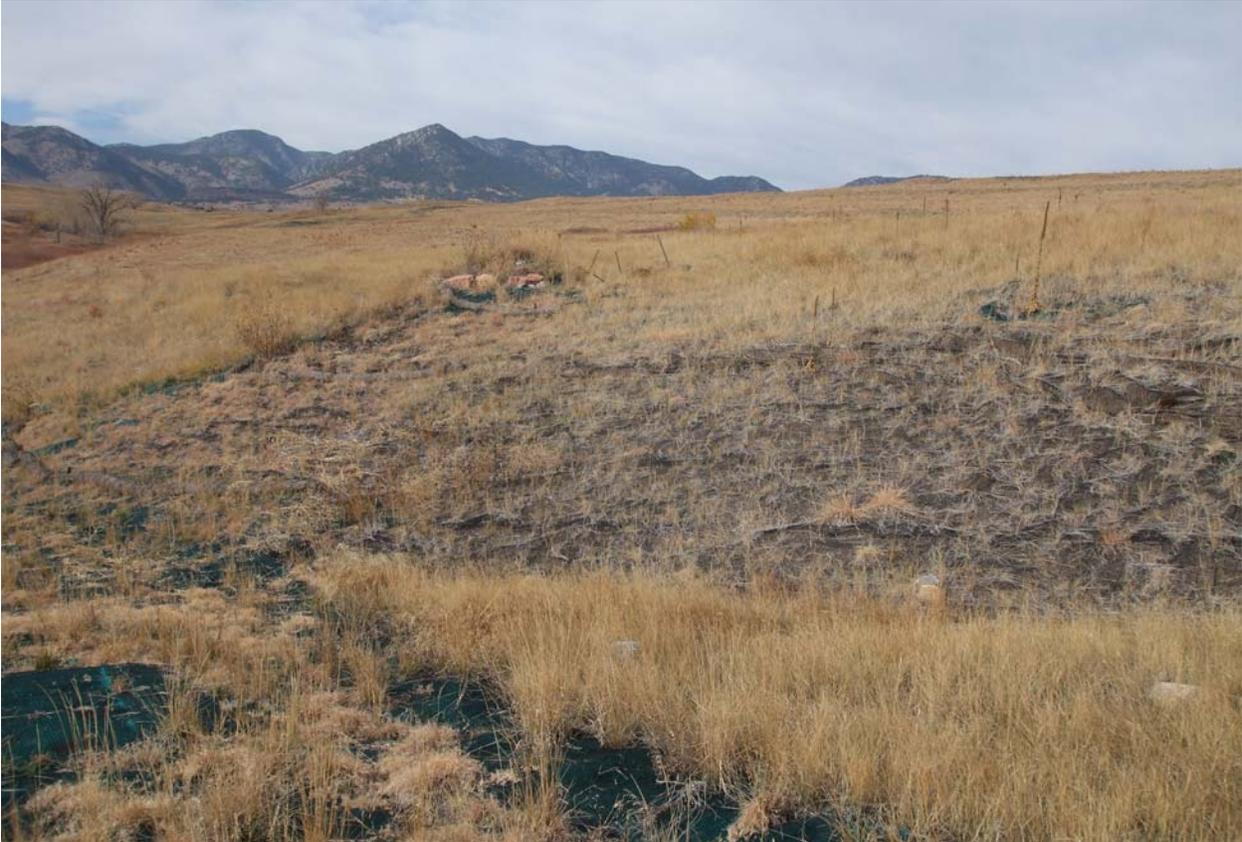
End of Berm 7

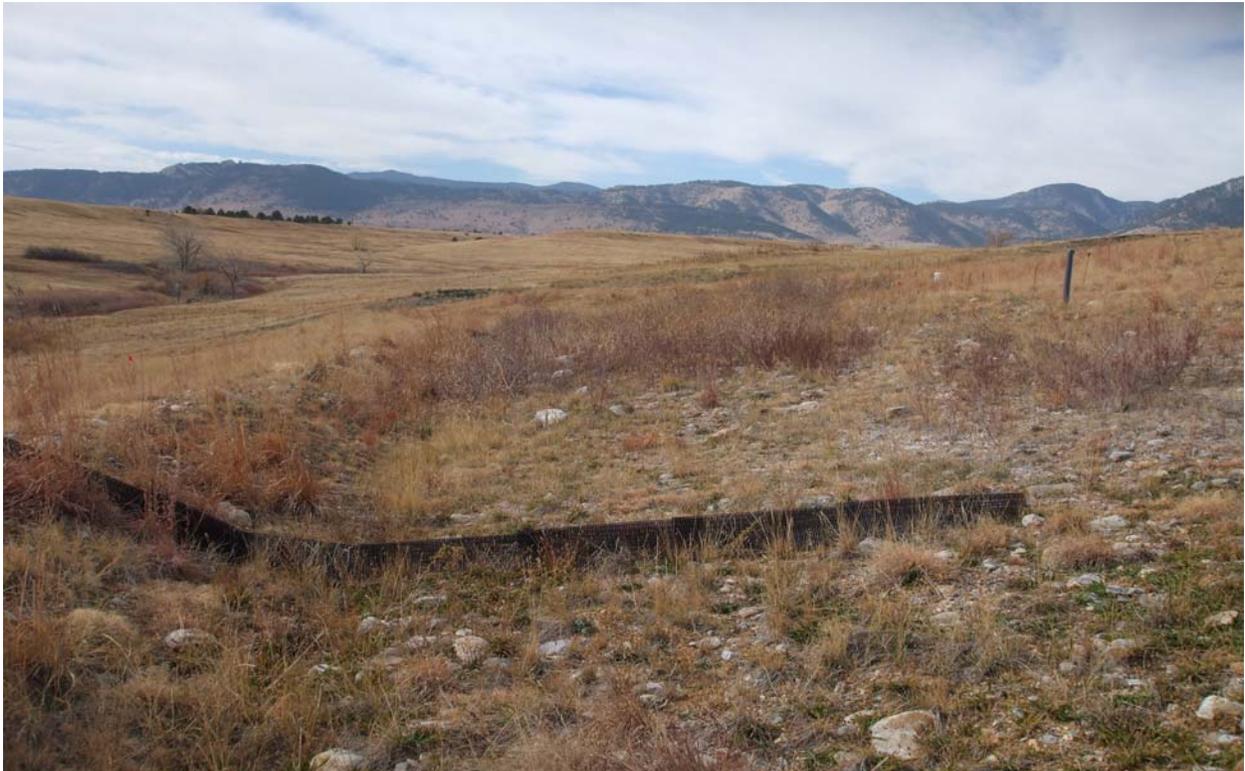
Seep 4 Area

The seep locations were dry at the time of this inspection except for Seep 8. Seep 8 was flowing at approximately .5 gallons per minute. Vegetation in the seep locations is primarily dormant.

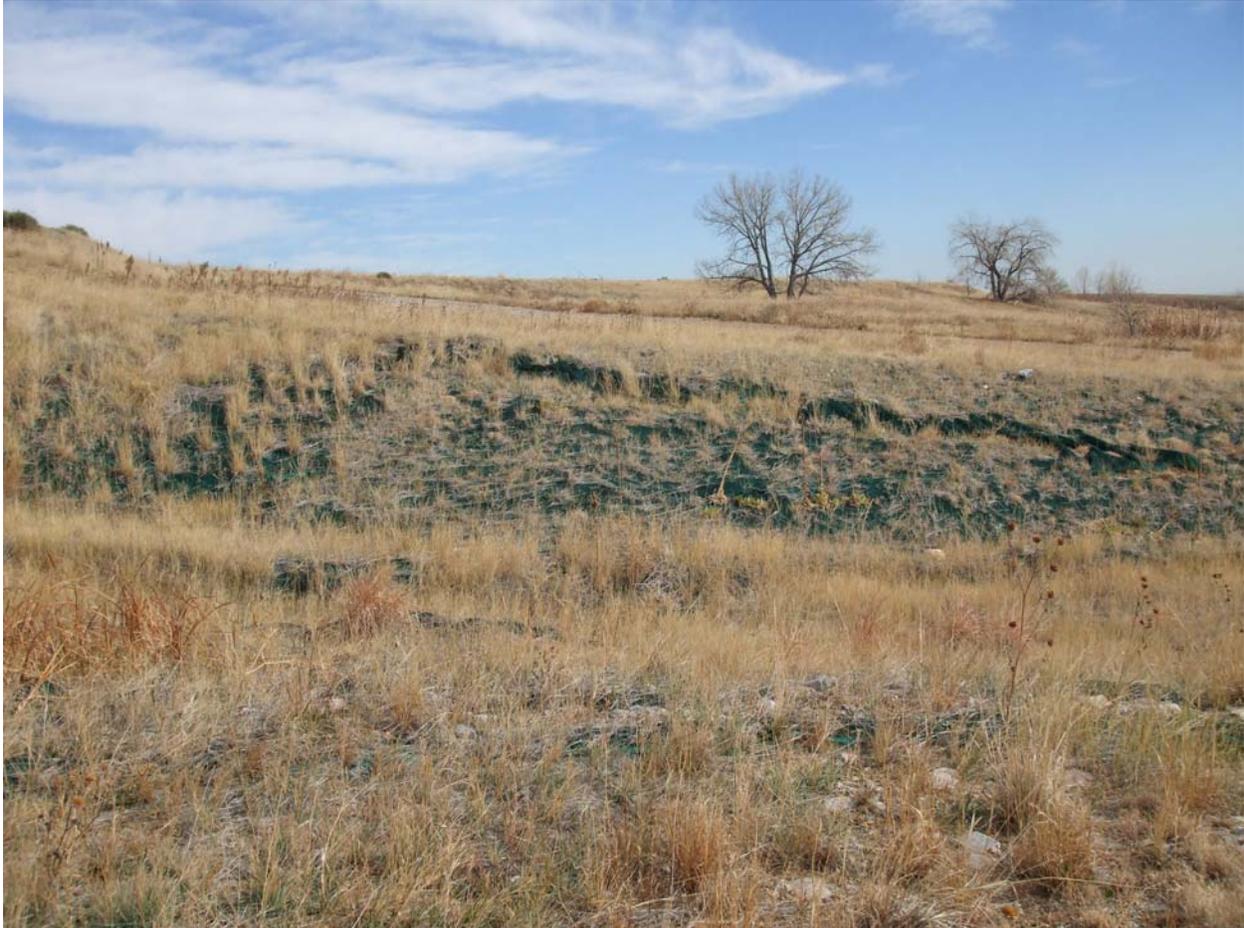
EPC Slump

The slump that was observed on the eastern slope of the EPC toward the top of the channel remains unchanged. The wooden stakes that were installed around the perimeter of the slumping area have not moved. No cracks are apparent. We will continue to monitor the slumping area for any changes during routine and nonroutine inspections of the OLF.

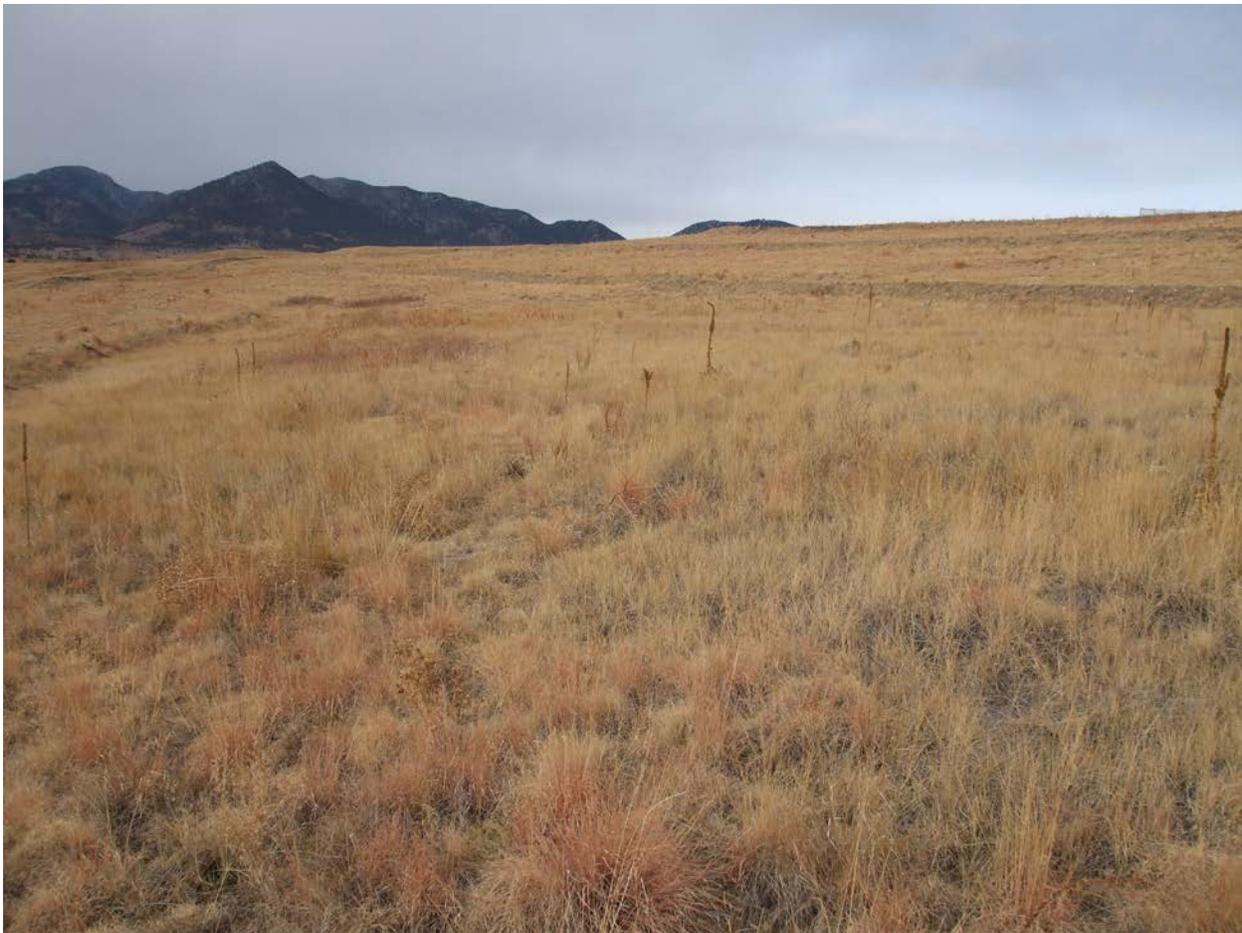
OLF Cover Facing Northwest

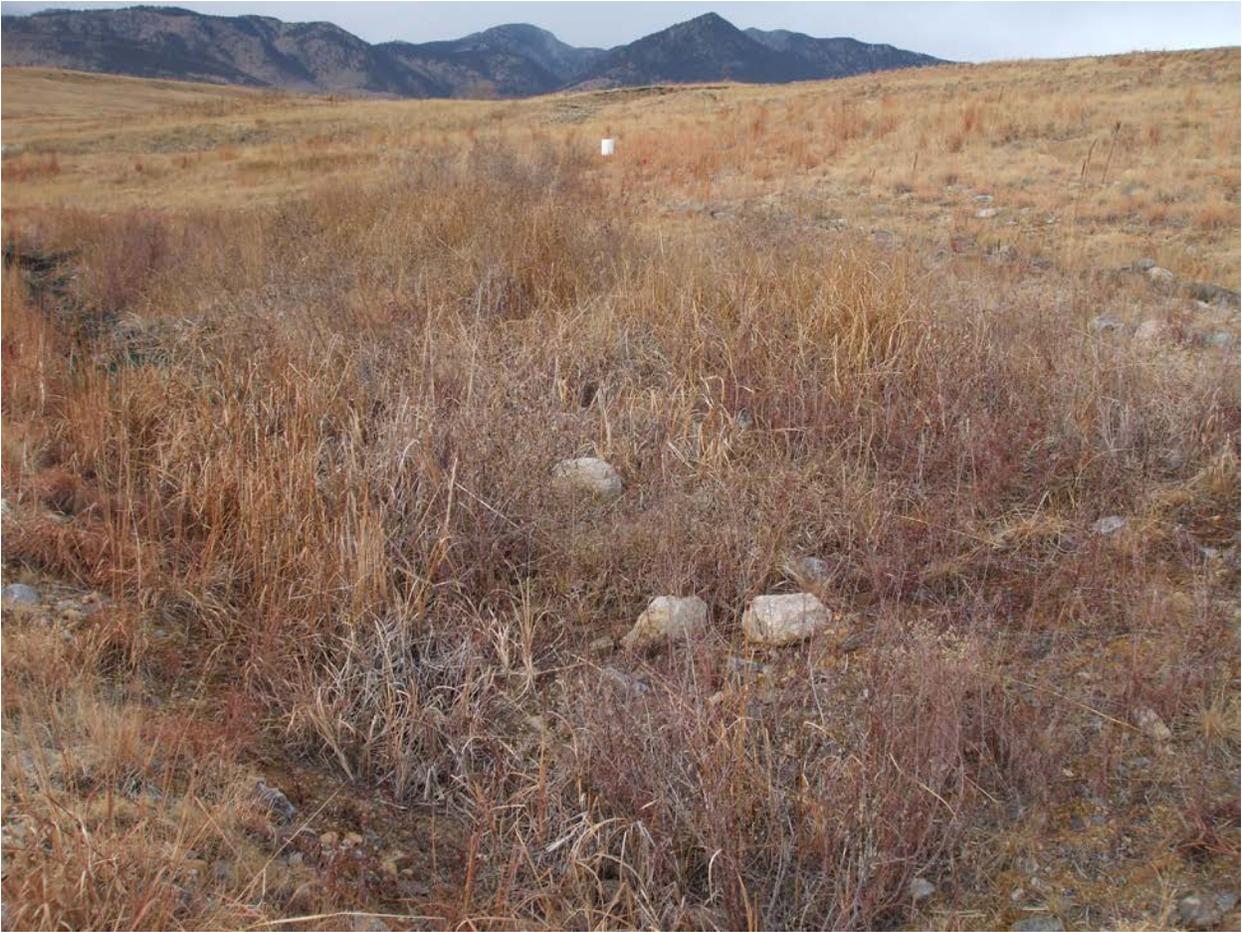
Seep 4 Area

The seep locations were dry at the time of this inspection except for Seep 4 and Seep 8. Seep 4 was saturated and Seep 8 was flowing at approximately .5 gallons per minute. Vegetation in the seep locations is primarily dormant.

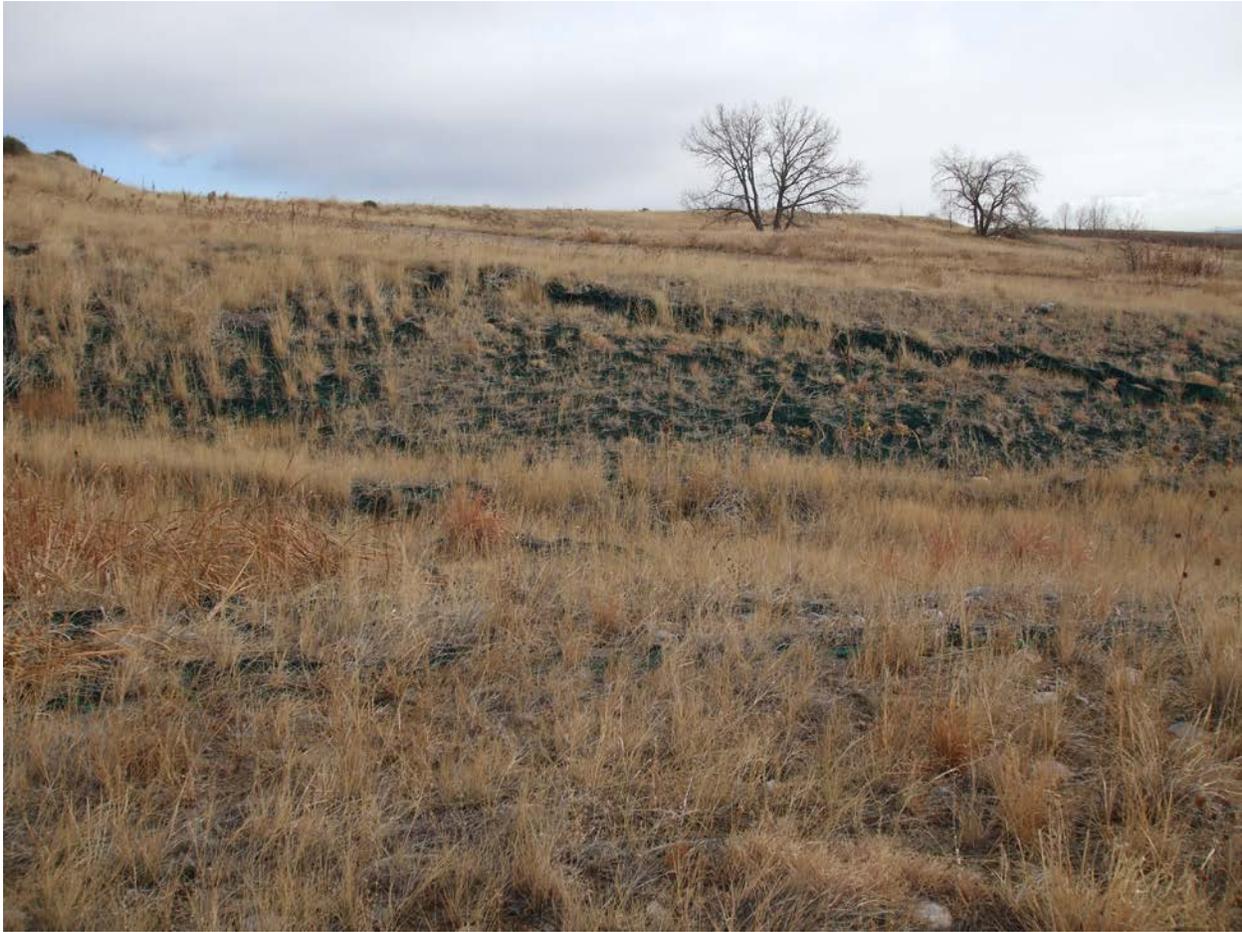
EPC Slump

The slump that was observed on the eastern slope of the EPC toward the top of the channel remains unchanged. The wooden stakes that were installed around the perimeter of the slumping area have not moved. No cracks are apparent. We will continue to monitor the slumping area for any changes during routine and nonroutine inspections of the OLF.

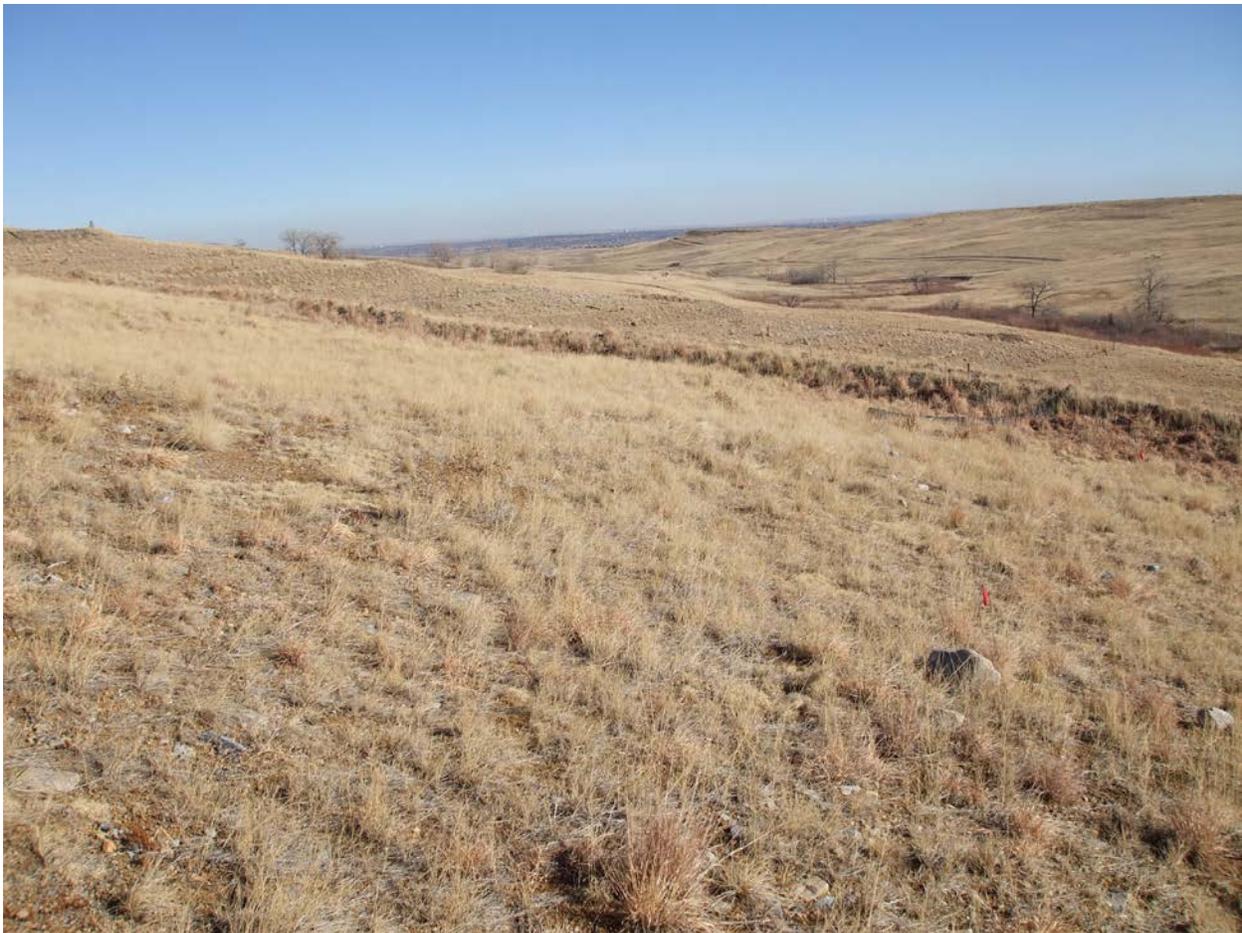
OLF Cover Facing East

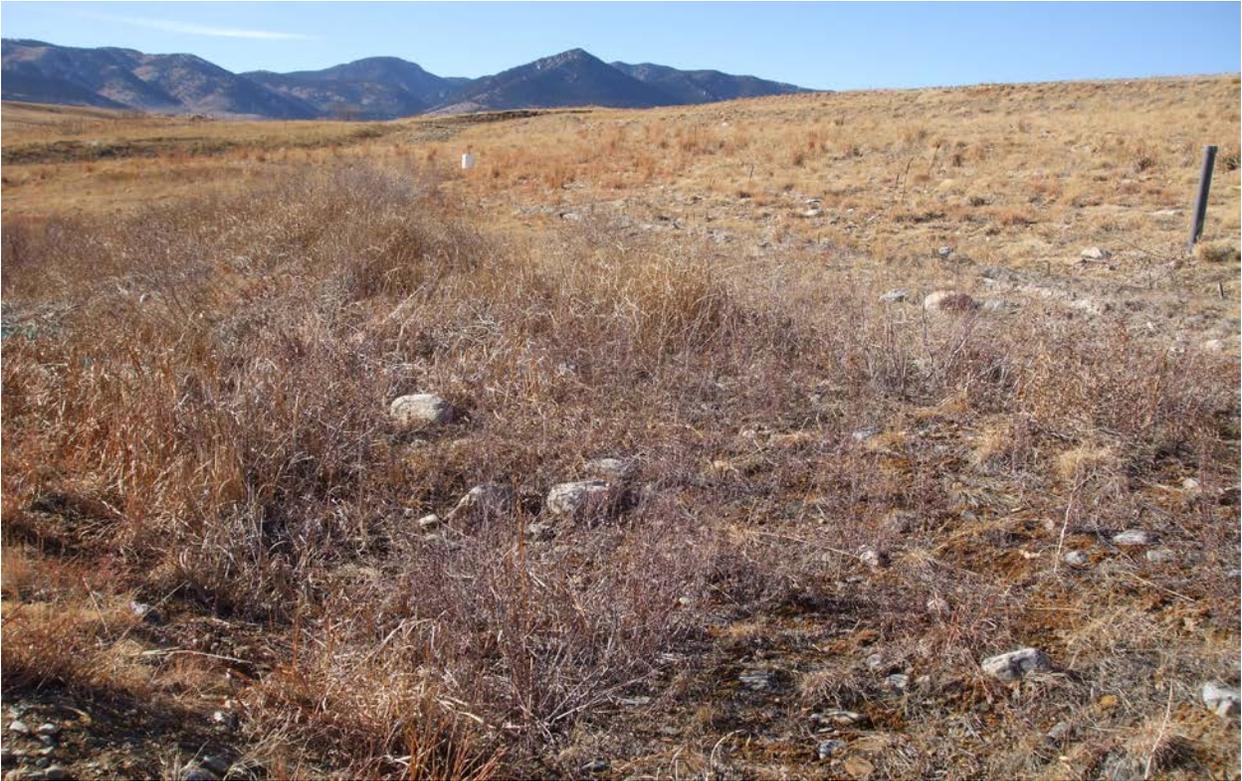
Seep 4 Area

The seep locations were dry at the time of this inspection except for Seep 4 and Seep 8. Seep 4 was saturated and Seep 8 was flowing at approximately .5 gallons per minute. Vegetation in the seep locations is primarily dormant.

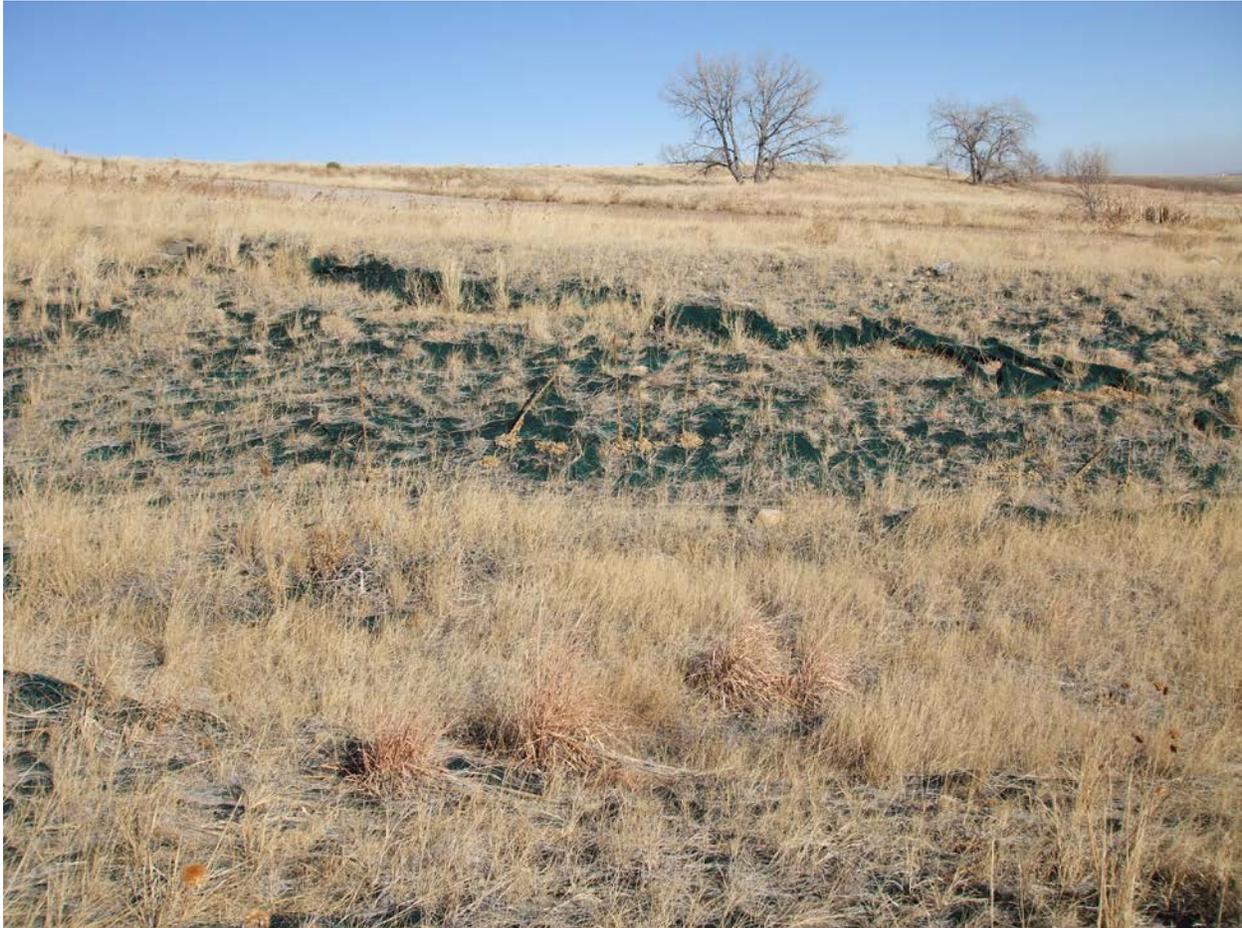
EPC Slump

The slump that was observed on the eastern slope of the EPC toward the top of the channel remains unchanged. The wooden stakes that were installed around the perimeter of the slumping area have not moved. No cracks are apparent. We will continue to monitor the slumping area for any changes during routine and nonroutine inspections of the OLF.
