## **Appendix C: Landfill Inspection Forms - Fourth Quarter CY 201'**

## C.1 Original Landfill

## OLF October Monthly Inspection – Attachment 1

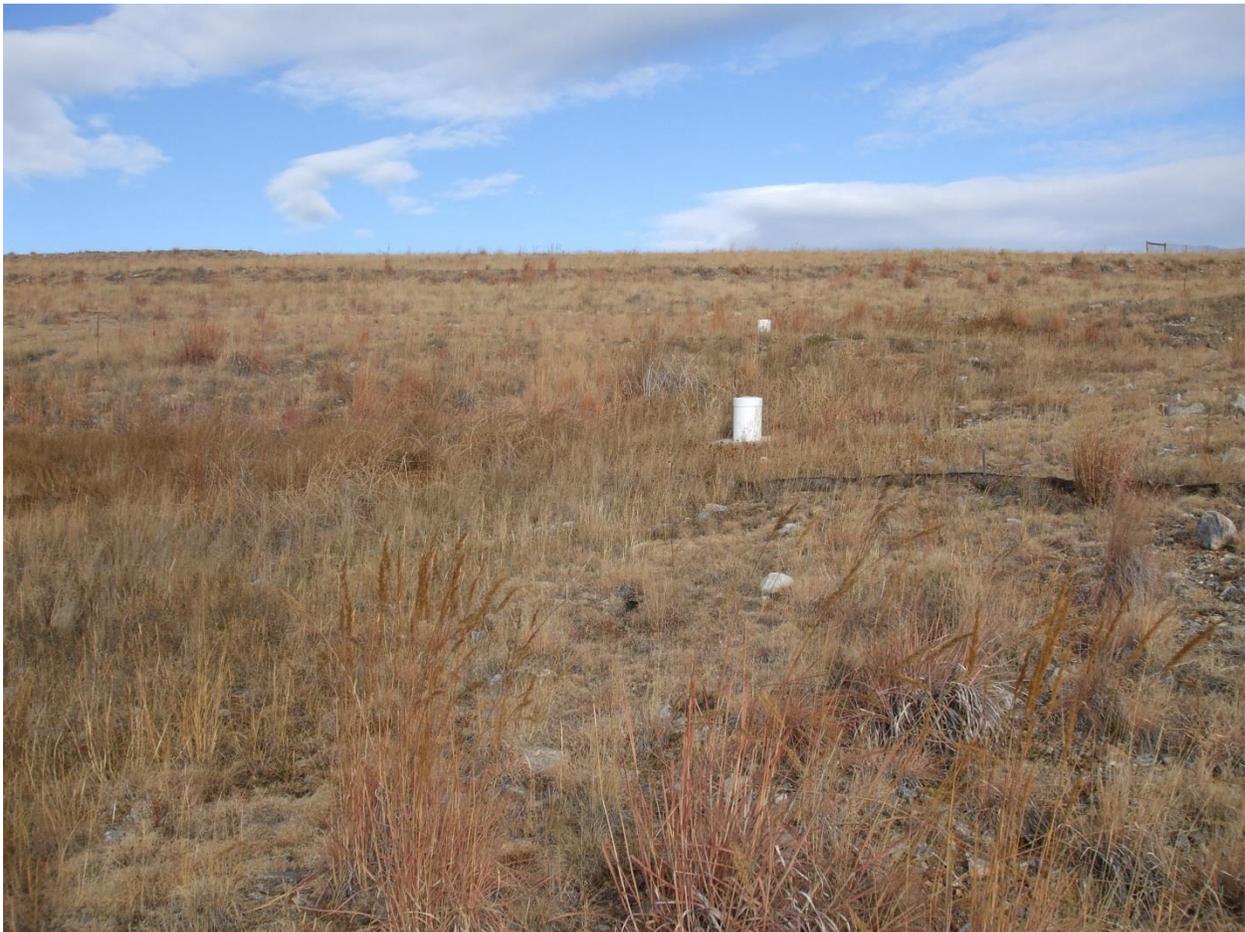
The site received 2.24" of precipitation in October. The seep locations were all saturated except for Seep 1. Seep 2 and Seep 4 showed surface expression and Seep 8 was flowing at approximately 2 gallons per minute.

*Seep 7 Area*

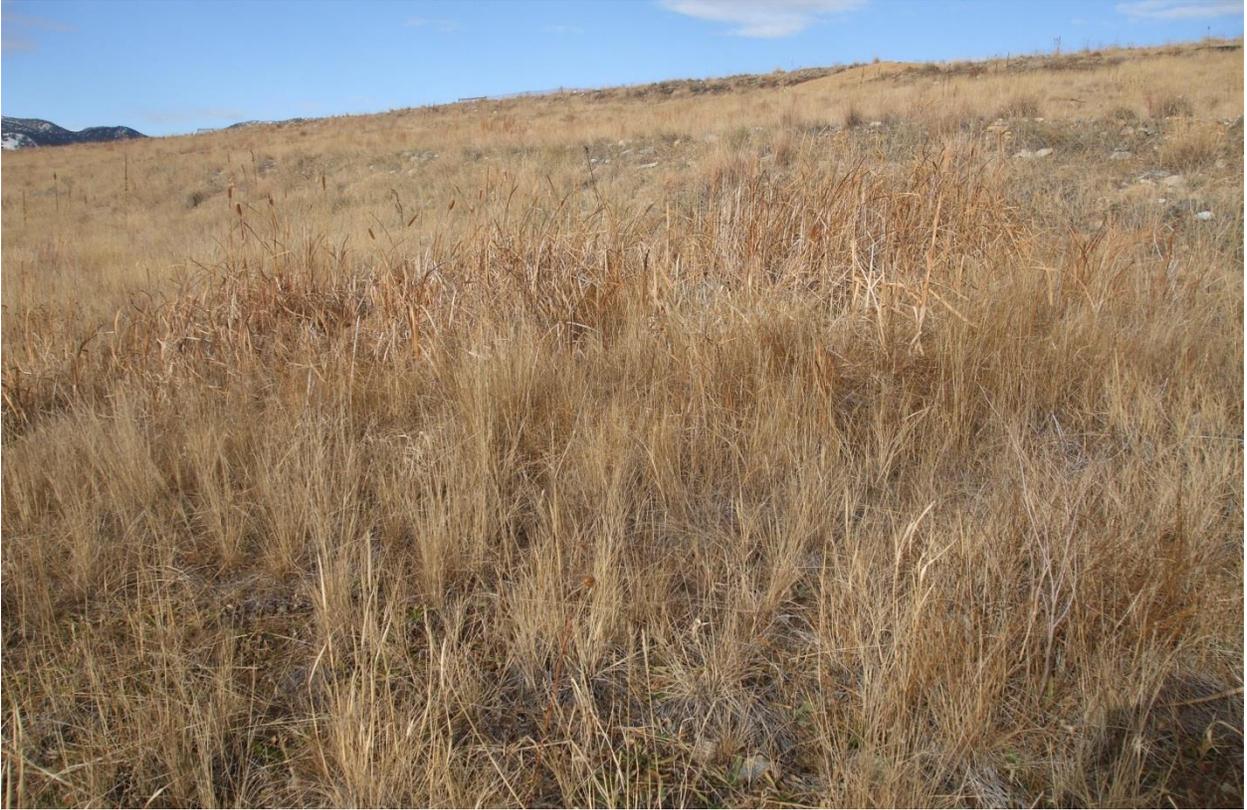
*Seep 2 Area*

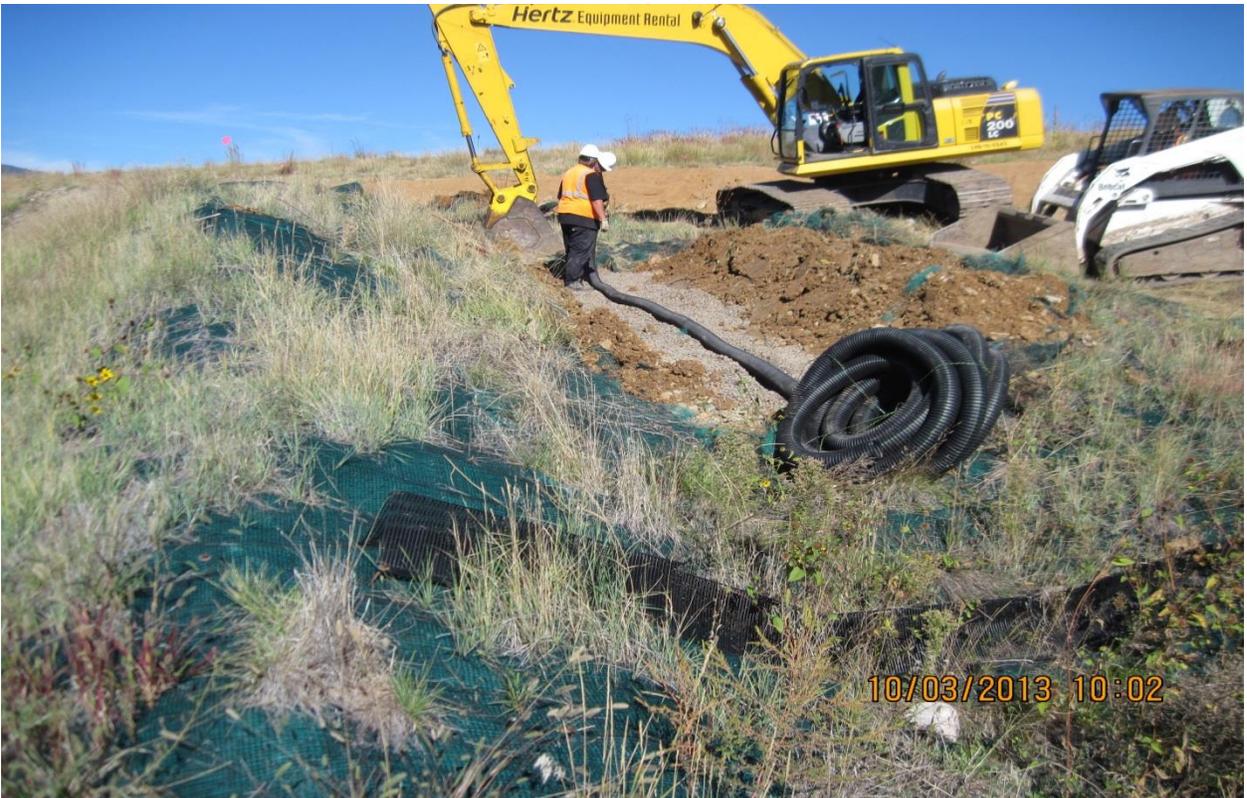
*OLF Berm 4 Drainage Tile Installation*

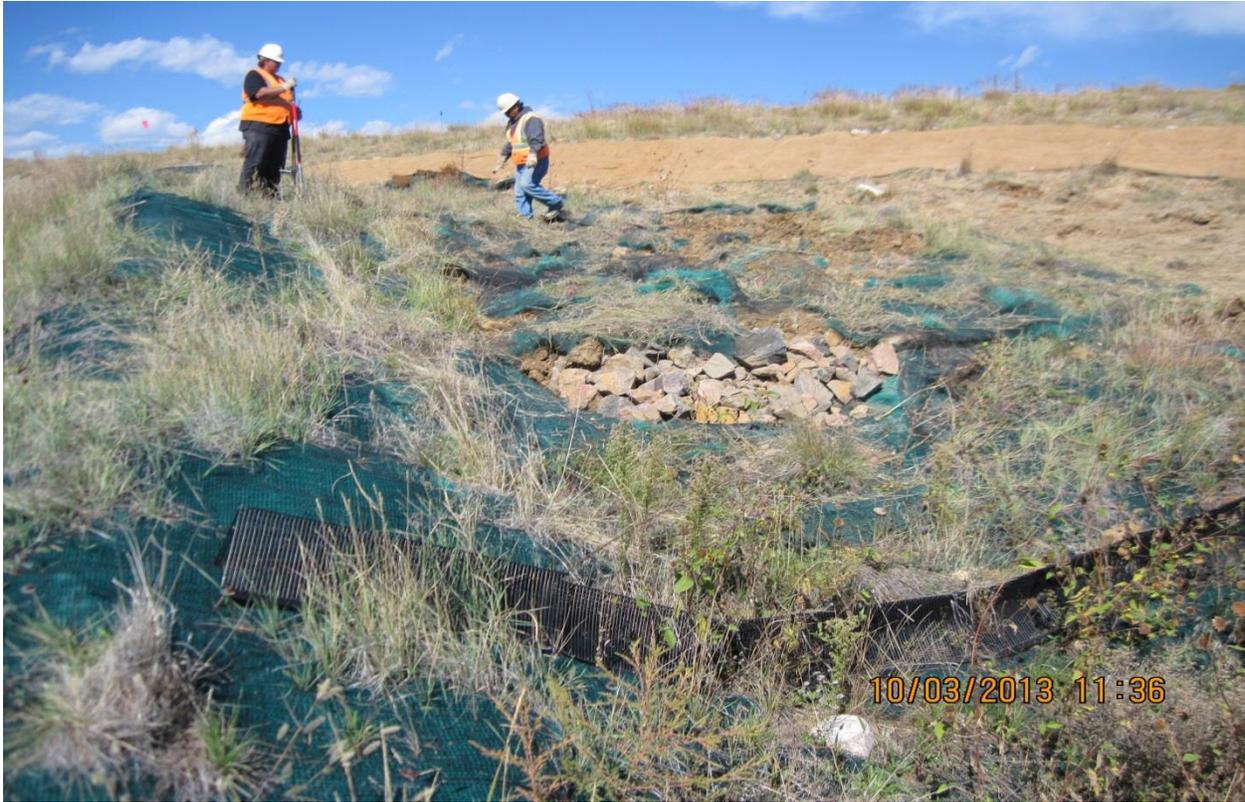
*Berm 4 Drain Installed*

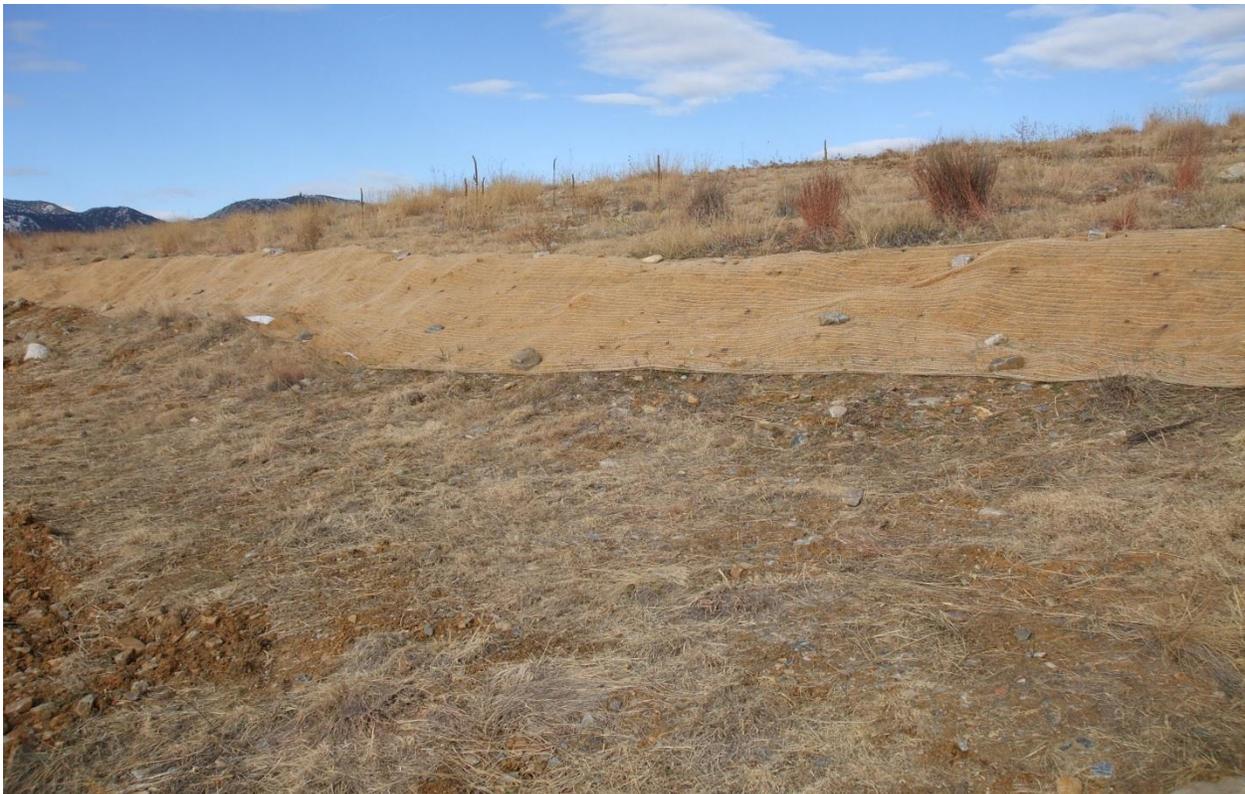
The monthly inspection of the OLF was completed on October 28, 2013. The repairs completed on the surface cracks in the Berm 1 and Berm 4 areas remain in good condition with no new cracking observed. A drain consisting of 4" drainage tile bedded in  $\frac{3}{4}$ " gravel was installed in the channel of Berm 4 on October 3 to help remove water from the channel until more permanent repairs can be completed in that location. A geotechnical engineering firm is completing an evaluation of the slumping area on the OLF and will provide recommendations on a path forward for addressing the slumping and repairing the cover and berm outfalls. The repair project is tentatively scheduled to be completed in late November or early December.

*Repaired Crack Location above Berm 4*

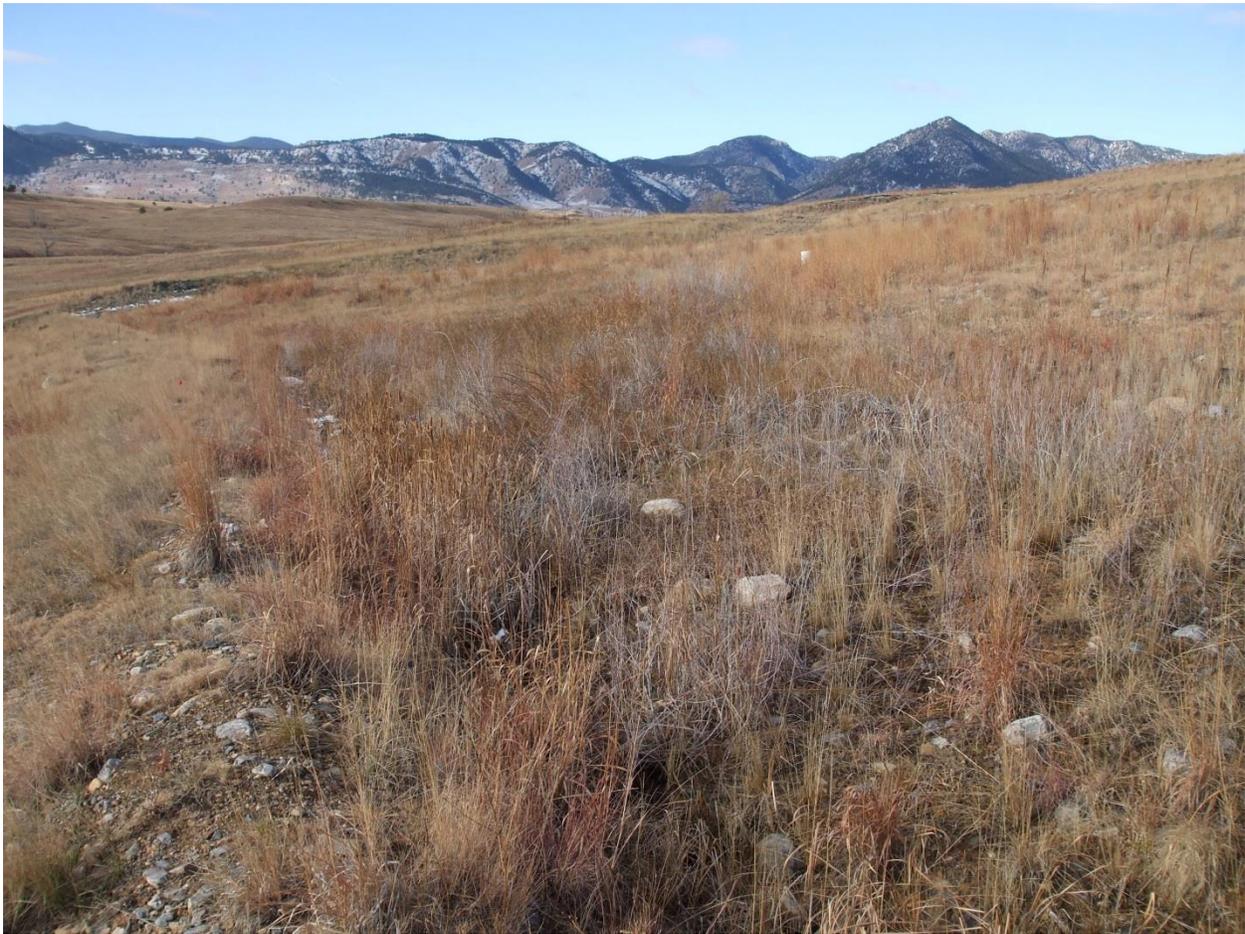
The site received 0.29" of precipitation in November. The seep locations were all saturated except for Seep 1. Seeps 4 and 7 showed surface expression and Seep 8 was flowing at approximately 1-2 gallons per minute.

*Seep 4 Area*

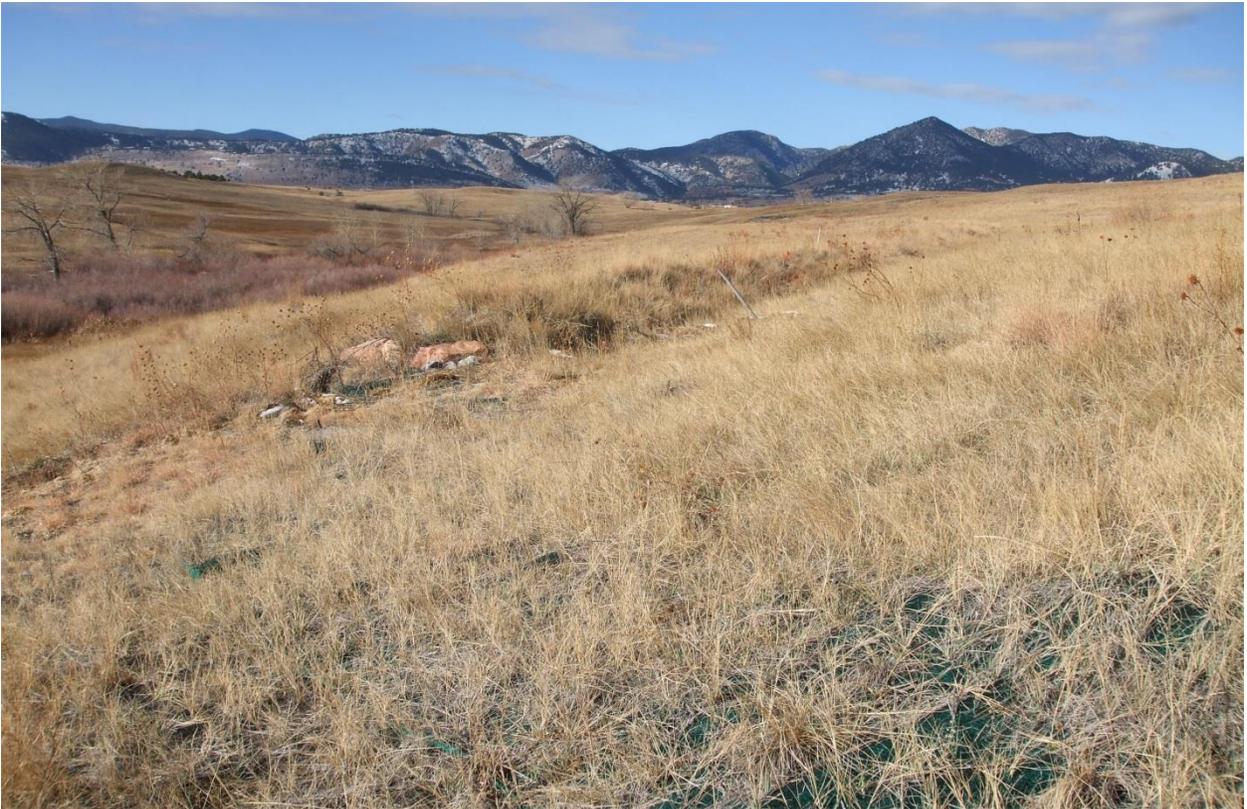
*Berm 7 Outfall*

Repairs to berm outfalls will be completed during OLF Maintenance Project.

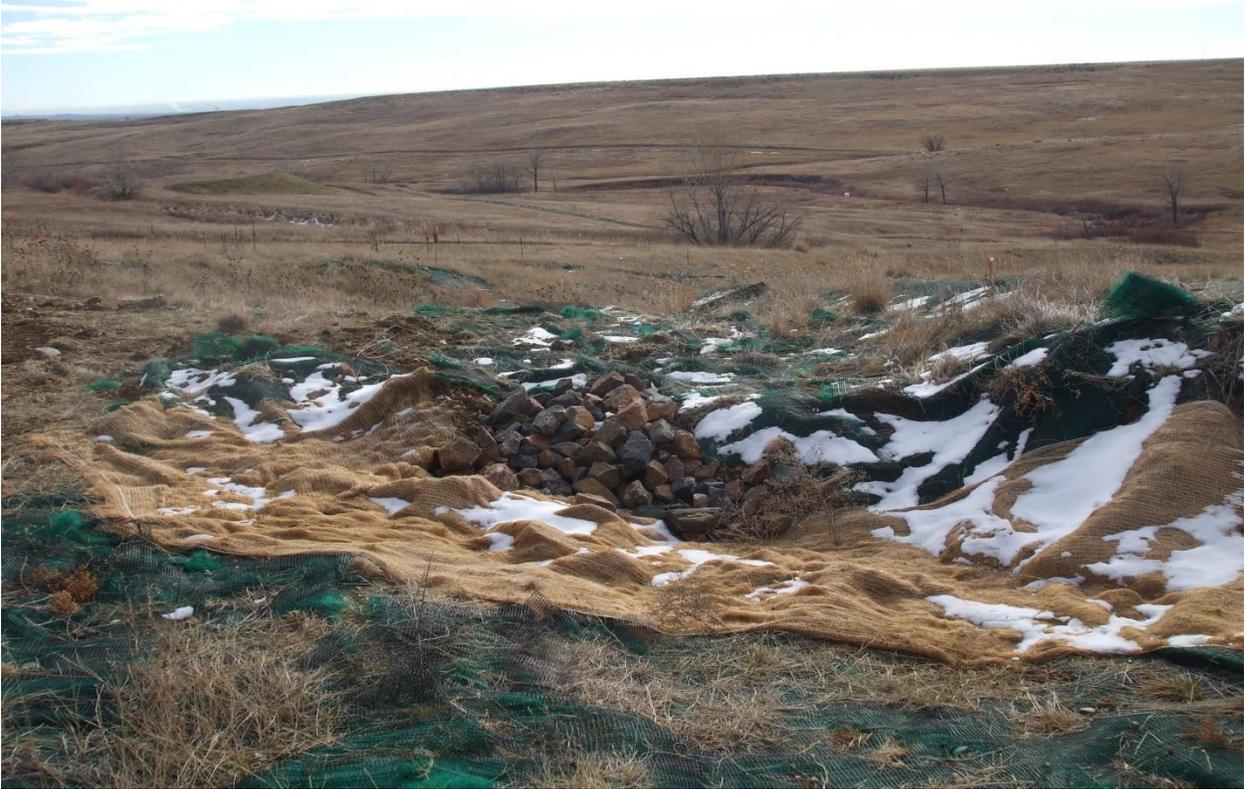
*Berm 4 Drainage Tile Inlet*

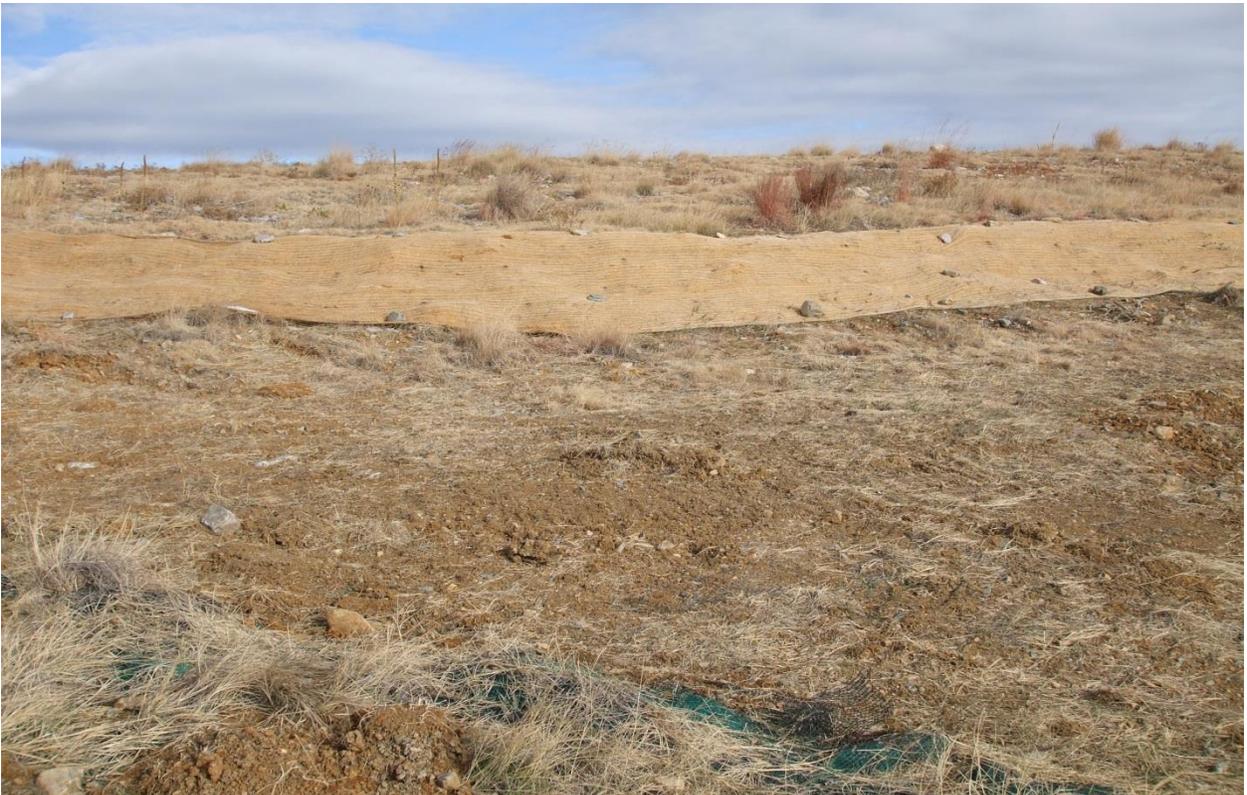
The monthly inspection of the OLF was completed on November 19, 2013. The repairs completed in the Berm 1 and Berm 4 areas remain in good condition with no new cracking observed. The 4" drainage tile that was installed in the channel of Berm 4 remains in good condition and is functioning properly. A geotechnical engineering firm has completed their evaluation of the slumping area on the OLF and has submitted recommendations for stabilizing the cover in that area. The maintenance project incorporating these recommended changes will be completed as soon as conditions permit.

*Repaired Crack Location above Berm 4*

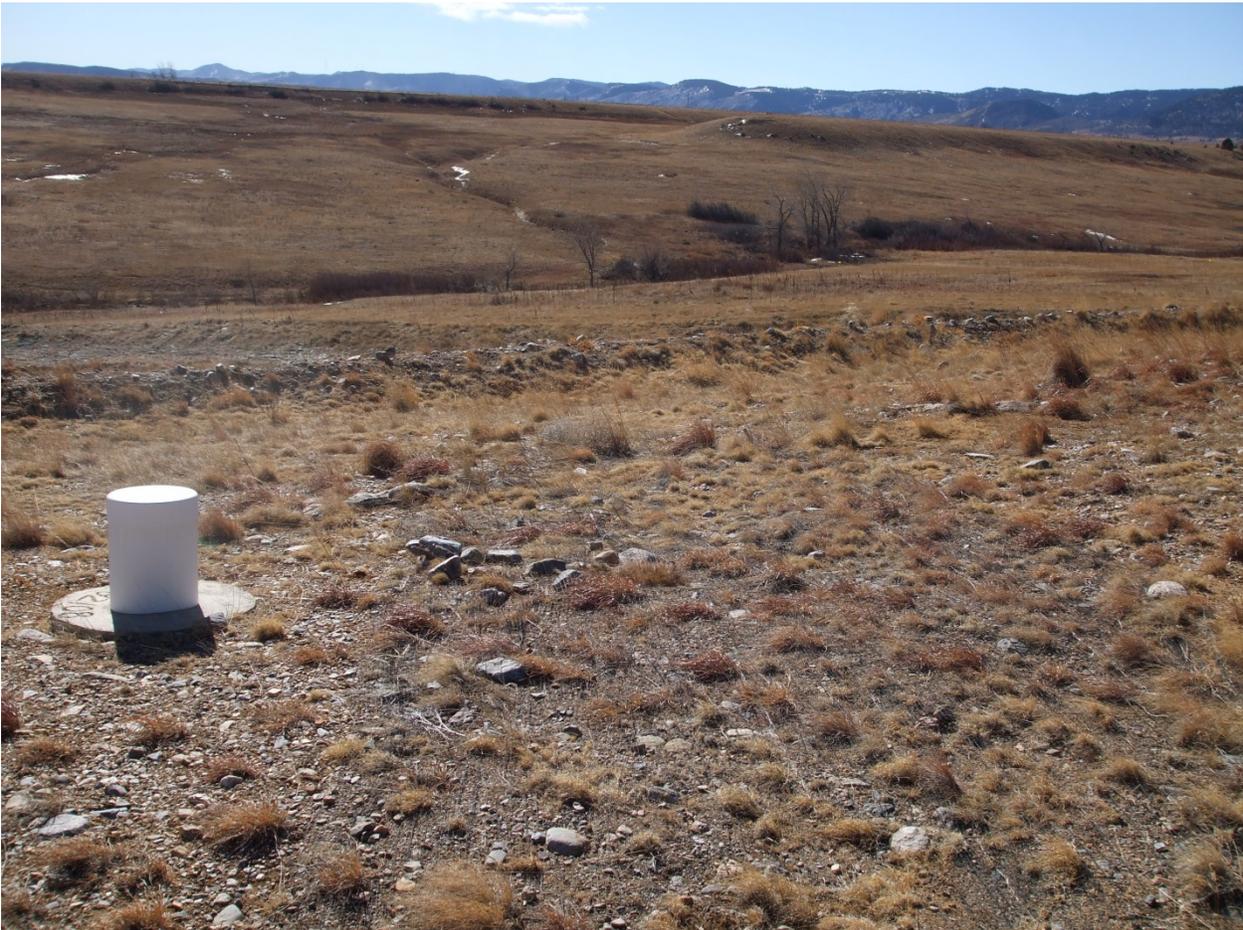
The monthly inspection of the OLF was completed on December 23, 2013. The repairs completed in the Berm 1 and Berm 4 areas remain in good condition. A new minor cracking location was observed along the top of the East Perimeter Channel on the eastern edge. The crack was approximately 2 inches wide and 10 feet long. The crack ran parallel to the upper eastern edge of the East Perimeter Channel slump that has been documented in previous inspections. The crack was filled and compacted with Rocky Flats Alluvium the same day it was observed. The extent of the crack location was also flagged to make it easier to locate and monitor in future inspections. Additional repairs to the OLF slumping and cracking areas will be completed during the OLF Maintenance Project which will be completed when soil conditions are more favorable.

*Berm 1 Area*

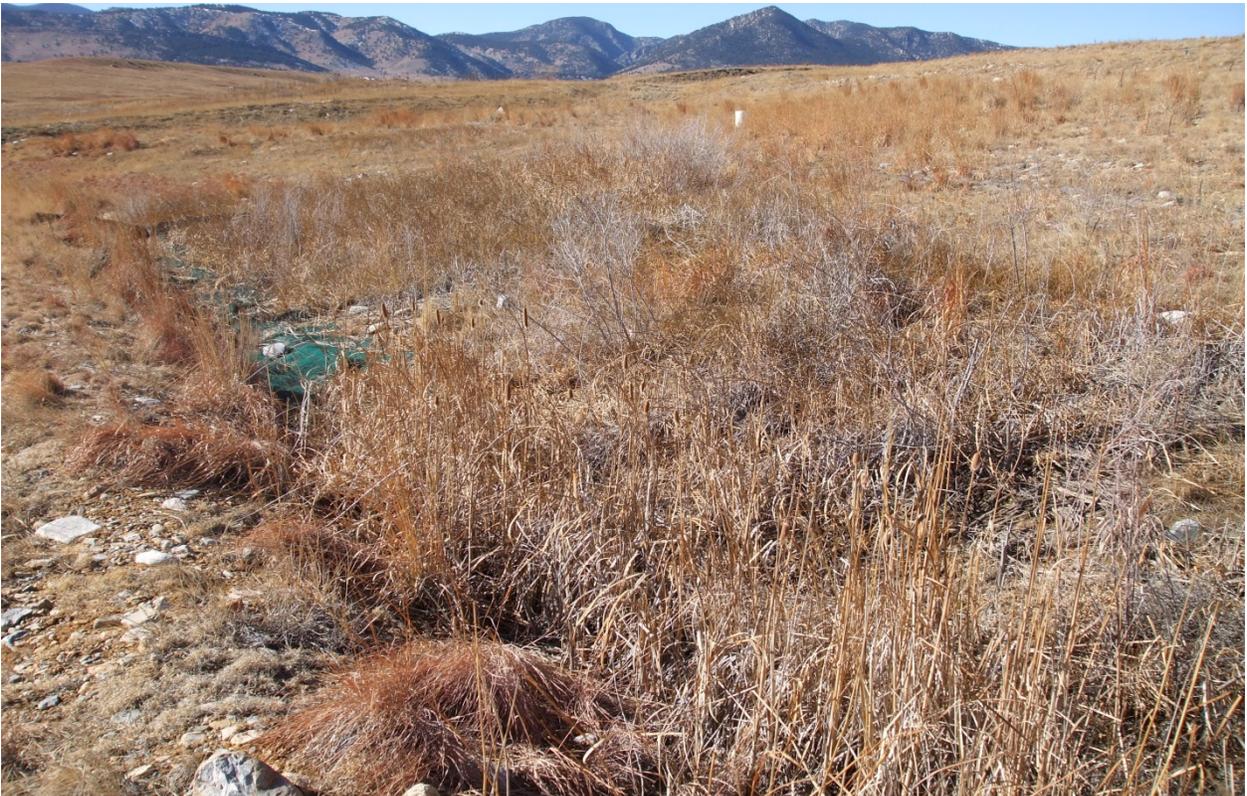
The site received 0.50 inches of precipitation in December. The seep locations were all saturated except for Seep 1. Seeps 4 and 7 showed surface expression and Seep 8 was flowing at approximately 1 gallon per minute.

*Seep 4 Area*

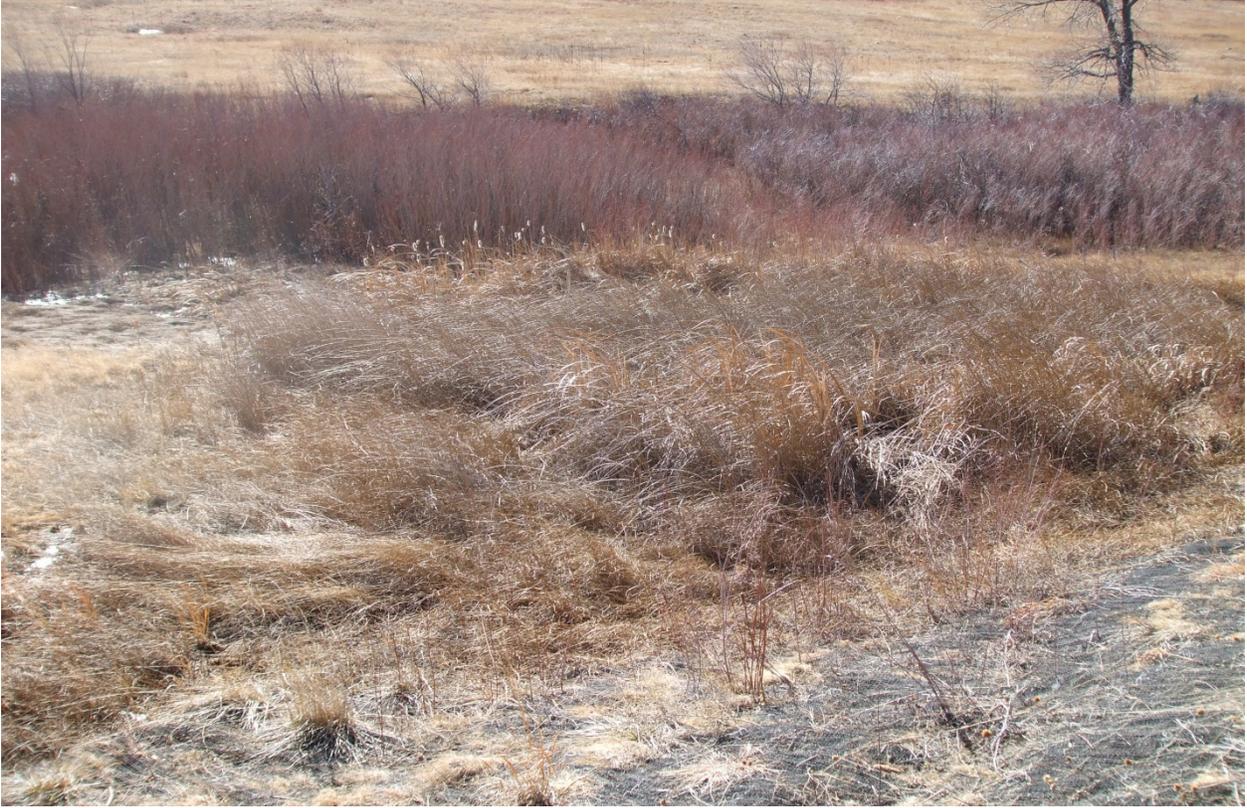
*Seep 8*

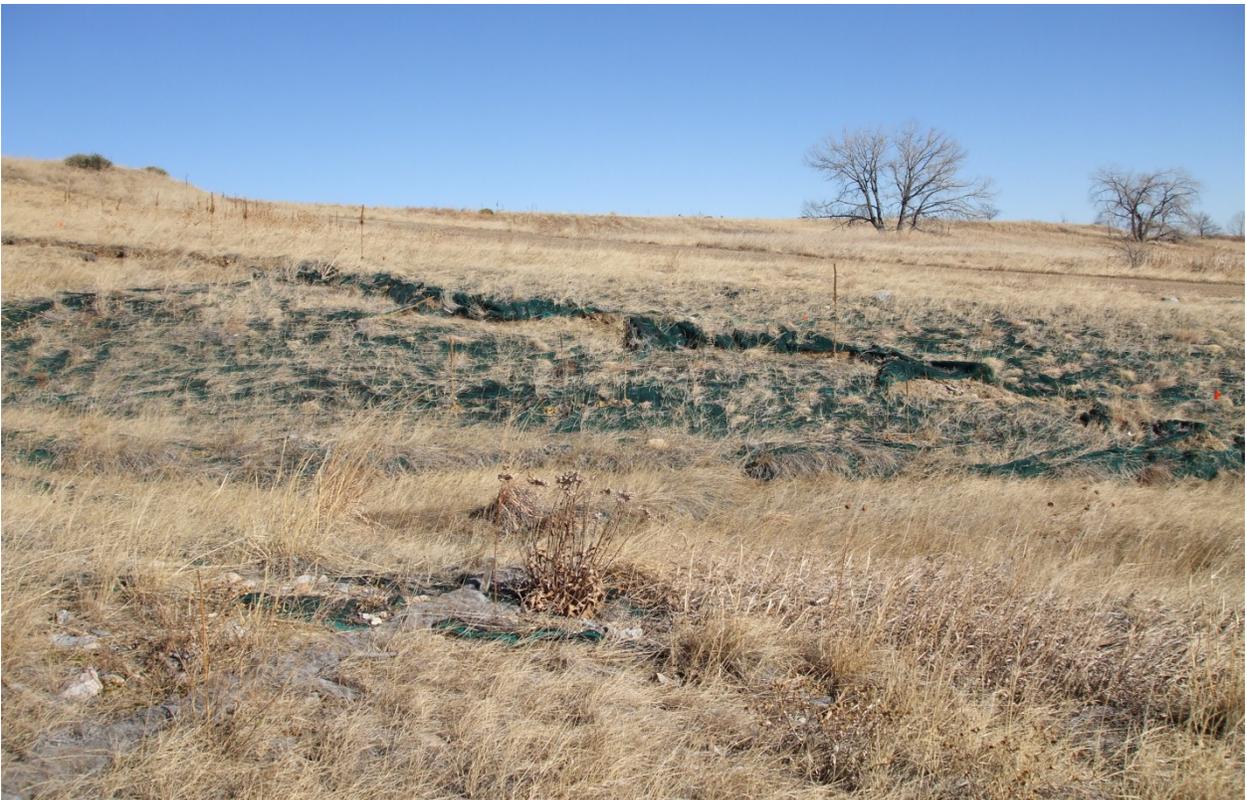
Details and pictures of EPC + BERM 4 slumping and cracking are included in Attachment 1.

*East Perimeter Channel Slump*

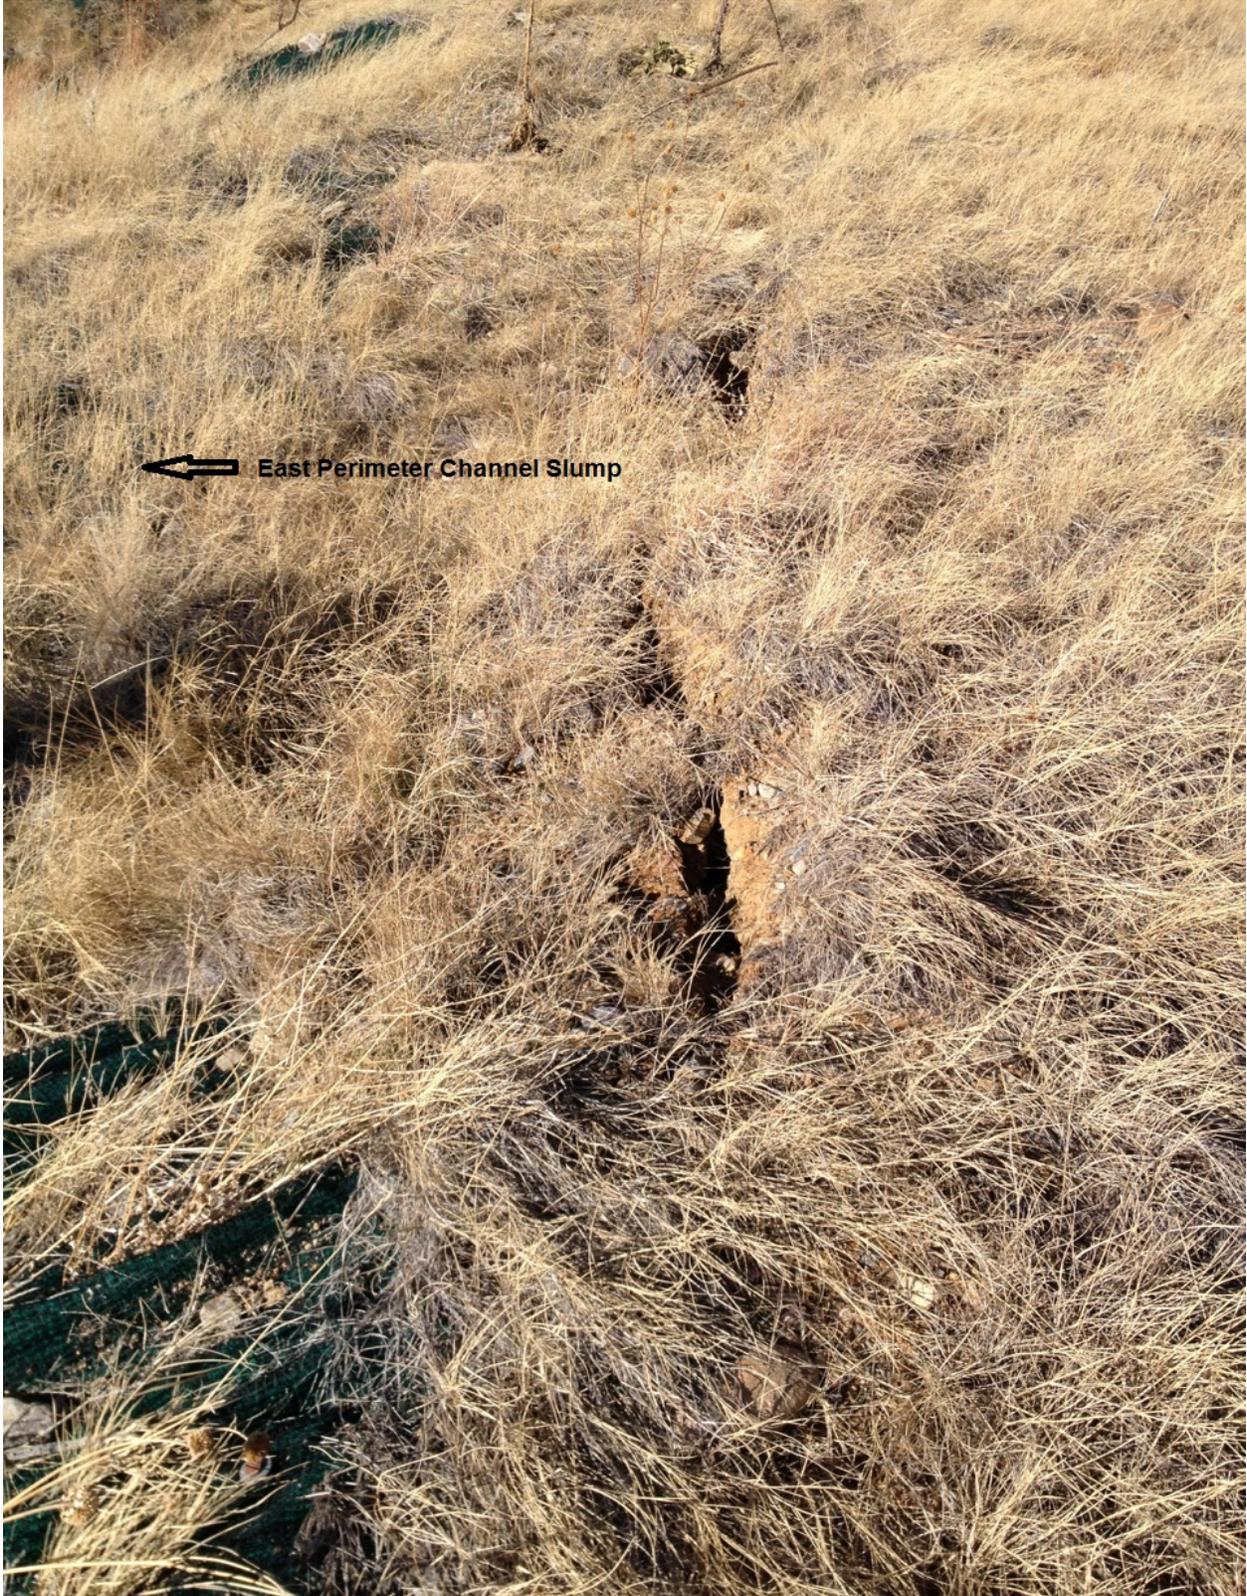
A new crack along the top of the eastern side of the EPC was observed during this inspection. See Attachment 1 for details.

DEFICIENCY	DATE NOTED	ACTION	DATE COMPLETED	COMMENTS
cracking observed along top of EPC on east side	12/23/13	Fill in cracks with Roadway Flats Alluvium and compact	12/23/13	See Attachment 1 for details

*New Crack Location above East Perimeter Channel Slump*
