**Appendix C: Landfill Inspection Forms - Fourth Quarter CY 201(**

## C.1 Original Landfill

**ORIGINAL LANDFILL – MONITORING AND MAINTENANCE PLAN INSPECTION FORM**

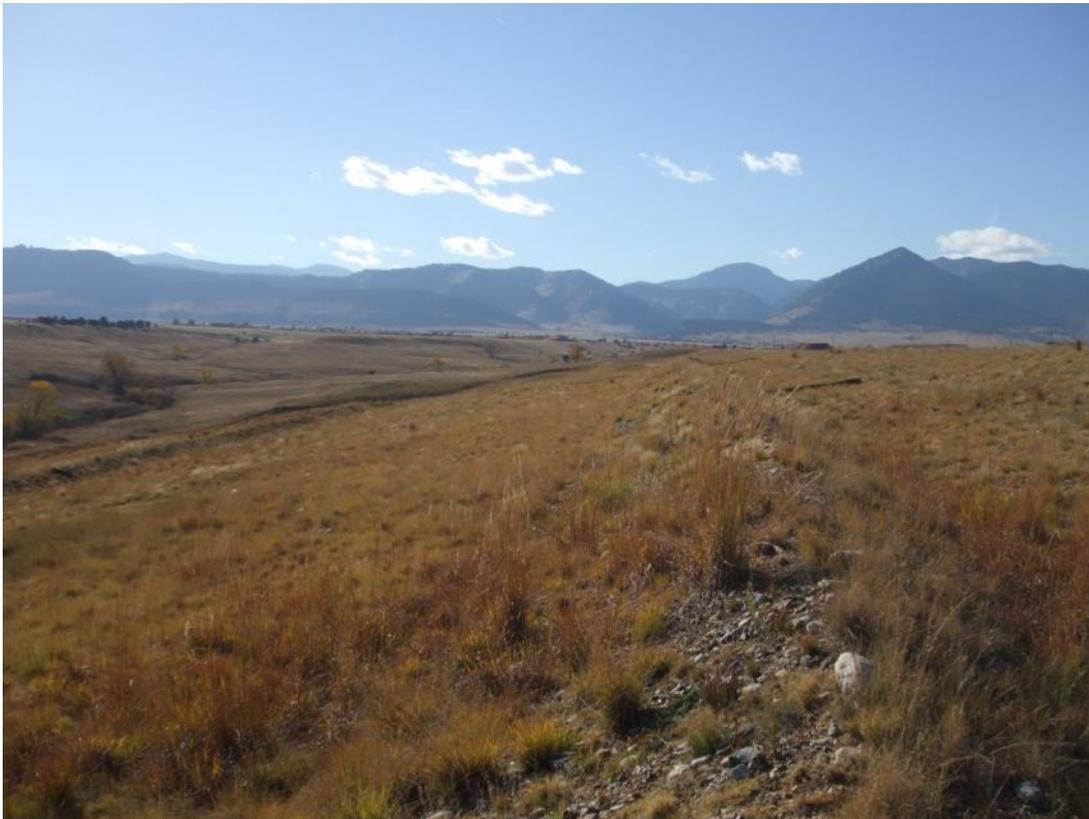
*West cover area from atop Berm 4: looking west*

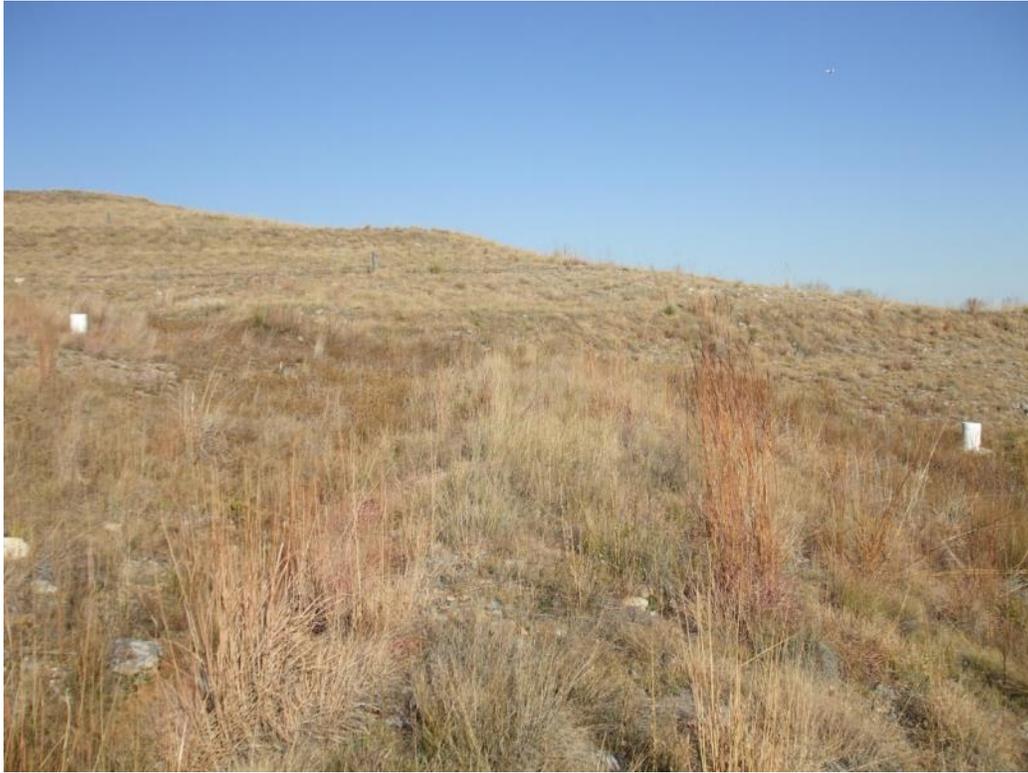
The site received 1.16 inches of precipitation in October. Except for Seep 1, the seep locations were all saturated at the time of the inspection. Seeps 4, 7, and 8 showed a surface flow of approximately 0.5 gallon per minute. Vegetation on the cover and in the seep areas is well established due to the frequent precipitation events that were received during the summer months.

*Seep 4 area: looking east*

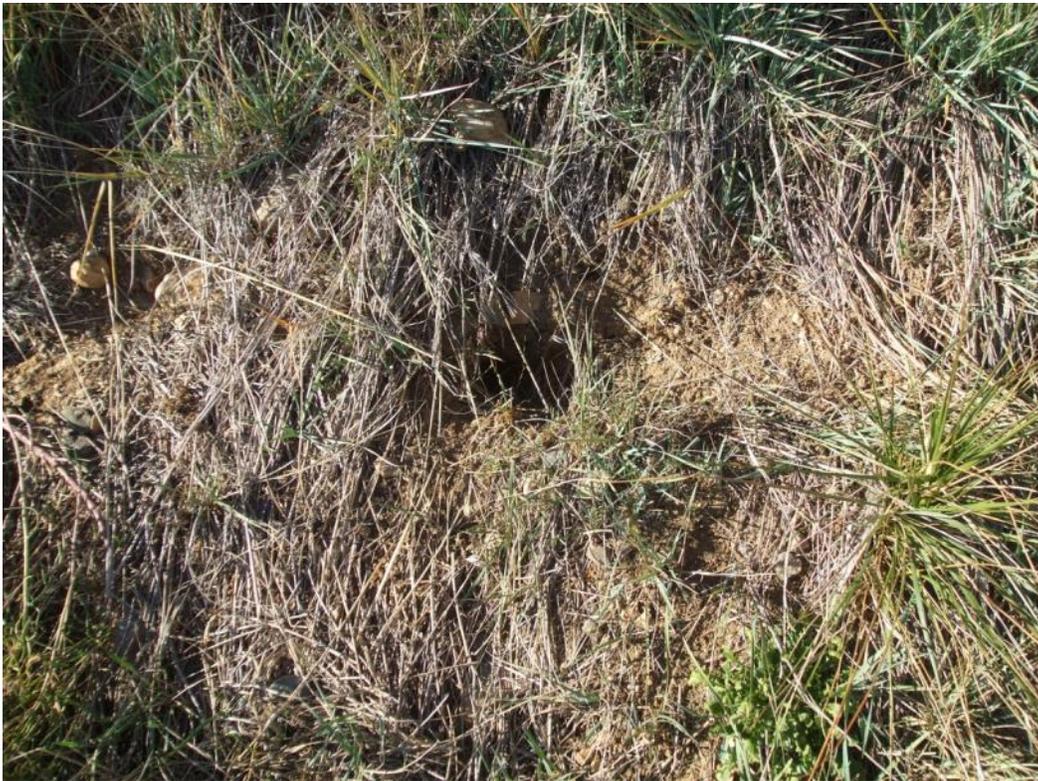
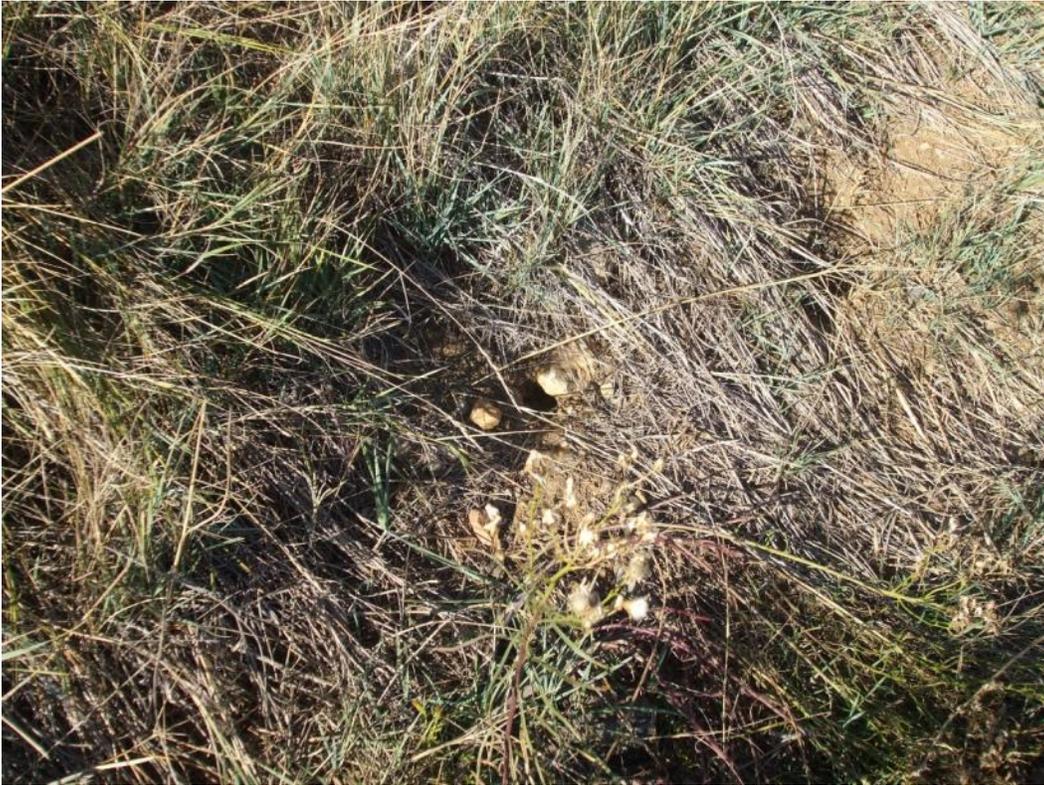
Approximately eight burrowing-animal dens were observed adjacent to the EPC between Berms 6 and 7. The dens are small and show no signs of recent activity. They are located outside of the waste footprint and will continue to be monitored to ensure that they do not expand in size or in quantity. At this time the dens do not pose an immediate threat to the integrity of the OLF.

*Burrowing animal dens, south of Berm 7*

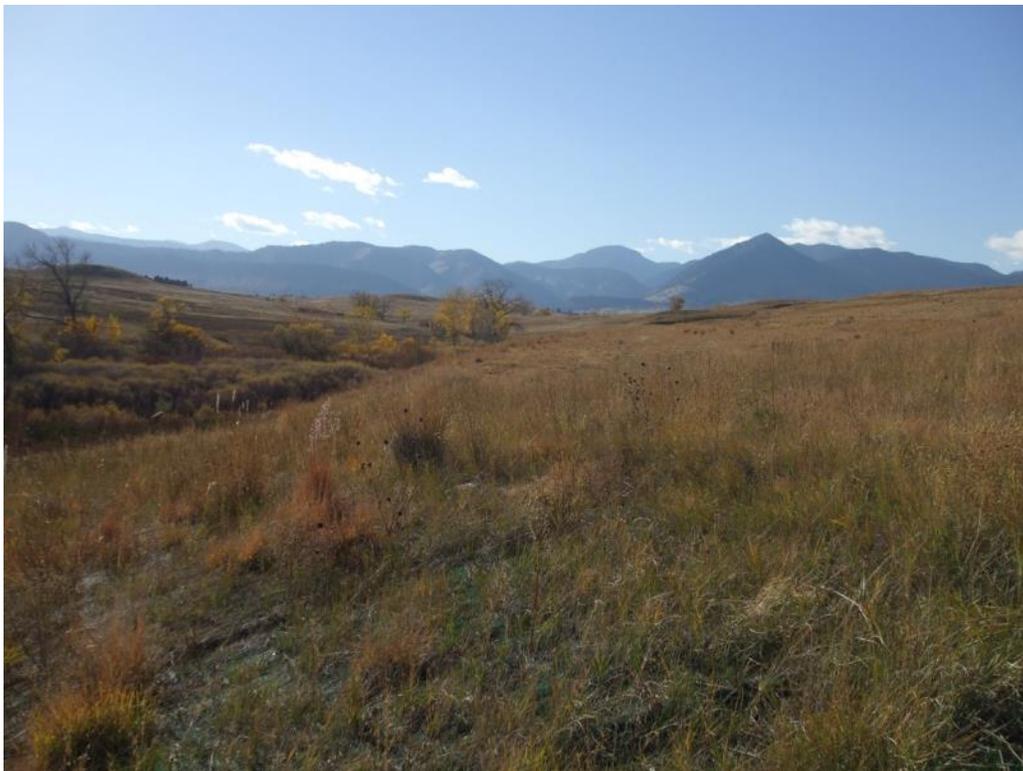
*Buttress area: looking west*

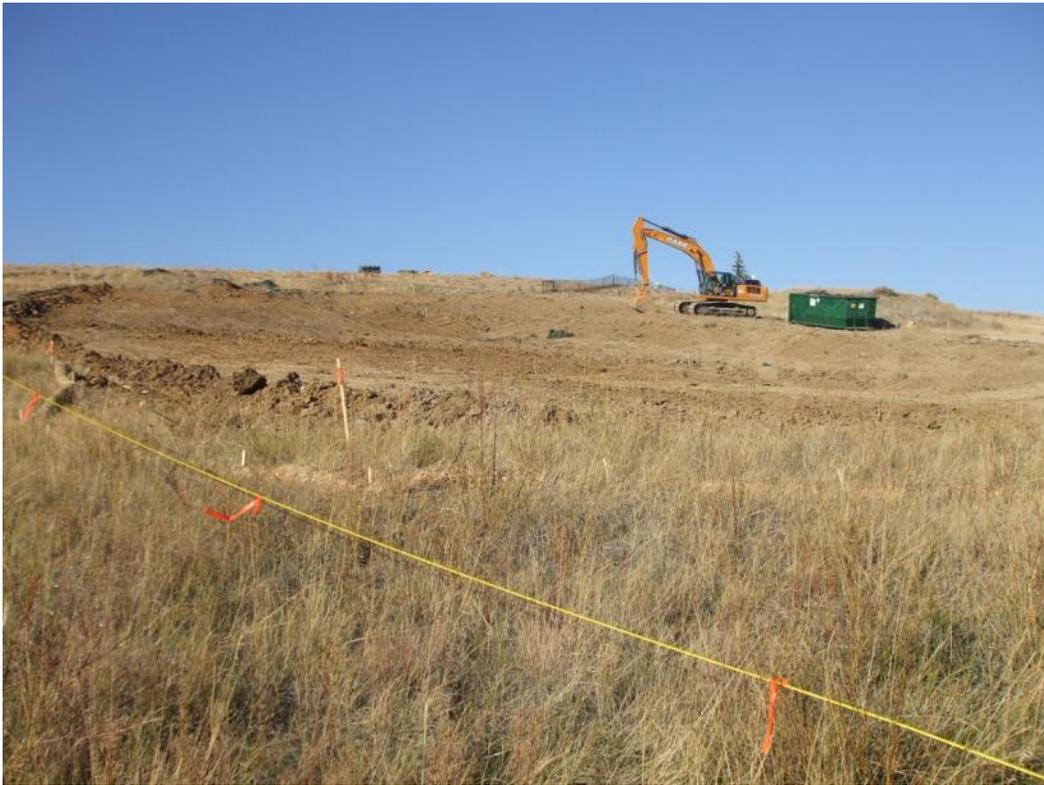
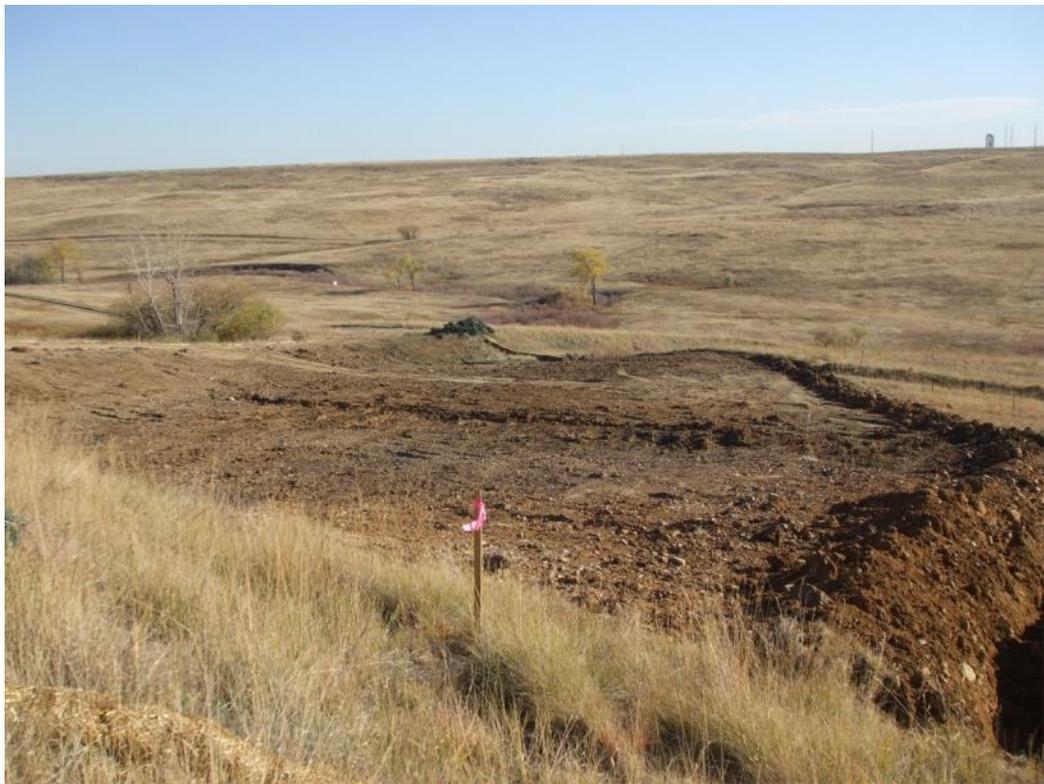
The EPC reconfiguration project is currently in progress- please see Attachment 1 for photos

*EPC construction zone: looking north*

*EPC construction zone: looking south*

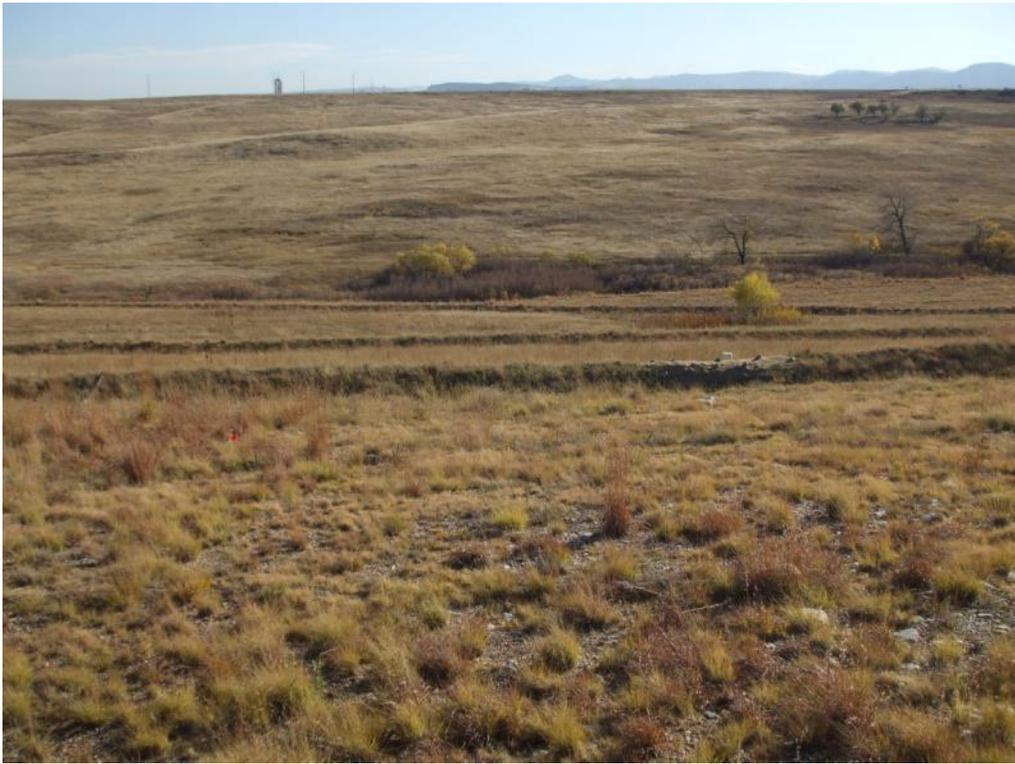
*East cover area: looking south over Berms 5, 6, and 7*

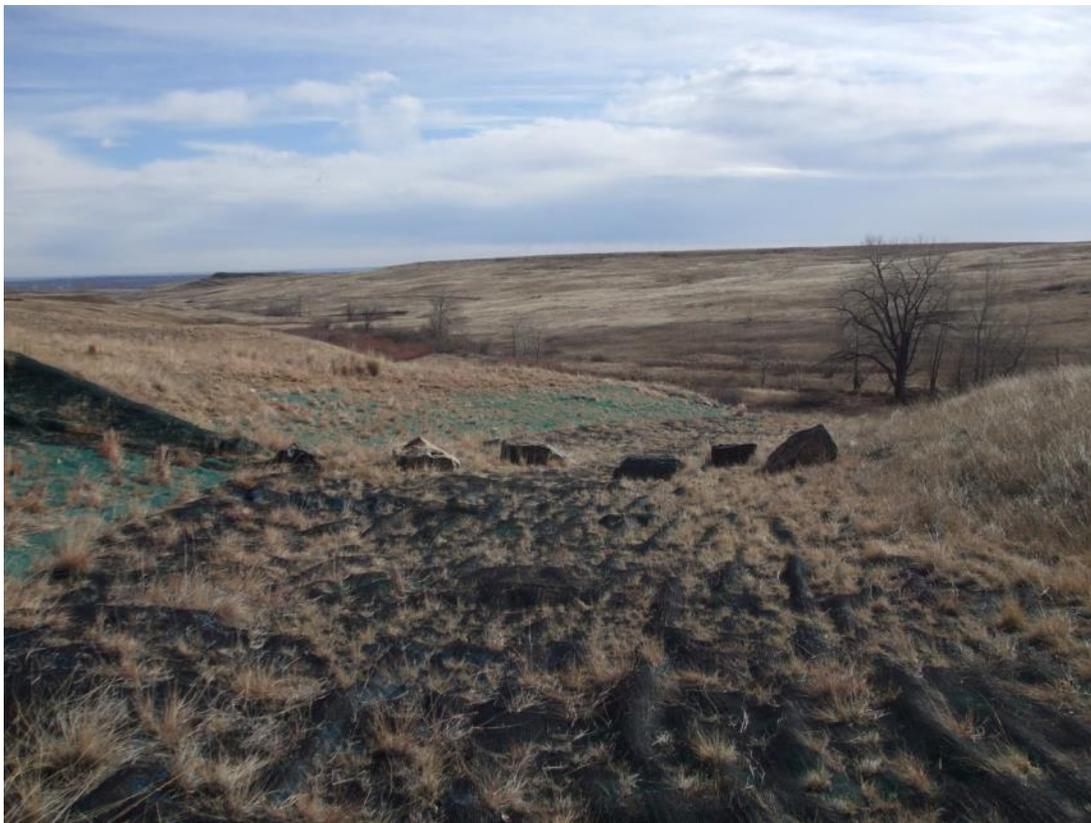
*West Perimeter Channel: looking south*

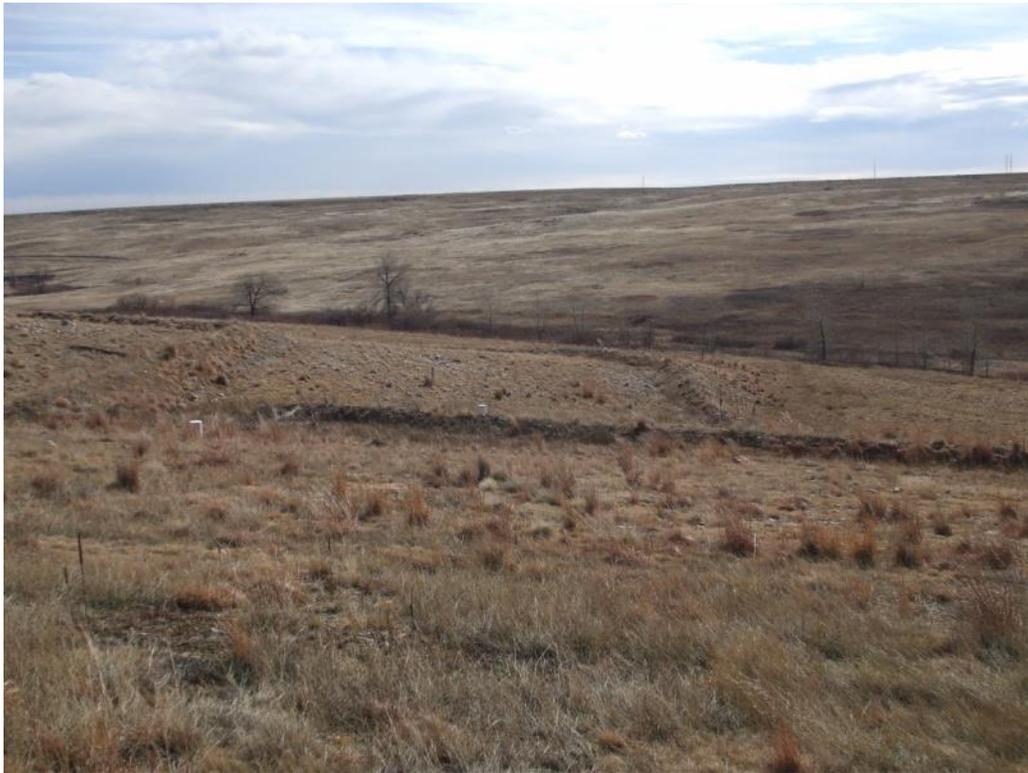
*Berms 3, 6, & 7: looking south*

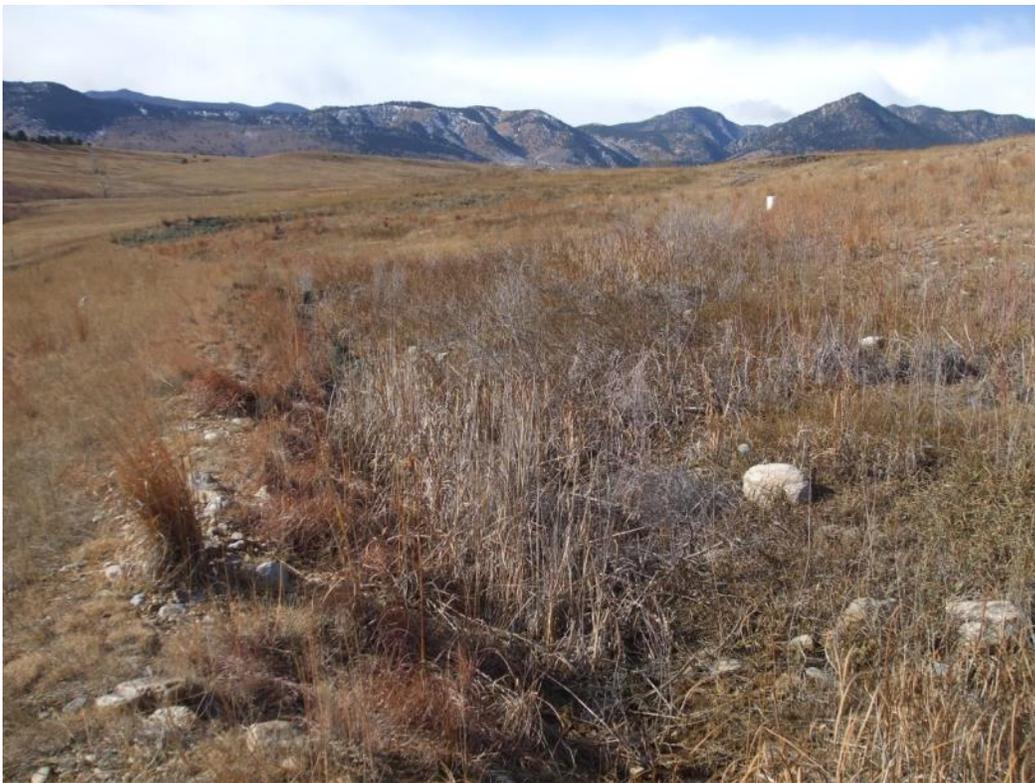
The site received 0.88 inch of precipitation in November. Seeps 4, 7, and 8 showed a surface flow of approximately 0.25 gallon per minute. Vegetation on the cover and in the seep areas is well established due to frequent rainfall during the summer months.

*Seep 7: looking west*

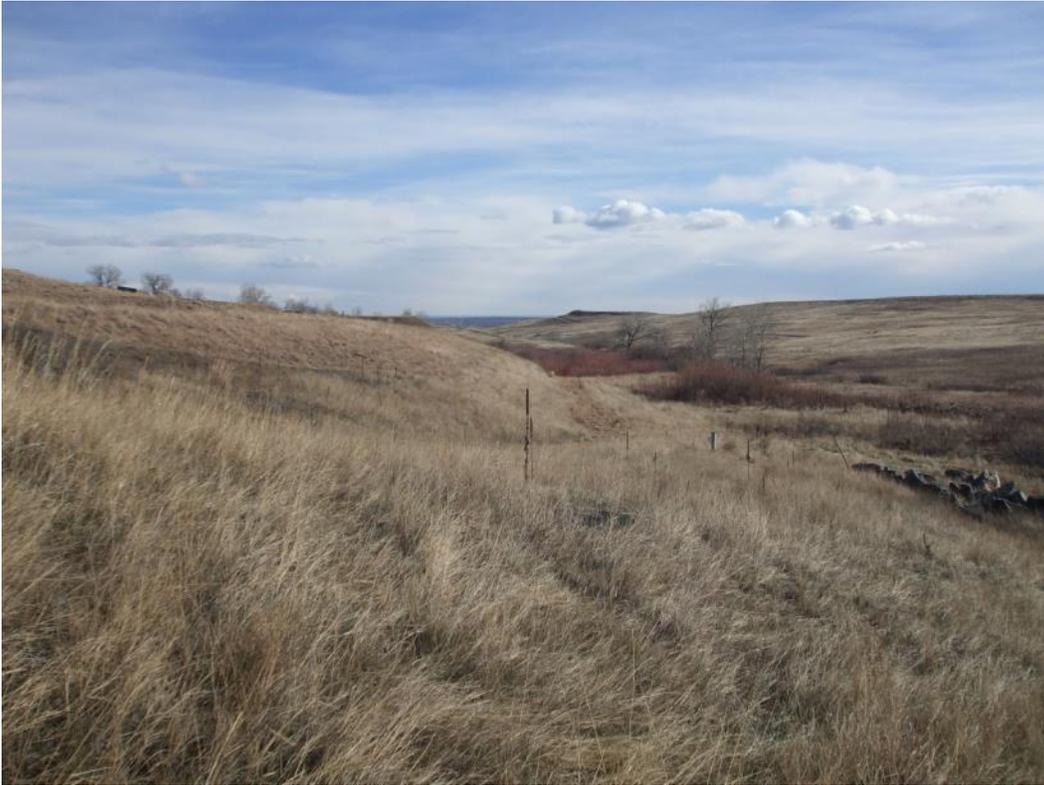
*Buttress area: looking east*

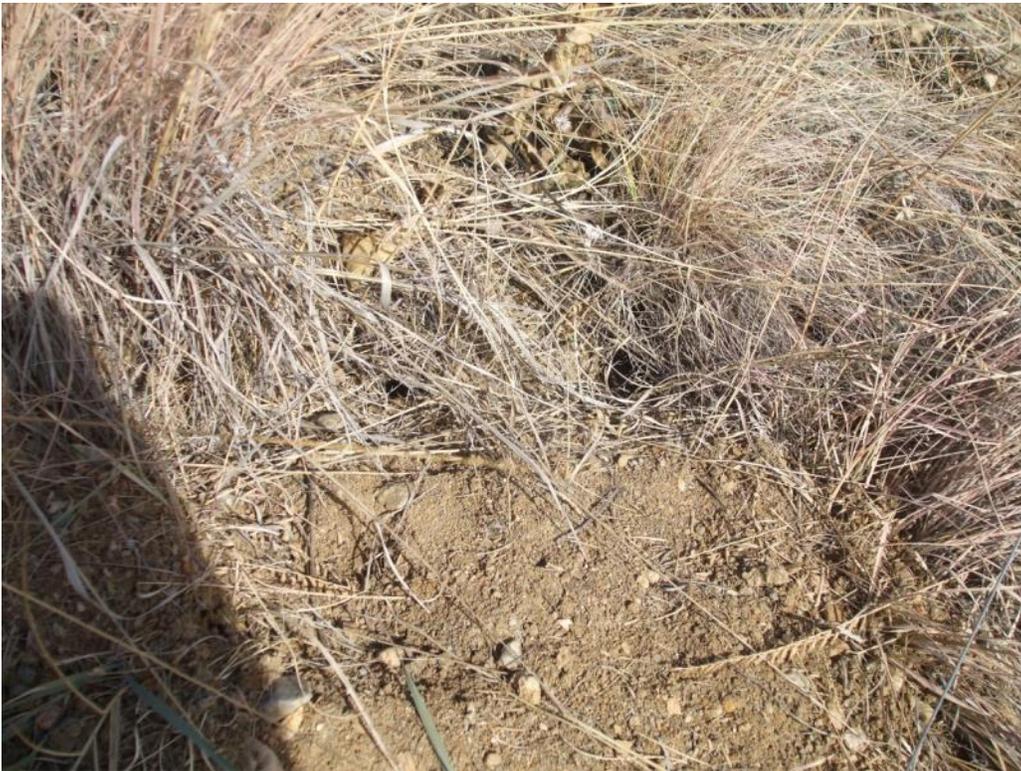
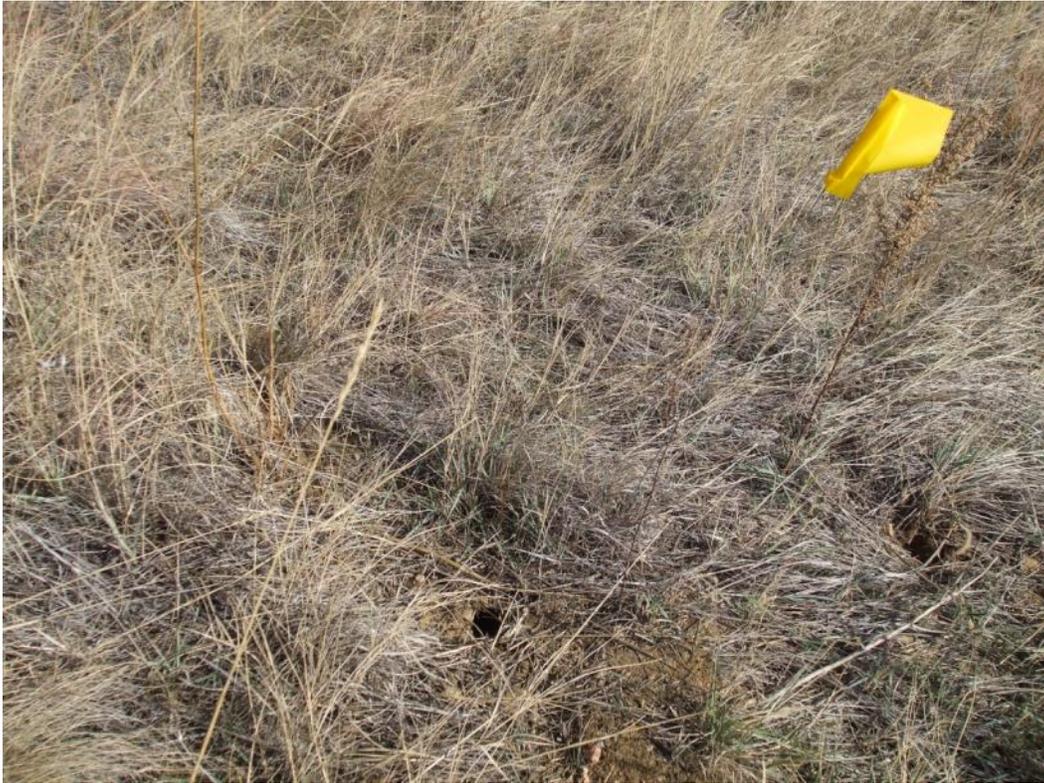
Approximately eight burrowing-animal dens were observed adjacent to the EPC between Berms 6 and 7. The dens are small, show no signs of recent activity, and do not pose an immediate threat to the integrity of the OLF. They are located outside of the waste footprint and will continue to be monitored to ensure that they do not expand in size or number.

*Burrowing animal dens between Berms 6 & 7*

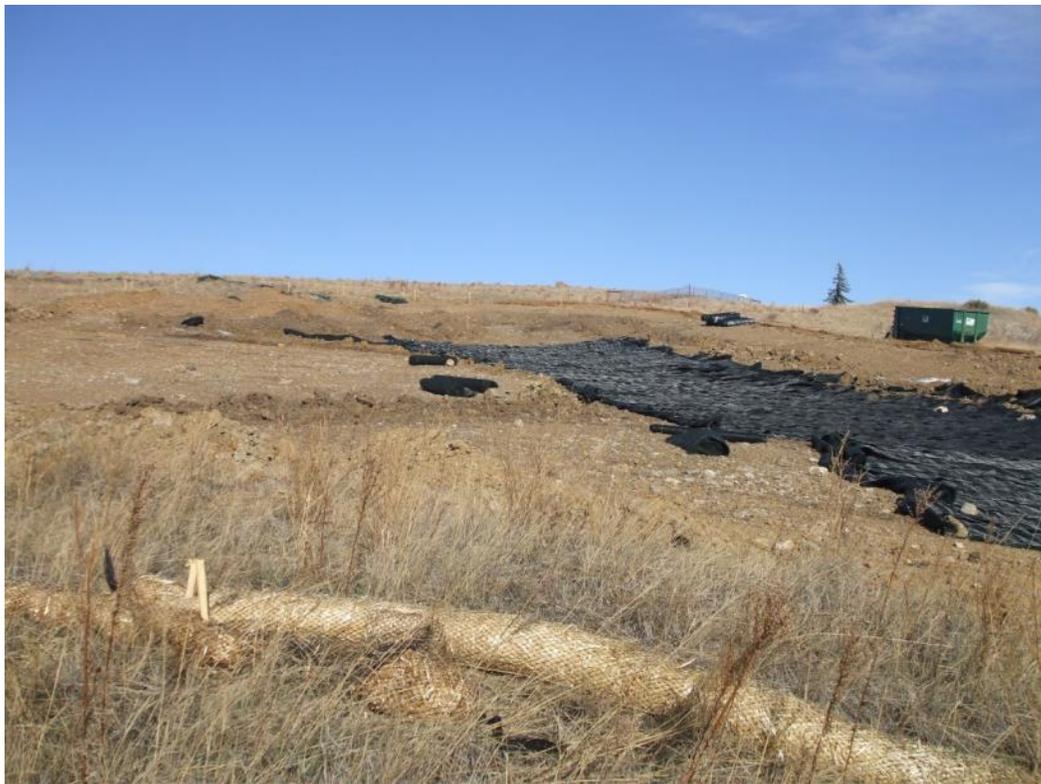
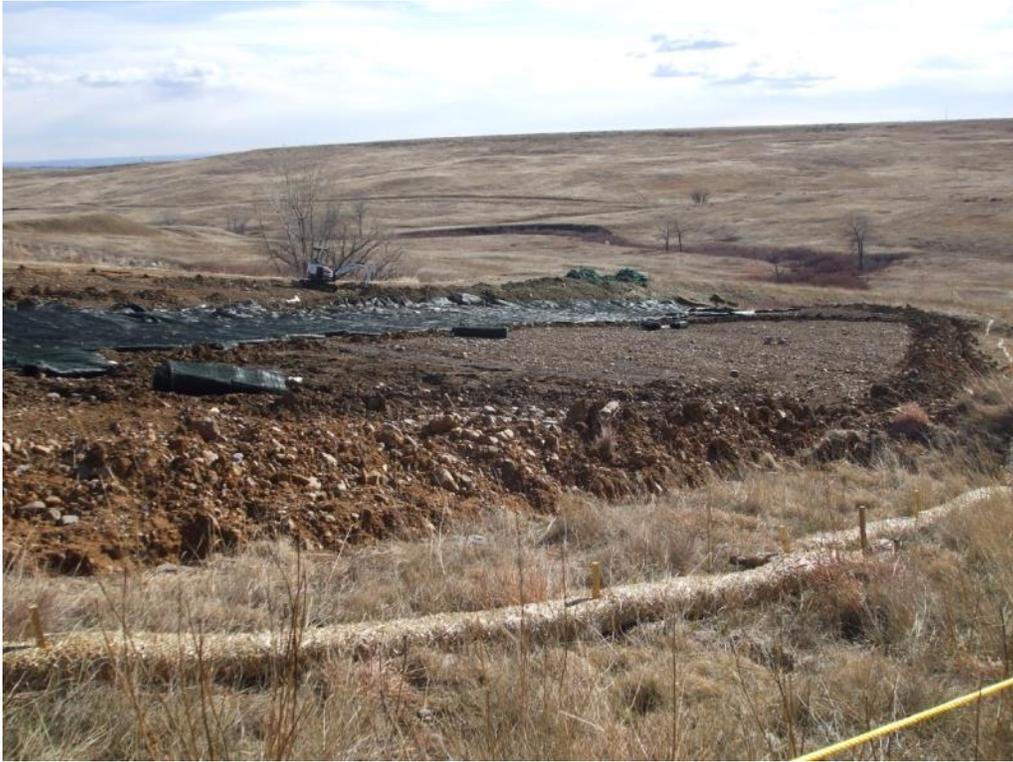
The EPC reconfiguration project is currently in progress - please see Attachment 1

*EPC construction zone: looking north*

*EPC construction zone: looking south*

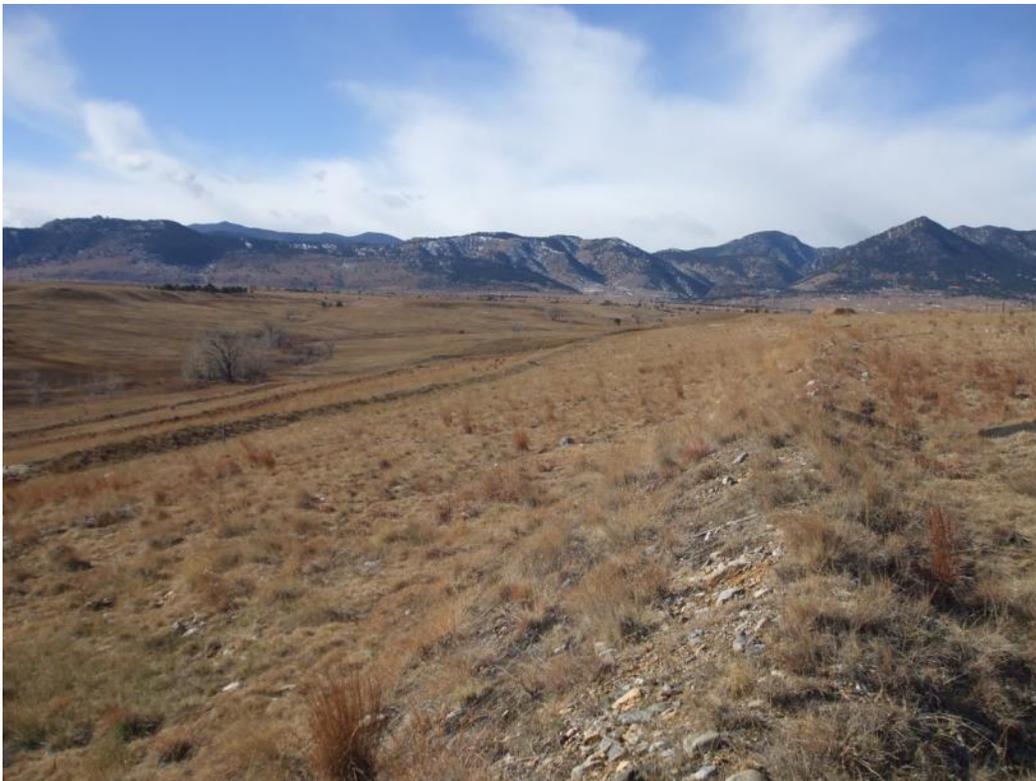
The cracks and depressions on the eastern cover and berm 4 are associated with the previously documented slump. No new cracks or depressions were apparent during this inspection.

*Top of Berm 4: looking west*

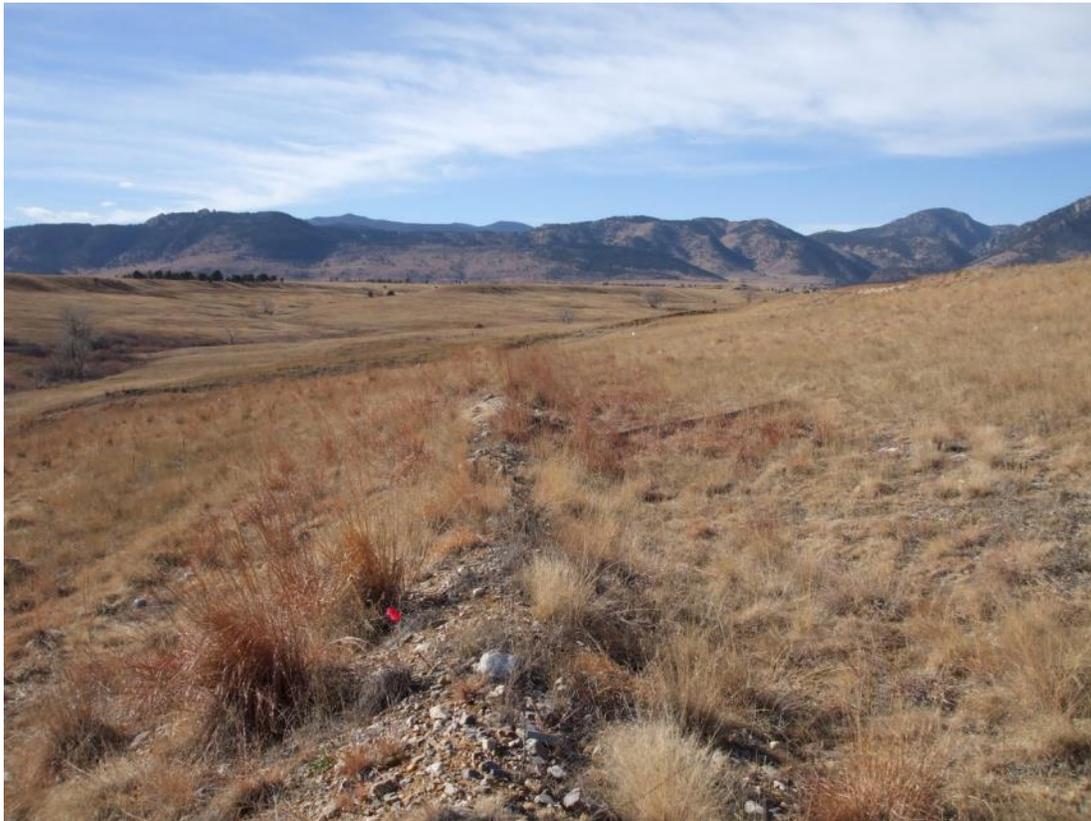
*Top of Berm 1: looking west*

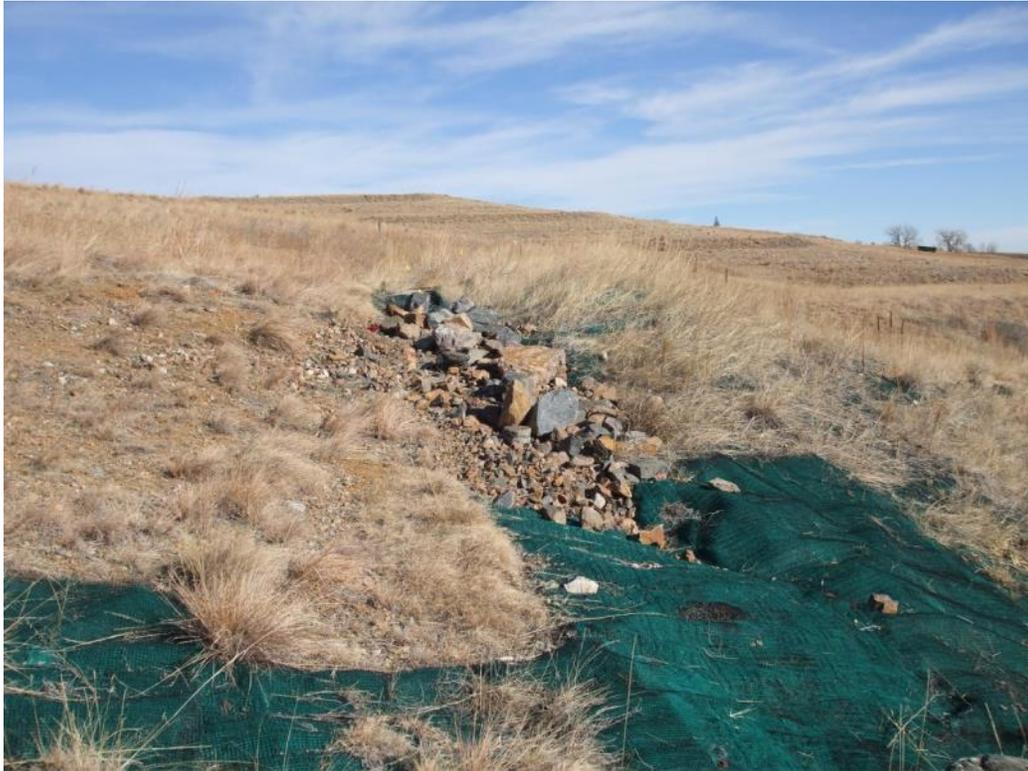
*Berm 3 outfall*

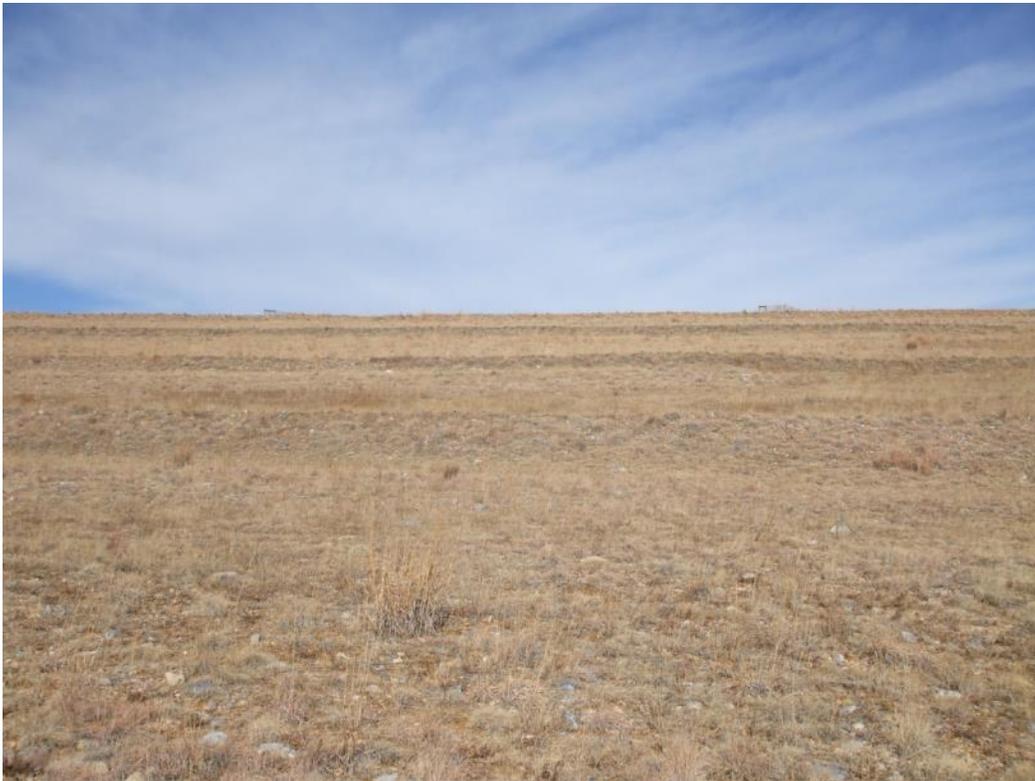
*East cover: looking north*

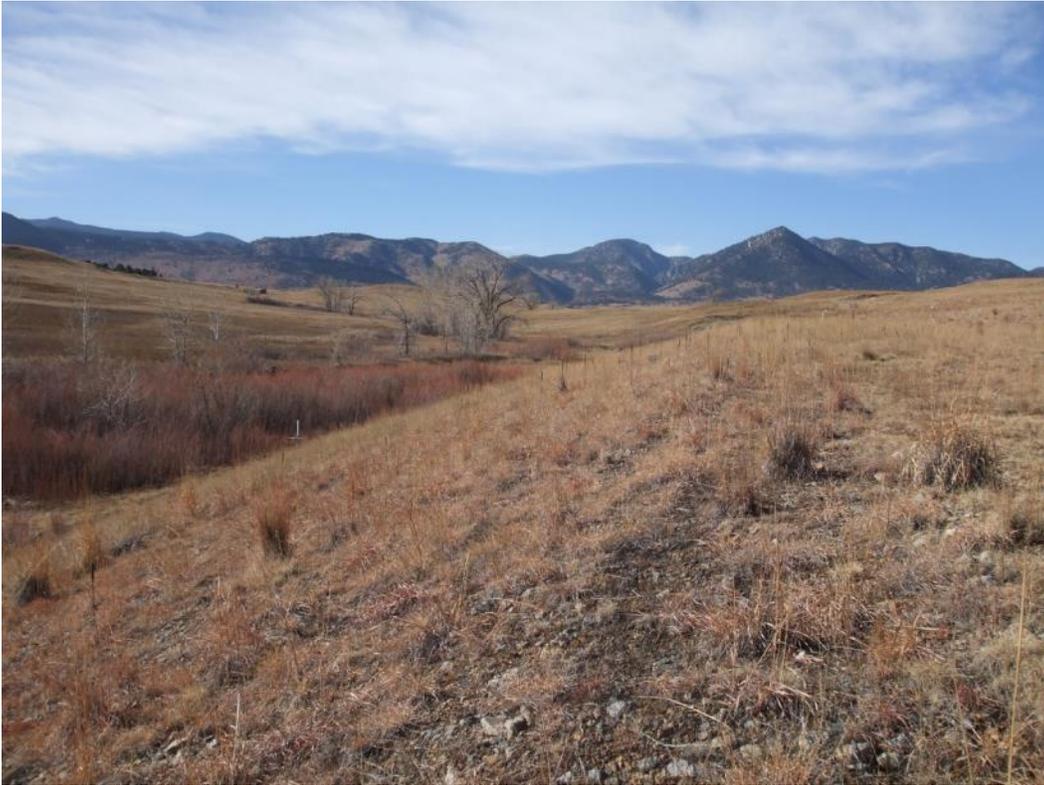
*Buttress area: looking west*

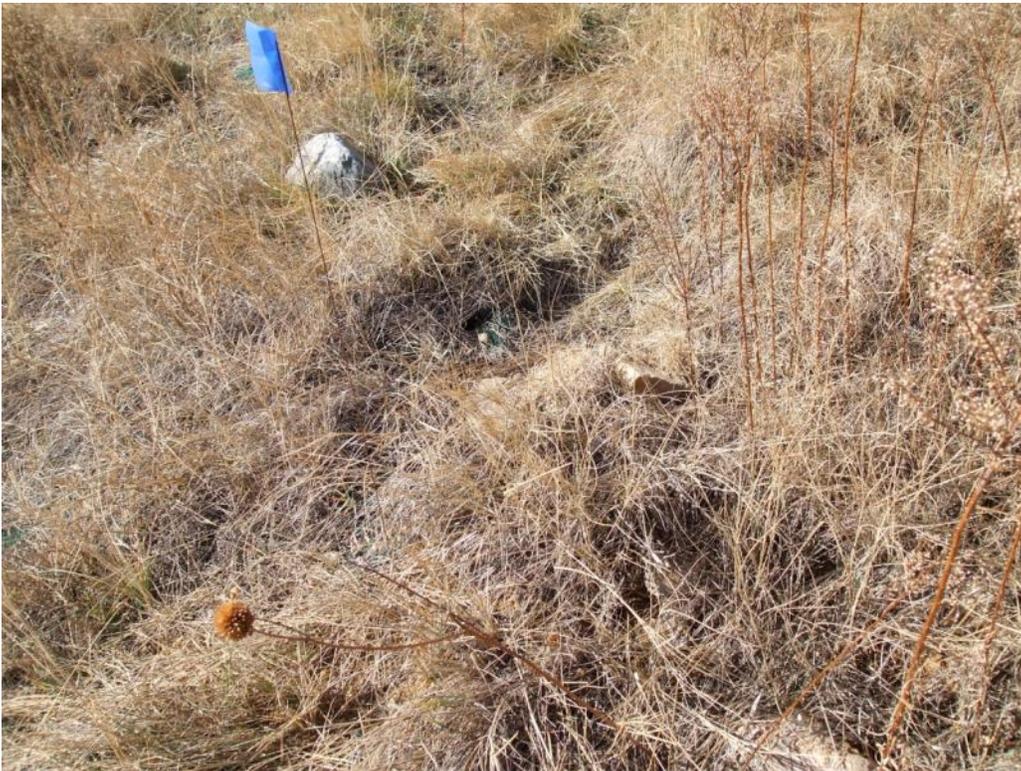
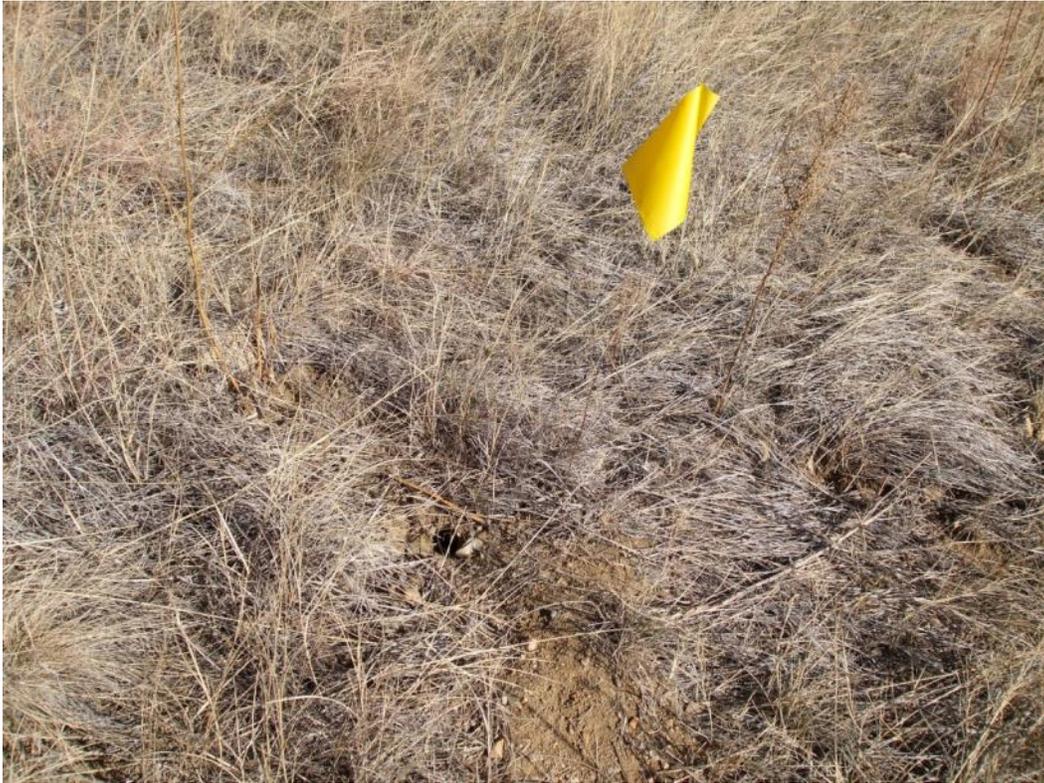
Approximately eight burrowing-animal dens were observed adjacent to the EPC between Berms 6 and 7. The dens are small, show no signs of recent activity, and do not pose an immediate threat to the integrity of the OLF. They are located outside of the waste footprint and will continue to be monitored to ensure that they do not expand in size or number. Two additional dens were observed south of Berm 7; however, these dens also show little to no signs of frequent use. They will continue to be monitored as well.

*Burrowing animal dens, south of Berm 7*

*Burrowing animal dens between Berms 6 and 7*

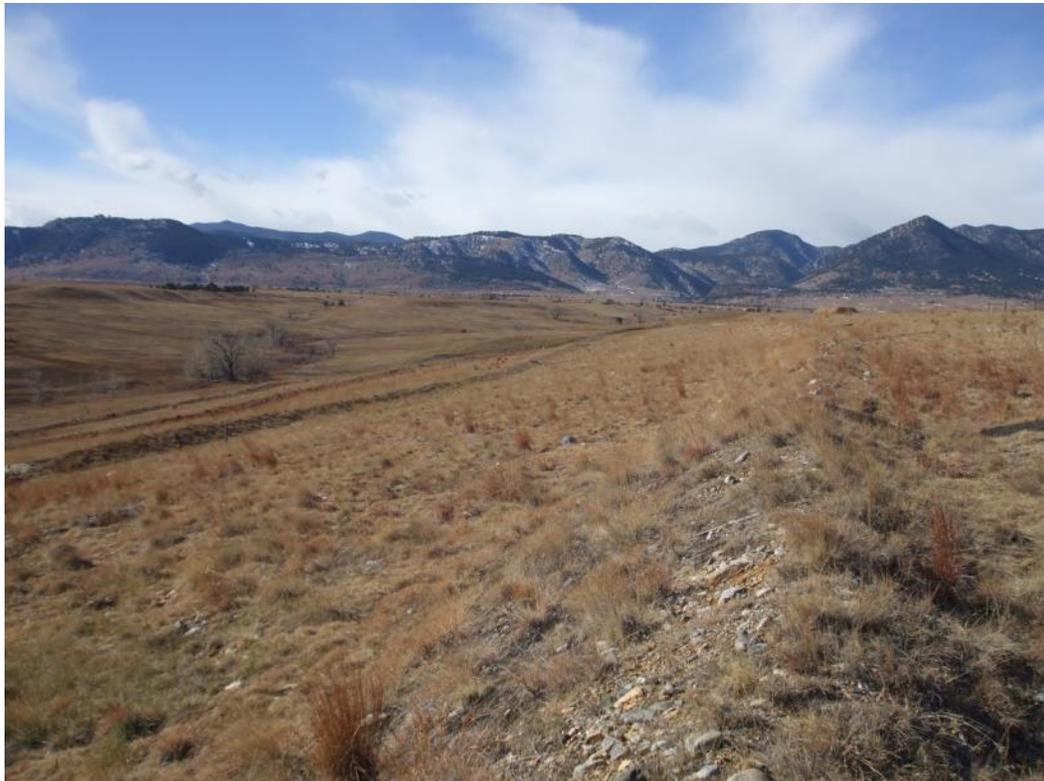
The cracks + depressions on the eastern cover + berm 4 are associated with the previously documented slump. No new cracks or depressions were apparent during this inspection.

*Top of Berm 4: looking west*
