ROCKY FLATS SITE REGULATORY CONTACT RECORD

Purpose: Reportable Condition at the Original Landfill (OLF)

Contact Record Approval Date: October 21, 2013

To: Mr. Rick DiSalvo
Mr. Melvin Madril, PE
Mr. Stephen Pitton From: Thomas A. Chapel, CPG, PE
Company: S.M. Stoller Corporation Date: October 10, 2013
Rocky Flats OLF Berm 4 Grading
Re: and Drainage Project No.: 114-181750

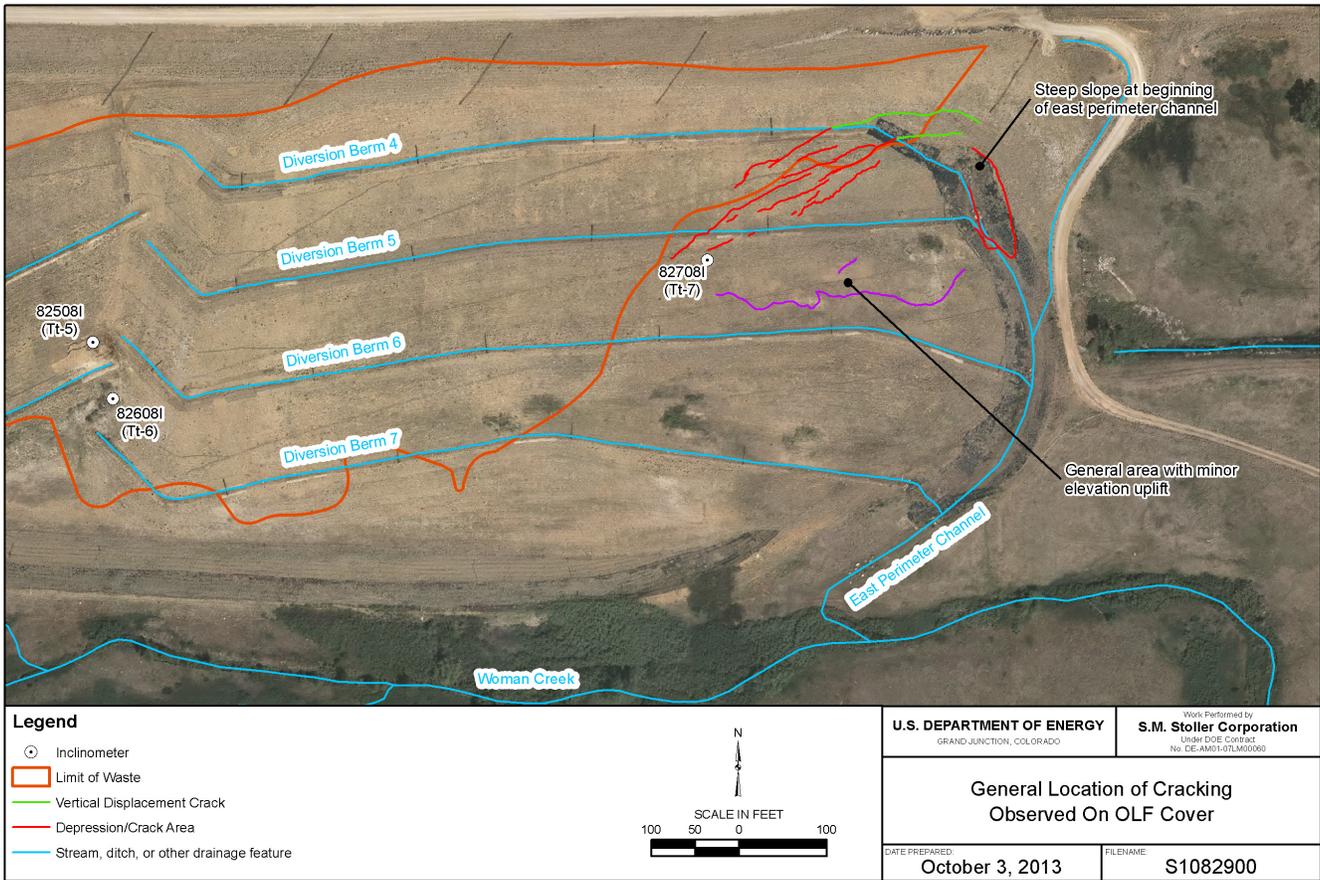
Figure 1. General Location of Cracking Observed on OLF Cover

Localized surface cracking and differential settlement in the northeastern portion of the cover were noted during the inspection on September 16, 2013. In accordance with RFLMA Attachment 2, Section 6.0, "Action Determinations," DOE determined this was a reportable condition affecting the effectiveness of the OLF cover. Section 6.0 provides:

Cracks with vertical displacement of up to approximately 2 feet and cracks up to approximately 0.5 feet wide were observed during the inspection. The cracking and settling extended through portions of Diversion Berms 4 and 5, and a minor depression was formed in the Diversion Berm 4 channel between the cracks. Figure 1 shows the general location of the observed cracks based on handheld GPS measurements.

Initial Response: Initial mitigation steps were undertaken by DOE to minimize the potential for infiltration of precipitation. Initial steps included (1) regrading the differential displacement cracks to seal the openings using the RFA from the adjacent area and (2) filling minor cracks by smoothing and tamping the surrounding surface. Erosion mats were placed over the regraded area. This work was completed on September 20, 2013. This area will be inspected weekly and any continuation of the cracking will be filled by smoothing out and tamping the surface as needed.

The cracks with vertical displacement running through Diversion Berm 4 created a slight depression about 50 feet long in the berm channel. The depression prevents positive storm water drainage. This was temporarily corrected by installing perforated drain pipe and drain rock in the channel to convey runoff and to prevent ponding in this channel.

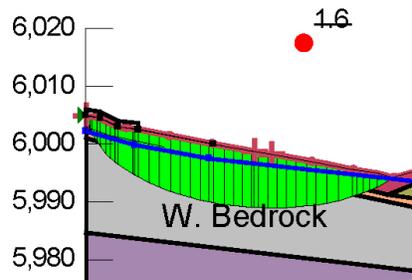
(a) Elevated water table, no surcharge.

We have considered two alternative, short-term methods for reducing the occurrence of standing water in this area. Fill could be placed on the berm and in the channel invert to raise the lower portion so that positive drainage will occur across the zone. This alternative adds additional weight to the cracked area which tends to decrease the stability. Using previous slope stability models that we constructed as part of our geotechnical engineering evaluation, Tetra Tech simulated a wet condition and placement of additional fill by increasing the water level in the model and adding a surcharge to the ground surface at the failure plane. The surcharge applied approximates a two-foot layer of Rocky Flats Alluvium placed at the upper portion of the failure zone. Figure 1 (below) illustrates these conditions. Figure 1(a) shows the slope and localized failure with no surcharge, but with an elevated water level. The model calculated a minimum factor of safety (FoS) of 1.6, with failure occurring in the upper portion of the weathered claystone bedrock. Figure 1(b) shows the effect of adding a two-foot layer of fill as a surcharge. The calculated minimum FoS dropped

to 1.002 and the failure is predicted to occur in the organic layer at the surface of the weathered bedrock. These results indicate that the slope is marginally stable and on the verge of failure following the addition of two feet of fill. Because a localized, minor failure did actually occur when the water level increased, but without an additional surcharge, the model results may actually under-predict the potential risk of additional failures if surcharge is added.

Another alternative that would appear to have a lower risk for decreasing stability of the area is the construction of a temporary drain in the invert of Berm 4 to convey water from the low segment eastward to the outfall. This could be a trench and flexible drain pipe constructed such that the upper end of the drain is at the downstream end of the low segment and the drain outfall is at the eastern end of Berm 4 or in the EPC. This drain could be removed when longer term remedies have been designed and constructed (see below).
