ROCKY FLATS SITE REGULATORY CONTACT RECORD 2014-07

Purpose: Abandonment of Sentinel well 88104 at the Rocky Flats Site, Colorado.

Contact Record Approval Date: July 21, 2014

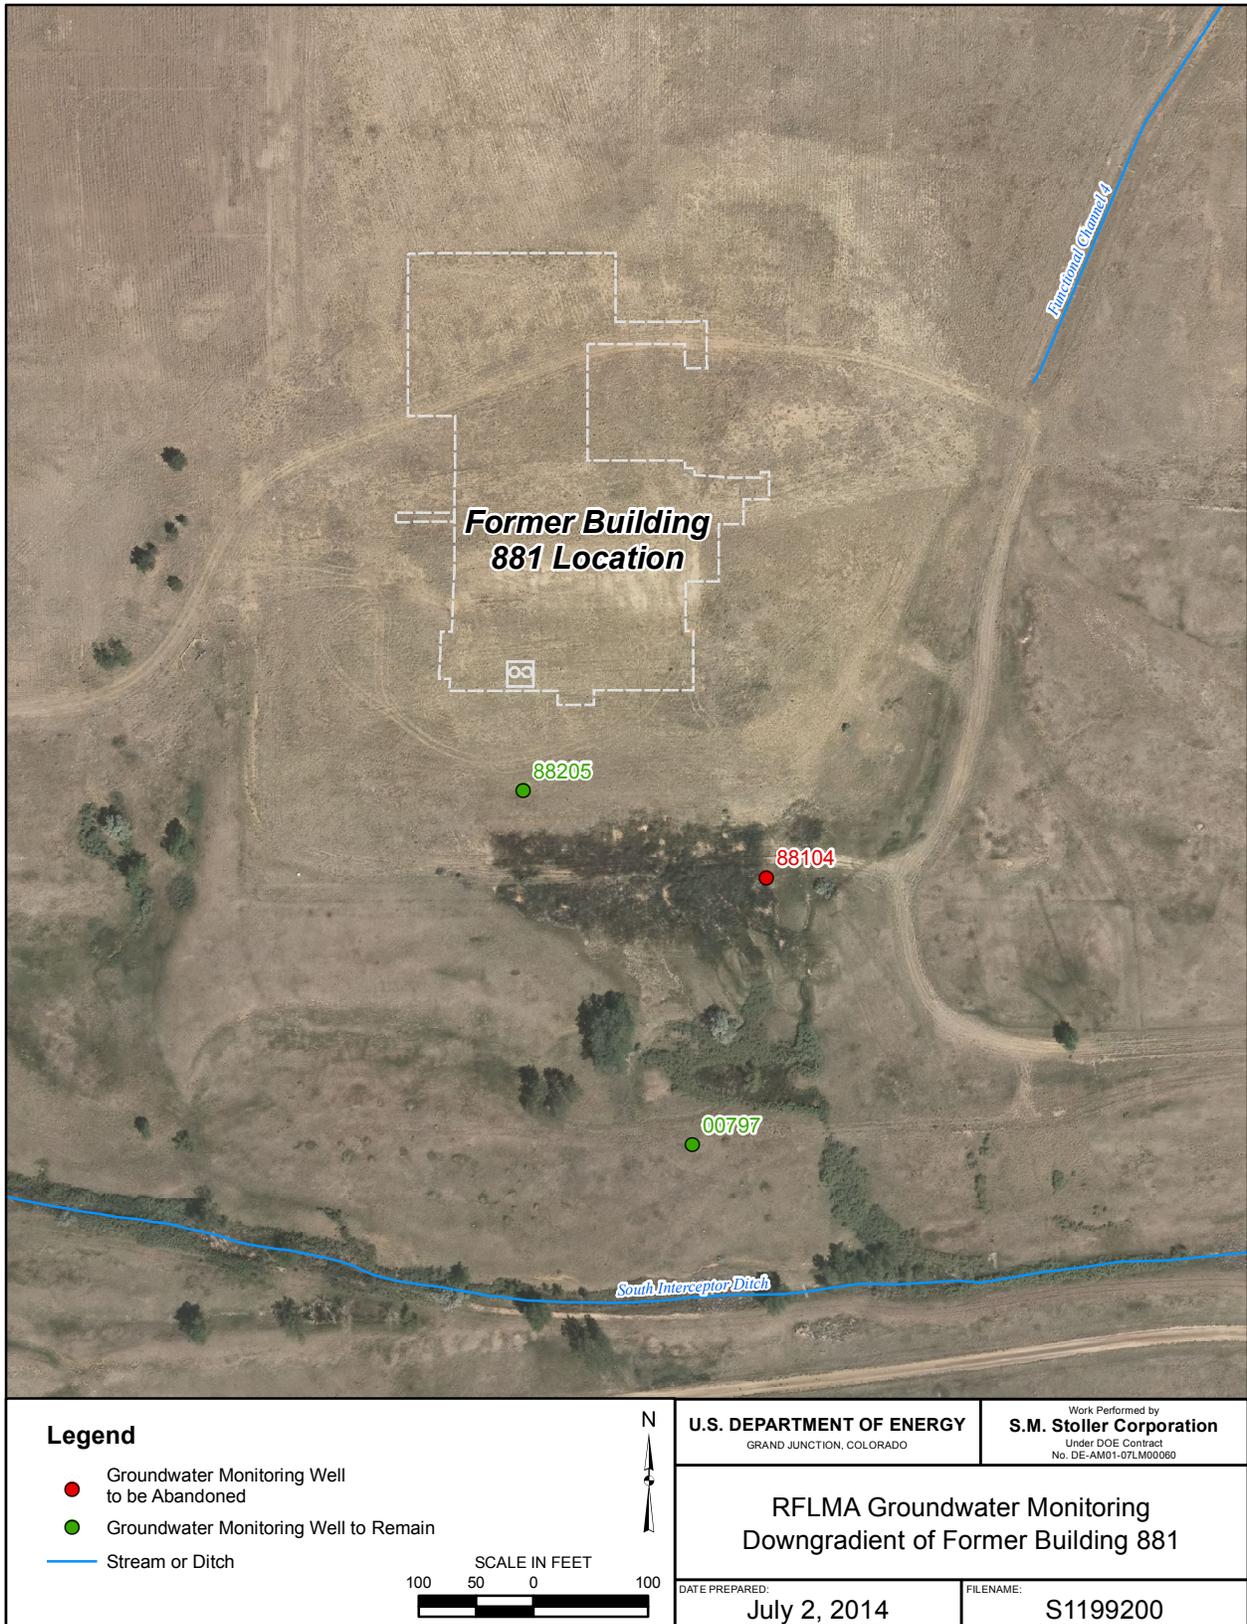
Figure 1

This condition and three primary response alternatives were discussed: (1) install a replacement well, (2) insert a smaller-diameter casing in the existing breached casing and continue to monitor this location until that inner casing also breaks, or (3) discontinue sampling and abandon the well. Recent data from well 88104 and the two closest wells that also monitor former B881, Evaluation well 88205 and Sentinel well 00797, were evaluated (see attached map for well locations).
