# Original Landfill

February 1, 2016

Legacy  
Management

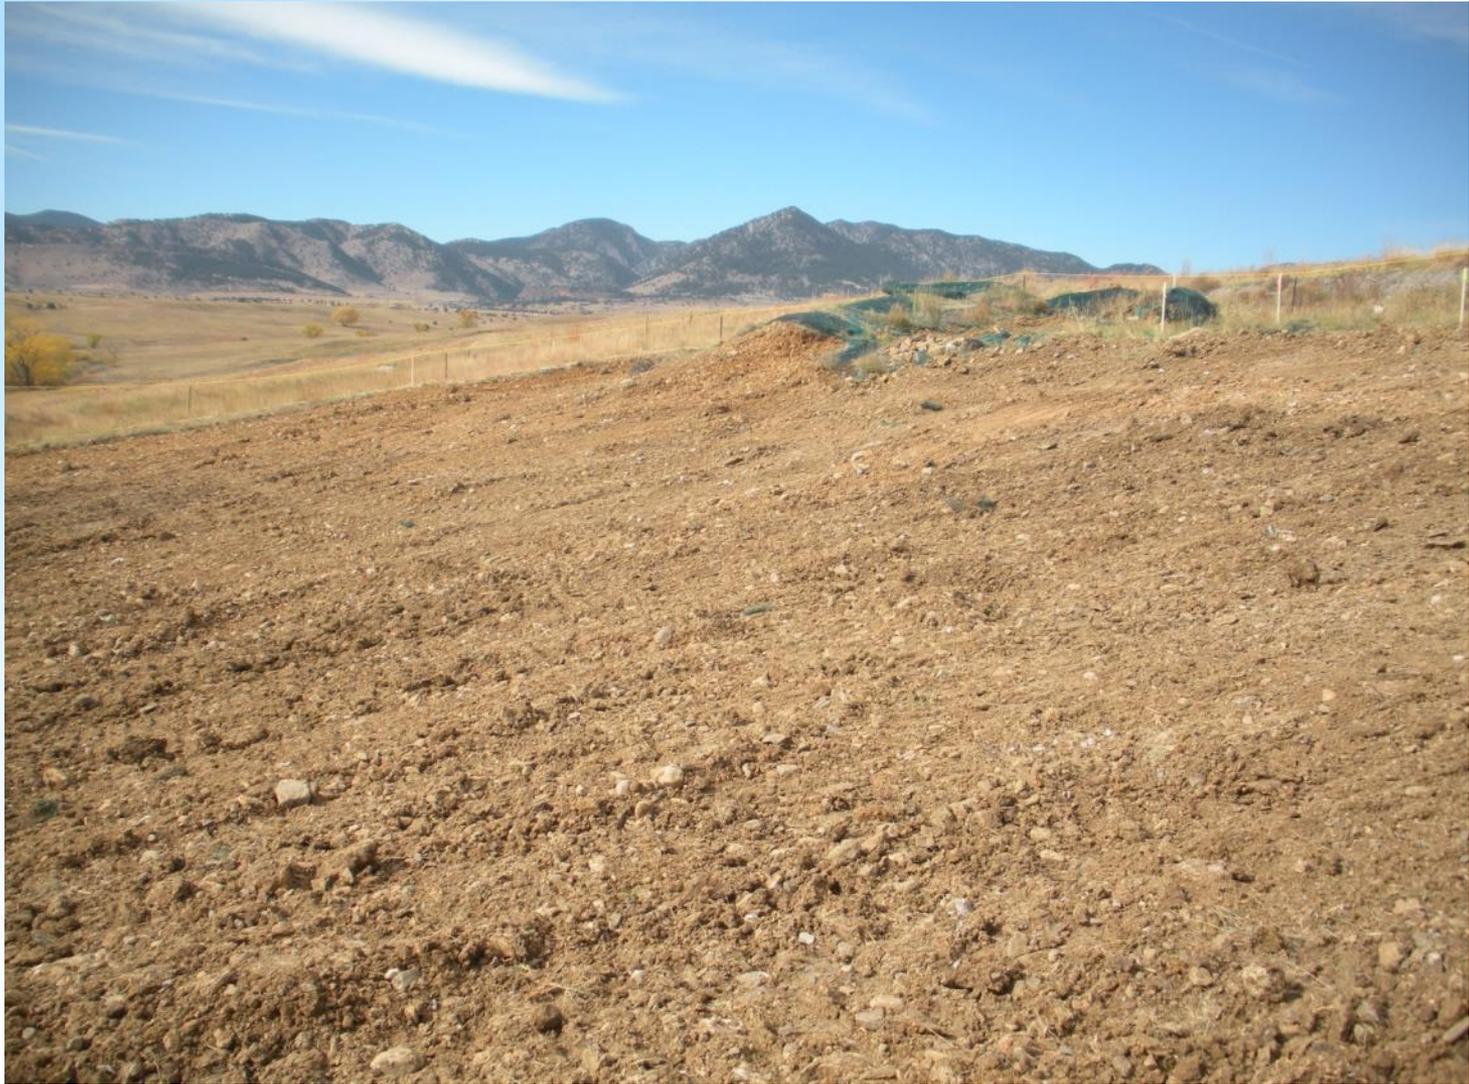
- Cracking and slumping, mostly associated with the east perimeter channel and the berm 4 area, continued through spring of 2014
- DOE re-evaluated the design for the east perimeter channel reconfiguration
- East perimeter channel reconfiguration construction completed second week of January 2015
- All soil disturbance and regrading was performed outside the waste footprint

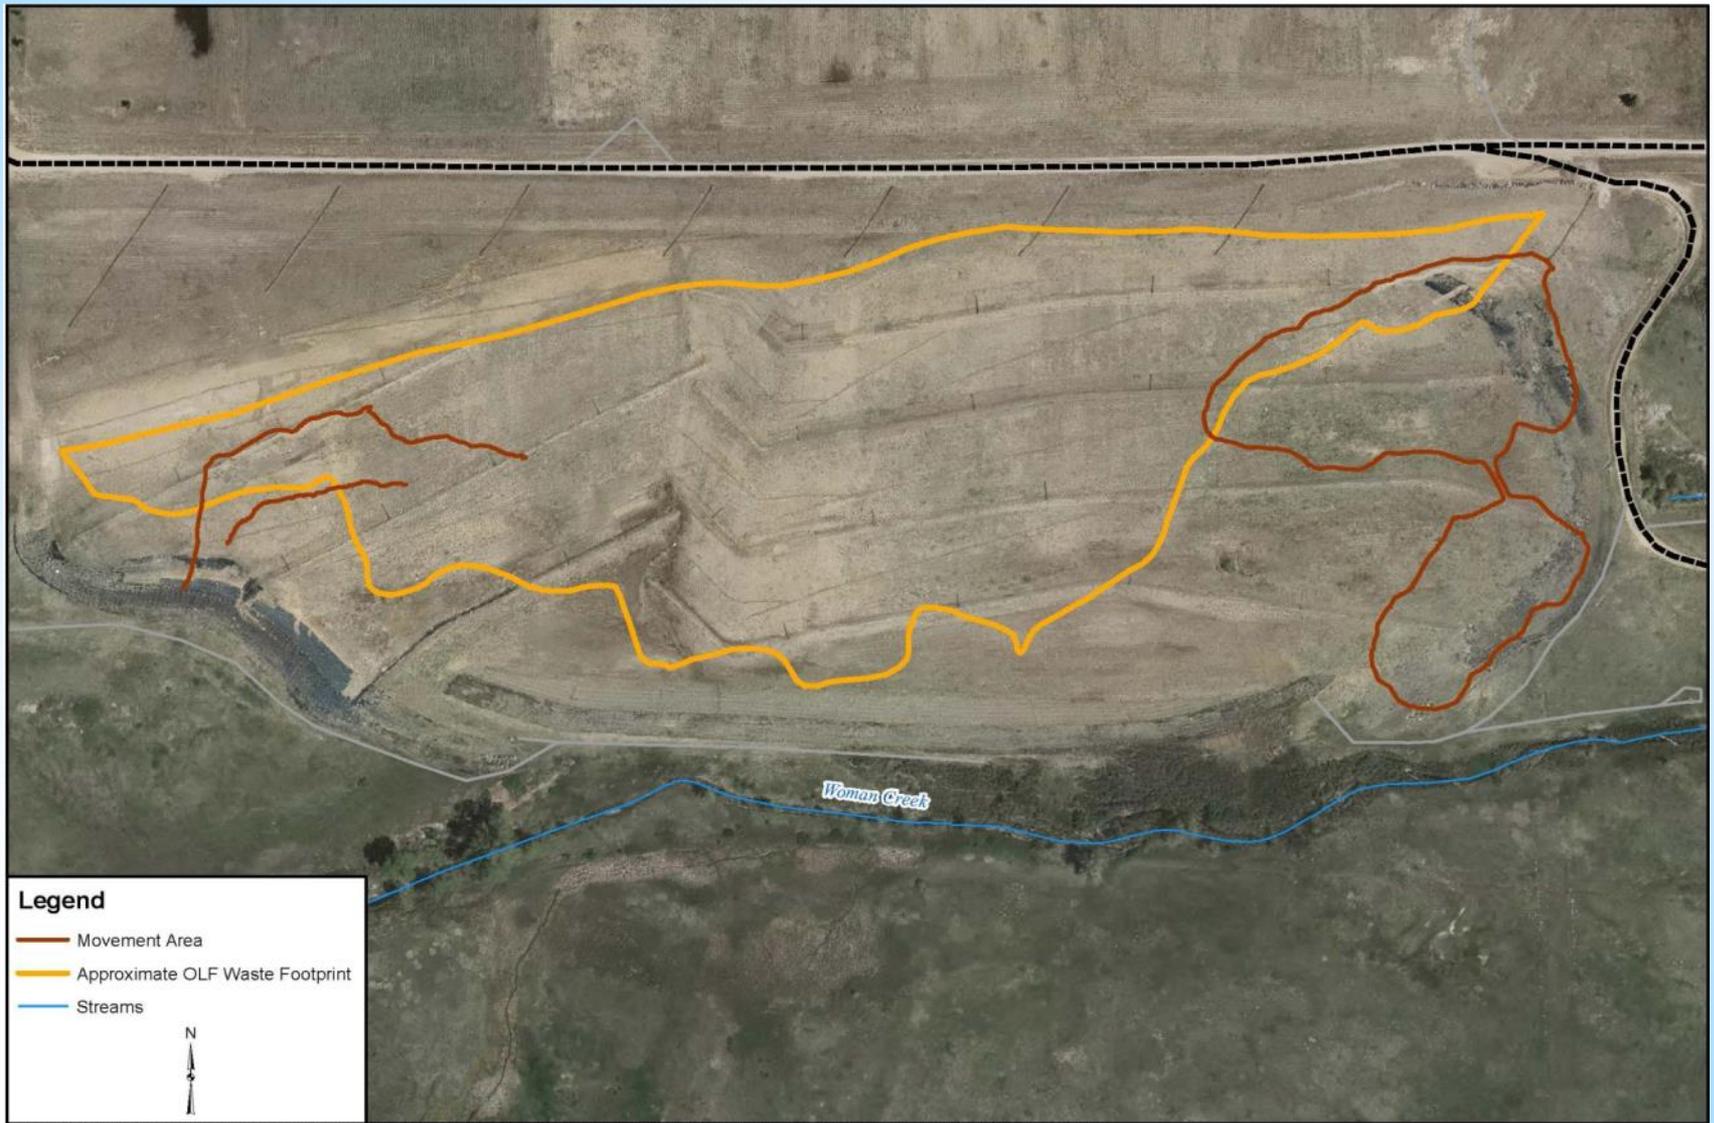
# OLF Movement Areas

- Extended heavy precipitation over several months in spring of 2015
  - Significant cracking, slumping, and movement on the east side.
  - West side experienced some movement on the west end of berms 1 and 2
  - Center section of the landfill experienced no visible movement (small cracks in a few locations)
- Immediate actions included installing overland drain pipe and developing small drainage channels to conduct water off the cover

- Re-graded affected areas to restore the water management functions of the cover and close cracks
- Two-foot cover requirement was not maintained in some areas, primarily outside the waste footprint
- A few pieces of debris were noted during regrading; none were radiologically contaminated

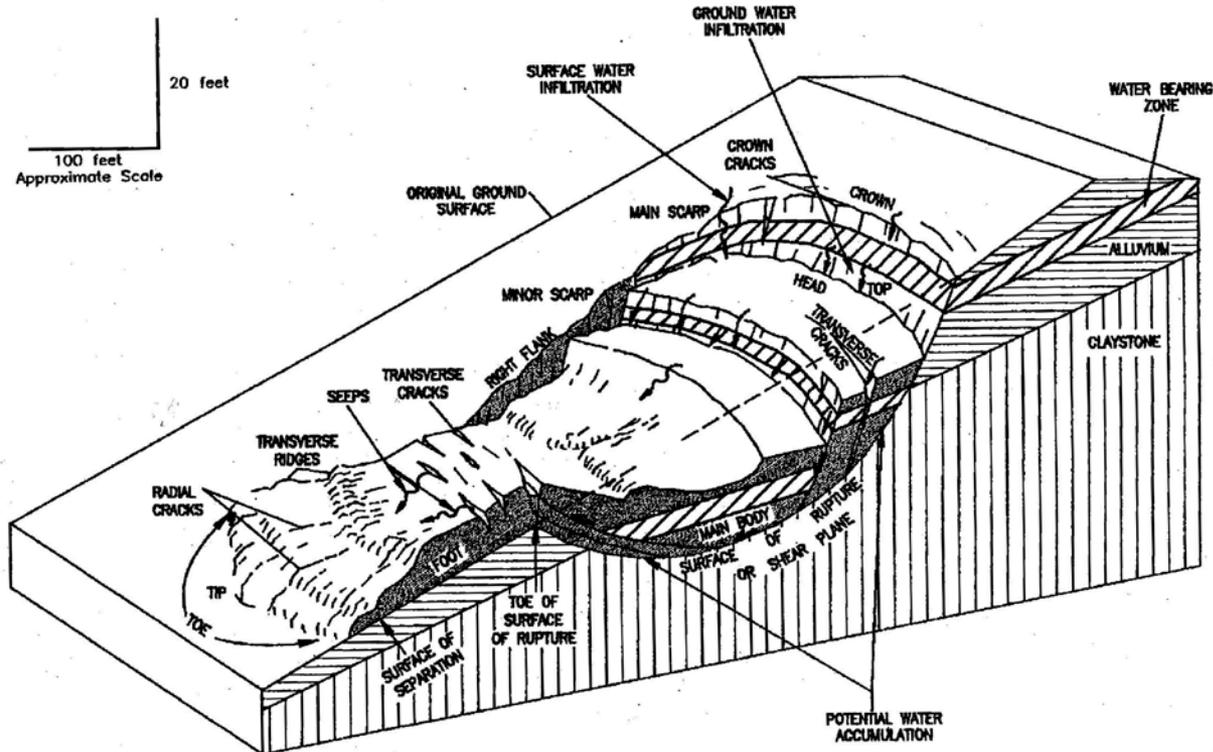
# Typical Slump

Rocky Flats Site, Golden, Colorado	
<b>Potential Hydrogeologic Conditions of a Typical Slump</b>	
Hydrogeologic Characterization Report	
April 1995	Figure 6-14
