THE EFFECTS OF THE RULISON EVENT
ON BUILDINGS AND OTHER SURFACE STRUCTURES

Lloyd A. Lee and Roger E. Skjei

January 14, 1970

John A. Blume & Associates
Research Division
San Francisco, California

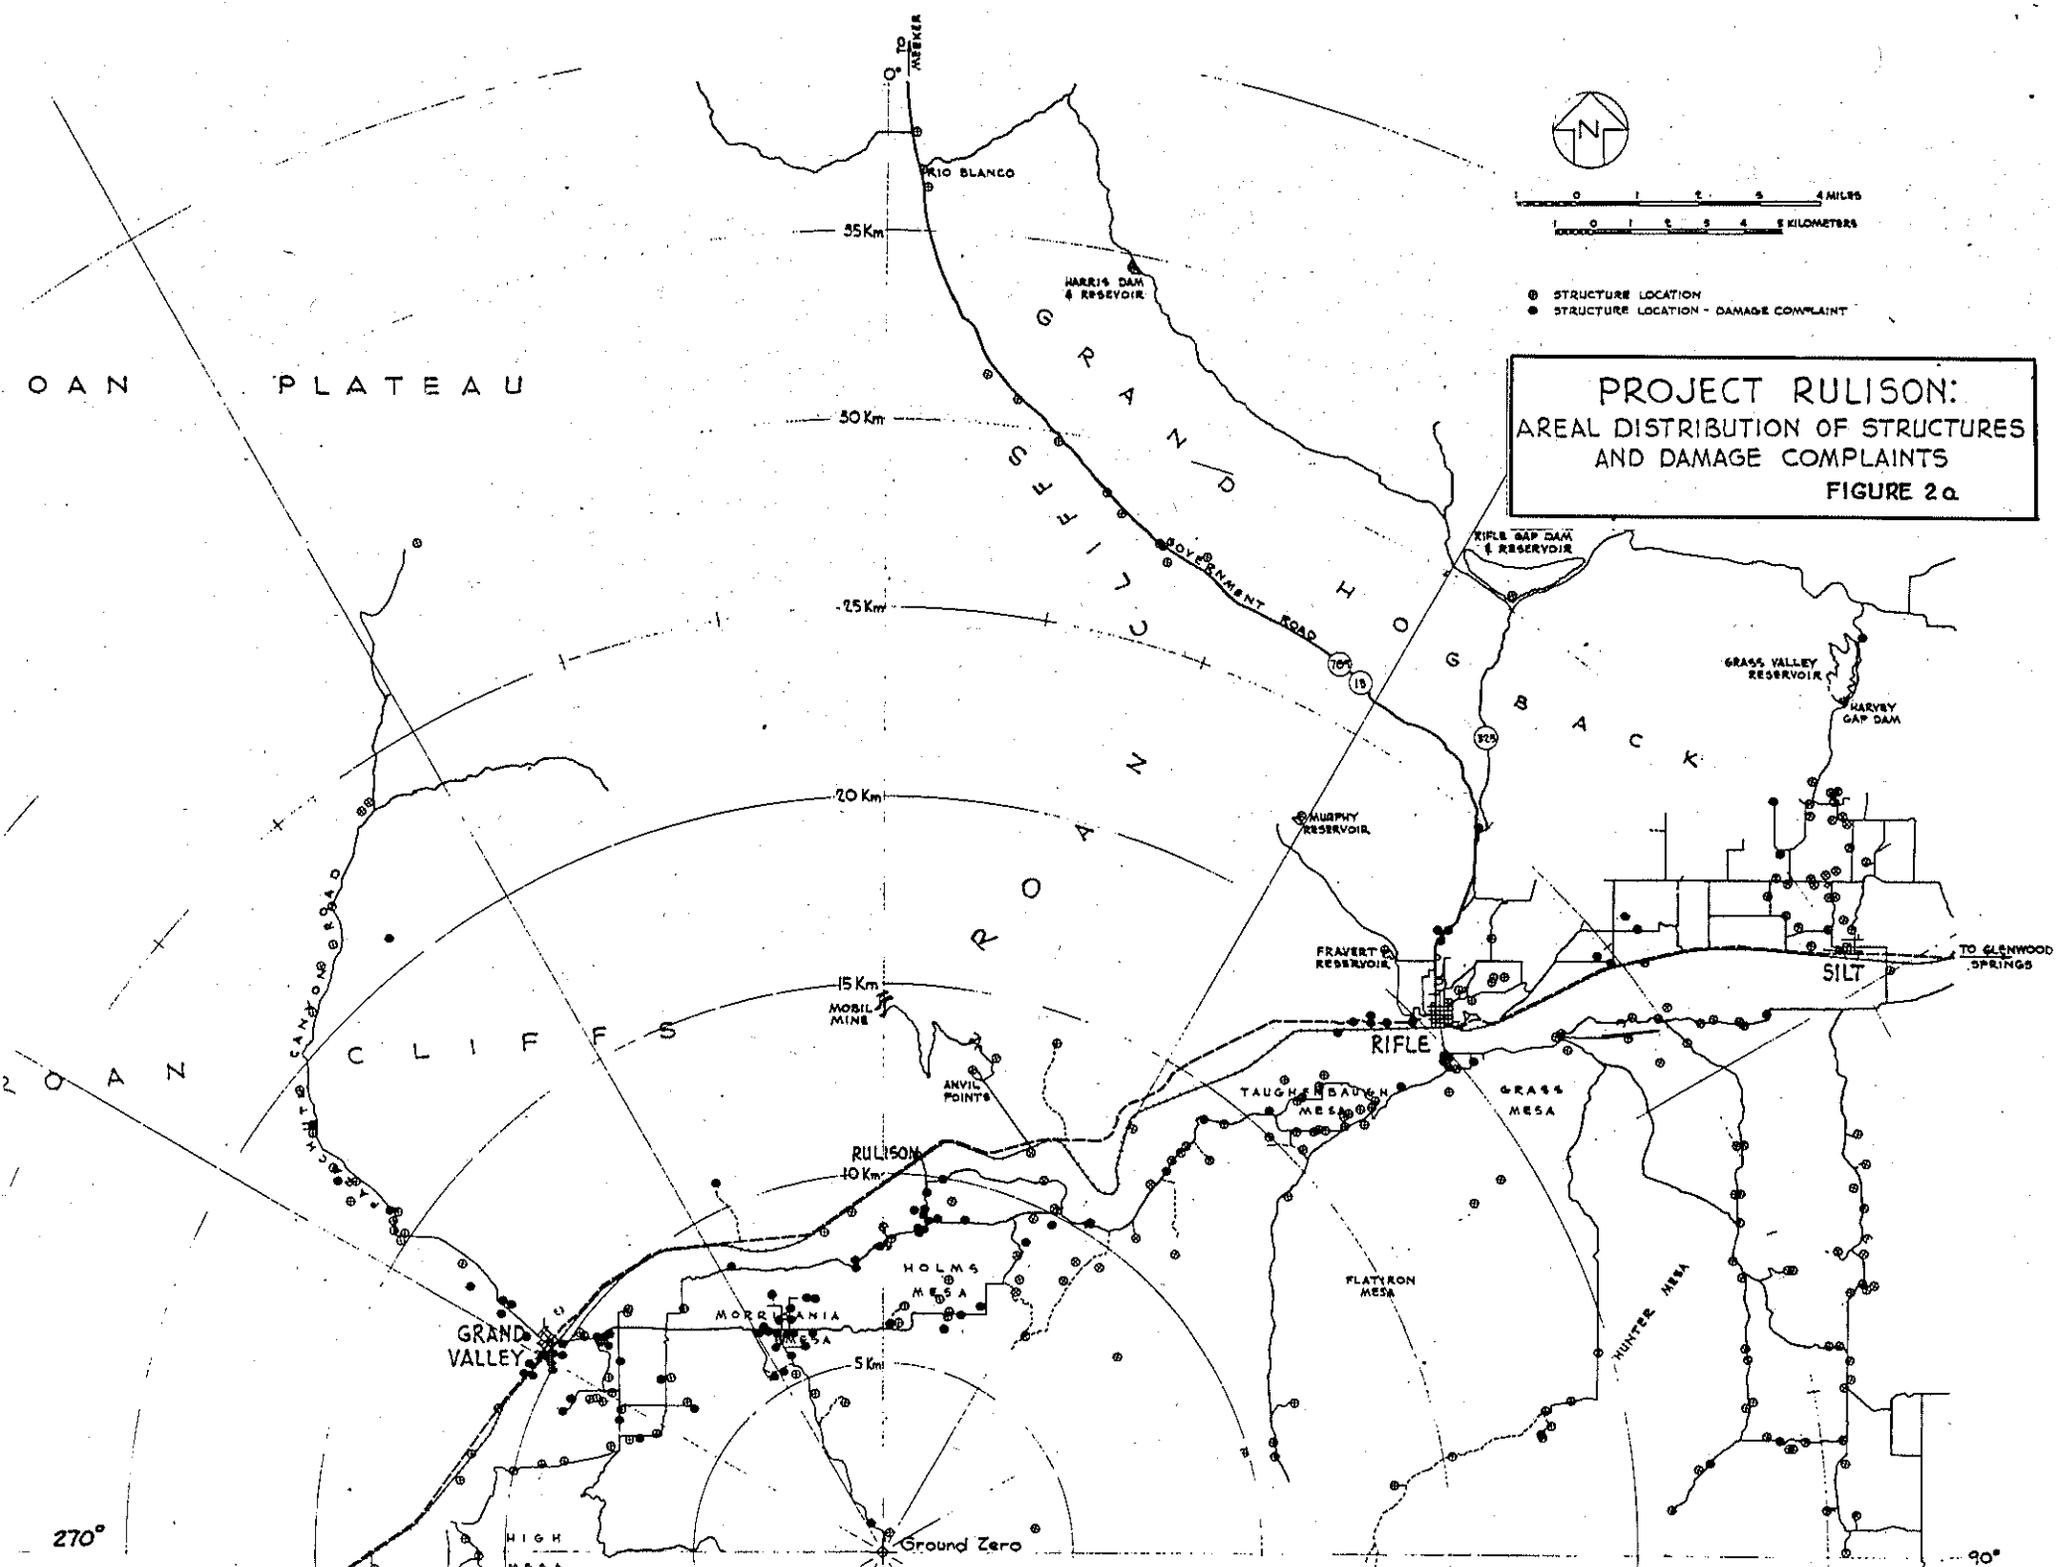
PROJECT RULISON:
AREAL DISTRIBUTION OF STRUCTURES
AND DAMAGE COMPLAINTS
FIGURE 2a

Table IV presents a breakdown, again by 5-kilometer increments, of the total number of structure locations versus damage complaints. A structure location as used here is a house or cabin location with or without outbuildings. Thus, a ranch is a structure location and a house in Grand Valley is also a structure location. The areal distribution of structure locations and damage complaints outside of the towns is shown in Figure 2. The 69 complaints in Grand Valley and the 74 complaints in Rifle are not shown in this Figure.
