Structural Response Studies for  
Project Rulison

John A. Blume & Associates Research Division  
san francisco

February 1971

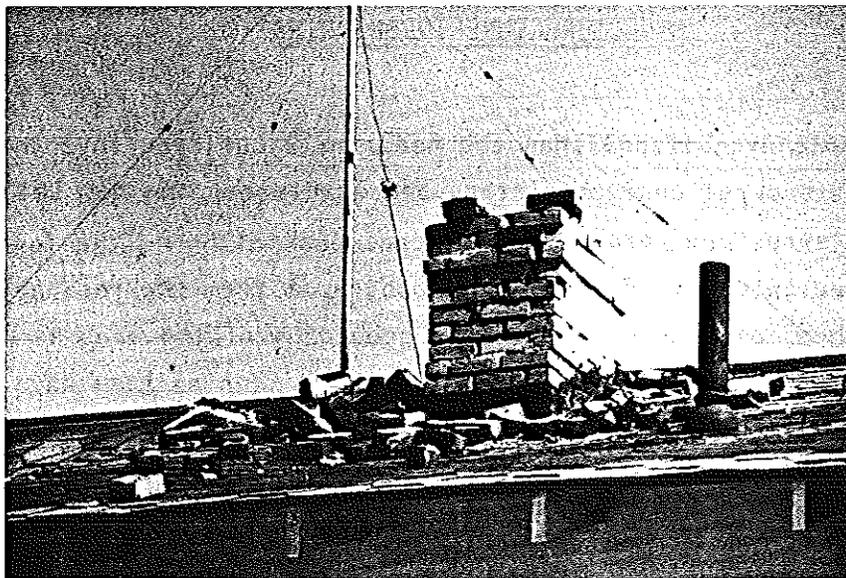
FIGURE 11. POST-SHOT CHIMNEY CONDITION.

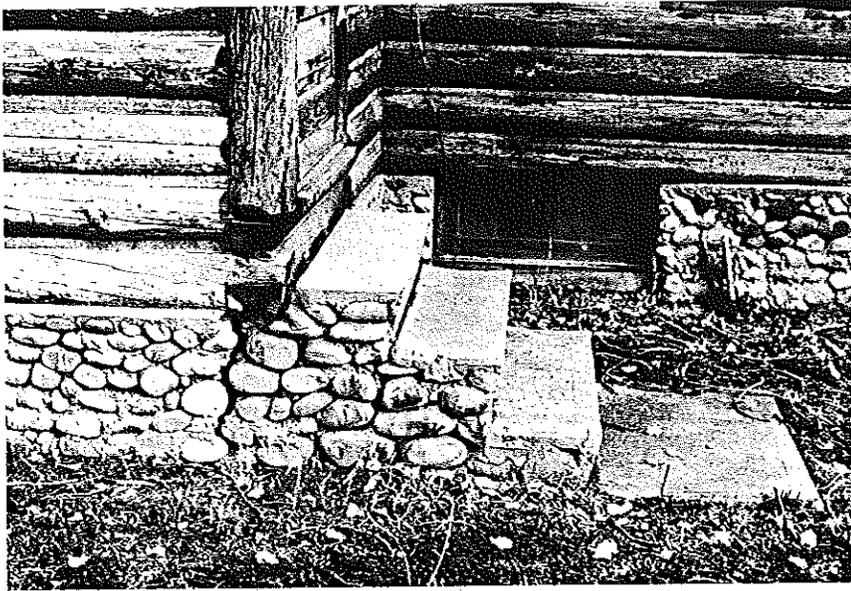
FIGURE 18. CRACKED FOUNDATION AND STEPS  
SEPARATED FROM HOUSE.

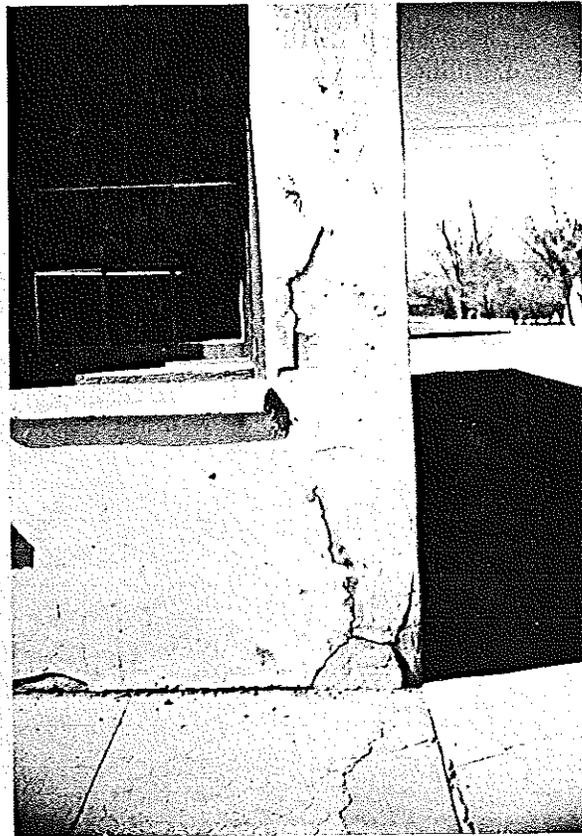
FIGURE 19. TYPICAL CRACKING  
AND SPALLING OF STUCCO OVER  
MORTARED STONE WALL.

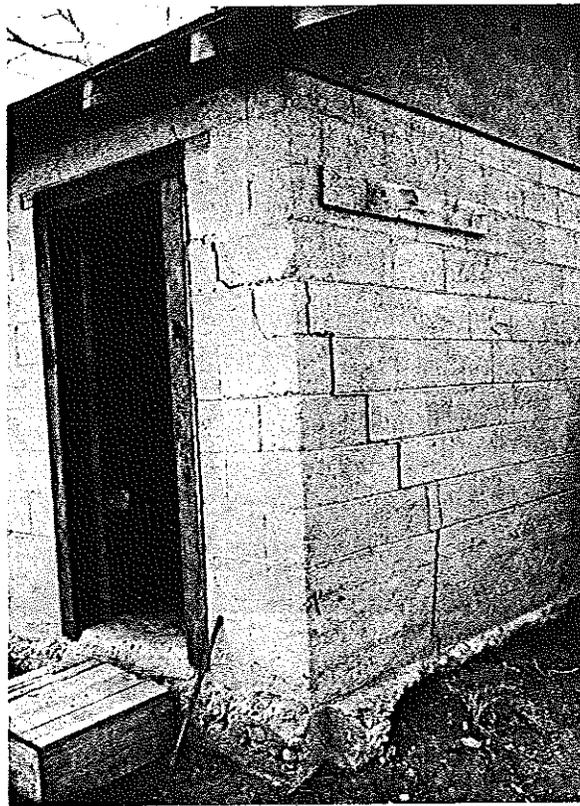
FIGURE 20. STAIRSTEP CRACKING OF MORTARED JOINTS IN CINDER BLOCK WALLS.

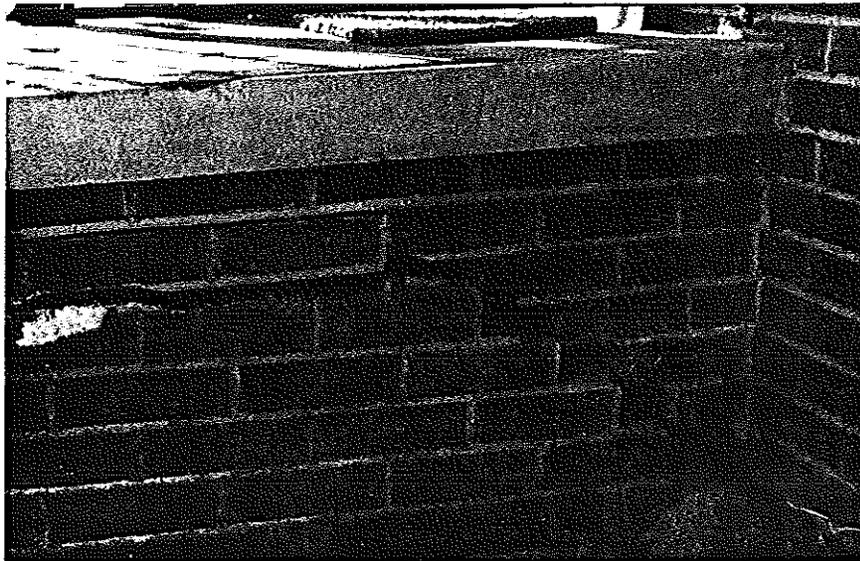
FIGURE 21. STAIRSTEP CRACKING OF MORTARED JOINTS IN BRICK WALL.

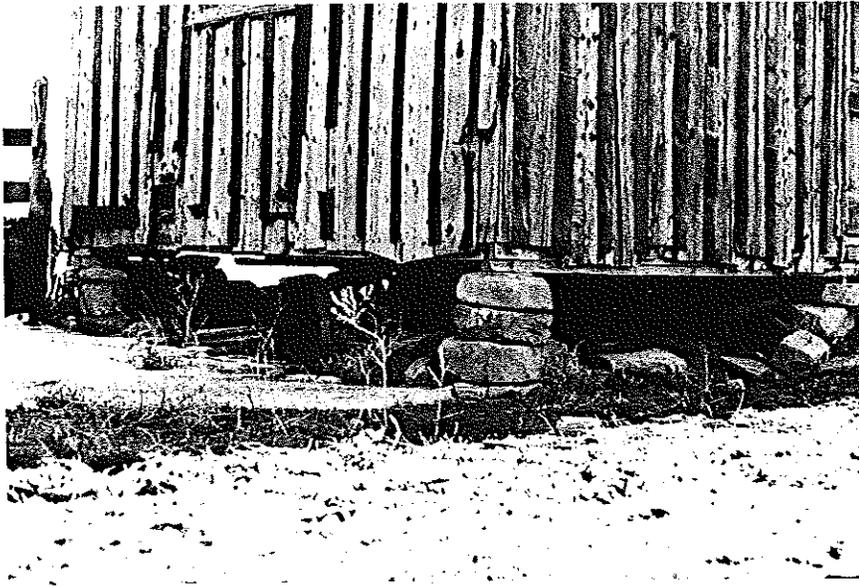
FIGURE 23. PRE-SHOT REMEDIAL WORK WAS RECOMMENDED FOR THIS INADEQUATE BUILDING FOUNDATION CONDITION.

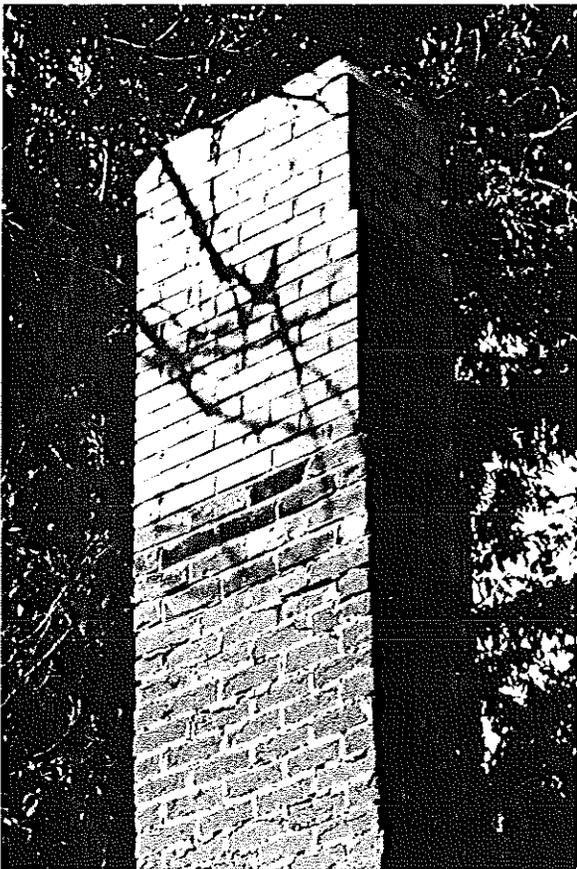
FIGURE 31. POST-EVENT CONDITION WITH SOME MORTAR DAMAGE TO THE OLDER SECTION OF THE CHIMNEY. COMPARE WITH FIGURE 30.

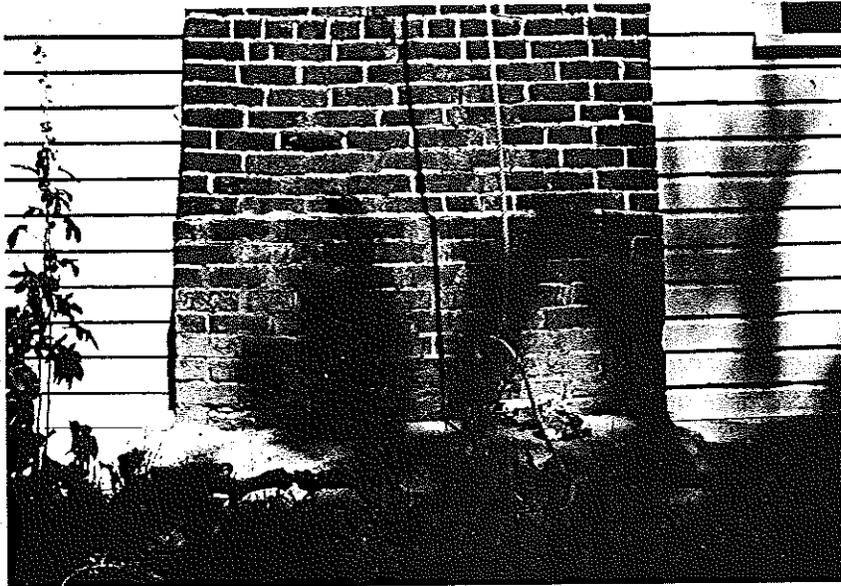
FIGURE 32. PRE-EVENT CONDITION OF THE CHIMNEY BASE AND FOUNDATION. NOTE THE NUMEROUS MORTAR PATCHES.

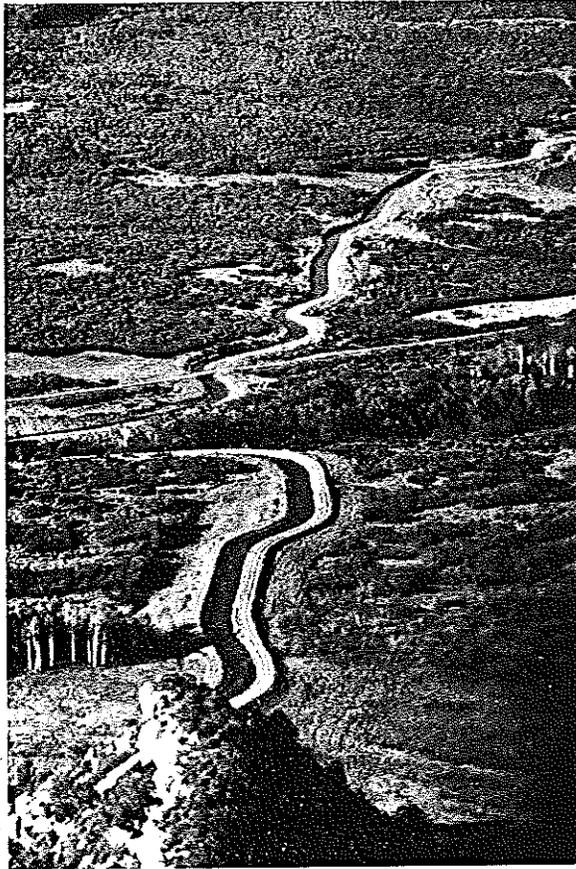
FIGURE 60. SOUTHSIDE CANAL HAD SOME AREAS WHERE SLOPE INSTABILITY WAS NOTED.

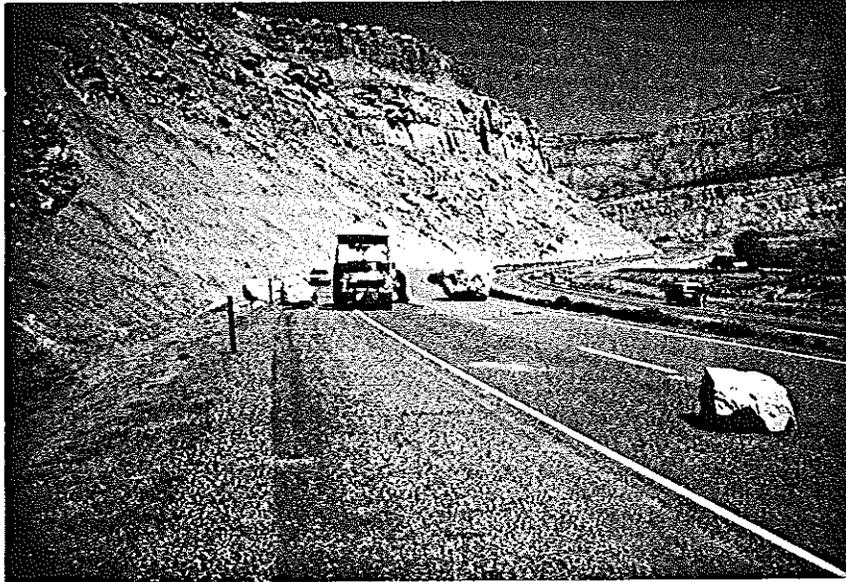
FIGURE 62. ROCKFALL FROM THE BOOK CLIFFS  
ALONG I-70 NORTH OF PALISADE. THIS ROCK  
FALL OCCURRED DURING THE LATTER PART OF  
APRIL 1969.

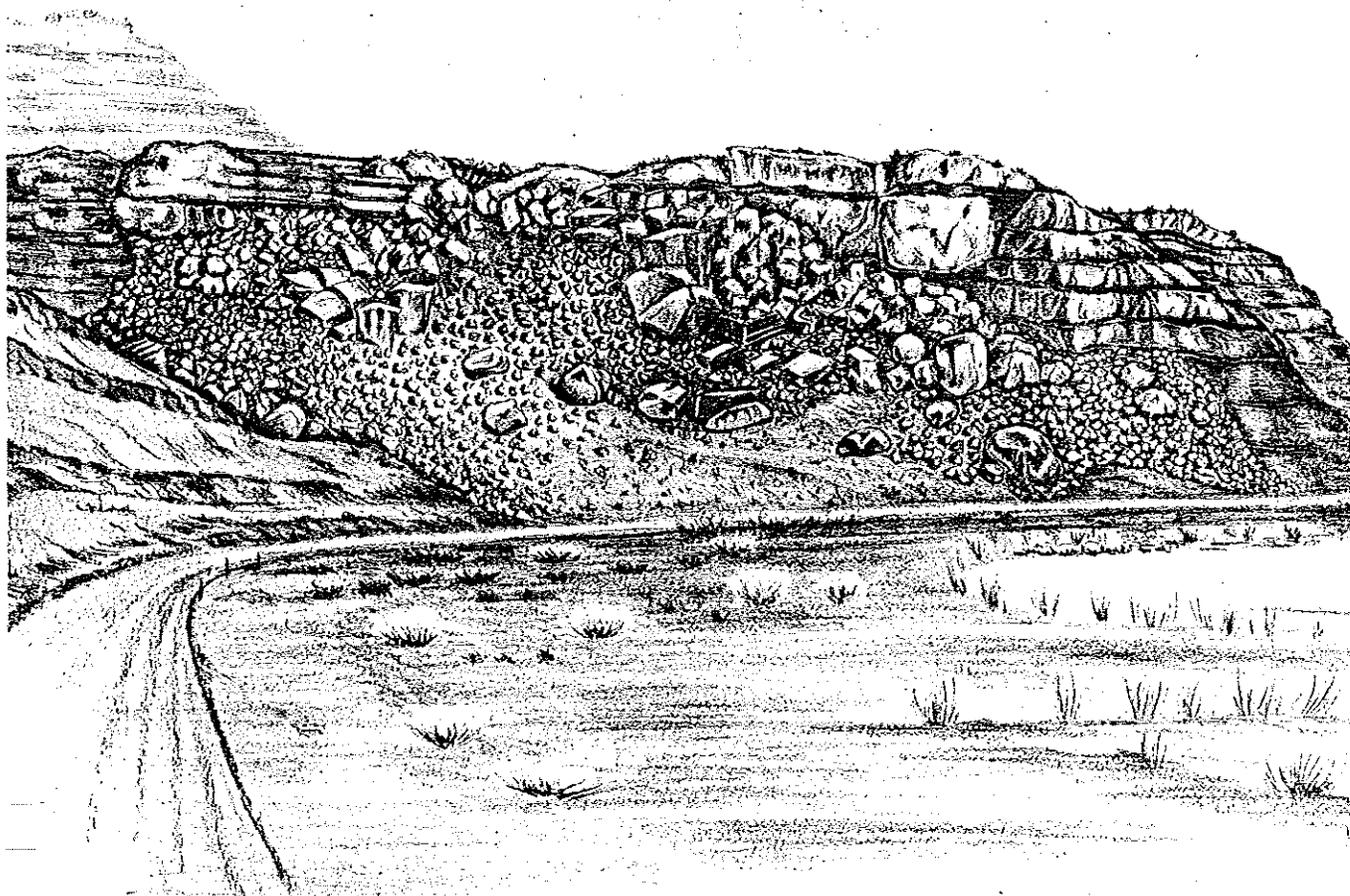
FIGURE 63. VIEW OF DEBEQUE CANYON, COLORADO LANDSLIDE, SHOWING FEATURES OF SLOPE INSTABILITY IN THE CANYON. INTERSTATE HIGHWAY 70 IS SHOWN EXTENDING FROM THE LOWER LEFT-HAND CORNER ACROSS THE TOE OF THE SLIDE. THE COLORADO RIVER IS BELOW THE HIGHWAY TO THE RIGHT OF CENTER.

THE RIM ROCK COLLAPSE IS BELIEVED TO HAVE TAKEN PLACE IN 1929. THE SLIDE CONTINUES TO BE A HAZARD, AS IT IS A SOURCE OF ROCK FALLS ONTO THE HIGHWAY AND A CHRONIC HIGHWAY MAINTENANCE PROBLEM. COMPARE THIS FIGURE WITH FIGURE 64.

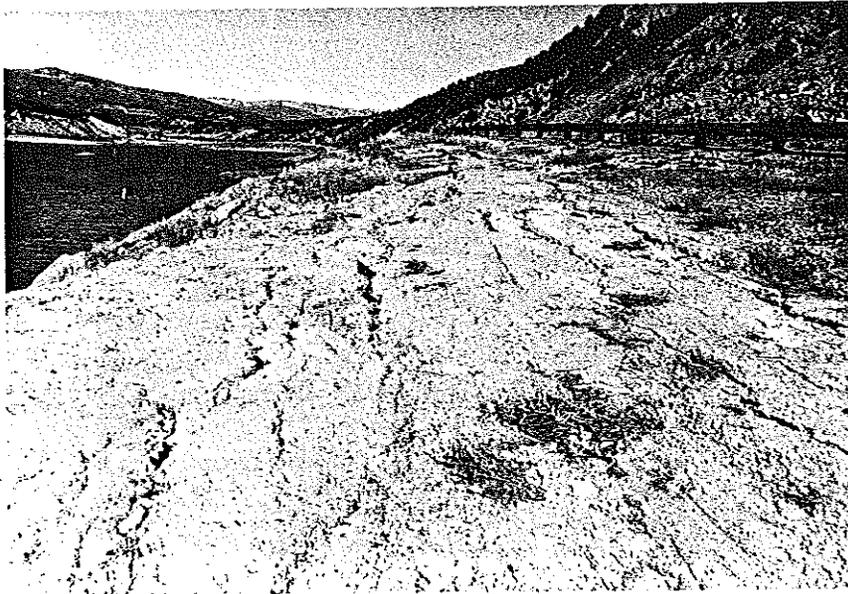
FIGURE 68. AN AREA BETWEEN RELOCATED STATE HIGHWAY 325 AND RIFLE GAP RESERVOIR THAT SHOWS DISTRESS. SEE FIGURE 67 AND SLUMPING CAN BE OBSERVED.

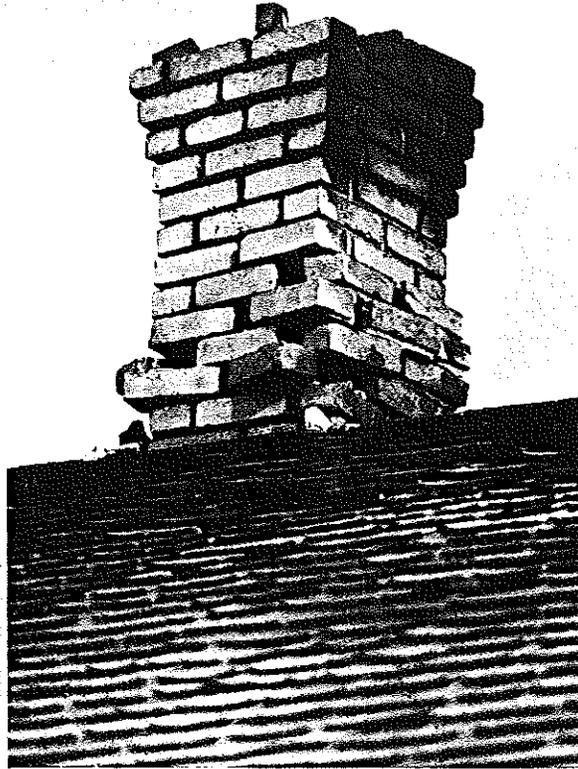
FIGURE 70. Cap bricks have fallen from this chimney. This chimney also appears to have rotated.

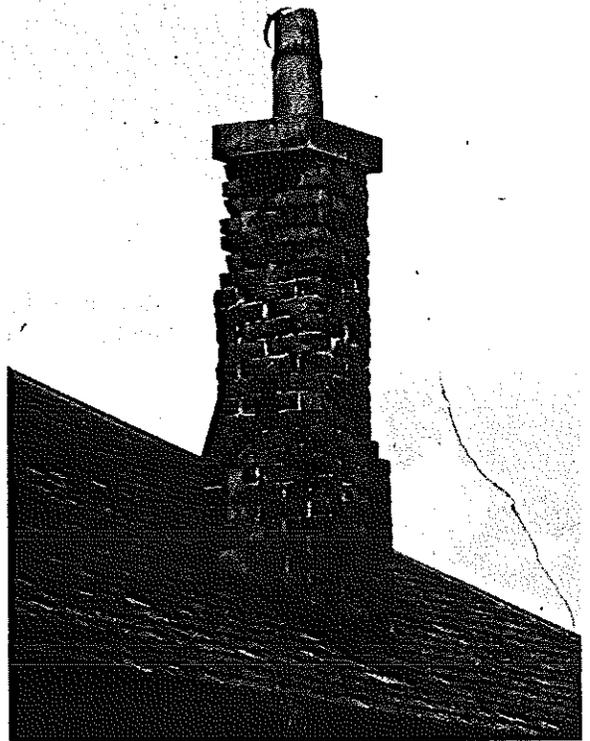
FIGURE 72. The post-event condition of this chimney shows that the chimney has moved because of ground motion. Compare with Figure 71.

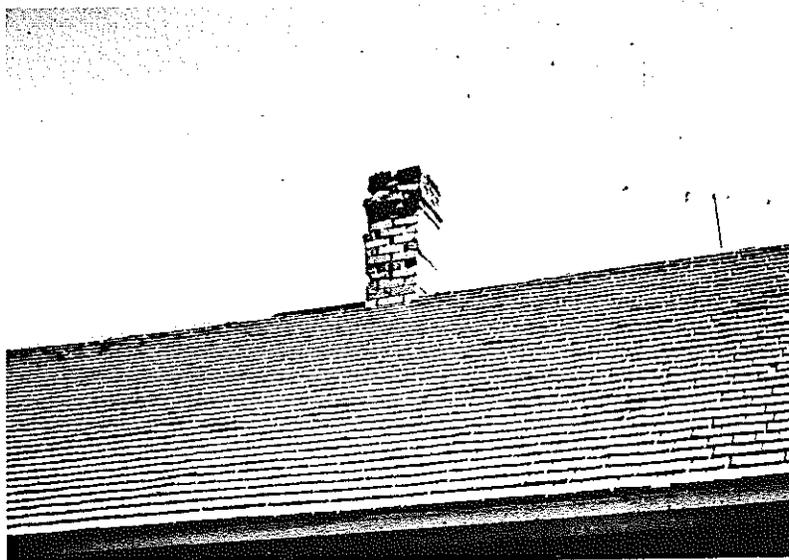
FIGURE 74. Damaged chimney near Grand Valley, showing deteriorated mortar damage.

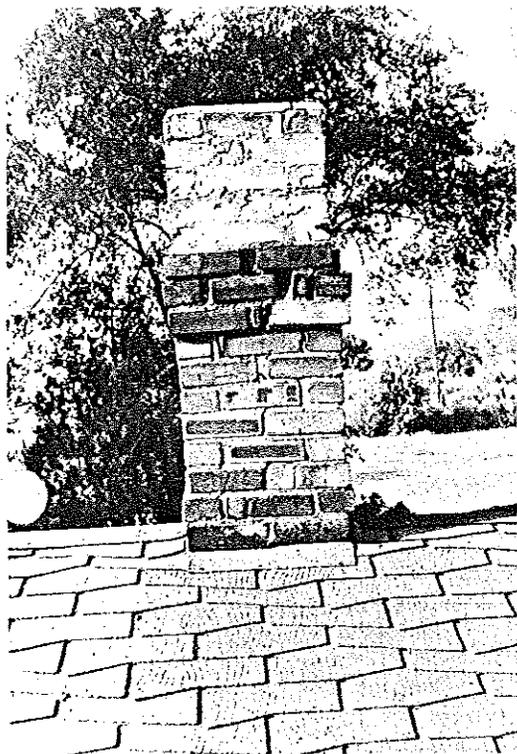
FIGURE 75. Chimney damage on Morrisania Mesa, indicating loose bricks that have fallen into the chimney.

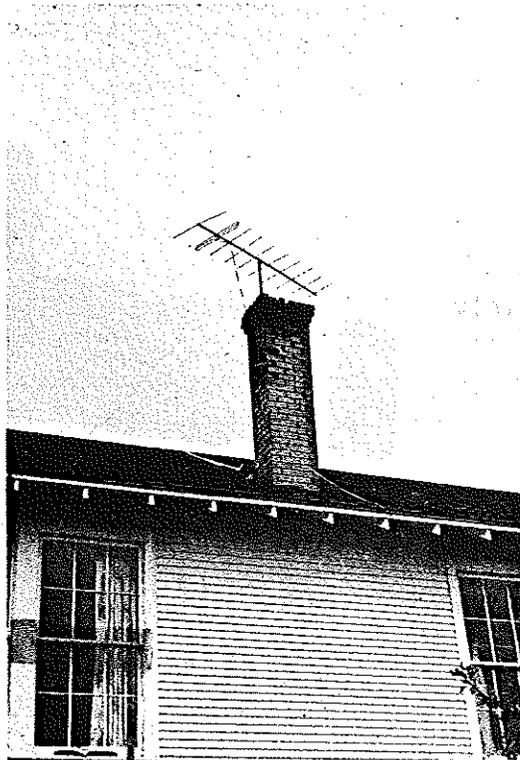
FIGURE 76. Chimney damage  
at Kansas Mesa south of  
Collbran.

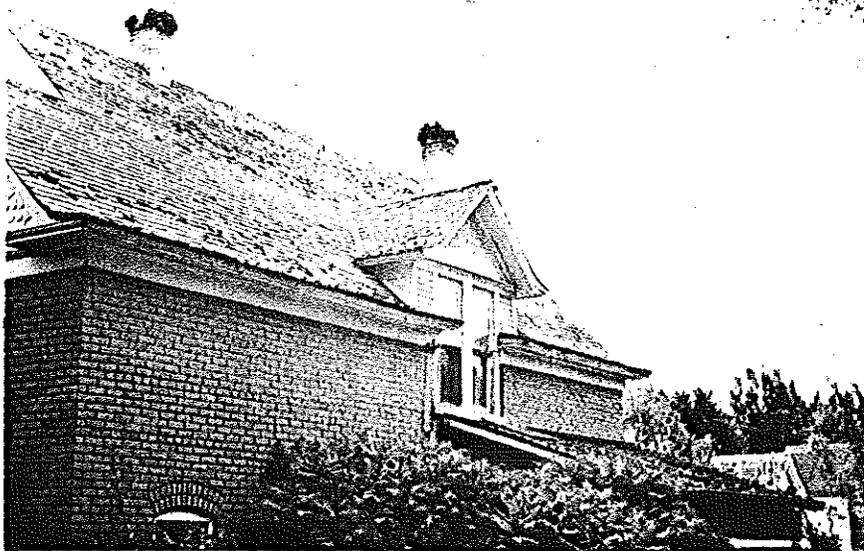
FIGURE 77. Two chimneys displaying damage  
to the cap bricks. This location is in  
Rifle, approximately 20 kilometers north-  
east of ground zero.

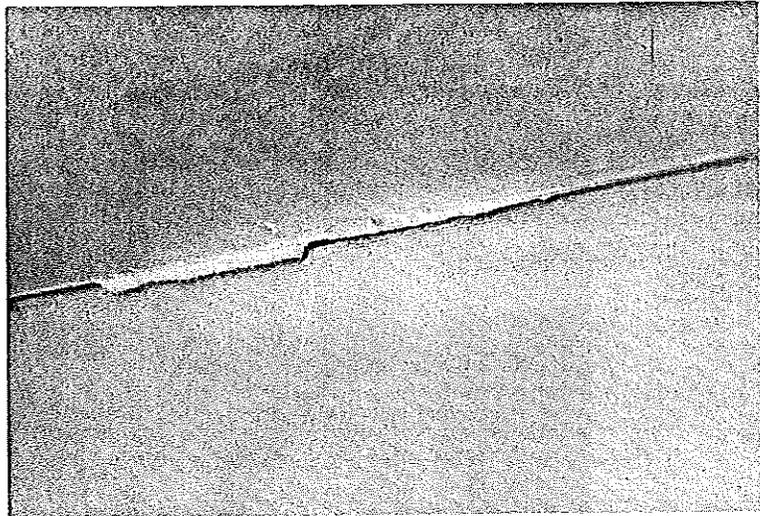
FIGURE 79. Interior plaster cracking and spalling at a door frame.

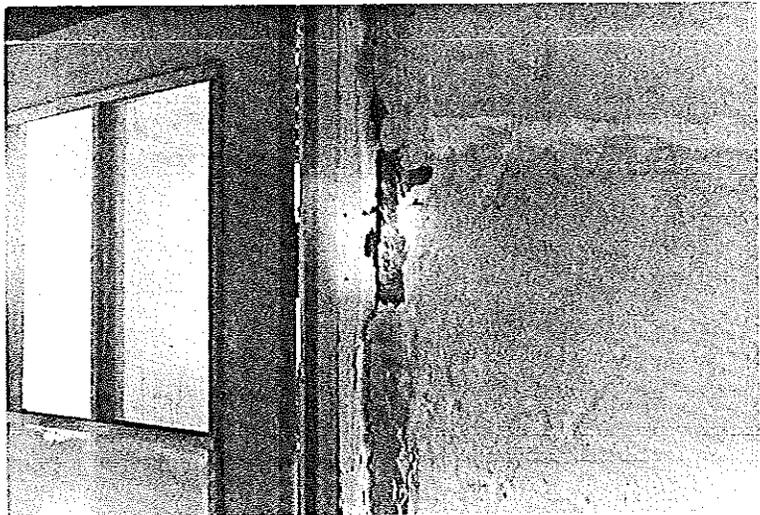
FIGURE 80. Interior plaster cracking of a partition wall.

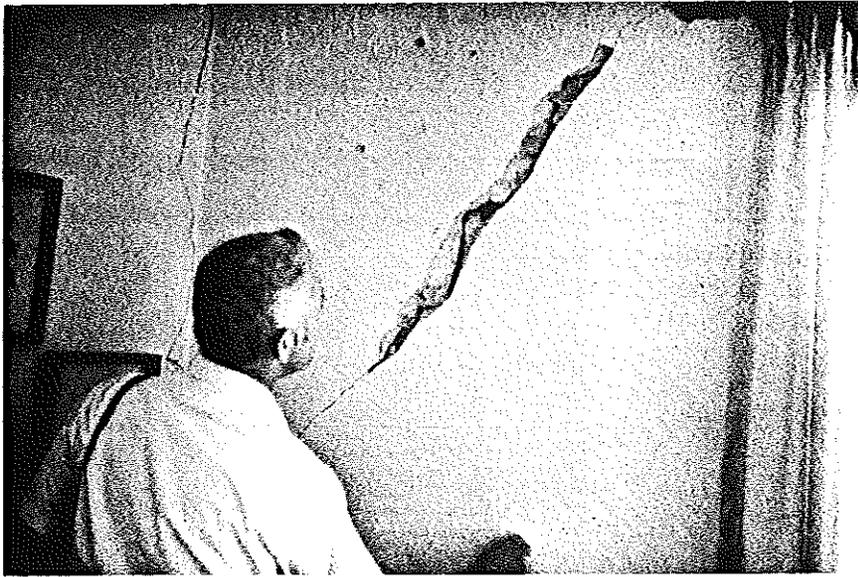
FIGURE 81. Reopened diagonal cracks on the interior wall of a stone house.

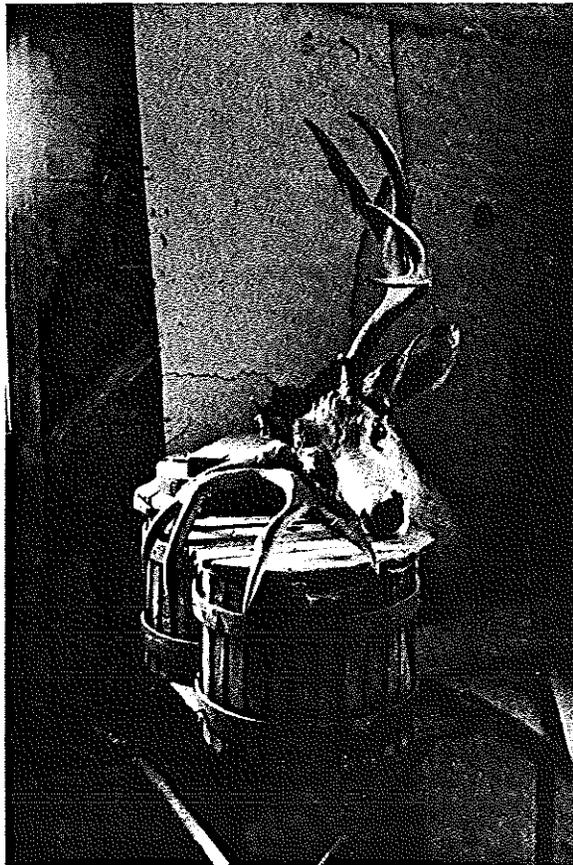
FIGURE 82. Damage also occurred to items that were hanging on walls and were displaced.
