## 5.0 Shirley Basin South, Wyoming, Disposal Site

### 5.1 Compliance Summary

Figure 5-1. 2008 Annual Compliance Drawing for the Shirley Basin South, Wyoming, Disposal Site

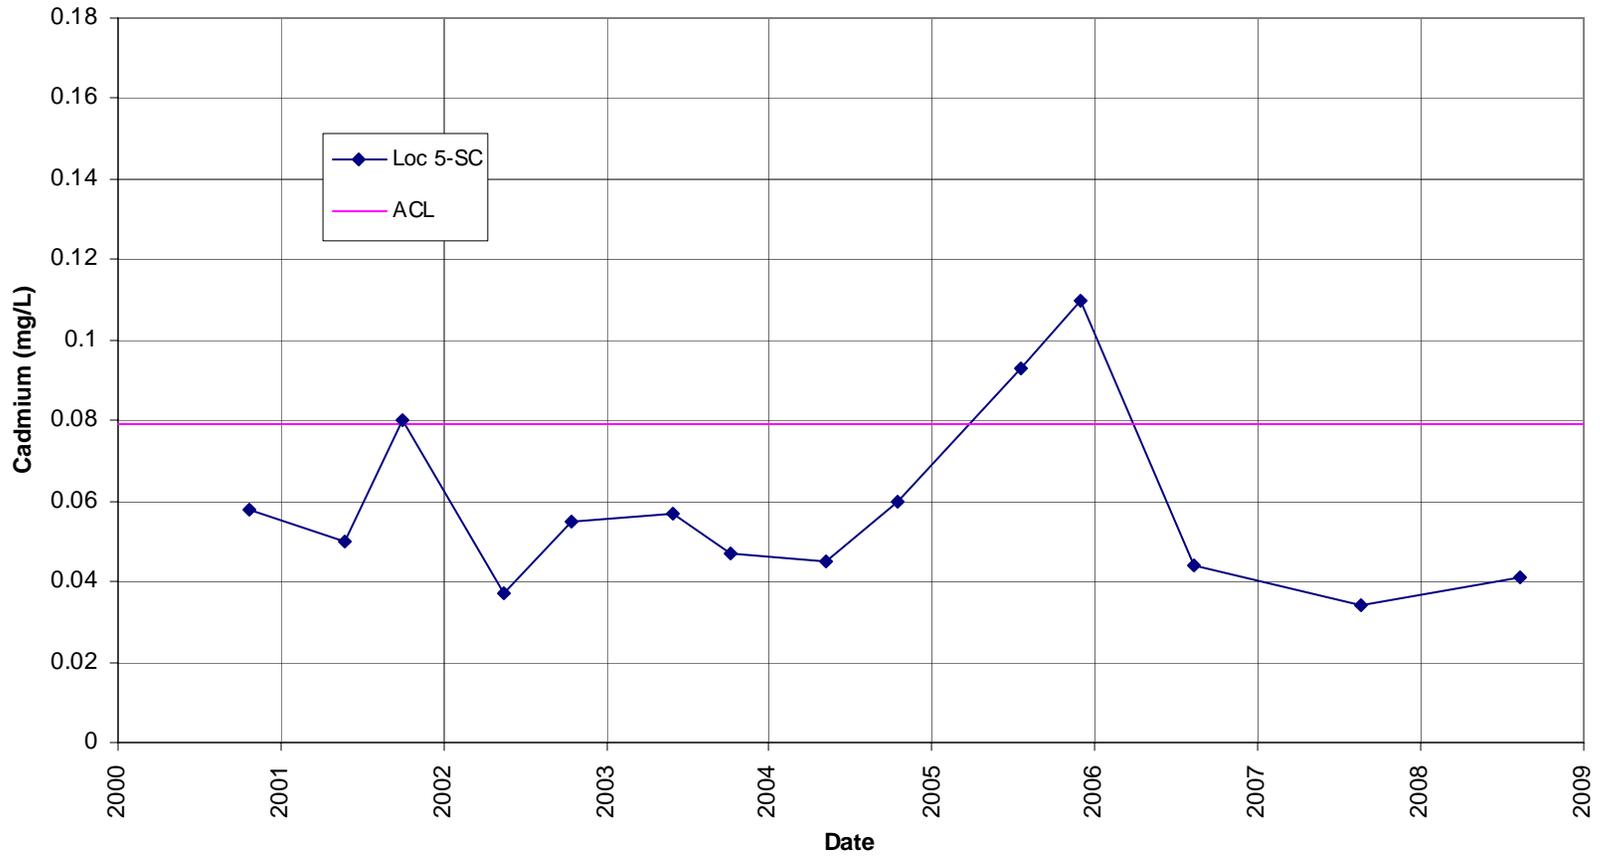
Figure 5-2. Cadmium Concentration in Well MW-5-SC Since Completion of the Disposal Cell

5D Analytical results for the August 2008 sampling event are provided in Table 5-4. The concentration for cadmium in MW-5-SC remained below the ACL as it has for the last three sampling events (Figure 5-2). However, radium-228 continued above the ACL in an upward trend in both MW-5-DC and MW-54-SC (Figure 5-3). No other ACLs were exceeded.

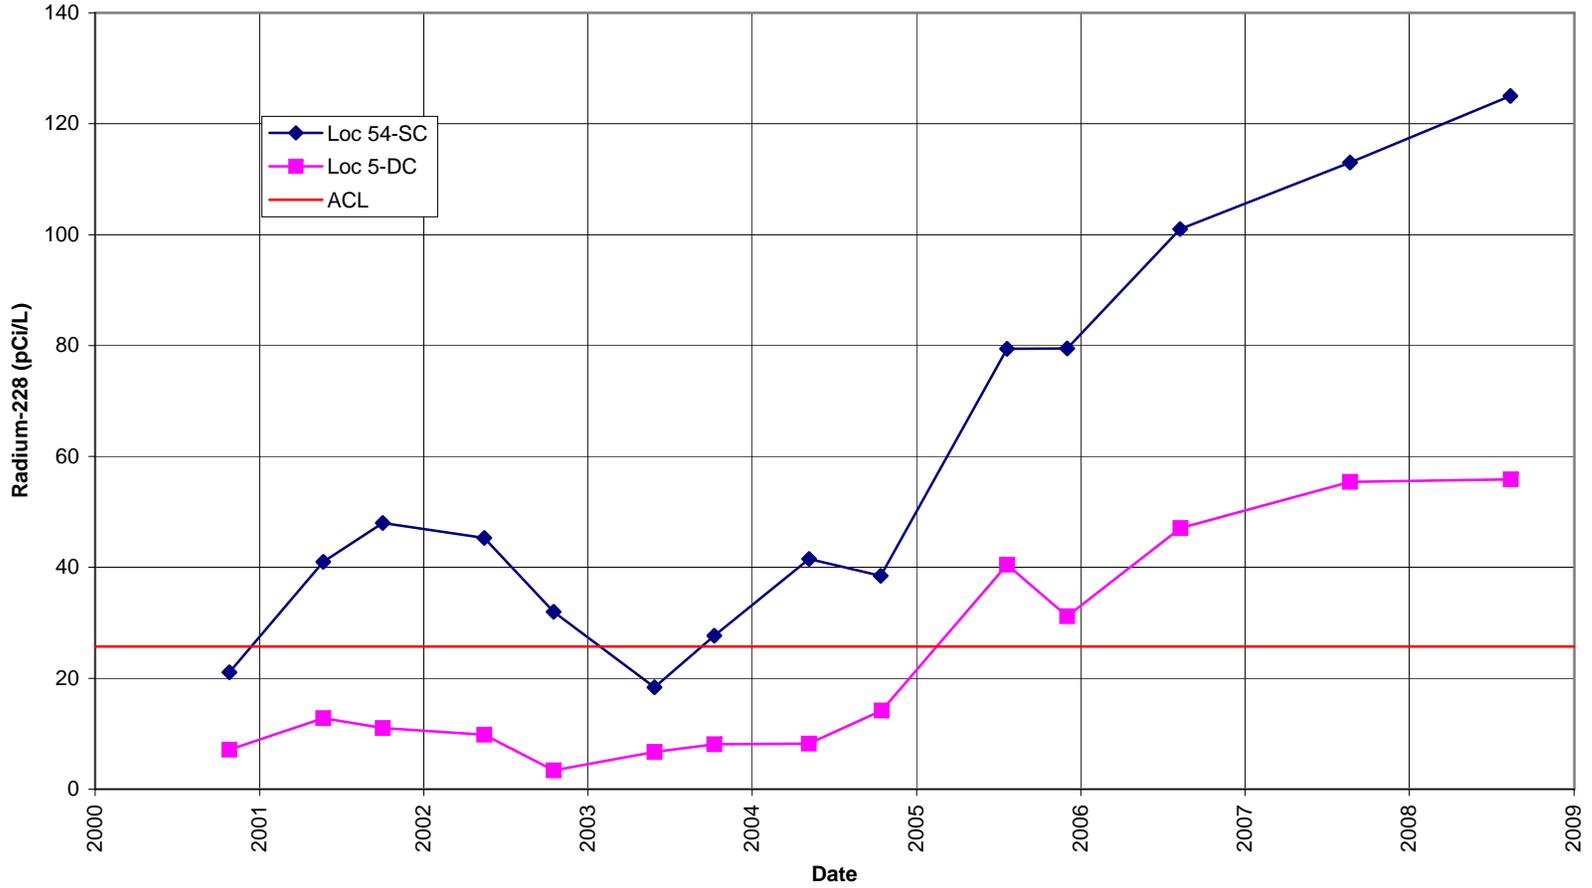
Figure 5-3. Radium-228 Concentrations in Wells MW-5-DC and MW-54-SC Since Completion of the Disposal Cell

Although the radium-228 concentrations are increasing in two of the wells, they are less than peak concentrations that occurred in these wells in the early 1990s during site groundwater remediation activities but prior to cell construction. Radium-228 is a decay product of thorium-232, which is highly immobile. Because the half-life of radium-228 is very short, the thorium-232 source must be near the wells of concern. Both of the aquifers at the site were dewatered during mining and remediation, and are still in the process of recovering; therefore, as the sand units are re-saturating, groundwater may be coming back into contact with thorium and other minerals in the ore body and the quality is returning to pre-remediation concentrations.

An evaluation of the well completion log and a 2008 video log of the well indicate that the screen in well MW-54-SC spans both the upper and main sand aquifers; the water level in the well suggests that it represents the main sand aquifer. The main sand unit of the Wind River Formation contained the uranium ore that was mined at the site; therefore, it is likely that the elevated radium-228 in this well is derived from natural thorium mineralization in the main sand unit instead of from milling or cell-related contamination in the upper sand aquifer.

5E As agreed to by DOE and NRC, DOE installed six additional monitor wells in fall 2008 to provide a better understanding of the groundwater chemistry and flow directions of the two aquifers of concern. Three wells were installed in the upper sand aquifer (one near MW-54-SC) and three wells were installed in the main sand aquifer. These wells will be sampled as part of

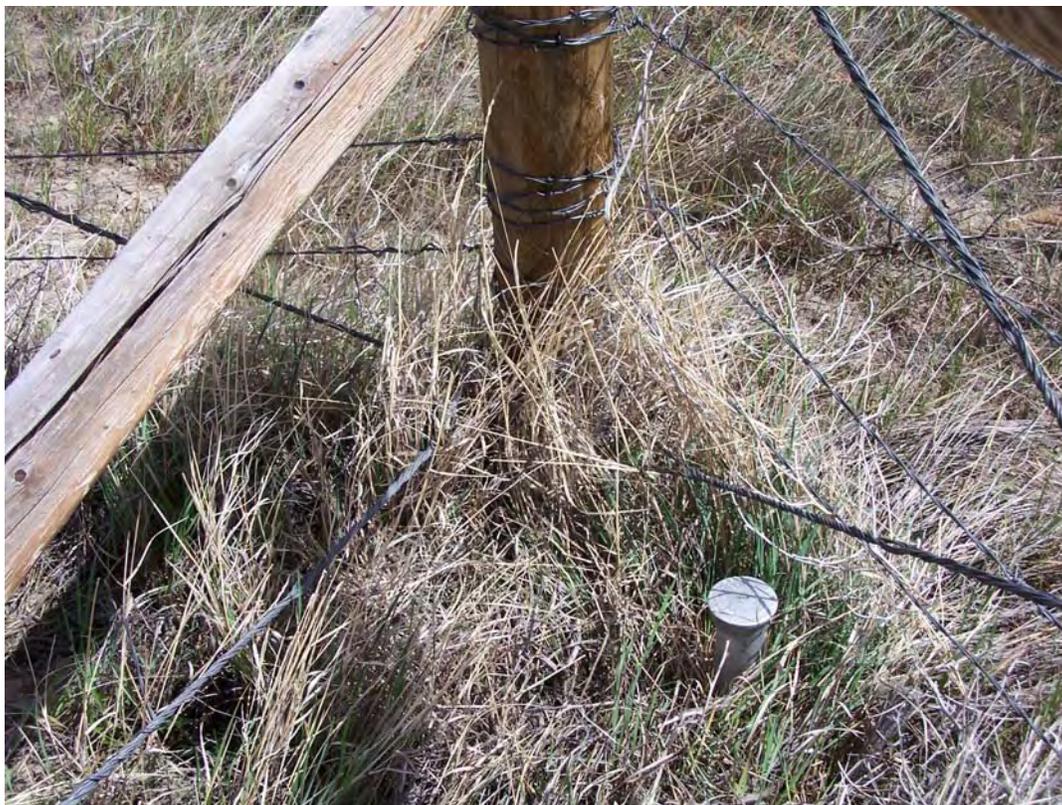
**Site Marker and Boundary Monuments**—The granite site marker, located at the site entrance, was in excellent condition. All 26 boundary monuments delineating DOE property were located and were in excellent condition (PL-1).

*SBS 6/2007. PL-1. Boundary monument BM-23 at the fence corner.*

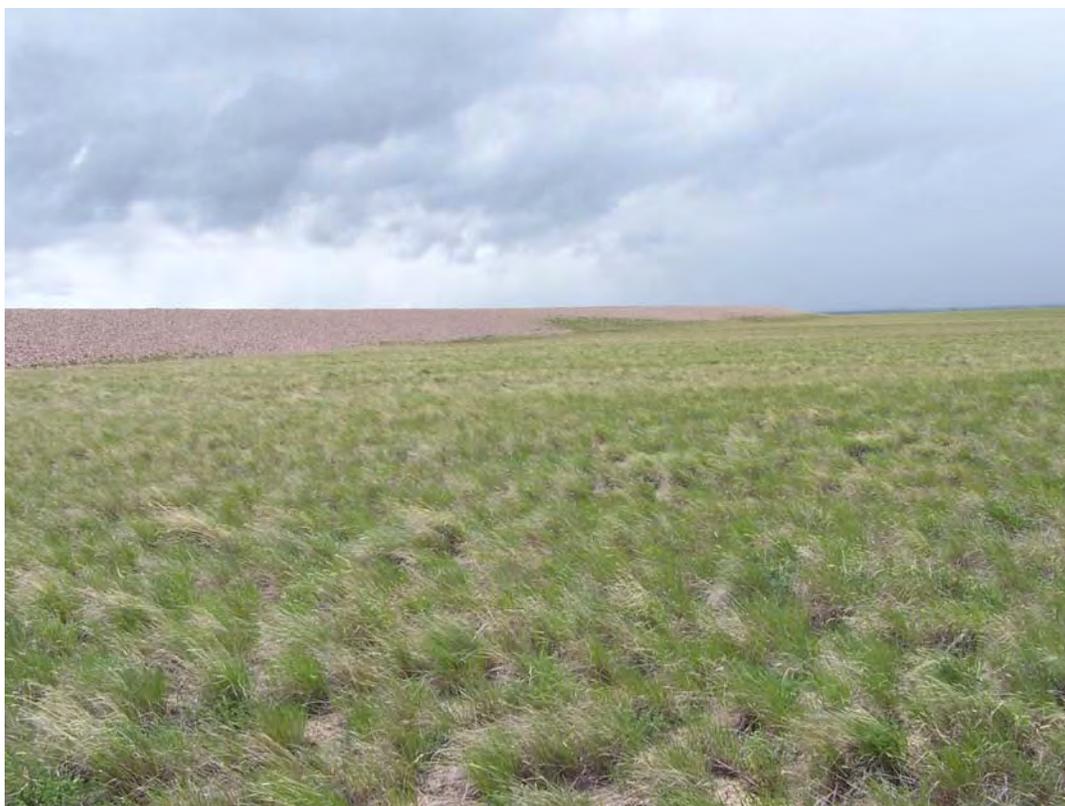
**Cover of the Tailings Impoundment**—The tailings impoundment, completed in 2000, occupies approximately 142 acres and has a grass cover (PL-2). The cell surface is constructed at two elevations separated by a riprap-armored slope (PL-3). The slope is in excellent condition.

*SBS 6/2007. PL-2. The lower disposal cell cover and the rock-armored slope of the upper cell surface.*

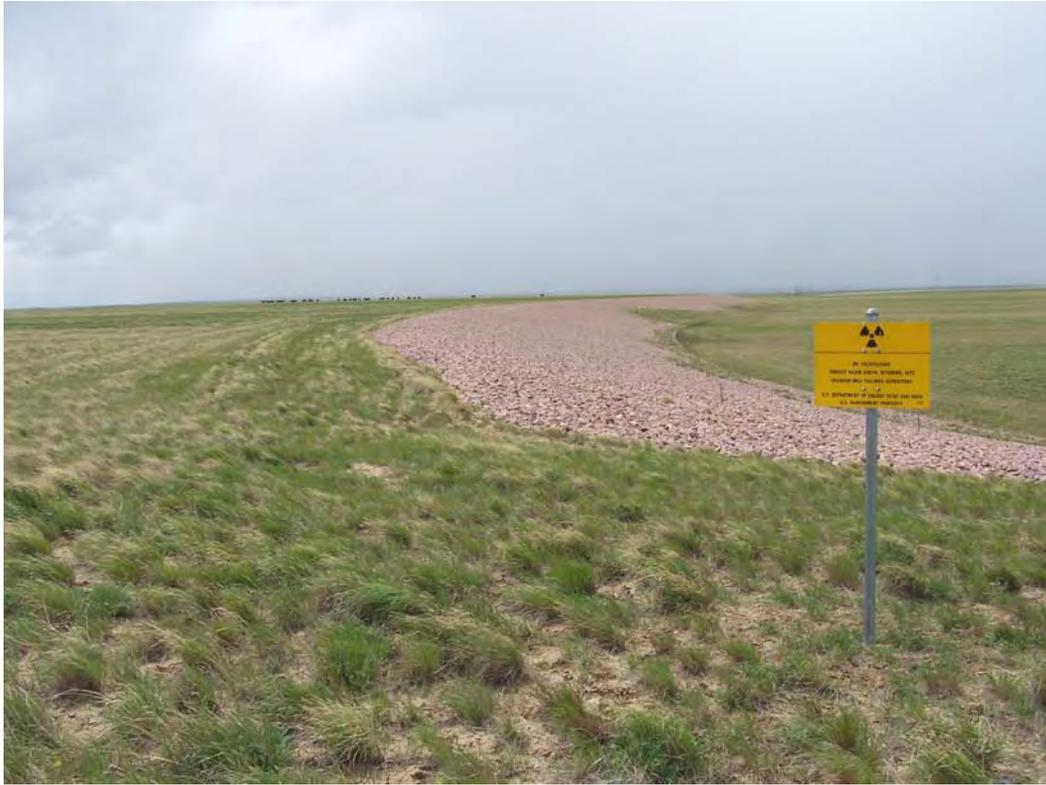
*SBS 6/2007. PL-3. Perimeter sign P13 and the rock-armored slope of the upper cell surface.*

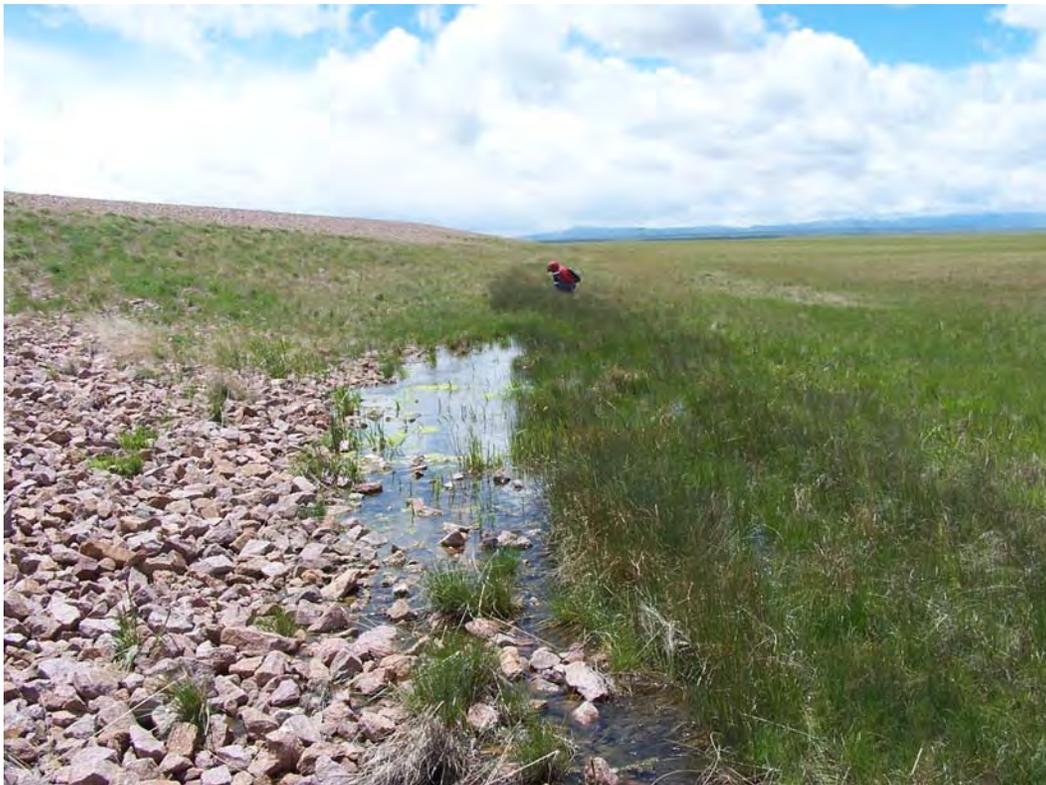
Windblown sediment is accumulating and vegetation continues to encroach on the slope, and wetland vegetation is beginning to establish in areas at the toe of the slope that are wet due to precipitation and snowmelt runoff (PL-4).

*SBS 6/2007. PL-4. Ponded water and wetland vegetation along the toe of the rock-armored slope of the upper cell surface.*

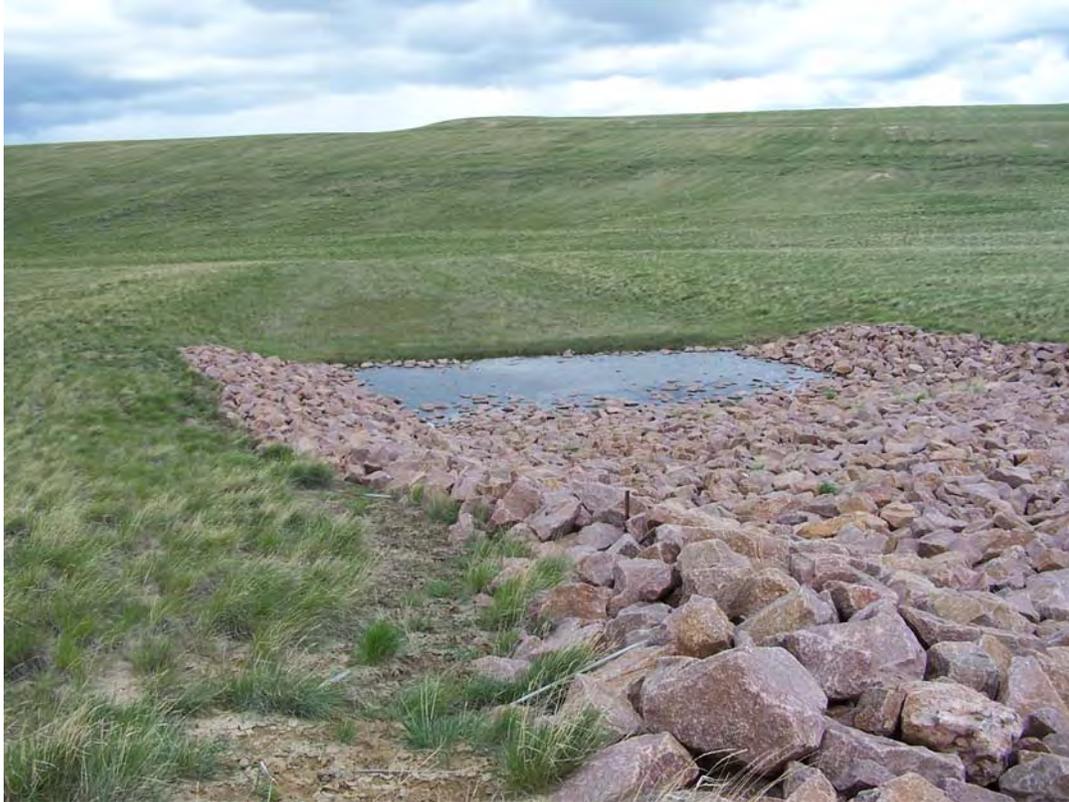
The eastern (upper) surface is contoured to drain into a basin east of the cell and west over the riprap-protected slope to the western (lower) surface. The lower surface drains to the north and south at riprap-armored discharge points. Standing water was present at the base of both discharge points (PL-5).

*SBS 6/2007. PL-5. Ponded water at the base of the north swale discharge point.*

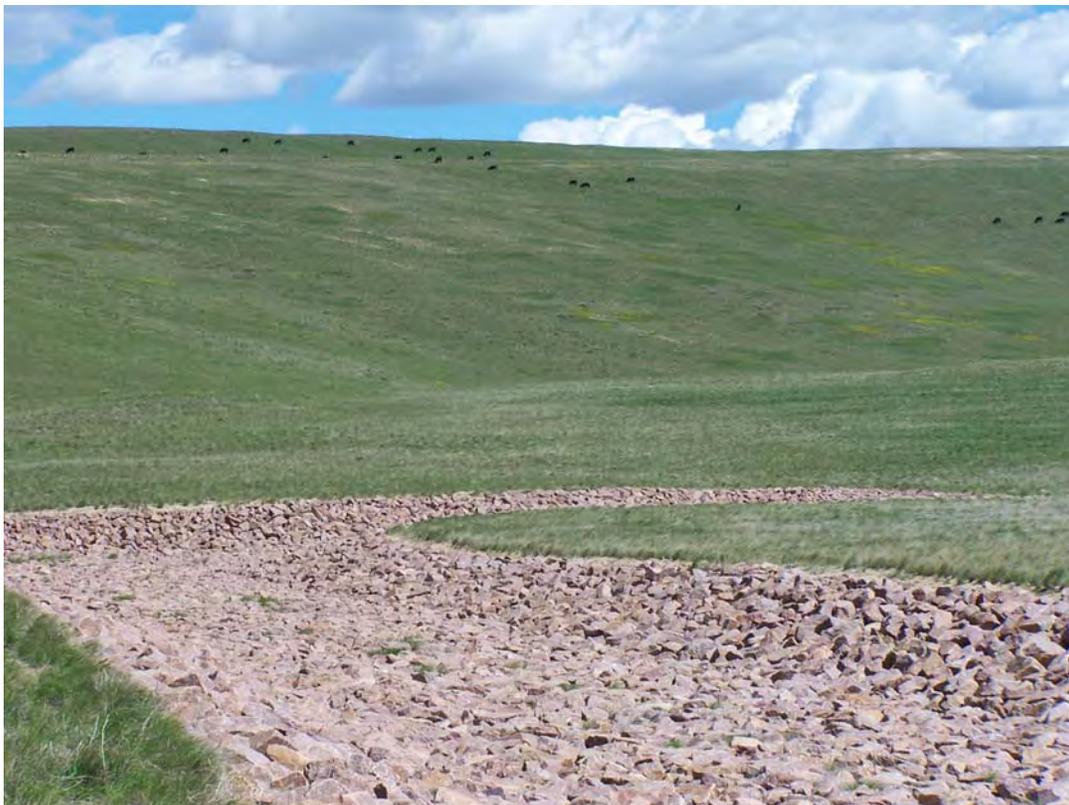
The grass is well established and in excellent condition. The grazing licensee is allowed to graze his cattle on the grass cover and to cut it for hay. Cattle feeding stations have been installed by the grazing licensee at several locations, and cattle were present on the site at the time of the inspection (PL-6). There were no indications of erosion, settlement, or other modifying processes that might affect the integrity of the cell. Animal burrows have been observed in previous inspections, and the approximately 5-foot-thick cover will continue to be monitored for burrowing activity to ensure that tailings are not brought to the surface.

*SBS 6/2007. PL-6. Rock-armored southwest channel and cattle near the PMF channel.*

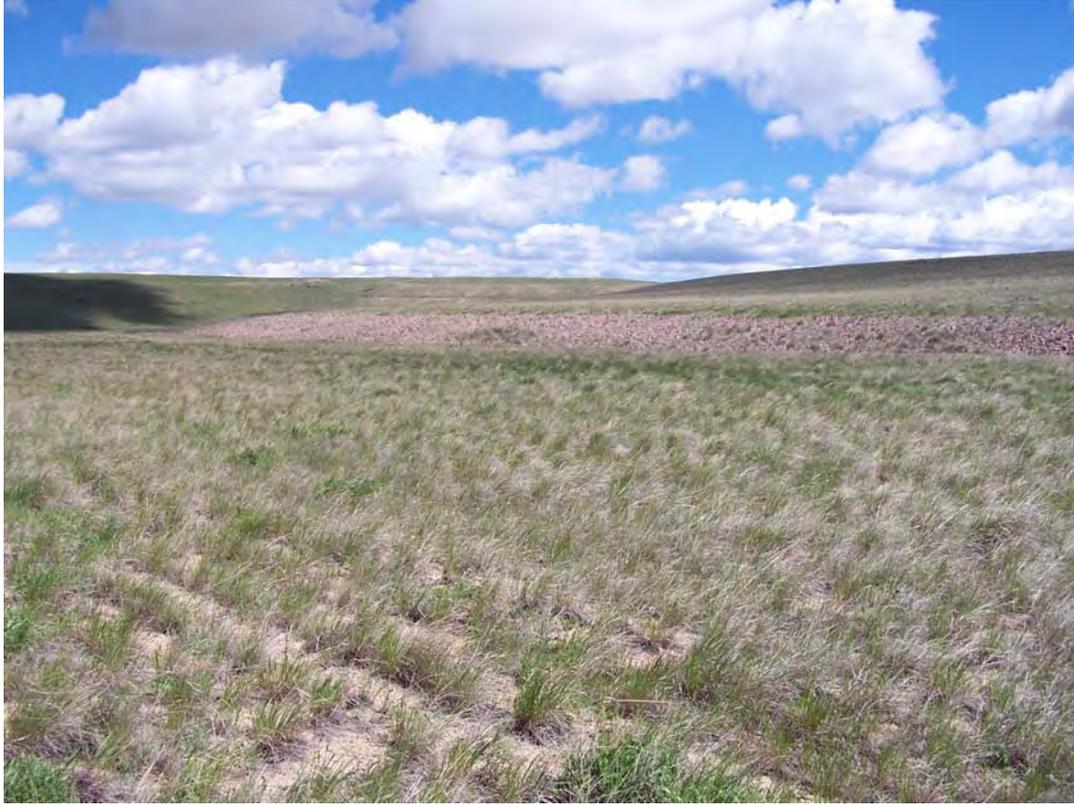
**Containment Dam and Diversion Channels**—The tailings pile was reclaimed in place and was contained behind a horseshoe-shaped earthen dam. The containment dam is predominantly grass covered, with the north and south swale discharge points and the steeper sections (5:1 slope) of the dam protected by riprap (PL-7). There were no indications of erosion, settlement, or other modifying processes that might affect the integrity of the dam. Vegetation is encroaching on the riprap surfaces, which enhances the stability of the slopes.

*SBS 6/2007. PL-7. Rock-armored slope of the disposal cell dam.*

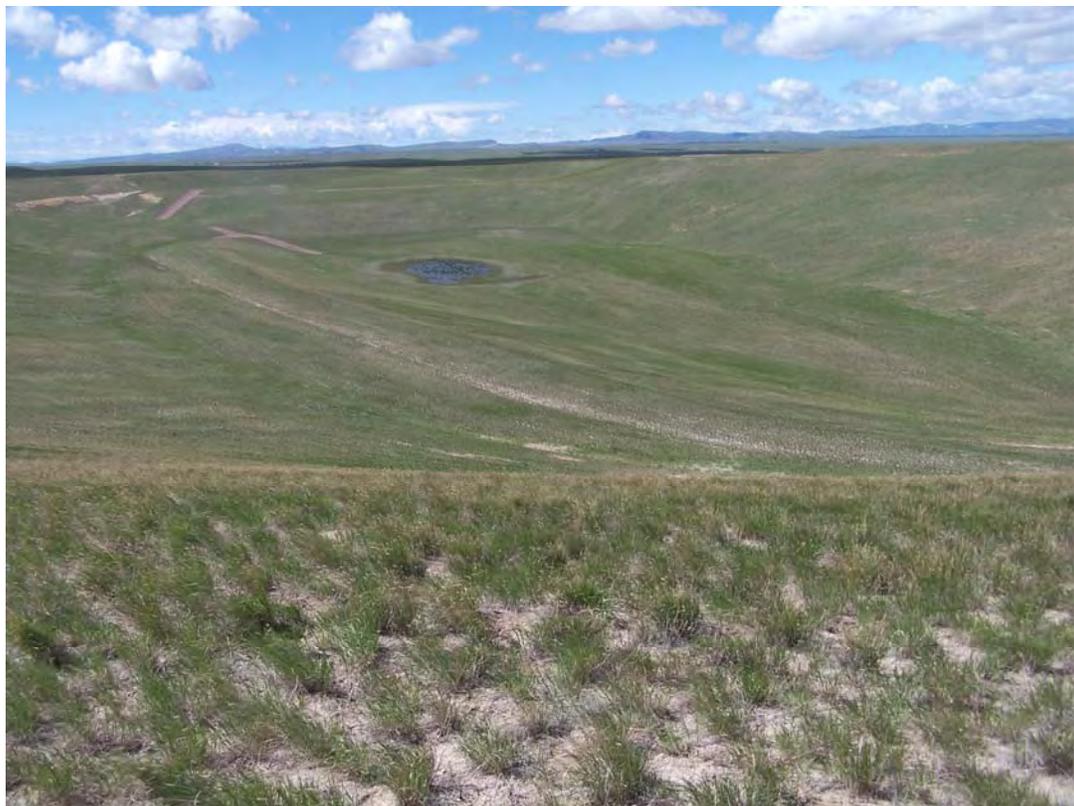
**Balance of the Site and the Site Perimeter**—The other major feature on the site is reclaimed Pit 4 located in the northeast portion of the site (PL-8). Reclamation activities included rounding the side slopes, partially backfilling the pit to an elevation above the local water table, revegetating the surfaces, and protecting potential erosion areas with riprap. Vegetation is well established, and a wetland area is forming at the bottom of the pit where standing water from runoff often is present (PL-9). One small land slump (PL-10) and other minor displacement features are present on the west side slope of the pit; otherwise, the pit is in excellent condition.

*SBS 6/2007. PL-8. View of Pit 4 area.*

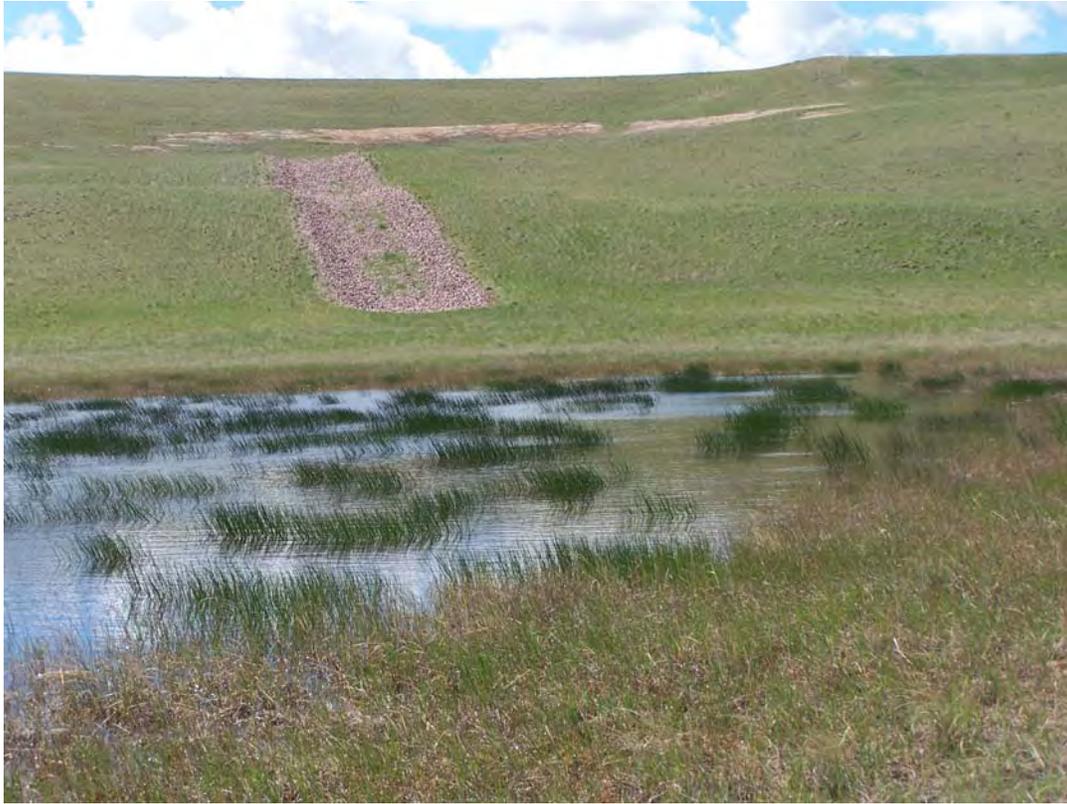
*SBS 6/2007. PL-9. Wetland area in the bottom of Pit 4.*

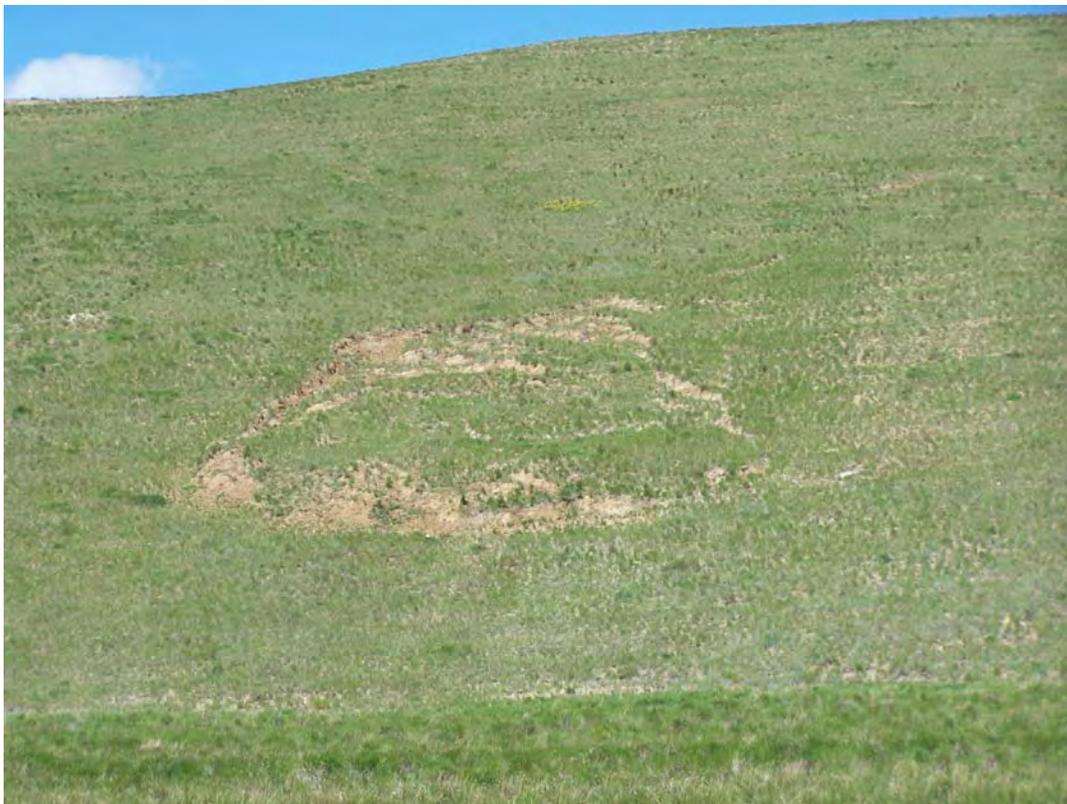
*SBS 6/2007. PL-10. Land slump on a side slope of Pit 4.*
