17.0 Annual Inspection of the Slick Rock, Colorado, UMTRCA Title I Disposal Site

17.1 Compliance Summary

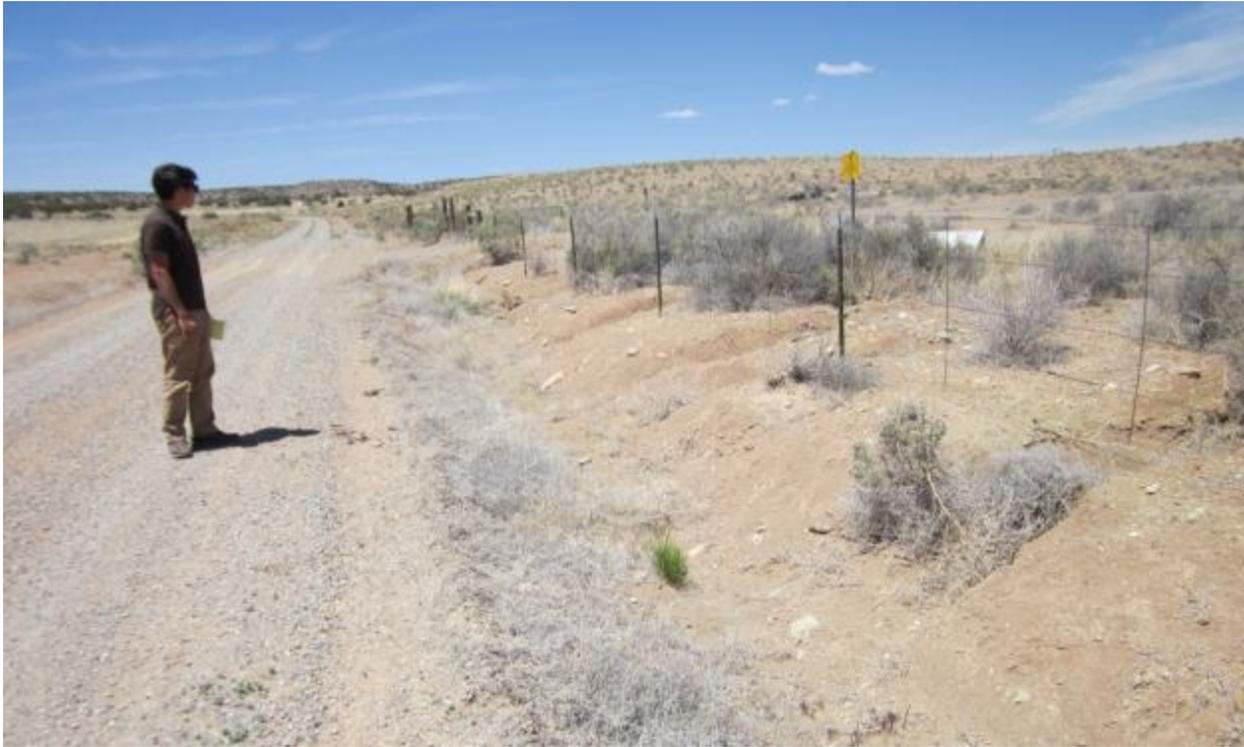
Site access is by an improved gravel and dirt road maintained by San Miguel County. The road is in good condition. Soil erosion under the fence along the county road continues to be monitored (PL–1).

SRK 5/2012. PL-1. View toward northwest along county road; fence line erosion.

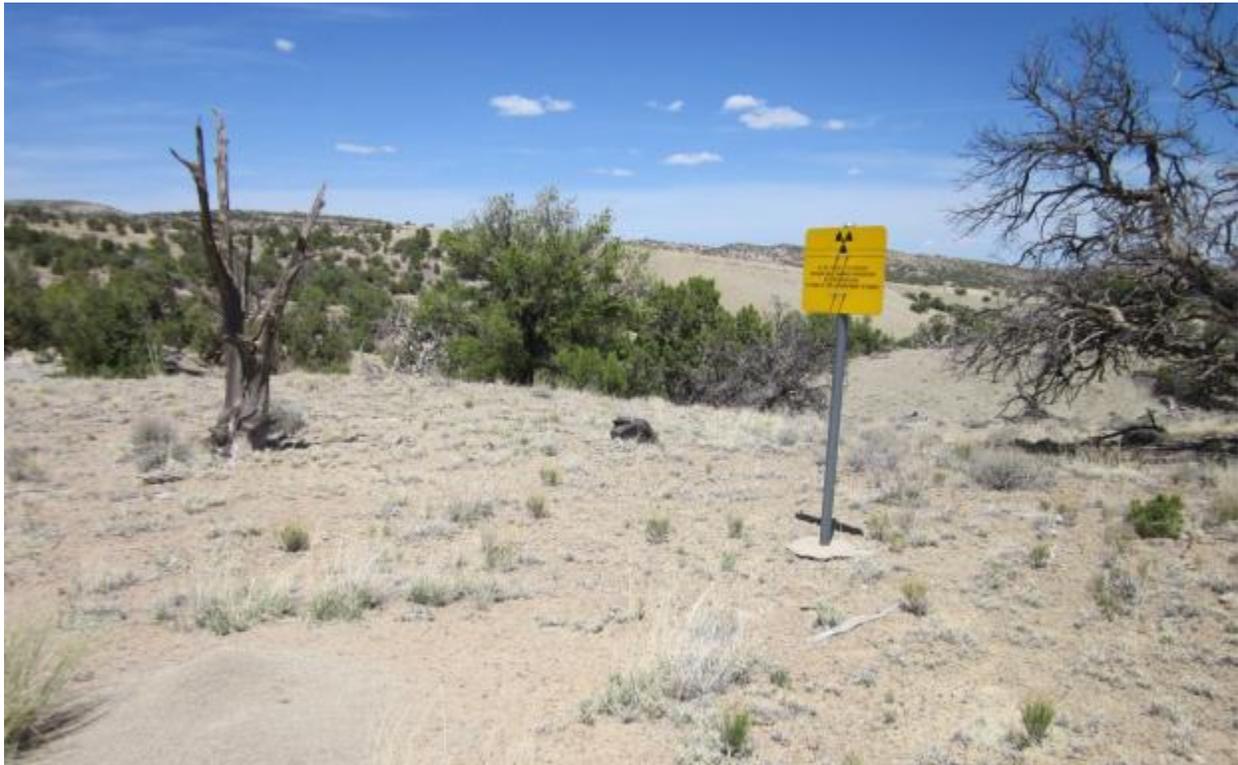
Thirty-two perimeter signs, designated P1 through P32, are spaced at approximately 200-foot intervals around the site (PL–2). The signs, attached to steel posts set in concrete, are 5 feet inside the site boundary. Perimeter sign P30 was missing in July 2011 and was replaced in October 2011 using theft-resistant fasteners. All other signs are in good condition.

SRK 5/2012. PL-2. Typical perimeter sign along west boundary of site.

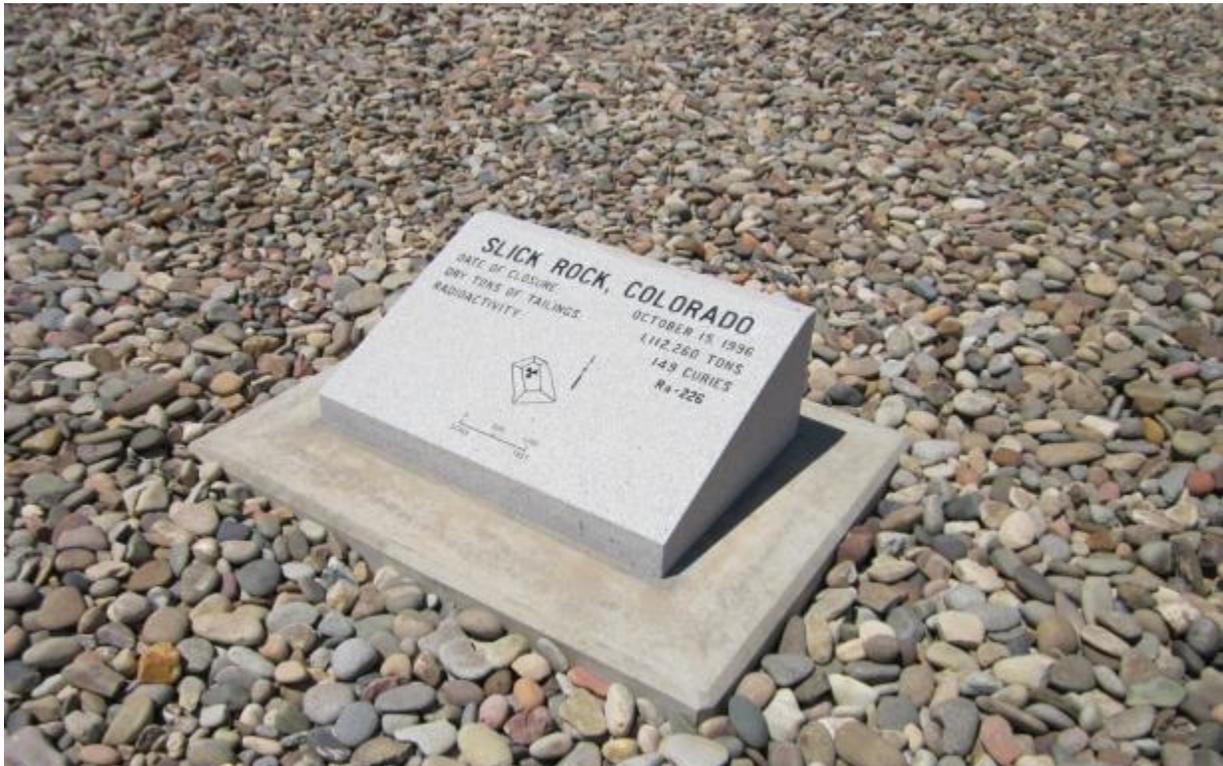
The two granite site markers, SMK–1 near the entrance gate and SMK–2 (PL–3) on the north-central part of the disposal cell, are in excellent condition. Erosion near SMK–1 is being monitored and may require remedial work if heavy rainfalls occur and erosion of the surrounding soil continues.

SRK 5/2012. PL-3. Site marker 2 on top of disposal cell.

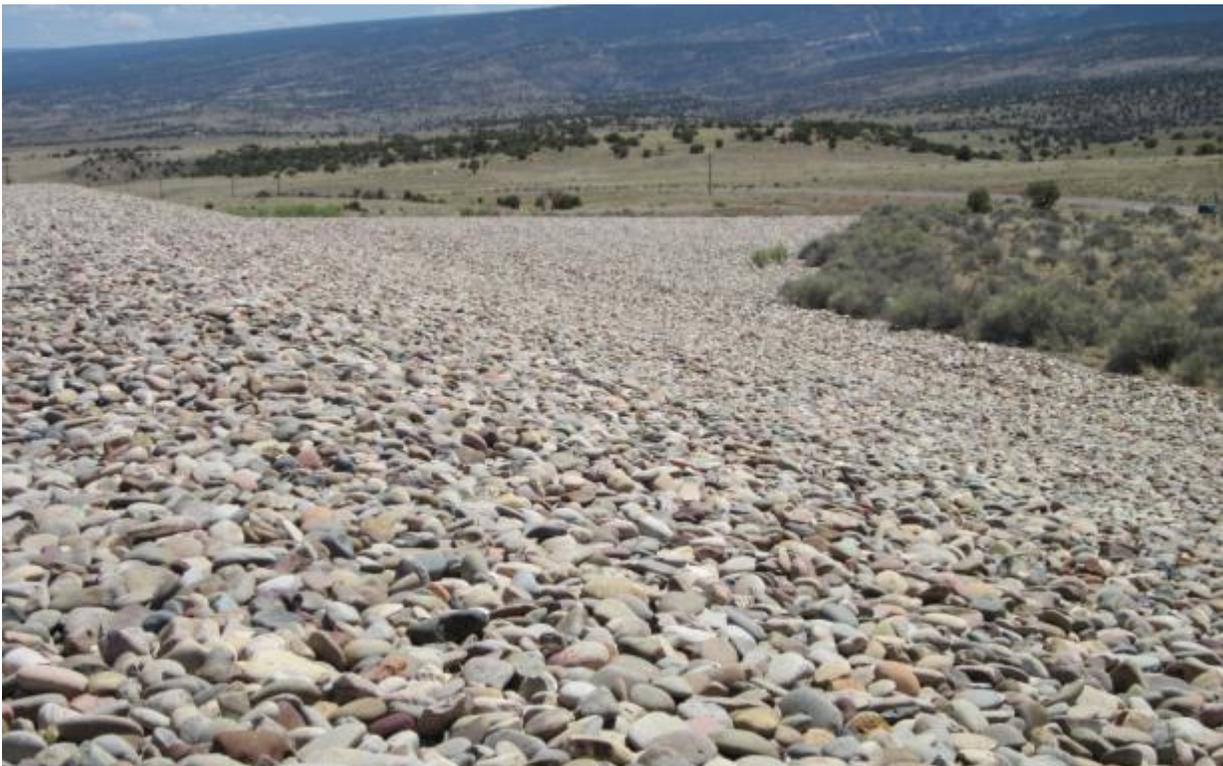
Rock covering the disposal cell, key trench, and apron is rounded cobble- and pebble-sized material. The rock is in excellent condition (PL-4 and PL-5). No evidence of settling, slumping, or erosion was seen on any of the rock-covered surfaces of the disposal cell. No phreatophytes or other deep-rooted plant species were observed on the surface of the cell.

SRK 5/2012. PL-4. Southeast face of cell, across apron.

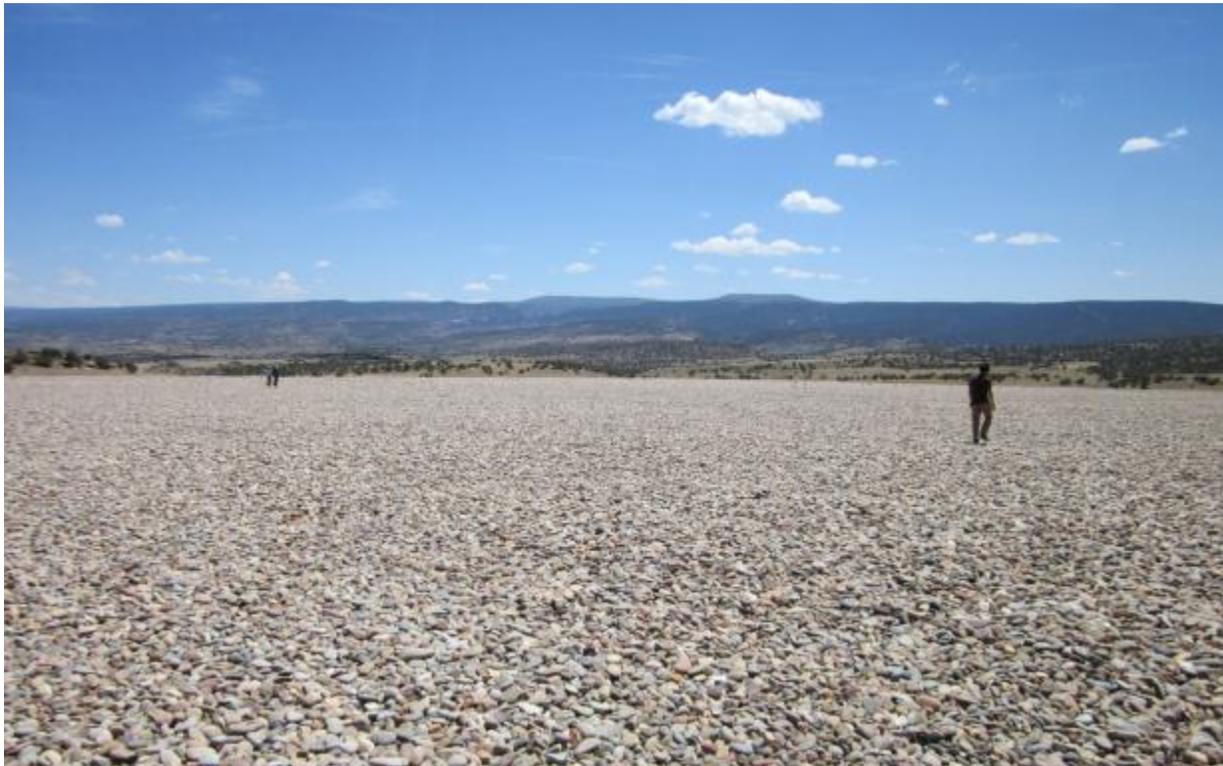
SRK 5/2012. PL-5. Top of cell from northwest to southeast.

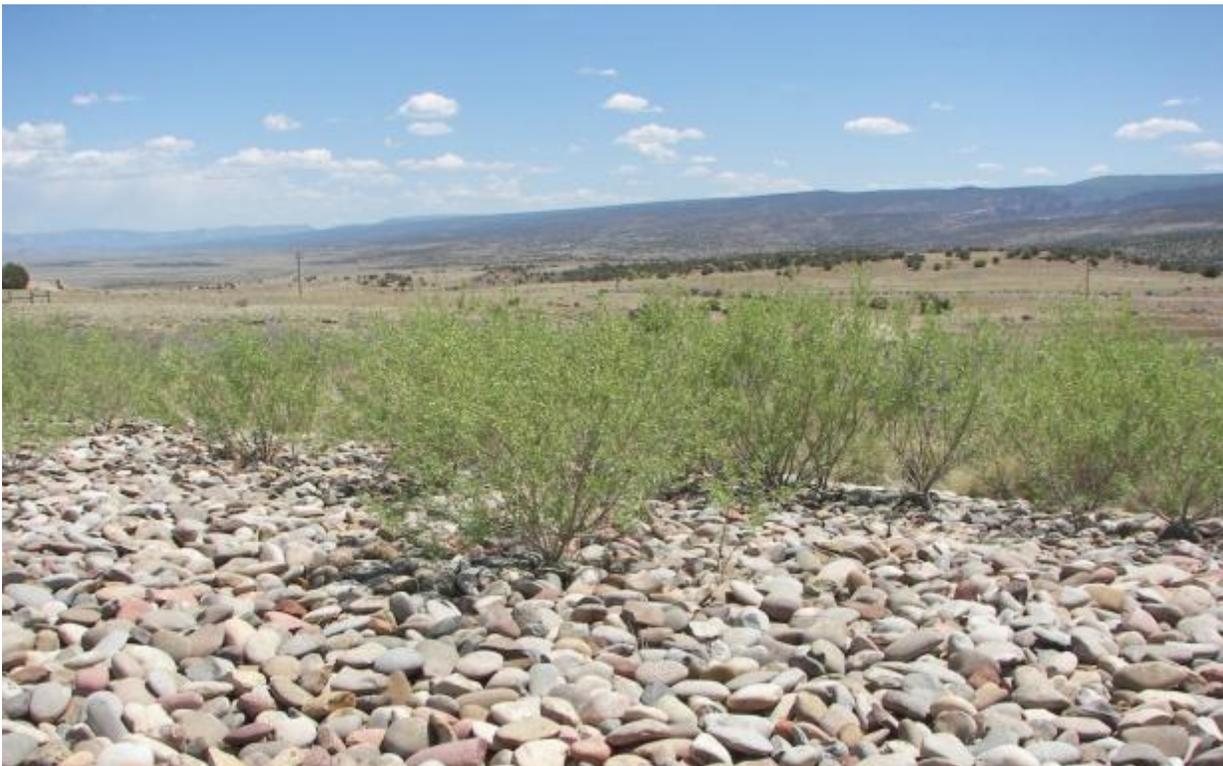
The top of the disposal cell is roughly pentagonal. Five side slopes descend from the disposal cell top at a maximum grade of 25 percent and are covered with riprap. At the base of the side slopes is a key trench that encircles the disposal cell. The key trench is as much as 5 feet deep and 20 feet wide and filled with riprap. South and downslope of the disposal cell, an apron of riprap extends for 50 to 200 feet beyond the key trench (PL-6). All side slopes, the key trench, and the apron are in excellent condition.

SRK 5/2012. PL-6. Willows growing at base of apron.
