18.0 Spook, Wyoming, Disposal Site

18.1 Compliance Summary

The Spook, Wyoming, Uranium Mill Tailings Radiation Control Act (UMTRCA) Title I Disposal Site was inspected on July 8, 2015. The site was in excellent condition. Three perimeter signs were delaminating but remained legible. These three signs were replaced in September when staff was in the area. One broken perimeter sign was replaced during the inspection. Inspectors identified no other maintenance needs or cause for a follow-up or contingency inspection.

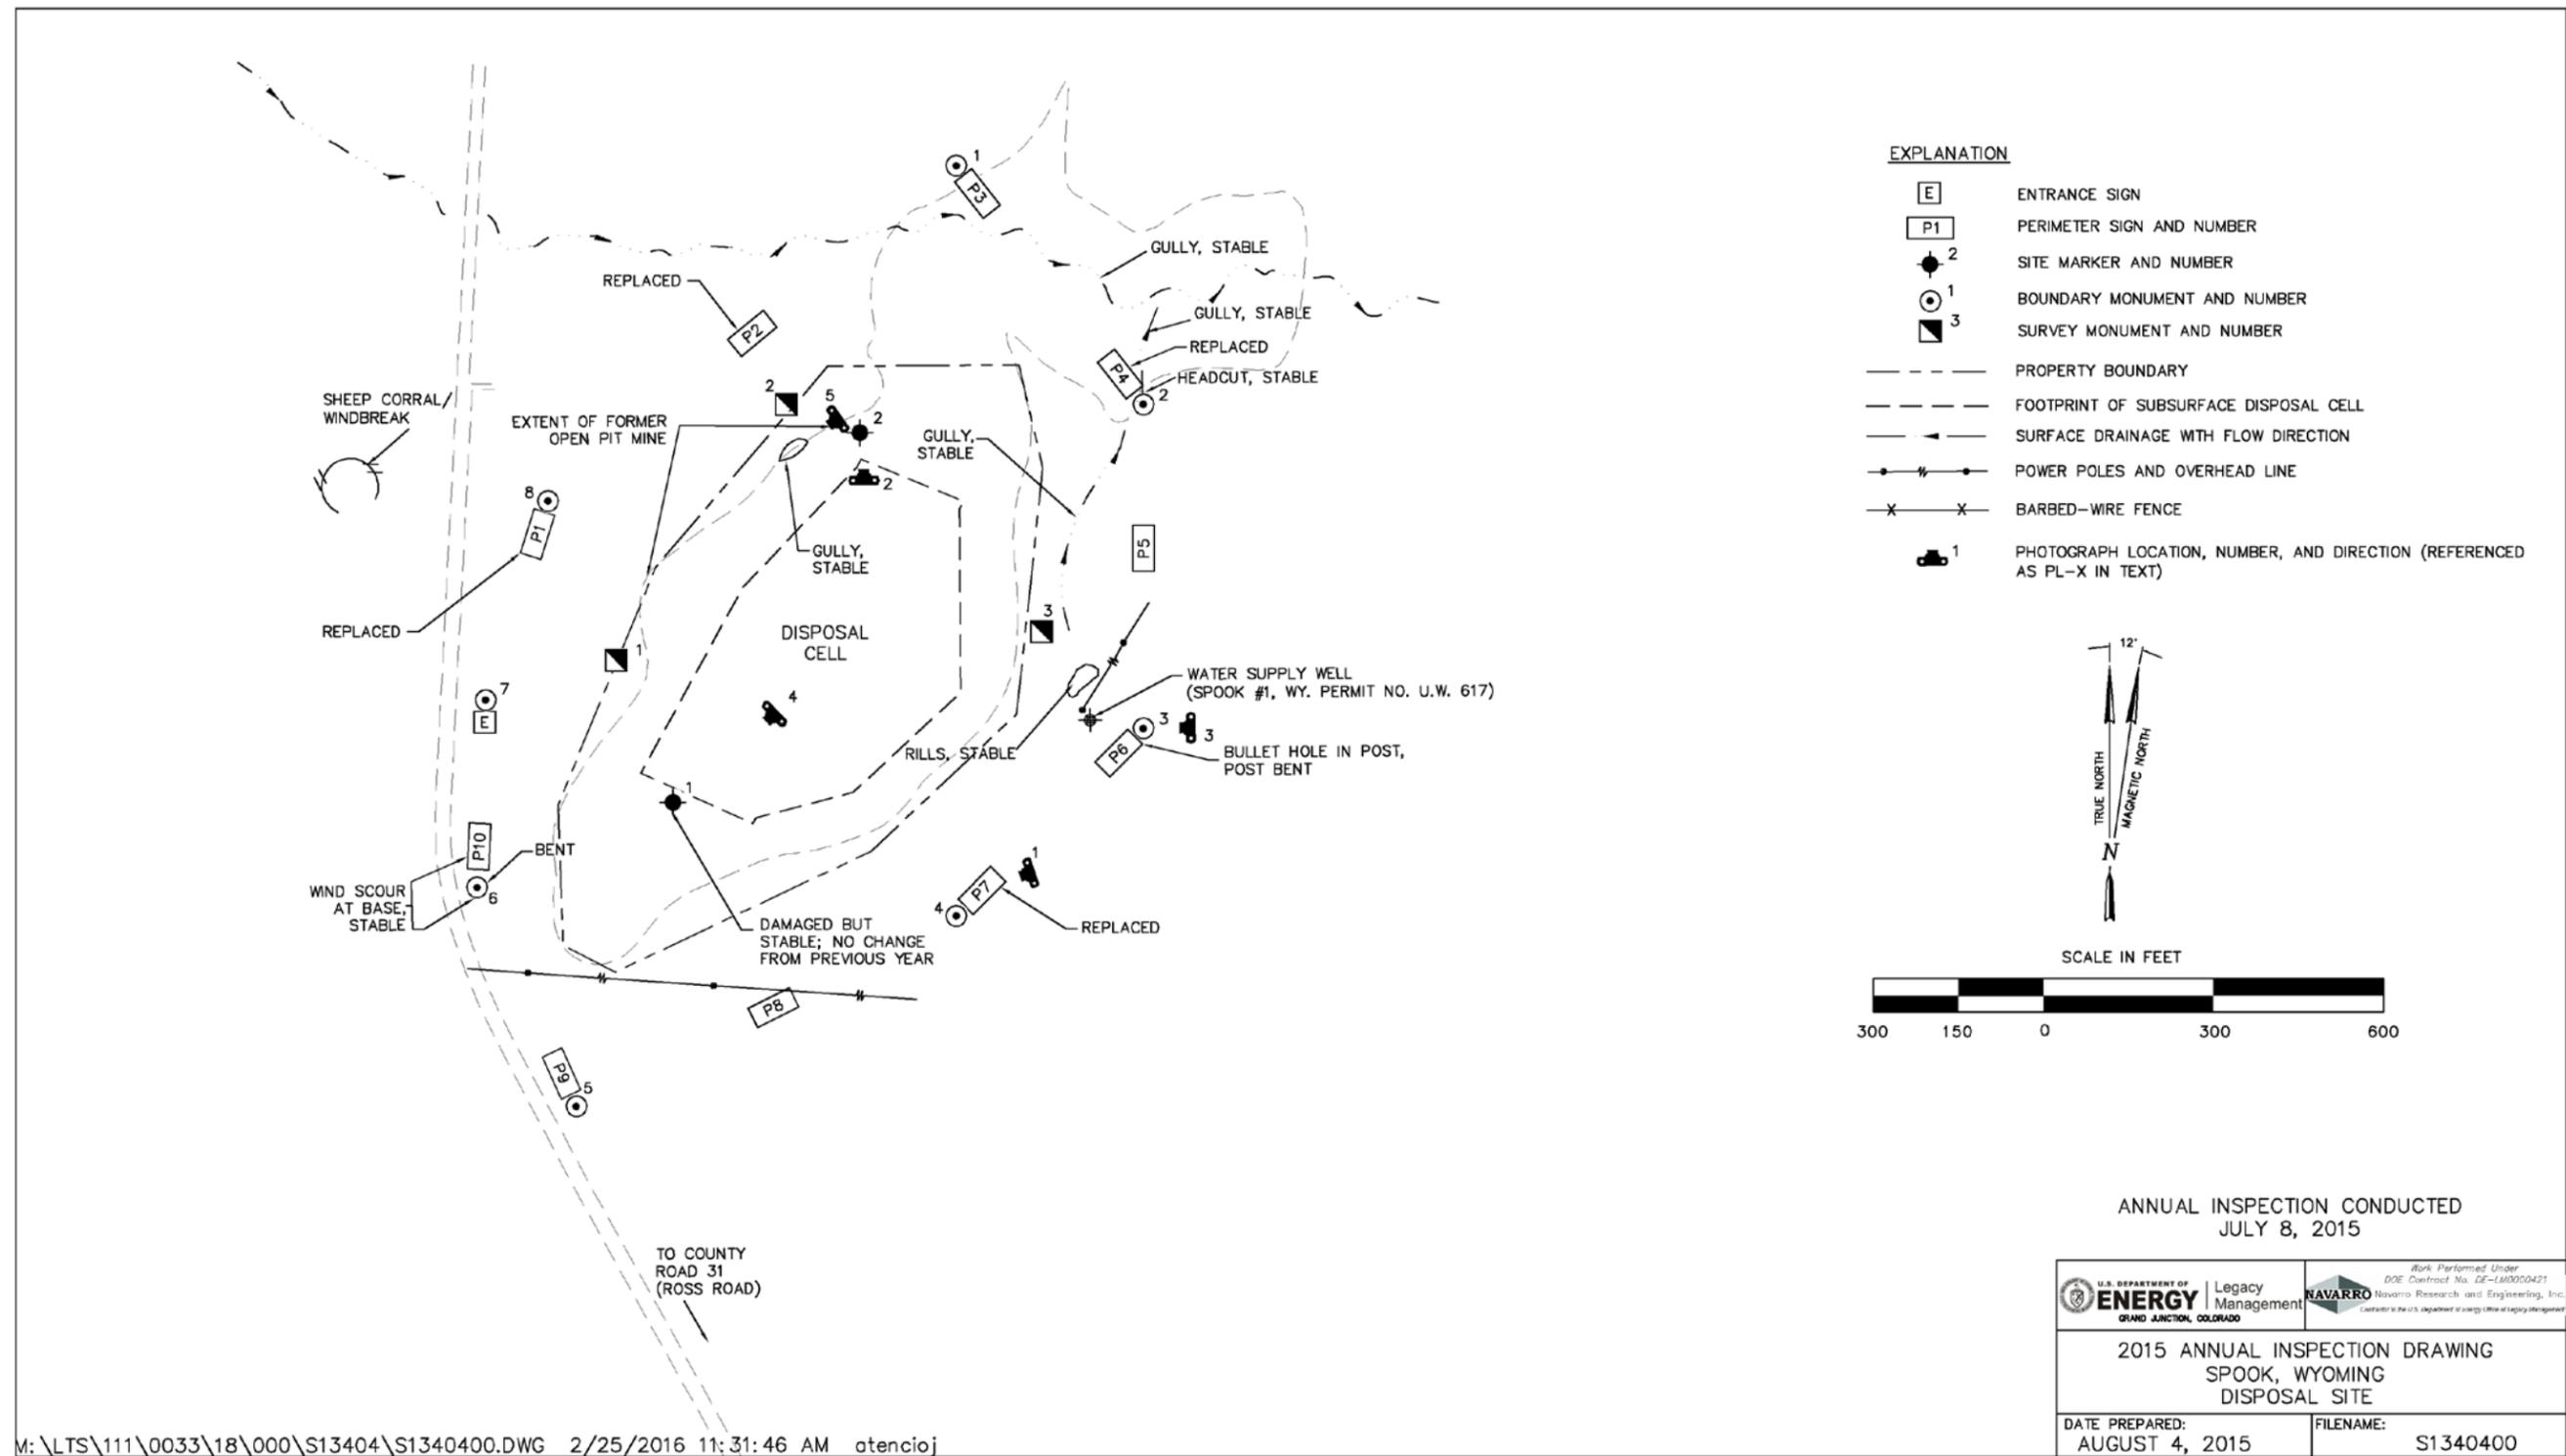
Figure 18-1. 2015 Annual Inspection Drawing for the Spook Disposal Site

Figure 18-1 shows the locations of site surveillance features. Inspection results and recommended maintenance activities associated with site surveillance features are included in the following subsections. Photographs to support specific observations are identified in the text and in Figure 18-1 by photograph location (PL) numbers.

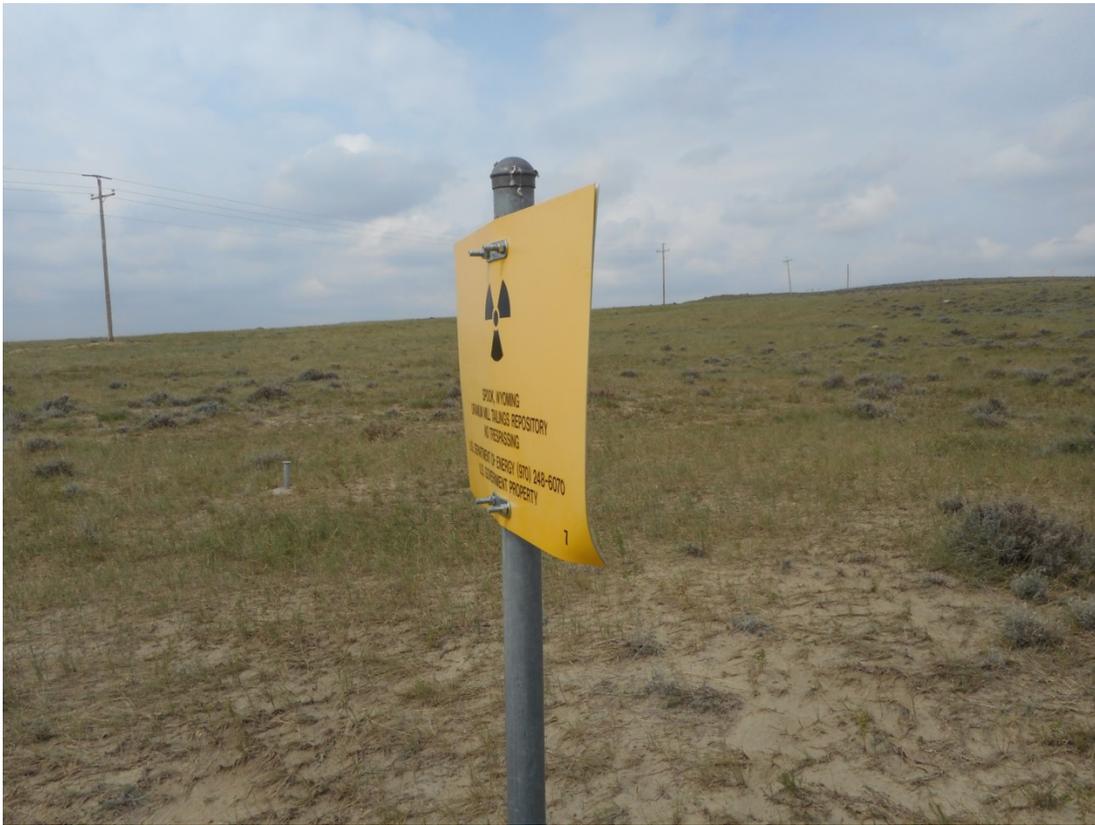
The site is surrounded by 10 perimeter signs and the entrance sign. All of the signs were legible; however, perimeter signs P1, P4, and P7 (PL-1) (which are constructed of thin, bonded aluminum sheets) were delaminating. These three signs were replaced in mid-September when staff was in the area. Perimeter sign P2 was broken and was replaced during the 2015 inspection.

SPK 7/2015. PL-1. Perimeter sign P7 and boundary monument BM-4.

- 18A Damaged perimeter sign P2 was identified and replaced during the 2015 inspection. Delaminated perimeter signs (P1, P4, and P7) were replaced in September after the site inspection. A t-post will be placed adjacent to bent boundary monument BM-6 to identify its location when it is buried by snow. No other maintenance needs were identified.

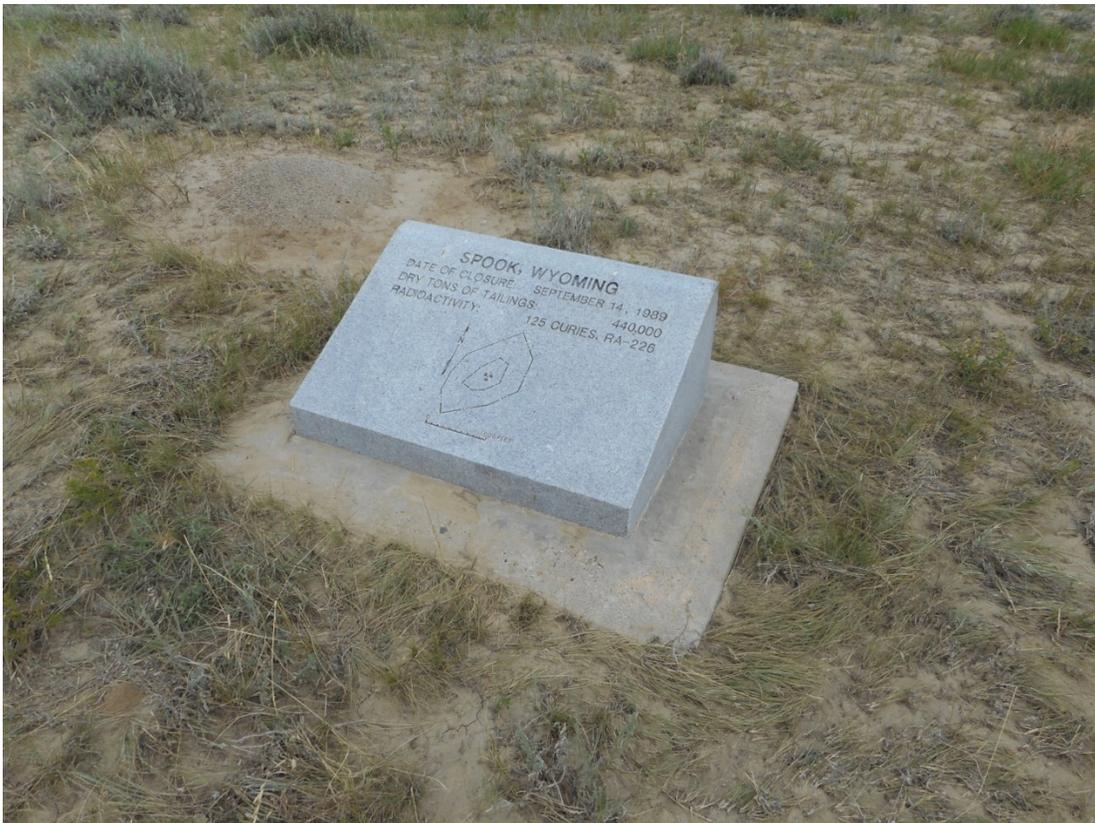
Two granite site markers identify the site. Both site markers were in excellent condition (PL-2). The concrete base of site marker SMK-1 is damaged due to spalling but is stable; there were no apparent changes from the previous year.

SPK 7/2015. PL-2. Site marker SMK-2.

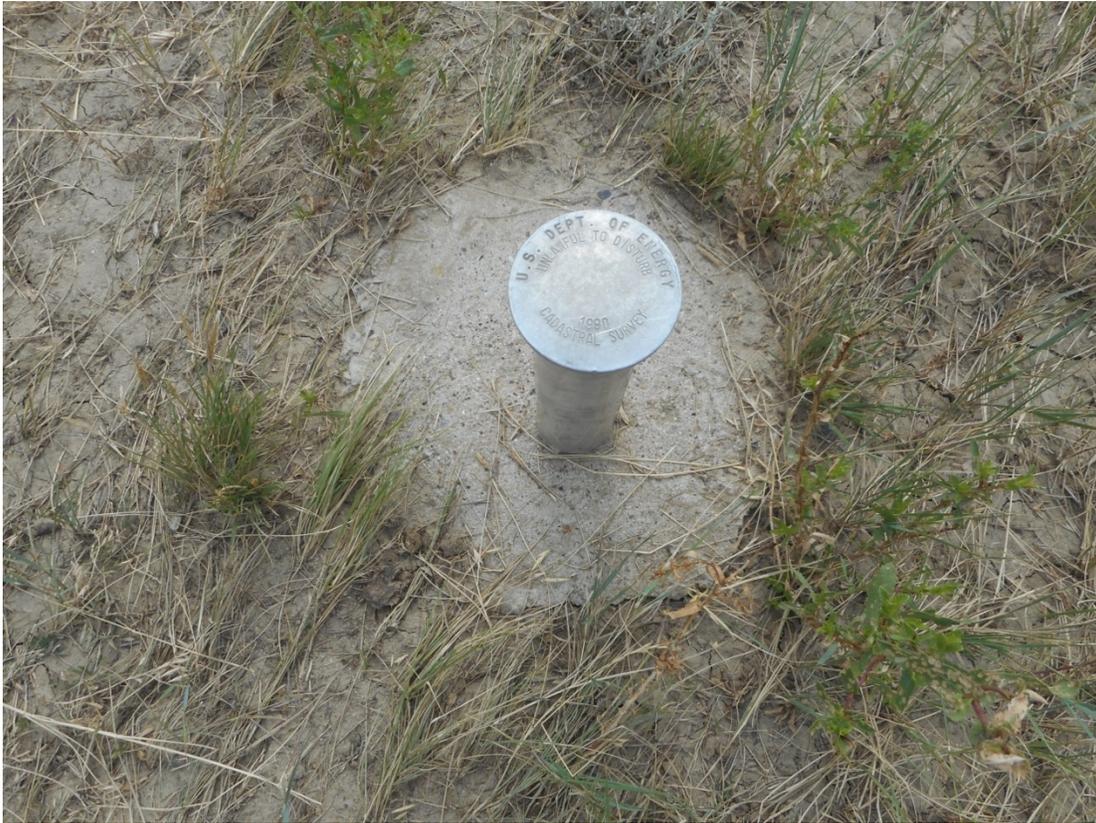
Eight boundary monuments and three survey monuments are present at the site. Except for boundary monument BM-6, which was observed to be bent during last year's inspection, all other monuments were in excellent condition (PL-3).

SPK 7/2015. PL-3. Boundary monument BM-3.

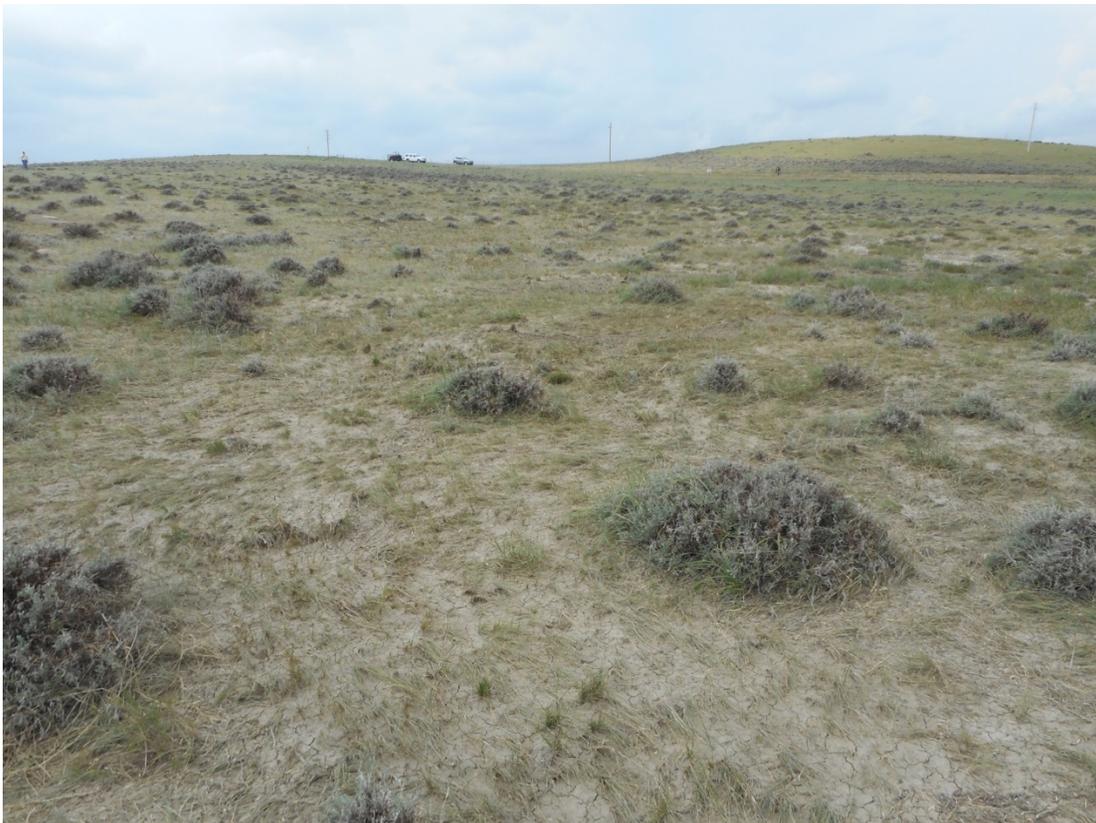
The site is unique among Title I sites in that tailings were encapsulated in the bottom of an open pit mine and covered with 40–60 feet of clean fill and topsoil. Therefore, many of the observations and concerns routinely associated with above-grade disposal cells—such as the quality of the riprap and the stability of side slopes—do not apply to this site. The surface of the 5-acre disposal cell, completed in 1989, was in excellent condition. No evidence of settling was observed over the former mine pit. Vegetation on the cell cover, consisting of grasses and forbs, was healthy and indistinguishable from that growing on the remainder of the site and on the surrounding ranch land (PL-4).

SPK 7/2015. PL-4. View southwest from north of site marker SMK-1, swirled grass due to sheet flow.

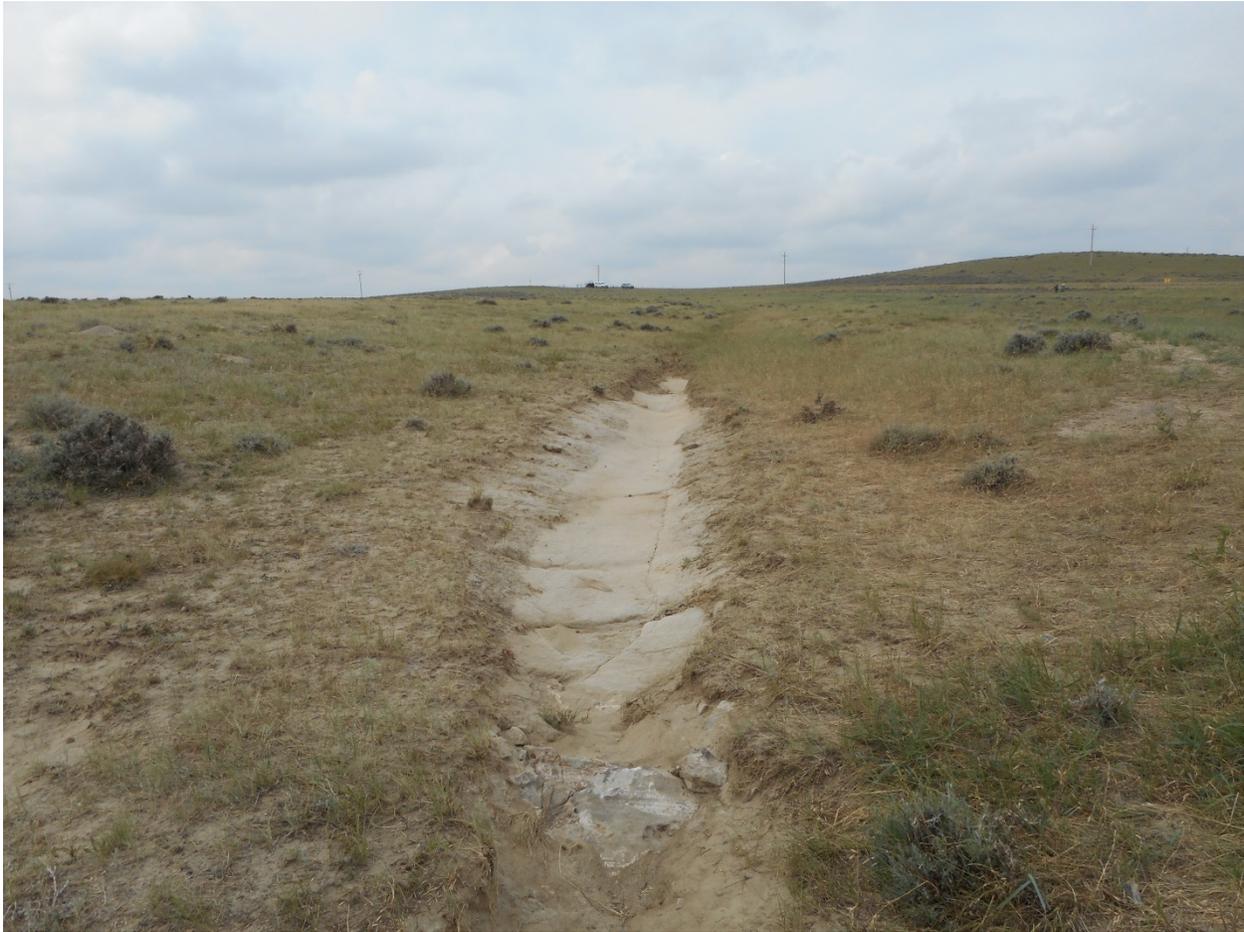
The area beyond the site boundary for a distance of about 0.25 mile was visually observed for erosion, disturbance, change in land use, or other phenomena that might affect the long-term integrity of the site. Several minor rills and gullies are near the site (PL-5), and they appeared to be stable. The erosion is not harming the function of the cell cover or other site features, and it is not a concern at this time.

SPK 7/2015. PL-5. Gully in sandstone bedrock, view to southwest.
