**CHANGES TO THE RCRA GROUNDWATER  
MONITORING PROGRAM AT THE FEMP**

**DOE-167-92  
DOE-FO/OEPA  
8  
ENCLOSURE**

INSPECTION REPORT  
DOWNHOLE CAMERA SURVEY AT 013 WELL CLUSTER

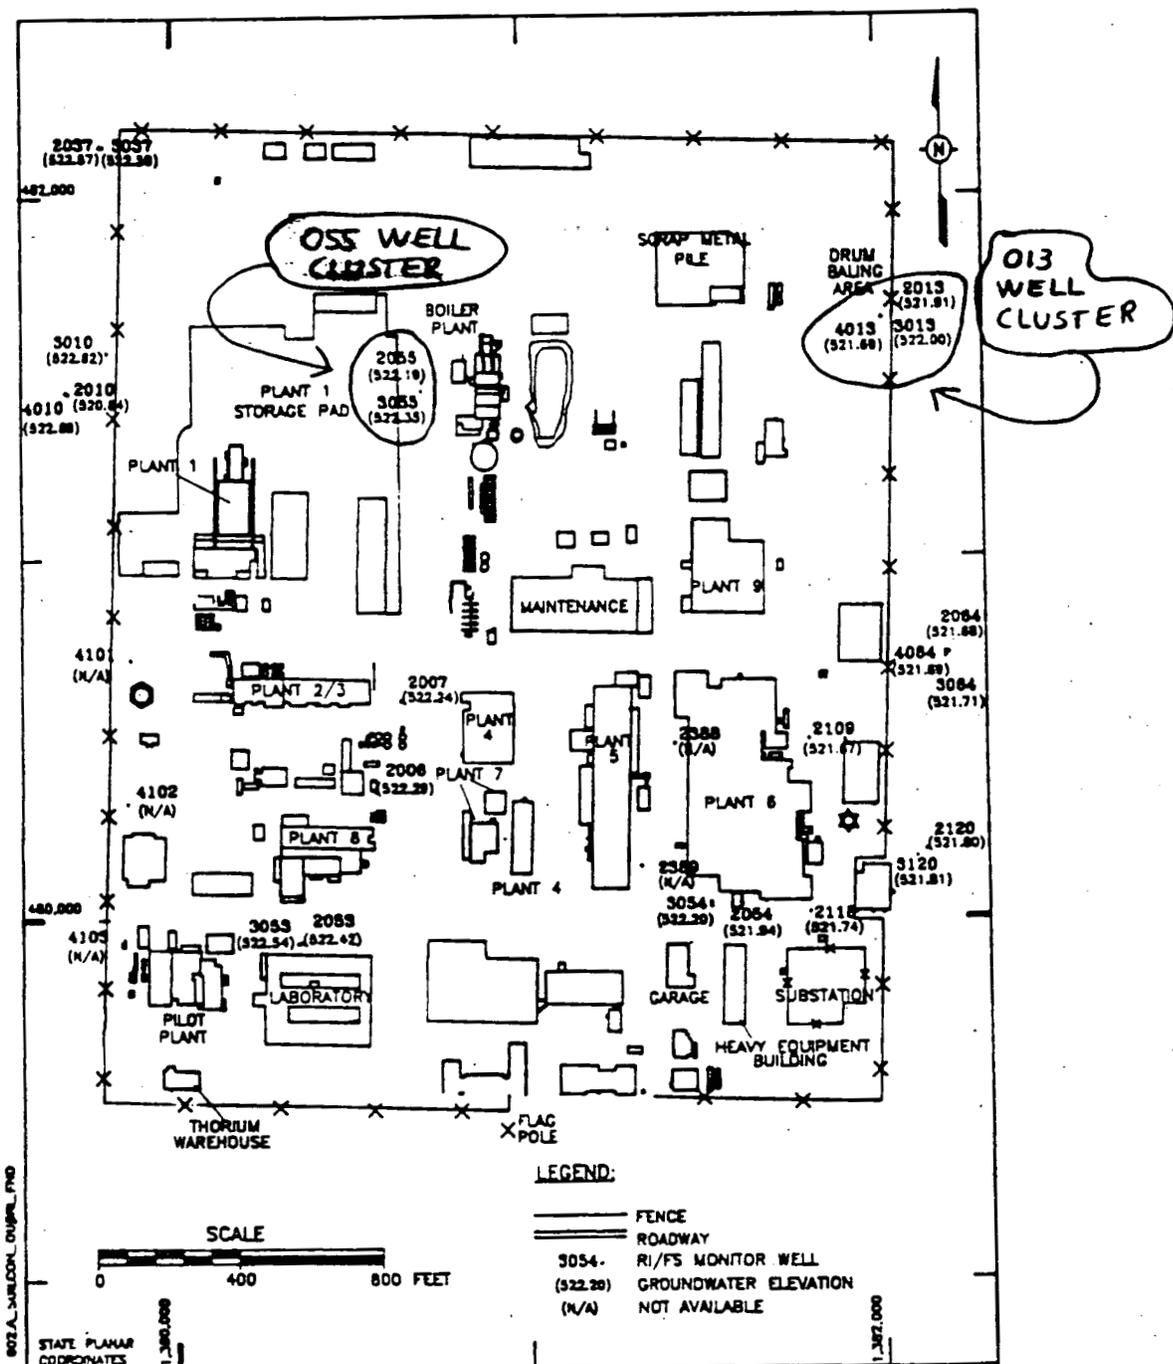
Figure 1

Groundwater samples collected from Monitoring Well 3013 (located in the northeast corner of the Production Area, southeast of the Scrap Metal Pile, at the 013 well cluster (Figure 1) indicate that the concentration of total uranium in the regional sand and gravel aquifer has increased from 11.7 ug/l to 1150 ug/l at this location (Figure 2) over the period from the first quarter of 1990 to the third quarter of 1991.

The flow direction in this area is generally east. The gradient is very slight indicating that the velocity of flow is very slow. Up-gradient to the 013 cluster, the nearest monitoring location is Monitoring Well 2055 (Figure 1). Total uranium at this location measured 3.9 ug/l in the third quarter of 1991. This indicates that uranium contamination is entering the regional aquifer somewhere between Plant 6 and the Scrap Metal Pile. Down-gradient to the 013 cluster, the nearest monitoring locations are Monitoring Wells 2051 and 3051. Monitoring Well 3051 has a pump stuck in the well and is impossible to sample at this time. The concentration of uranium in water samples collected from Monitoring Well 2051 is approximately 2 ug/l.

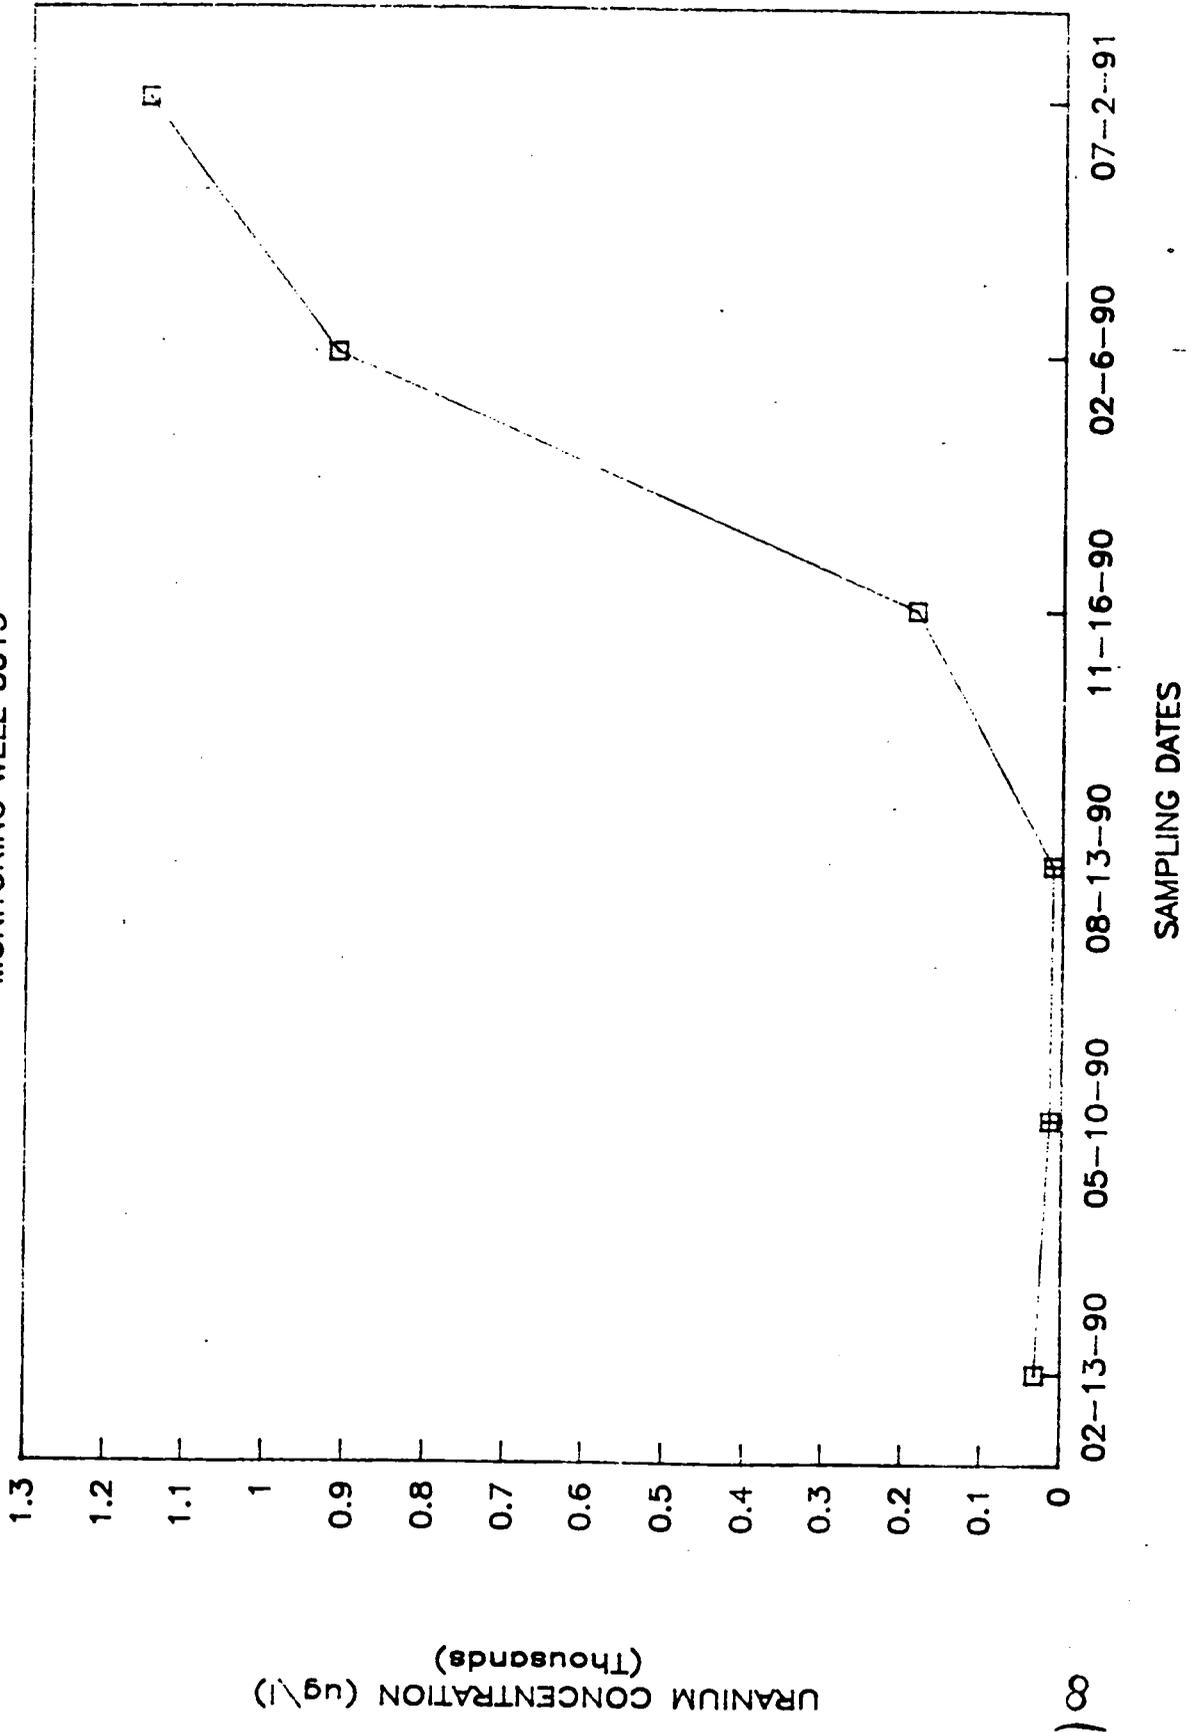
Figure 2

Routine groundwater sampling of Monitoring Well 3013, conducted by the WEMCO Groundwater Programs Group, indicates that uranium concentrations have increased from 11.7 ug/l in 1990 to 1150 ug/l in 1991. In late 1990 a test result of 183 ug/l total uranium was obtained. Discussions with ASI/IT personnel in late 1990 indicated that wells at the 013 well cluster have a history of erratic uranium readings (Table 1). Testing conducted in the first and third quarter of 1991 have confirmed that an increasing trend has developed (Figure 2).

Monitoring Wells 2013, 3013, and 3051 are listed as RCRA Groundwater Assessment Monitoring Wells in the RCRA GQAPP revision 2, issued in 1991. Due to concerns for the aquifer, these monitoring wells (2013, 3013, and 3051) will be plugged and abandoned. New monitoring wells will be installed to continue monitoring the aquifer in these areas.
