**WASTE PIT 5 LINER REPAIR PROJECT FINAL
REPORT CERCLA/RCRA UNIT 1**

FERNALD ENVIRONMENTAL RESTORATION MANAGEMENT COMPANY

FERNALD ENVIRONMENTAL MANAGEMENT PROJECT

JANUARY 1993

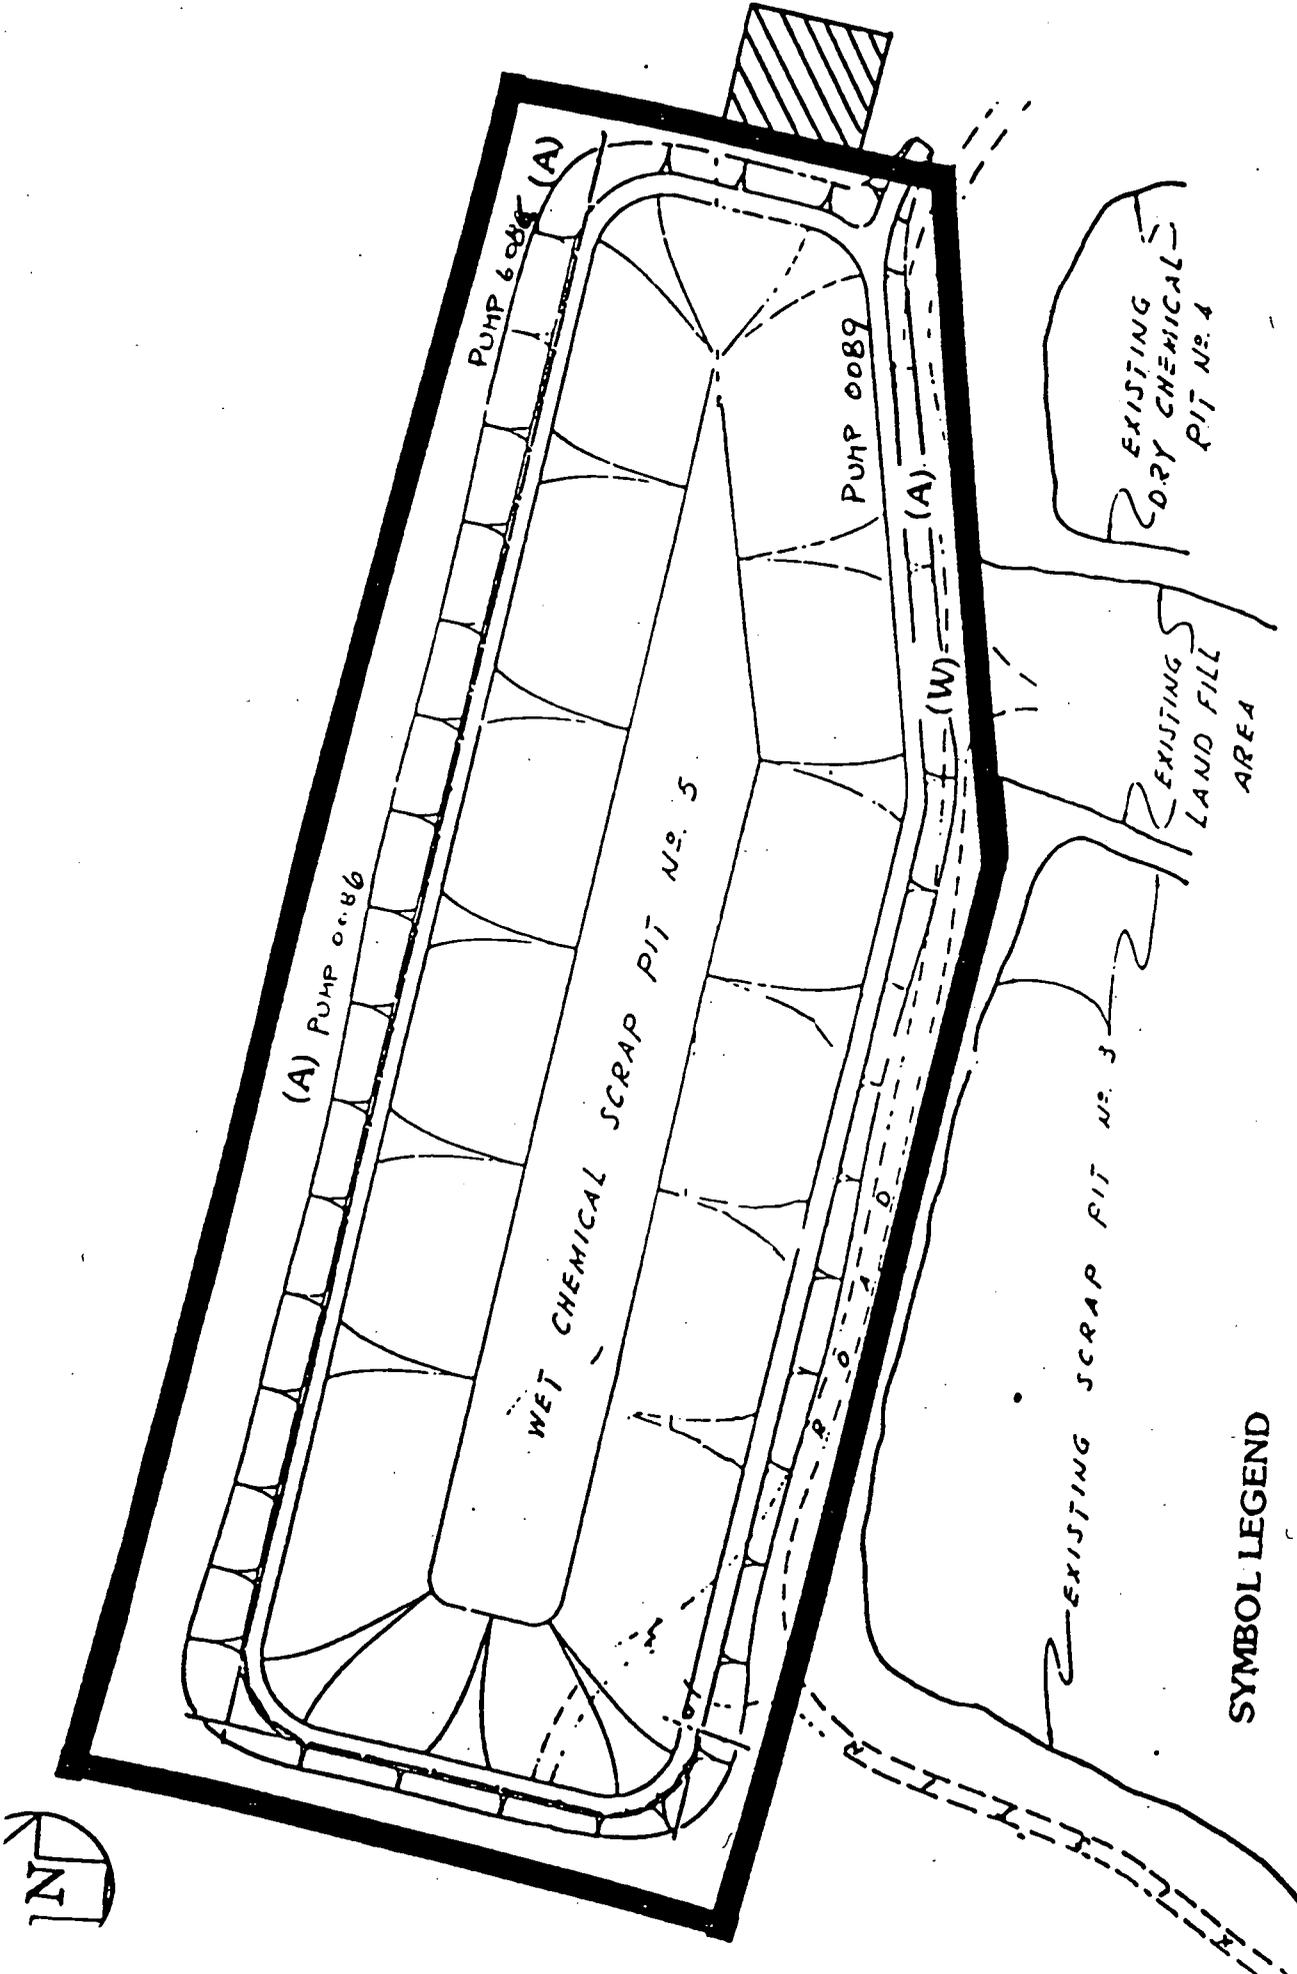
As specified in the Corrective Action Work Plan, radionuclide monitoring was conducted while the liner repairs were being performed. Three high volume air monitors were set up in an area adjacent to the pit as identified in Figure 2. These locations were determined based upon the predominant wind direction in the area.
