**ON-SITE DISPOSAL FACILITY  
LEACHATE CONVEYANCE SYSTEM  
LEAK INVESTIGATION REPORT  
GRAVITY LINE SECTION**

**FERNALD ENVIRONMENTAL MANAGEMENT PROJECT  
FERNALD, OHIO**

**U.S. DEPARTMENT OF ENERGY**

**20110-RP-0003**

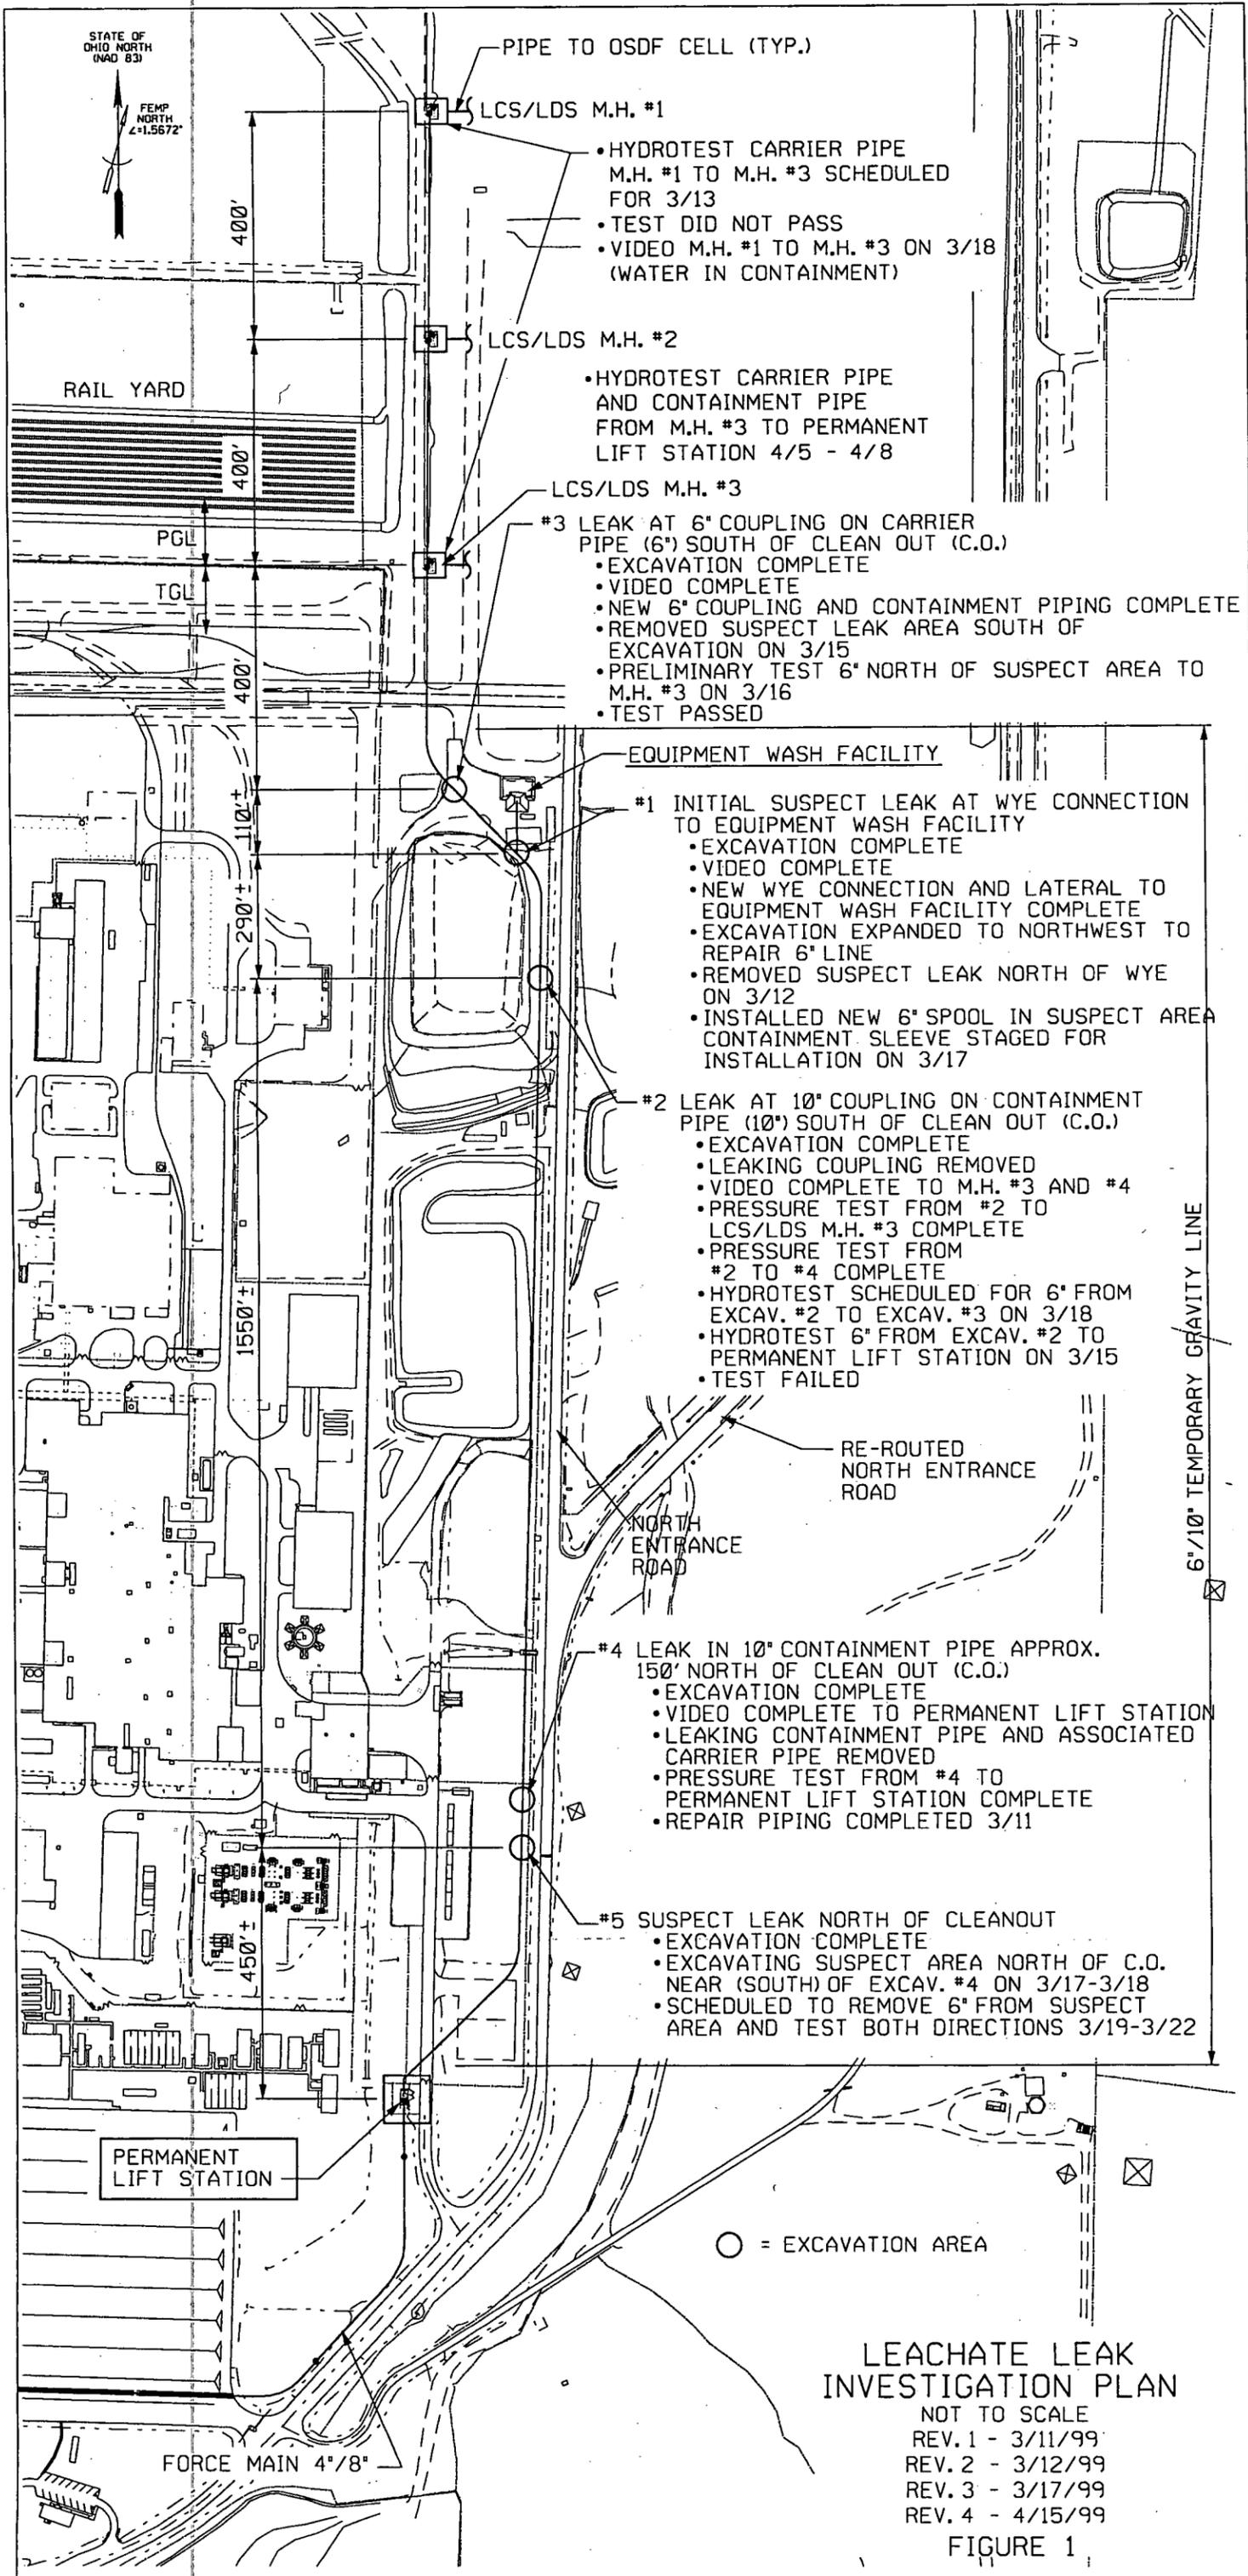
LEACHATE LEAK INVESTIGATION PLAN

- #3 LEAK AT 6" COUPLING ON CARRIER PIPE (6") SOUTH OF CLEAN OUT (C.O.)
- EXCAVATION COMPLETE
- VIDEO COMPLETE
- NEW 6" COUPLING AND CONTAINMENT PIPING COMPLETE
- REMOVED SUSPECT LEAK AREA SOUTH OF EXCAVATION ON 3/15
- PRELIMINARY TEST 6" NORTH OF SUSPECT AREA TO M.H. #3 ON 3/16
- TEST PASSED

- #1 INITIAL SUSPECT LEAK AT WYE CONNECTION TO EQUIPMENT WASH FACILITY
- EXCAVATION COMPLETE
- VIDEO COMPLETE
- NEW WYE CONNECTION AND LATERAL TO EQUIPMENT WASH FACILITY COMPLETE
- EXCAVATION EXPANDED TO NORTHWEST TO REPAIR 6" LINE
- REMOVED SUSPECT LEAK NORTH OF WYE ON 3/12
- INSTALLED NEW 6" SPOOL IN SUSPECT AREA CONTAINMENT SLEEVE STAGED FOR INSTALLATION ON 3/17

#2 LEAK AT 10" COUPLING ON CONTAINMENT PIPE (10") SOUTH OF CLEAN OUT (C.O.)

- EXCAVATION COMPLETE
- LEAKING COUPLING REMOVED
- VIDEO COMPLETE TO M.H. #3 AND #4
- PRESSURE TEST FROM #2 TO LCS/LDS M.H. #3 COMPLETE
- PRESSURE TEST FROM #2 TO #4 COMPLETE
- HYDROTEST SCHEDULED FOR 6" FROM EXCAV. #2 TO EXCAV. #3 ON 3/18
- HYDROTEST 6" FROM EXCAV. #2 TO PERMANENT LIFT STATION ON 3/15
- TEST FAILED

#4 LEAK IN 10" CONTAINMENT PIPE APPROX. 150' NORTH OF CLEAN OUT (C.O.)

#5 SUSPECT LEAK NORTH OF CLEANOUT

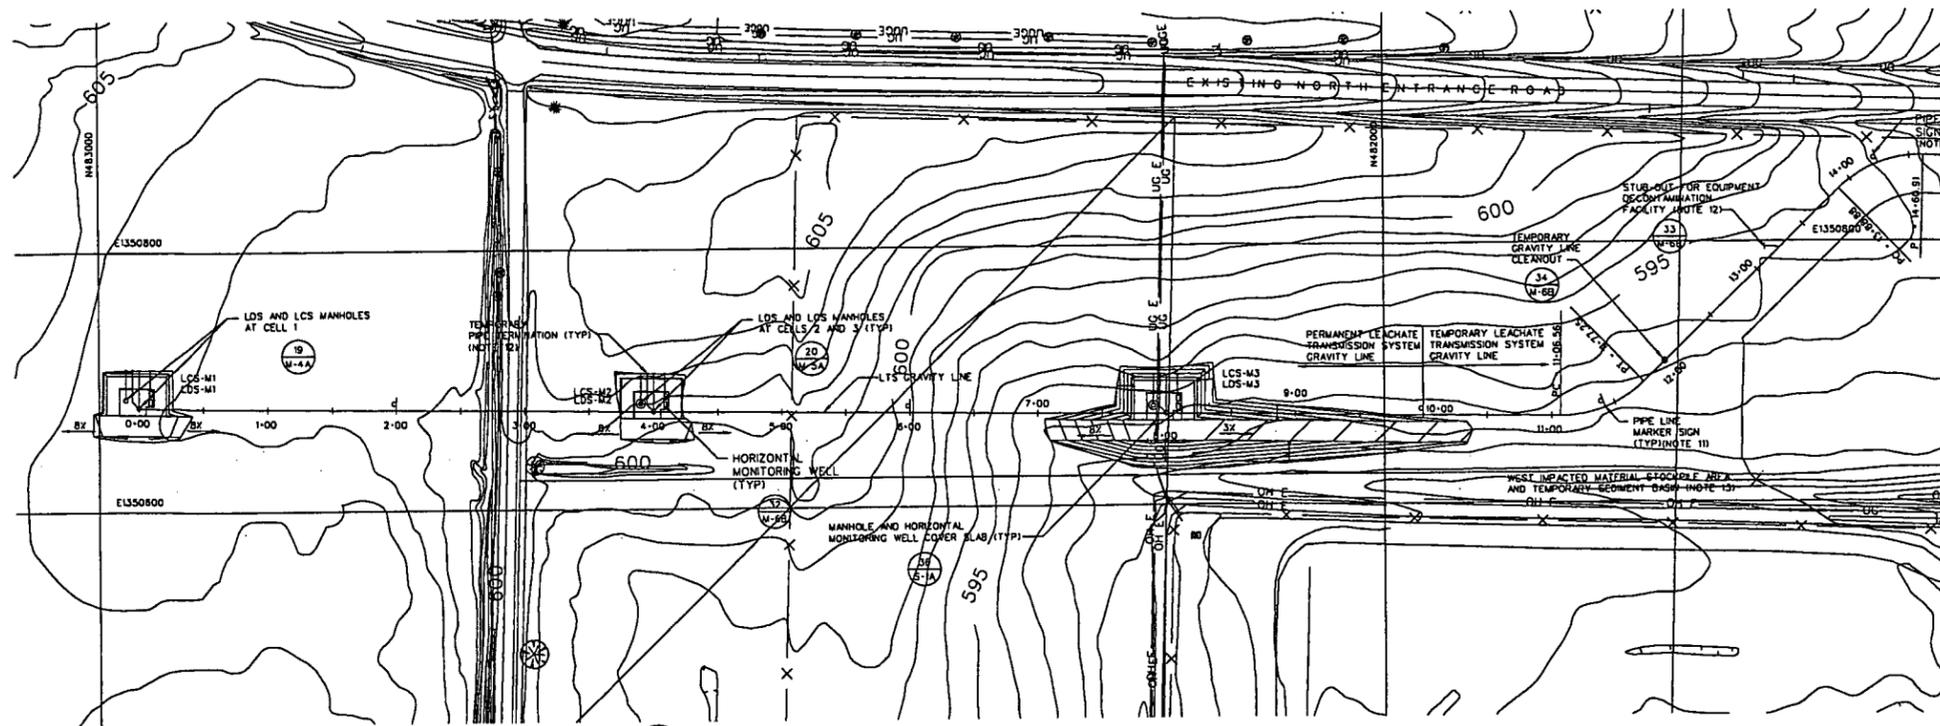
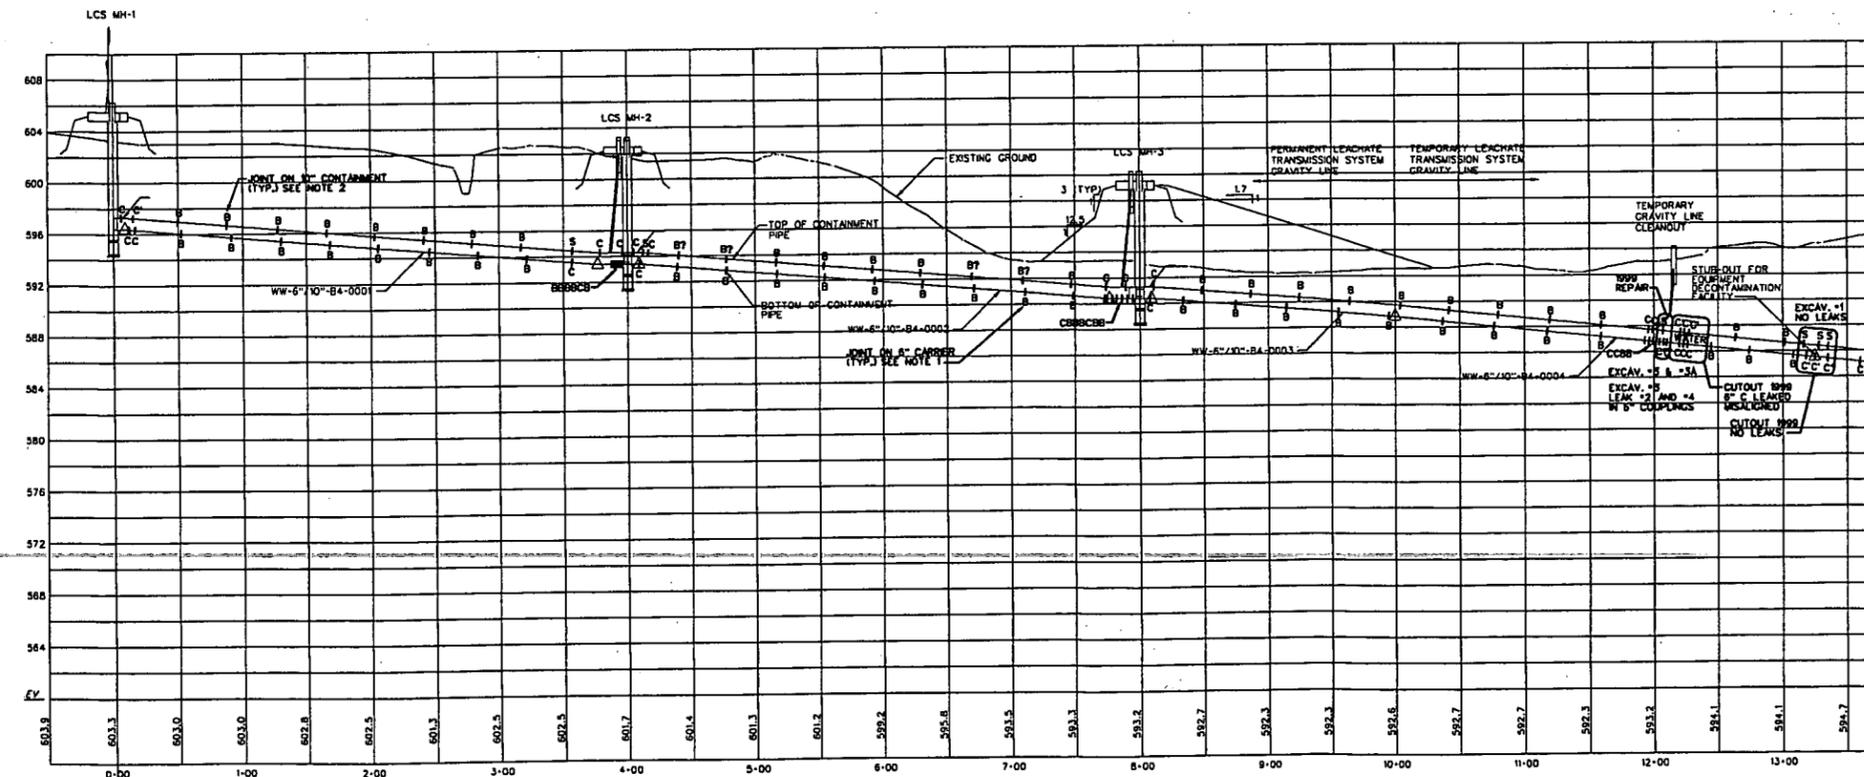
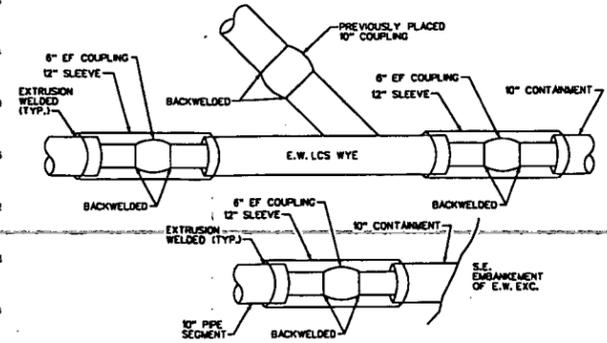
LEACHATE CONVEYANCE SYSTEM  
LEAK INVESTIGATION  
PLAN AND PROFILE DATA  
3/29/99  
FIGURE 2

REPAIR @ C.O. @ STA. 12+00 (APPROX.)

E.W.-LCS REPAIR @ STA. 13+20 (APPROX.)

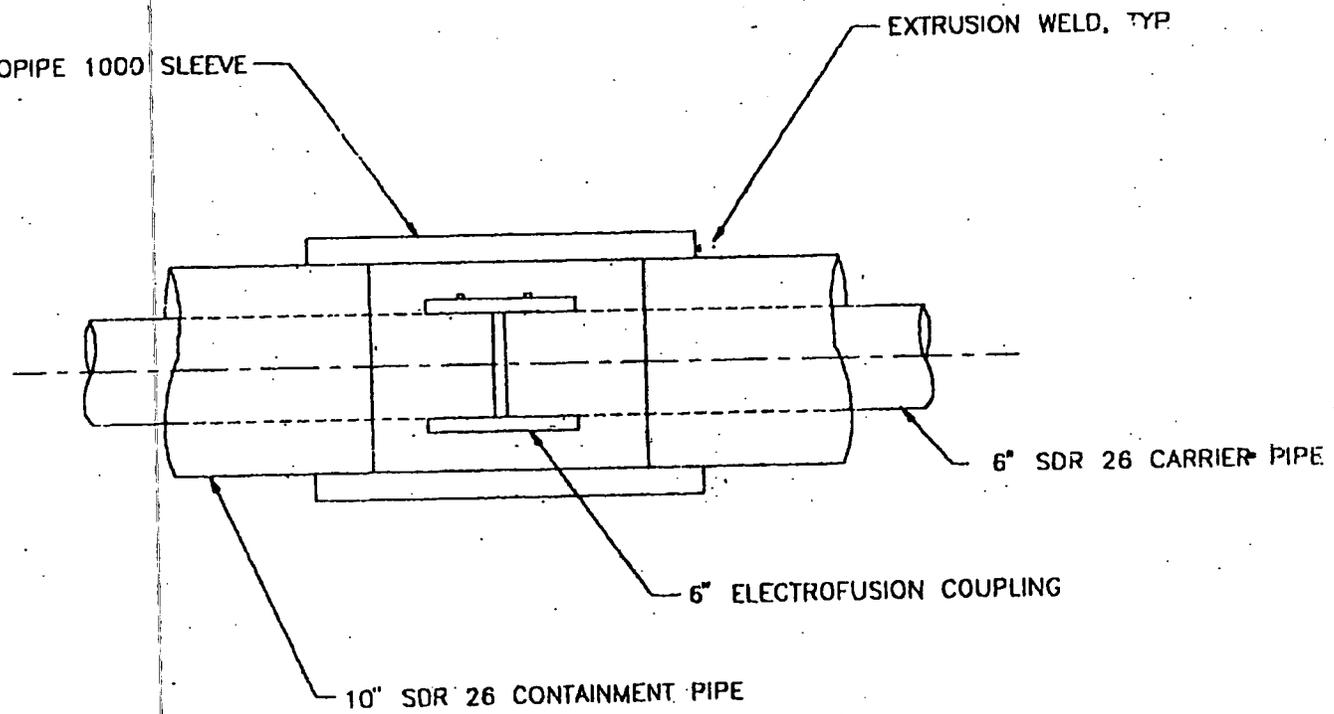
Sheet 8 of 10  
FIGURE 5

Electrofusion coupling leaks due to various contributing causes were observed. A summary of all electrofusion couplings and 12-inch sleeves (See Figure 5 for use of sleeve) installed as of March 29, 1999 is presented in Table 1. Also refer to Figures 2, 3, and 4 of this report for physical locations of all joints. Contributing causes for Leaks #1, #2, and #4 are presented below.

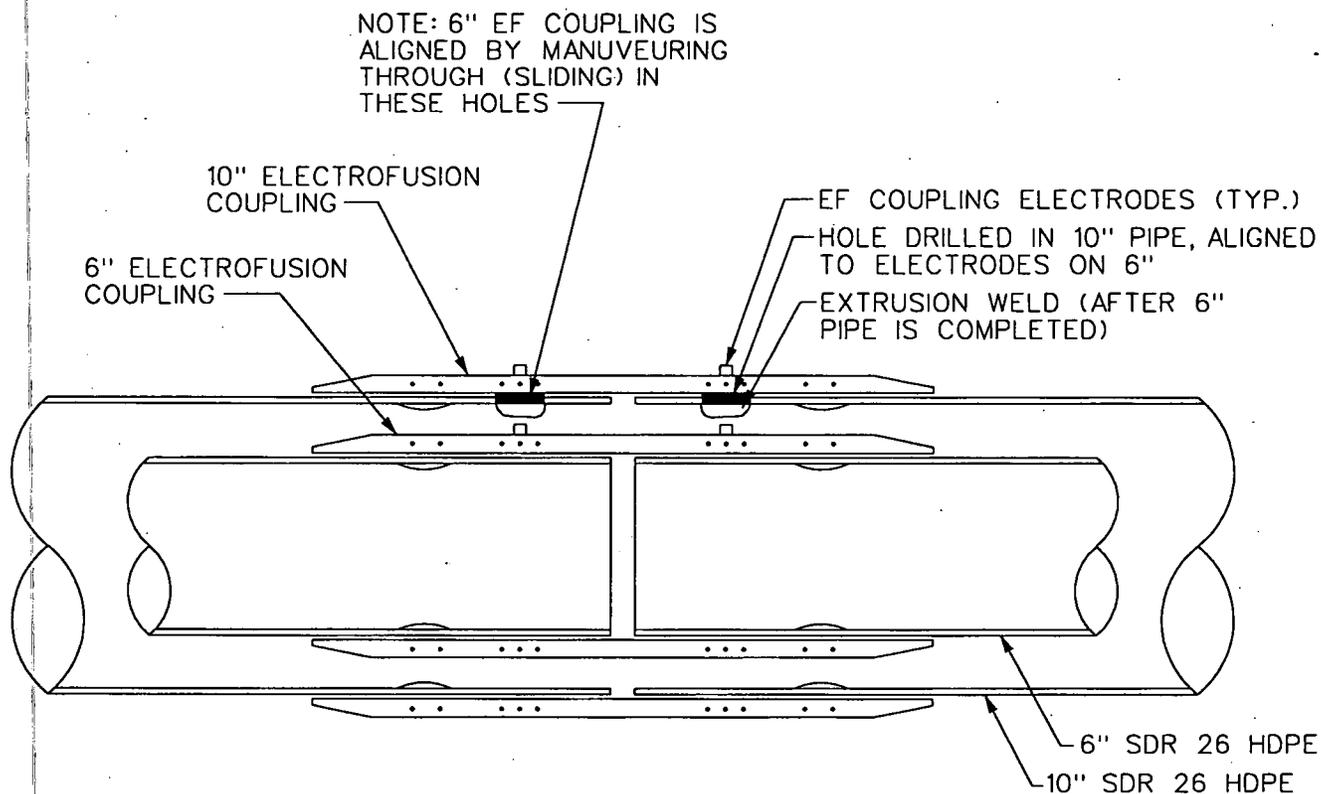
GRAVITY LEACHATE LINE  
EXISTING FIXED END METHOD

An air pressure test was used to discover Leak #4 at a 6-inch electrofusion coupling located south of the cleanout and Leak #2. A 15-foot section of dual containment pipe was removed. This section of pipe contained three sets of couplings (three 6-inch electrofusion couplings and three 10-inch electrofusion couplings). The middle 6-inch pipe and 10-inch pipe couplings were both vertically misaligned. The coupling arrangement used was the "fixed end method" (see Figure 6). In addition, inadequate surface preparation in this area was also noted.

During the course of the installation, a different method for joining the dual containment pipe, called the fixed end method, was used without being formally submitted, reviewed and approved. This method was observed in the field by GeoSyntec and FDF construction personnel and no objections to the method were raised, which indicates that approval of the method would have most likely been granted had it been submitted for formal approval. A more thorough description of the fixed end method is provided in Section 3.5.3 of the GeoSyntec report.

NOTE:  
 THE ABOVE DETAIL IS HISTORICAL EVIDENCE OF JOINT. IT IS NOT THE APPROVED (OR SUBMITTED) PROCEDURE.

The lesson learned for HDPE pipe installation is to maximize the installation of pipe in only one direction. When HDPE pipe is installed in one direction there is always a free end and the butt fusion joining method can be used.

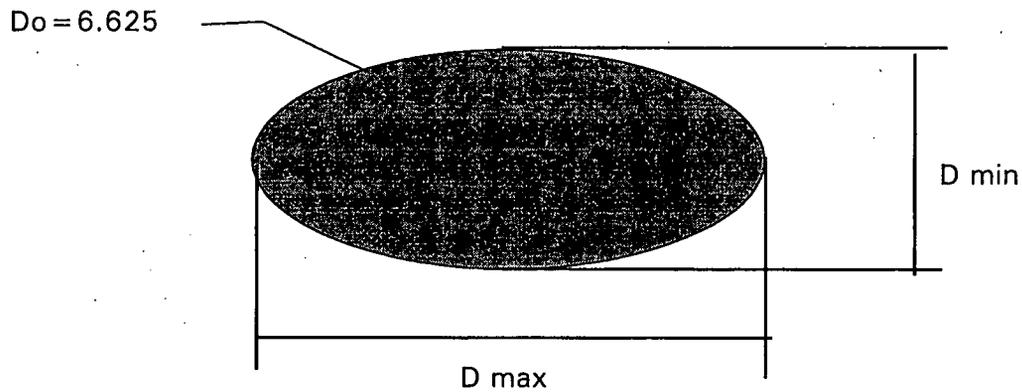
B. Leachate Investigation-Pipe Ovality Determination  
 By: EJK Date: 3/12/99

The 6-inch carrier pipe had deformed to an oval shape from Manhole No. 1 to the permanent lift station, except at points of the electrofusion coupling. There was no documentation available stating the condition of the carrier pipe during hydrostatic testing of the 10-inch containment pipe, however, the carrier pipe was assumed to be empty. With the 6-inch carrier pipe empty, the annular space between the 6-inch and 10-inch pipe exerted a pressure on the 6-inch pipe and exceeded the pipe's buckling capacity (see Calculation A in Appendix B to this report). Hence, the 6-inch pipe deformed to an oval shape. The field samples of pipes removed were measured showing a 9 to 16 percent range in ovality (see Calculation B in Appendix B). GeoSyntec's report presents a detailed review and analysis of the ovality and its effect on the continued use of the 6-inch line.

The ovality of the 6-inch carrier pipe resulted when the buckling pressure of the SDR 26 pipe was exceeded during hydrostatic testing of the 10-inch containment pipe. The ovality does not affect the ability of the constructed system to meet the design intent, including the hydraulic capacity. The long-term implications of exceeding the buckling capacity on the carrier pipe in the permanent section of the leachate conveyance pipeline may require follow-up analysis. Section 6 of GeoSyntec's report presents a detailed review and analysis of the effect of containment pipe pressure on carrier pipe integrity.

<u>Sta./leak</u>	<u>Dmax</u>	<u>Dmin</u>	<u>%Ovality (Dmax/Do)</u>
16+00	7.375"	5.75"	111.3%
Leak #4	7.5"	5.5"	113.2%
Leak#1	7.375"	5.75"	111.3%
Leak #4	7.625"	5.375"	115.1%
12+23	7.25"	6"	109.4%
