Department of Energy
Ohio Field Office
Fernald Environmental Management Project
P. O. Box 538705
Cincinnati, Ohio 45253-8705
(513) 648-3155

APRIL 24, 2003 INSPECTION CHECKLIST FOR ON-SITE DISPOSAL FACILITY CELL 1 CAP

OSDF Cell 1 Post Closure Inspection Checklist

Date: 5-9-03
 Scale: 1" = 40'
 OSDF CELL 1 CAP
 CORRECTIVE ACTIONS
 4-24-03 INSPECTION
 1 OF 1

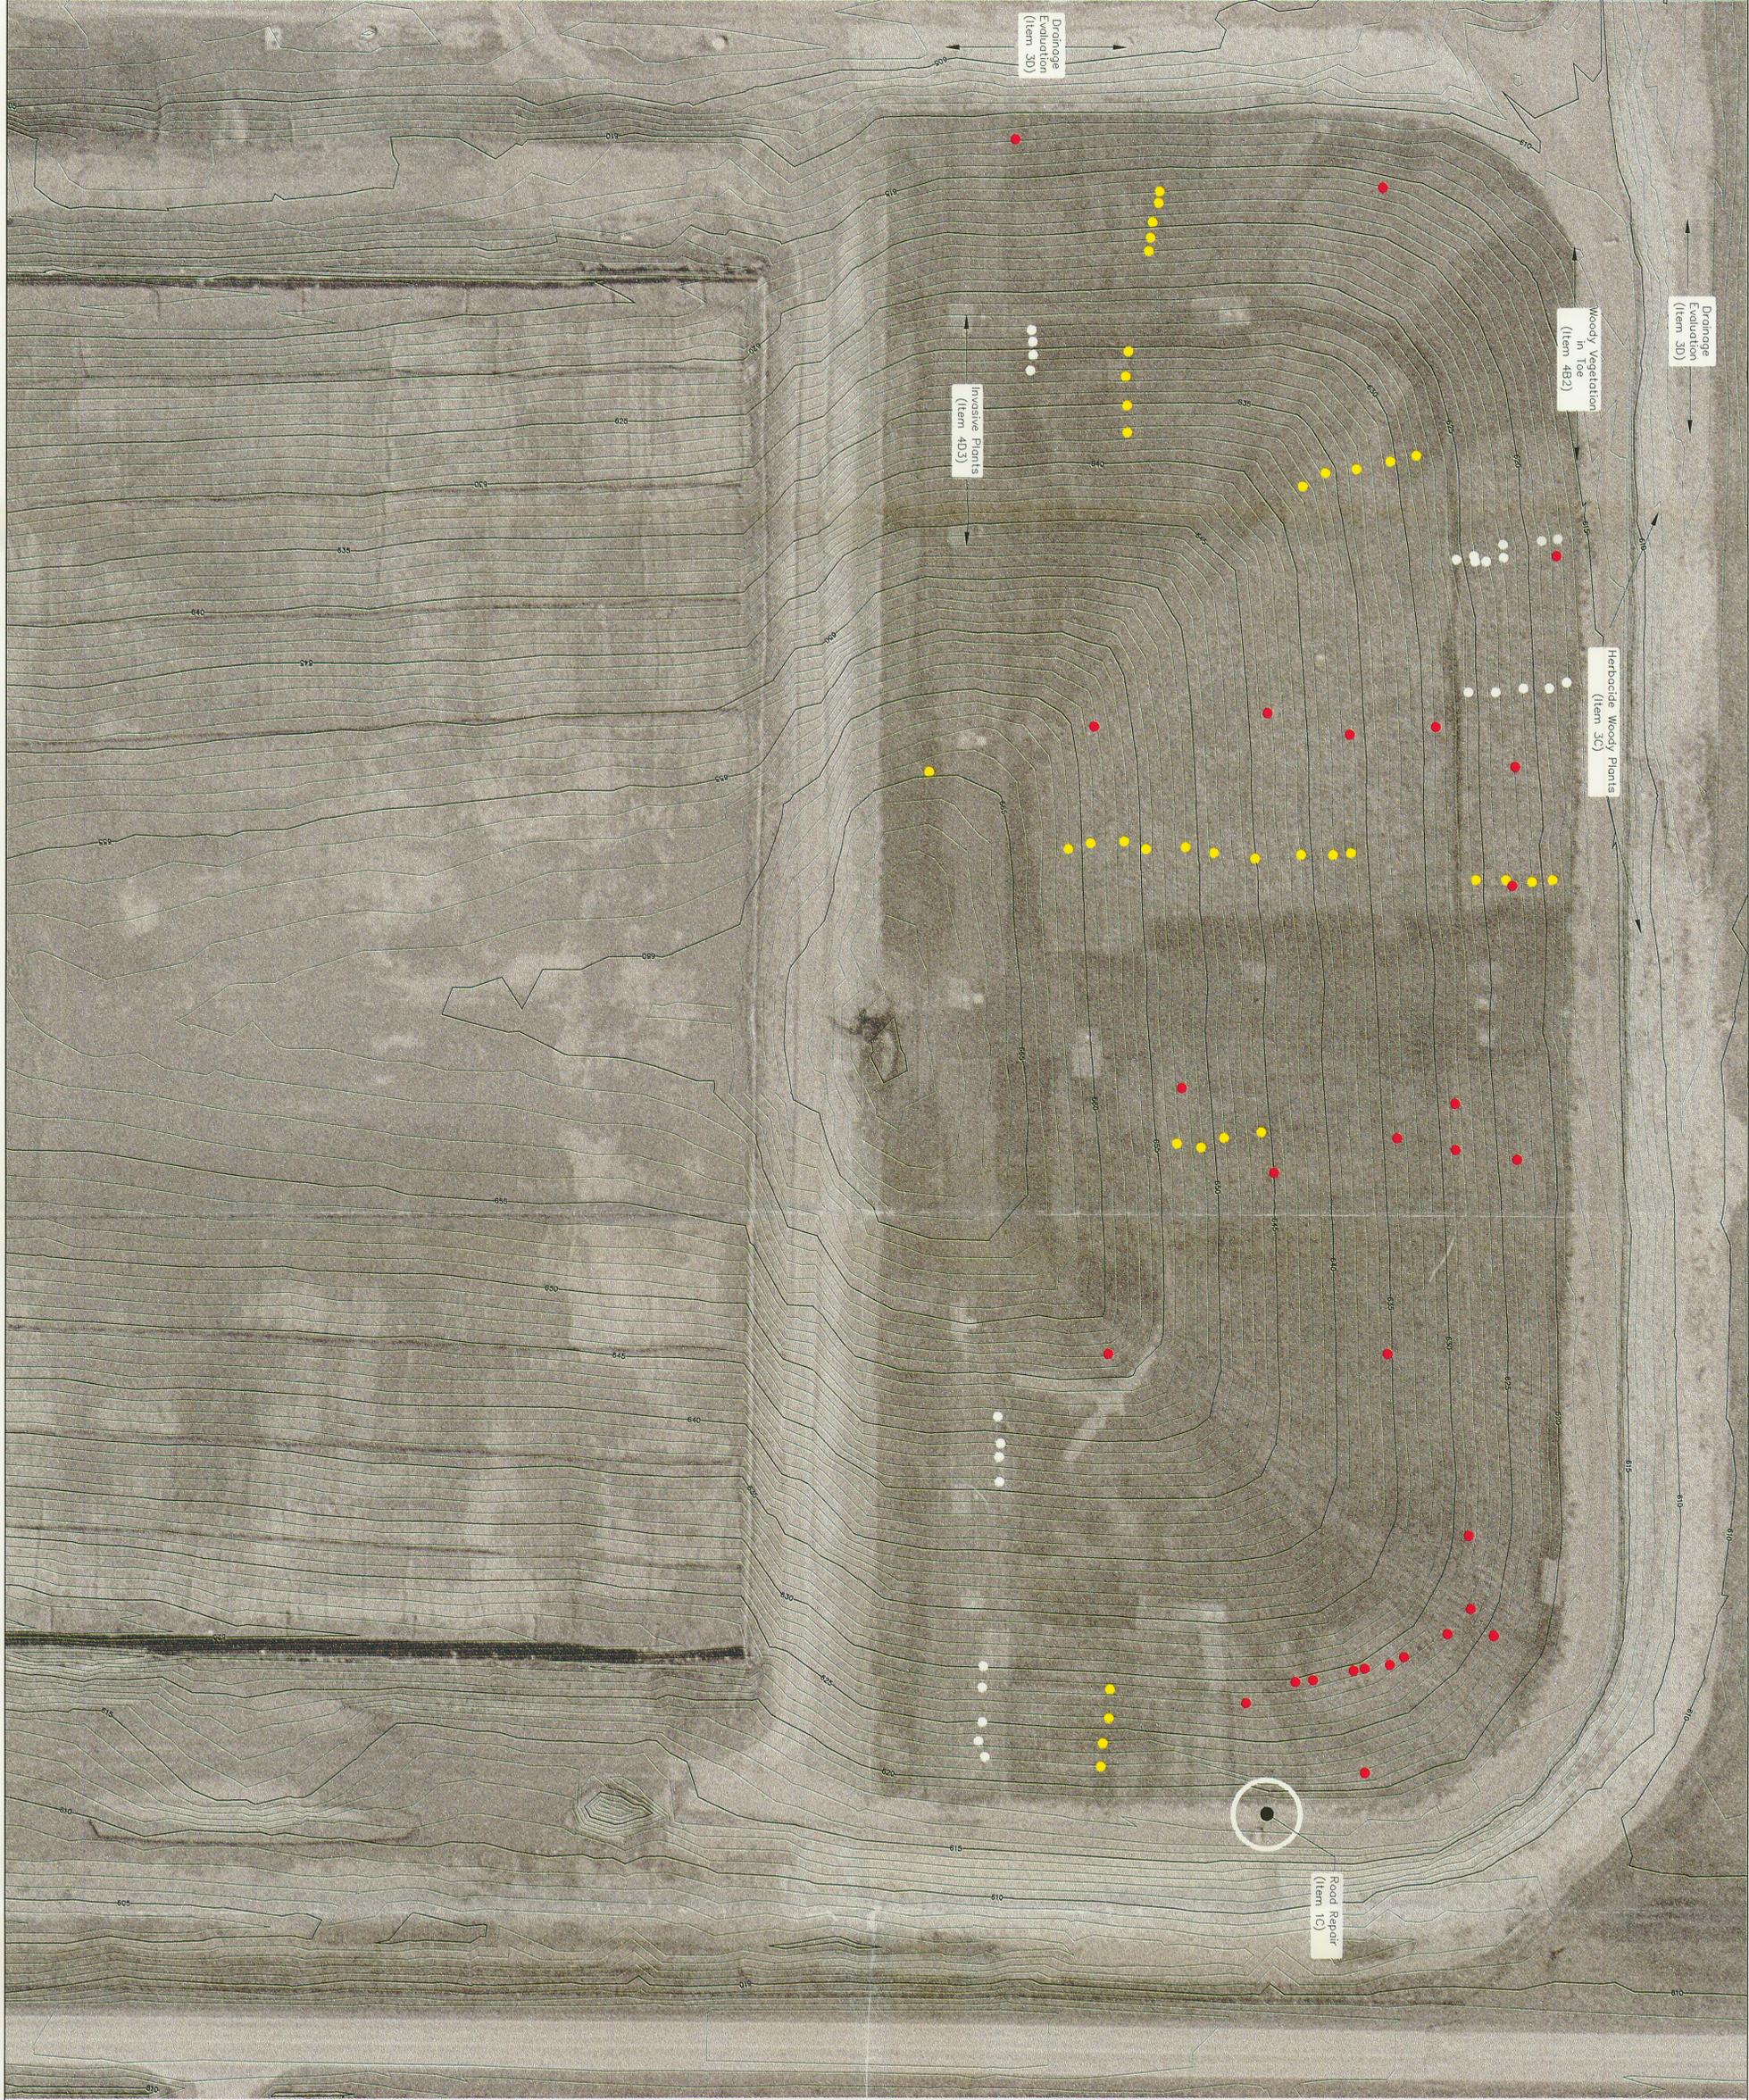
During the April inspection, the team identified several minor corrective actions that will require repair prior to the next inspection. Several erosion rills were identified that will be filled and seeded. Several, less significant erosion rills were identified, surveyed, and will be evaluated in future inspections. A number of animal burrows were identified on the cap that may require repair. Woody vegetation was identified on the toe of the cap and in the adjacent drainage channel, and some invasive vegetation was identified on the cap. Photographs of the areas requiring correct action will be taken after mowing of the Cell 1 Cap is complete and will be submitted under separate cover.

Inspection Component	Condition A* or U*	Comments	Corrective Action(s) Proposed	Reference Source
4. (A) Final Cover				
4A. Walk cover and side slopes in 25-ft (+/- 5-ft) transects and visually inspect for the following items:**				PCC&IP
4A1. Inspect erosion rills/channels. Flag any observable rills/channels greater than 3 inches wide and 6 inches deep or excessive erosion.	U	Multiple erosion rills/channels identified on cap	Repair erosion rills/channels by hand and reseed. Map and monitor less severe rills	"
4A2. Any observable depressions, settlement/subsidence, slumping or desiccation cracks. Flag any observable depressions, slumps, settlement/subsidence or dessication cracks.	U	Three areas of slight settlement identified – Evaluated by Engineering – determined to meet specifications	None Required	"
4A3. Any ponding or standing water. Flag any standing water.	A	N/A	N/A	"
4A4. Evidence of burrowing animals or other bio-intrusion. Flag any observable evidence of bio-intrusion.	U	Multiple animal burrows present and flagged on cap	Identify types of animals present and determine if corrective action is needed	"
