# OSDF Cell 1 Post Closure Inspection Checklist

Date of Inspection: February 17, 2005

# On-Site Disposal Facility Inspection Report February 2005

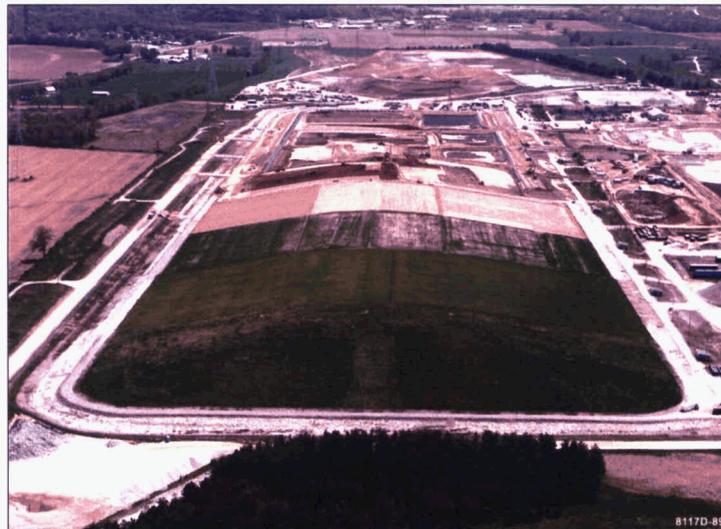
Graphic 8370.1

**OSDF 5/05  
(looking south)**

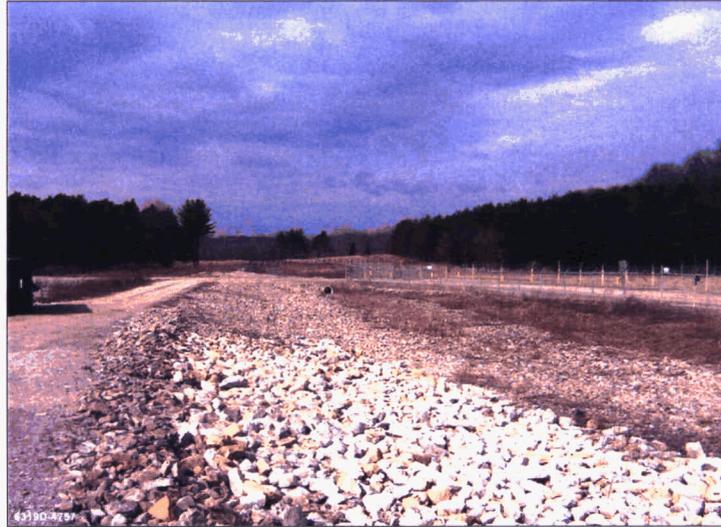
Graphic 8370.2

**Cell 1 North Drainage**  
(looking west)

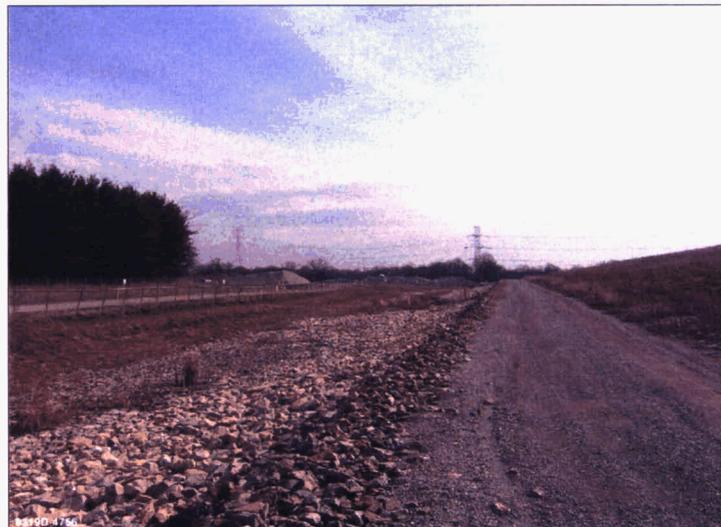
Graphic 8370.3

**Cell 1 North Drainage**  
(looking east)

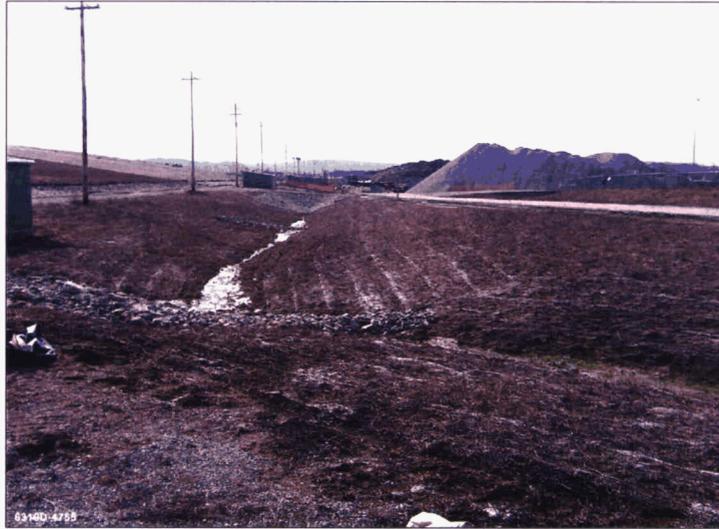
Graphic 8370.4

**Cell 2 West Drainage**  
(looking south)

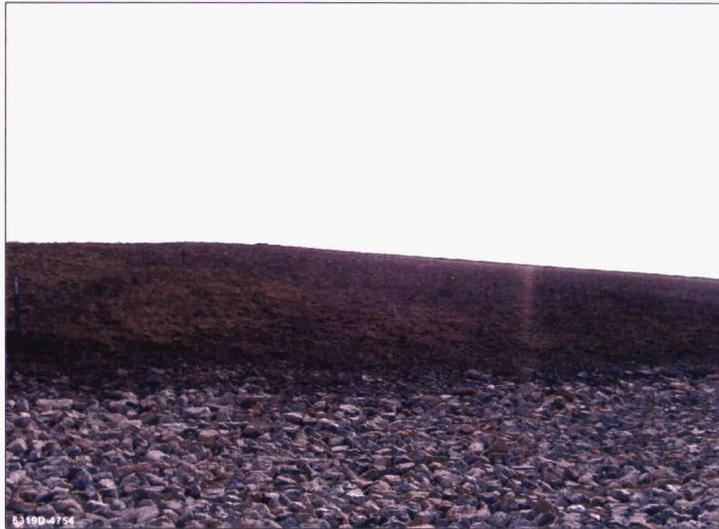
Graphic 8370.5

**Cell 1 West Face**

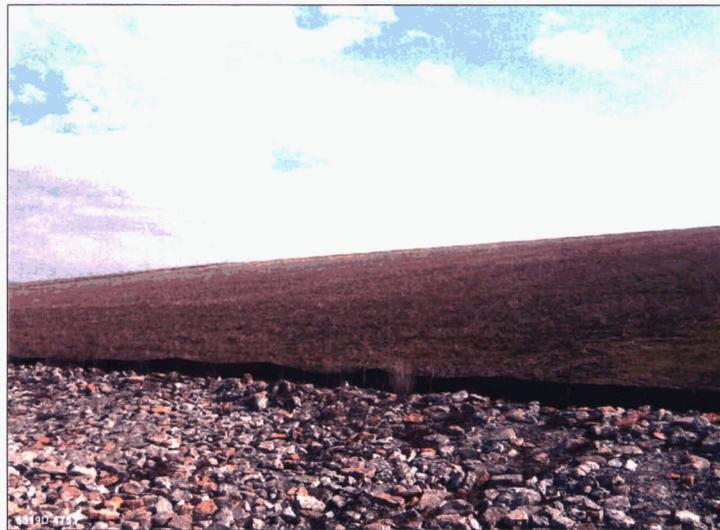
Graphic 8370.6

**Cell 2 West Face**

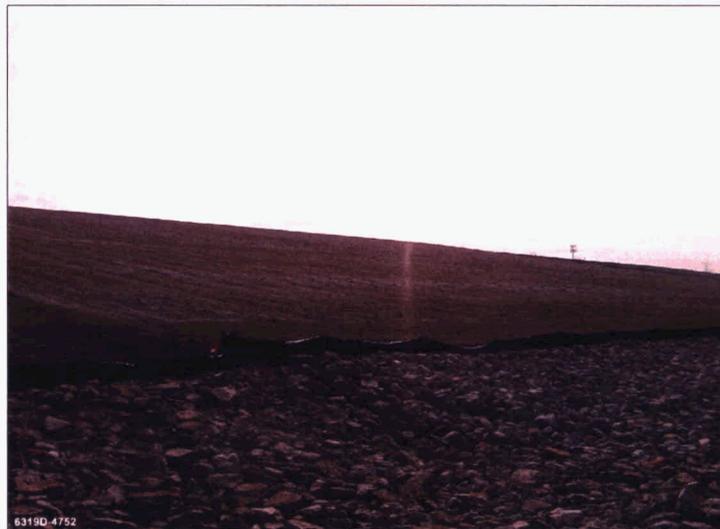
Graphic 8370.7

**Cell 3 West Face**

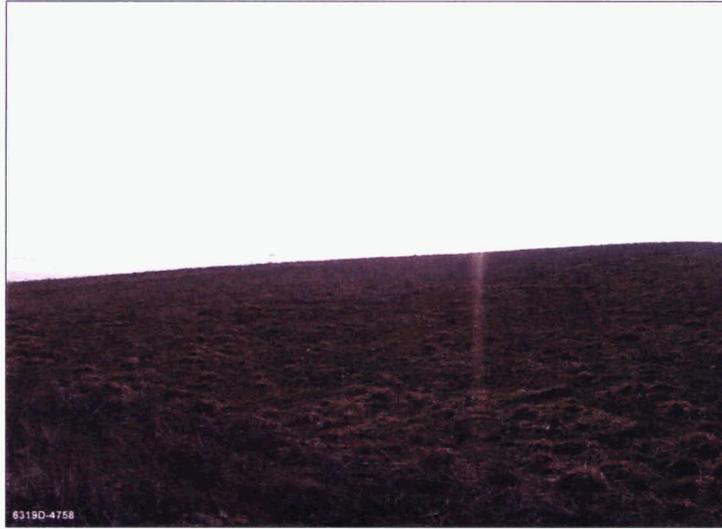
Graphic 8370.8

**Cell 1 North Face**

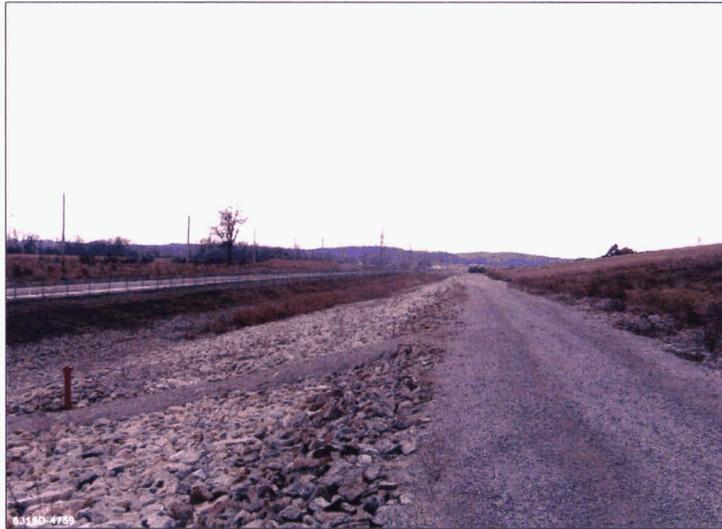
Graphic 8370.9

**Cell 1 East Drainage  
(looking south)**

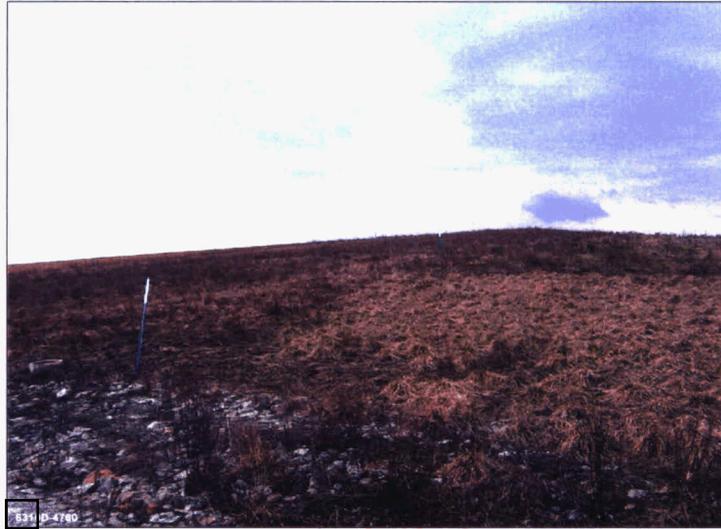
Graphic 8370.10

**Cell 1 East Face**

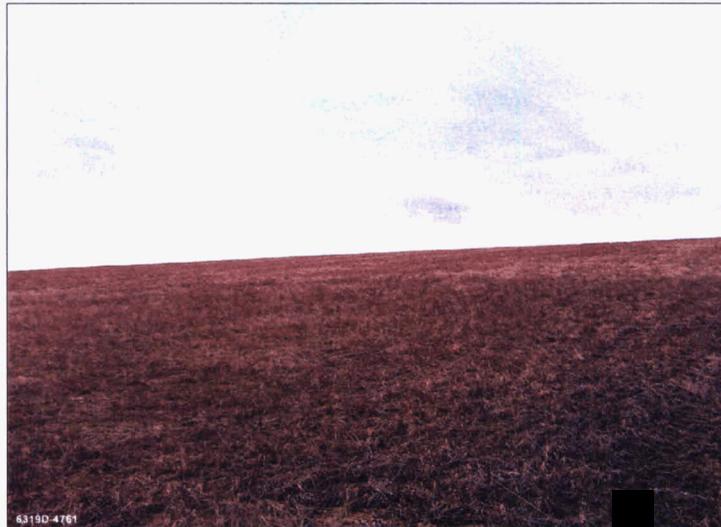
Graphic 8370.11

**Cell 2 East Face**

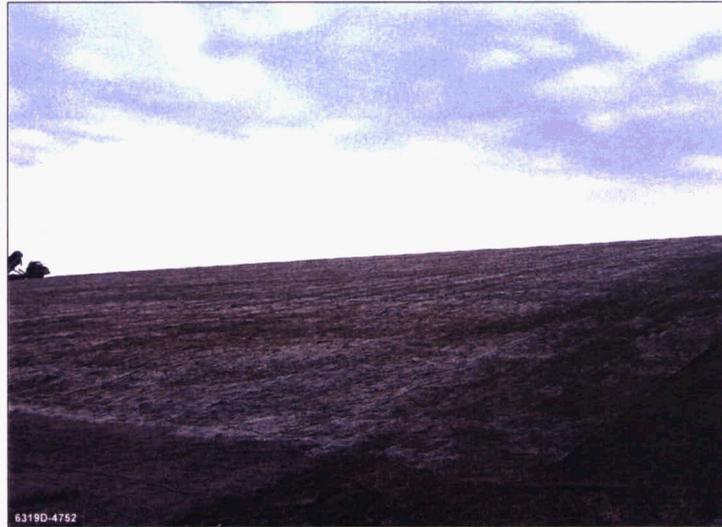
Graphic 8370.12

**Cell 3 East Face**

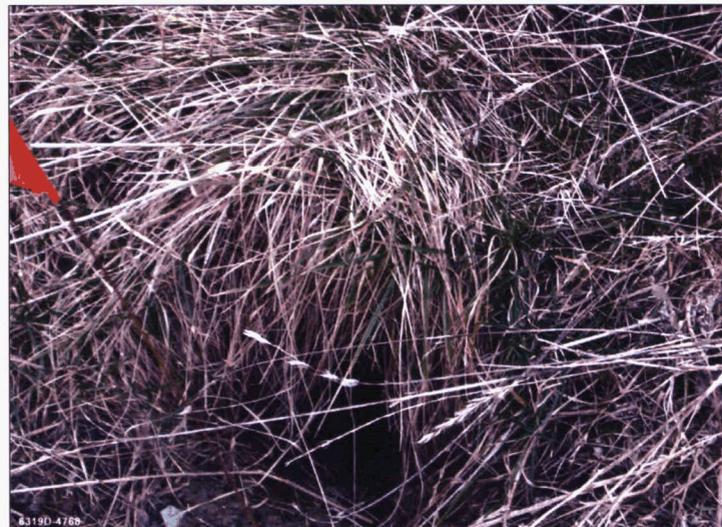
Graphic 8370.13

Inspection Component	Condition A* or U*	Comments	Corrective Action(s) Proposed	Reference Source
<b>4. (A) Final Cover</b>				
4A. Walk cover and side slopes in 25-ft (+/- 5-ft) transects and visually inspect for the following items:**				PCC&IP
4A1. Inspect erosion rills/channels. Flag any observable rills/channels greater than 3 inches wide and 6 inches deep or excessive erosion.	U	Some small erosion rills present	Rills did not measure 3" by 6" and do not require repair	"
4A2. Any observable depressions, settlement/subsidence, slumping or desiccation cracks. Flag any observable depressions, slumps, settlement/subsidence or desiccation cracks.	U	There is one area on the east side where a rill has opened up into a shallow depression.	Depression will be filled with topsoil and seeded.	"
4A3. Any ponding or standing water. Flag any standing water.	A	N/A	N/A	"
4A4. Evidence of burrowing animals or other bio-intrusion. Flag any observable evidence of bio-intrusion.	U	There are locations where animals were digging. Most of the burrows do not go more than a few inches at most locations. One burrow is deeper than a few inches and has two openings.	None of the burrows are currently active after a few weeks. Removed soil was pushed back into holes. One burrow was filled with new topsoil and seeded.	"

**Animal Burrow**
