### **CONTRACT DE-AC24-01OH20115, TRANSMITTAL OF THE SEPTEMBER 26, 2006 INSPECTION CHECKLIST FOR ON-SITE DISPOSAL FACILITY CELL 1, 2, 3, 4, 5 AND 6 CAPS**

# OSDF Cell Cap Post Closure Inspection Checklist

# On-Site Disposal Facility Inspection Report

## September 2006

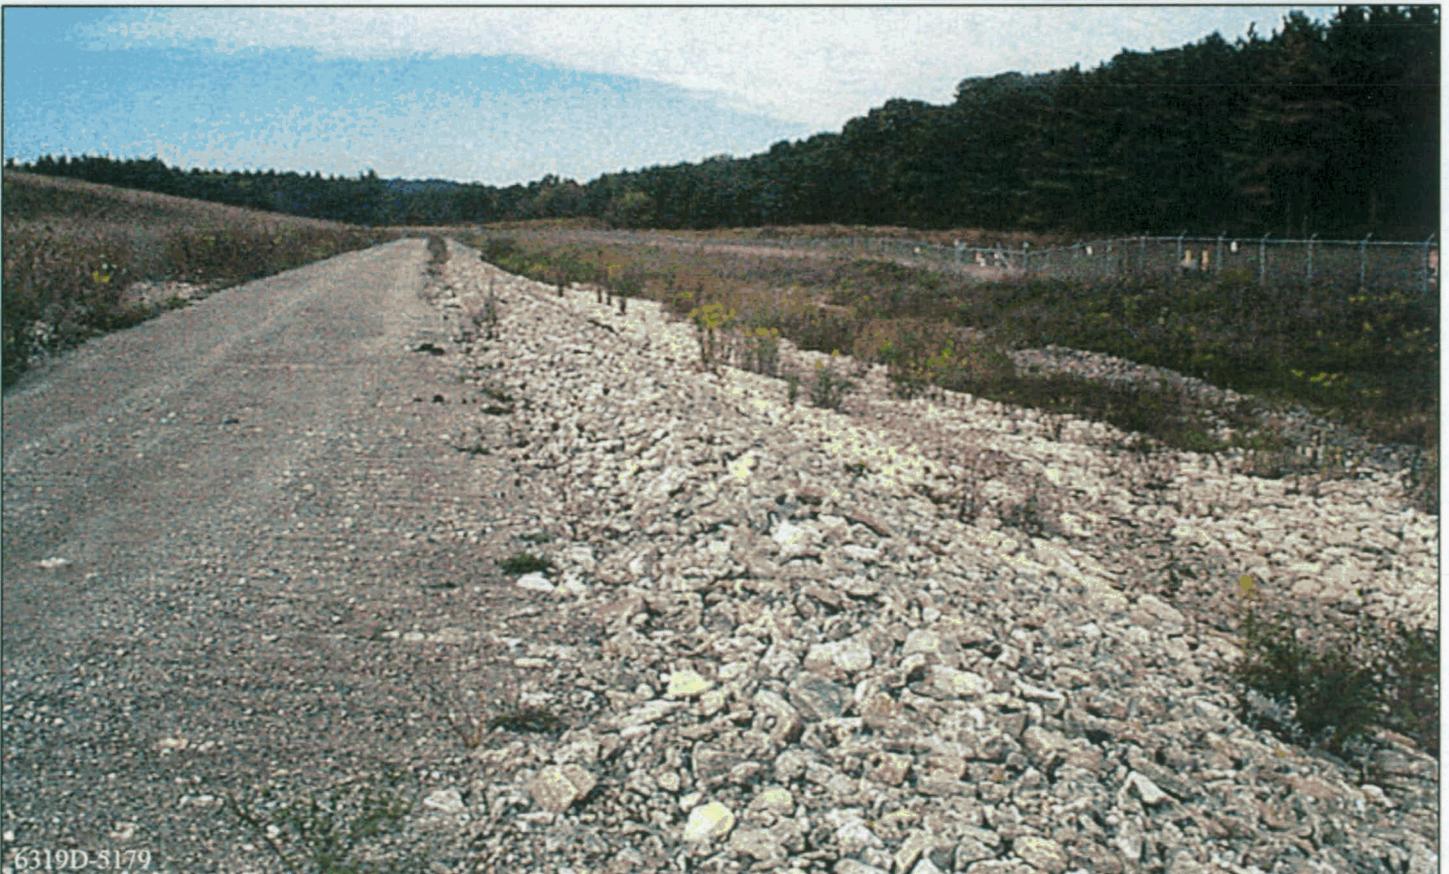
**North Drainage (looking west)**

3B. Visually check the integrity of riprap in drainage channels for signs of deterioration or removal of rock.	A	A	A	A	A	A	A	N		
3C. Visually check for the presence of woody vegetation growing in drainage channels and in Rip-Rap	U	U	U	U	U	U	U	N	Woody vegetation is present in the north and east drainages and needs to be removed by hand (currently) and/or treated with selective herbicide (in Spring 2007).	October 2006
3D. Visually check the integrity of run-on and run-off control features including: Ditch checks, Gravity Inlet structures, and Culverts.	A	A	A	A	A	A	A	N
