TRANSMITTAL OF THE FEBRUARY 15, 2006 INSPECTION CHECKLIST FOR ON-SITE DISPOSAL FACILITY CELL 1, 2, 3, 4, 5 AND 6 CAPS

OSDF Cell Cap Post Closure Inspection Checklist

On-Site Disposal Facility Inspection Report

February 2006

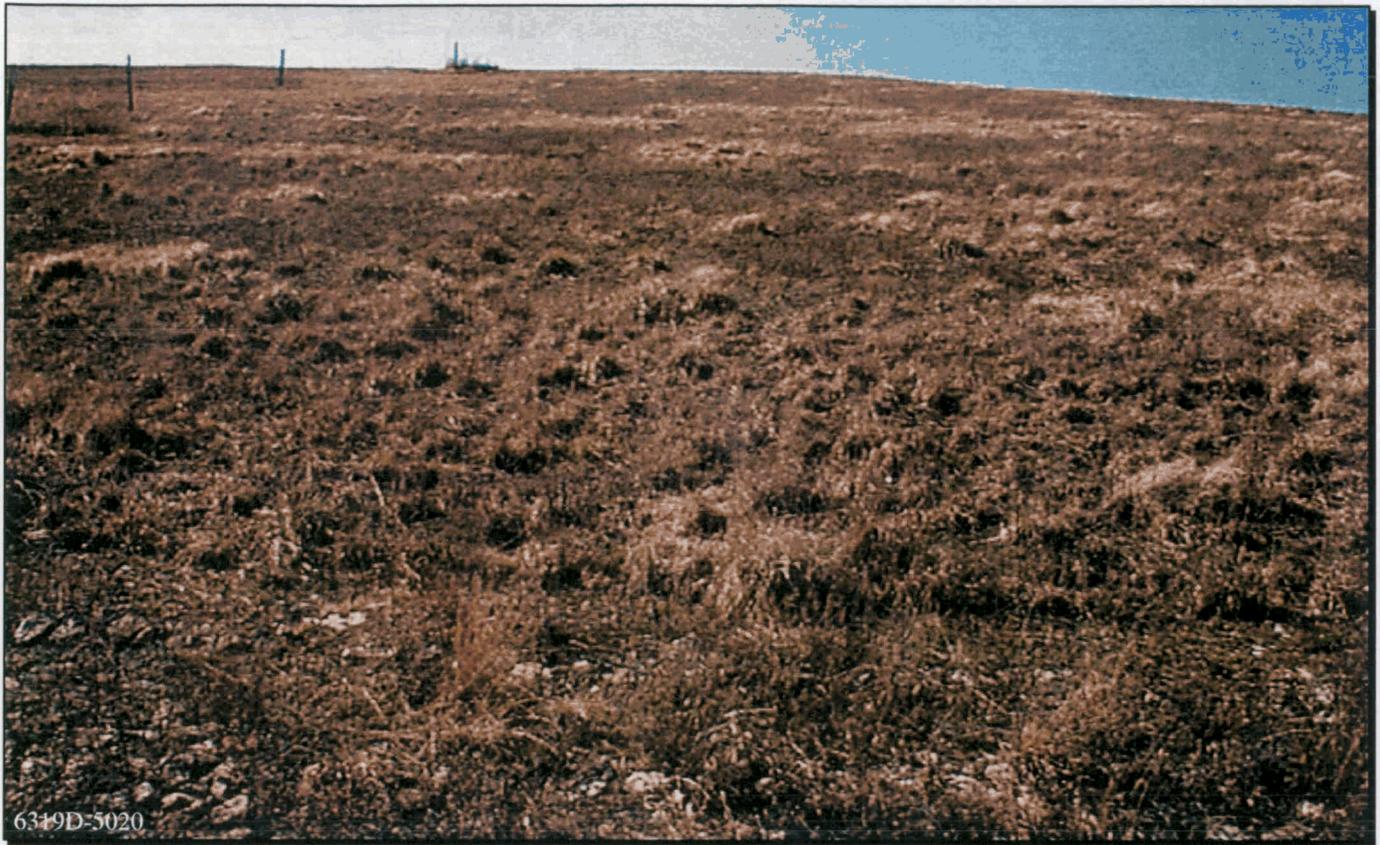
6319D-5020

East Face Cell 1

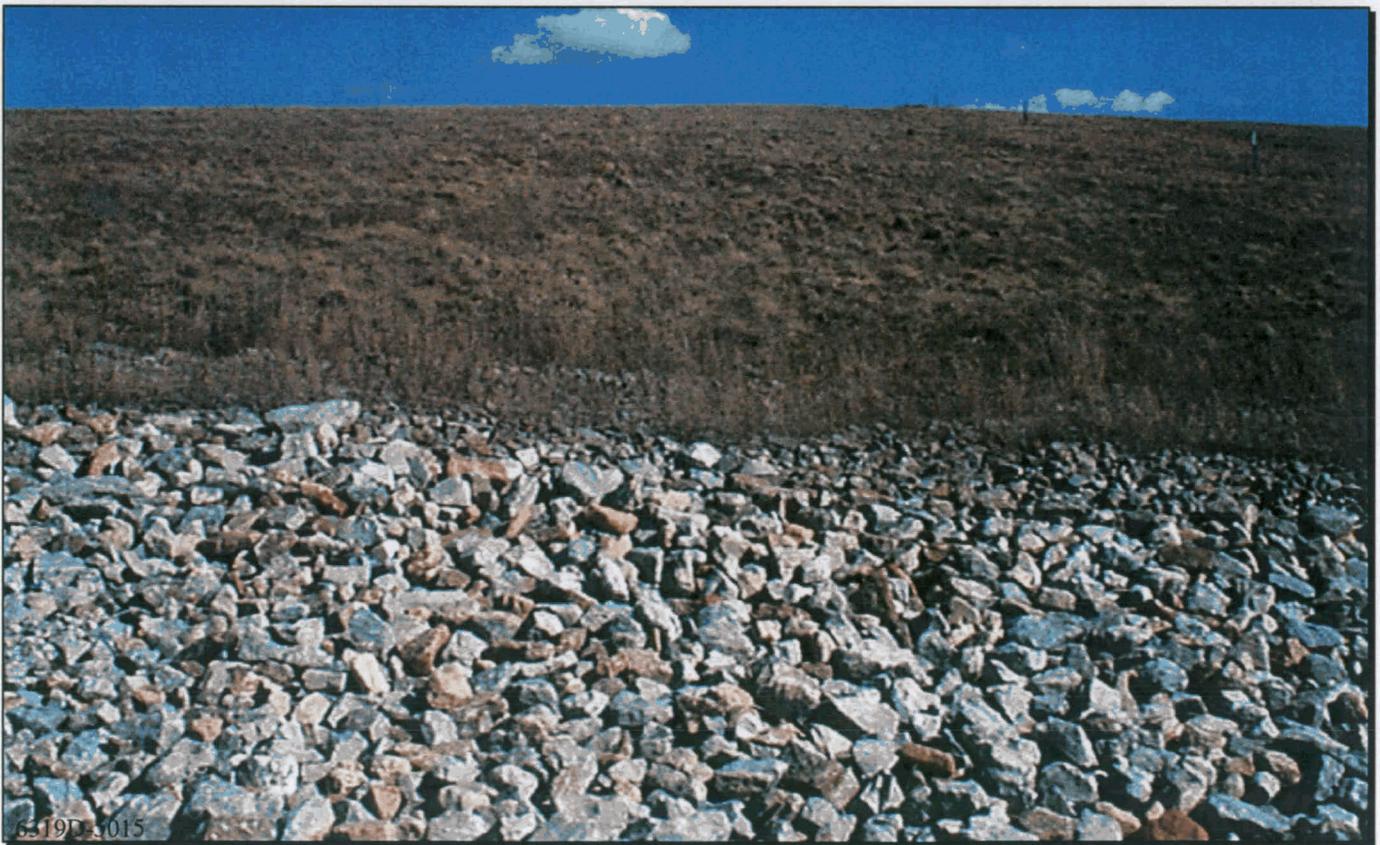
6319D-5015

West Face Cell 1

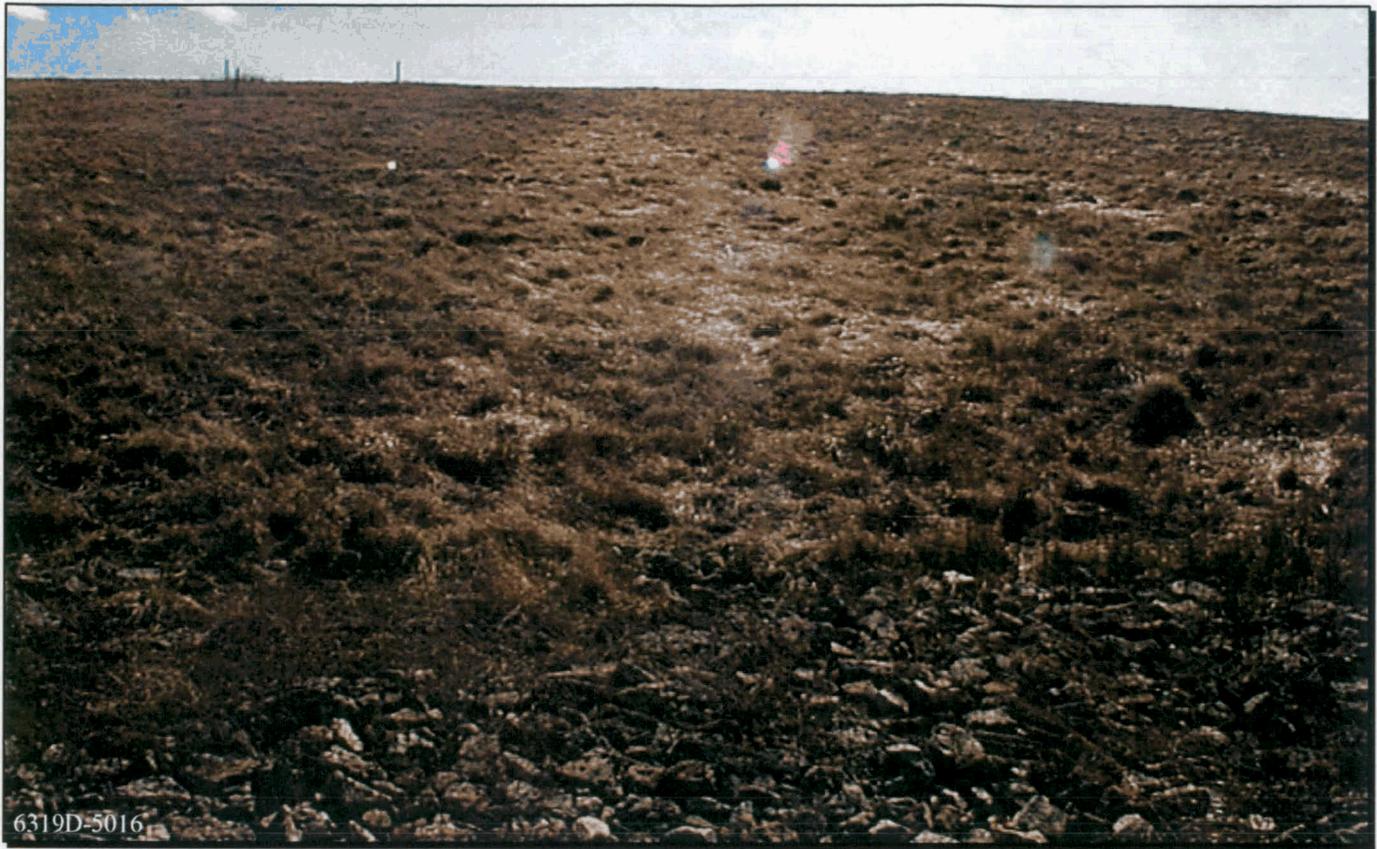
6319D-5016

North Face Cell 1

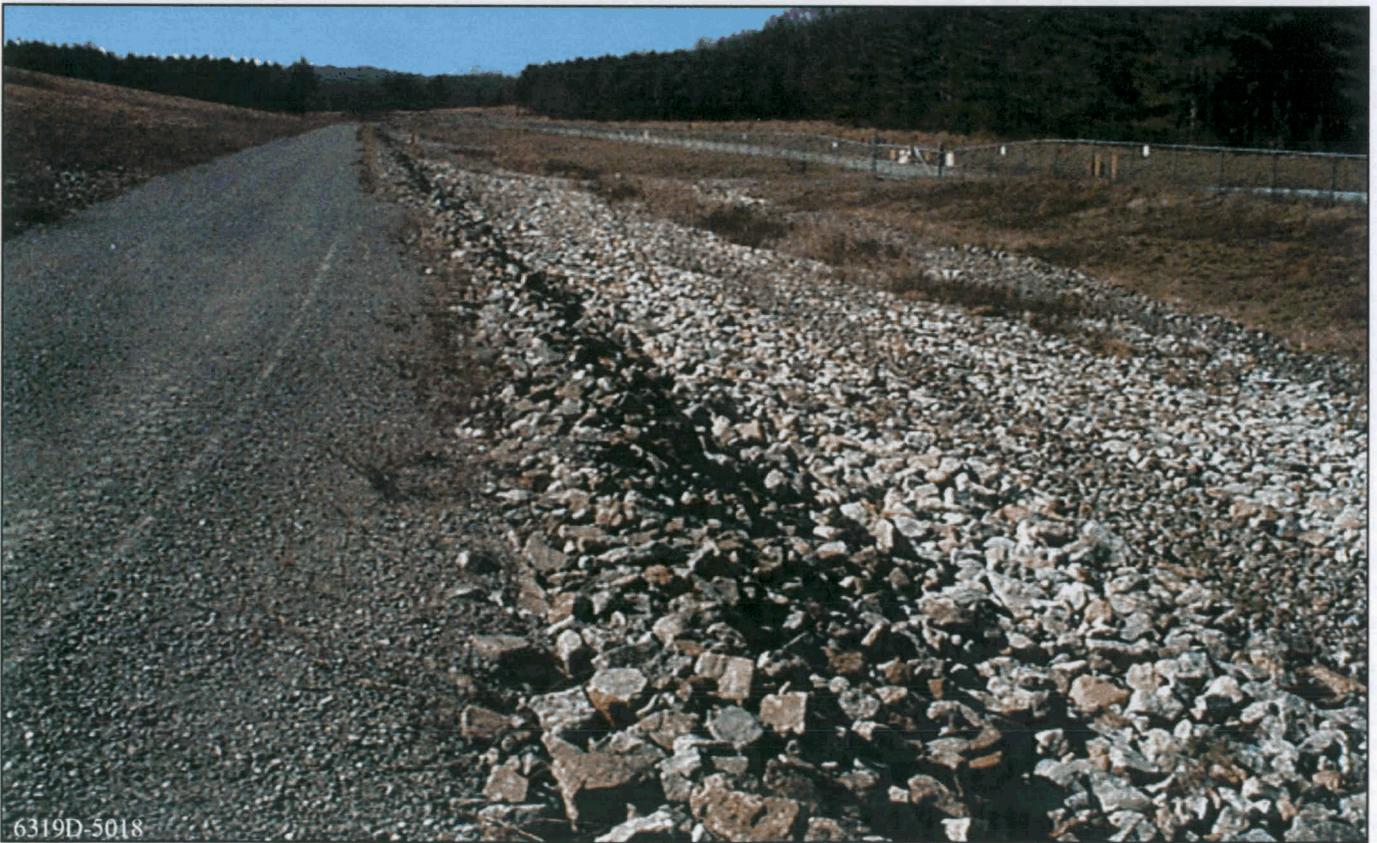
6319D-5018

North Drainage (looking west)

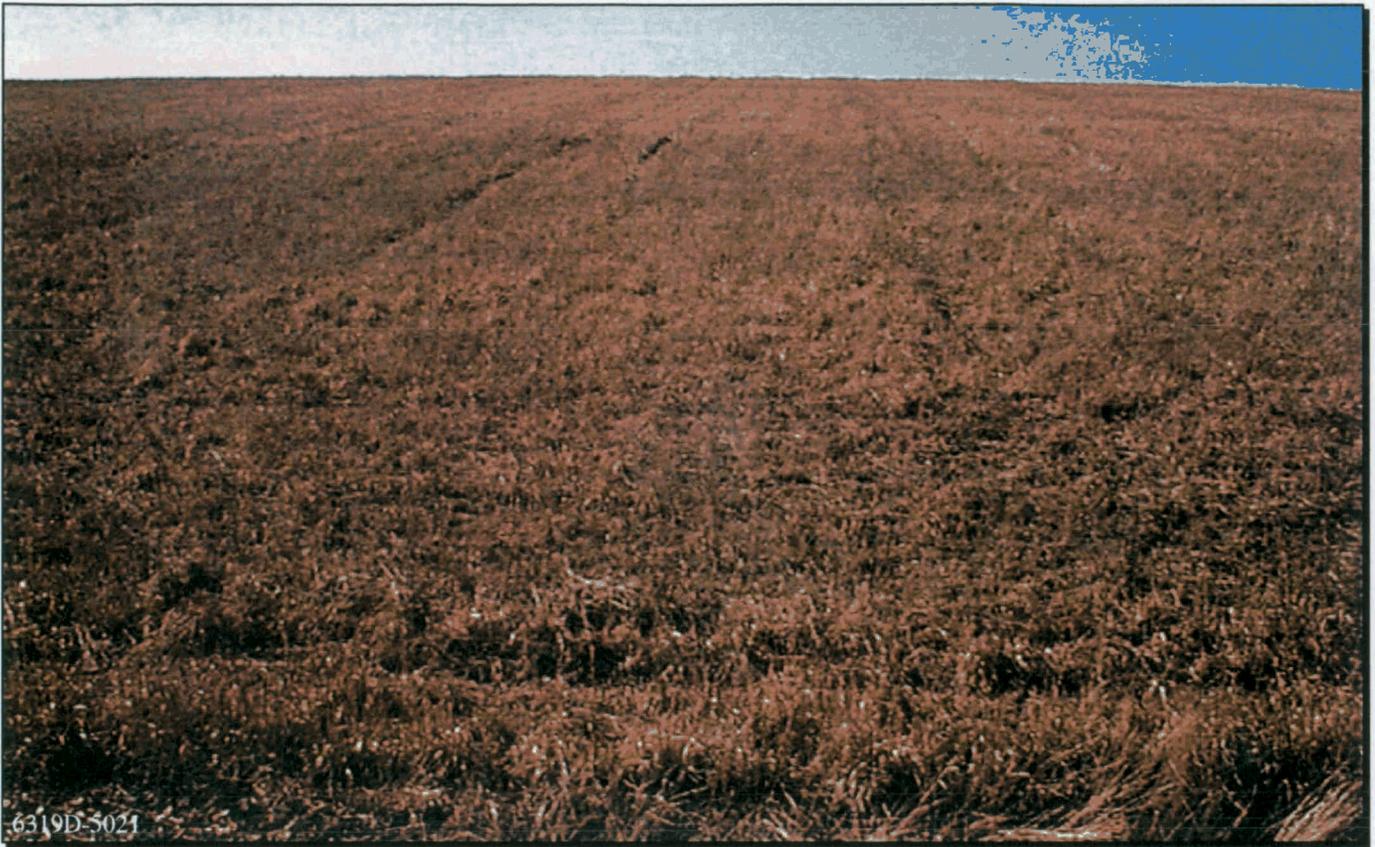
6319D-5021

East Face Cell 2

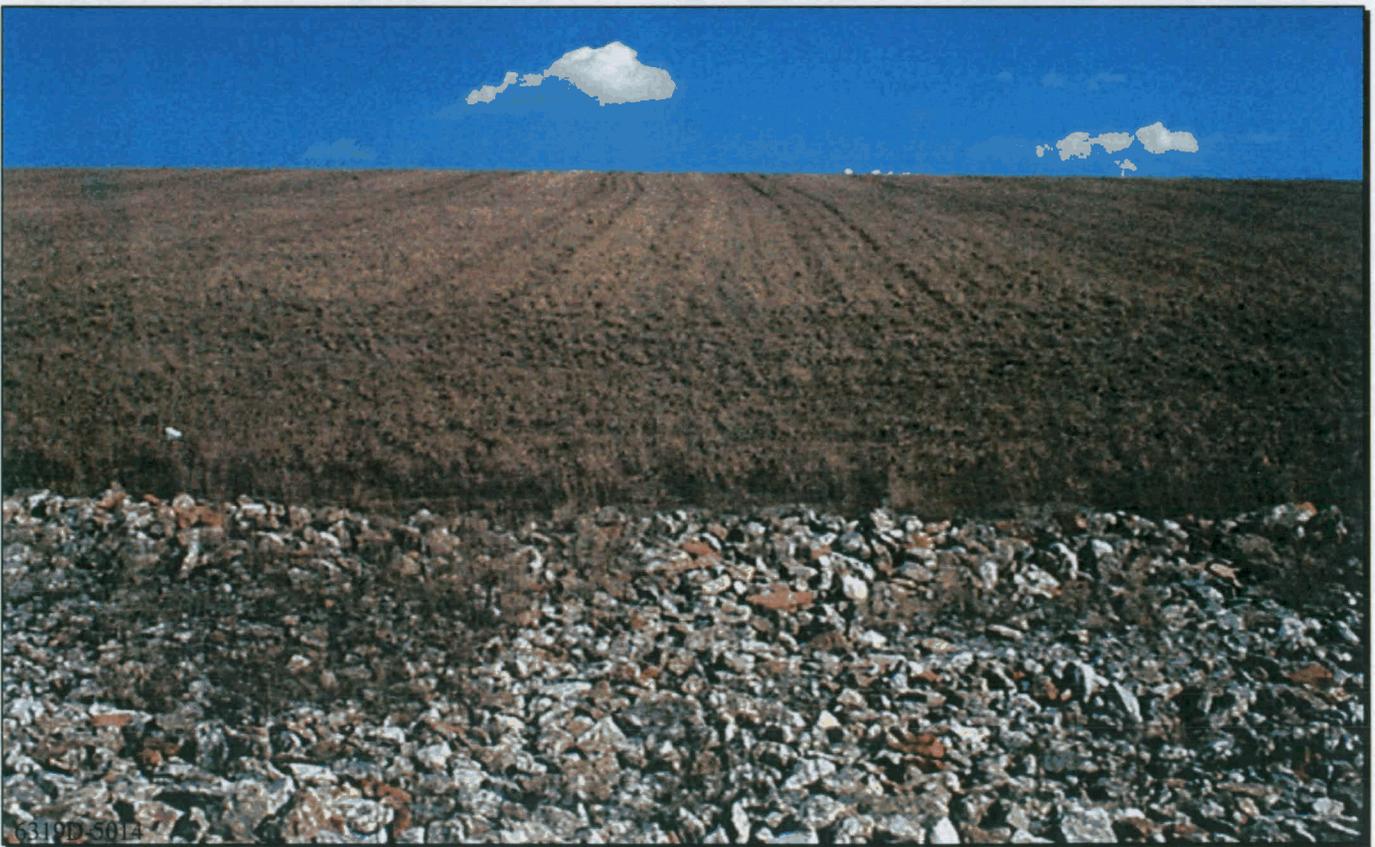
6319D-5014

West Face Cell 2

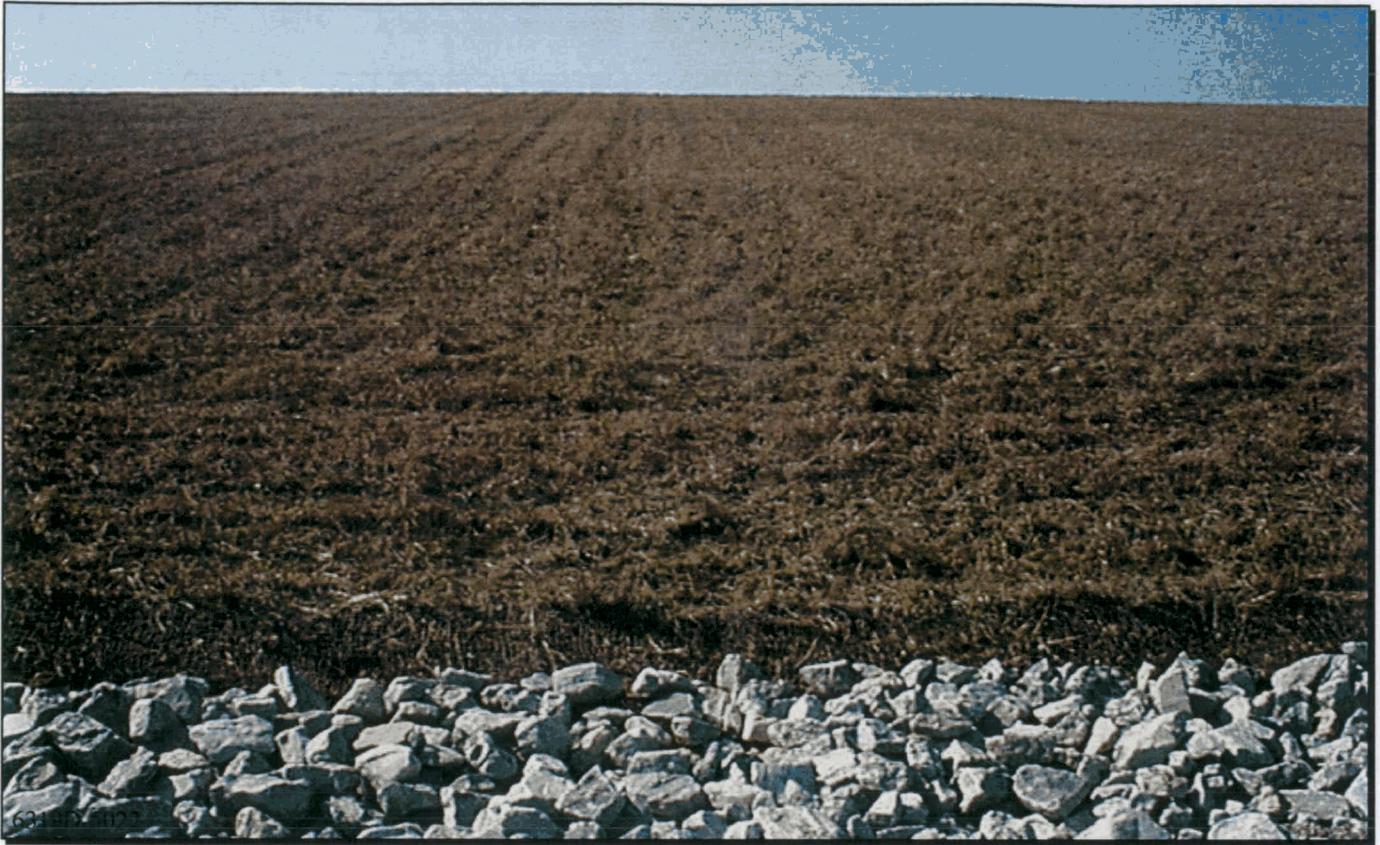
East Face Cell 3

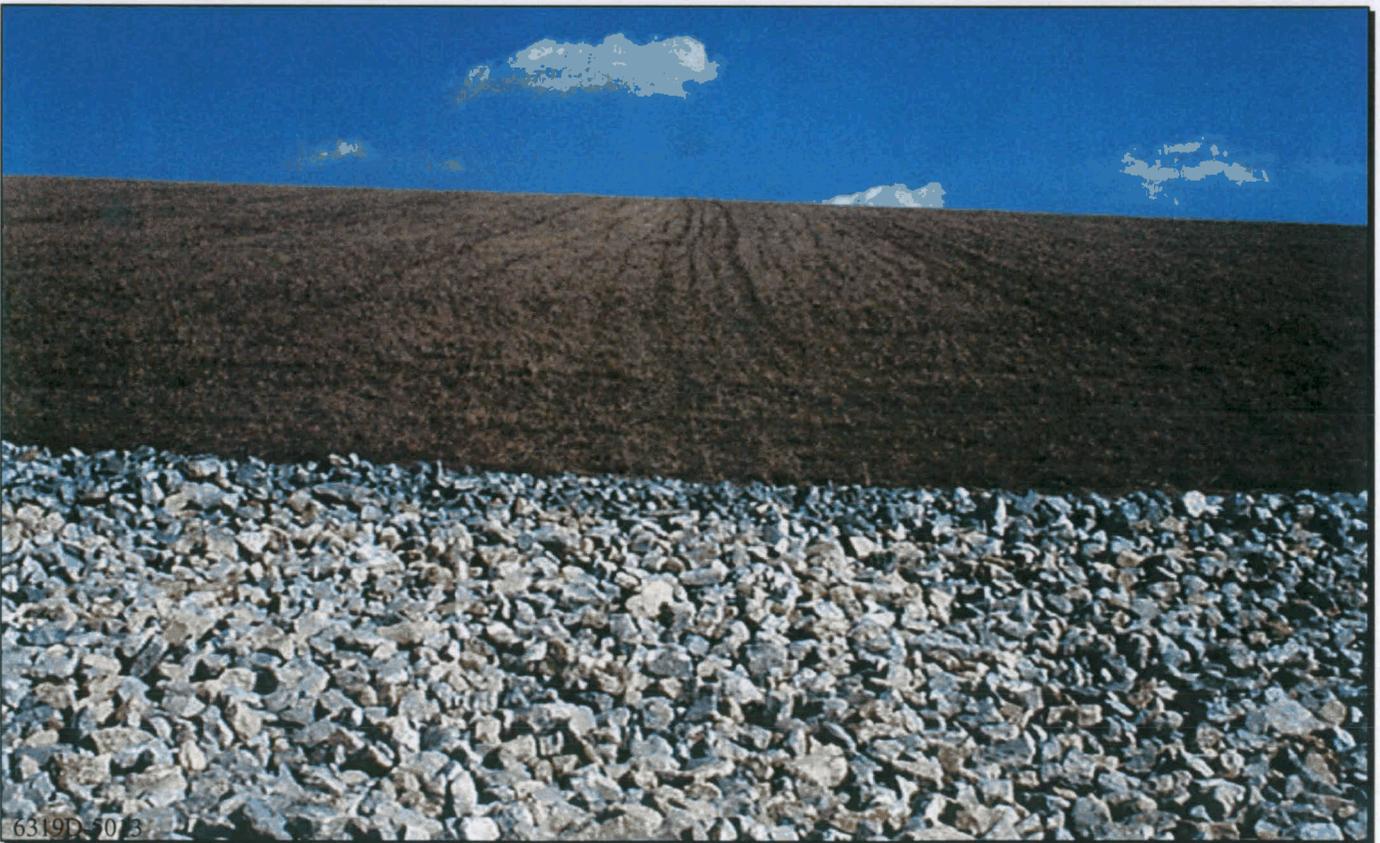
West Face Cell 3

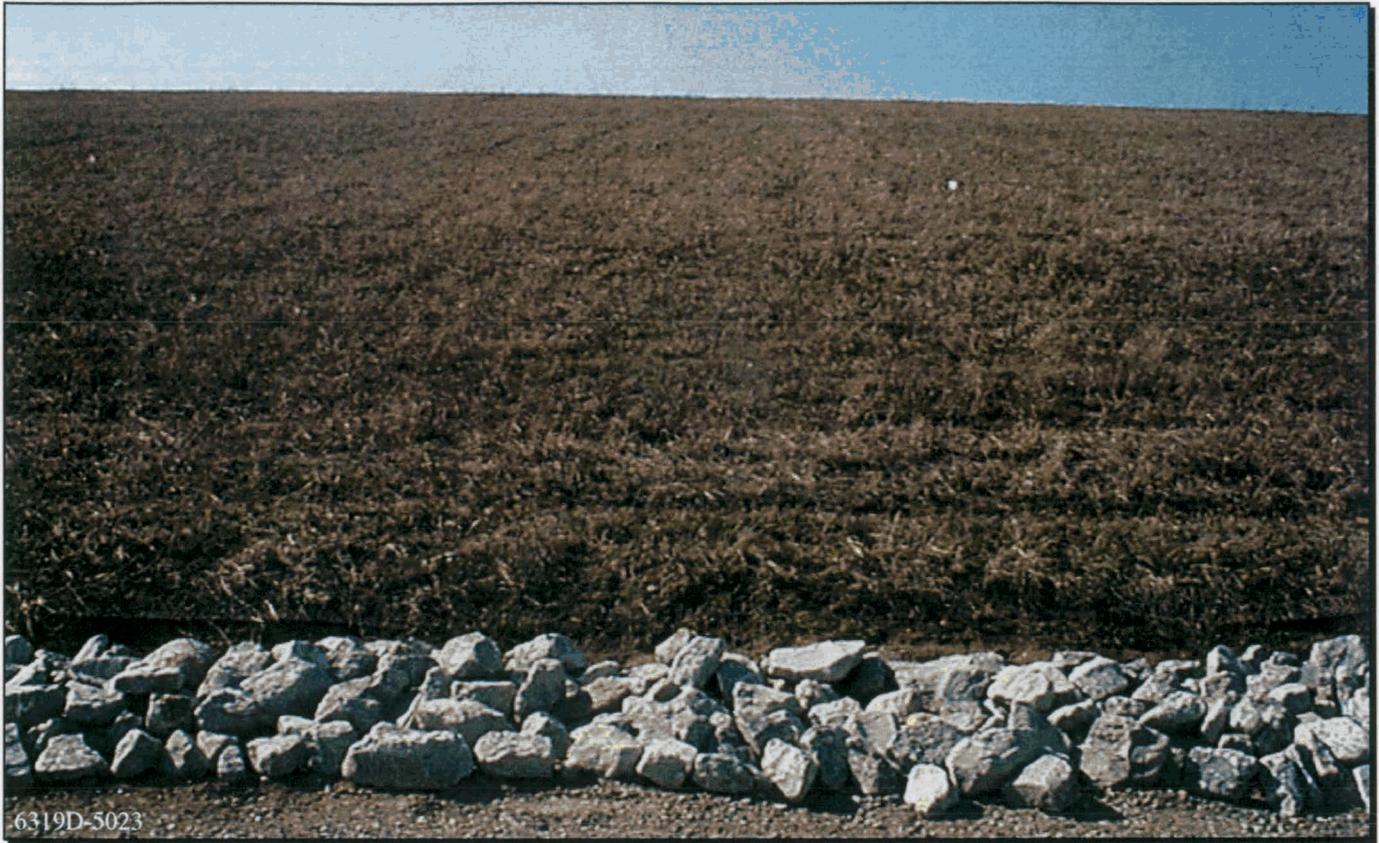
East Face Cell 4

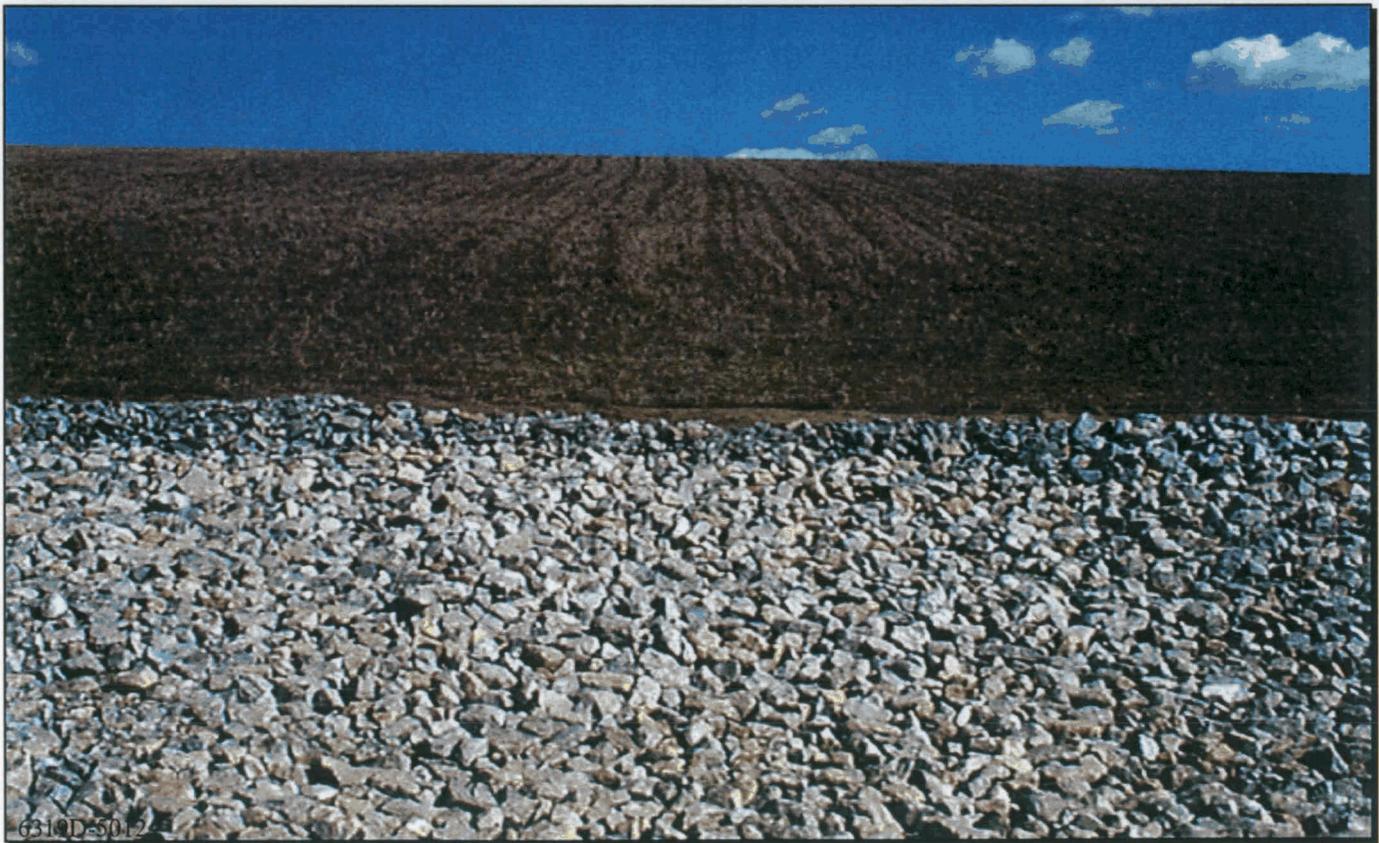
West Face Cell 4

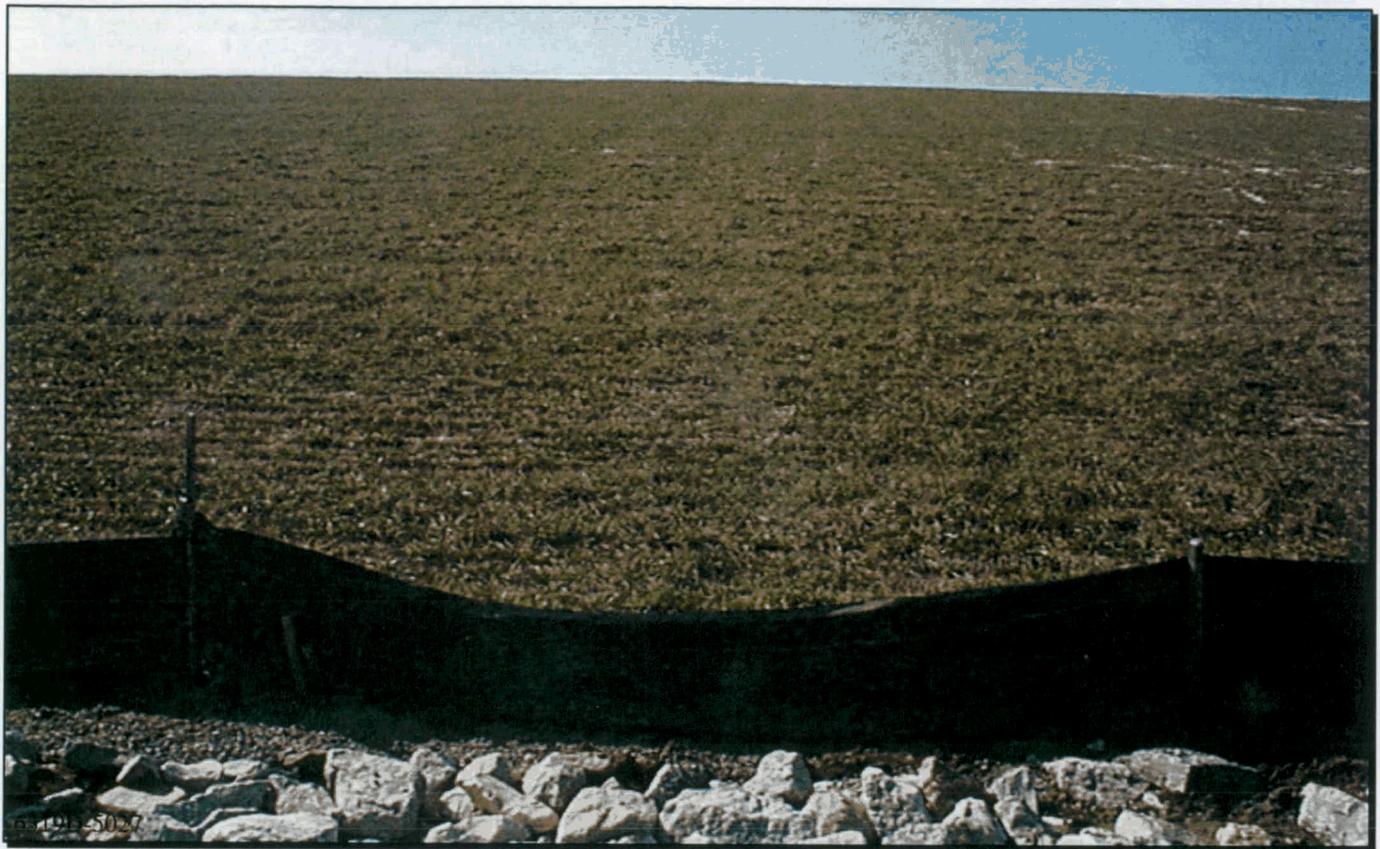
East Face Cell 5

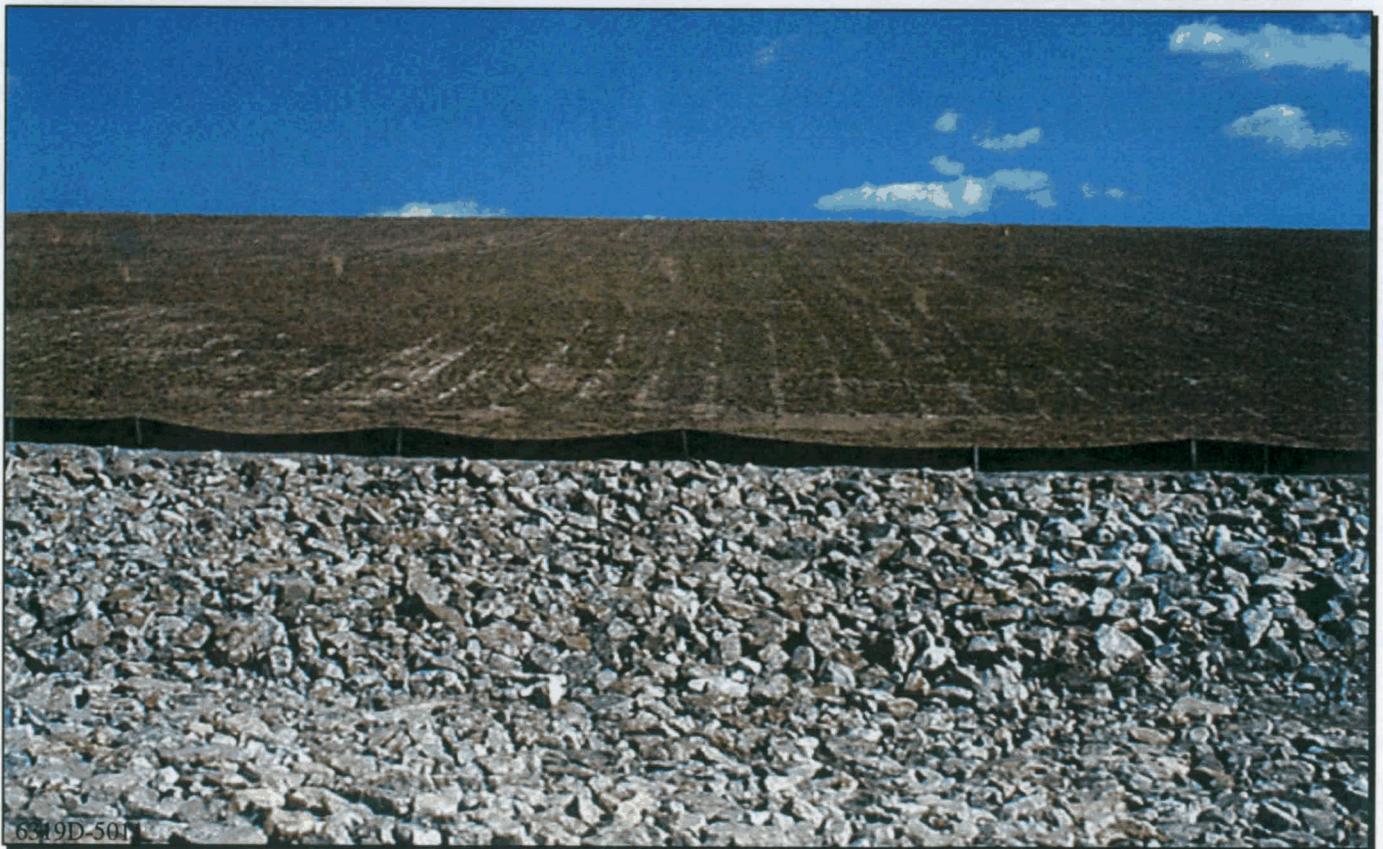
West Face Cell 5

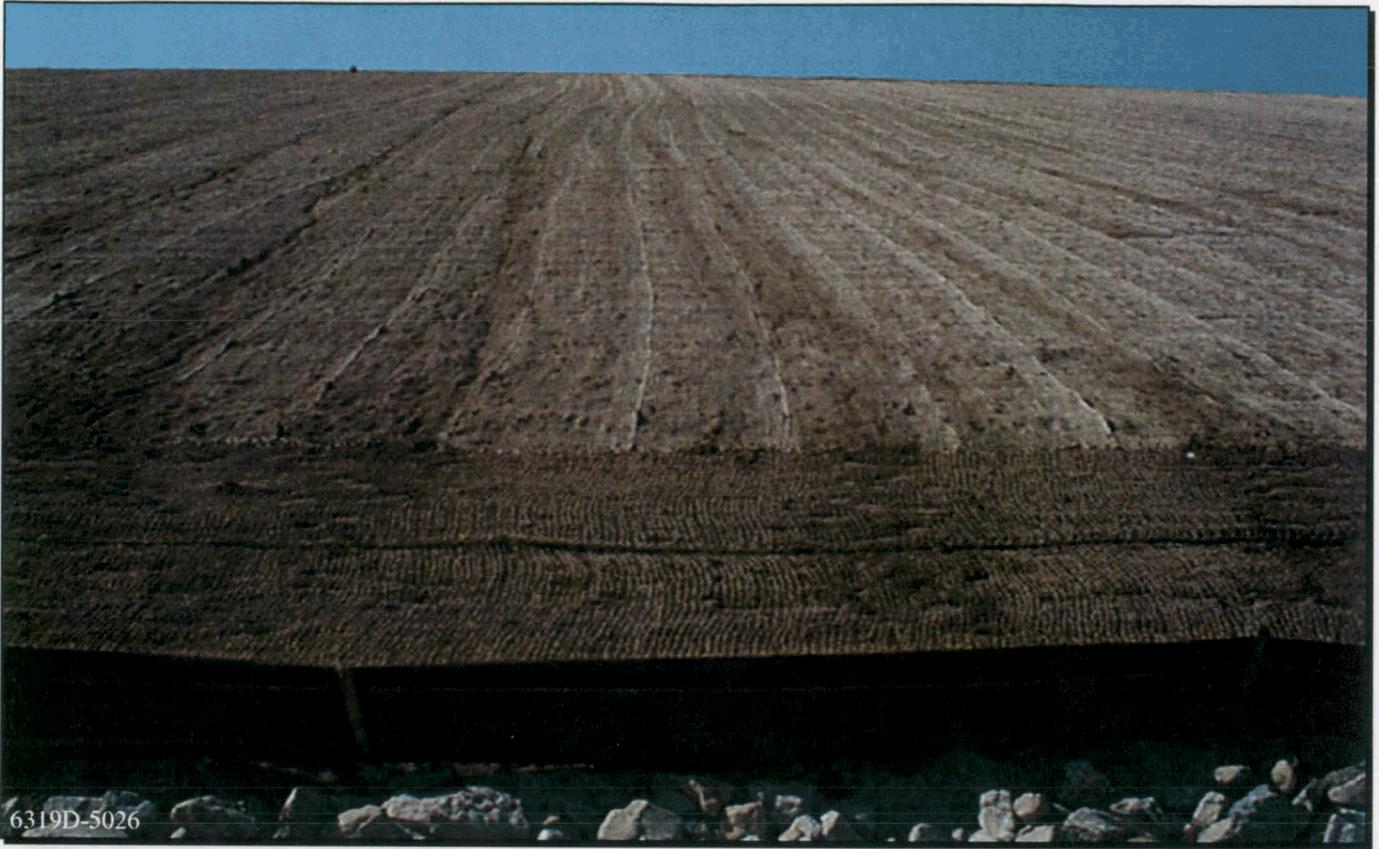
East Face Cell 6

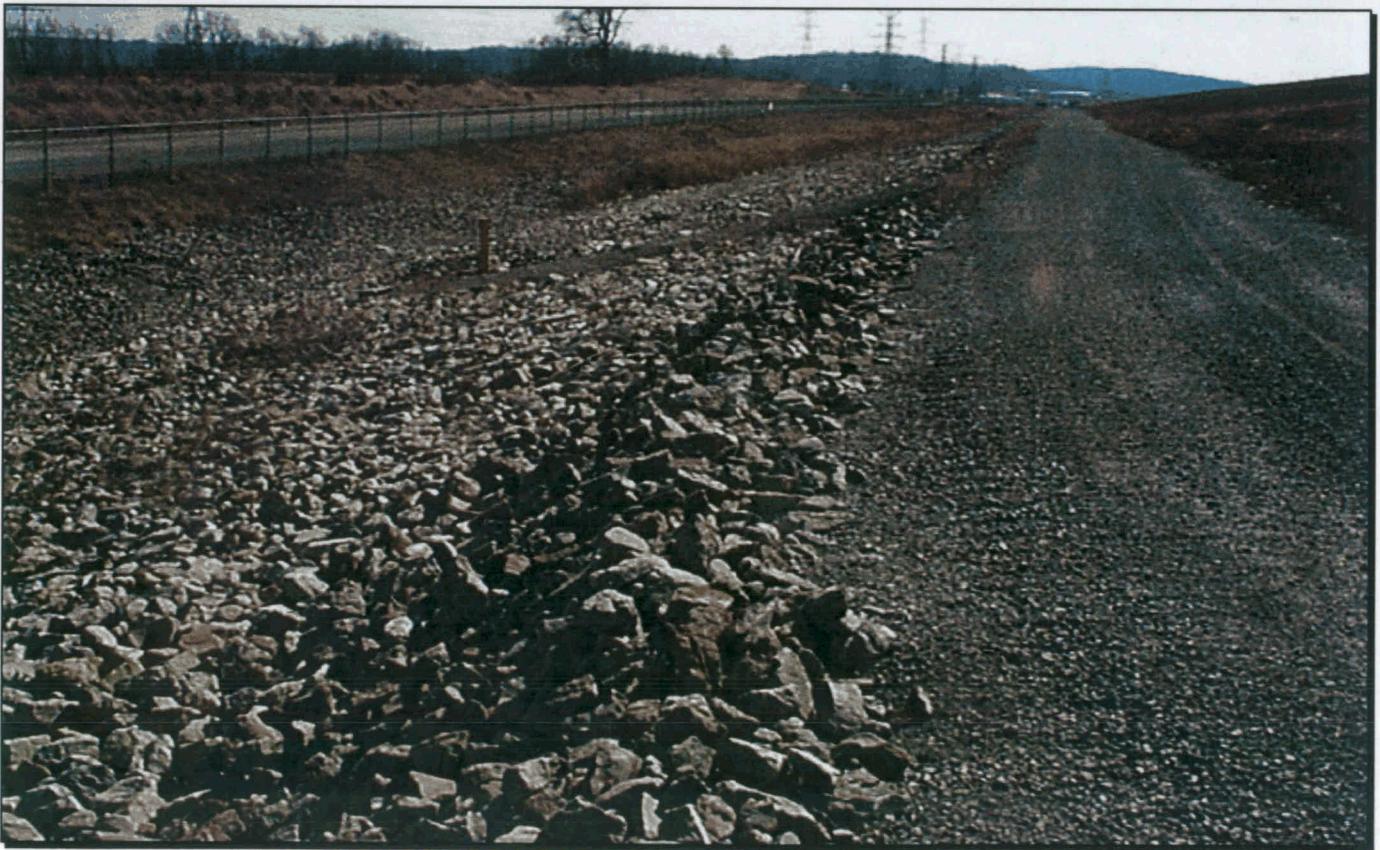
East Drainage (looking south)
