**Department of Energy
Office of Legacy Management**

SUBJECT: Transmittal of the June 20, 2007 Inspection Checklist for On-Site Disposal Facility

OSDF Cell Cap Post Closure Inspection Checklist

On-Site Disposal Facility Inspection Report

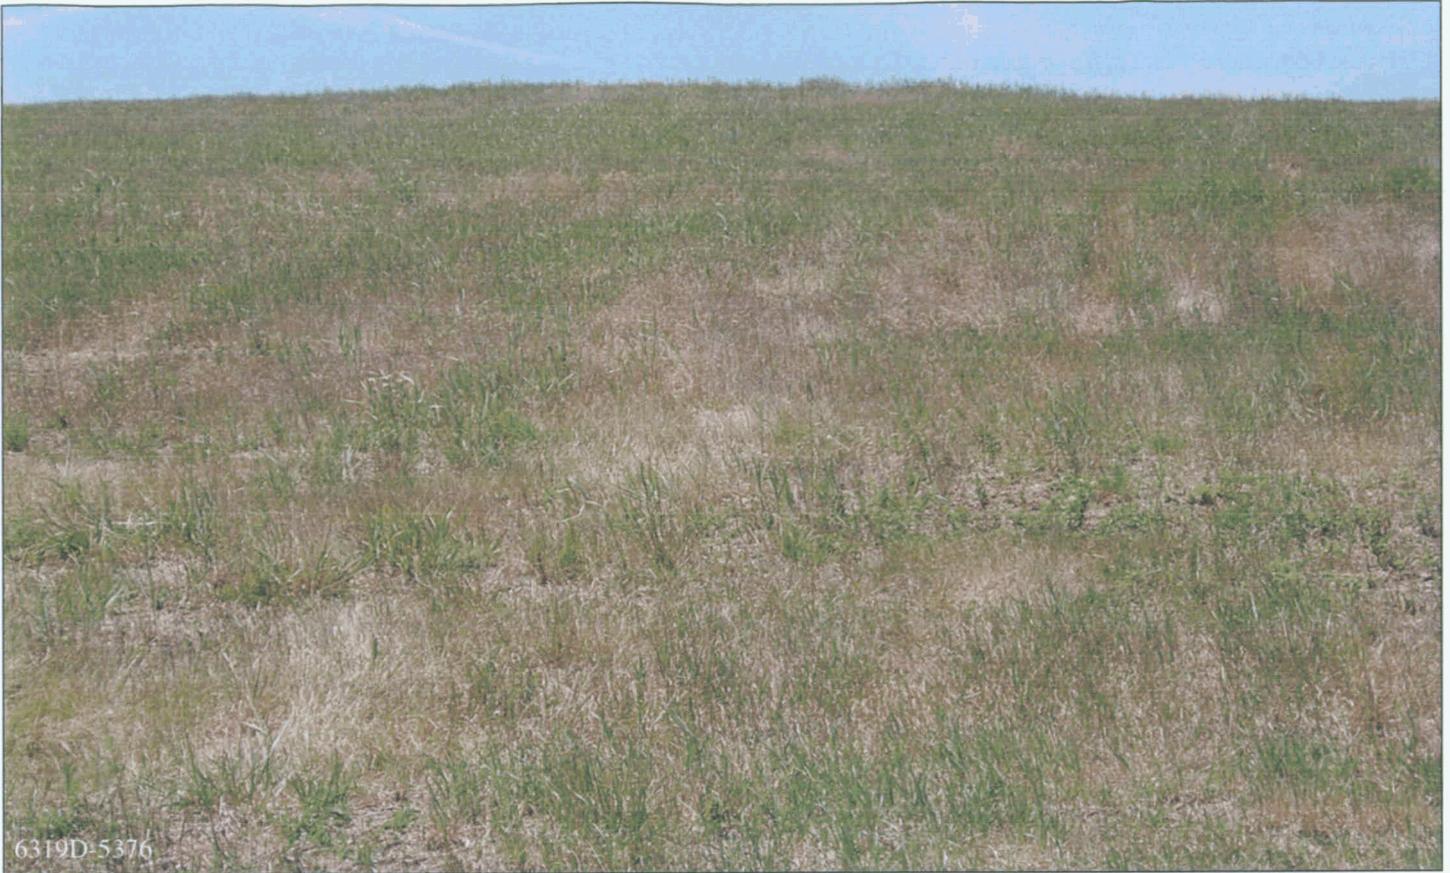
6319D-5376

East Face Cell 1

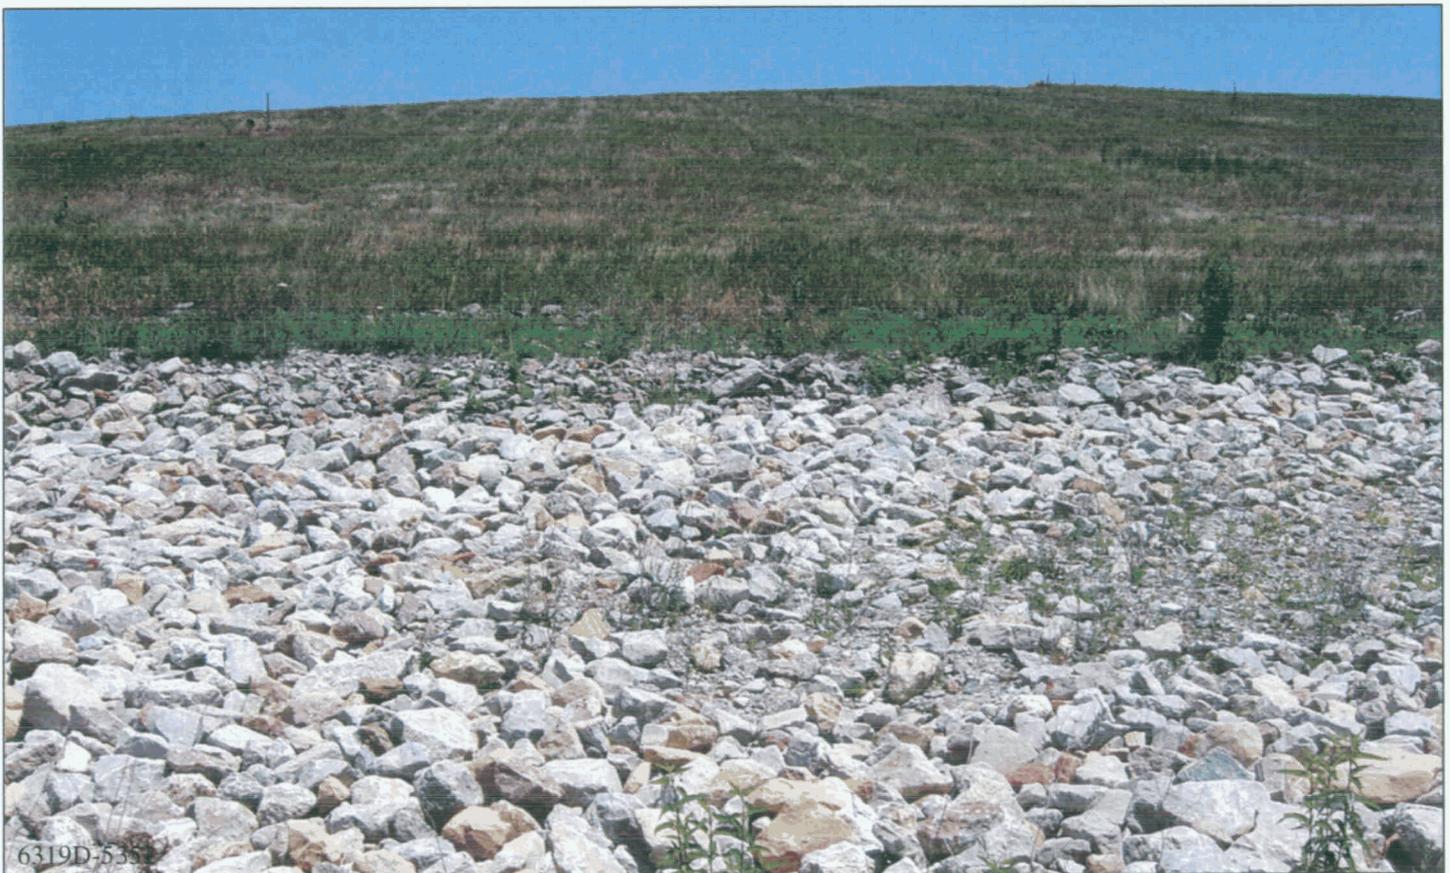
6319D-5375

West Face Cell 1

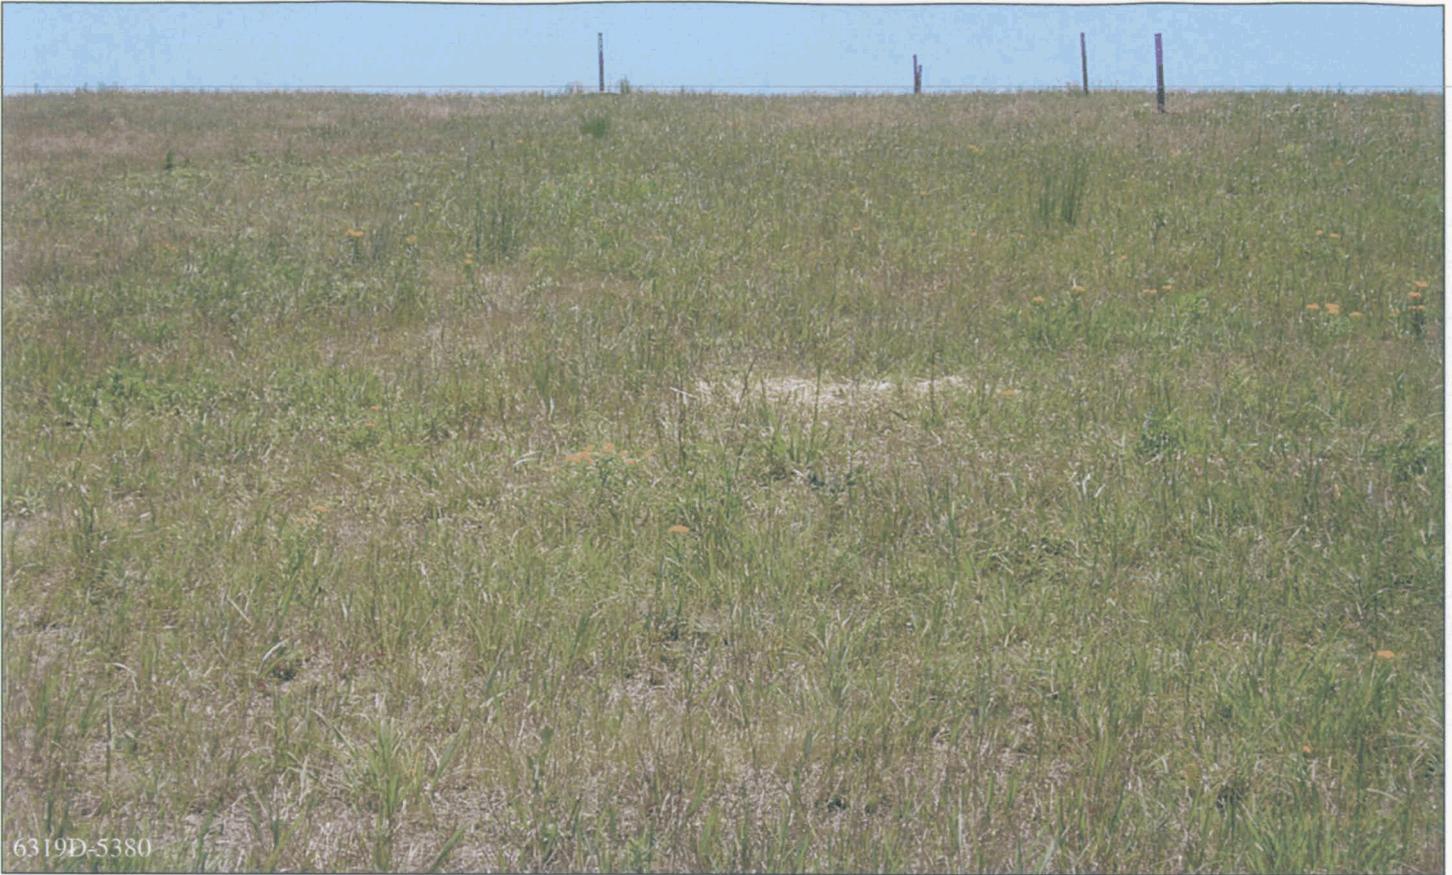
6319D-5380

North Face Cell 1

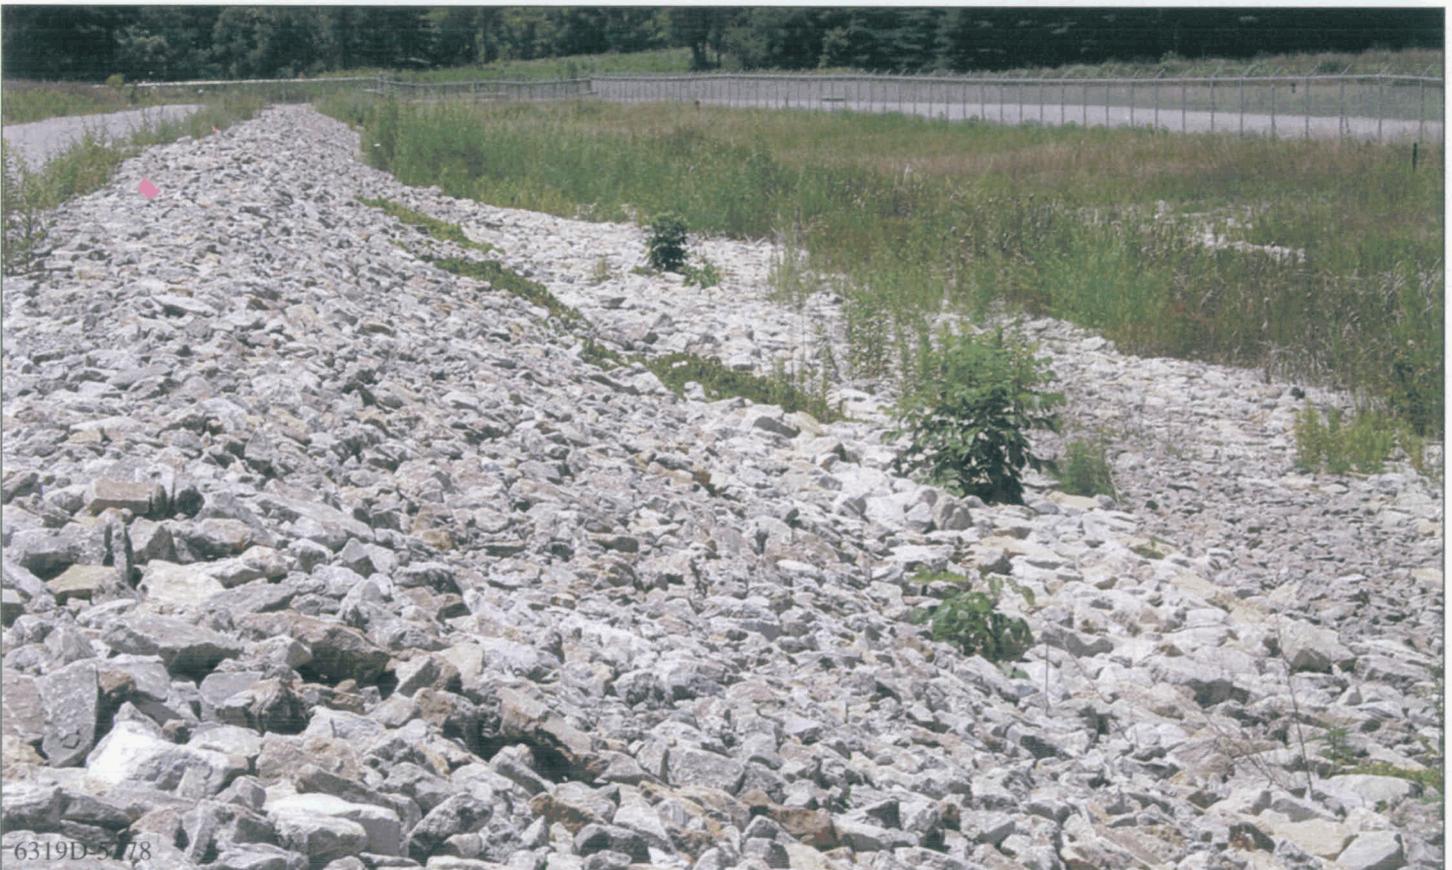
6319D-5178

North Drainage (looking west)

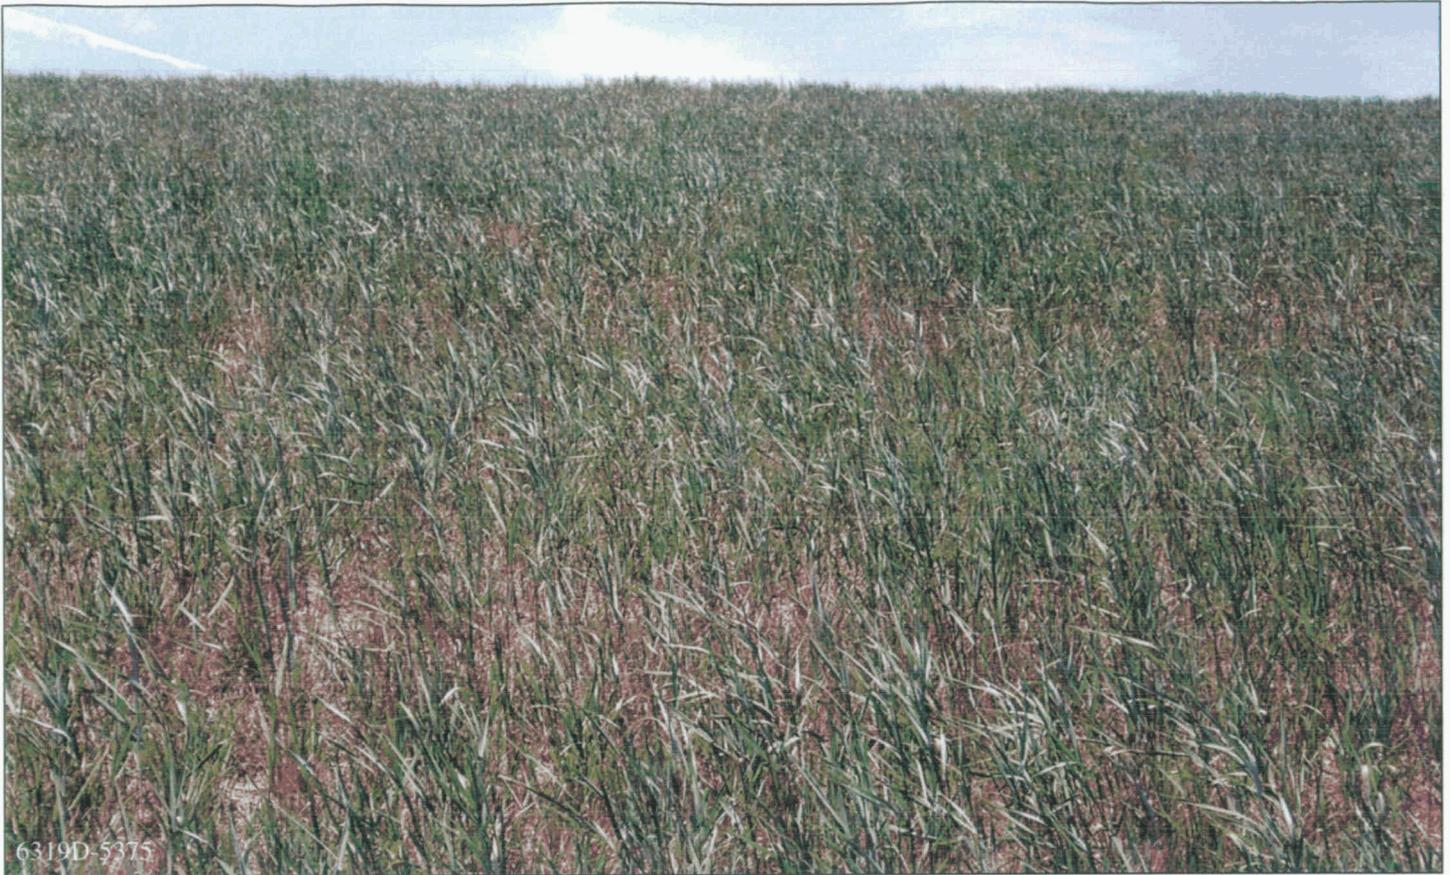
East Face Cell 2

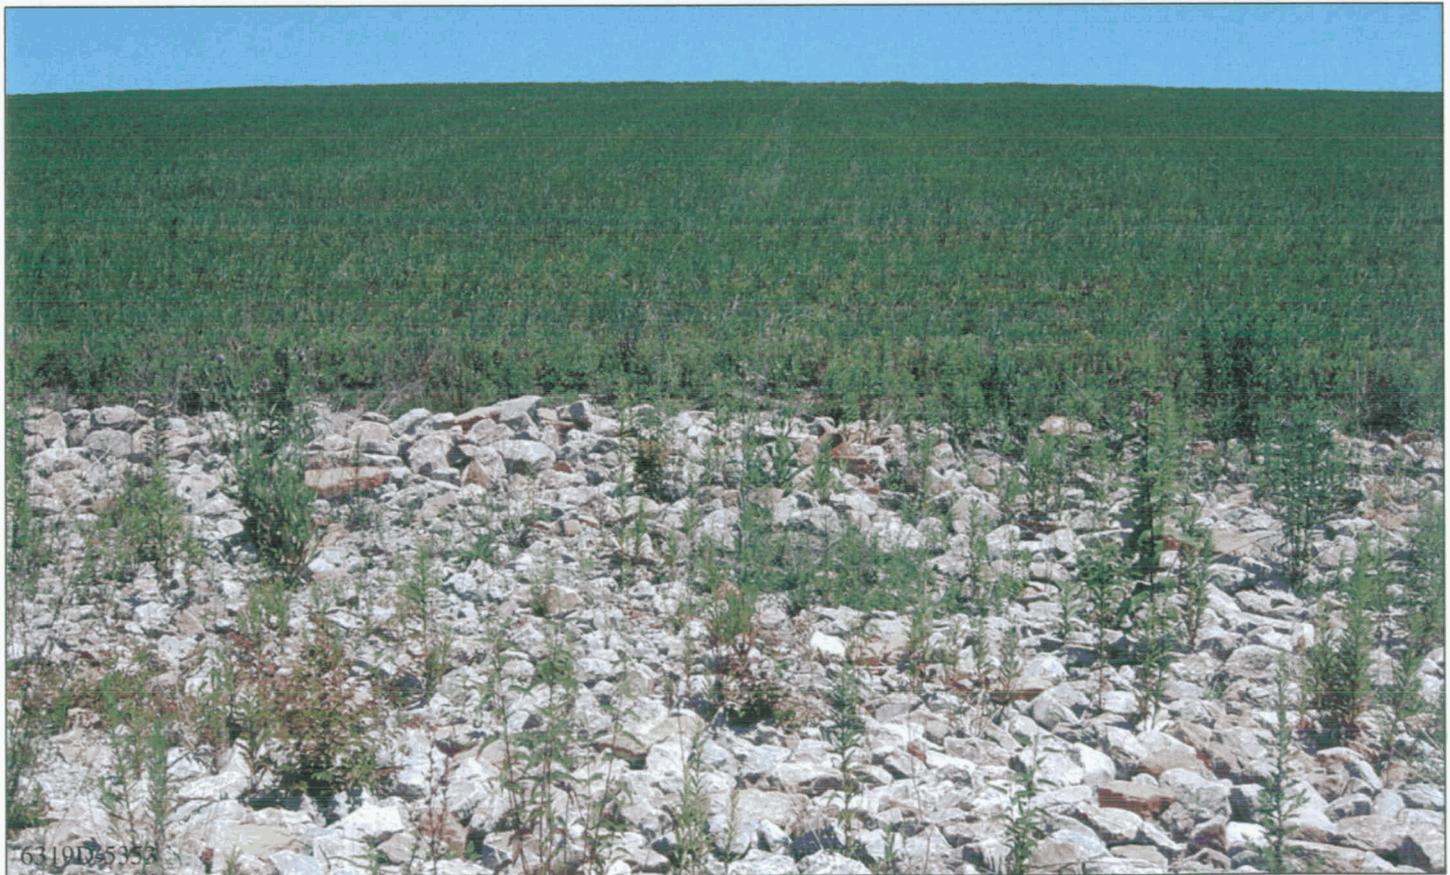
West Face Cell 2

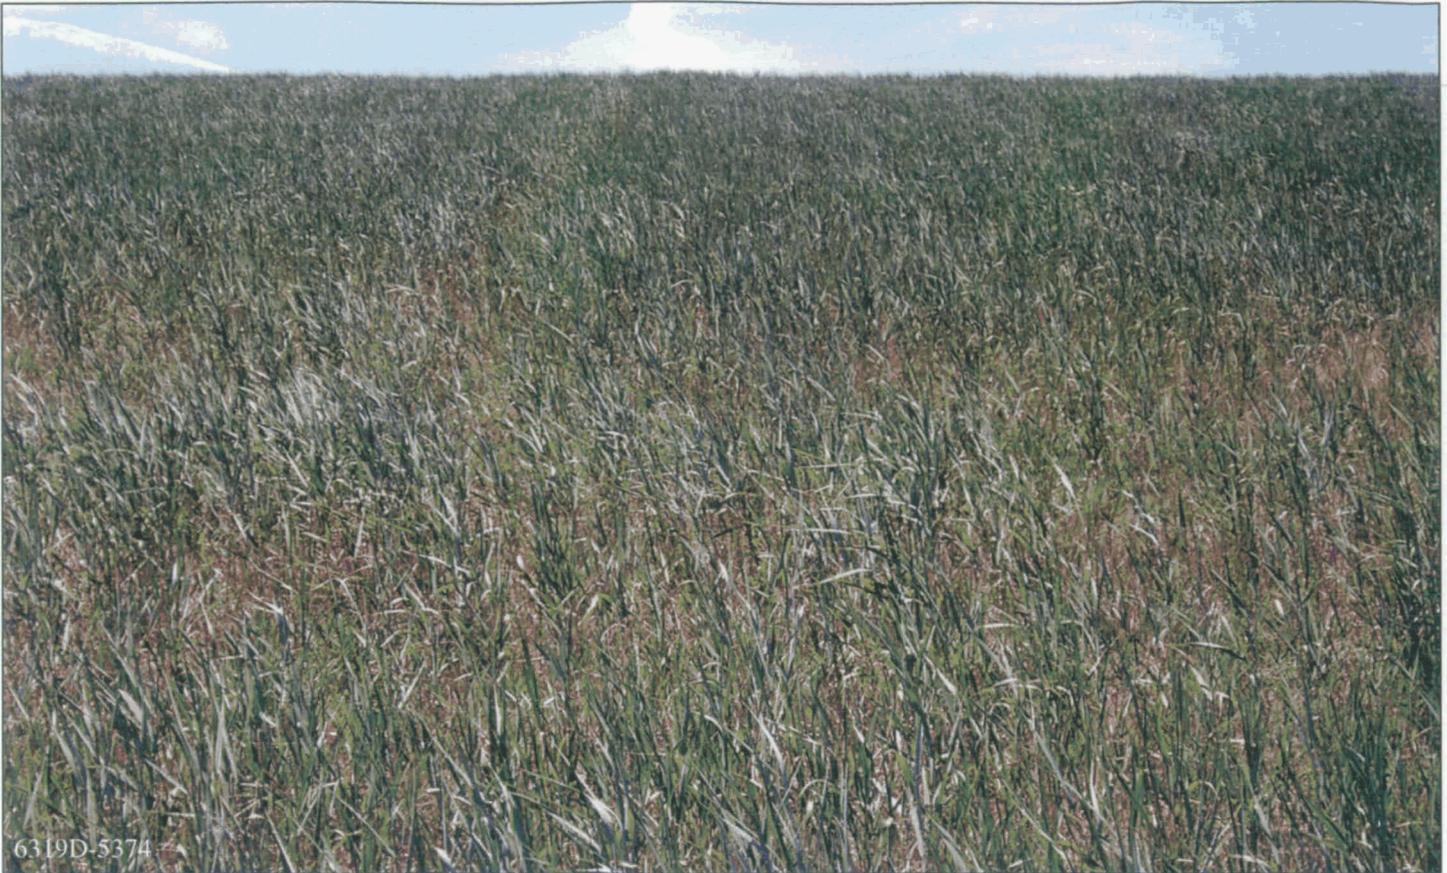
6319D-5374

East Face Cell 3

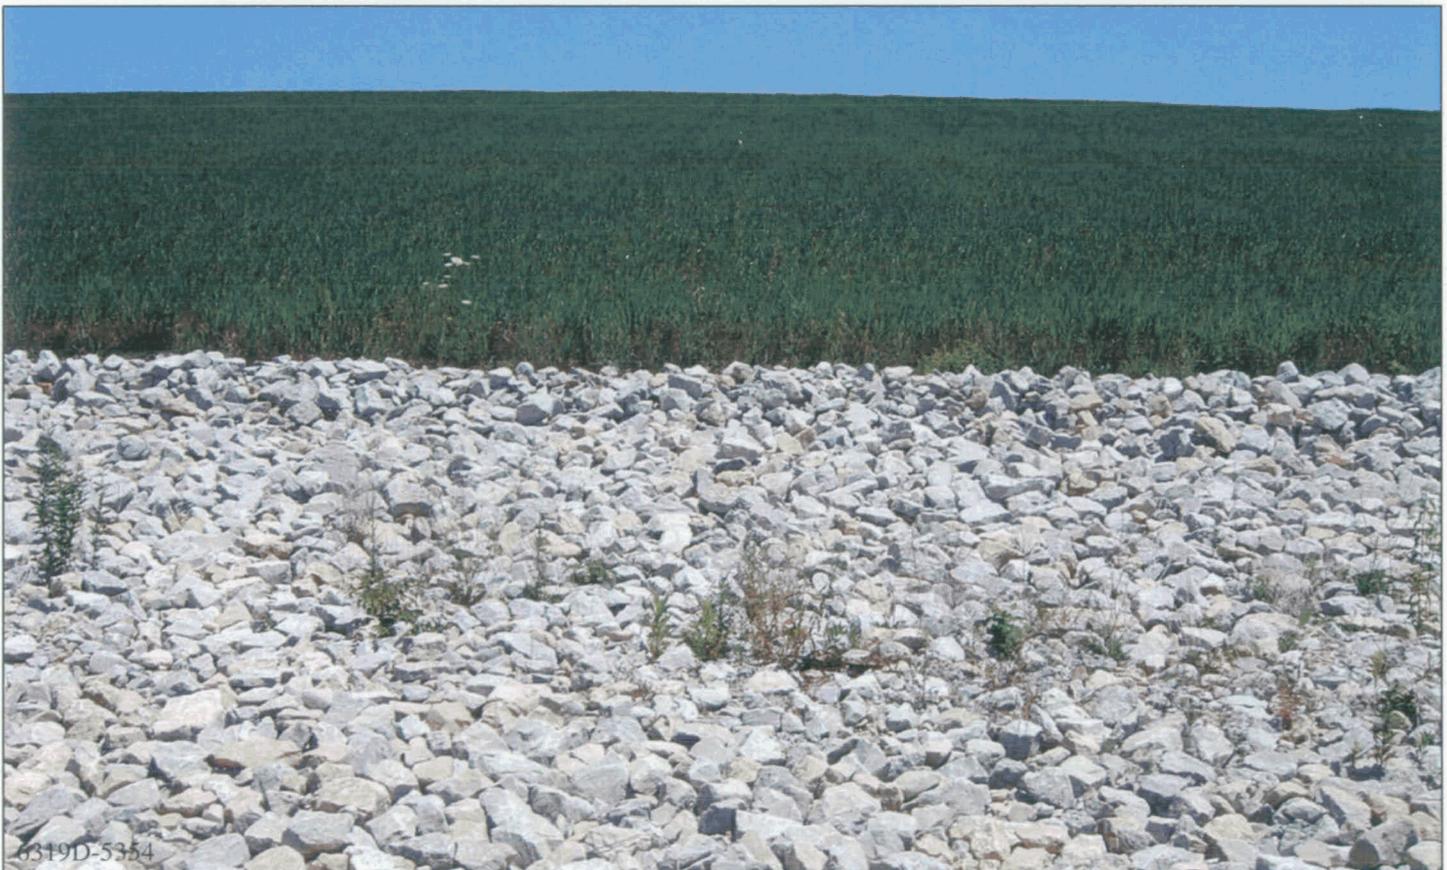
6319D-5354

West Face Cell 3

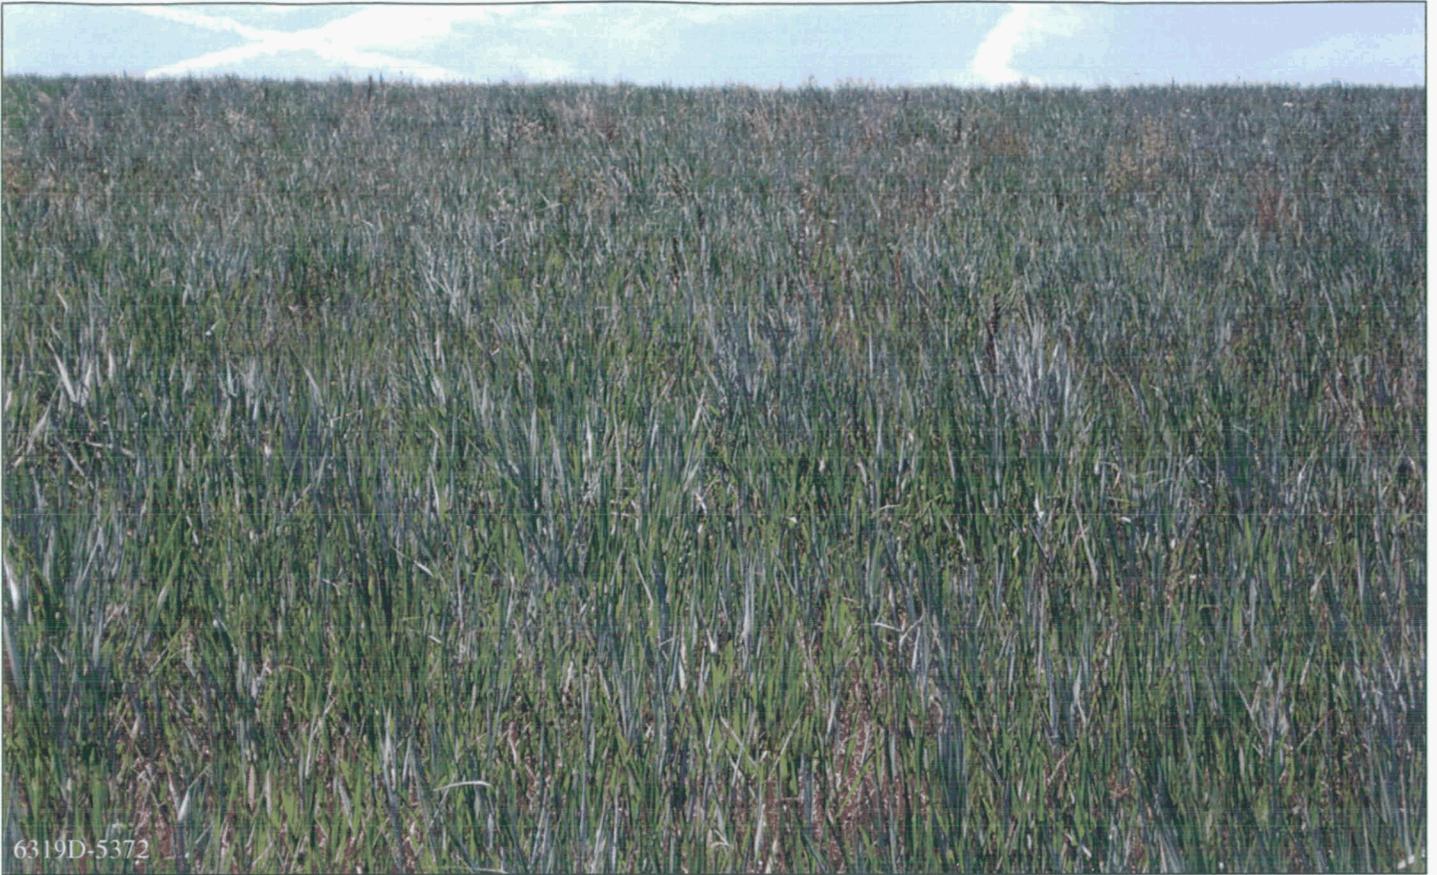
East Face Cell 4

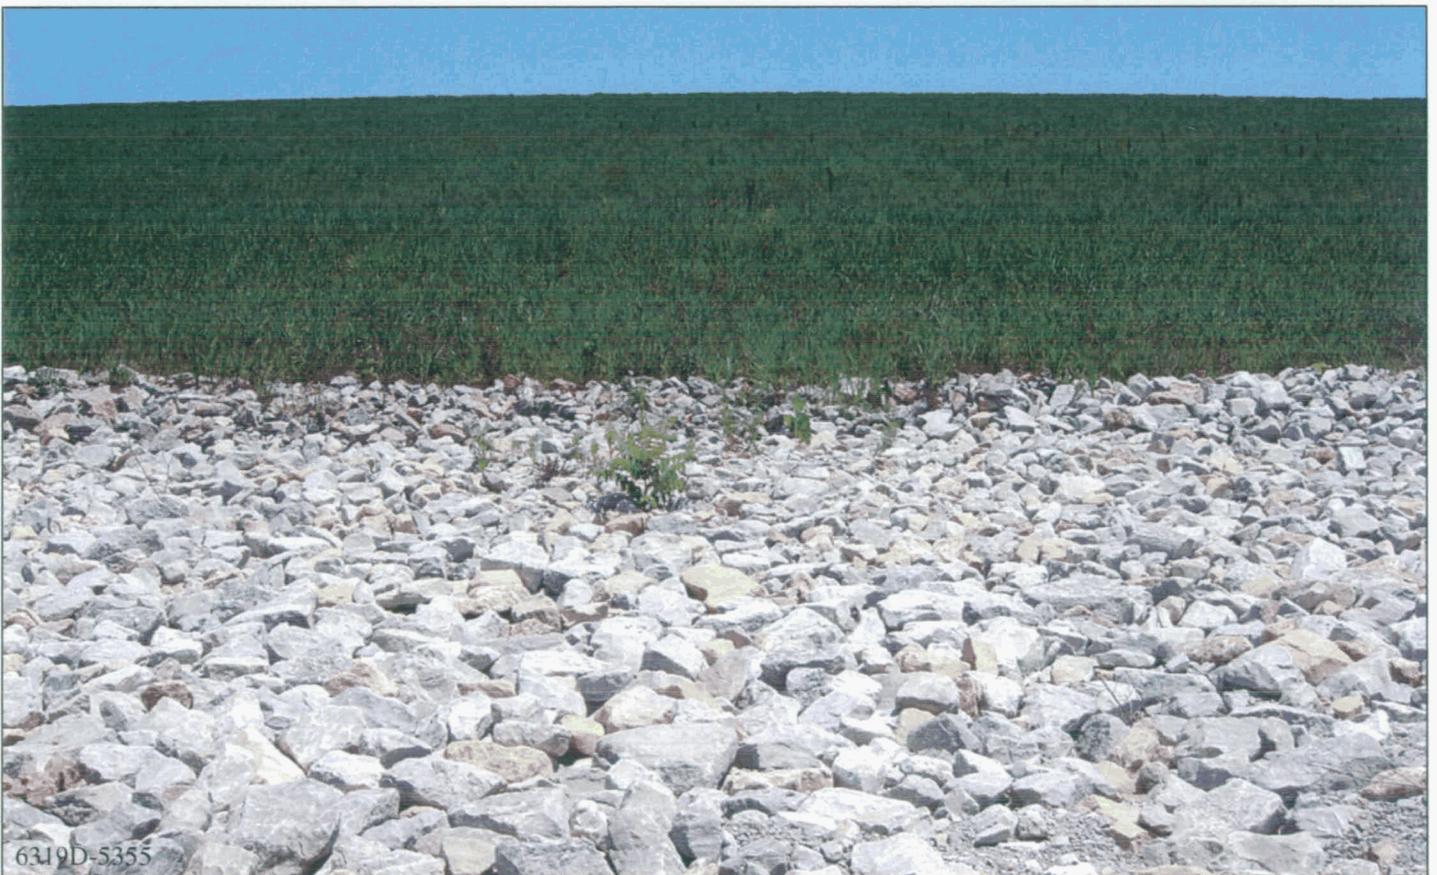
West Face Cell 4

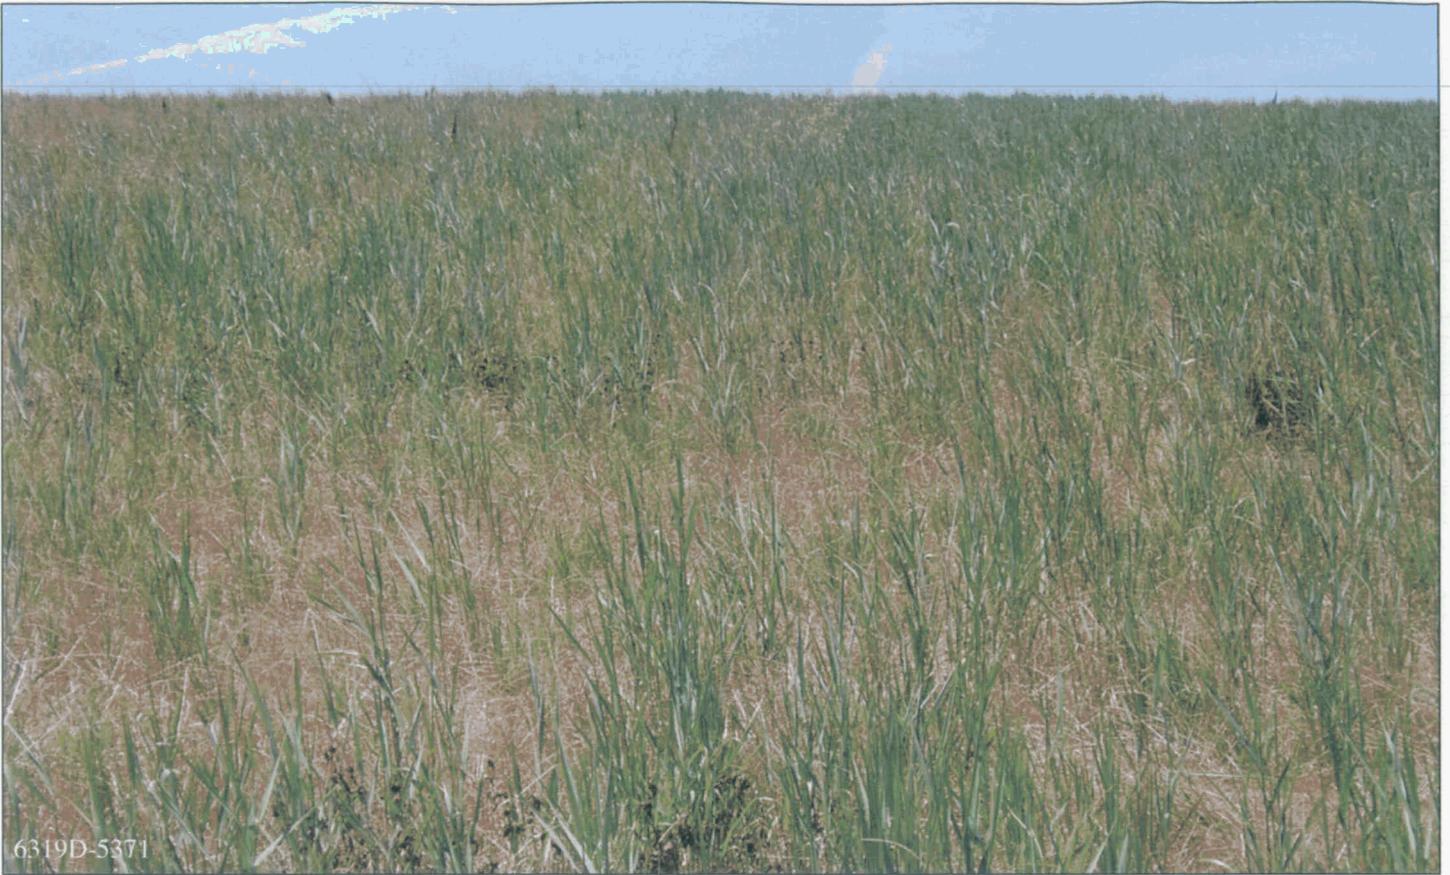
East Face Cell 5

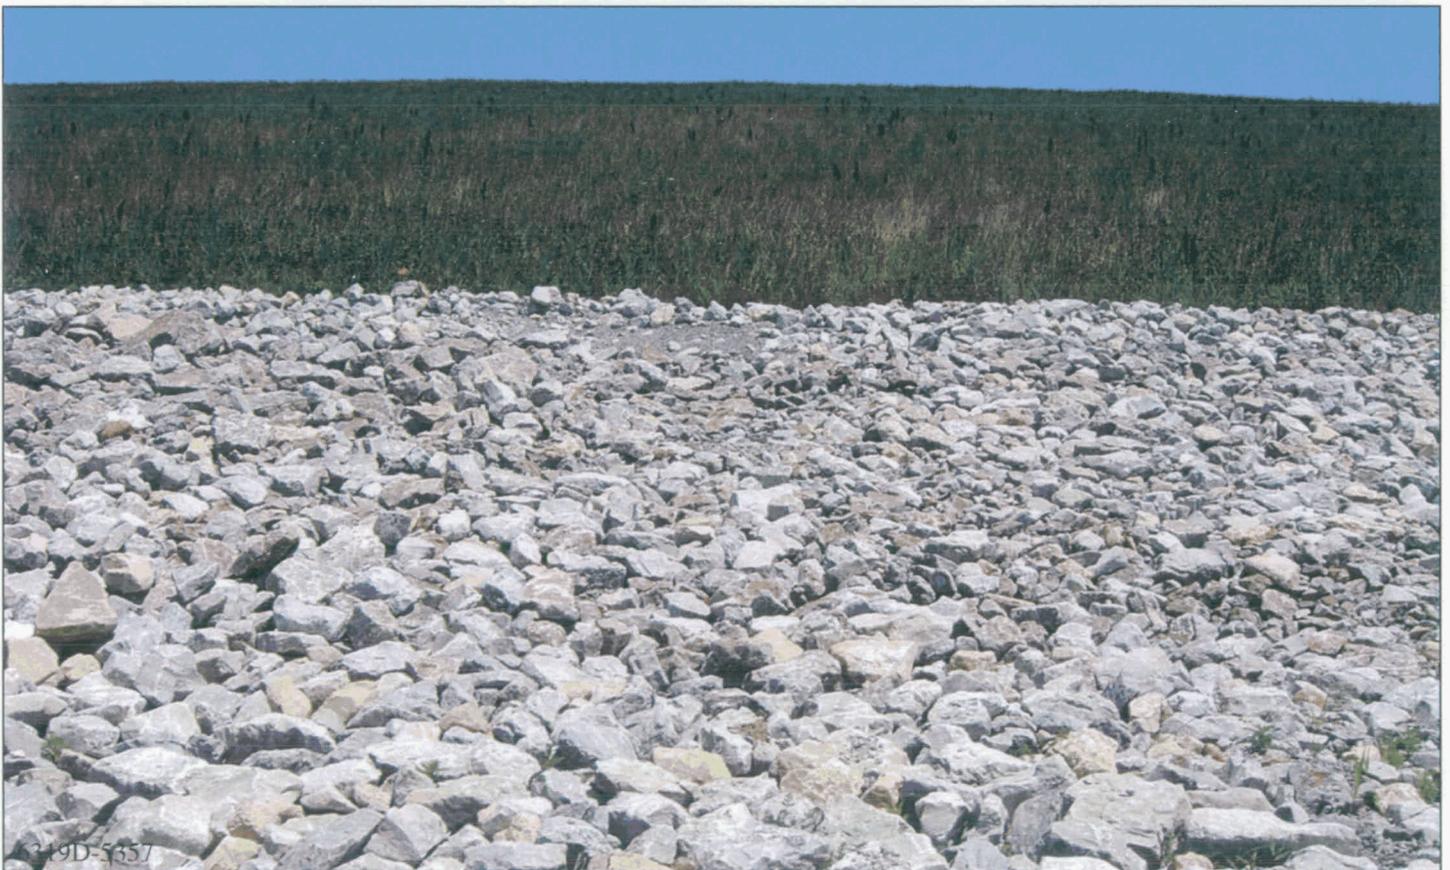
West Face Cell 5

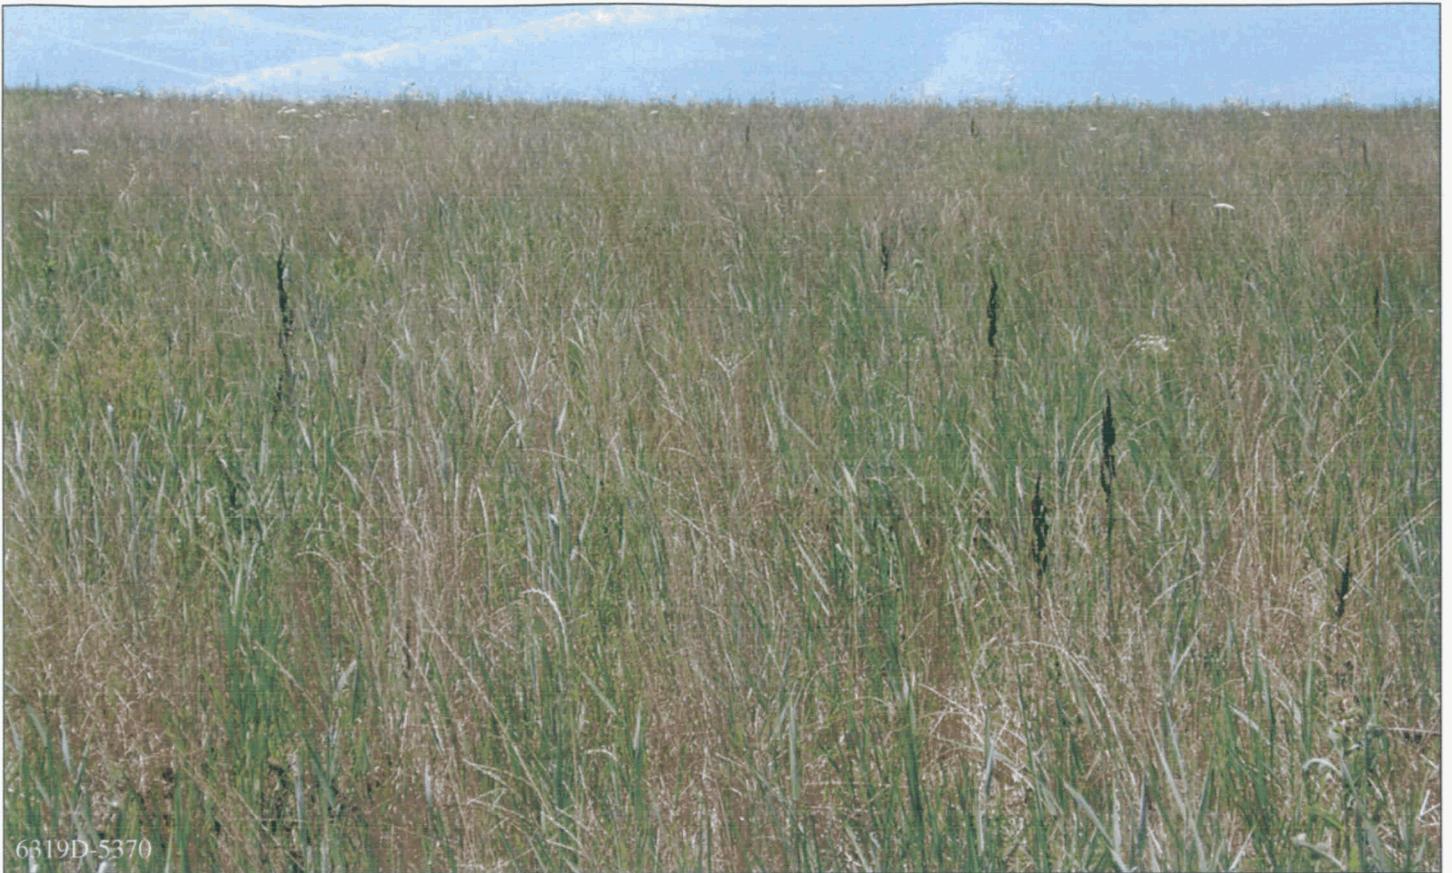
East Face Cell 6

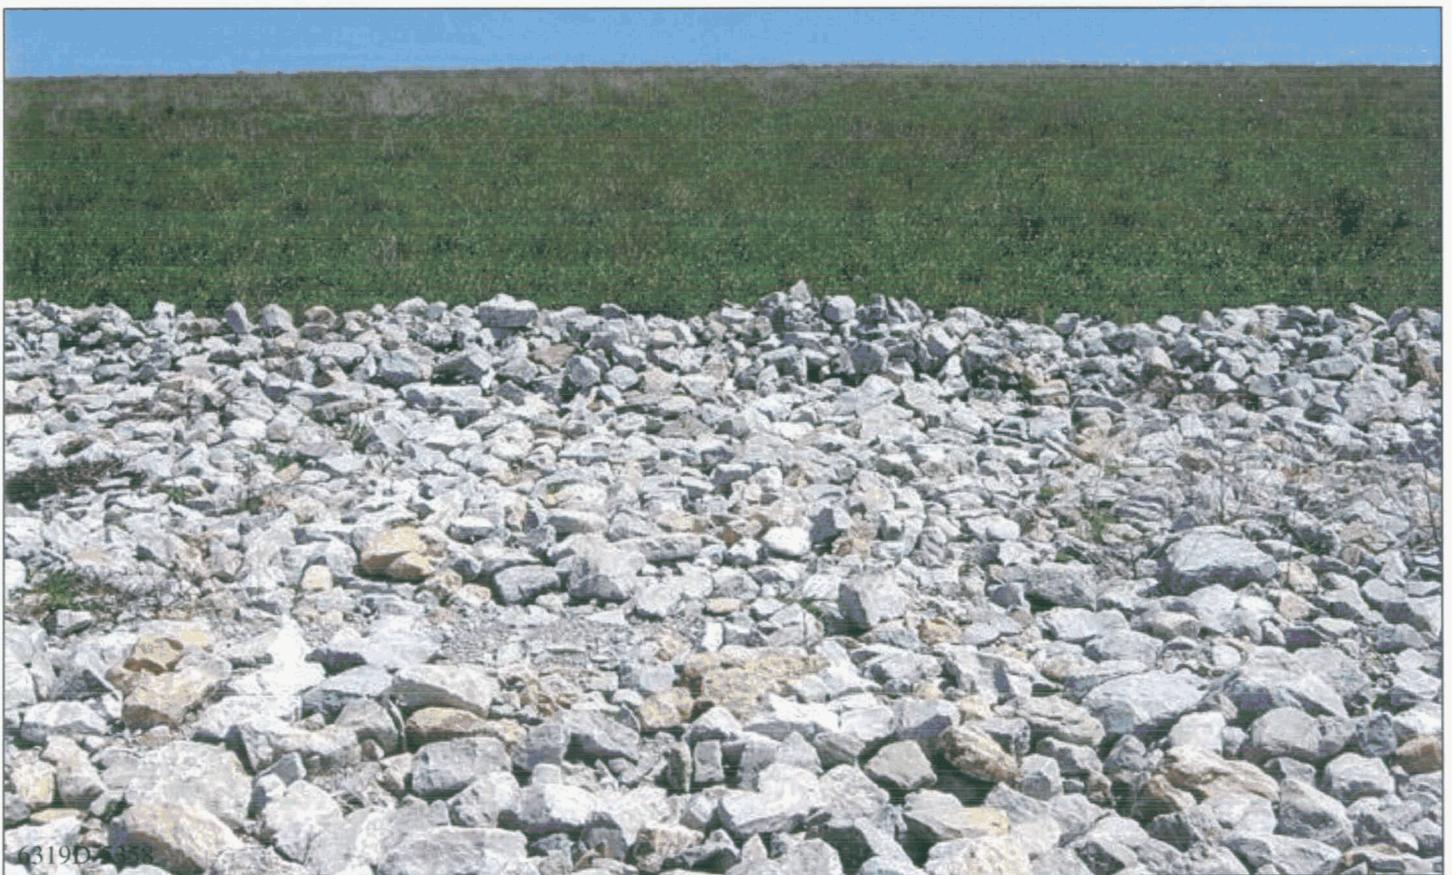
West Face Cell 6

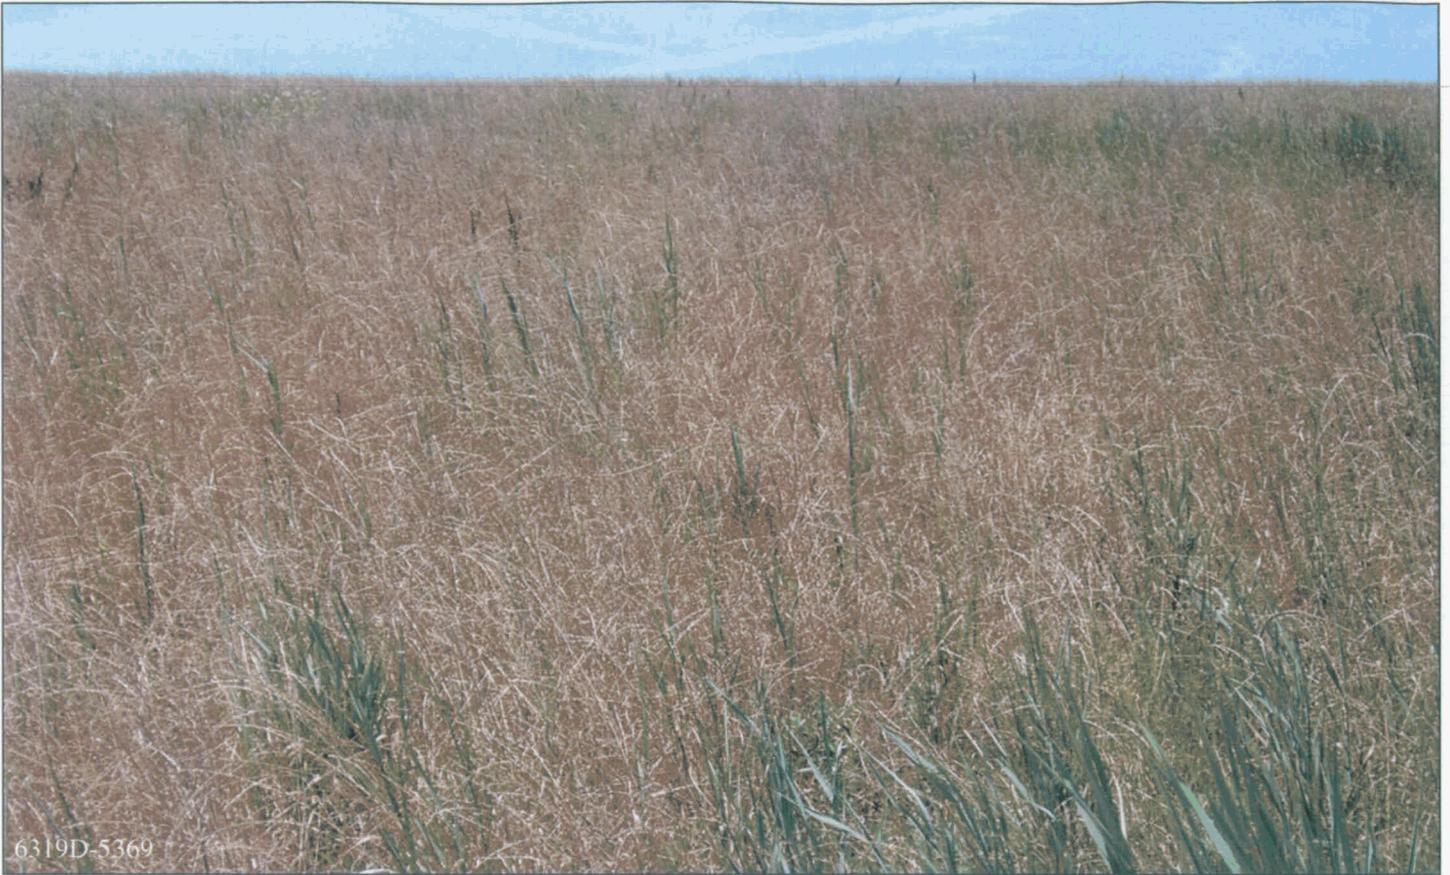
East Face Cell 7

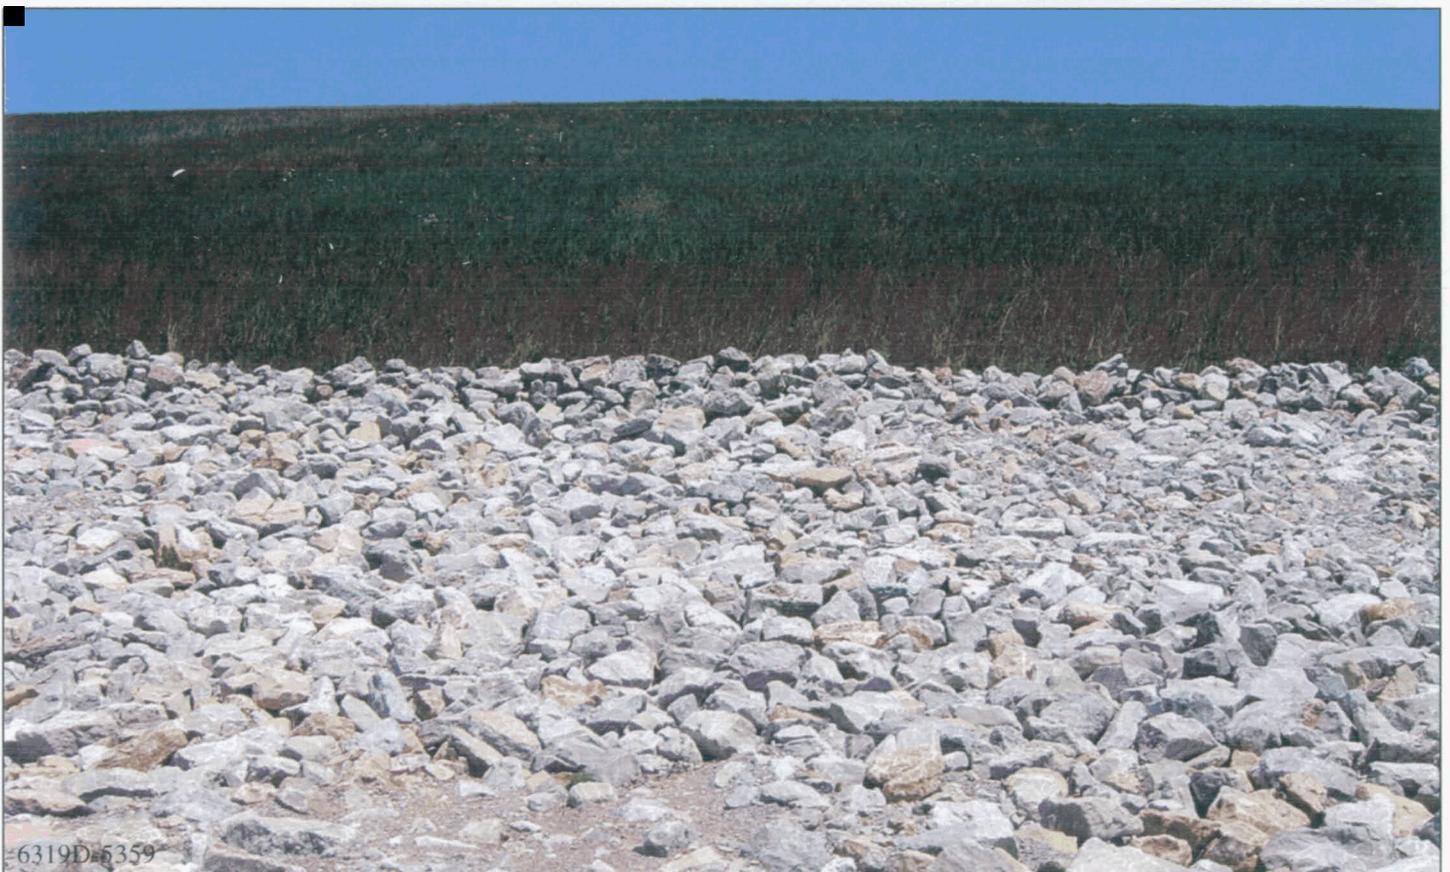
West Face Cell 7

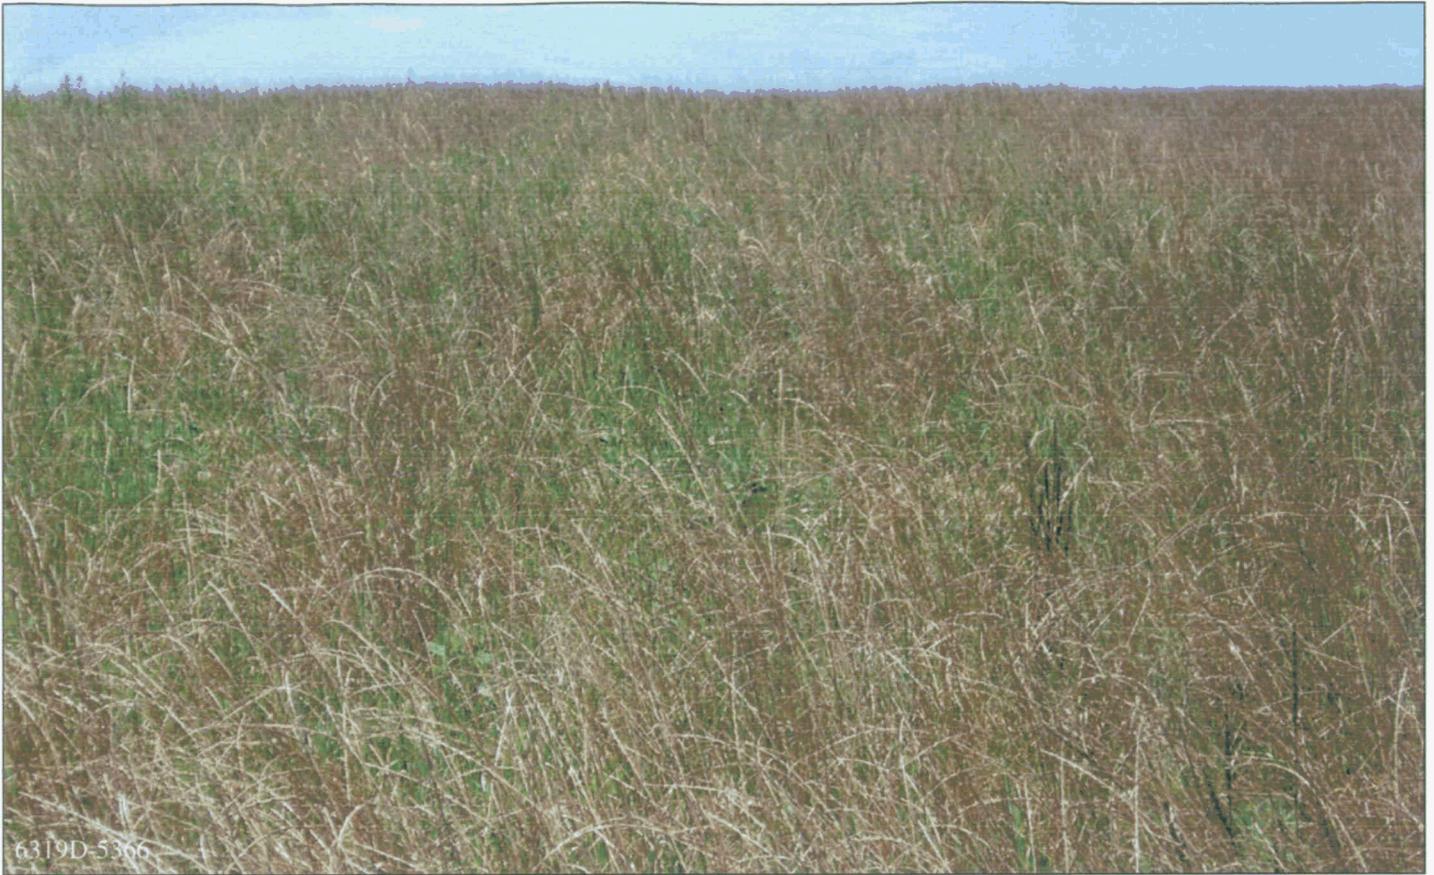
East Face Cell 8

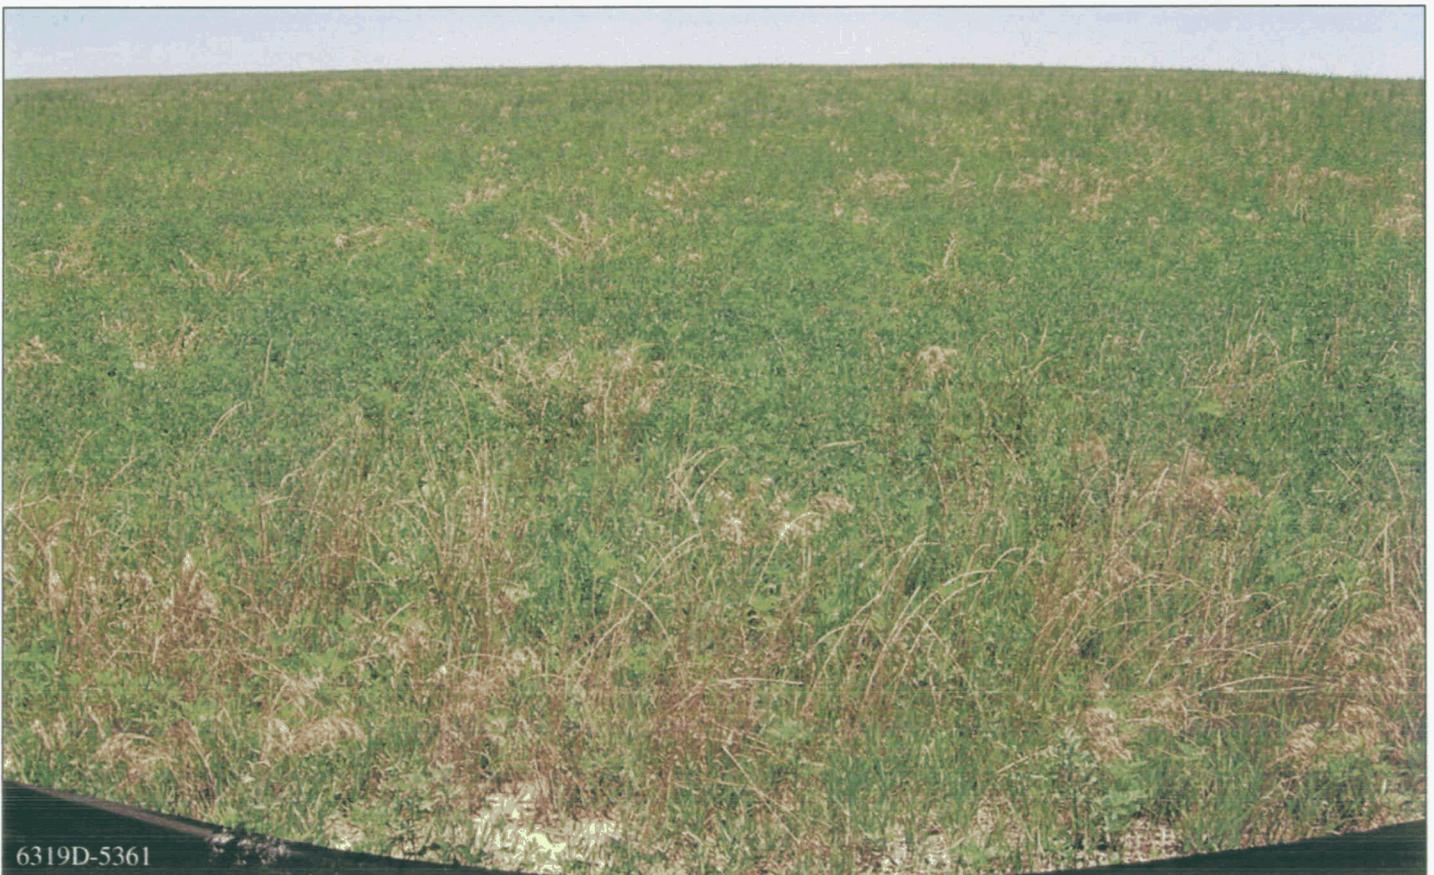
West Face Cell 8
