**Department of Energy
Office of Legacy Management**

SUBJECT: Transmittal of the June 20, 2007 Inspection Checklist for On-Site Disposal Facility

OSDF Cell Cap Post Closure Inspection Checklist

On-Site Disposal Facility Inspection Report

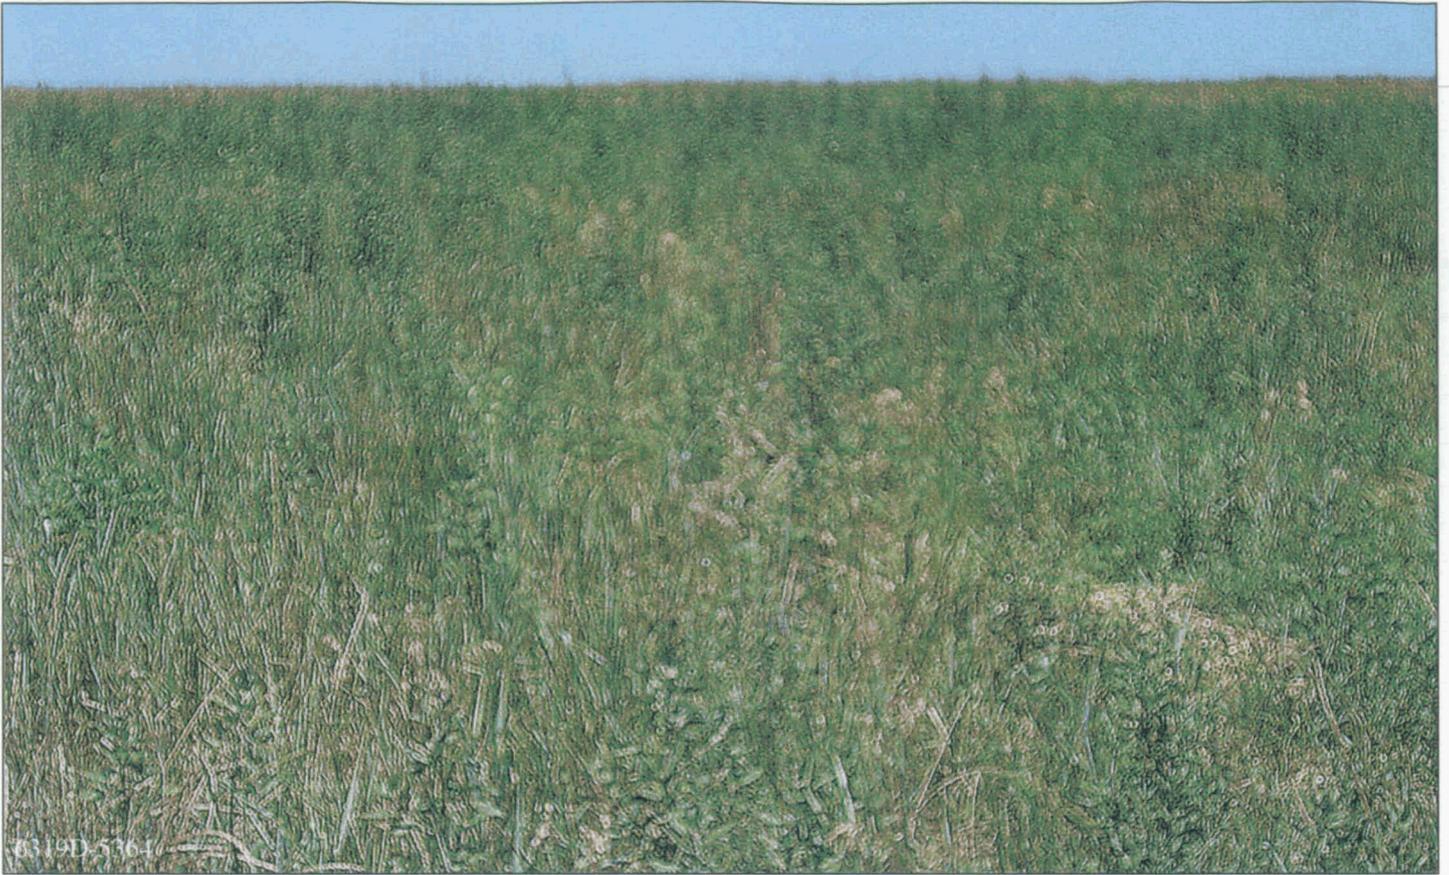
South Face Cell 8

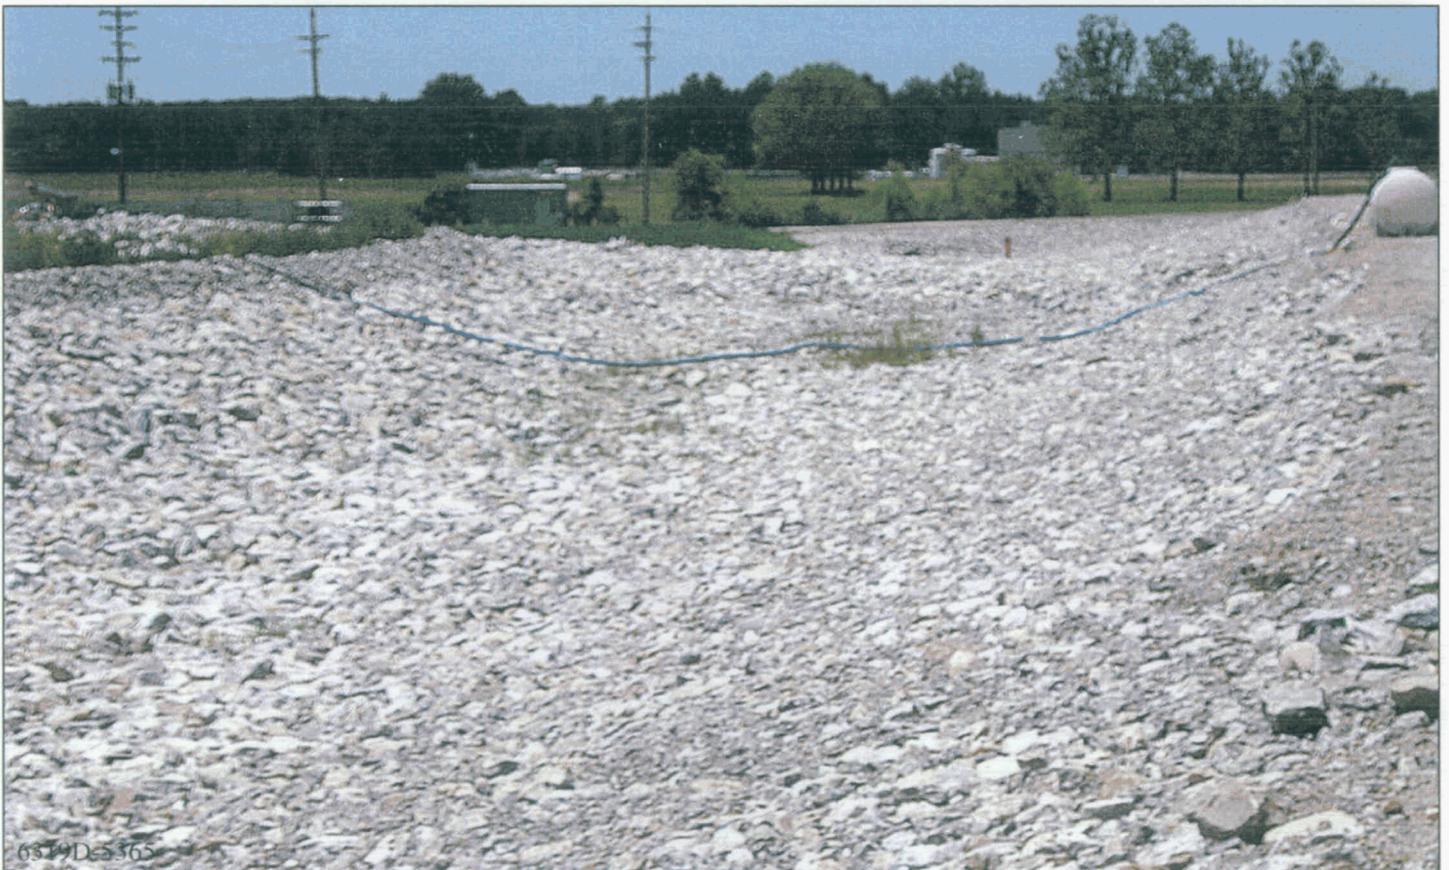
South Drainage (looking west)

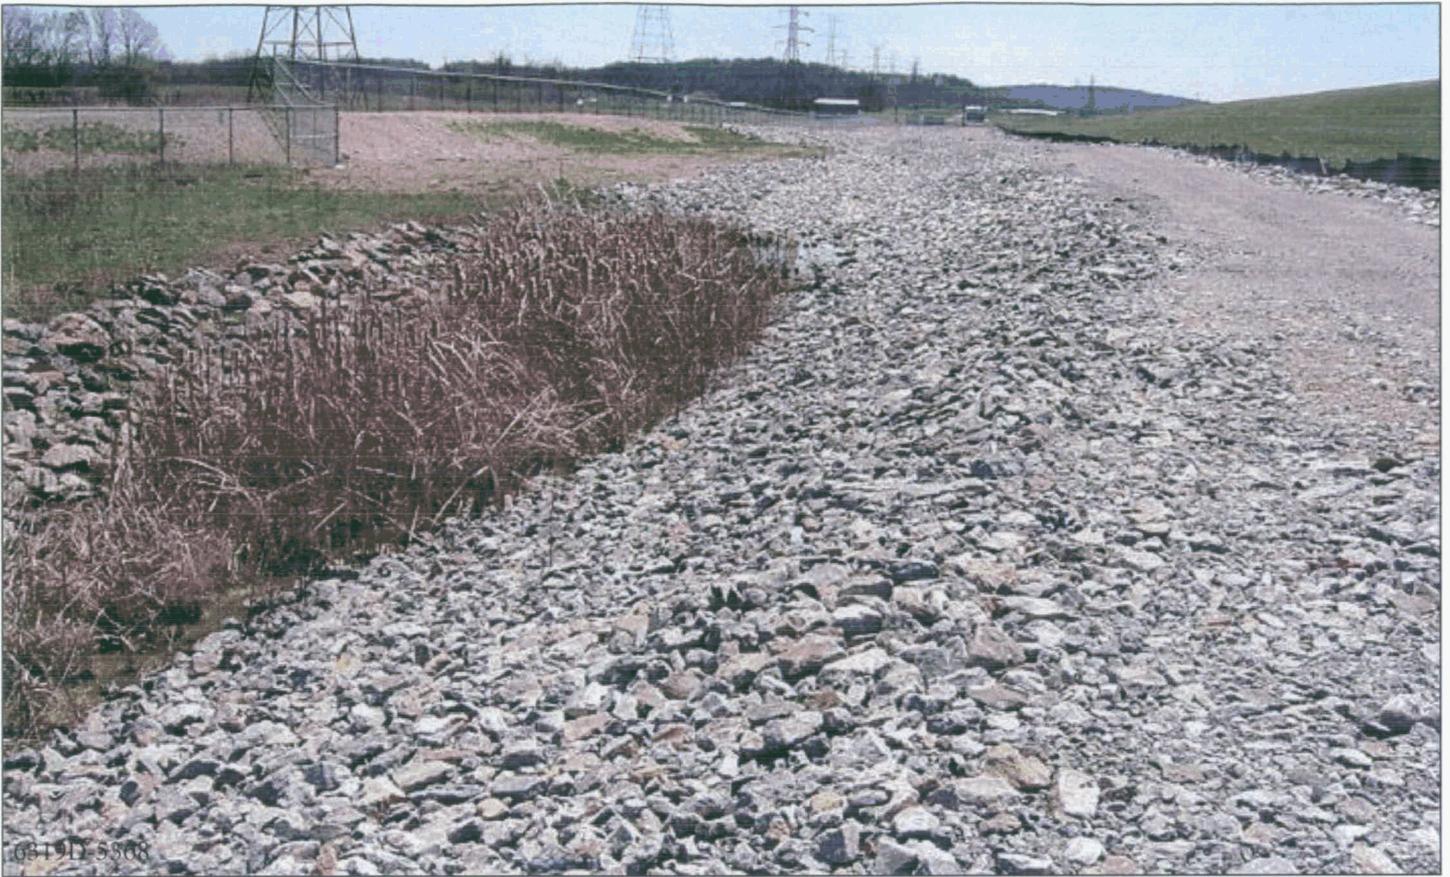
0819D 5868

East Drainage Cell 7 (looking south)

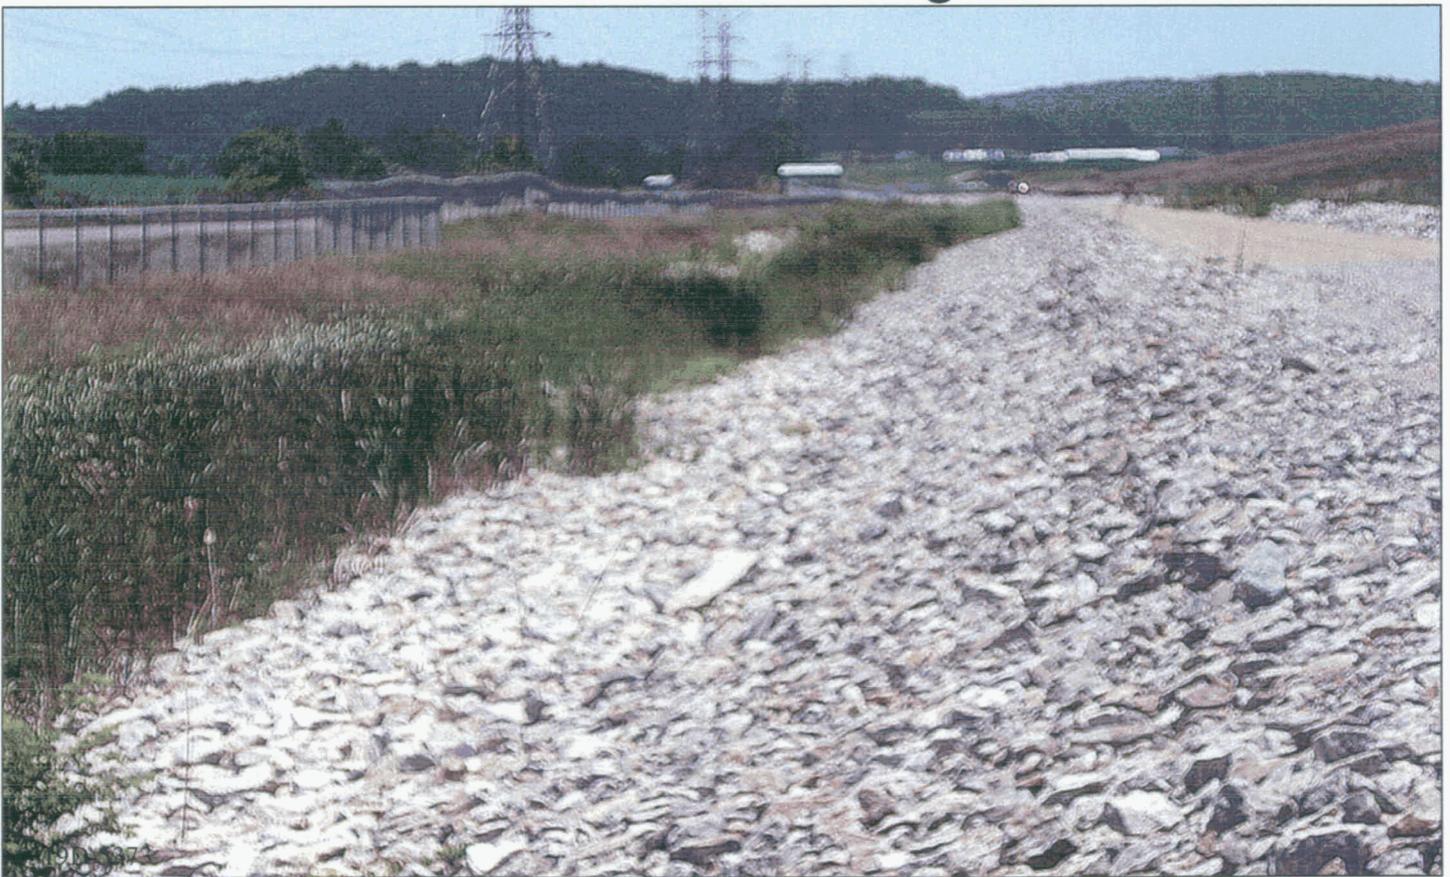
9D 5873

East Drainage Cell 4 (looking south)

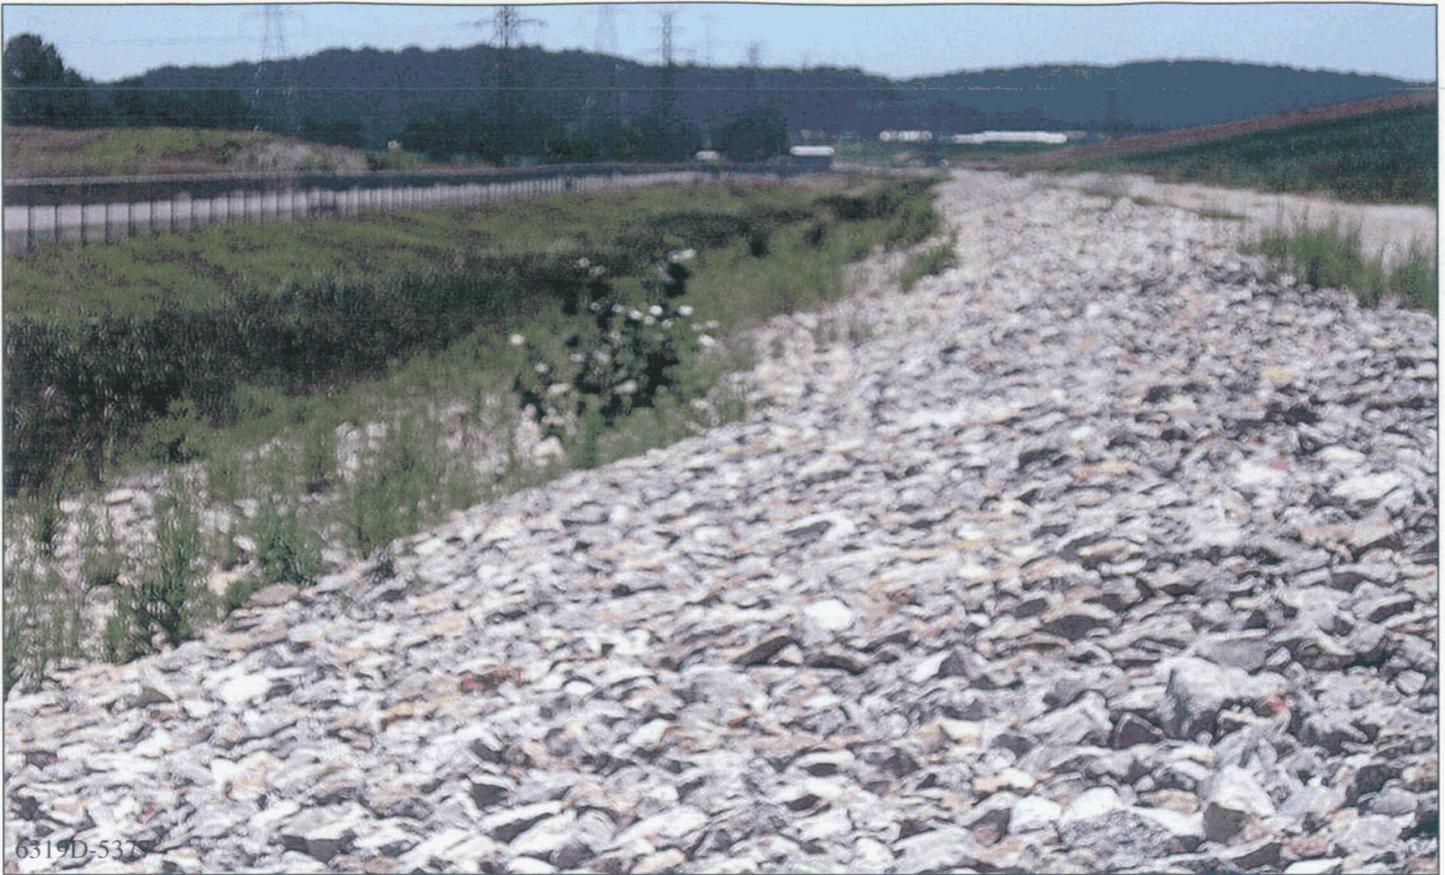
East Drainage Cell 1 (looking south)

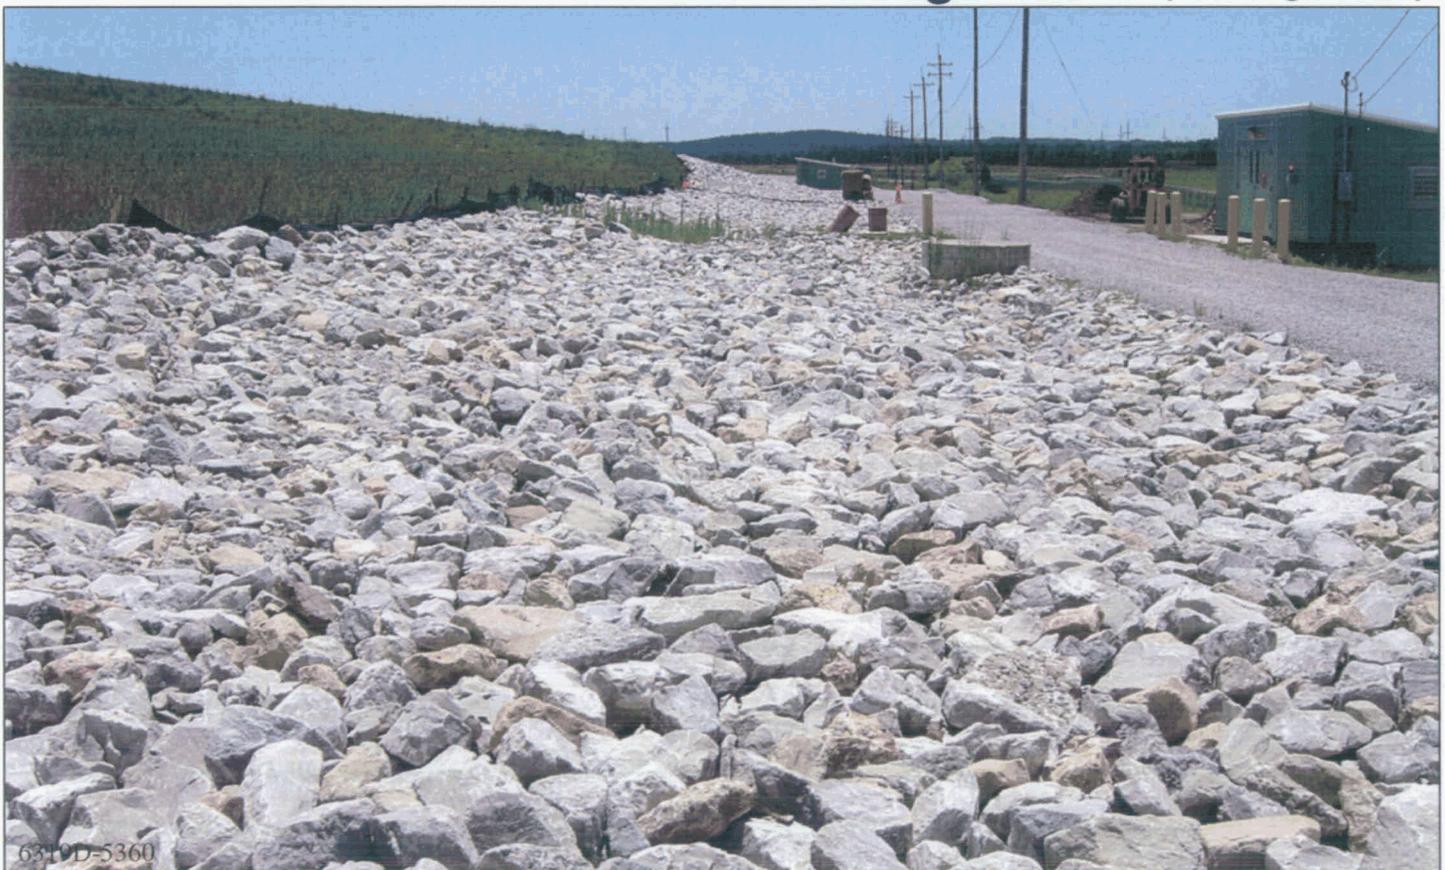
West Inner Drainage Cell 7 (looking south)

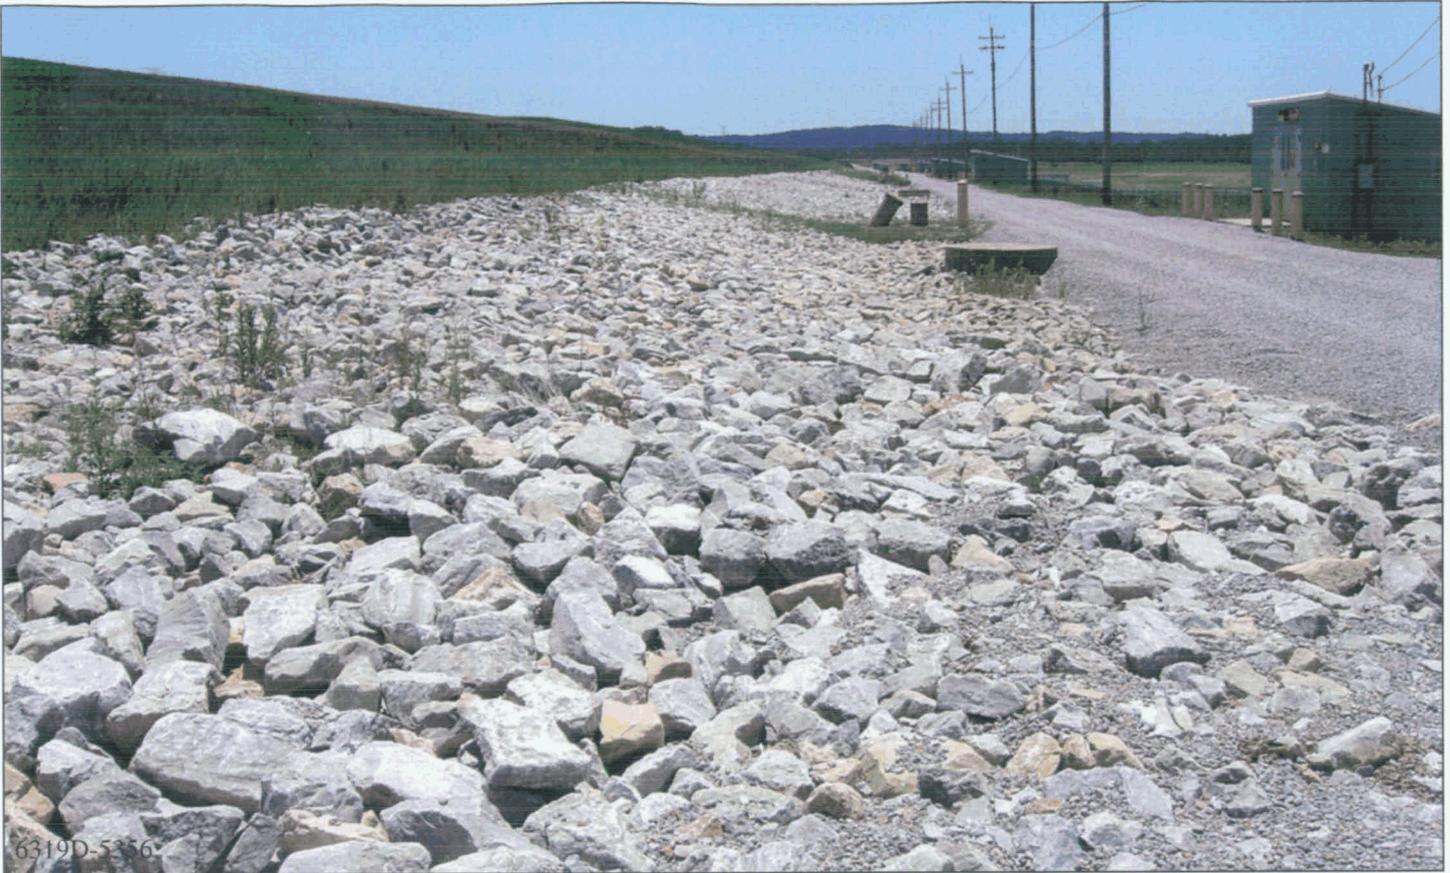
West Inner Drainage Cell 4 (looking south)

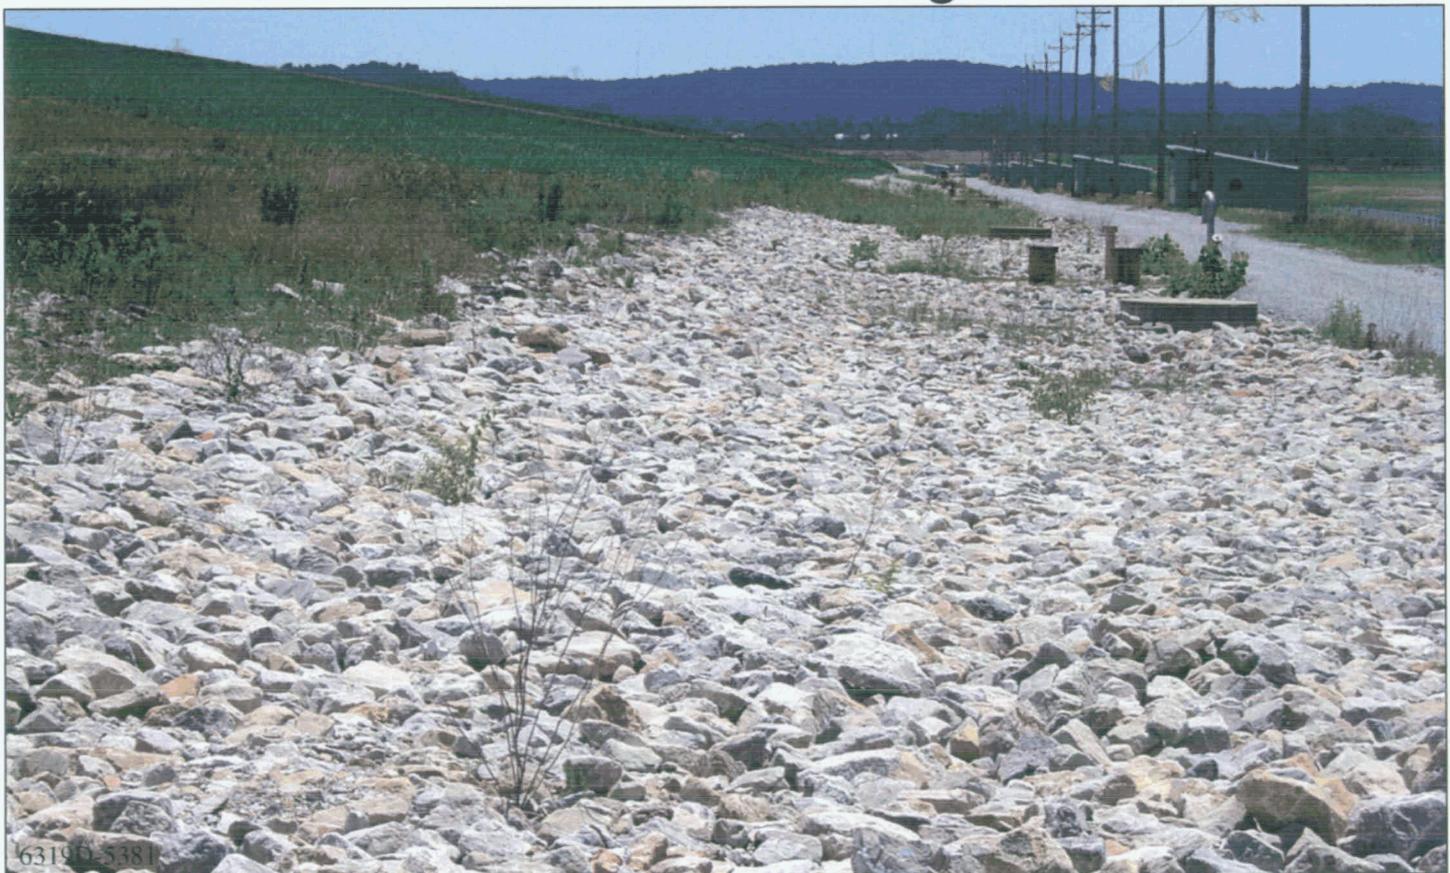
West Inner Drainage Cell 1 (looking south)

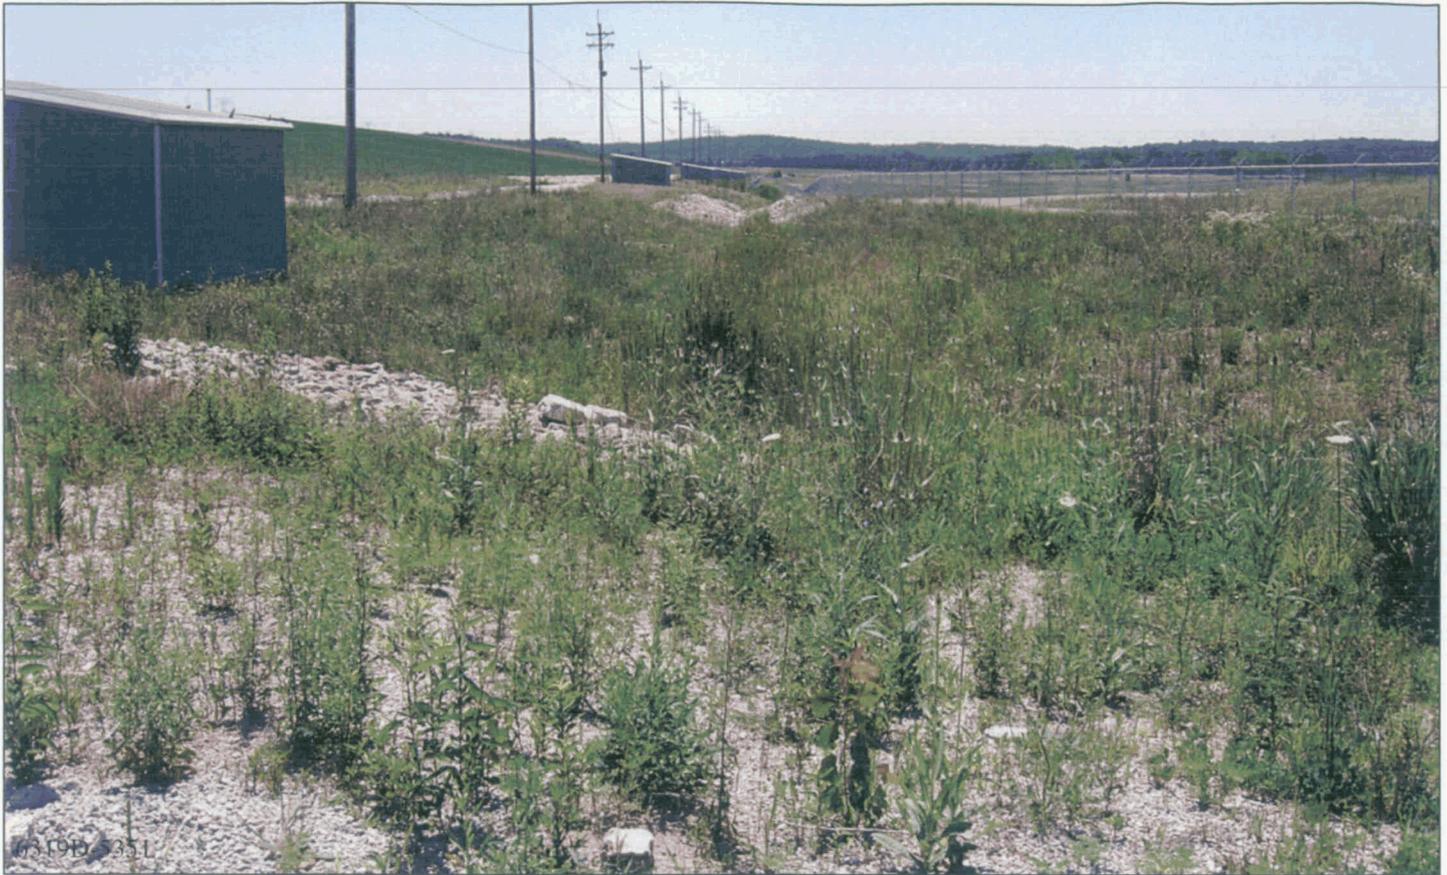
6319D-5351

West Outer Drainage Cell 1 (looking south)

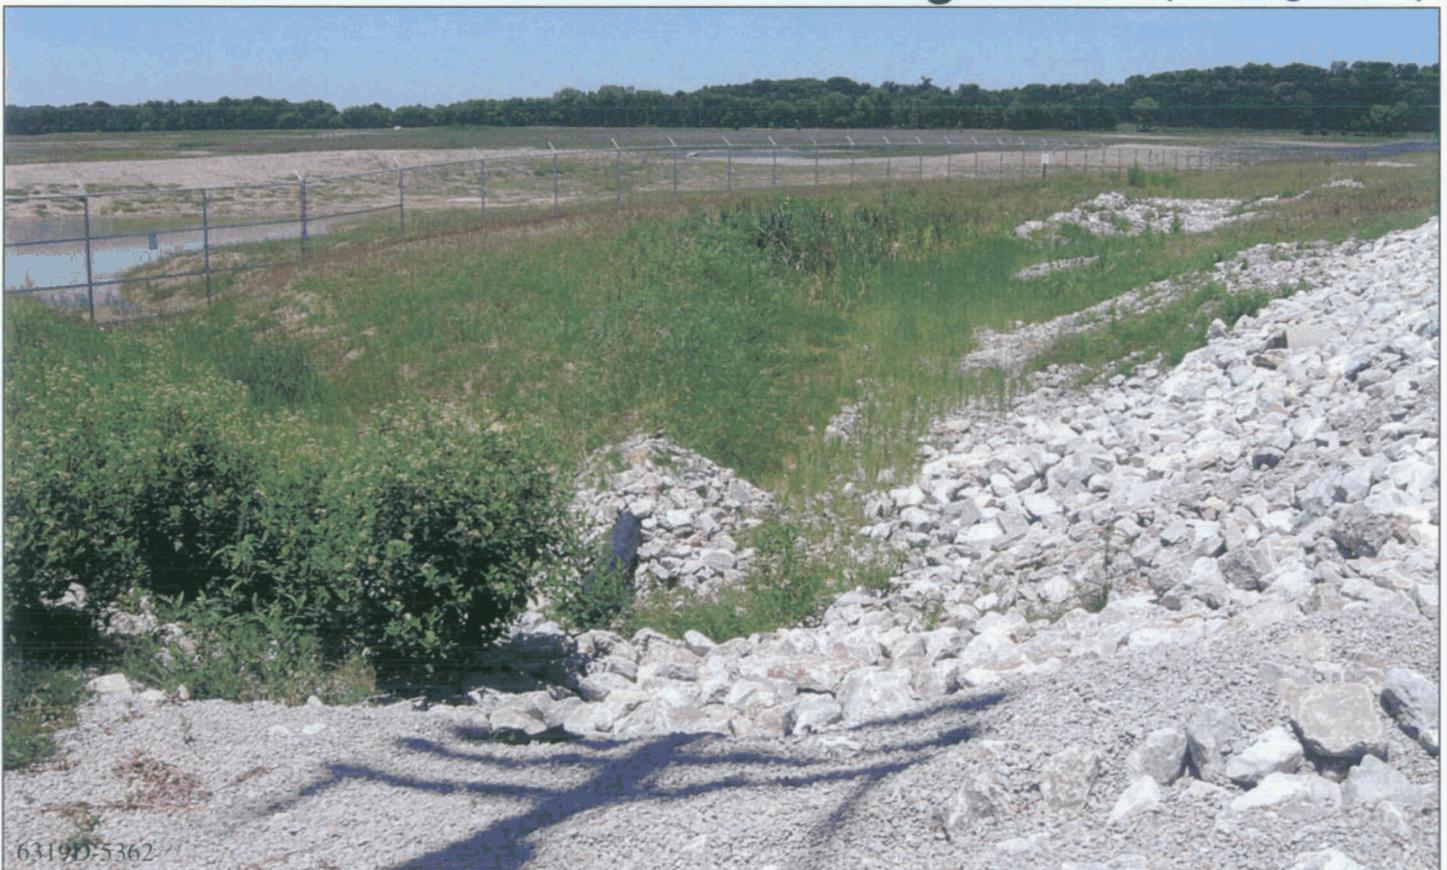
6319D-5362

West Outer Drainage Cell 8 (looking north)

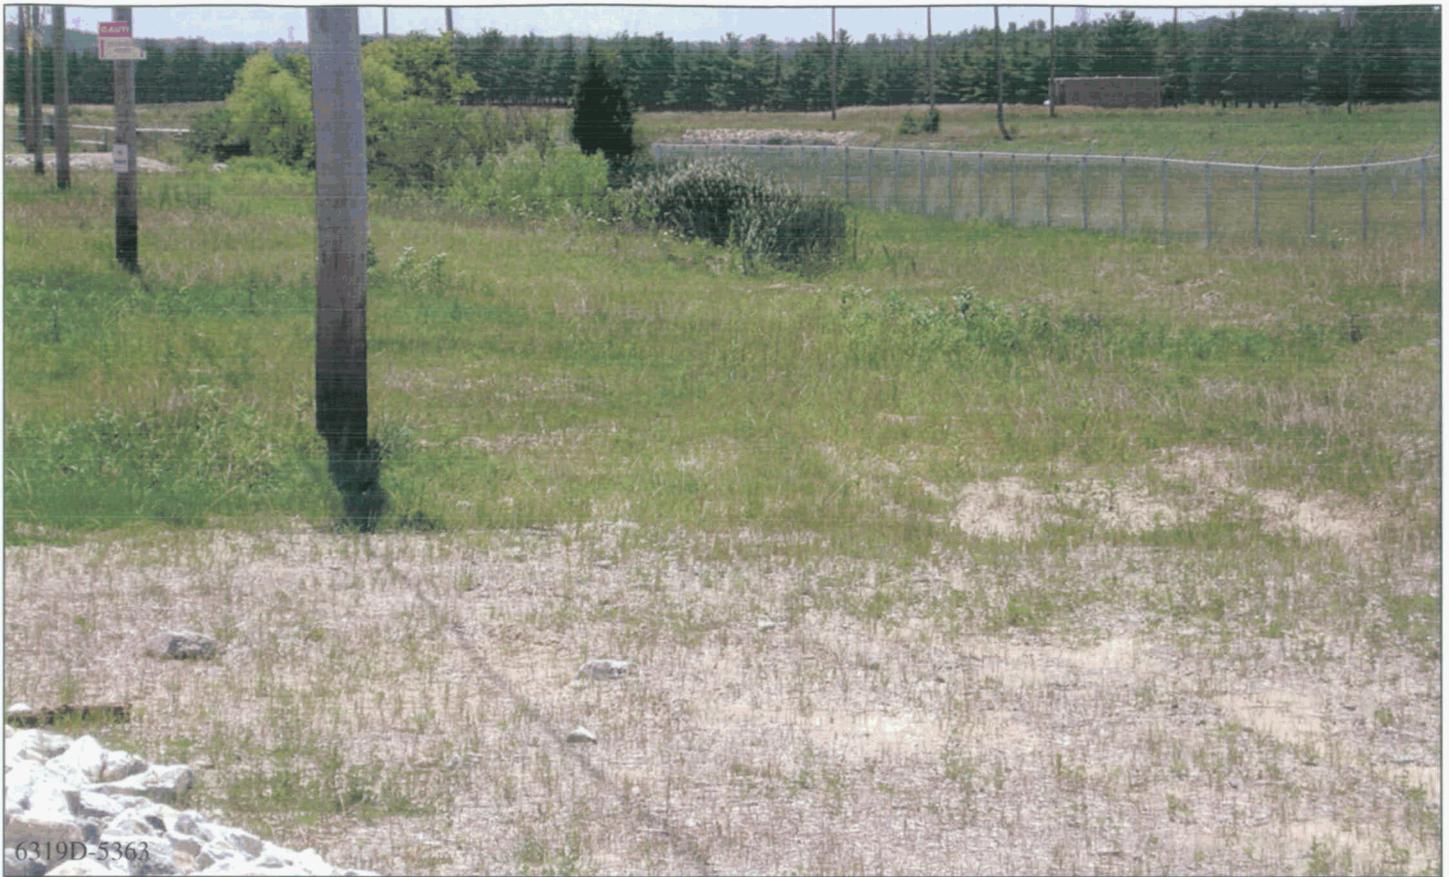
West Outer Drainage Cell 8 (looking south)
