**ELEVATED TOTAL URANIUM CONCENTRATION LEVELS IN SURFACE WATER  
WEST OF FORMER WASTE PIT 3**

Attachment 1 – Photograph Package

**RE: Maintenance Action Report Regarding the Swale West of Former Waste Pit 3**

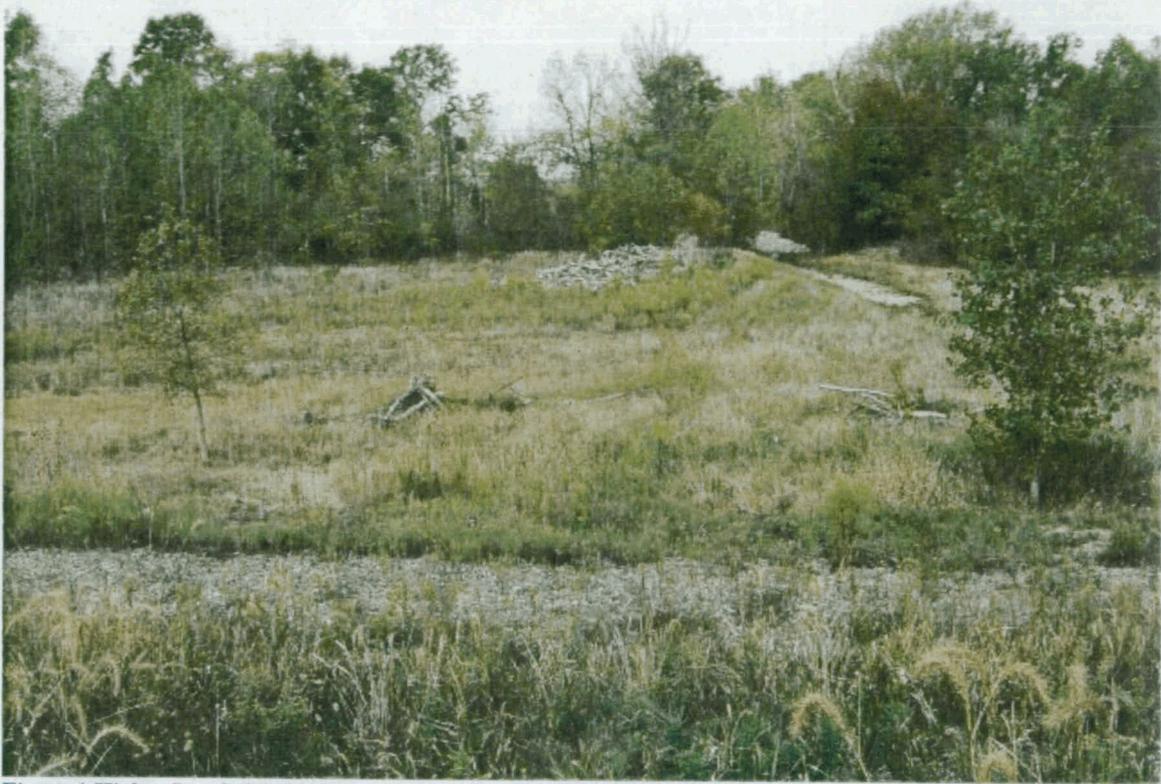
**Figure 1 Higher Leachable Uranium Suspect Area – Starting Conditions (Looking West From Pit 3 Berm)**

The scope of work for this maintenance action, in short, was to remove approximately six inches of the surface of the area suspected as being the source of higher leachable uranium causing elevated levels of uranium in small surface water ponds. This removed material was to be transported to a “high spot” in a nearby area and distributed sufficiently to prevent extended contact time with ponding rain water and leaching of the residual uranium, treated with lime or phosphate to further reduce leachability, and adequately revegetated to stop erosion and spread of this soil. The scraped area and nearby depressions were to be filled and graded to reduce or eliminate future ponding. Prior to movement of any soil, two brush piles lying in the footprint of the scrape area would need to be moved to the west and consolidated into an existing and much larger brush pile allowing access to the suspect soil. (Refer to the attached Photo Package, Figures 1 and 2, for a view of the starting conditions.)

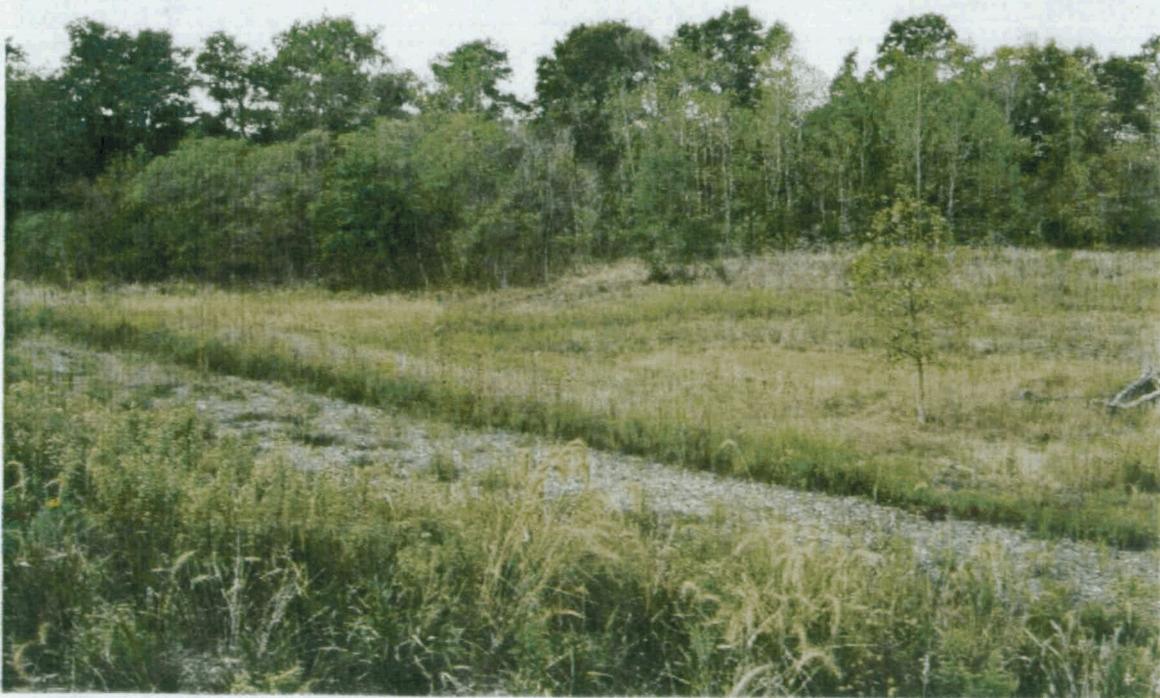
**Figure 2 Area Due South of Suspect Area – Starting Conditions (Looking Southwest From Pit 3 Berm)†**

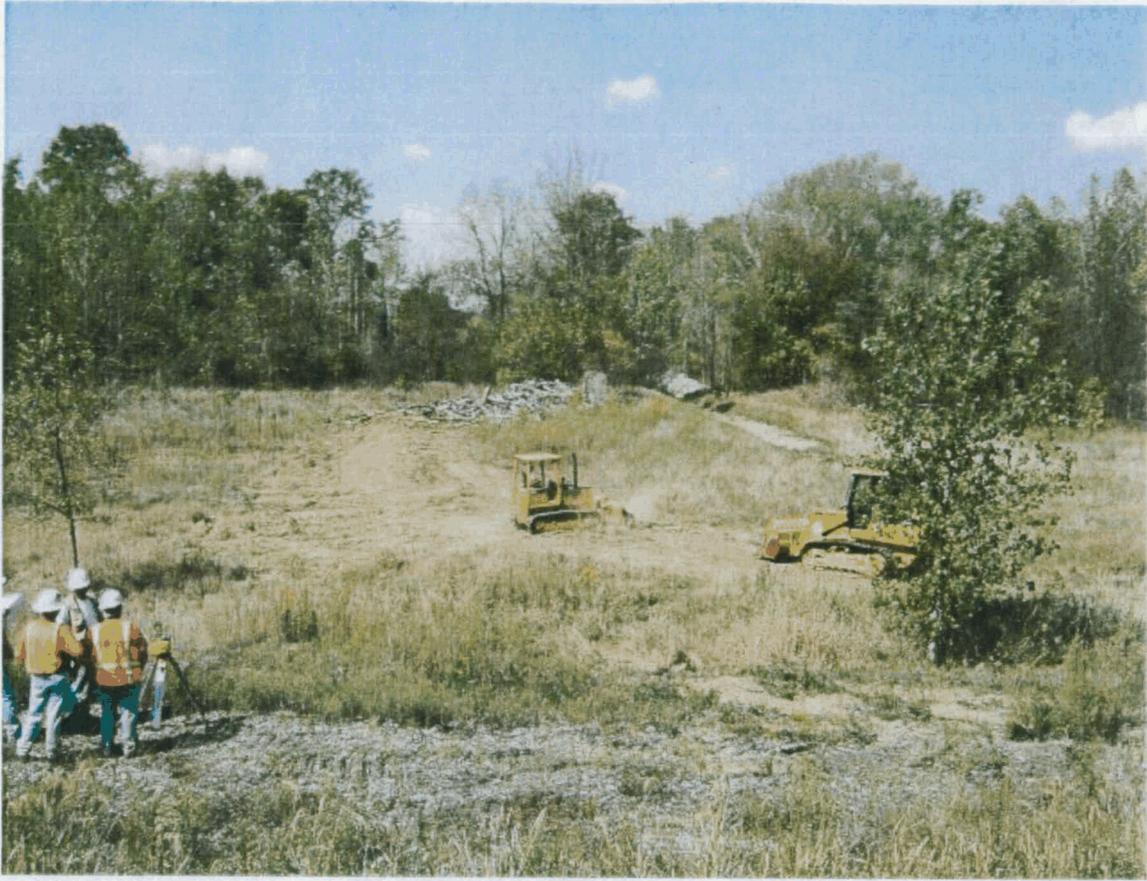
Figure 3 Consolidation of Brush Piles (Looking West From Pit 3 Berm)†

On September 24<sup>th</sup>, 2007 a field crew was mobilized and work began on this maintenance action. The brush piles were easily moved and consolidated with the use of a CAT D-4 Bulldozer and a CAT 953 Track Loader (Refer to Figure 3). Subsequently, the dozer performed the scrape of the suspect area measuring roughly 40-feet (east-west) by 65-feet (north-south). The soil was pushed to the northern boundary of the suspect area where it was loaded out using the track loader (Refer to Figures 4 and 5). All excavated material was transported to the berm between the former pit 5 and former pit 3. The soil was spread in an approximate 6-inch lift along the southern edge of former pit 5, where 250-pounds of phosphate-based fertilizer (15-30-15, N-P-K) was mixed thoroughly with the aid of a small bobcat skid steer equipped with a toothed-bucket. This area was then seeded and covered with straw for revegetation (Refer to Figures 6 and 7.)

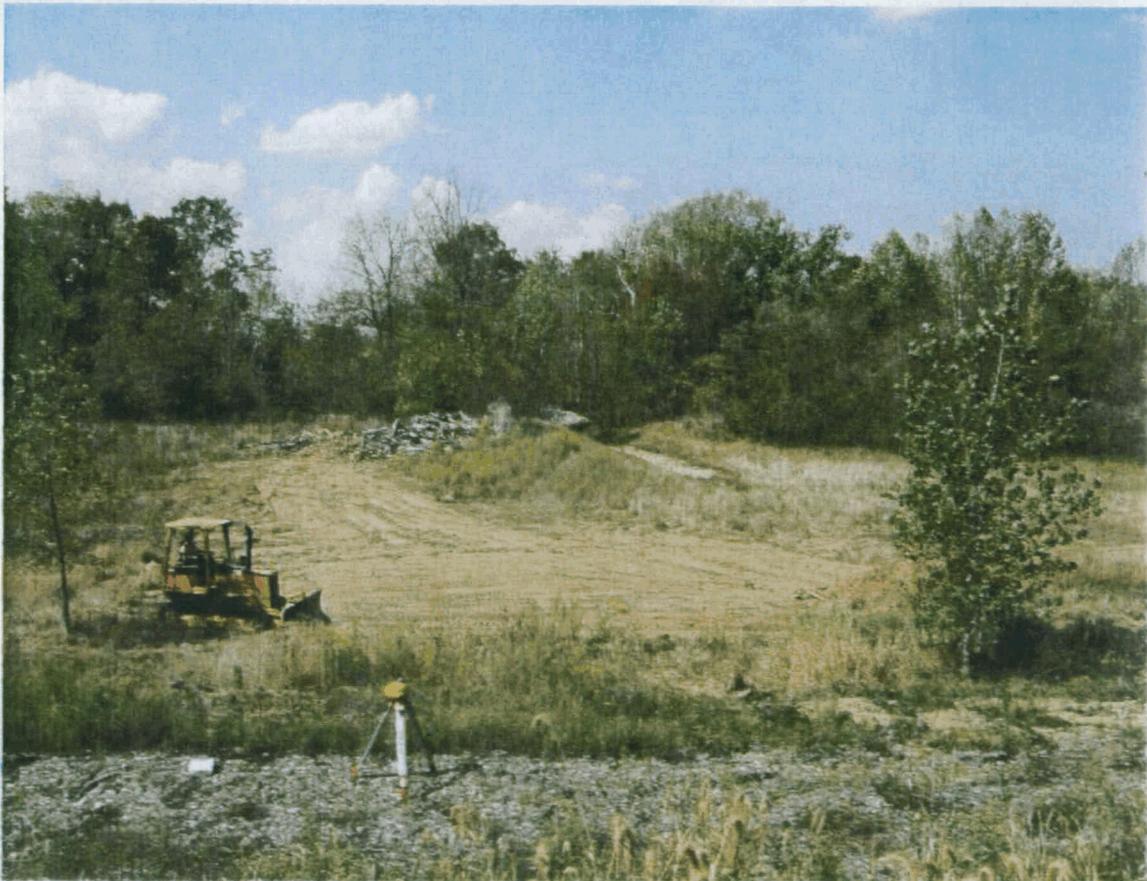
Figure 4 6-inch Scrape of Suspect Area (Looking West From Pit 3 Berm)†

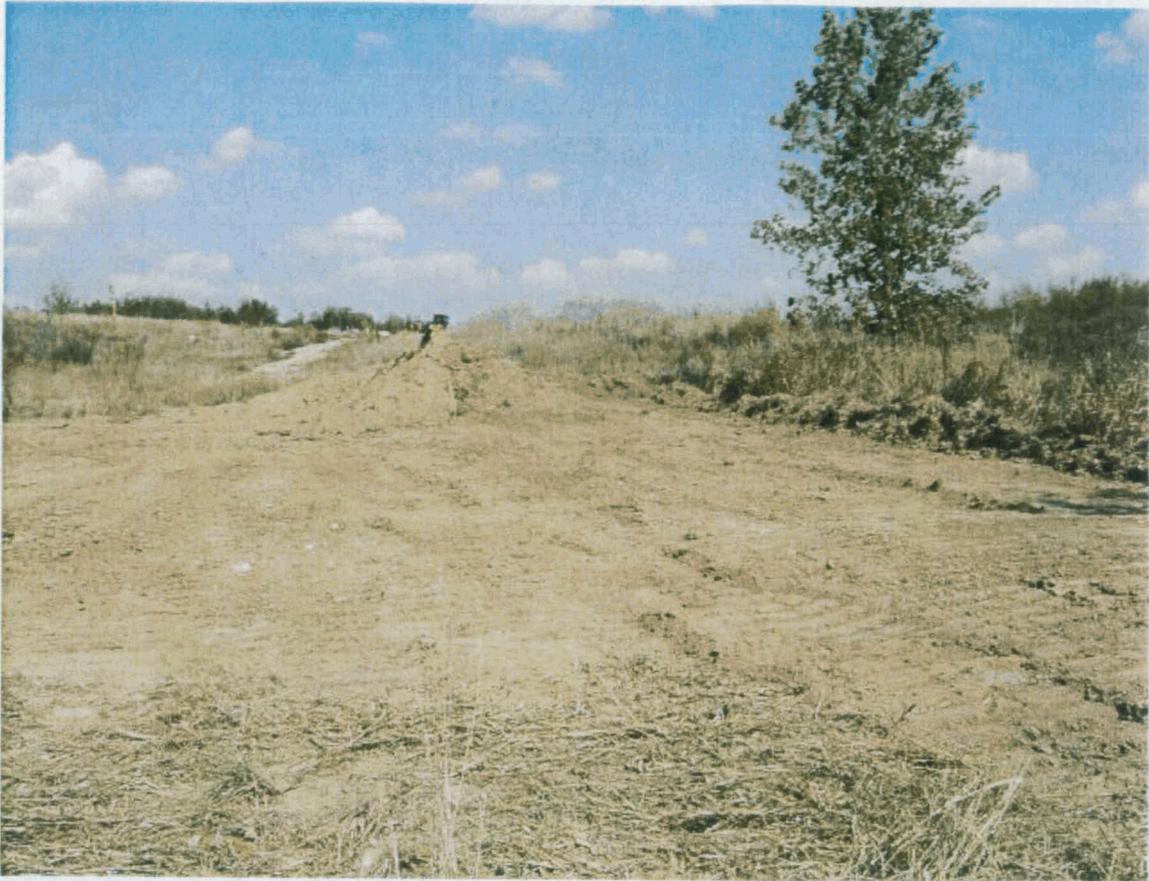
Figure 5 6-inch Scrape of Suspect Area (Looking North From Southern Boundary of Area) ↑

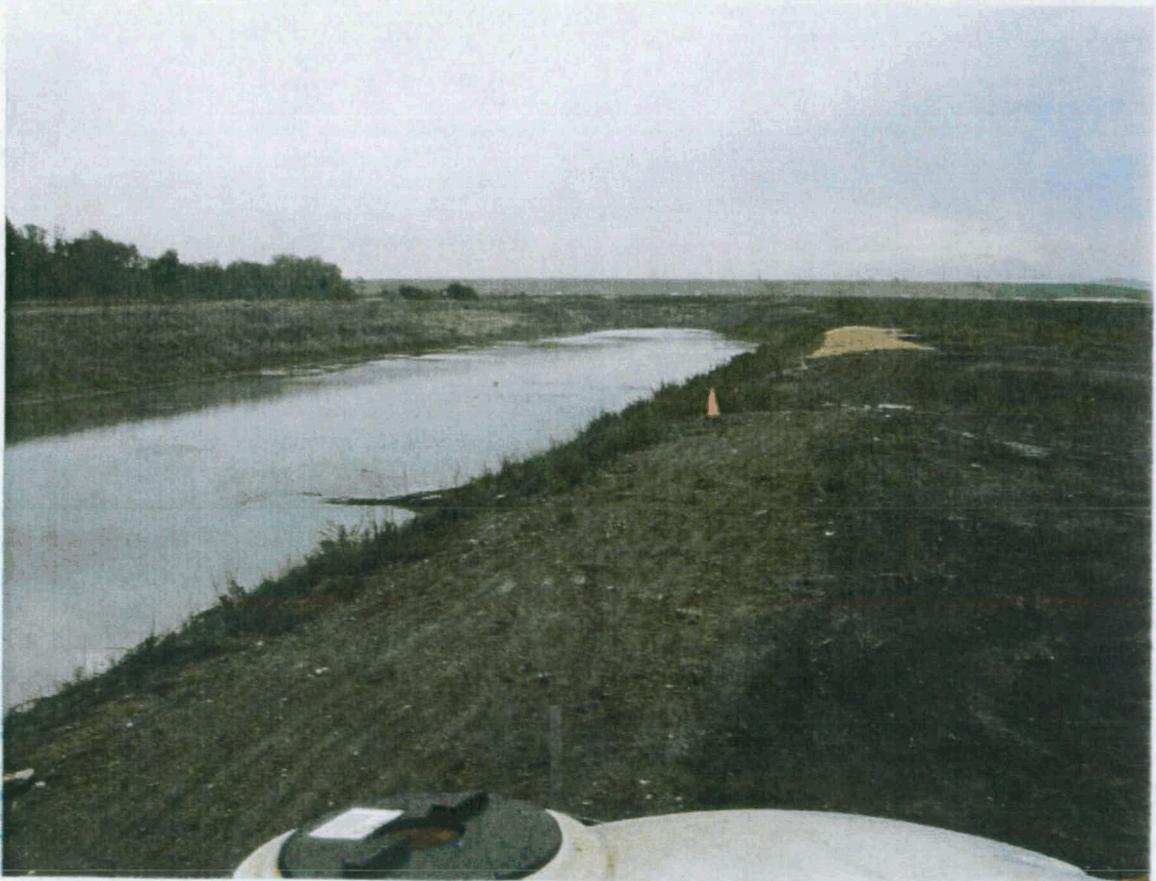
Figure 6 Spread of Excavated Soil on Southern Berm of Pit 5 (Looking East) ↑

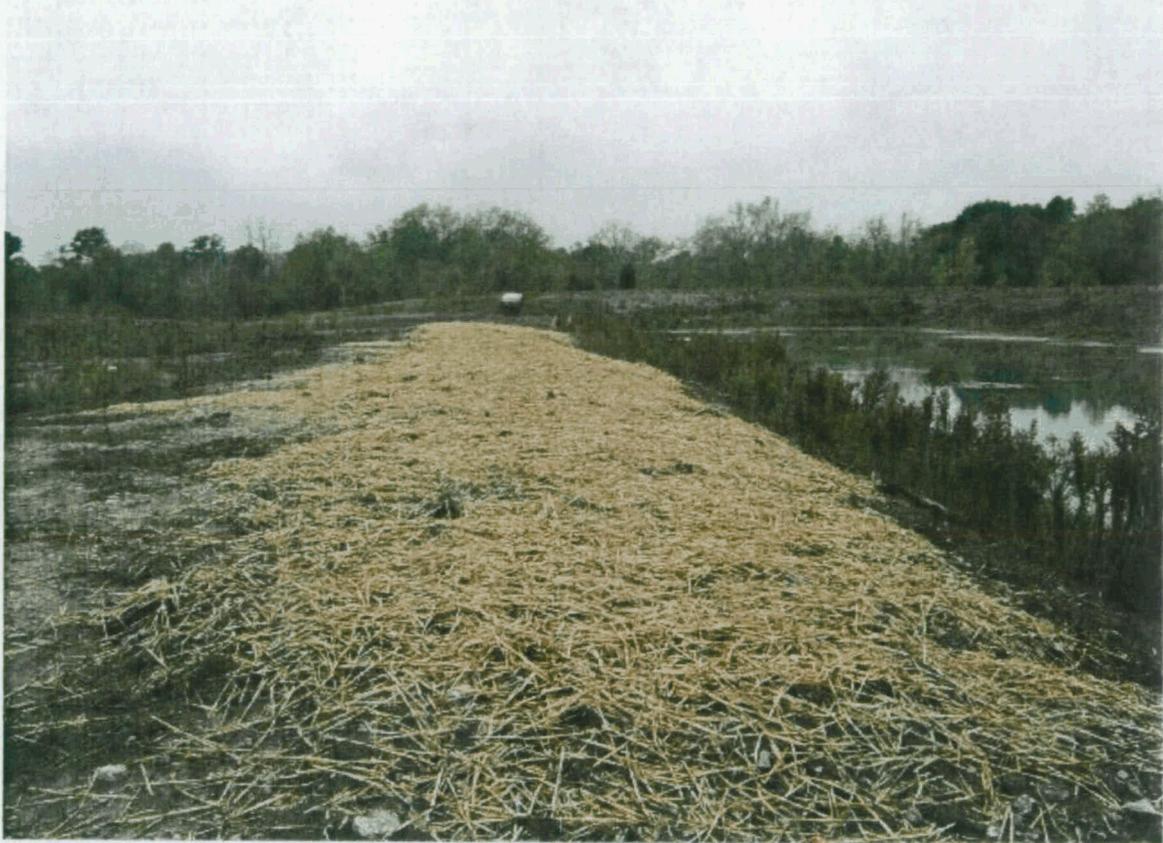
Figure 7 Spread of Excavated Soil on Southern Berm of Pit 5 (Looking West) ↑

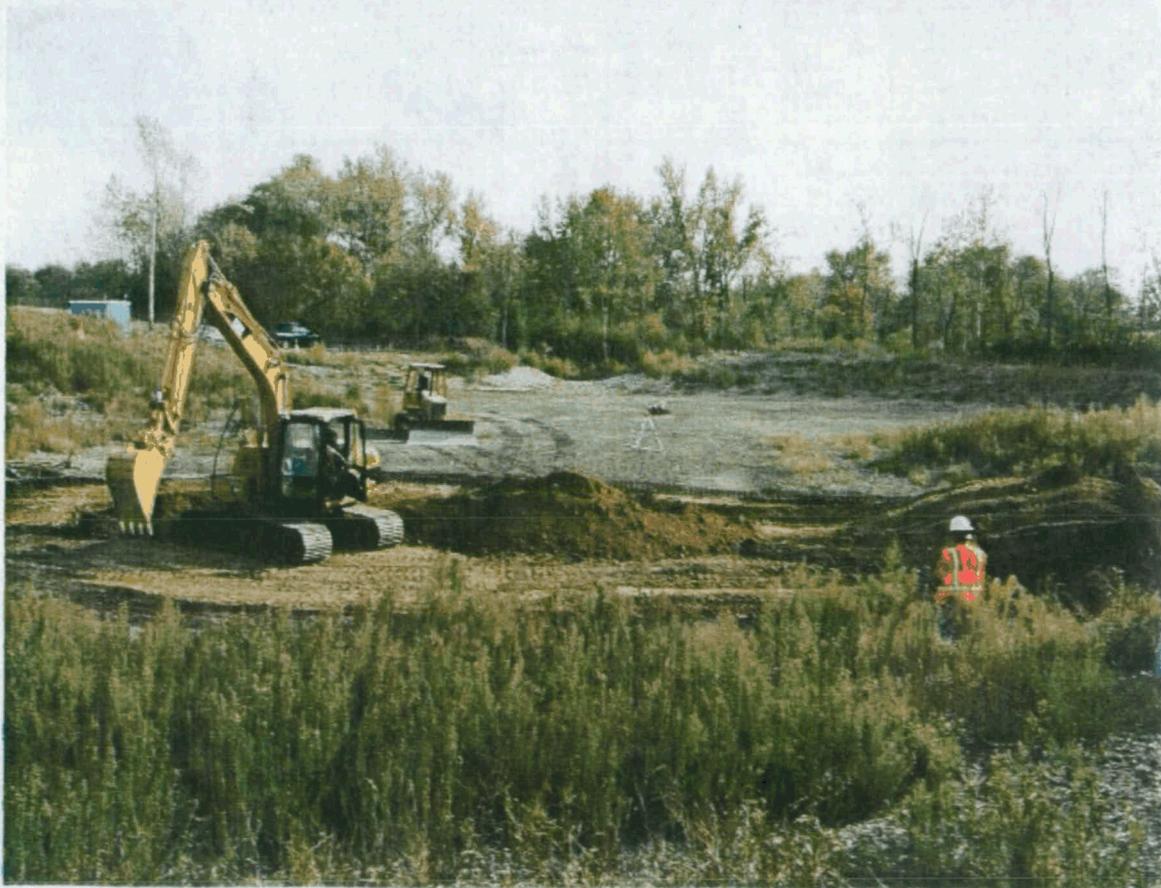
Figure 8 Excavation of the Base of the Former Clearwell (Looking South From Southern Edge of Pit 3) ↑

The scraped suspect area was immediately backfilled with the soil removed from the base of the former Clearwell (from an unrelated but concurrent maintenance activity). (Refer to Figure 8 for a photo of the former Clearwell excavation and Figure 9 for a photo of the suspect area being filled/graded) In an effort to prevent future ponding in this vicinity, two mounds of soil that were present approximately 50-feet due south were leveled with the excess soil pushed into a large depression even further south of the mounds. This depression, associated with surface water sampling location #65, was approximately 1-foot deep prior to backfill. Additional soil from the former Clearwell excavation was brought to this southern depression ("Location #65") to bring the ground elevation up to a grade that promoted a southerly water flow from the entire area.

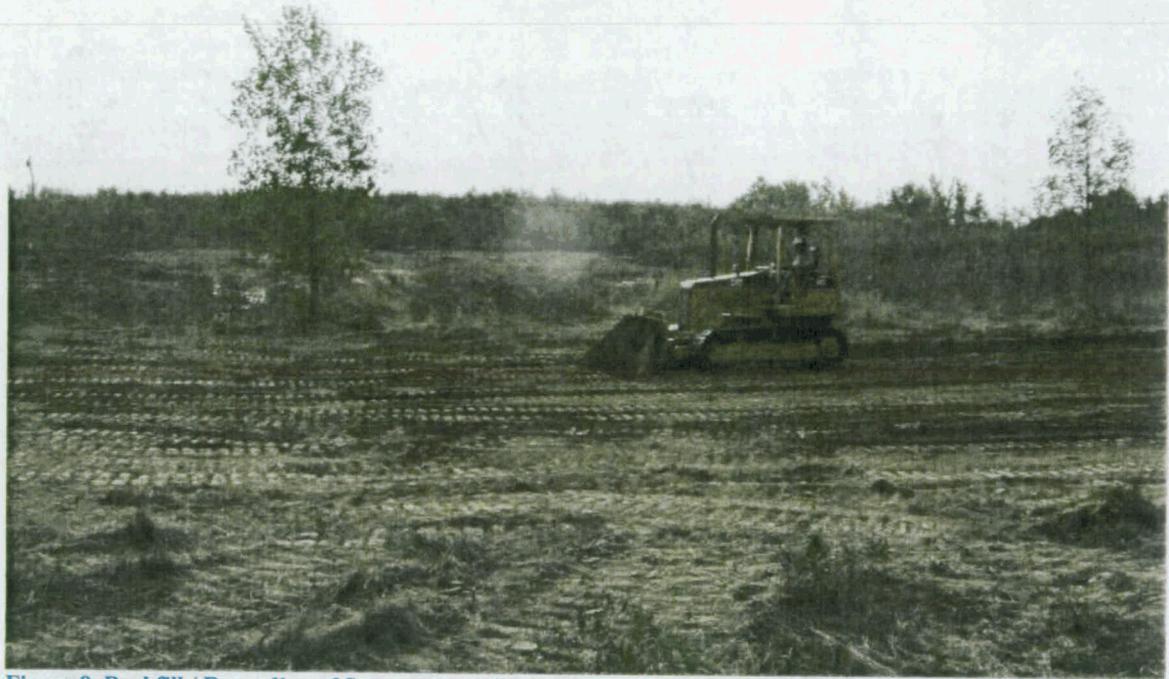
**Figure 9 Backfill / Regrading of Suspect Area (Looking East From Consolidated Brush Pile) ↑**

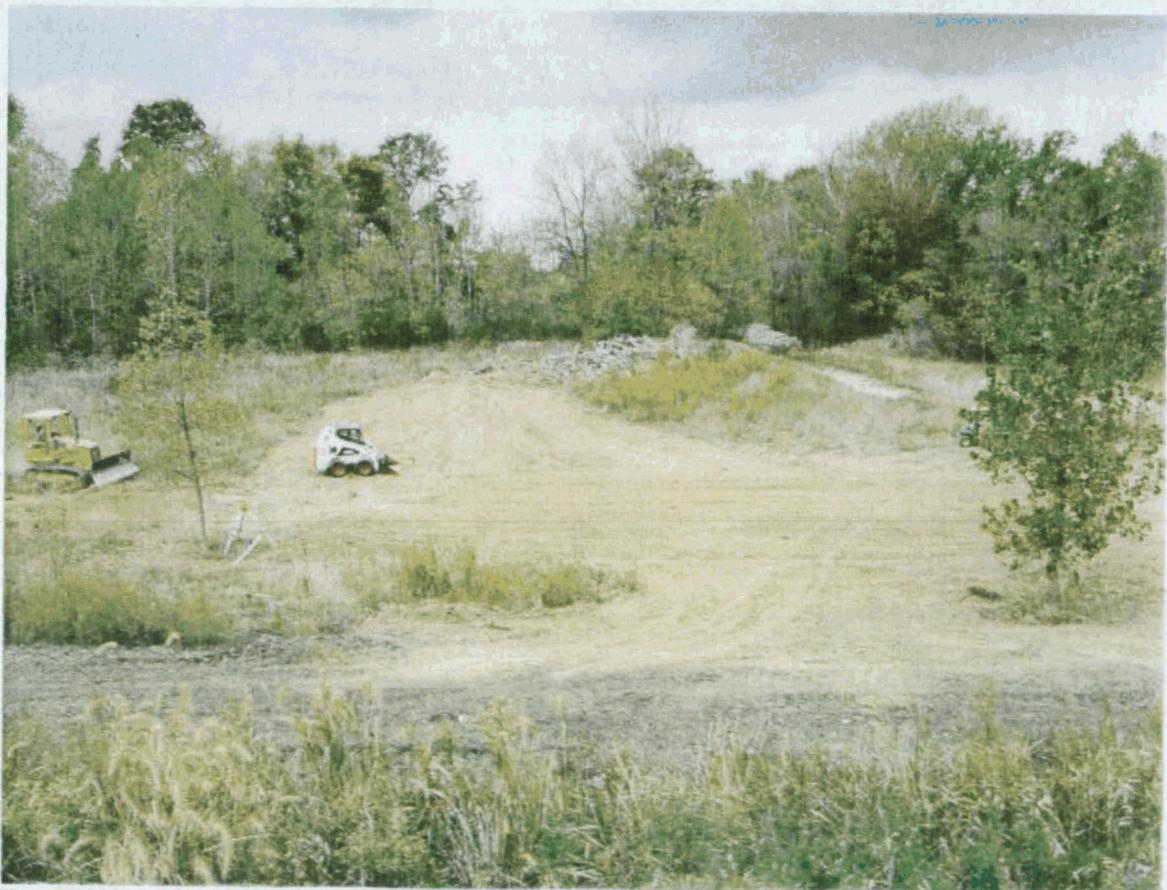
**Figure 10 Completed Backfill and Regrading of Suspect Area (Looking West From Pit 3 Berm) ↑**

The grading of the entire area spanning from the scraped suspect area to the southern end of the large depression near surface water sampling location #65 was completed on Wednesday, October 3<sup>rd</sup>, 2007. (Refer to Figure 10.)

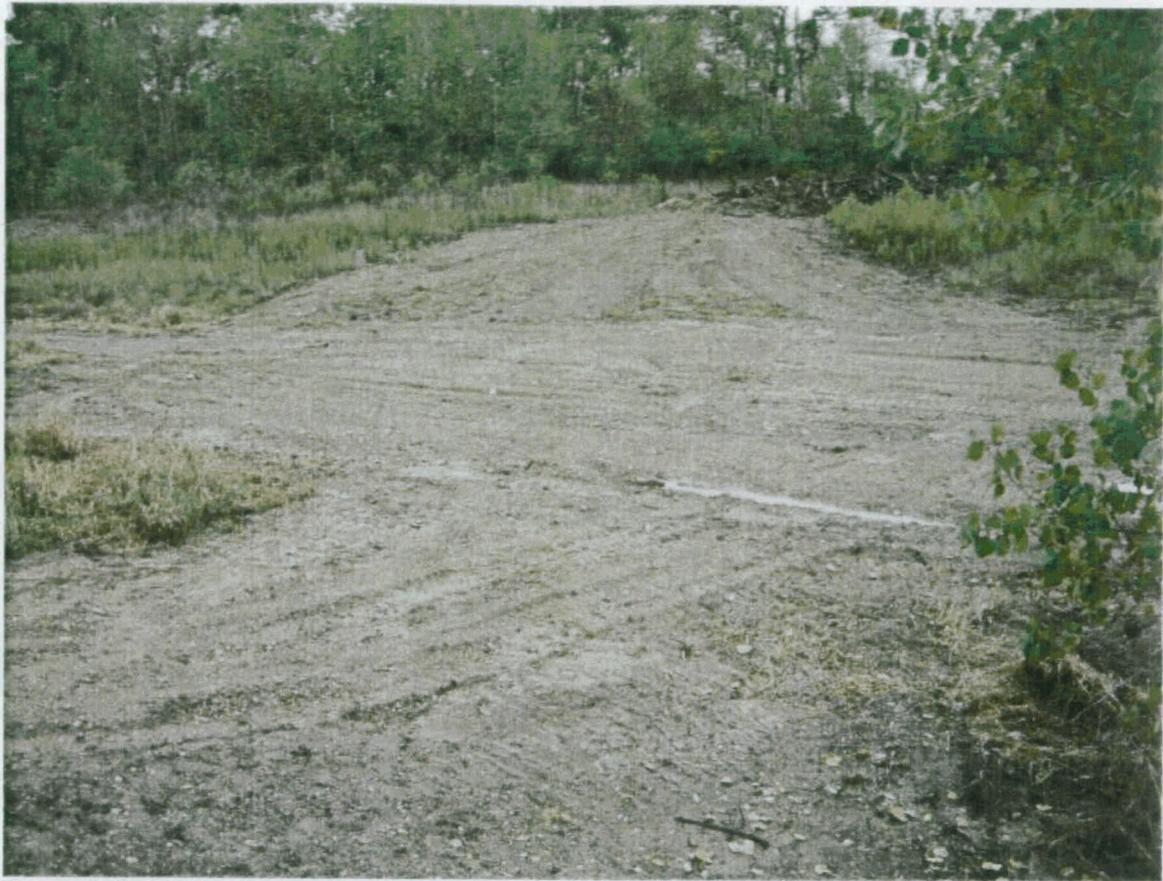
Figure 11 Puddle From Track Rut in Suspect Area [Sampled] (Looking Southwest From Pit 3 Berm) ↑

Prior to completion of grading activities, a two-day rainfall produced several areas of ponding water, which were used as indicators as to where to focus the remaining grading activities. These small ponds (and/or puddles) were sampled by both the Ohio Environmental Protection Agency and members of DOE's Legacy Management contractor, Stoller. (Refer to Figures 11, 12, and 13.) The four locations that were sampled with their associated uranium concentrations were: top of former pit 5 slope (<1 ug/L), scraped area (16.8 ug/L), small low-lying area due south of the scraped area (22.9 ug/L), and the former large depression "location #65" (21.5 ug/L). All of these concentrations are significantly lower than the uranium drinking water criterion of 30 ug/L and the surface water FRL of 530 ug/L.

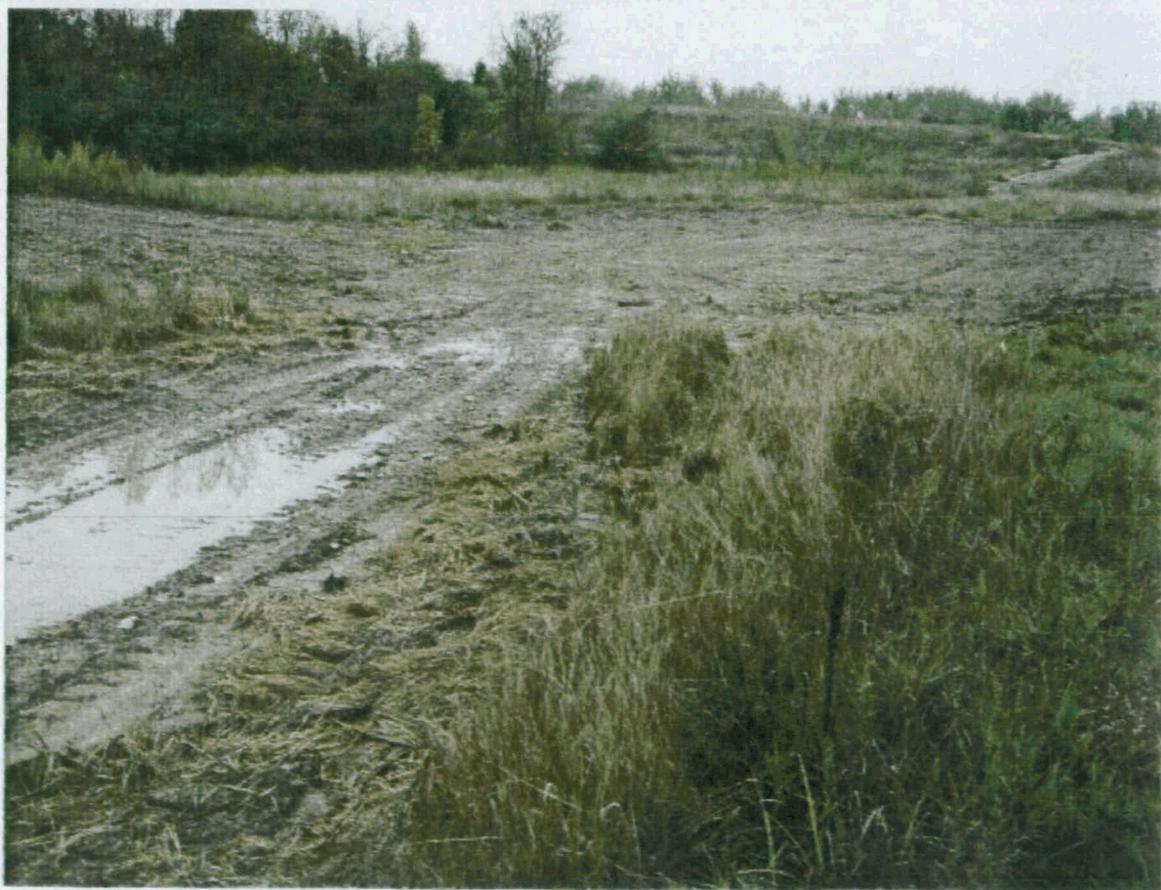
Figure 12 Puddle in Low-Lying Area Due South of Suspect Area [Sampled] (Looking North) ↑

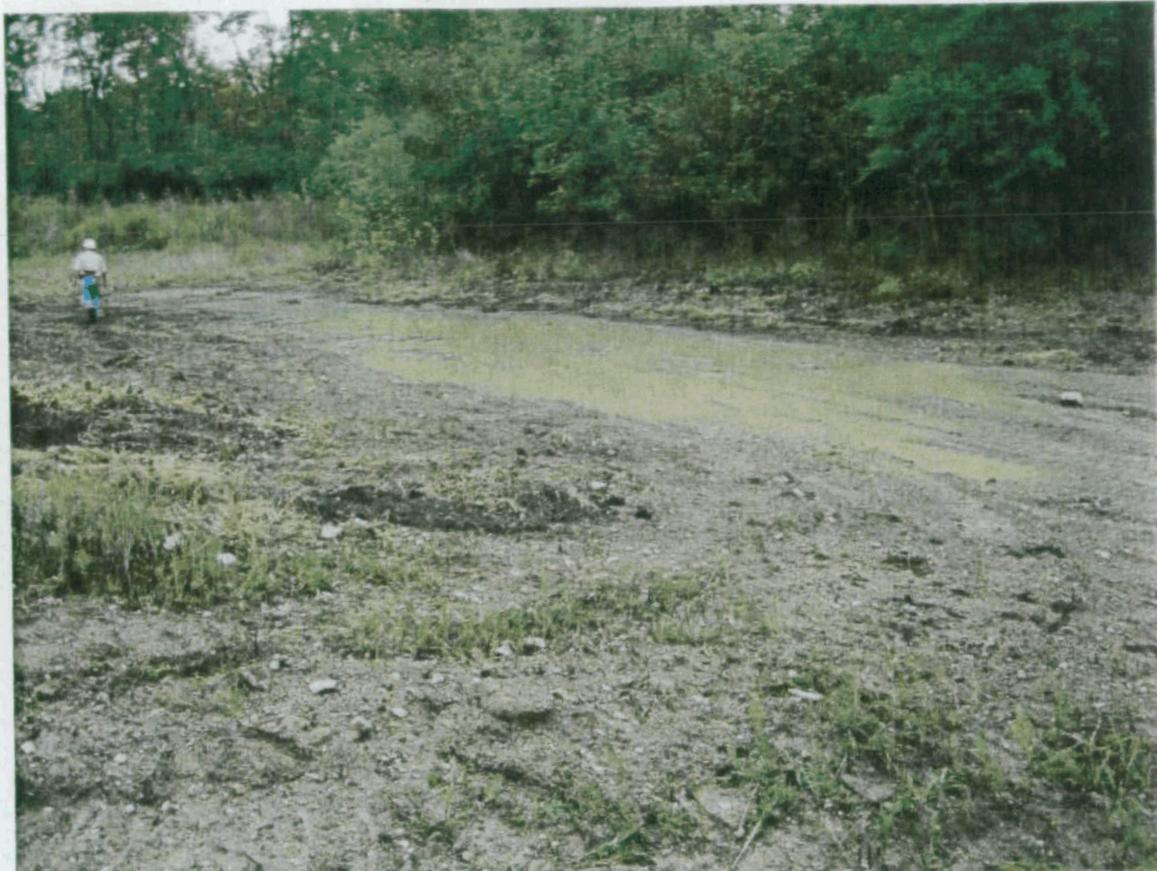
Figure 13 Pond in Backfilled "Location #65" [Sampled] (Looking Southwest From Pit 3 Berm) ↑
