**SUBJECT: Transmittal of the December 19, 2007 Inspection Checklist for On-Site Disposal Facility**

# On-Site Disposal Facility Inspection Report

## December 2007

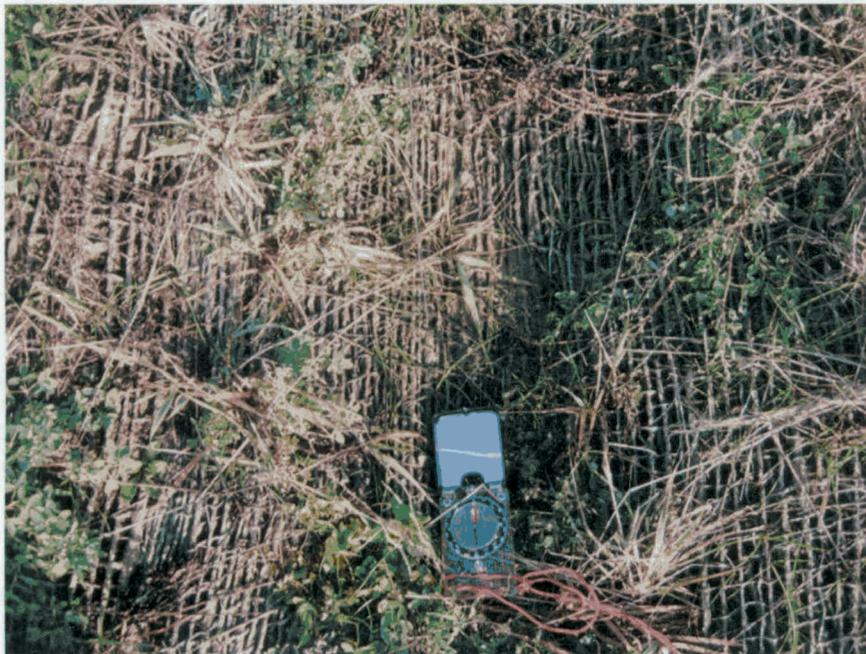
6319-D5462.JPG

| No. | Cell/Area | Location (use map whenever possible) | GPS? | Type of Finding (see definitions back page) | | | | | Description | Photo? | Followup | | |
|---|---|---|---|---|---|---|---|---|--|---|---|---|---|
| JH-3 | 8 | south 6:1 slope | Yes | X | | | | | Depression | 6319-D5462 | | | X |

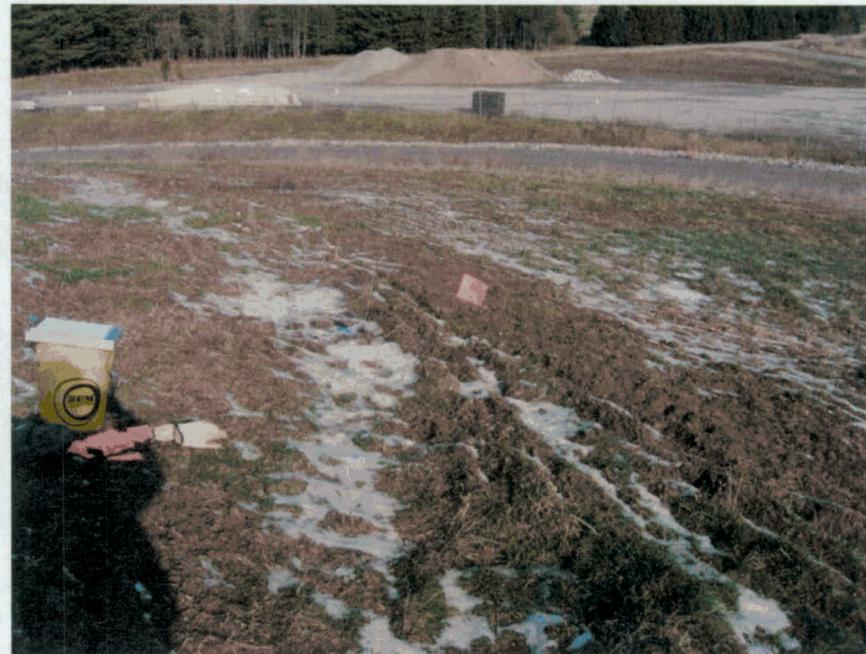
6319-D5463.JPG

| No. | Cell/Area | Location (use map whenever possible) | GPS? | Type of Finding (see definitions back page) | | | | | Description | Photo? | Followup | | |
|---|---|---|---|---|---|---|---|---|--|---|---|---|---|
| JH-6 | 1 | northeast 6:1 slope | Yes | X | | | | | Depression on corner | 6319-D5463 | | | X |

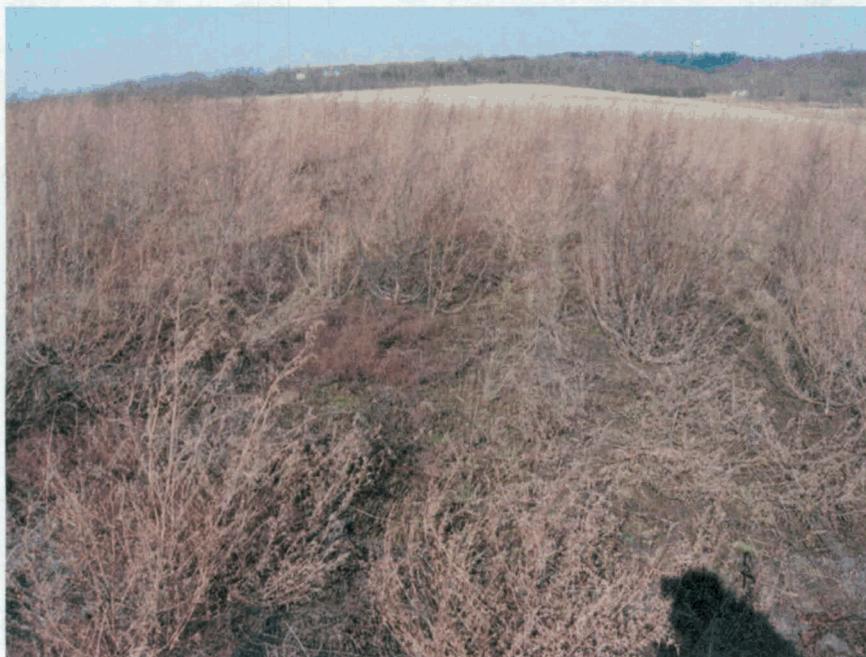
6319-D5464.JPG

| No. | Cell/Area | Location (use map whenever possible) | GPS? | Type of Finding (see definitions back page) | | | | | Description | Photo? | Followup | | |
|---|---|---|---|---|---|---|---|---|--|---|---|---|---|
| HB-3 | 7/8 | east 10:1 slope | Yes | X | | | | | Sparse vegetation | 6319-D5464 | | | X |

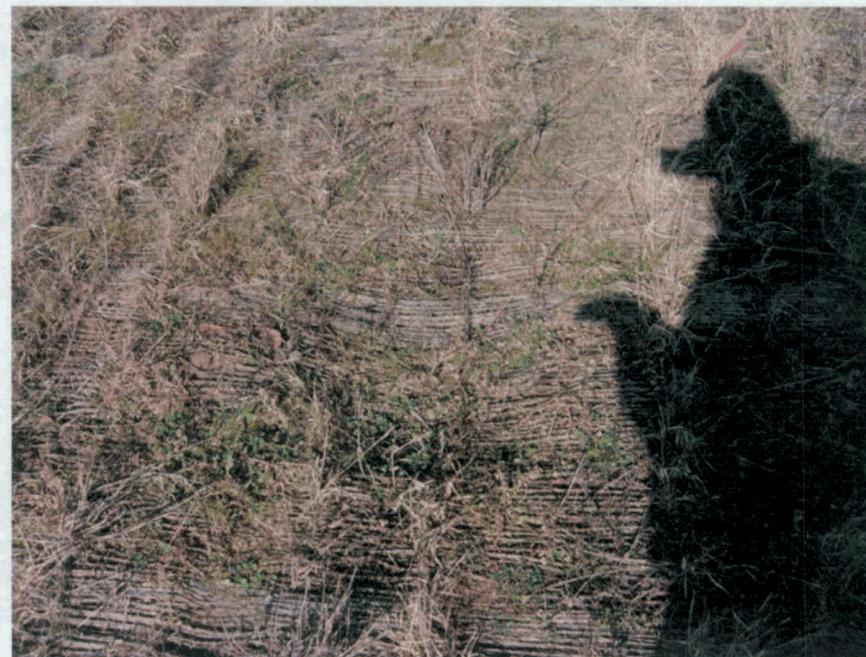
6319-D5465.JPG

| No. | Cell/Area | Location (use map whenever possible) | GPS? | Type of Finding (see definitions back page) | | | | | Description | Photo? | Followup | | |
|---|---|---|---|---|---|---|---|---|--|---|---|---|---|
| 1 | 7 | west 6:1 slope | Yes | X | | | | | Two foot diameter area 6 inches deep localized settlement. | 6319-D5465 | | X | |

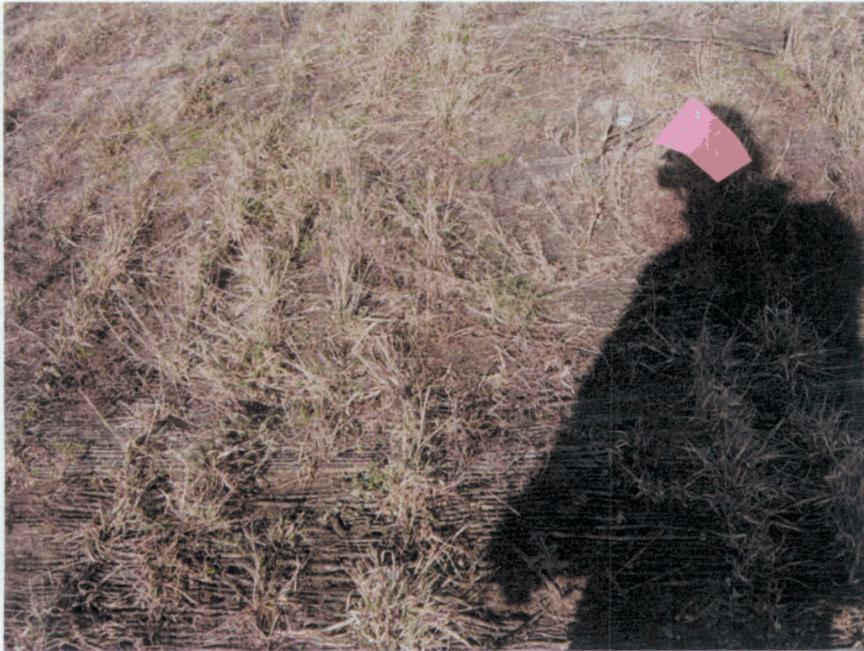
6319-D5466.JPG

| No. | Cell/Area | Location (use map whenever possible) | GPS? | Type of Finding (see definitions back page) | | | | | Description | Photo? | Followup | | | |
|---|---|--|---|---|---|---|---|---|---|---|---|---|---|---|
| 22 | 7 | west 6:1 slope | Yes | X | | | | | | | | | X | X |

Localized area of depression due to small erosion rills. Additional soil is not required, however, the area should be overseeded to prevent additional loss of topsoil.

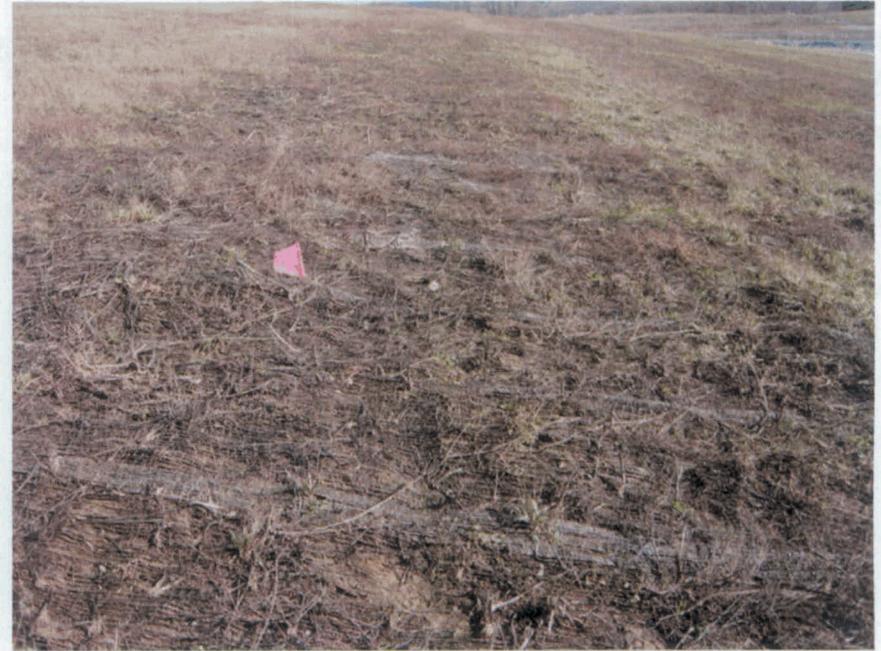
6319-D5467.JPG

| No. | Cell/Area | Location (use map whenever possible) | GPS? | Type of Finding (see definitions back page) | | | | | Description | Photo? | Followup | | |
|---|---|---|---|---|---|---|---|---|--|---|---|---|---|
| HB-2 | 8 | south 6:1 slope | Yes | | X | | | | Sparse vegetation | 6319-D5467 | | | X |
| JH-2 | 8 | south 6:1 slope | Yes | | X | | | | Sparse vegetation | 6319-D5467 | | | X |

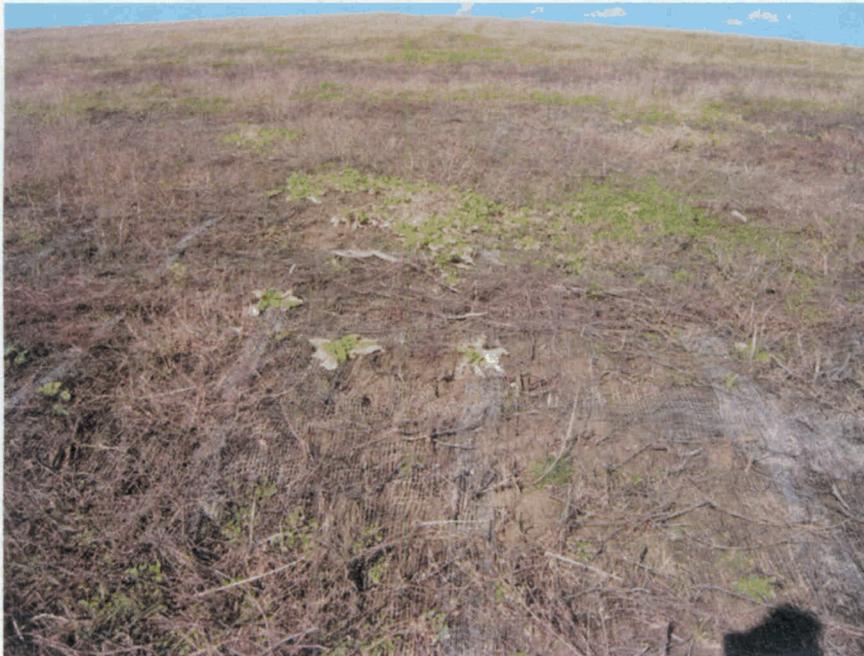
6319-D5468.JPG

| No. | Cell/Area | Location (use map whenever possible) | GPS? | Type of Finding (see definitions back page) | | | | | Description | Photo? | Followup | | |
|---|---|---|---|---|---|---|---|---|--|---|---|---|---|
| 2 | 8 | south 6:1 slope | Yes | | X | | | | Sparse vegetation | 6319-D5468 | | | X |

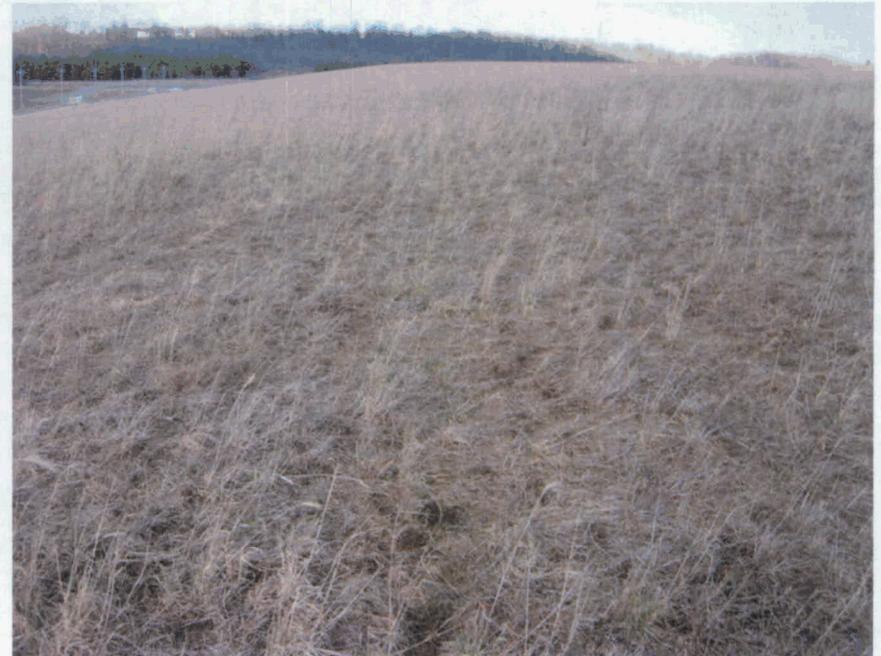
6319-D5469.JPG

| No. | Cell/Area | Location (use map whenever possible) | GPS? | Type of Finding (see definitions back page) | | | | | Description | Photo? | Followup | | | |
|---|---|---|---|---|---|---|---|---|---|---|---|---|---|---|
| HB-1 | 5/6 | west 20:1, 10:1 slope | Yes | X | | | | | | Sparse vegetation | 6319-D5469 | | | X |

| No. | Cell/Area | Location (use map whenever possible) | GPS? | Type of Finding (see definitions back page) | | | | | Description | Photo? | Followup | | |
|---|---|---|---|---|---|---|---|---|--|---|---|---|---|
| JH-1 | 5/6 | west slopes | Yes | | X | | | | Sparse vegetation | 6319-D5469 | | | X |
