Department of Energy
Office of Legacy Management

**SUBJECT: Transmittal of the March 2008 Fernald Preserve On-Site Disposal Facility
Inspection Forms**

On-Site Disposal Facility Inspection Report

March 2008

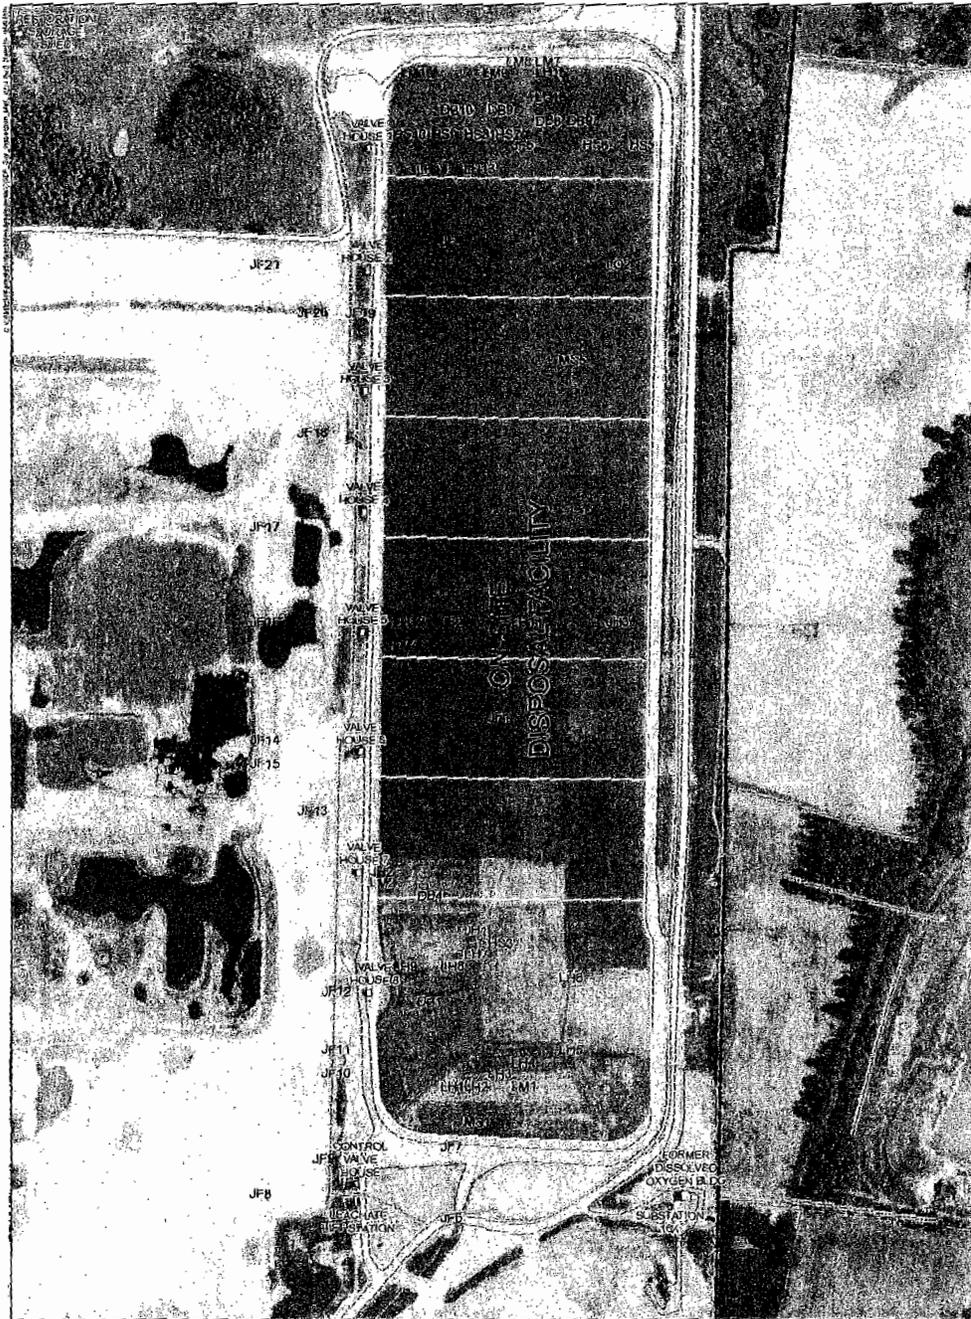
**Fernald Preserve
OSDF (On-Site Disposal Facility)**

March 2008 Inspection Findings
(Requiring repair or follow-up during next quarterly inspection)
